STRATEGIES FOR REDUCING RAILROAD TRESPASSING

Florida East Coast Railway Corridor -
Cocoa to Miami

August 6, 2021

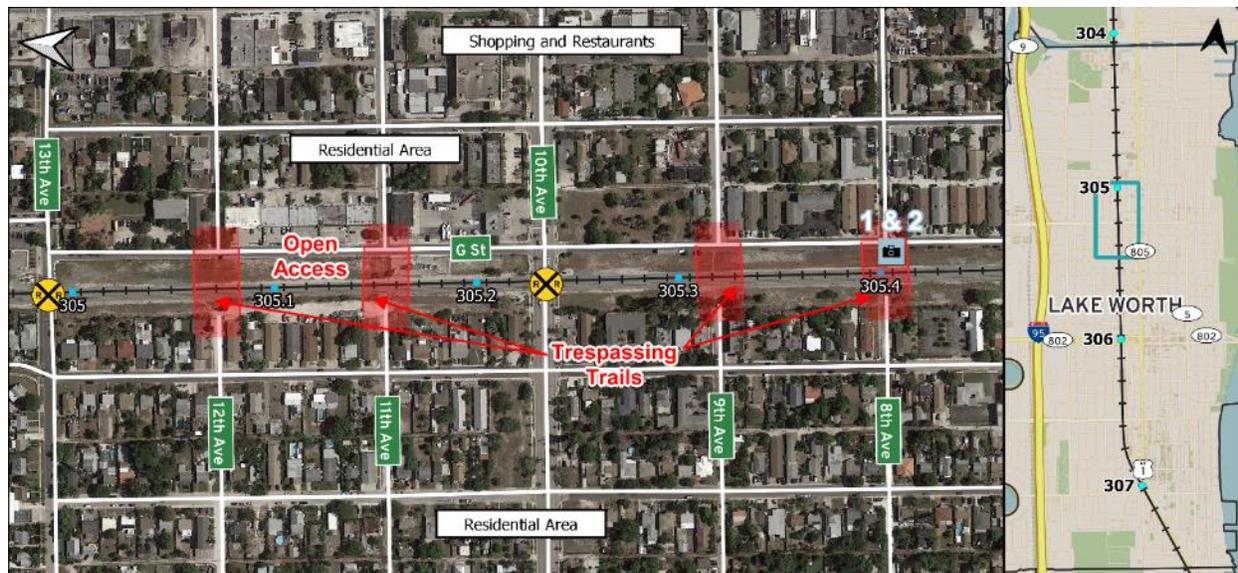
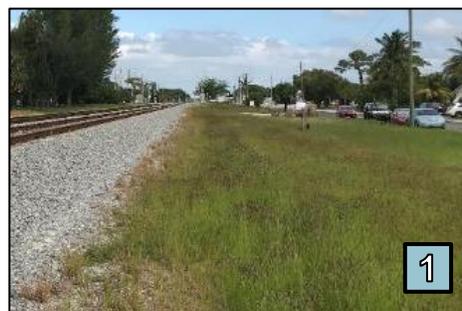
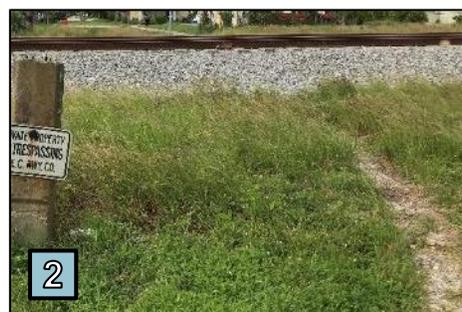
MP 305.0 to MP 305.5

Between 13th Ave. and 7th Ave. (not shown, MP 305.5) in Lake Worth, the right-of-way has open access with little to no vegetation or barriers between the parallel G St. (photo 1). Well-established paths cross the tracks to G St. from the dead-end streets on the west side of the corridor (photo 2).

The trails are well established and are the shortest route for a pedestrian. This area is mostly residential, but there are major destination points including retail stores and restaurants along Dixie Hwy. (US 1) (not shown), 0.1 miles east of the corridor.

Recommendations: Construct **8 ft. hardened fencing** on the west side between 13th Ave. and 7th Ave. due to the well-established trespassing trails. It is suggested that a **vegetation barrier** be constructed on the east side of the corridor to provide additional deterrent to the corridor access. **Guardrail** and signage are recommended at each dead-end street to protect against vehicle intrusion. At several locations in this project, the FECR right-of-way has insufficient width to add barriers or vegetation within the existing right-of-way without property acquisition.

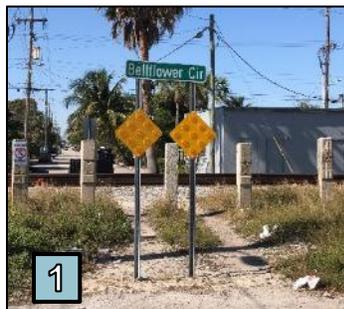
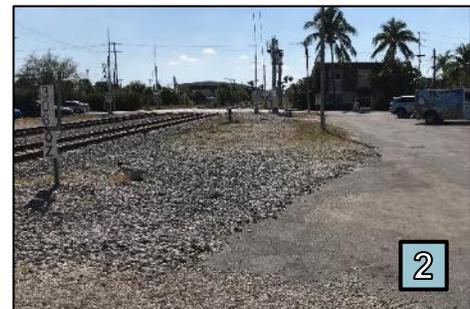
MP 305.7 to MP 306.1

Between 4th Ave. and 1st Ave. in Lake Worth, industrial buildings and parking lots are adjacent to the right-of-way. The east side of the corridor is composed of gravel with a curb between the railroad and G St. On the north and south side of Lucerne Ave. are two parking

lots with no barriers between the parking lots and railroad tracks (photo 2). In February 2018, an injury to a trespasser occurred just north of Lucerne Ave.

Additionally, a trespassing trail has become established at the dead-end of 4th Ave. (photo 1). The area is mostly residential, but there are commercial businesses along Dixie Hwy. (US 1), 0.1 miles to the east of the corridor. While the corridor is open between 4th Ave. and 2nd Ave, the alignment of the homes and buildings limits potential trespassing.

Recommendation: Construct **8 ft. hardened fencing** on the west side of the corridor at 4th Ave. to block the existing trespassing trail and channelize pedestrians to 3rd Ave. **4 ft. aluminum fencing** is recommended between the parking lots at Lucerne Ave. and the tracks.

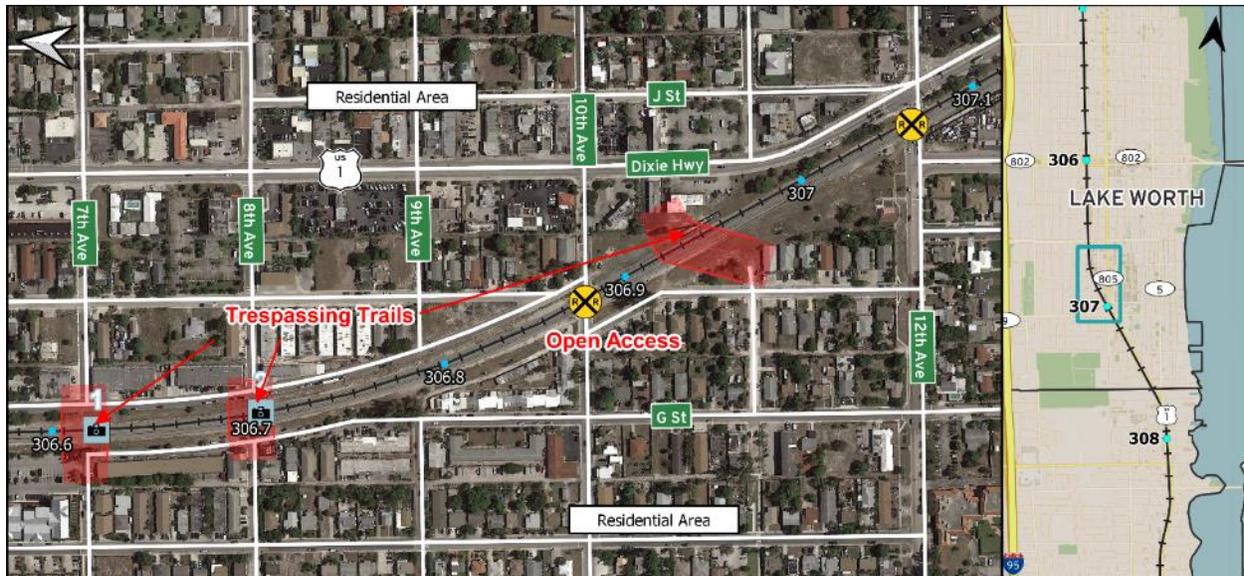
MP 306.5 to MP 307.1

In Lake Worth, the FECR track alignment begins a large S-curve to a north-south alignment to the east. The corridor is open with multiple clearly defined trespassing trails. In 2019 a fatality occurred near the 10th Ave. grade crossing.

The curves in the railroad increase the risk of trespassing casualties. Trespassers cannot see approaching trains and vice versa. The area is mostly residential, but commercial businesses along Dixie Hwy. (US 1) serve as potential trespassing destinations.

Recommendations: Construct **8 ft. hardened fencing** on the west side of the right-of-way between 6th Ave. (not shown, MP 306.5) and 12th Ave. due to the curvature and entrenched trespassing locations. The paths are near existing grade crossings with sufficient sidewalks. Therefore, additional channelization is not recommended.

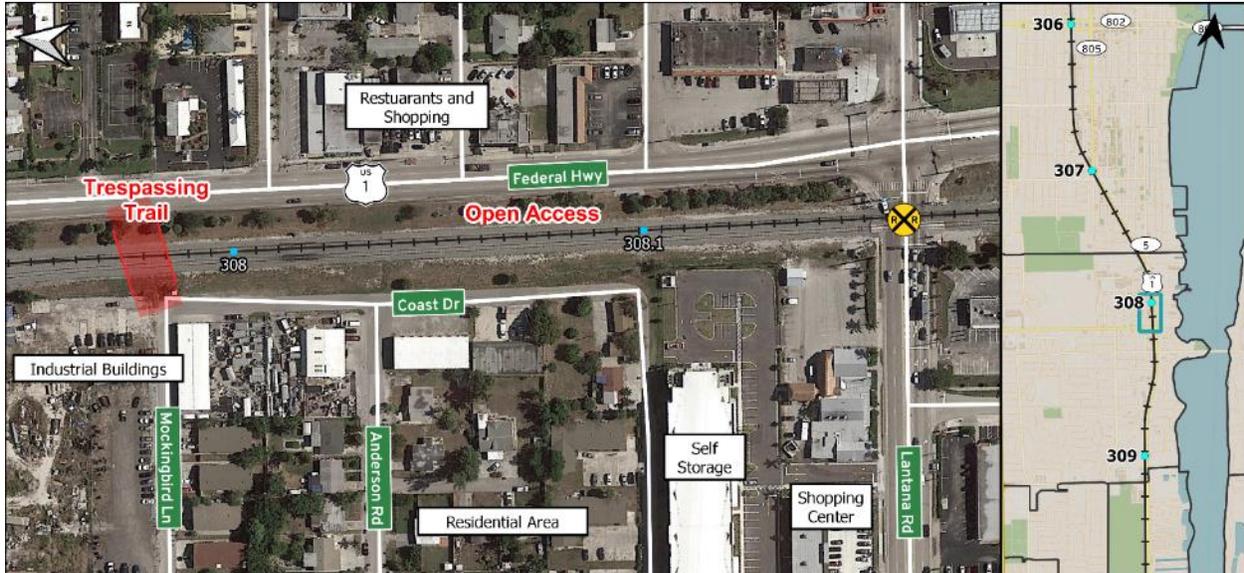
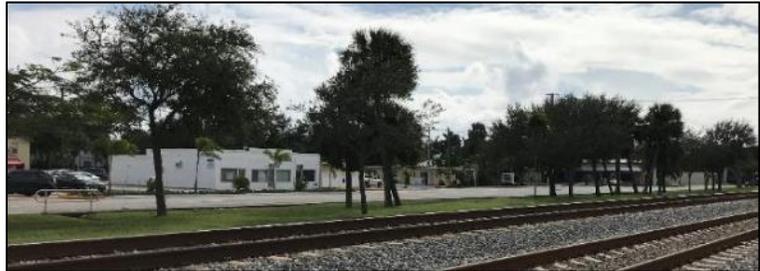
MP 307.6 to MP 309.2

Between 12th Ave. (not shown, MP 307.1) and Hypoluxo Rd. (not shown, MP 309.2). the FECR runs parallel to Dixie Hwy. (US 1) and Federal Hwy. (SR 5) in Lake Worth and Lantana. This section typically has 30 ft. of grass and trees lining the corridor between the edge of the railroad property and the track. A trespassing trail with evidence of recent and regular use is located at Mockingbird Ln. This section of the corridor has had five casualties (three fatalities, two injuries) between 2018 and 2020.

Recommendation: Install a **vegetation barrier** on the east side of the corridor for the entire length between 12th Ave. and Hypoluxo Rd. This section has shown to be a high risk for trespassing incidents, but the corridor is well-manicured, discouraging fencing. The vegetation will complement the existing trees while providing a barrier to the right-of-way. Between Mockingbird Ln. and Lantana Rd., installing a **sidewalk** with **vegetation** is recommended on the west side of the corridor to channelize pedestrians to the Lantana Rd. grade crossing.

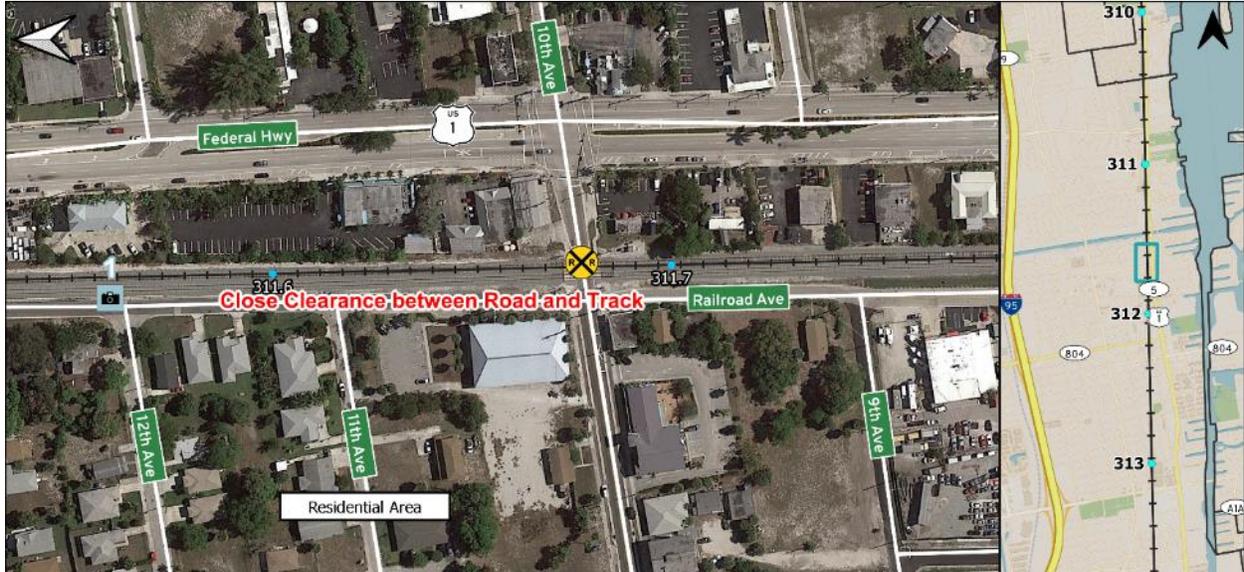
Railroad Ave. runs parallel to the railroad corridor just south of the Boynton Canal (not shown, MP 311.5) in Boynton Beach. Between 12th Ave. and 9th Ave., the road's curb is less than 10 ft. from the outside rail.

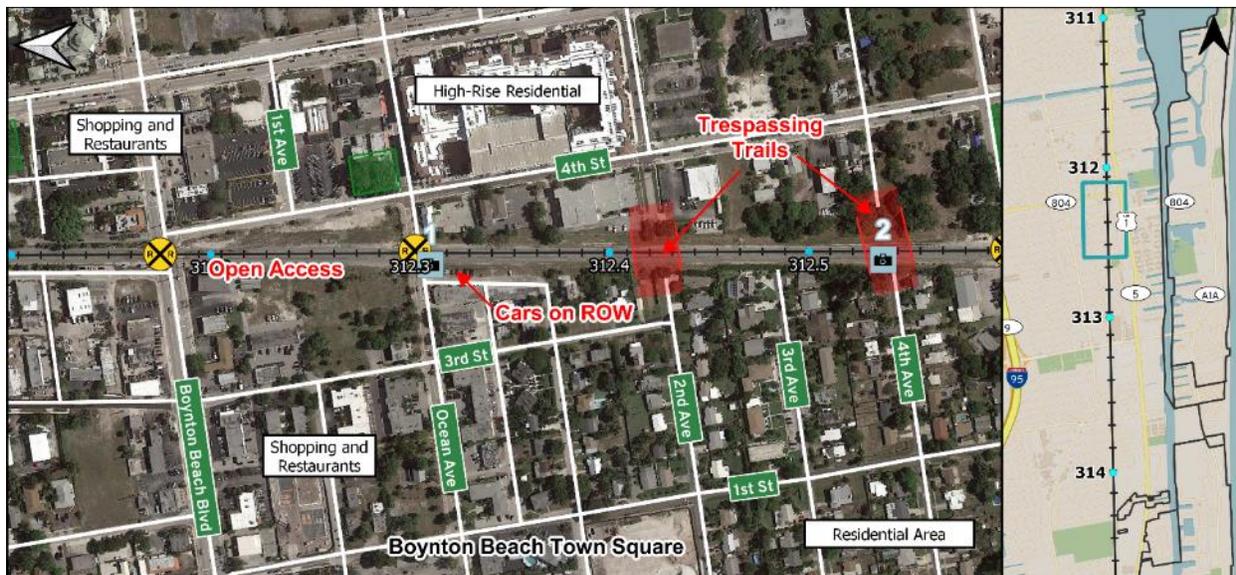
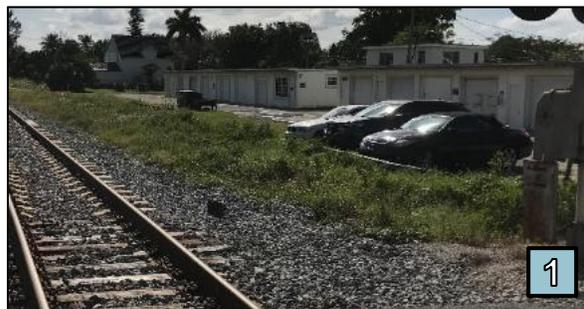
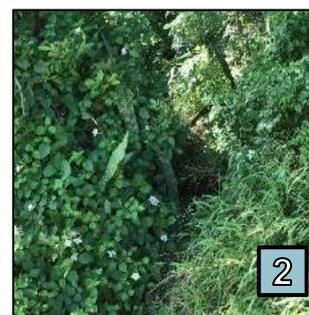
MP 312.2 to MP 312.6

Open access and several trespassing trails exist at dead-end streets in Boynton Beach. Just south of Boynton Beach Blvd. it appears that cars are parked within the right-of-way (photo 1). 2nd Ave. and 4th Ave. (photo 2) are dead-end streets that have indications of trespassing.

In downtown Boynton Beach a new high-rise apartment building was constructed on the east side of the corridor in 2017. West of 1st St. the new Town Square development will include residential, restaurants, public library, amphitheater, and playgrounds. These draws are all trespassing origins and destinations. Trespassing mitigation is suggested before the completion of the of the Town Square project to prevent the development of unsafe pedestrian traffic patterns.

Recommendations: Construct **4 ft. aluminum fencing** on the west side of the corridor in the commercial area from Boynton Beach Blvd. to Ocean Ave. The aluminum fencing will limit trespassing and vehicle encroachment on the corridor while maintaining a more decorative style. From Ocean Ave. to 5th Ave, the construction of a **6 ft. chain link fencing** is suggested on the west side of the corridor. The existing vegetation will provide further protection and hide the fence.

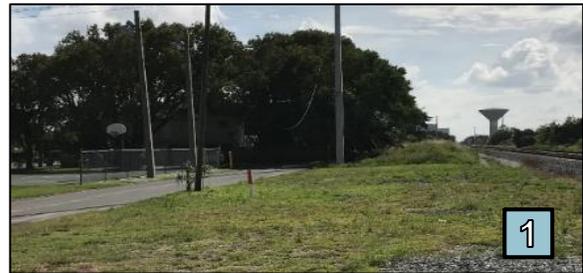
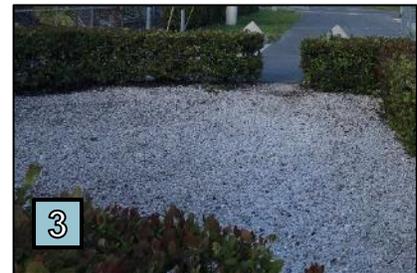
There is open access to the corridor next to Pence Park (photo 1), and a trespassing trail exists at the 10th St. dead-end (photo 2). The park has a fence that only encloses the baseball field. At 10th Ave, there is a maintained area on the west side of the railroad that provides access to the corridor from the industrial buildings (photos 2 and 3). Between 3rd St. and the railroad tracks, next to the park, is an open gravel field. The area, mostly on railroad property, is likely used for parking by visitors of the park.

The park and businesses along Federal Hwy. (not shown) to the east are a destination for trespassing from the residential area on the west side of the corridor.

Recommendations: Construct **6 ft. chain link fencing** along the west side of the corridor where gaps in the fencing between businesses exist to create a continuous barrier between the 5th Ave. and 12th Ave. grade crossings. The fence channelizes pedestrians onto 5th Ave, where **sidewalks**

are recommended to encourage its use. Along the park, **vegetation** is suggested to delineate the railroad corridor. Most of the parking area is on the railroad right-of-way. If not already in place, an agreement can be sought between FECR and the city to lease the property for parking.

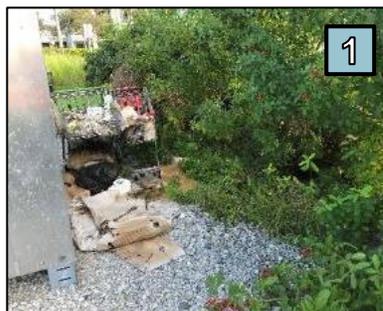
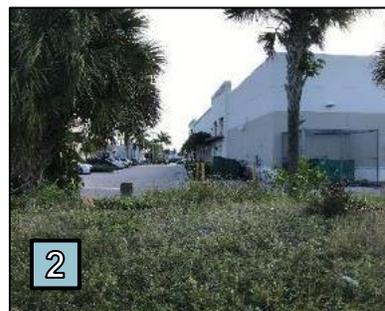
Evidence of loitering within the right-of-way exists in this area (photo 1). Open access to and from the corridor also exists from a shopping center containing a grocery store and several restaurants just south of Woolbright Rd. in Boynton Beach (photo 2).

The water treatment plant on the west side of the corridor has fencing that limits any trespassing across the corridor. However, trespassing was observed during the field review along the corridor from the south, with the grocery store being a potential destination.

Recommendations: Construct a **vegetation barrier** from Woolbright Rd. to 18th Ave. behind the shopping center to discourage the use of the corridor as a shortcut. Remove overgrowth to eliminate potential locations to loiter unseen along the corridor.

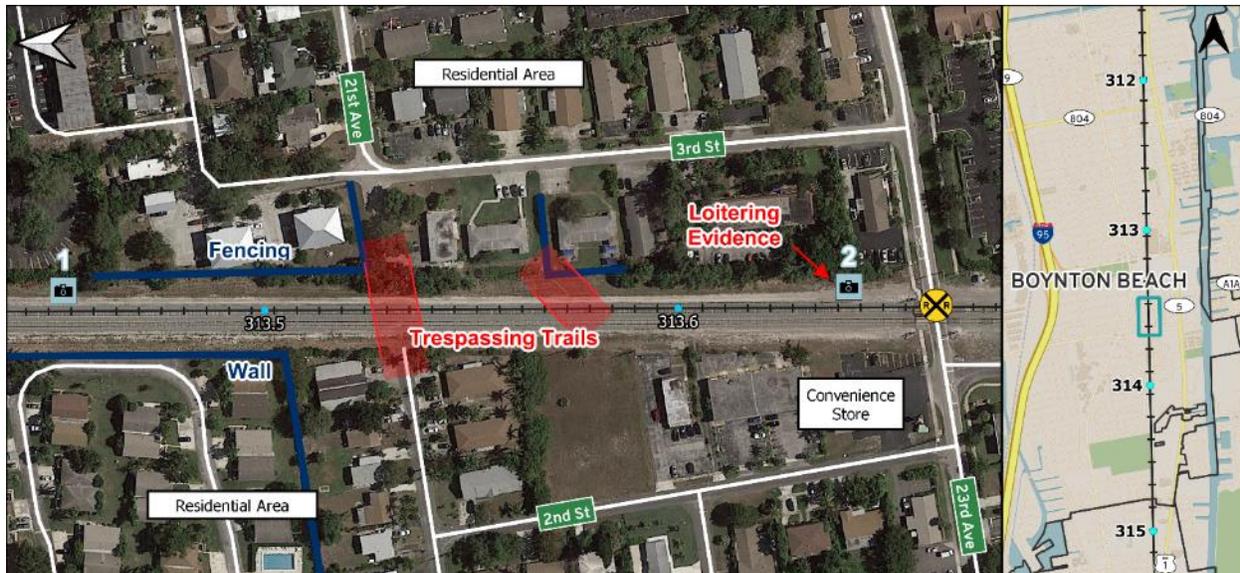
Trespassing trails and loitering exist north of 23rd Ave. in Boynton Beach. Bottles, cans, and other debris were also found in the vegetation at the grade crossing at the northeast corner of 23rd Ave. (photo 2).

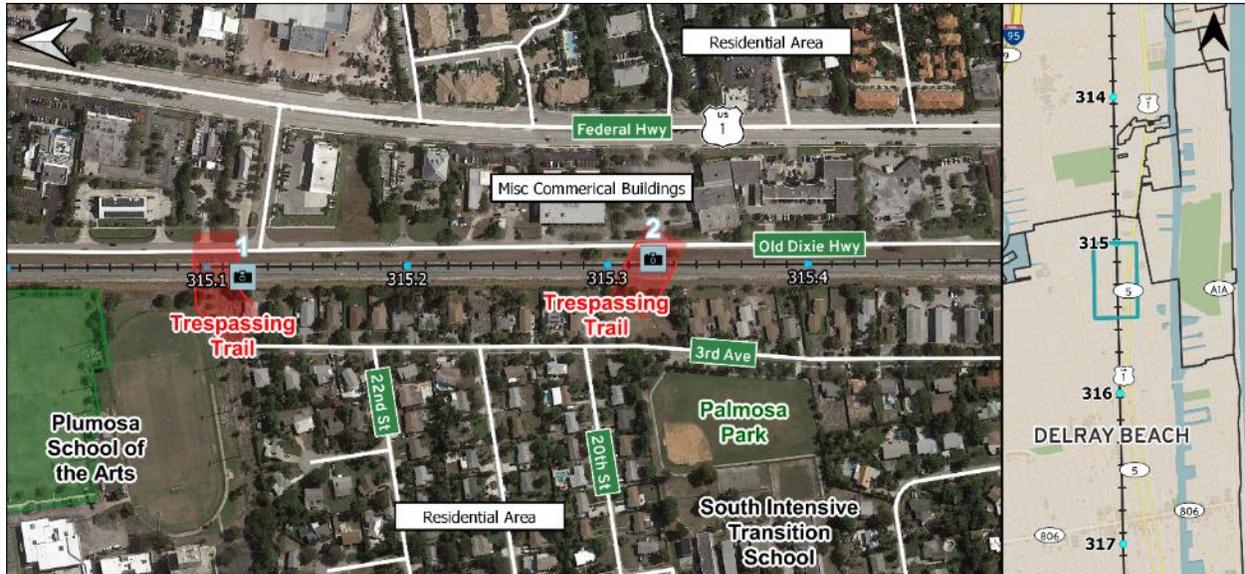
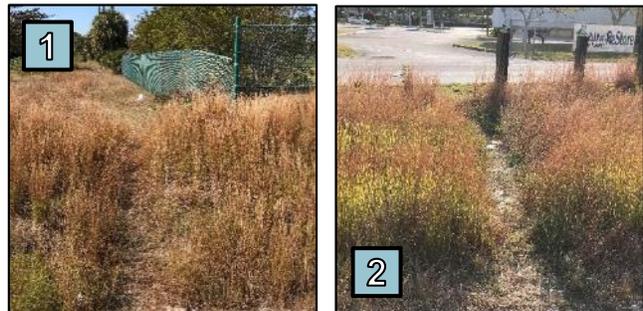
MP 315.1 to MP 315.4

Two trespassing trails exist along Old Dixie Hwy. in Delray Beach. One trail connects Old Dixie Hwy. to an undeveloped strip of land next to the Plumosa School of the Arts (photo 1). The second trail used by trespassers, crosses the railroad from Old Dixie Hwy. through a vacant lot (photo 2). The path is near Palmosa Park and a school building. The school building has been vacant since 2010 but is currently undergoing renovations to house the South Intensive Transition School.

Recommendations: Construct **8 ft. hardened fencing** on the west side of the corridor in the existing openings to provide a complete barrier between 36th Ave./Gulfstream Blvd. (MP 314.8) and 14th St. (MP 315.6). The trespassing trails connect to the only two locations between 36th Ave. and 14th St. that do not currently have fencing. It is recommended that FECR work with the City of Delray Beach, which owns the vacant property, and Plumosa School of the Arts, which owns the undeveloped strip of land.

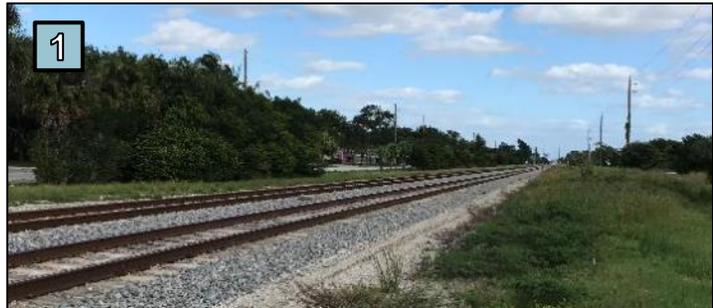
The railroad runs parallel to 3rd Ave. and Old Dixie Hwy. in Delray Beach. The right-of-way is open except for minor vegetation. A trespassing trail was identified between 11th St. and Old Dixie Hwy. A fatality occurred at this location in March 2018.

Recommendation: Install a **vegetation barrier** on the west side of the corridor between 14th St. (not shown, MP 315.6) and George Bush Blvd. (not shown, MP 316.0) to provide a barrier and define the right-of-way. The trespassing trail identified here was not well defined, and no clear origin-destination pairs exist suggesting minimal mitigation is sufficient.

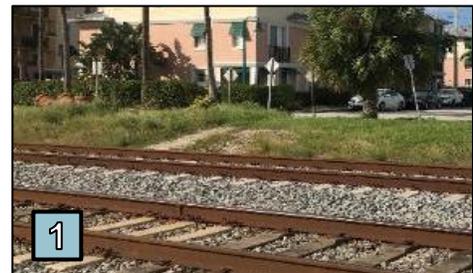
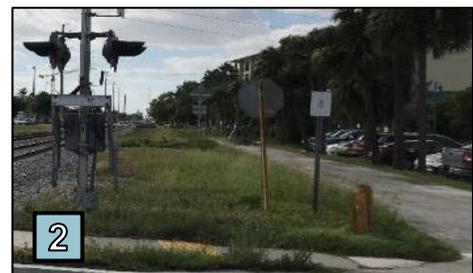
A trespassing trail exists in this area, and the risk of trespassing is high due to the density of residents and shopping between 4th St. and 1st St. in downtown Delray Beach. At 3rd St, which dead-ends at the railroad, a trespassing trail is present (photo 1). The corridor is open with no barriers (photo 2). A fatality occurred in September 2019 and an injury in October 2018 have occurred at this location.

Over the past decade, multiple high-rise residential and shopping buildings built in downtown Delray Beach, likely increasing frequency of trespassing. The city has begun to protect the downtown area and enhance the corridor by adding a sidewalk and aluminum fencing between 1st St. and Atlantic Ave. (not shown, MP 316.9) in 2017.

Recommendation: Construct a **sidewalk with aluminum fencing** on the west side of the corridor between 4th St. and 1st St., matching the style south of 1st St. It is recommended that a **pedestrian crossing** be added at 3rd St. The high number of pedestrians and trespassers in this area and the well-worn trespassing trail at 3rd St. make fencing alone insufficient to deter the trespassing, suggesting the installation of a pedestrian crossing. An urban trail along the corridor prevents trespassing and enhances the aesthetic appeal of the area.

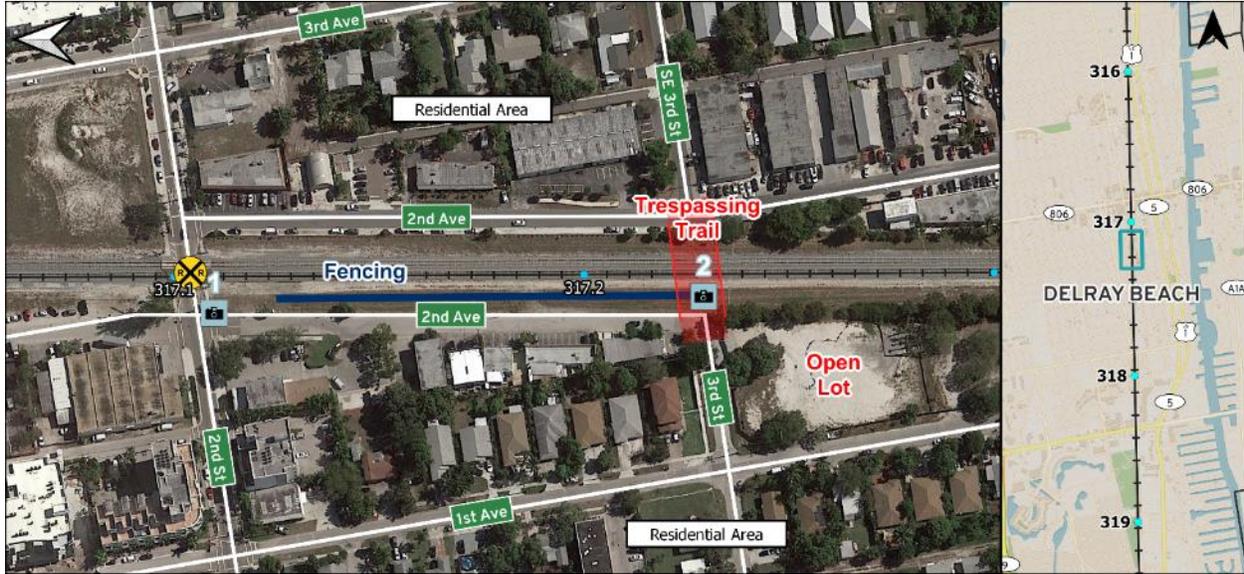
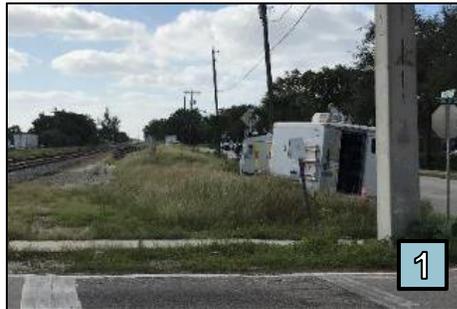
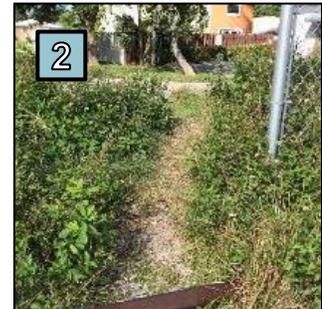
MP 317.1 to MP 317.3

There is a clear trespassing trail between the dead ends of 3rd St. in Delray Beach. Chain link fencing was installed between 2nd St. and 3rd St. in early 2019. However, it did not block this existing trespassing trail (photo 2). From 3rd St. to 4th St. (not shown, MP 317.3) there is an open lot on the west side of the corridor with no barriers. While the area on both sides of the tracks is mostly residential with no clear trespassing destinations, the trespassing trail is clearly defined.

Recommendation: Construct **6 ft. chain link fencing** from the end of the existing fencing near 3rd St. to 4th St. Installing **sidewalks** is recommended along 2nd Ave. on the west side of the corridor to help channelize the trespassers currently crossing the railroad from 3rd St. to 2nd St.

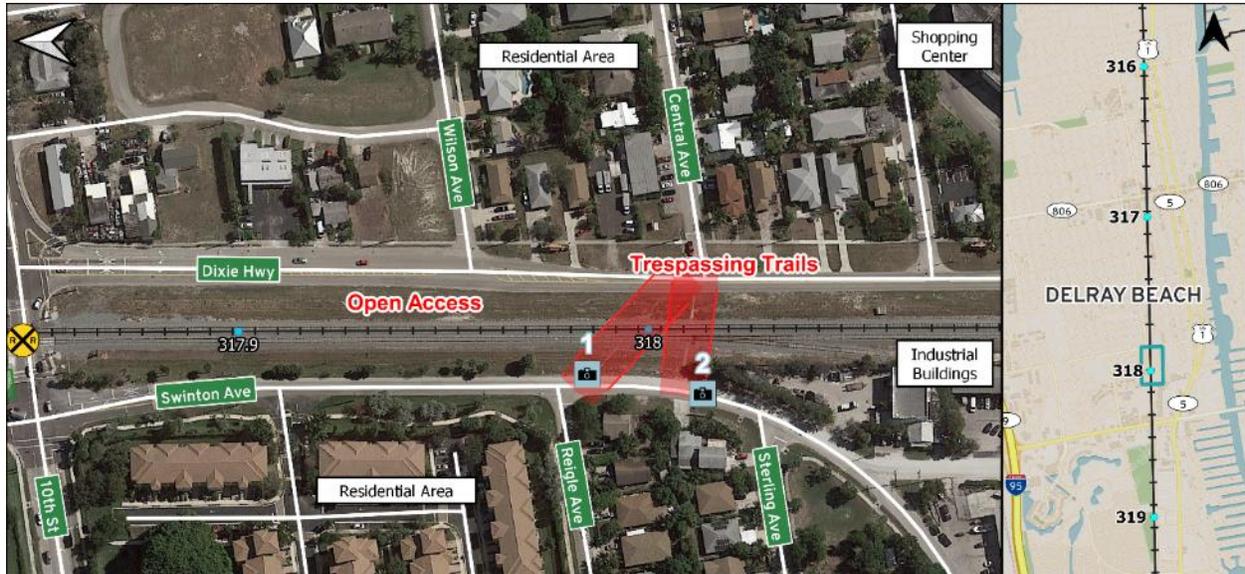
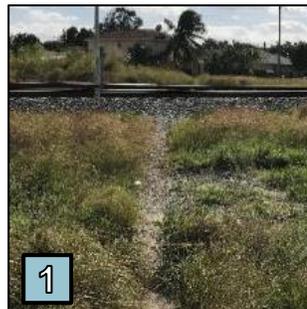
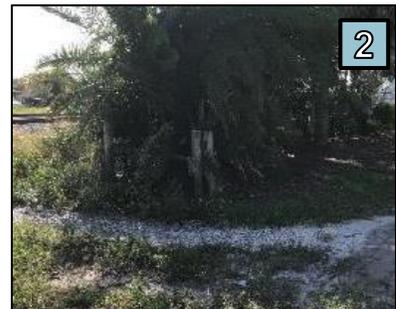
MP 317.9 to MP 318.0

There are two trespassing trails crossing the tracks from Dixie Hwy. and Swinton Ave. The trails connect the intersection of Central Ave. and Dixie Hwy. to Reigle Ave. (photo 1) and to Swinton Ave. between Reigle and Sterling Ave. (photo 2). One block to the south of Central Ave. is a large shopping center that includes a grocery store, retail stores, and restaurants. Immediately to the south of the trails along Swinton Ave. is a fenced industrial area.

The origin for trespassing is likely the residential area on the west side of the corridor. The most likely destination for trespassers from the west side of the corridor is the shopping center. The residential area on the east side is limited in size and the only potential trespassing destination is an elementary school. The school is located to the west along 10th St. It is likely that pedestrians use the existing sidewalk and grade crossings along 10th St. instead of trespassing across the tracks.

Recommendation: Install a **vegetation barrier** on the west side of the corridor between 10th St. and Sterling Ave. Constructing **sidewalk** is recommended to connect existing sidewalks between Reigle Ave. and Sterling Ave. that channelize pedestrians to 10th St. Due to the well-established path, more substantial barriers may be needed. However, vegetation is recommended to not diminish the well maintained aesthetics of the corridor along Swinton Ave.

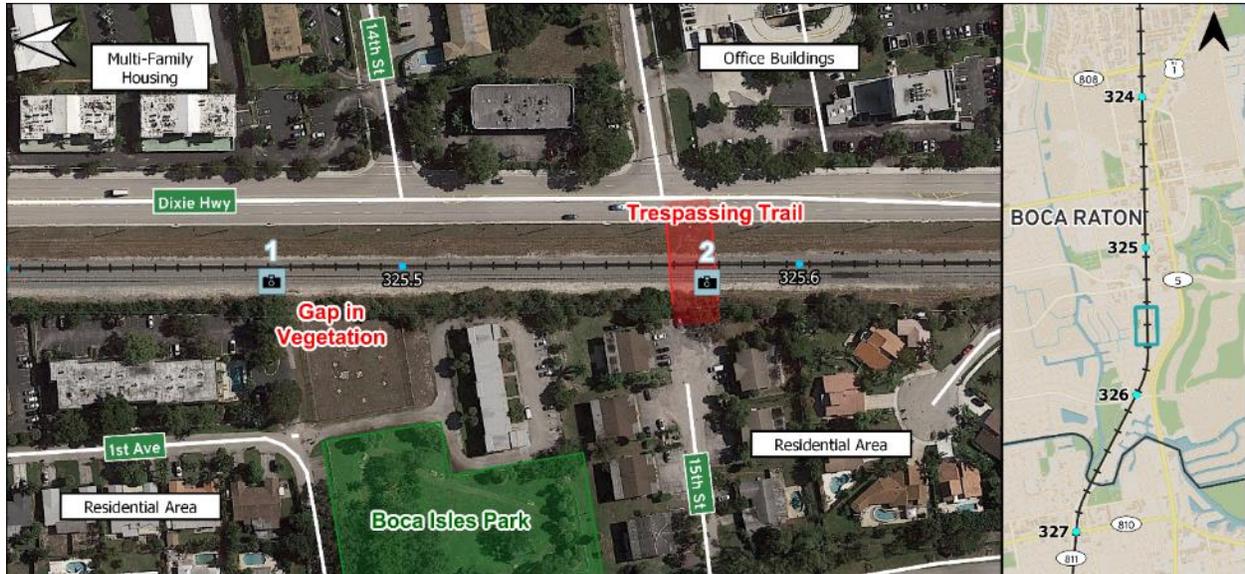
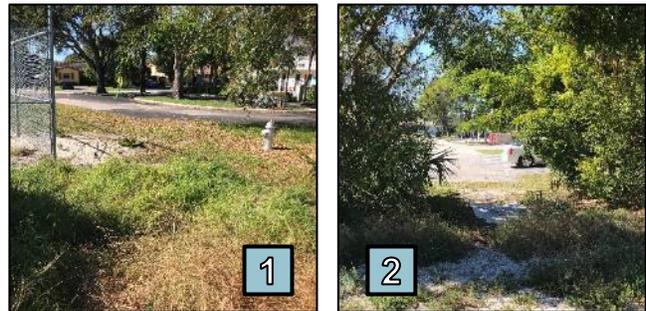
Several gaps occur in the vegetation along the right-of-way providing access to the tracks in Boca Raton. Vegetation or fencing exists for most of this section of the corridor, but gaps, providing access to apartment buildings, are visible (photo 1). A lightly used trespassing trail was found connecting one of the openings to 15th St. (photo 2). Just to the south of the trespassing trail, the railroad enters a curve reducing the sight distance and increasing the risk of a casualty.

Recommendation: **Vegetation** should be planted to fill in the gaps in the existing vegetation. Stronger fencing may not be necessary at this location since the corridor's east side is mostly office buildings or housing, so there are no strong origin-destination pairs.

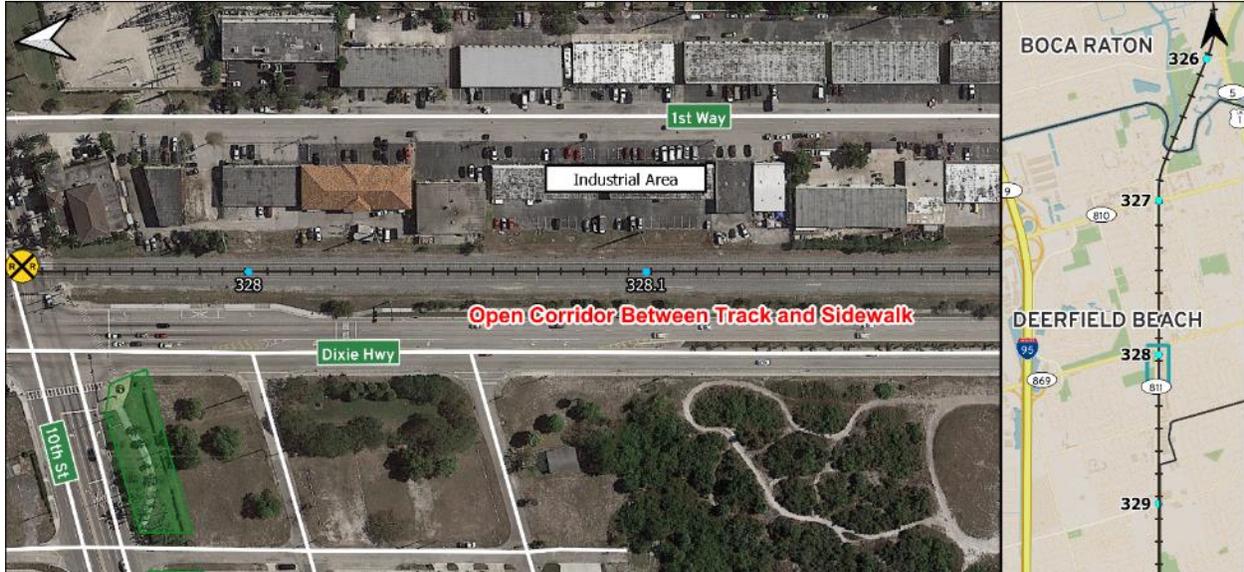
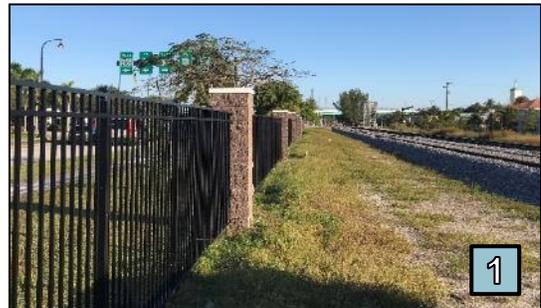
MP 328.0 to MP 328.5

There is no barrier between the sidewalk along Dixie Hwy. and railroad tracks in Deerfield Beach. North of 10th St., the City of Deerfield Beach has recently installed a decorative fence to deter trespassing after multiple incidents (photo 1).

At this location, the industrial area east of the tracks provides a barrier to trespassing across the tracks; however, sidewalk should not parallel the railroad corridor without a barrier.

Recommendation: Construct **decorative fencing** from 10th St. to 15th St. (not shown, MP 328.5), matching the existing style of fencing north of 10th St.

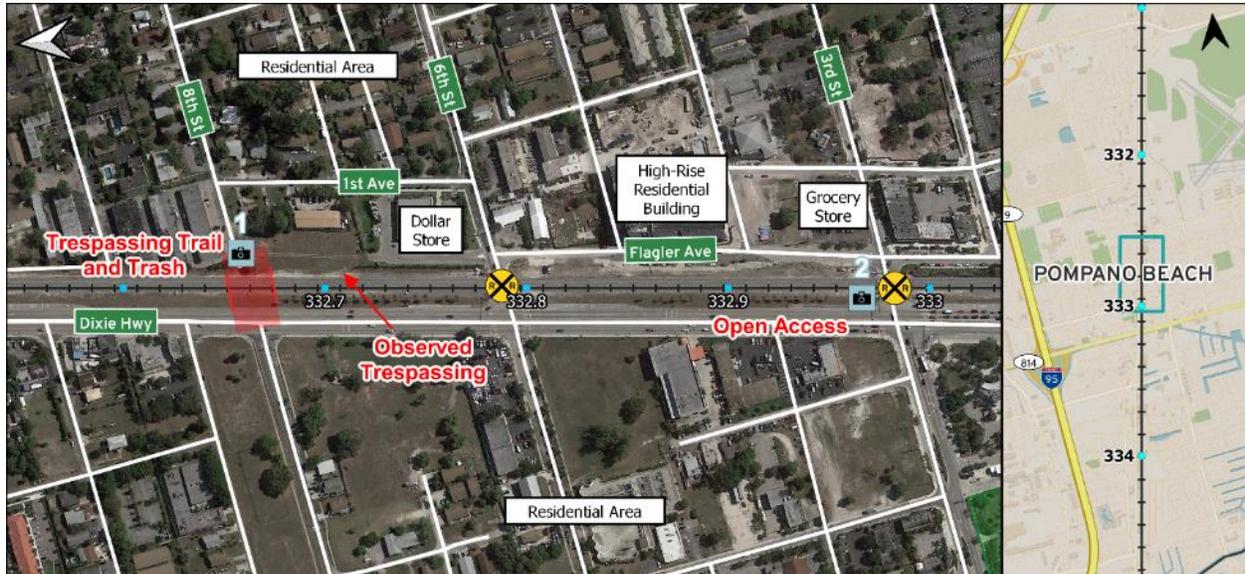
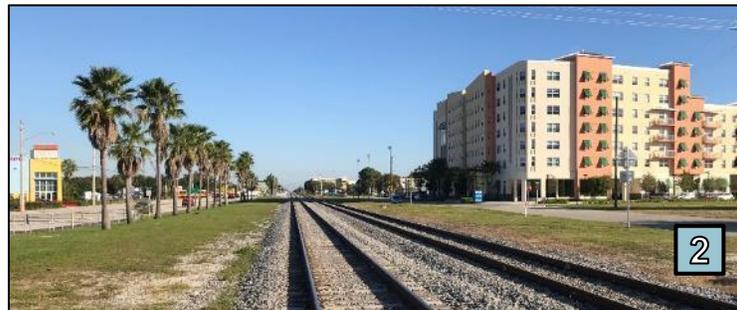
There was observed trespassing, a trespassing trail, and two fatalities since 2018 between 8th St. and 3rd St. in Pompano Beach. A trespasser was observed crossing the tracks west-to-east at 8th St. to get to the Dollar Store, located at the corner of 1st Ave. and 6th St. A trespassing trail connecting the dead end of 8th St. was found, as well as a dumping area on the corridor (photo 1). Limited vegetation along the railroad corridor (photo 2) is insufficient to deter trespassing. Immediately to the south between 3rd St. and Atlantic Blvd. (not shown, MP 333.2) there is fencing, vegetation, and a sidewalk.

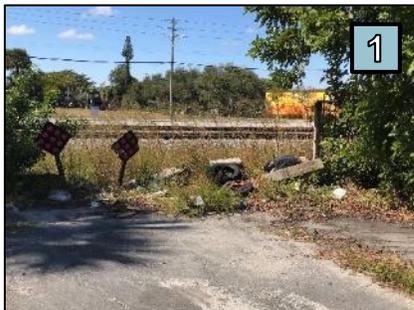
MP 332.4 to MP 332.8

The area is projected to see a large increase in residents and pedestrians. A new high-rise residential building was completed in early 2020 and the City of Pompano Beach has defined the area as the Downtown Pompano Innovation District. The district is envisioned as a high-density, core commercial area with new housing, retail, and commercial space on both sides of the tracks. The openness of the corridor combined with the anticipated destinations make it an area that could experience increased trespassing.

Recommendation: Construct **4 ft. aluminum fencing** on the east side of the corridor between 8th St. and 3rd St. to deter trespassing across the corridor and channelize the pedestrians to the existing grade crossings. The aluminum fencing will prevent the creation of entrenched trespassing trails while aligning with the proposed development.

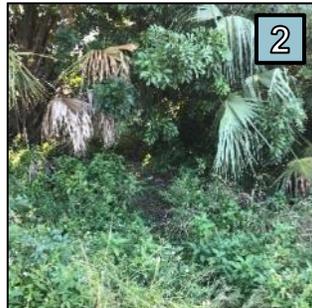
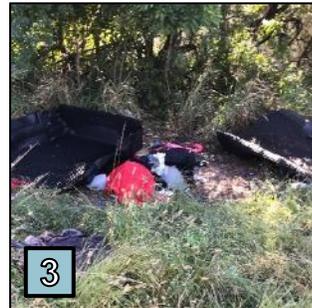
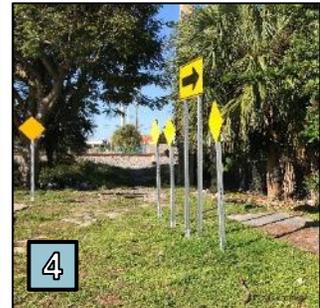
Multiple instances of trespassing can be seen south of Cypress Elementary School in Pompano Beach. There are gaps in the fencing and vegetation between the railroad and the Village Townhouse Condominium complex (photos 1 & 2), located between the railroad and Flagler Ave. The exiting chain-link fence has been cut and the post knocked to the ground. Near Cypress Elementary School is a trespassing trail connecting 9th Ct. to the complex. Along the railroad corridor at the south end of the conodminium complex is evidence of a homeless encampment (photo 3). There is a trespassing trail at McNab Rd. The road has a dead end at the railroad tracks, but a sidewalk on the east side continues up to the railroad (photo 4).

West of the railroads along Dixie Hwy. is mostly industrial buildings, and two blocks of residential housing before reaching I-95. These are not strong trespassing destinations. Cypress Elementary School is the most substantial trespassing destination in the area, and it is likely children are crossing the tracks to reach the school. There are no grade crossings between 6th St. (not shown, MP 333.8) and the Cypress Creek Canal (not shown, MP 334.9), meaning that any pedestrian not trespassing is required to walk nearly triple the distance to reach the school.

Recommendation: Construct **8 ft. hardened fencing** between the Village Townhome Condominiums and the railroad. The barrier will channelize pedestrians to **two new pedestrian crossings**, one connecting 9th Ct. to Cypress Elementary School and another at McNab Rd. Adding a **sidewalk** is recommended along Flagler Ave. to provide a safer path for pedestrians coming from McNab Ave. to reach the school.

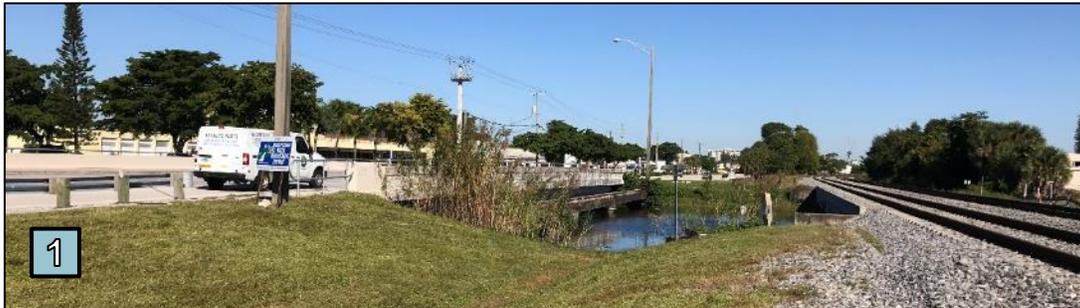
The railroad crosses the Cypress Creek Canal in Pompano Beach with open access on either side of the bridge and a trespassing trail at the north end. Two trespassing casualties have occurred at the bridge since 2018.

Dixie Hwy. runs parallel to the railroad at the bridge and has a sidewalk. Trespassers can use the road and avoid trespassing on the bridge. People are likely loitering on the bridge, and an increased risk is apparent due to a curve to the north reducing sight distance.

Recommendation: Install **bridge fencing** to discourage any loitering on the bridge, and a **motion actuated camera with speakers** to deter trespassing across the bridge.

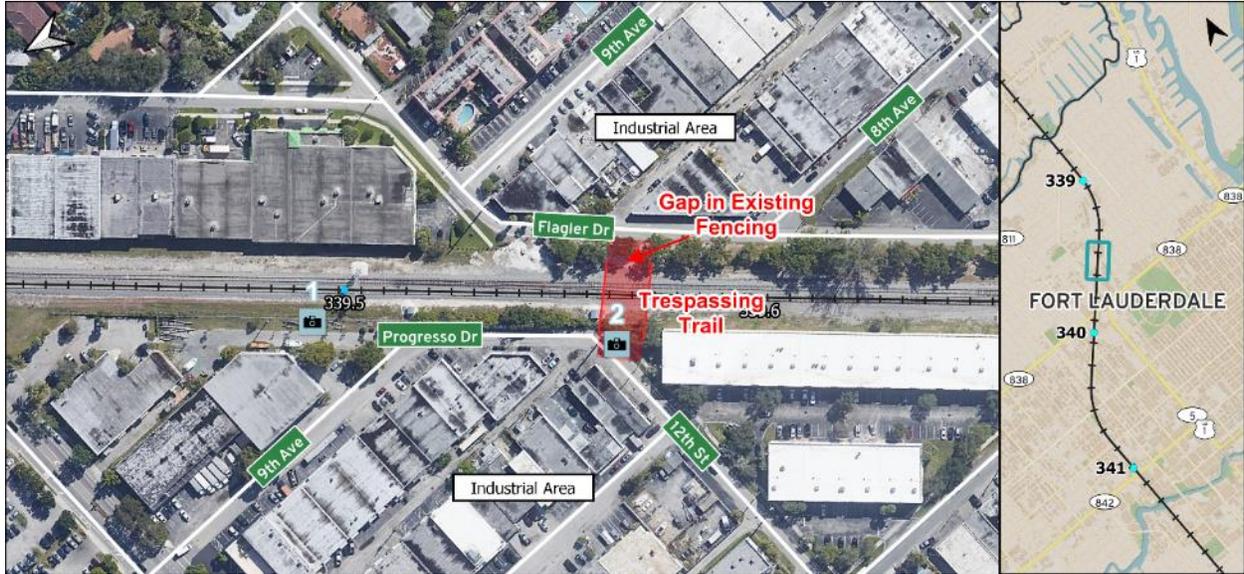
A trespassing trail was found between Progresso Dr. and Flagler Dr. in Fort Lauderdale. Vegetation and an existing chain link fencing exist along Progresso Dr. between 9th Ave. and 12th St. However, a gap in the fencing is present at the corner of 12th St. and Progresso Dr.

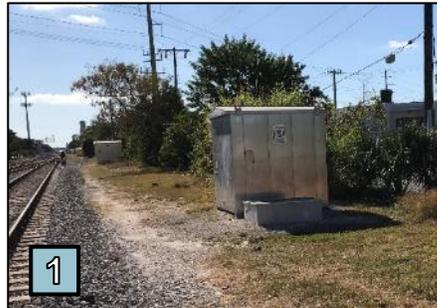
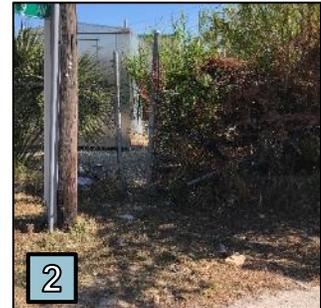
The trespassing trail crosses the tracks in the middle of a railroad track crossover, a dangerous location with moving track components. This increases the potential harm to trespassers, the risk to train movements and the potential for vandalism.

Recommendation: Replace the chain link fencing with **8 ft. hardened fencing** to channelize pedestrians to nearby at-grade crossings at 13th St. (not shown, MP 339.4) and Sunrise Blvd. (not shown, MP 339.9).

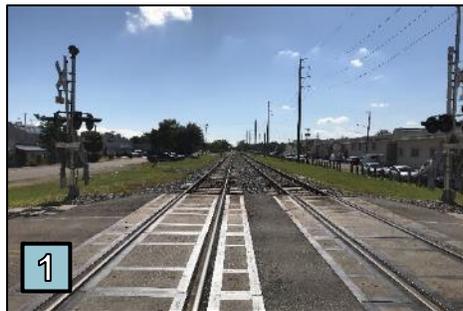
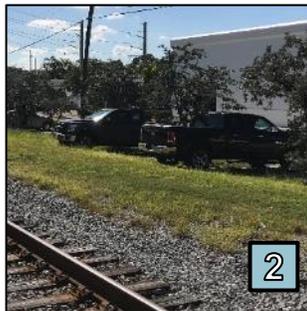
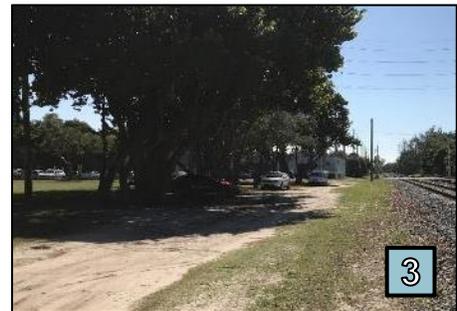
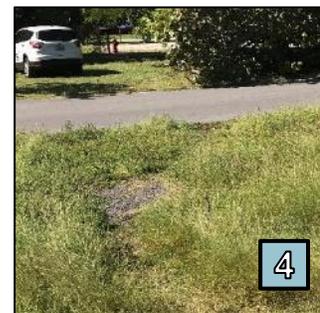
Open access to the corridor exists (photo 1) with multiple examples of encroachment south of the New River (not shown, MP 341.3) in Fort Lauderdale. North of 7th St., vehicles are parked against the tracks (photo 2). Along Florence C. Hardy Park & Cultural Center, a gravel road was constructed on the railroad right-of-way (photo 3). South of the park is a residential area with a mix of open access and sporadic vegetation with trespassing trails at 10th St. (photo 4) and 11th St. Since 2018, three trespassing casualties have occurred in this area.

The gravel road alongside the park has become more developed in recent years due to repeated use by visitors to the park. The park is also a trespassing destination for houses to the south using the trespassing trail at 10th St.

Recommendation: Install a **vegetation barrier** on the corridor's east side between 4th St. (not shown, MP 341.3) and the Tarpon River (not shown, MP 342.0). The barrier will define the

corridor. Along the park (between 7th St. and 9th St) construct a **6 ft. chain link** to provide a trespassing barrier. Alternatively, FECR can seek entering into a lease agreement with the city for the road area, including a requirement to build a barrier to protect the railroad. Notices should be sent to vehicle owners and inform them of the encroachment. It is recommended that a **vehicle gate** at 7th St. be constructed to prevent vehicle access to the gravel road next to the park.

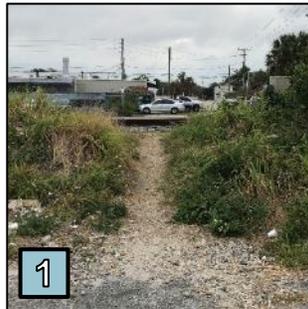
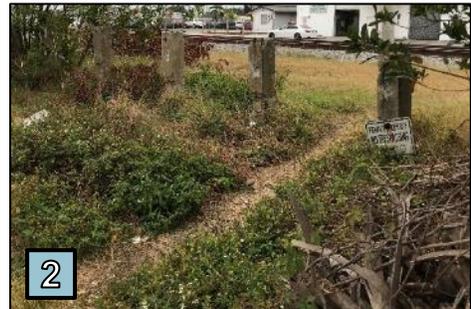
Vehicles are encroaching on the right-of-way between 20th St. and 22nd St., and trespassing trails are at 20th St. (photo 1) and 23rd St. (photo 2). Croissant Park Elementary School and Lauderdale Memorial Park are on the west side of the corridor and are major destination points.

While there are industrial buildings directly adjacent to the corridor, residential neighborhoods are present on both sides. Industrial buildings are not major trespassing destinations; therefore, trespassers mostly pass through them to reach destinations farther away. The school and park are two major expected destinations.

Recommendation: Construct **8 ft. hardened fencing** on the west side of the corridor from north of 20th St. to 24th St. (not shown, MP 343.1) The fencing will channelize the trespassing to the nearby grade crossings at 22nd St. and 24th St.

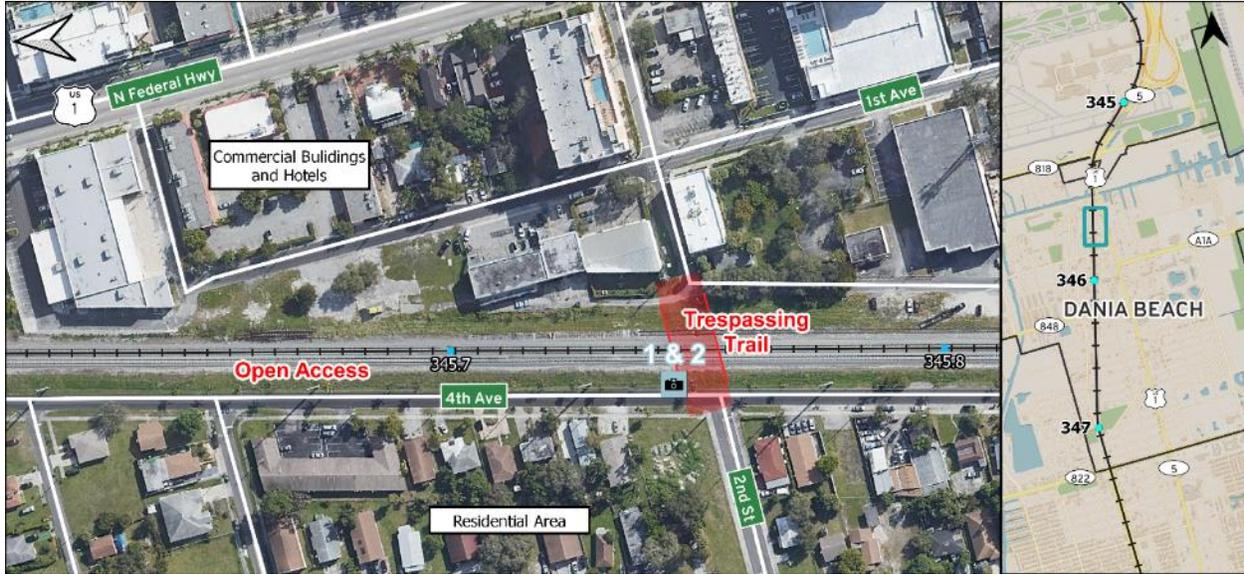
The corridor is open with a trespassing trail just south of the Fort Lauderdale Hollywood International Airport in Dania Beach. A trespassing trail was found connecting the residential area to the mixed businesses on the east side of the tracks at 2nd St.

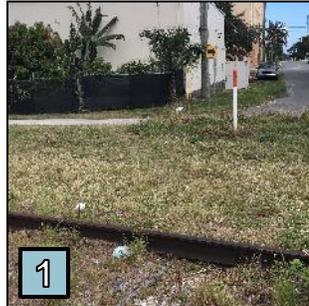
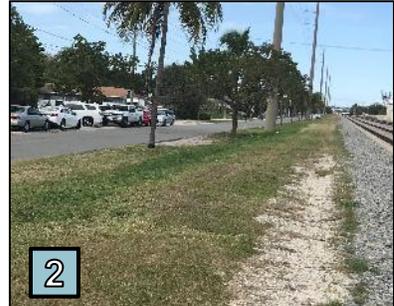
The majority of the buildings on the east side of the tracks are hotels serving the airport. There is a shopping center with a few shops and restaurants which could be a trespassing destination. The trespassing trail is not well defined and along with limited destinations, suggested trespassing is limited.

Recommendation: Install a **vegetation barrier** on the west side of the corridor from Old Griffin Rd. (not shown, MP 345.5) to 1st St. (not shown, MP 345.9) to define the corridor and to deter trespassing in this area.

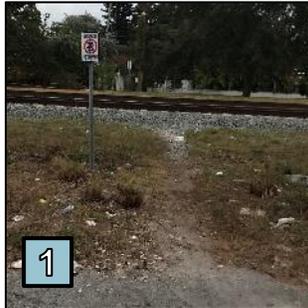
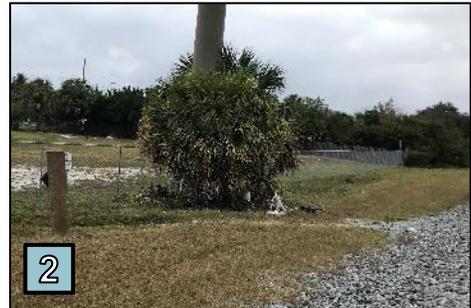
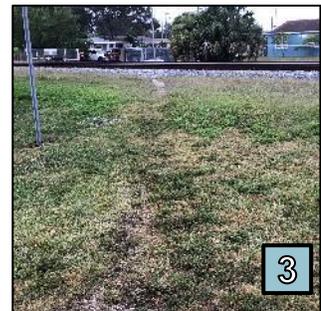
In Dania Beach, south of Stirling Rd., the corridor has open access and multiple trespassing trails. Trespassing trails are well established at 3rd St. (photo 1), 4th Ter. (photo 2), and 7th Ter. (photo 3). The area is mostly residential, but less than .25 miles west of the corridor is Attucks Middle School.

It is likely the school is the source of trespassing. There are nearly 0.9 miles between the at-grade crossings at Stirling Rd. and Dixie Hwy. Crossover (MP 347.1). Due to the distance to the nearest crossings and the well-established trails, traditional fencing will be insufficient to block the trespassing.

Recommendation: Construct **8 ft. hardened fencing** on the west side of the corridor between Stirling Rd. and 9th St. (not shown, MP 346.9) where there is no existing fencing. The fencing will channelize the trespassing to a proposed **pedestrian crossing** at 4th Ter.

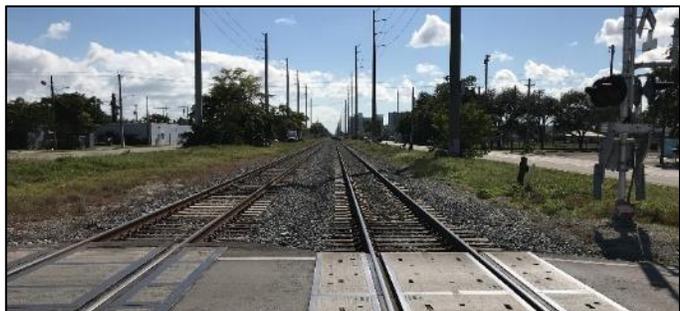
In Hollywood, Hallandale Beach, and Aventura, the railroad corridor runs parallel to two roads. On the west side is Dixie Hwy. and on the east side is 21st Ave. which later turns into 1st Ave. and Dixie Hwy. There are residential neighborhoods on both sides of the tracks and commercial buildings for much of the area. At Pembroke Rd. is the Big East Casino, and between 5th St. and 7th St. is a new Boys and Girls Club. At multiple locations, parking lots and vehicles are encroaching on the railroad property. There have been four trespassing casualties in this area since 2018. No well-established trails were visible, it is likely the result of trespassing distributed across multiple locations along the corridor.

Recommendation: Construct a **vegetation barrier** between Dixie Hwy. Crossover (not shown, MP 347.1) and 206th St. (not shown, MP 351.9). The barrier should be installed on the side of the corridor closest to any encroachment or trespassing destination. Where there are right-of-way constraints, it is recommended that **4 ft. aluminum fencing** be used due to smaller width. Vegetation will define the corridor and can discourage trespassing, while not diminishing the aesthetics of the current corridor.
