STRATEGIES FOR REDUCING RAILROAD TRESPASSING

Florida East Coast Railway Corridor -
Cocoa to Miami

August 6, 2021

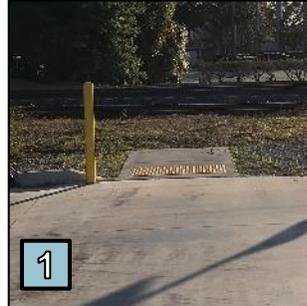
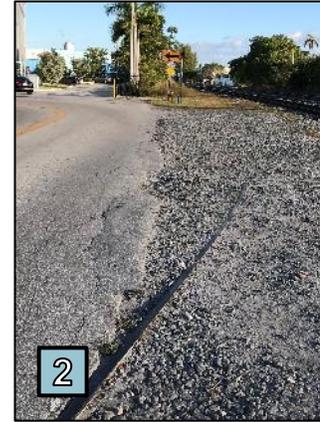
A trespassing trail and a lack of barriers exist between the roadway and tracks near 141st St. in North Miami. The trespassing trail continues across the tracks from the sidewalk that terminates at the intersections of 142nd and 141st St. (photo 1). There is no sidewalk at the existing at-grade crossing at 141st St.

When 141st St. runs parallel the tracks just to the northwest of the crossing, there is less than 30 ft. between the edge of the pavement and railroad track (photo 2). The area between the roadway and the tracks is crushed gravel with no clear delineation of the railroad corridor.

Recommendation: Construct **4 ft. aluminum fencing**, matching the style from the auto dealership to the north of 141st St. at the end of the sidewalk where the road turns. This mitigation will channelize any pedestrians to cross 142nd St. to the existing sidewalk and then to the proposed **pedestrian crossing** to be added to the existing vehicle crossing at 141st St. Where the gravel is against the roadway, installing a **curb** is recommended to provide delineation between the road and the railroad corridor.

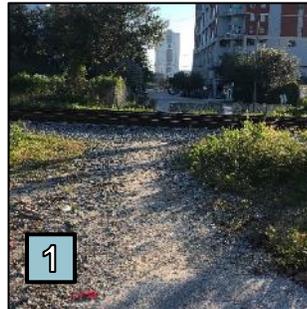
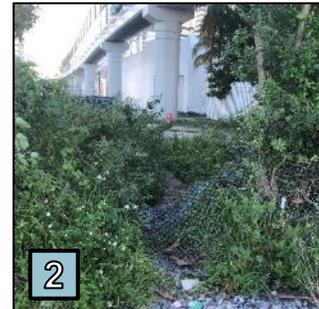
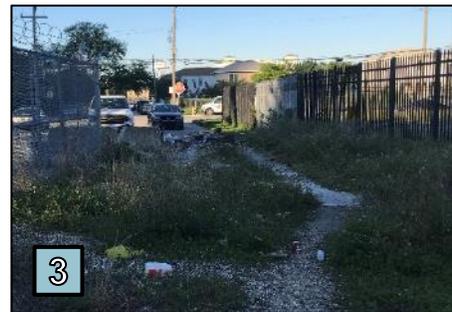
There are multiple trespassing trails and historical homeless activity along the right-of-way just north of MiamiCentral Station in Miami. While fencing was constructed along various parts of the corridor, the dead ends of 17th St. (photo 1) and 15th St. (photo 2) have open access and trespassing trails. Historically, the area under I-395 has been a homeless encampment. Current construction on the interstate has disrupted this encampment, but once construction is complete, it will likely return. Additionally, a trespasser was struck in this area in 2019.

Recommendation: Construct **6 ft. chain link fencing** on both sides of the corridor at the dead ends of 17th St., 16th St. and between 15th St. and 14th St. The fencing will limit the access to the corridor. At 17th St. and 15th St. **Vehicle gates** should be added as necessary to maintain vehicle access for railroad personnel. **Motion actuated cameras with speakers and lights** are recommended under I-395 to discourage the return of a homeless encampment.
