INNOVATIVE TECHNIQUES WITH MULTI-PURPOSE SURVEY VEHICLE FOR AUTOMATED ANALYSIS OF CROSS-SLOPE DATA

Alexander Mraz¹ and Abdenour Nazef²

⁽¹⁾ Applied Research Associates, Inc., Transportation Sector
5007 N.E. 39th Avenue, Gainesville, FL, 2609-2604
Phone: (352) 955-6324
Fax: (352) 955-6345
E-mail: amraz@ara.com

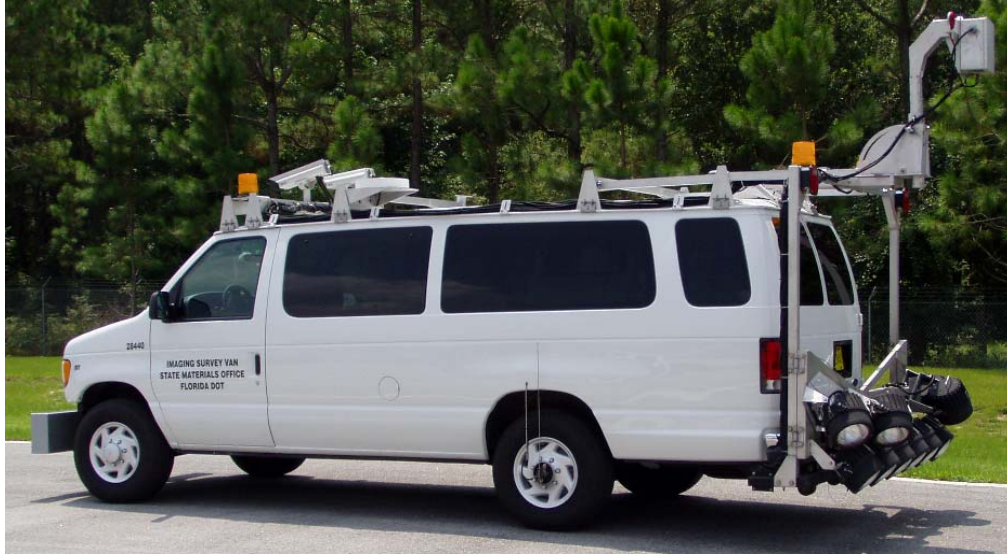
Presently, the Florida Department of Transportation (FDOT) uses the MPSV (Figure 1) to collect pavement and roadway images at normal operational speeds. It also collects cross-slope, longitudinal grade, curvature, rutting, and roughness information using milepost for linear referencing of such data. The MPSV is outfitted with the following main on-board systems: (a) inertial profiling, (b) imaging, and (c) inertial navigation.

FIGURE 1 FDOT MPSV

The inertial profiling system aboard the MPSV consists of three laser sensors, two accelerometers, and a Distance Measuring Instrument conforming to ASTM E950 Class I. [1]. The MPSV uses two front-mounted high resolution (1300 x 1024) digital area-scan cameras for collecting of right-of-way and side-view images at highway speed. A rear-mounted pavement imaging system which consists of a two megapixel line-scan camera captures images of the pavement surface with a 1.9 by 1.9 mm resolution. The pavement imaging system is coupled with a lighting system consisting of ten high intensity discharge 150 watts lamps to facilitate night-time surveys and minimize the casting of shadows on the pavement [2].

The FDOT MPSV also incorporates a Position and Orientation System for Land Vehicles (POS-LV) that integrates a Differential Global Position System (DGPS) and inertial technology into one robust, precise position and orientation system. The core of the POS is the Inertial Measurement Unit (IMU), which is a self-contained sensor consisting of three accelerometers and three fiber-optic gyroscopes. The physical principle of this type of gyroscope operation is analogous to the Doppler effect, but in this instance it involves determination of the phase shift between two counter propagating light beams. The sensor is bolted to the vehicle so it undergoes same motions as the vehicle. The accelerometers are used to establish a vertical position reference of the vehicle while gyroscopes are used to determine vehicle orientation as well as grade and cross-slope. The IMU is complemented with two GPS receivers which provide the inertial solution with position updates, thereby controlling the error growth. If the GPS receiver is unable to provide position information due to weak satellite signal, the IMU continues to provide position and orientation information unaided. The POS-LV system uses strap down inertial navigation, Kalman filtering, GPS, GPS azimuth measurement and distance measurement indicators (DMI) to provide position and orientation data that have a high bandwidth, excellent short-term accuracy and minimum long-term errors. The cross-slope and grade data can be used to evaluate roadway geometry and identify areas of deficiency.

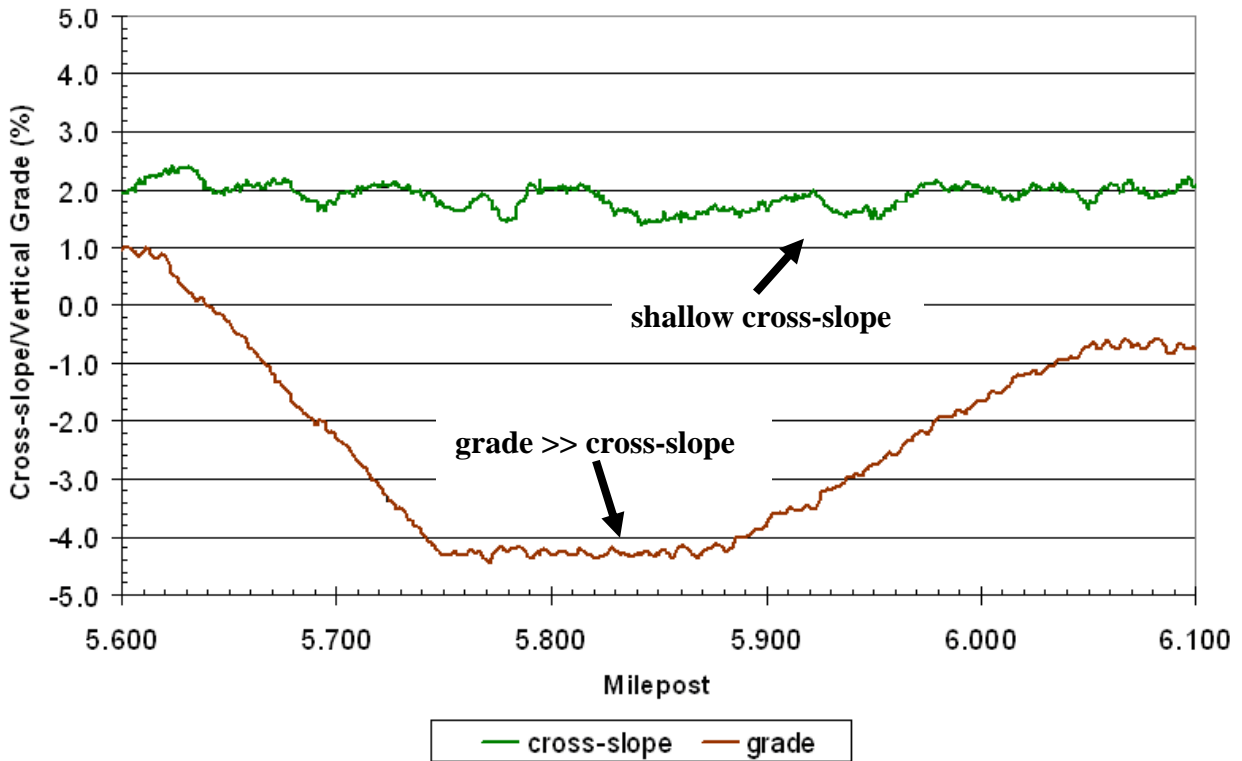
characteristic that affects surface drainage is the longitudinal grade. The longitudinal grade prolongs the drainage path length if it is substantially larger than the cross-slope. It also impacts heavy vehicle operation as it affects their stopping and passing distances. Therefore, longitudinal grade is an important factor of the roadway geometry evaluation and is incorporated into Equation 1. Figure 2 illustrates an example of an area prone to potential water sheeting due to a relatively large grade in comparison to cross-slope.

FIGURE 2 Potential Water Sheeting Area

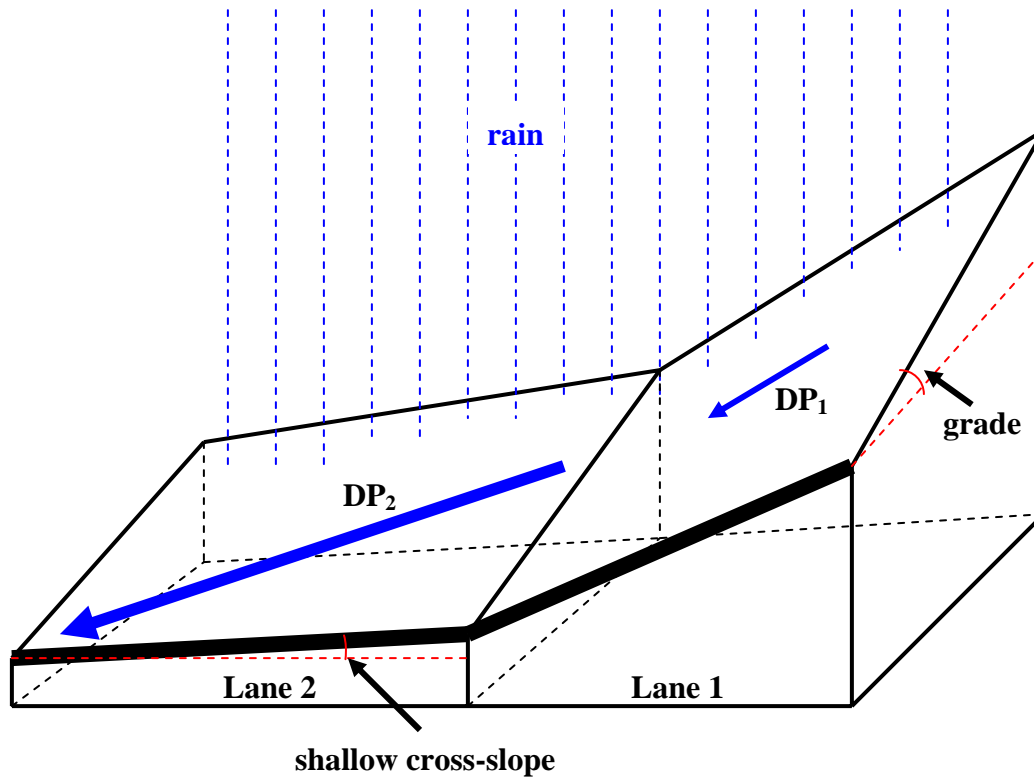
An example of a pavement with poor surface drainage represented by a relatively long drainage path length (DP_2) due to shallow cross-slope in lane 2 is illustrated in Figure 3. Since the cross-slope runs in the same direction for both lanes and cross-slope of the lane 1 is significantly larger than its grade, most of the surface runoff from both lanes is carried by lane 2. This amplifies the drainage problem in lane 2 resulting in a large DP_2 .

FIGURE 3 Long Drainage Path (DP₂) Due to Shallow Cross-slope

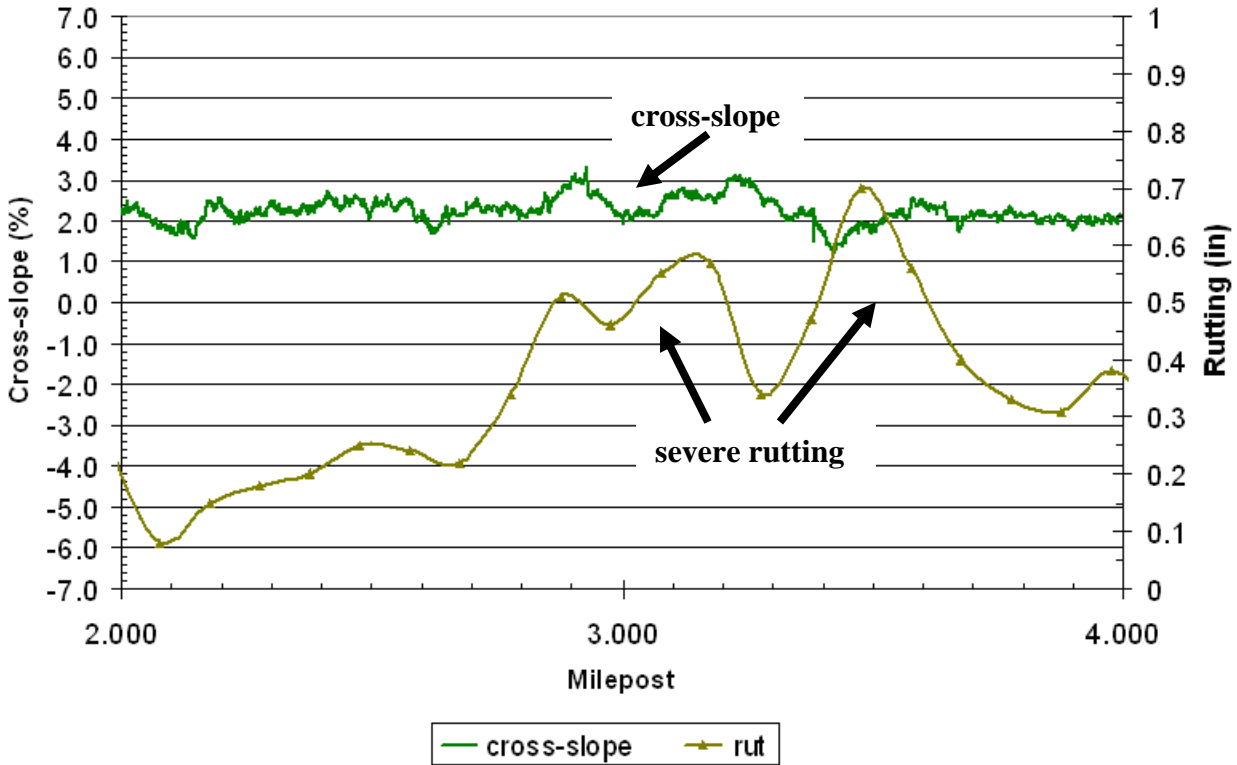
Rutting which is characterized as a cumulative, incremental, and permanent deformation of the pavement in the wheel paths, is another contributing factor that can lead to hydroplaning. In wet weather conditions a vehicle traveling at 50 mph can have its braking efficiency reduced by more than 80% due to water ponding in the ruts. A water depth of 0.15 inch can lead to hydroplaning for a passenger vehicle [5]. An example of severe rutting measured by the MPSV can be seen in Figure 4. Figures 3 and 4 illustrate the results of cross-slope analysis using the developed analysis program which is described in the next chapter.

FIGURE 4 Severe Rutting Measured by MPSV

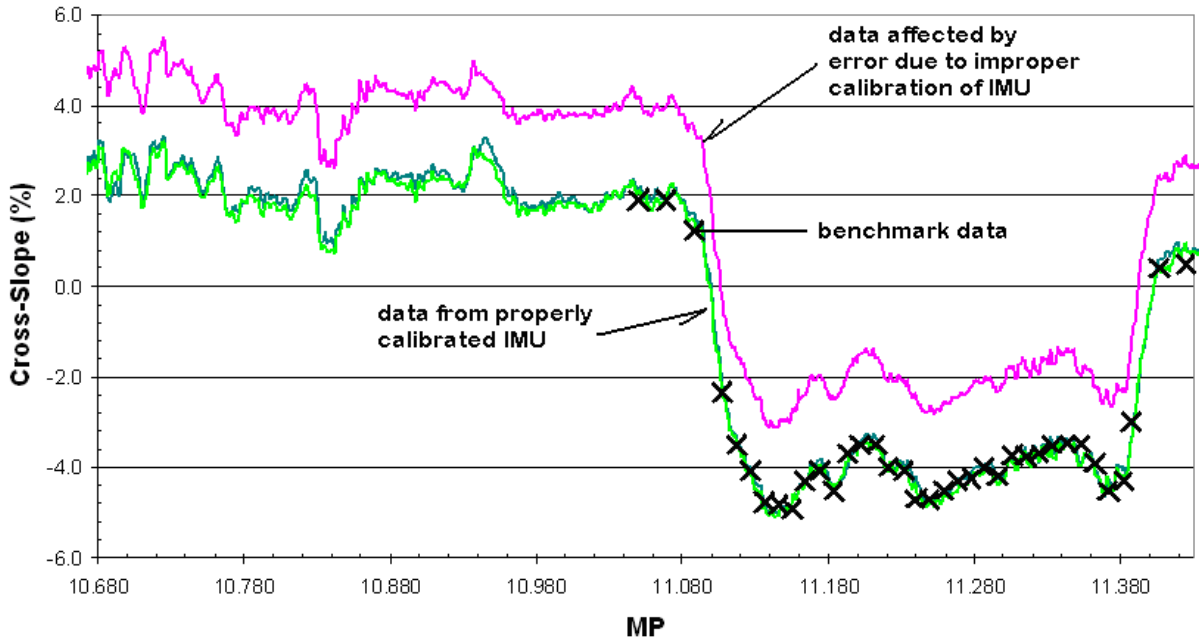
After acquiring the MPSV, the Florida Department of Transportation (FDOT) decided to assess limitation of the mounted IMU unit through evaluation of accuracy and repeatability. Therefore, a roadway containing a super-elevation was selected for this study and 37 distinctive locations, benchmarks, were manually surveyed using rod-and-level method. After, the MPSV measured cross-slope in ten repeated runs and results showed very high accuracy (cross-correlation R^2 of 99.4%) and a 94.7% repeatability. To minimize introduction of systematic error into cross-slope measurement, the test section has been selected for monthly verification of the IMU calibration. Example of result of improper IMU calibration on measurement of cross-slope data is shown in Figure 5.

FIGURE 5 Systematic Errors in Cross-slope Data Due to Improper Calibration of the IMU Unit

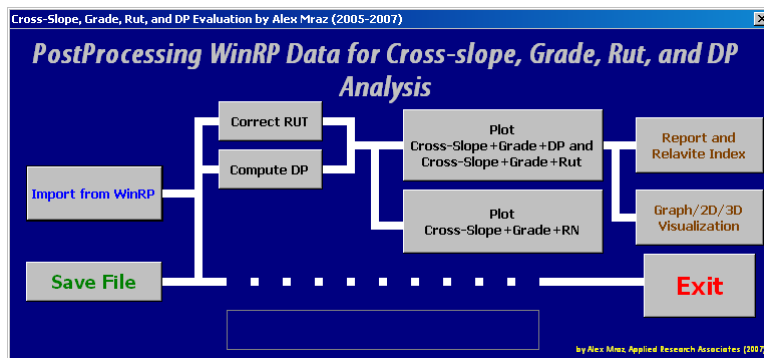
The MPSV collects a large amount of data, which if processed manually, would take considerable amount of time. Therefore, in order to keep up with their production schedule, the FDOT needed a faster way of importing, processing, and analyzing the collected data. As a result, a Cross-slope Analysis Program was developed in Excel, using the Visual Basic for Application (VBA) programming language. The Cross-slope Analysis Program, (Figure 6), allows the user to import and simultaneously process cross-slope, longitudinal grade, and rut data used to calculate drainage path as defined in Eqn.1. The program outputs cross-slope, grade, drainage path, and rut measurements in tabular as well as graphical form as illustrated in Table 1 and Figure 7, respectively.

FIGURE 6 Cross-slope Analysis Program Main Menu

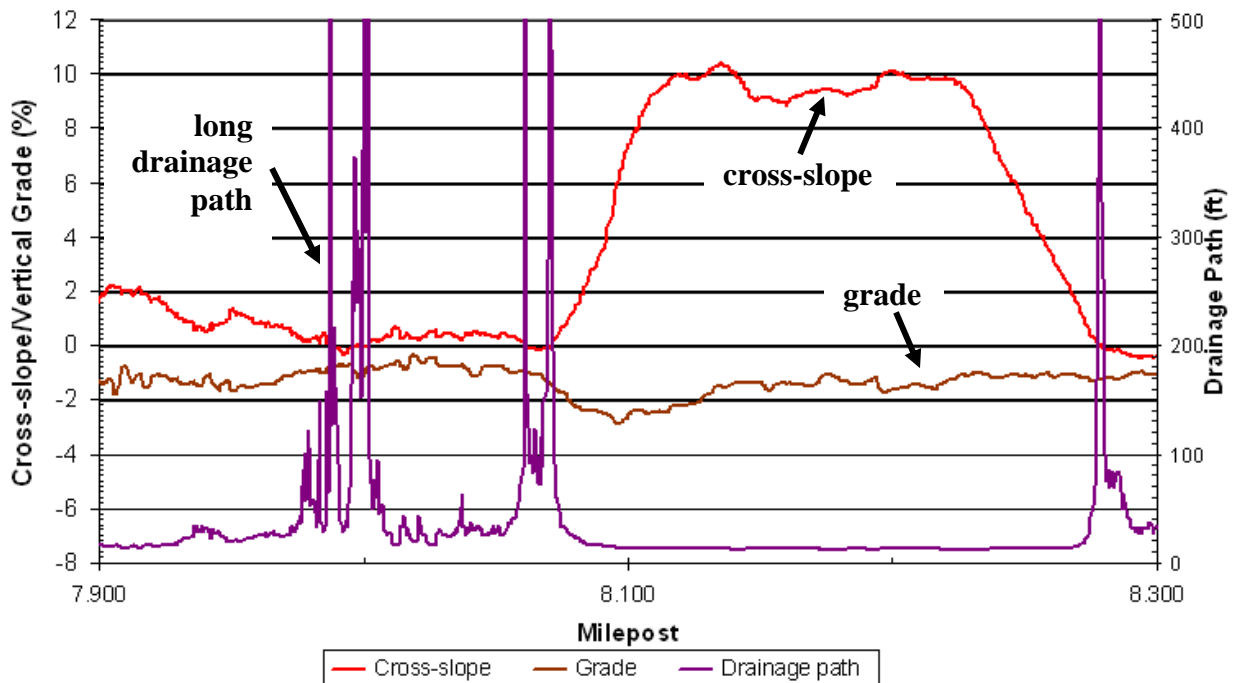
FIGURE 7 Illustration of Cross-slope Data Created by the Analysis Program

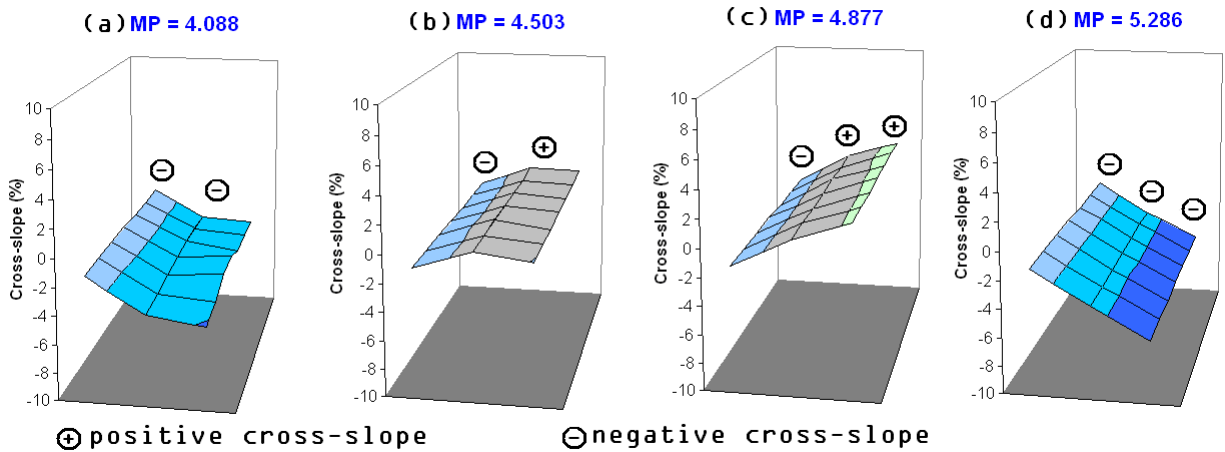
The analysis program has the ability to create 3-D renderings of cross-slope and longitudinal grade data as a function of mile post (MP) and plots them in real-time. An example of a 3-D

visualization graph of cross-slope is shown in Figure 8. This representation of cross-slope data provides pavement engineers the ability to better visualize roadway geometry and take appropriate corrective measures. The graphs are color-shaded to allow a better visualization of the cumulative effect of the cross-slope. The shades of blue color represent negative cross-slope (negative signs in Figure 8) and shades of green color represent positive cross-slope (positive signs in Figure 8), respectively.

FIGURE 8 (a) Vehicle Entering Super-elevation (Flat Cross-slope in Outside Lane); (b) Vehicle Within Super-elevation (Nearly Zero Cross-slope In Outside Lane); (c) Vehicle Within Super-elevation (Adequate Cross-slope In Both Lanes); (d) Vehicle Exiting Super-Elevation (Adequate Cross-slope In Both Lanes)

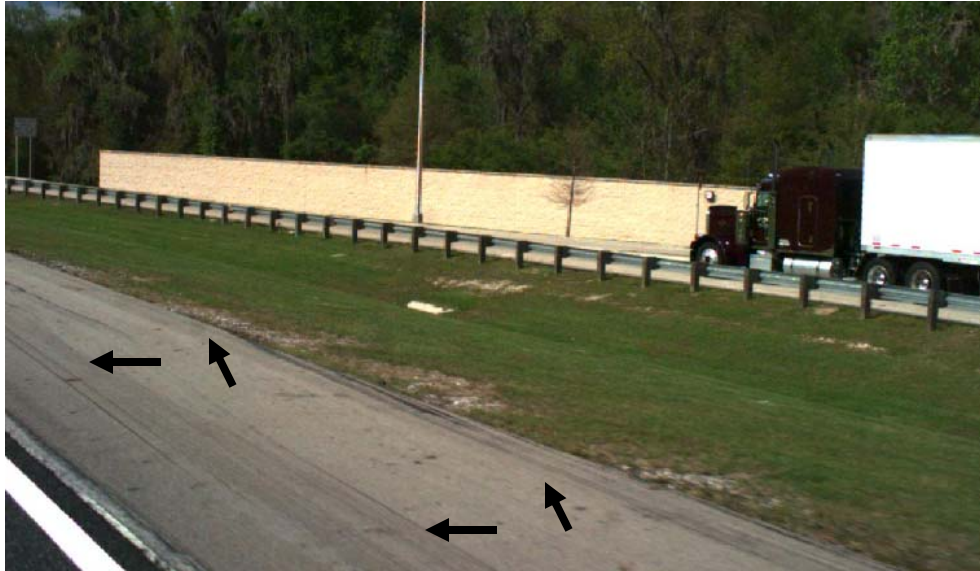
A rural four-lane interstate highway was selected for a case study. There had been reports of vehicle departures from the roadway during heavy rain on one isolated section of the facility. District engineers requested the use of the MPSV to determine the possible cause of vehicle departures that would assist in formulating appropriate corrective measures. After the MPSV survey was performed, skid marks were noted in the side-view images as shown in Figure 9.

FIGURE 9 Skid Marks on the Shoulder Recorded in MPSV Side-view Images

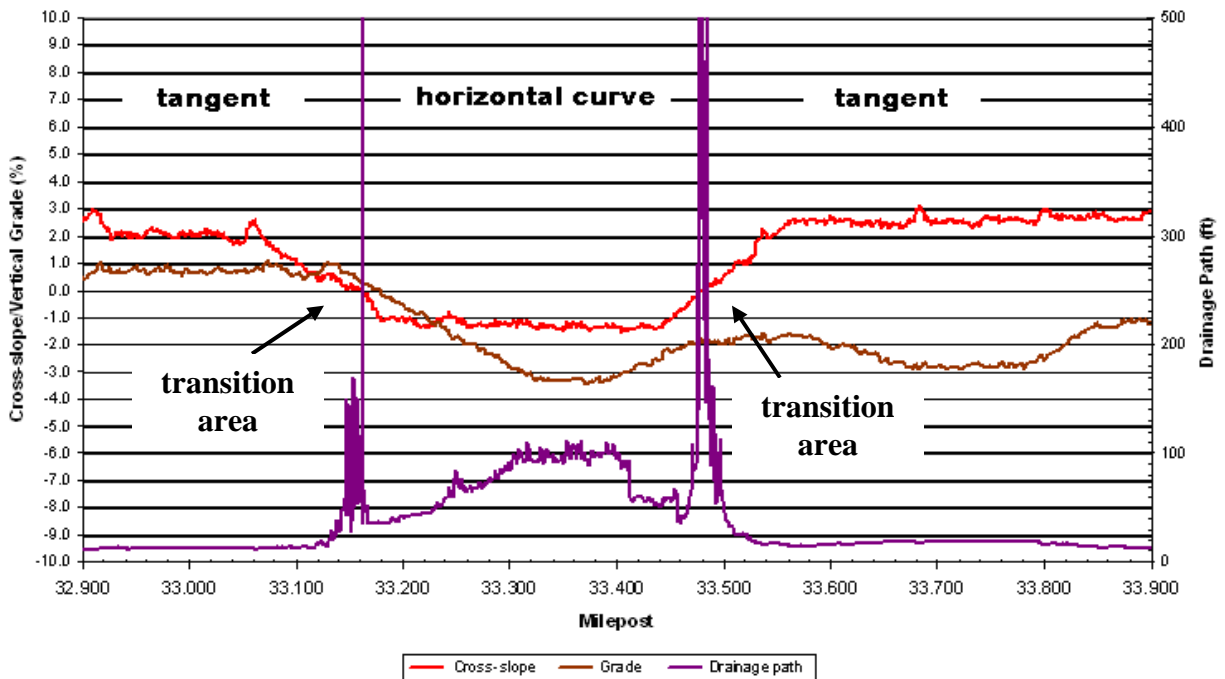
The results from the analysis of cross-slope, longitudinal grade, and rut data identified an isolated area within the horizontal curve with a relatively small cross-slope and a relatively large longitudinal grade. As illustrated in Figure 10, the corresponding drainage path within the horizontal curve is large due to the shallow cross-slope. Based on these results, district engineers were able to use this information to take immediate short-term actions and plan for a long-term mitigating solution.

FIGURE 10 Large Drainage Path Within Horizontal Curvature Identified with MPSV

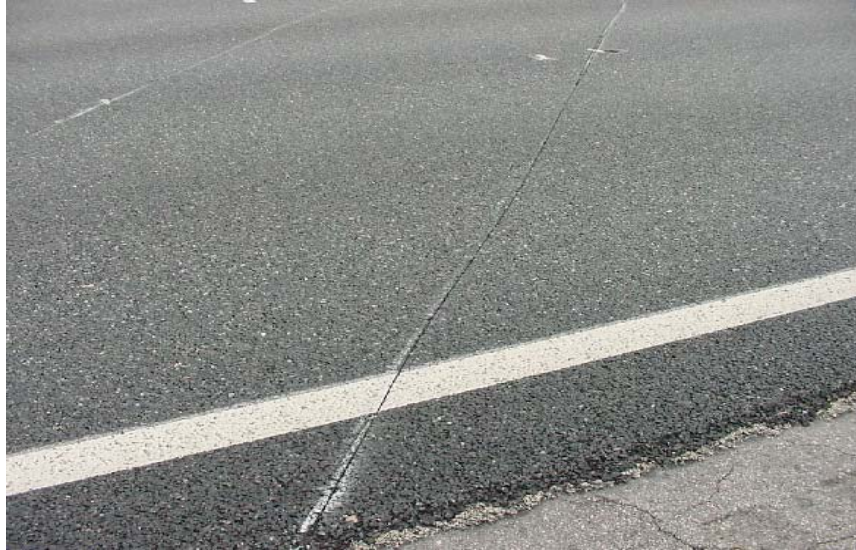
As a short-term solution, transverse angled grooves were cut into the friction layer of the pavement to improve surface drainage (Figure 11). In addition, variable message signs were used to inform motorists to exercise caution when driving through the area during heavy rains.

FIGURE 11 Transverse Angled Grooves as a Short-term Solution to Water Drainage Problem

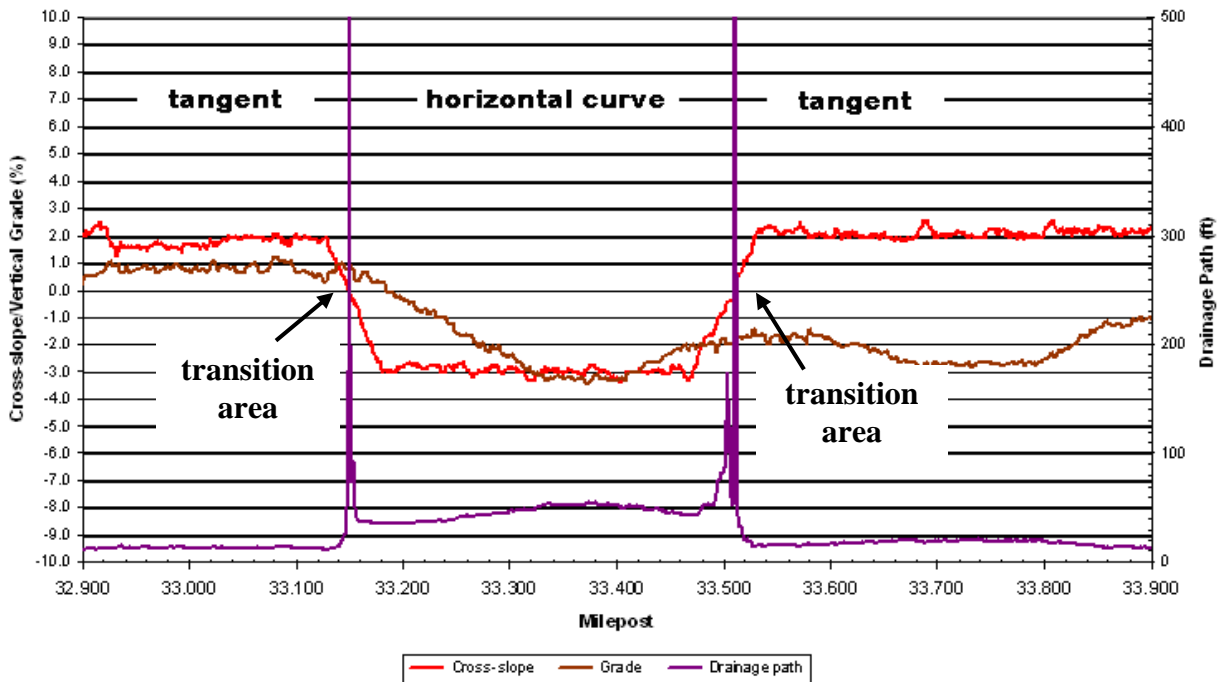
As a long-term solution to the drainage problem, the designers updated the resurfacing project scope to include the use of overbuild to correct the shallow cross-slope. After the resurfacing was completed, the section was resurveyed with the MPSV and the results are shown in Figure 12. From this figure it can be seen that the cross-slope was substantially improved, resulting in an elimination of the surface drainage problem. Figure 12 also shows that the narrow peaks of drainage path at the transition areas are indicative of a smooth transition into and out of the horizontal curve. It is important to note that there was no roadway departures reported after the corrective measures were implemented.

FIGURE 12 MPSV Cross-slope After Overbuild Correction was Applied
