**A SEMI-AUTOMATED FAULTING MEASUREMENT APPROACH FOR RIGID PAVEMENTS
USING HIGH SPEED INERTIAL PROFILER DATA**

Abdenour Nazef¹, Alexander Mraz², Shivprakash Iyer³, Bouzid Choubane⁴

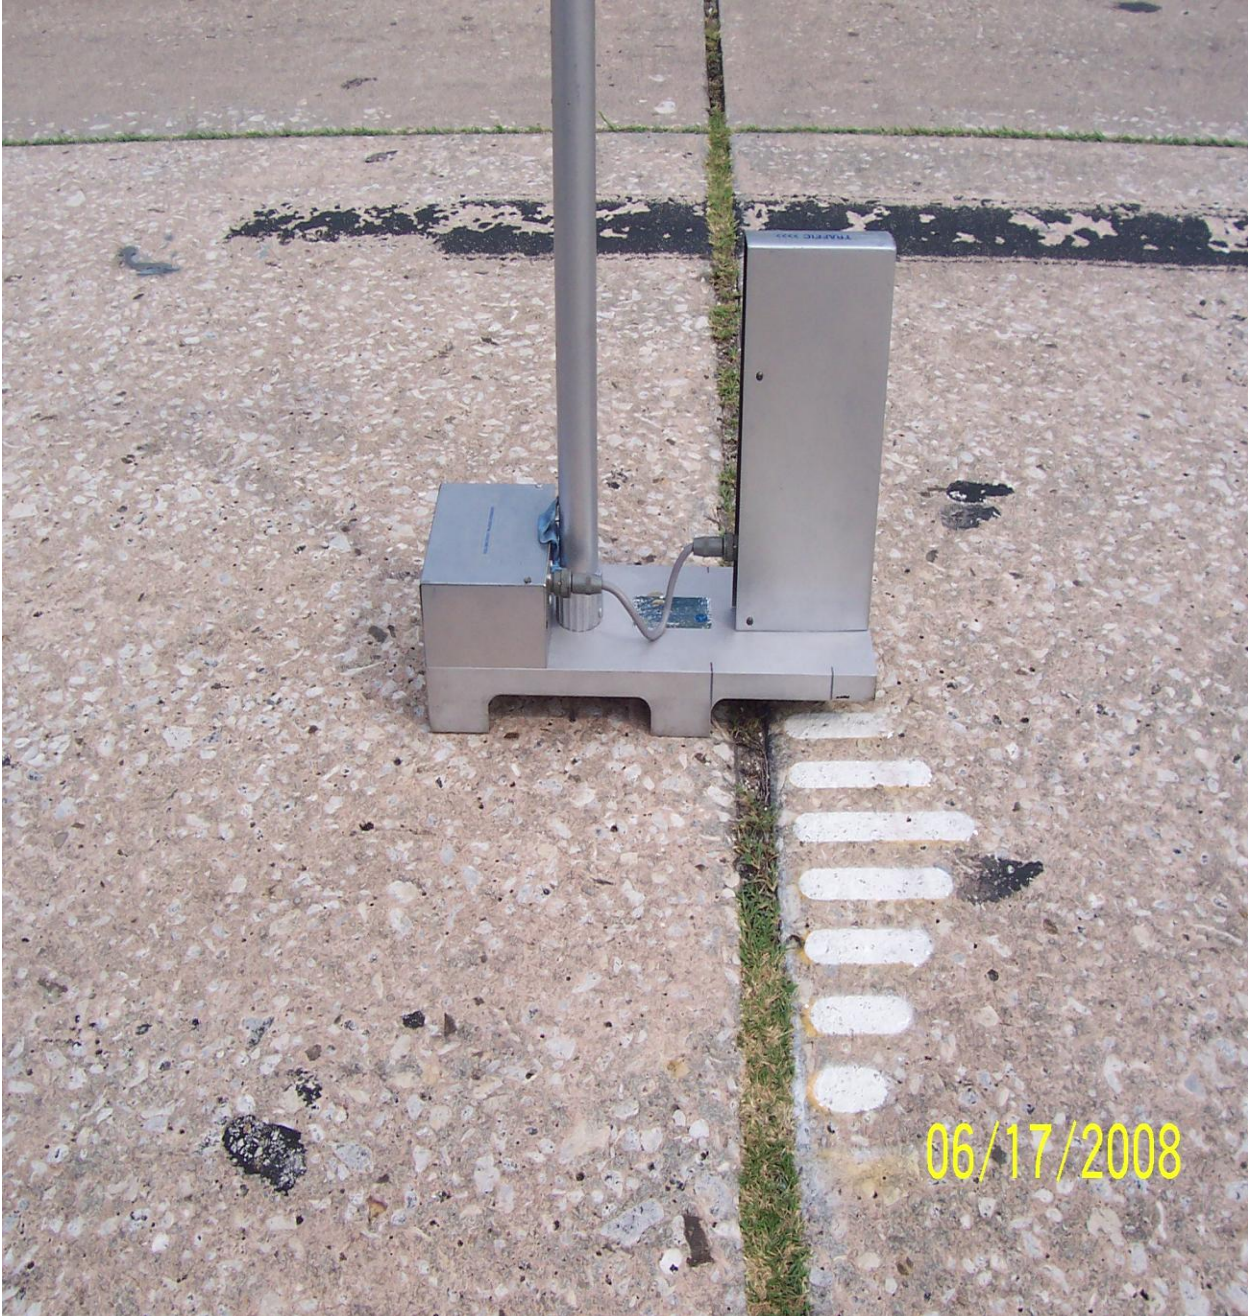
FIGURE 1 Georgia Faultmeter

The Georgia Faultmeter developed by the Georgia Department of Transportation has served the pavement community well for many years (Figure1). It was considered an improvement over other manual methods such as the ruler, straightedge, calipers, and other type of gauges [6]. The unit weighs approximately 7 lbs (3.2 kg) and supplies a digital readout with the push of a button located on the carrying handle. The readouts are displayed to nearest 0.1 mm with a positive or a negative sign, which represents positive or negative faulting. The Faultmeter’s support feet are positioned on the leave side of the slab joint, in the direction of traffic. The joint is centered between the guide marks visible on the side of the meter. The measuring probe contacts the slab on the approach side. The vertical movement of this probe is transmitted to a Linear Variable Displacement Transducer (LVDT) to measure joint faulting. A slab which is lower on the leave side of the joint will register a positive faulting value. If the slab leaving the joint is higher, the meter gives a negative reading [2]. The Faultmeter was found to be reliable after conducting several sequences of power on, calibrate, measure, and then power off.

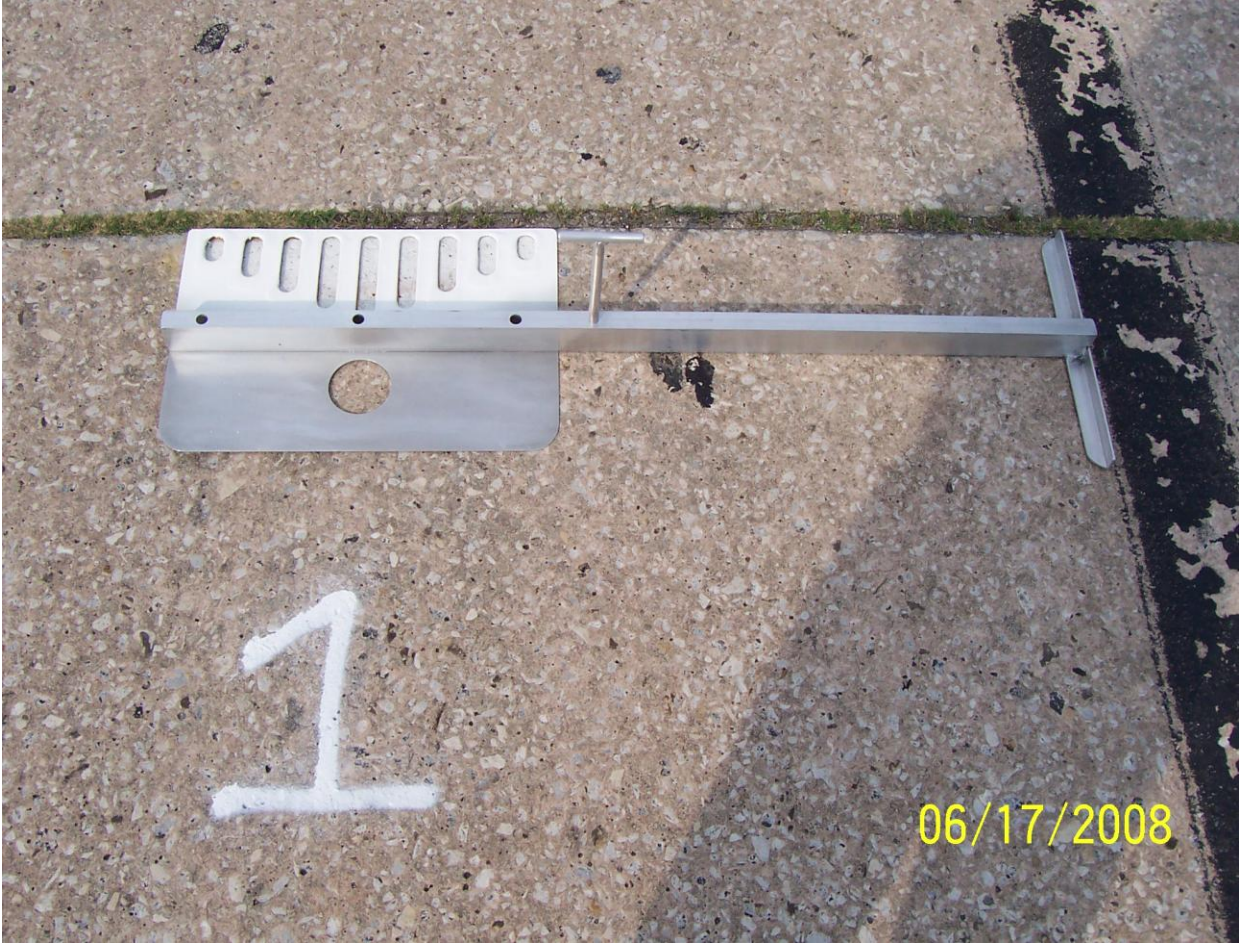
FIGURE 2 Manufactured template

To compare manual faulting measurements to faulting derived from profile elevation data, it is critical to first match the measurement locations of both devices. This presents a challenge as the test vehicle lateral wander can be as much as two feet from the targeted path. To help overcome this problem, the aluminum template shown in Figure 2 was fabricated. It consists of a 46 in (116.8 cm) x 2 in (5.1 cm) x 1 in (2.5 cm) hollow tube riveted to a 19 in (48.3 cm) x 13 in (33 cm) x 1/16 in (0.2 cm) rectangular plate. The plate has a 2.75 in (7 cm) diameter circular opening used to mark the right wheel-path and nine 2 in (5.1 cm) center to center slots used to mark the location of the Faultmeter when positioned to measure faulting about a joint. The template has a carrying handle consisting of a 6.5 in (16.5 cm) and a 4 in (10.2 cm) cylindrical aluminum pieces soldered together to form a “T”, and a 14 in (35.6 cm) x 1 in (2.5 cm) x 1 in (2.5 cm) angle soldered to one end of the tube. The template is placed on the approach side of a transverse joint with the angle aligned with the inside edge of the lane-line. Spray paint is then applied over the circular opening to mark the center of the right wheel path, and over the nine oval slots to mark the Faultmeter measurement locations.

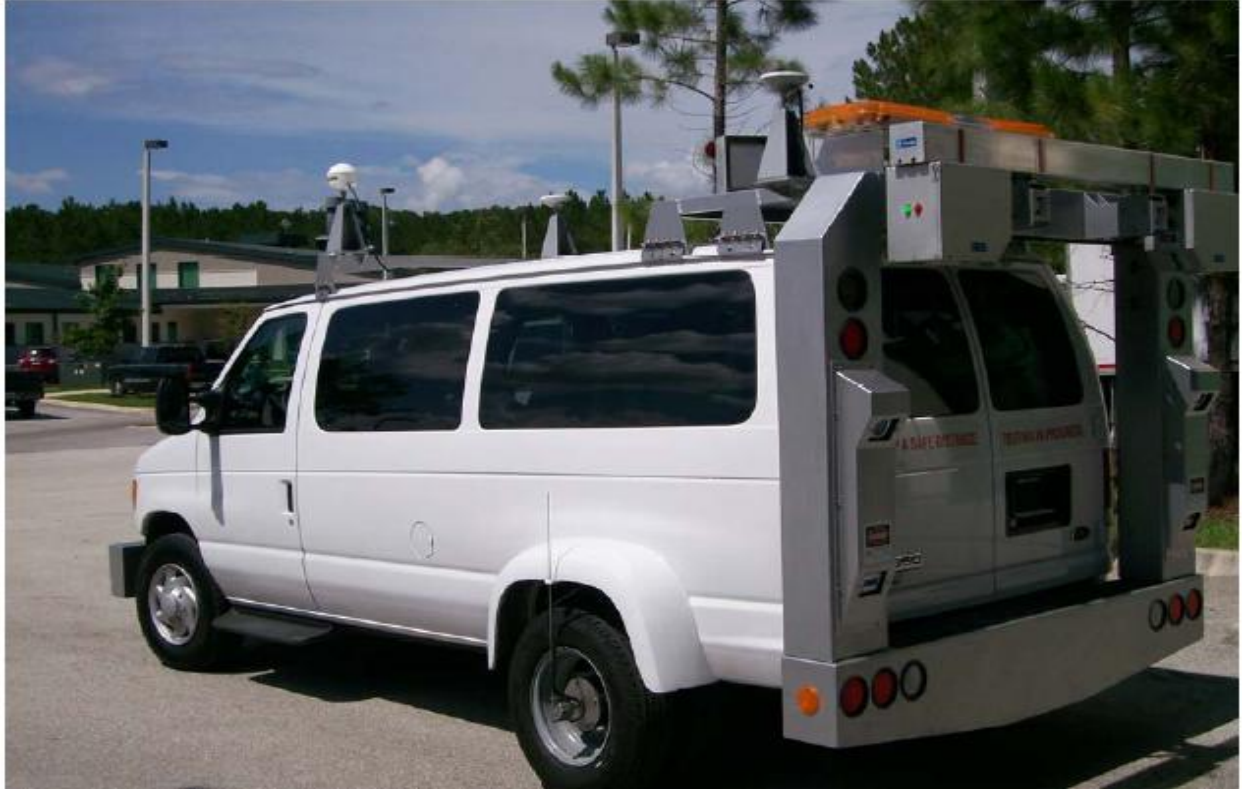
FIGURE 3 FDOT Multi- Purpose Survey Vehicle

In the present investigation, longitudinal profiles were acquired using a properly calibrated FDOT-owned Multi-Purpose Survey Vehicle (MPSV). This state of the art test vehicle is essentially a high-speed profiler van equipped with a forward-view camera, INO Laser Road Imaging System (LRIS), Laser Rut Measurement System (LRMS), and a DGPS enabled Position and Orientation System (POS). The profiler is fitted with two 32 KHz Selcom 5000 laser height sensors for measuring longitudinal profiles (Figure 3). Both sensors are mounted in the front bumper of the van, one sensor above each wheel-path. A third laser mounted in the middle of the bumper, is used for rut measurement. These height sensors measure the vertical distance from the vehicle body to the pavement surface. The profiler is also equipped with accelerometers at each of the wheel-path sensors to compensate for the vertical motion of the vehicle body [1]. The LRIS system is composed of two high-resolution line-scan cameras and two high-power laser line projectors aligned in the same plane, and configured to image almost 13 ft (4 m) wide pavement sections with a 0.04 in. (1mm) resolution at speeds that can surpass 62 mph (100 km/hr). In this study, the LRIS pavement images were used to identify the Faultmeter measurement marking that best matches the right sensor lateral position.

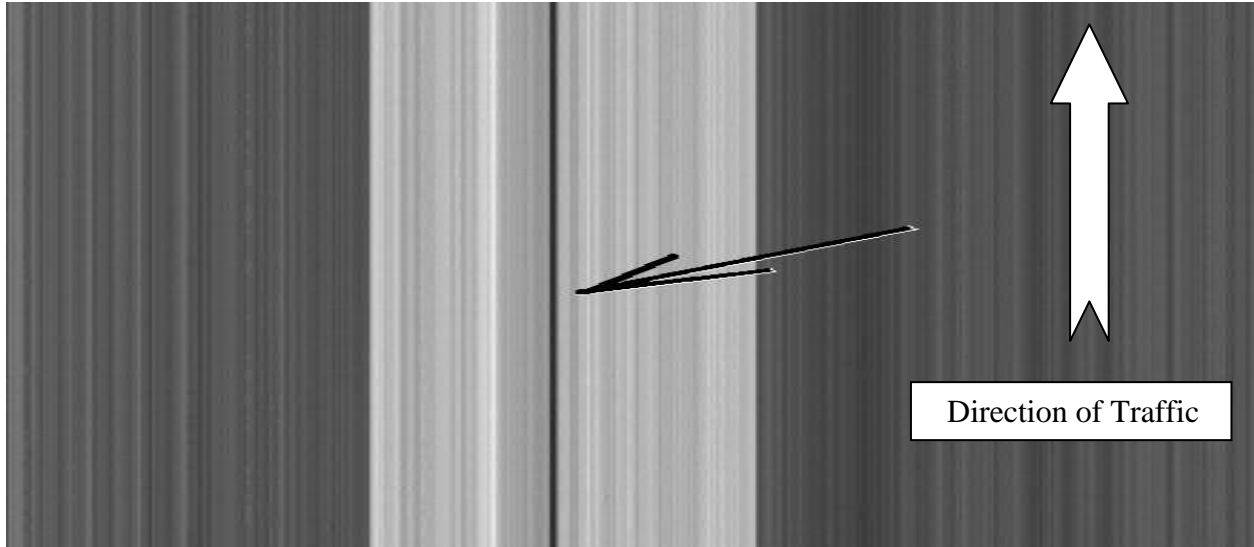
FIGURE 4 Lateral offset of MPSV's right laser

The effect of test vehicle lateral wander made it necessary to match the lateral position of the right laser spot with one of the nine faultmeter measurements at each joint. An image evaluation technique was improvised and was implemented accordingly. A 6 in (15.2 cm) wide white tape was glued to the floor of the MPSV calibration bay. A black line was drawn in the middle of the tape to mark the trace of the right laser in the center of the right wheel-path (Figure 4). This was done by positioning the vehicle body such that the right laser spot and rear right vehicle wheel were aligned with the black line. The MPSV was set on simulation mode to capture images of the floor surface. The black line was found to have an offset of 2,886 pixels from the left edge of a pavement image (Figure 4).

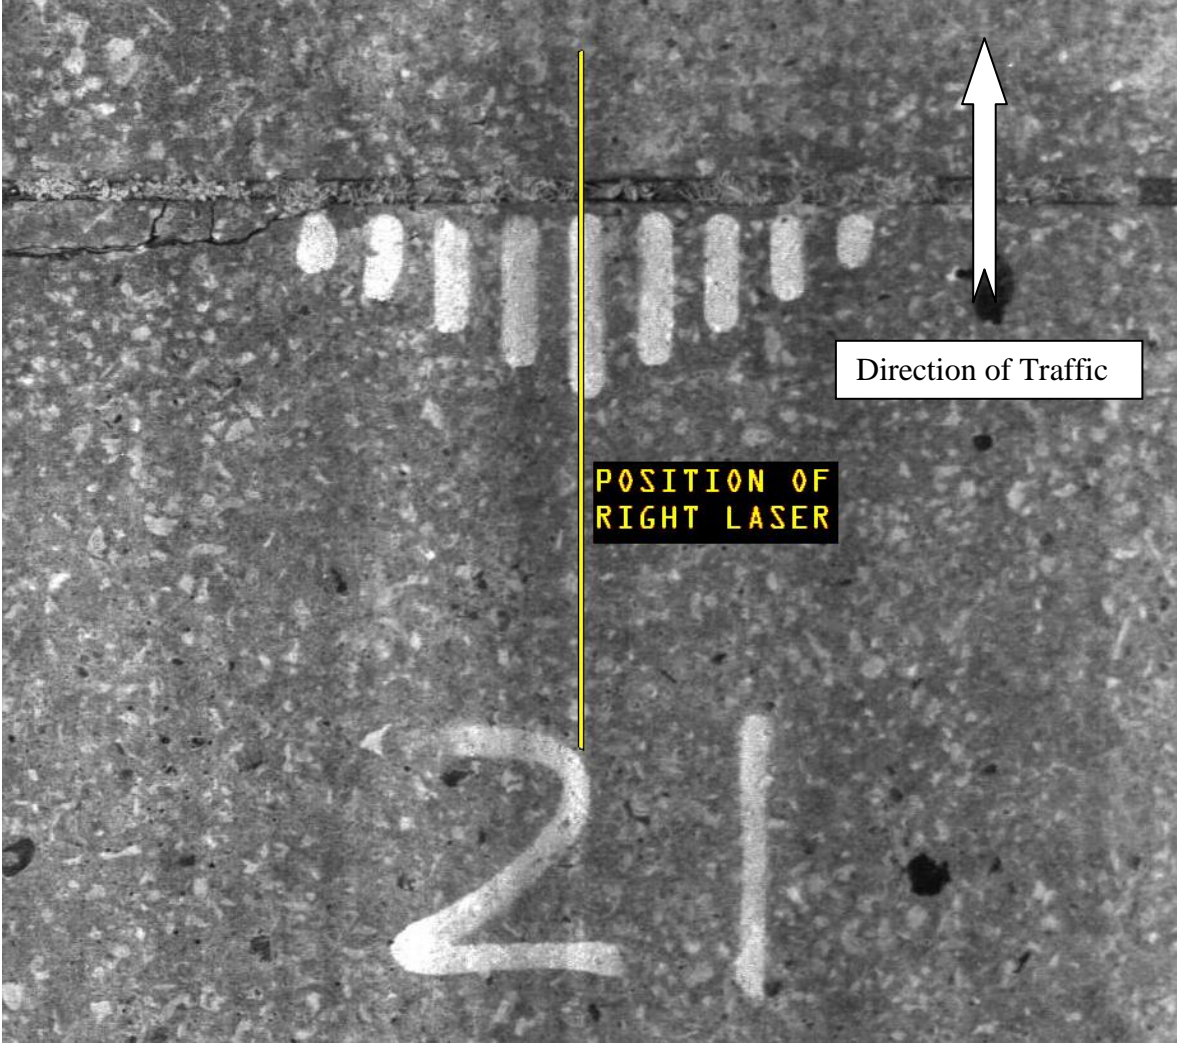
FIGURE 5 Matching of right laser lateral position with Faultmeter test location

The pavement images captured with the LRIS were viewed with the Photoshop software application, and only those images showing transverse joints and template markings were evaluated. A lateral offset of 2,886 pixels was measured from the left edge of each image, matching right laser position with corresponding Faultmeter test location (Figure 5). The same process was repeated for the image at each joint. In addition to pavement images, the MPSV simultaneously collected longitudinal profile elevations, which were later used by the developed algorithm to identify joint locations and estimate faulting.

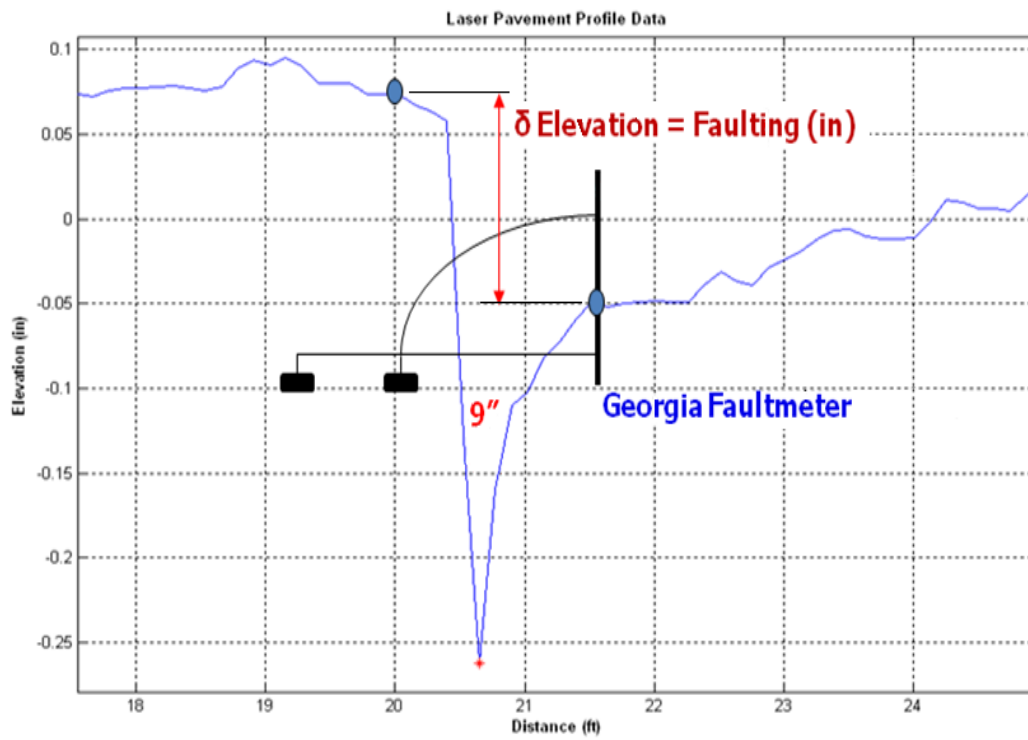
FIGURE 7 Faulting estimated by the “In-house” Method

In this method, the algorithm estimates faulting as measured by the Faultmeter. The algorithm first identifies the position of two points located 4.5 in (11.4 cm) on either side of a detected joint. The distance between these two points corresponds to the 9 in (22.9 cm) span between the Faultmeter’s measuring probe and its resting feet. The algorithm calculates faulting as the absolute difference in elevation between these two points (Figure 7).

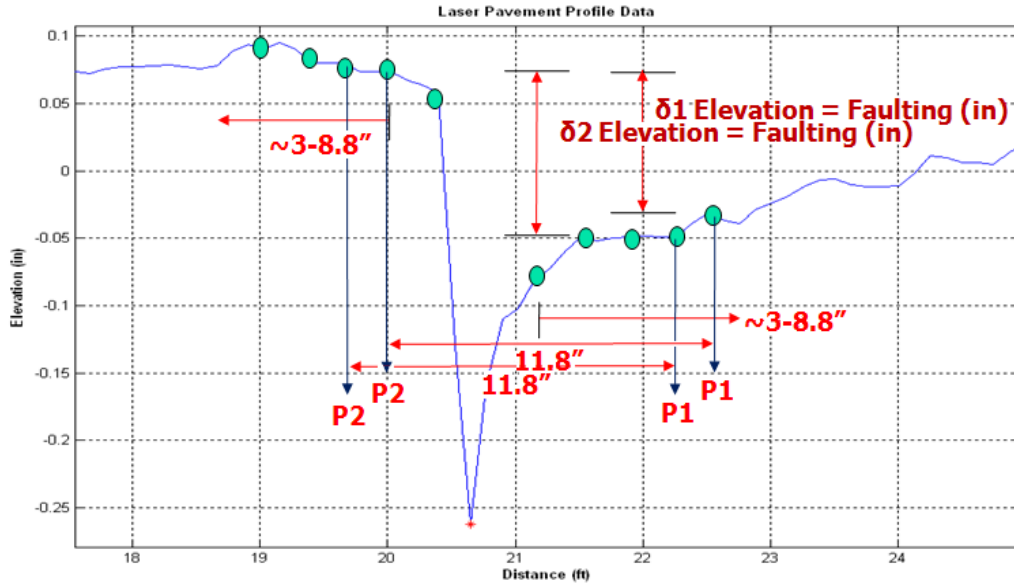
FIGURE 9 Faulting estimated by the AASHTO Method

In this method, the algorithm emulates the faulting measurement specified in the AASHTO R36-04 standard practice (Figure 8). The algorithm identifies sets of measurement points P1 and P2 located between 3 and 8.8 in (75 to 225 mm) away from a joint and separated by a constant distance of 11.8 in (300 mm) (Figure 9). The number of sets P1 and P2 is determined by dividing 5.8 in (139.7 mm) by the profile sampling interval plus one. For example, the number of measurement points for a sampling interval of 0.6812 in (Rate 1) is calculated as $[(5.8 \text{ in} / 0.6812 \text{ in}) + 1]$, which results in 10 sets of measurement points P1 and P2. The faulting at a joint is then calculated as the average difference in elevation between the set of points P1 and P2.
