EVALUATION OF INNOVATIVE SAFETY TREATMENTS

Volume 6: A Study of the Effectiveness of In-roadway Lights

Florida Department of Transportation

HNTB Corporation

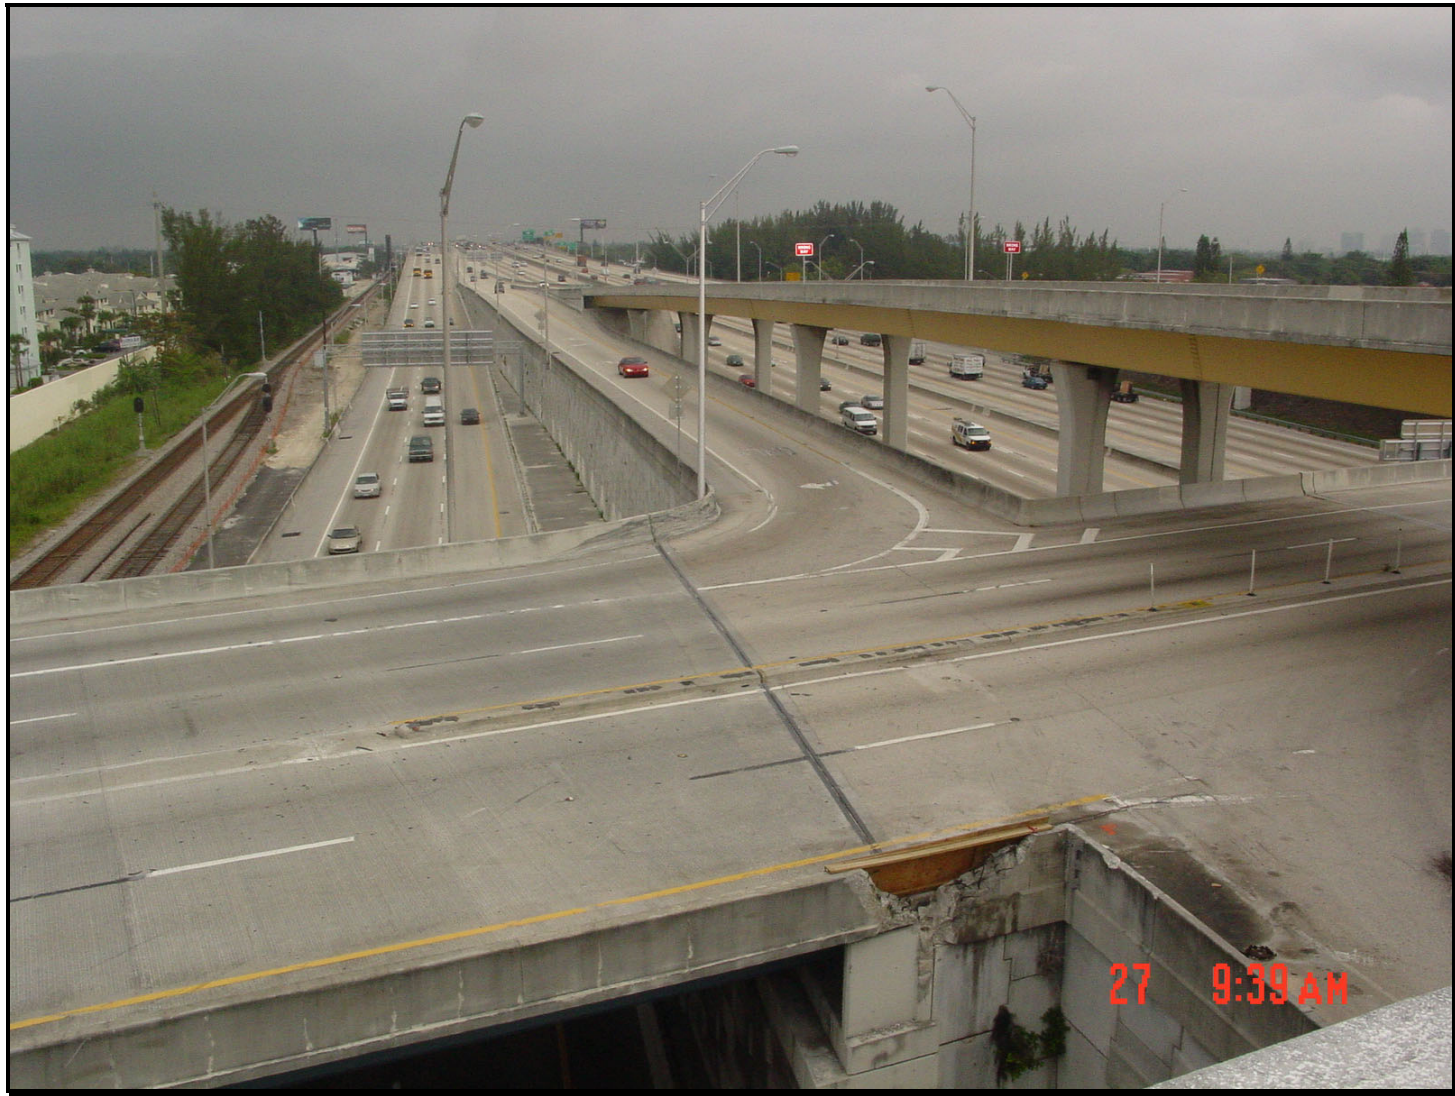
Figure 3. Looking north into the intersection of SB I-95 off-ramp at SR 84. Note damaged concrete wall on the south side.

The intersection of southbound I-95 off-ramp and westbound State Road 84 is a T-intersection located in the City of Fort Lauderdale, Broward County, Florida. The exit ramp is relatively long, approximately 2000 feet in length. As such, drivers tend to travel at a relatively high speed even after exiting the interstate. The exit ramp consists of one-lane and operates as a free-flow right-turn-only lane onto SR 84, which then merges with westbound SR 84 approximately 500 feet west of the intersection. The turning radius for this right turn is very small requiring drivers to slow down to 10 miles per hour. Figure 1 is an aerial view of the southbound I-95 off-ramp at SR 84. Figure 2 depicts the off-ramp configuration and existing signing/pavement marking approaching the intersection at SR 84. Figure 3 shows the intersection view from SR 84 looking north.
