**CORROSION RESISTANCE AND SERVICE  
LIFE OF DRAINAGE CULVERTS**

**State Job 99700-3335-119, WPI 0510756  
Contract No. B-9898  
Final Report to Florida Department of Transportation**

**Alberto A. Sagüés  
Principal Investigator  
Department of Civil and Environmental Engineering  
August 20, 2001**

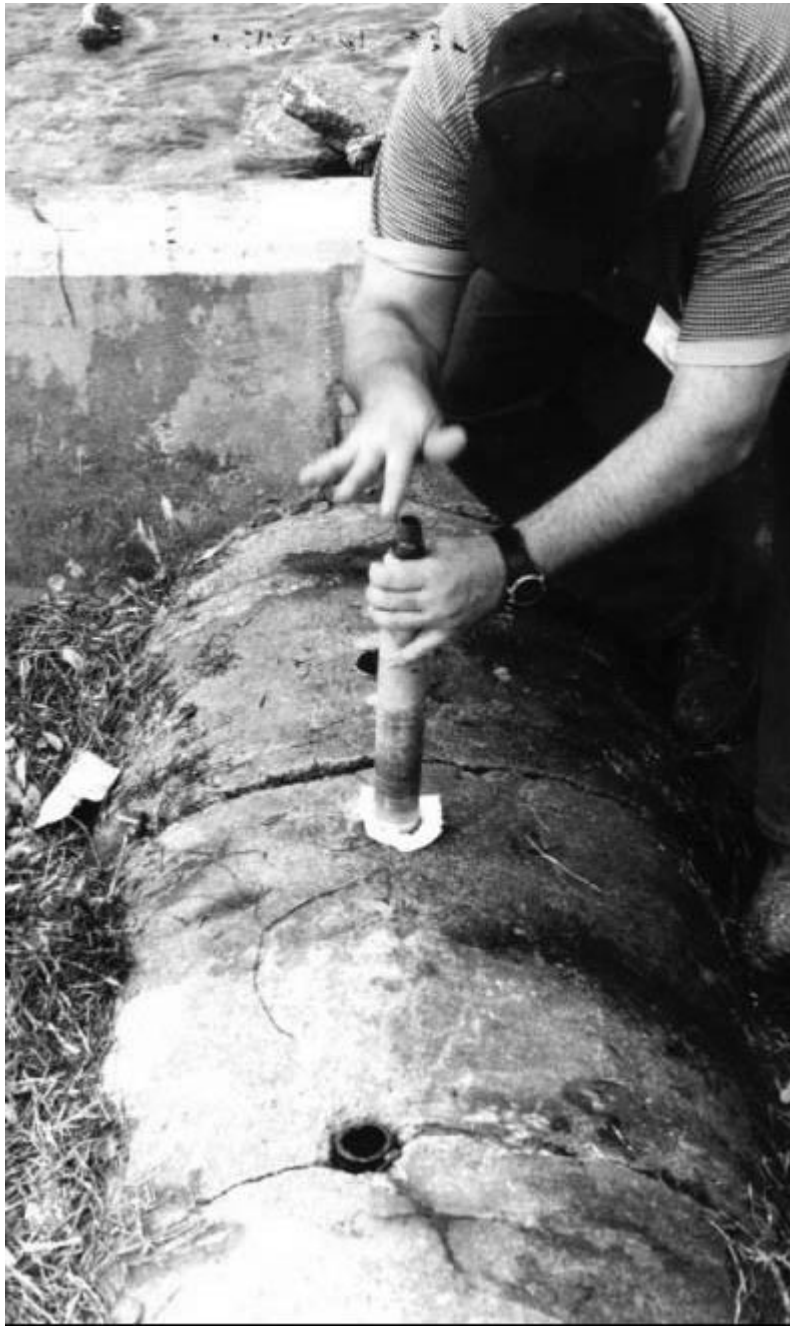
Figure 30. Site No. 7. End of San Jose Street. Low Tide. Core extraction. Evidence of pipe distress.

As shown by the chemical analysis information in Table 4, the water in locations 04 to 07 had a composition typical of seawater (with perhaps some minor dilution), and the soil next to the culvert showed significant seawater contamination in three of those locations. These extremely aggressive conditions are consistent with the evidence of pronounced corrosion seen at 3 of those sites. As expected, the sites where the Crown was below high tide (thus less likely to experience evaporative chloride concentration) have the best overall appearance and less evidence of rust in the rebar inside cores. The two sites with Crown above high tide had the most evidence of damage. Although all culverts examined appeared to be still fully functional, the condition at location 07 (estimated age 43 years) appears to be indicative of a structure approaching the end stages of its service life (See Figures 30 and 31).
