**FINAL REPORT**

**U.F. No. 49104504559-12  
State Project No. 99700-3359-010  
W.P.I. No. 0510792  
Contact No. BA513**

# **Development of Improved Procedures for the Removal of Pavement Markings During FDOT Construction Projects**

**JUNE 1999**

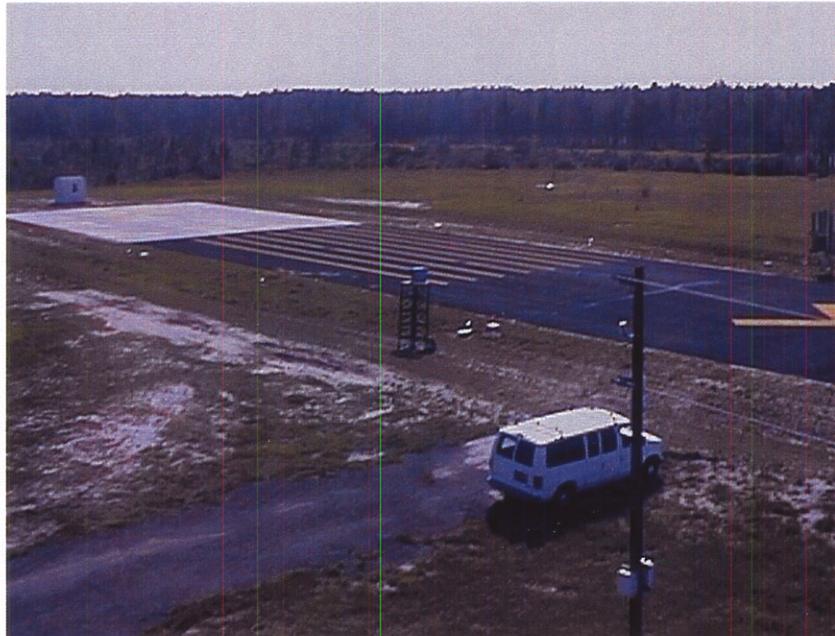
Figure 3-1 Pavement Marking Removal Test Site

The site for the pavement marking removal research was located at Camp Blanding in Starke, Florida. A 300 foot by 75 foot asphalt concrete and portland cement concrete runway test strip was used to place and subsequently remove paint, thermoplastic, and temporary tape. Only the asphalt concrete section was used for testing, as this it is the more common pavement used in Florida, and the one where most removal problems occur. A photo of the site is shown in Figure3-1 and a detailed site plan is included as Appendix C.

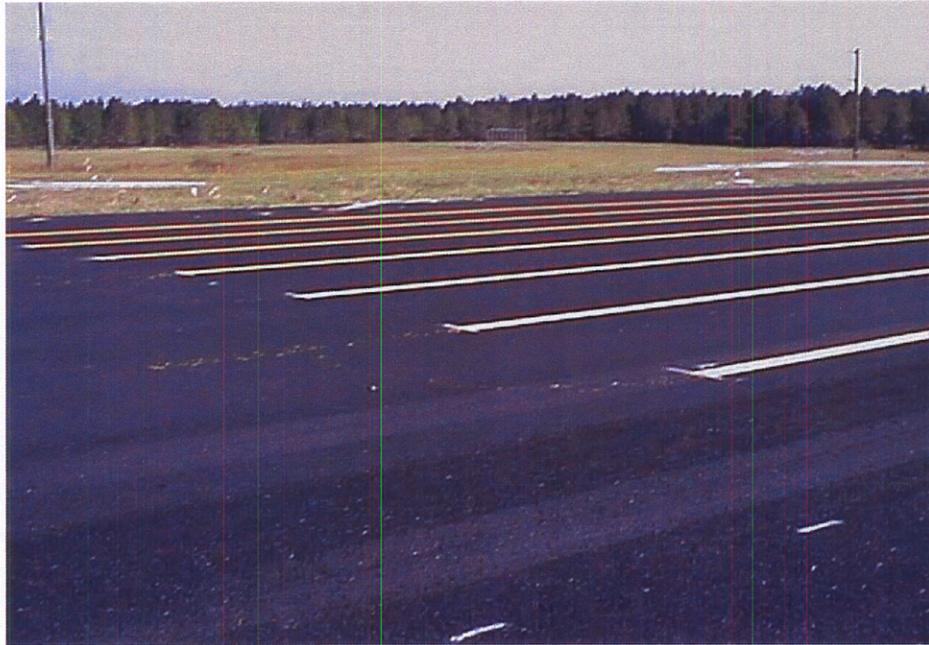
Figure 3-6 Test Site with all Markings Applied

- a. 20-mil Paint line
- b. 100-mil thermoplastic line
- c. 100-mil thermoplastic line
- d. 90-mil thermoplastic line
- e. 90-mil thermoplastic line
- f. 90-mil thermoplastic line
- g. 90-mil thermoplastic line
- h. 35-mil temporary tape line

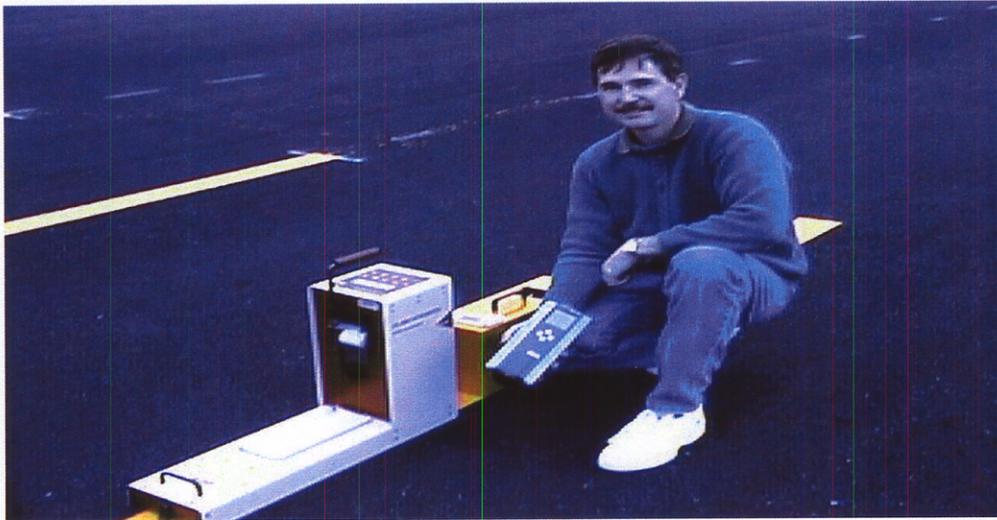
Figure 3-7 FDOT BYK Portable Chromaticity Instrument

machine was not available for use during testing. A photo of the equipment used to test the markings is shown in Figure 3-7.

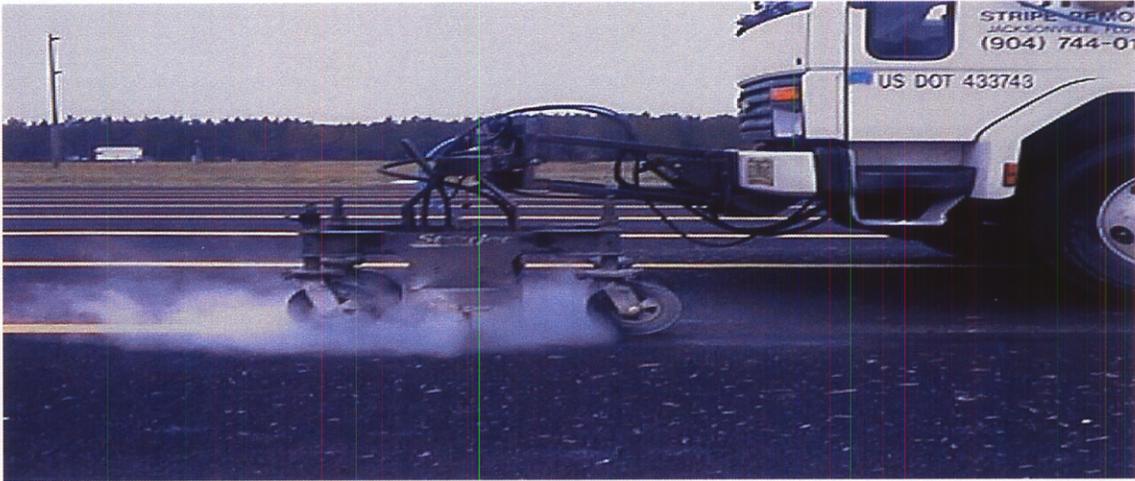
Figure 3-8. Water Blasting Paint Stripe (line A) with Truck Unit

- a. 20-mil paint line removed by Ultra High Pressure (UHP) waterblasting
- b. 100-mil thermoplastic line removed by UHP waterblasting
- c. 100-mil thermoplastic line removed by grinding flush followed by UHP blasting
- d. 90-mil thermoplastic removed by UHP waterblasting
- e. 90-mil thermoplastic removed by grinding to be followed with emulsion overlay
- f. 90-mil thermoplastic removed by grinding only
- g. 90-mil thermoplastic line removed by UHP waterblasting with portable unit
- h. 35-mil temporary tape line removed by UHP waterblasting

Figures 3-8 through 3-13 document the marking removal methods.

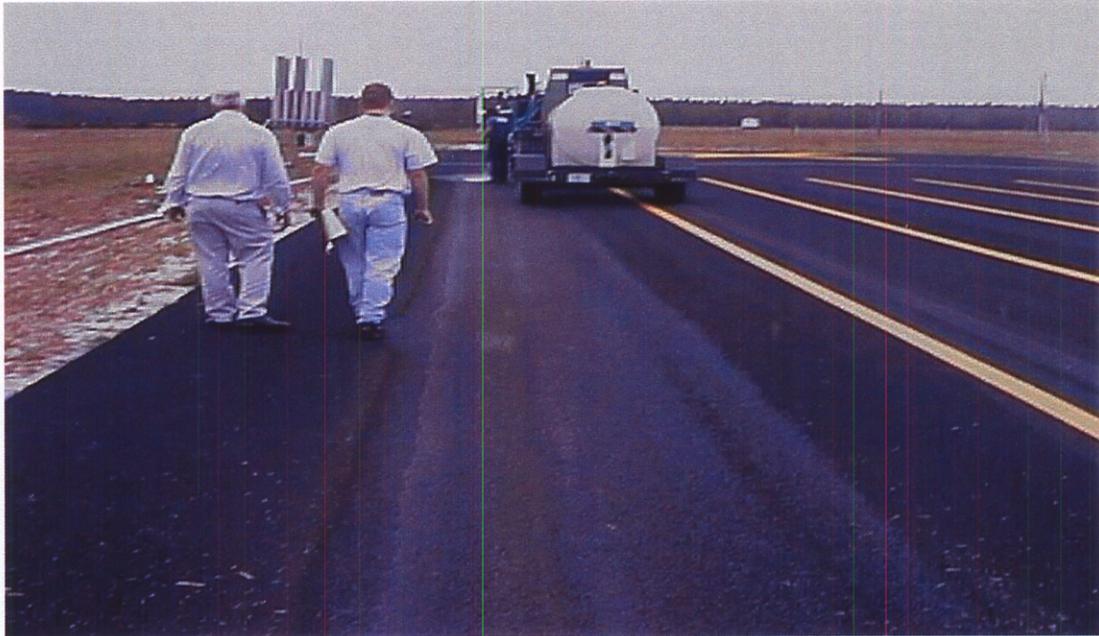
Figure 5-1. Line A After Water Blasting.

Table 5-2 Evaluation of Removal Results ( Daytime )

Line	Pvt. Type	Equipment & Procedure	Thickness Removed (mils)	Color Change	Texture Change	Potential for scar to be mistaken
A	AC	36,000 psi, 4.5 gal/min 2800 rpm, Single Pass	20	2 (+)	1	2
B	AC	Same as above. 80% on 1st pass, 20% on 2nd	100	3 (+)	1	2
C	AC	Same as above. Also, 9 HP Edco grinder	100	3 (+)	2	3
D	AC	Same as above, but low- ered nozzles to 1/2 in.	90	3 (+)	1	2
E	AC	Edco 9 HP grinder	90	4 (+)	5	5
F	AC	Edco 9 HP grinder	90	4 (+)	5	5
G	AC	36,000 psi walk-behind unit, single pass	90	3 (+)	1	2
H	AC	Same as above	35	3 (+)	1	2

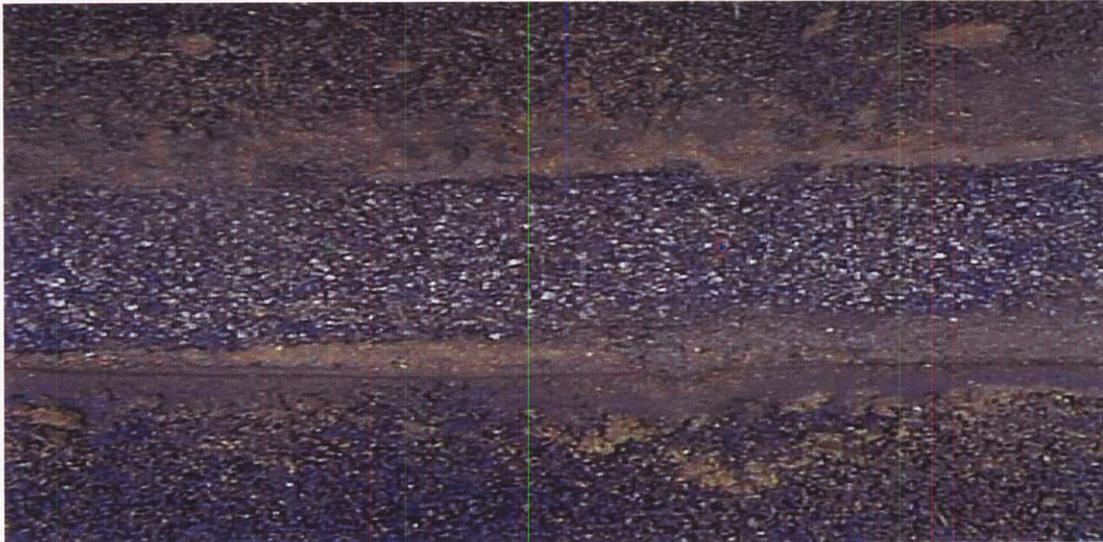
Figure 5-2. Final Surface Conditions of Line B after Water Blasting.

The second line consisted of a 100-mil thermoplastic, which was also removed by water blasting at the same pressure, flowrate, and head rotation as with Line A. As could be expected, the rate of removal (see table 5-1) was less than with the paint due to the thickness of the thermoplastic marking. The first pass removed about 80%, with the second pass removing about another 10-15%. A small percentage of thermoplastic remained in the pores of the AC friction course layer. There was a slightly more prominent color disparity between the removed marking and the surrounding pavement than with the painted marking. Once again, color contrast was “positive” because the scar was lighter than the surrounding pavement. Texture change was again negligible. Based on the color and texture changes, the potential for the scar to be mistaken for a marking was still low (also rated 2 out of 5). Therefore, although removal of

thermoplastic is slower than with paints, it is still quite effective. See Figure 5-2 below for the final surface conditions of Line B after removal was complete.

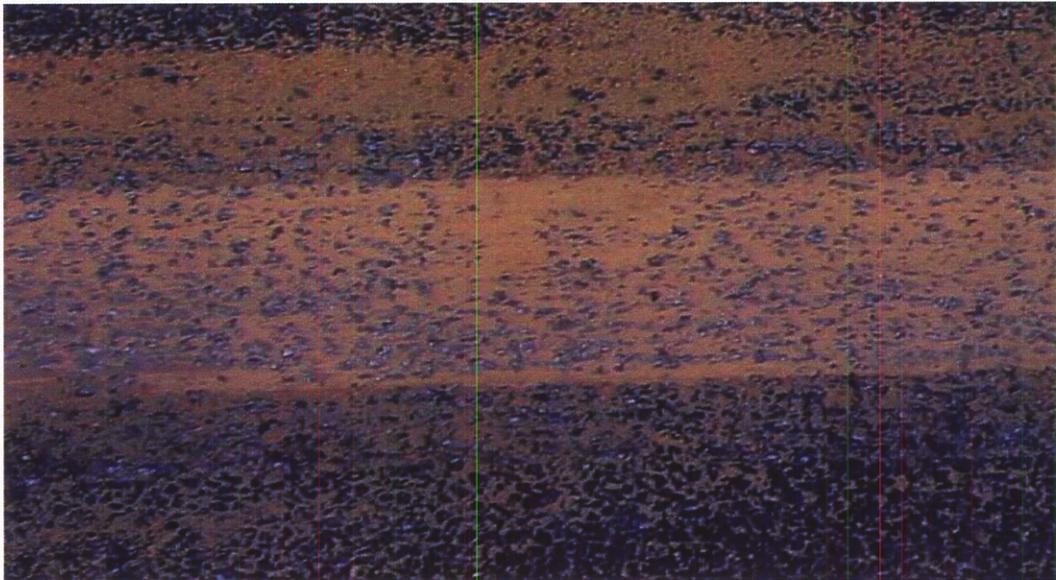
Figure 5-3 Line C after Grinding Flush

The third line also consisted of a 100-mil thermoplastic, which was removed by a combination of grinding the marking flush with the surface followed by water blasting the remaining layer using the same pressure, flowrate, head rotation, and nozzle distance. Production was a little slower (see Table 5-1) due to the extra step of grinding, but the results were almost identical to Line B's, where water blasting was used as the sole removal method for the 100 mil thermoplastic. As with Line B, removal was almost complete (4 out of 5), color disparity was moderate (3 out of 5), and color contrast was "positive" since the scar was lighter than the surrounding pavement. There was a slight texture change (2 out of 5), which was probably due to the grinder grazing the surface. For this reason, the potential for the scar to be mistaken for a marking was given a 3 out of 5. From these results, it appears that the combination of grinding the surface flush followed by water blasting the remaining layer is an effective removal option. See

Figures 5-3 and 5-4 for photos of the final surface conditions of line C after grinding the top layer, and after finishing the final layer with water blasting.

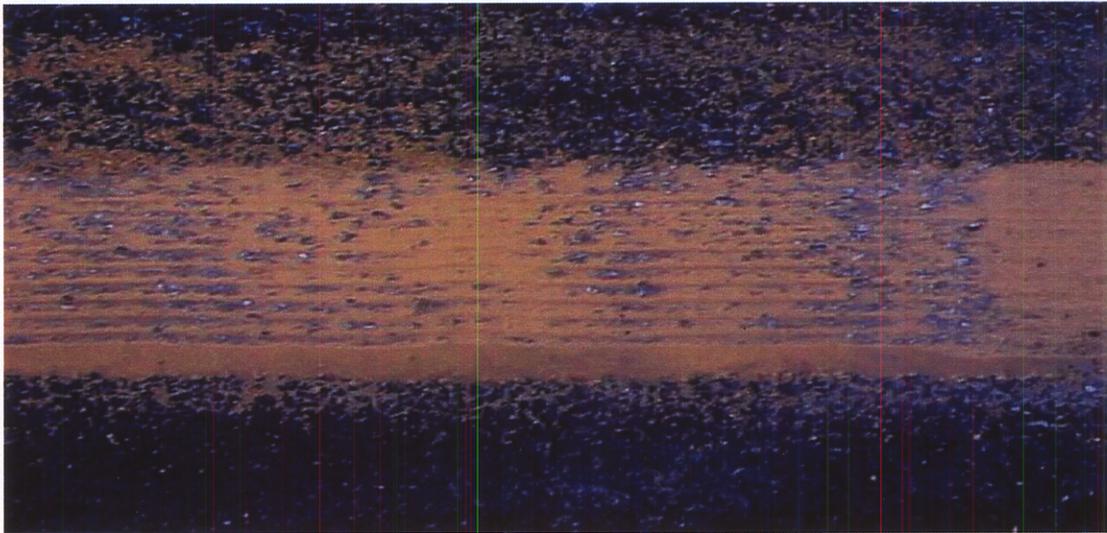
Figure 5-5 Line E after Grinding Pavement Marking

Line E consisted of a 90-mil thermoplastic removed by grinding with an Edco 9 HP grinder. Rate of removal was similar to removal of the paint line using water blasting (see Table 5-1). Completeness of removal was poor with a single pass (3 out of 5). Color disparity was high (4 out of 5), and color contrast was “positive”. This was due to the grinder scraping off the black coating of the AC friction course surface, which left what resembled a white marking. Texture change was quite noticeable (5 out of 5), manifested as deep grooves in the surface layer. Based on the color and texture of the surface after removal, the potential for the scar to be mistaken for a marking was high (5 out of 5). The grinding results were in accord with prior input obtained from FDOT construction and maintenance personnel. Grinding of the pavement markings resulted in pavement scarring. See Figure 5-5 for a photo of the surface after grinding.

Line F also consisted of a 90-mil thermoplastic line removed by grinding. The results were essentially identical to those for Line E. Once again, significant scarring was observed.

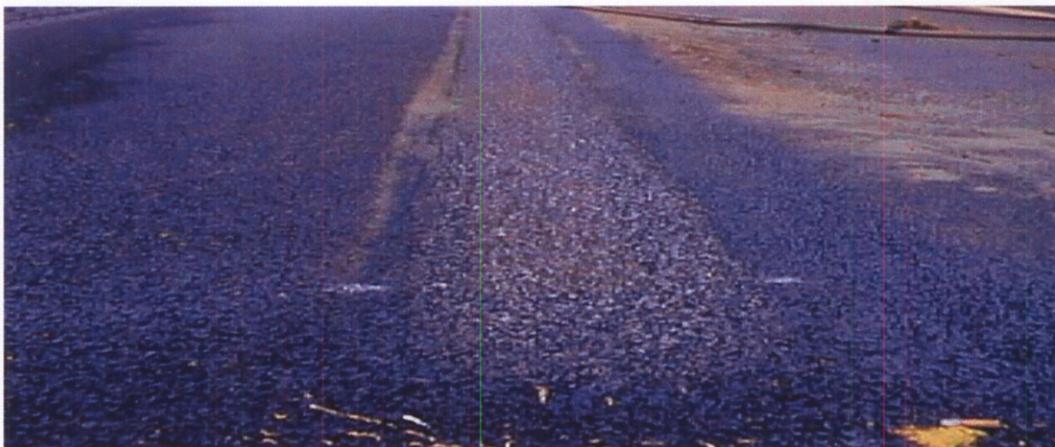
Figure 5-6. Line G after Removal with Walk-Behind Water Blast Unit.

Line G consisted of a 90-mil thermoplastic, which was removed with a portable walk-behind waterblaster. The waterblast unit provided similar conditions to the truck unit. Rate of removal was almost double that of the truck unit, but the removal was just as efficient as with the truck unit. Completeness of removal was high (5 out of 5), color disparity between scar and surrounding pavement was moderate (3 out of 5). Texture change was negligible (1 out of 5). Therefore, the potential for the scar to be mistaken for a marking was small (2 out of 5). It should be noted that the walk-behind unit is most useful for tight areas where the truck unit cannot easily access. Thus, the walk-behind unit is a viable option for removing markings effectively in difficult to access areas. See Figure 5-8, 5-9 below for final surface conditions after removal of 90-mil thermoplastic line using walk-behind waterblaster.

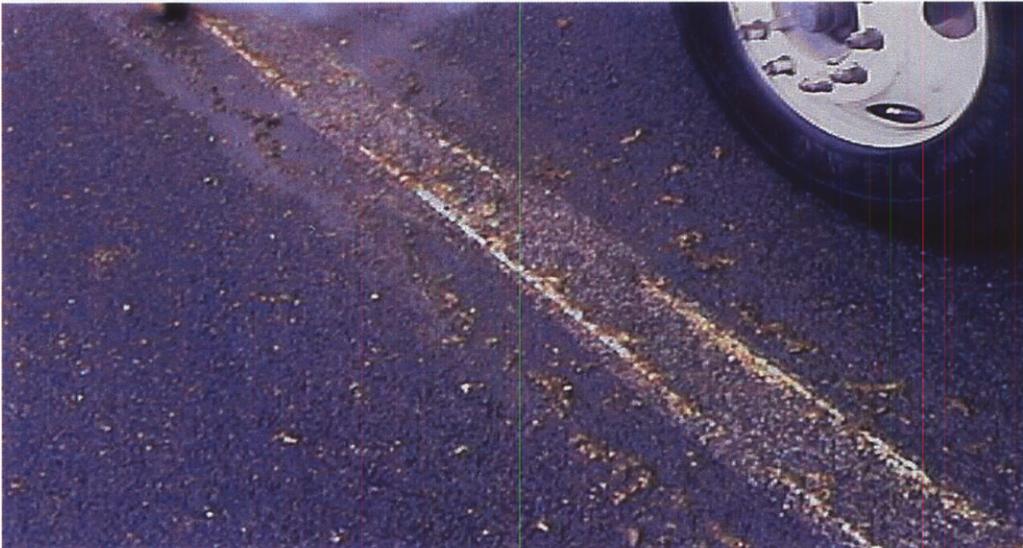
Figure 5-7. Removal of Temporary Tape (Line H) Using Water Blasting.

Line H consisted of a 35-mil temporary tape, which was removed by water blasting with the truck unit at the same conditions as the other lines. Removal was almost complete with one pass (4 out of 5), removal rate was slower than with paint, but quicker than with thermoplastic (see Table 5-1), color change was moderate (3 out of 5), and texture change was negligible (1 out of 5). Therefore, the potential to mistake the scar for a marking was small (2 out of 5). In short, removal of temporary tape using water blasting was quite effective. See Figure 5-7 for a photo of the final surface conditions. A second pass would have removed the tape that still remains in the picture.

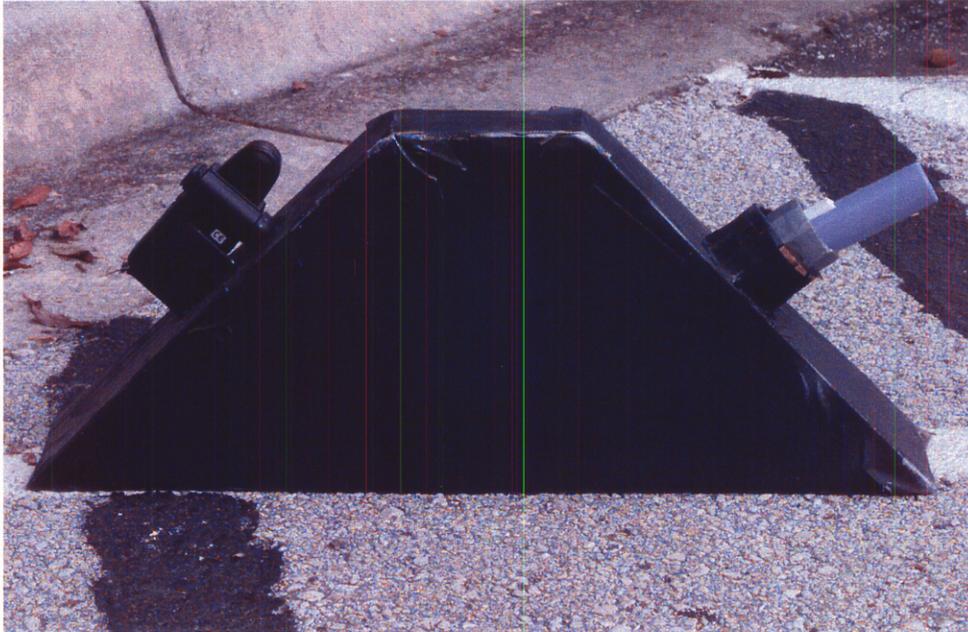
Figure 6-1 Reflectance Testing Device

adjacent to the spot where the stripe reading was taken. The objective was to determine the relative change in reflectivity resulting from the removal process.

Figure 6-1 presents a photograph of the reflectivity testing device. Figure 6-2 presents a photograph of the Sekonic meter.

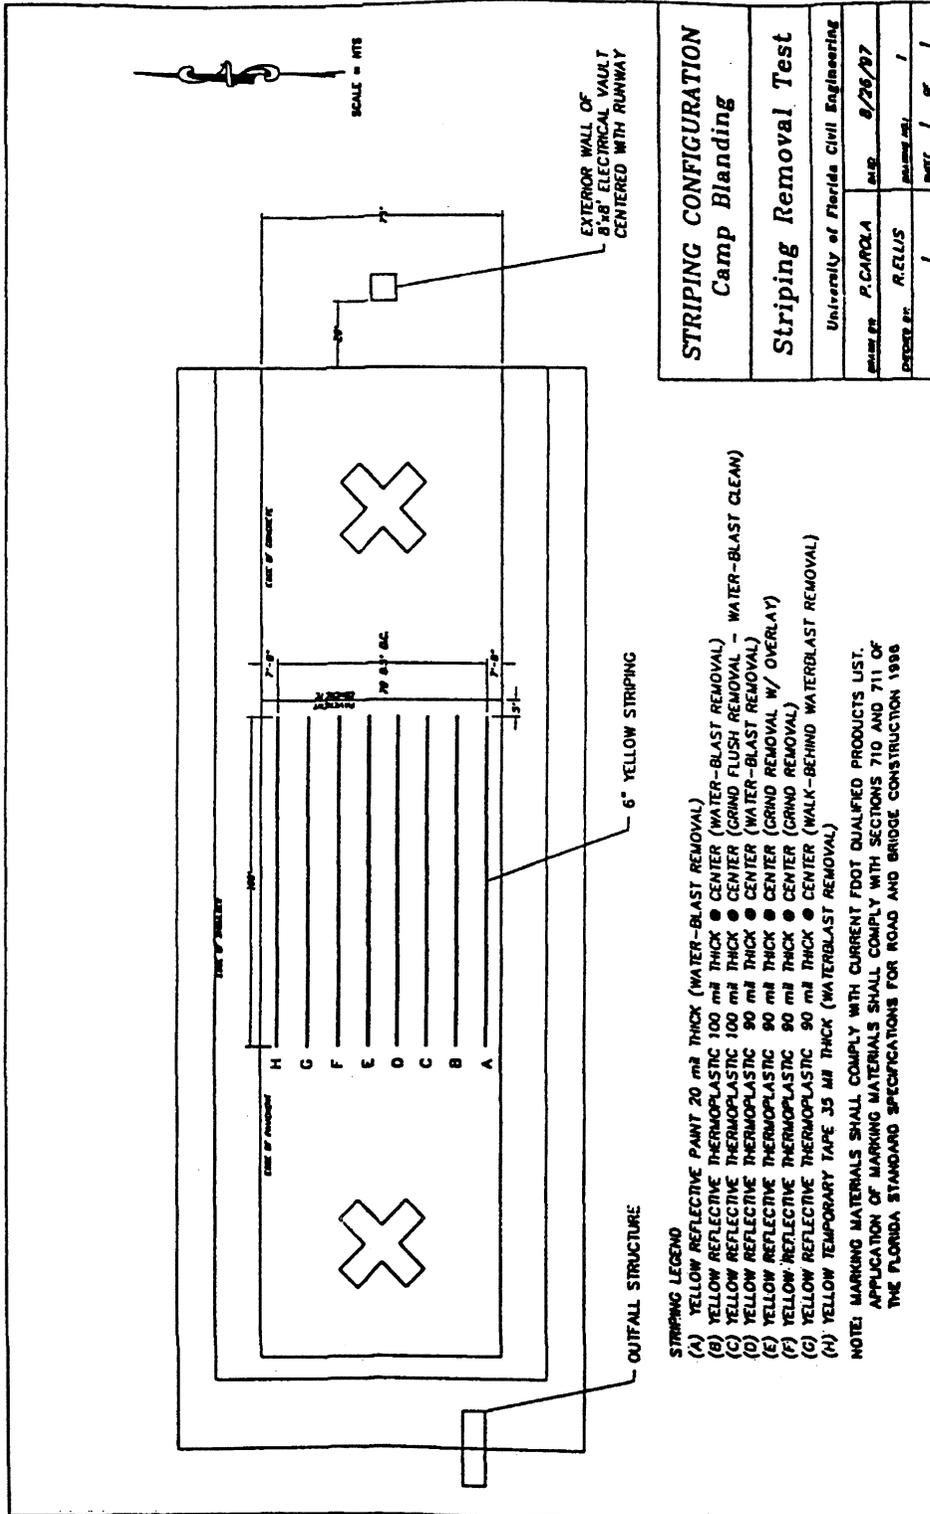
**STRIPING CONFIGURATION**  
Camp Blanding

**Striping Removal Test**

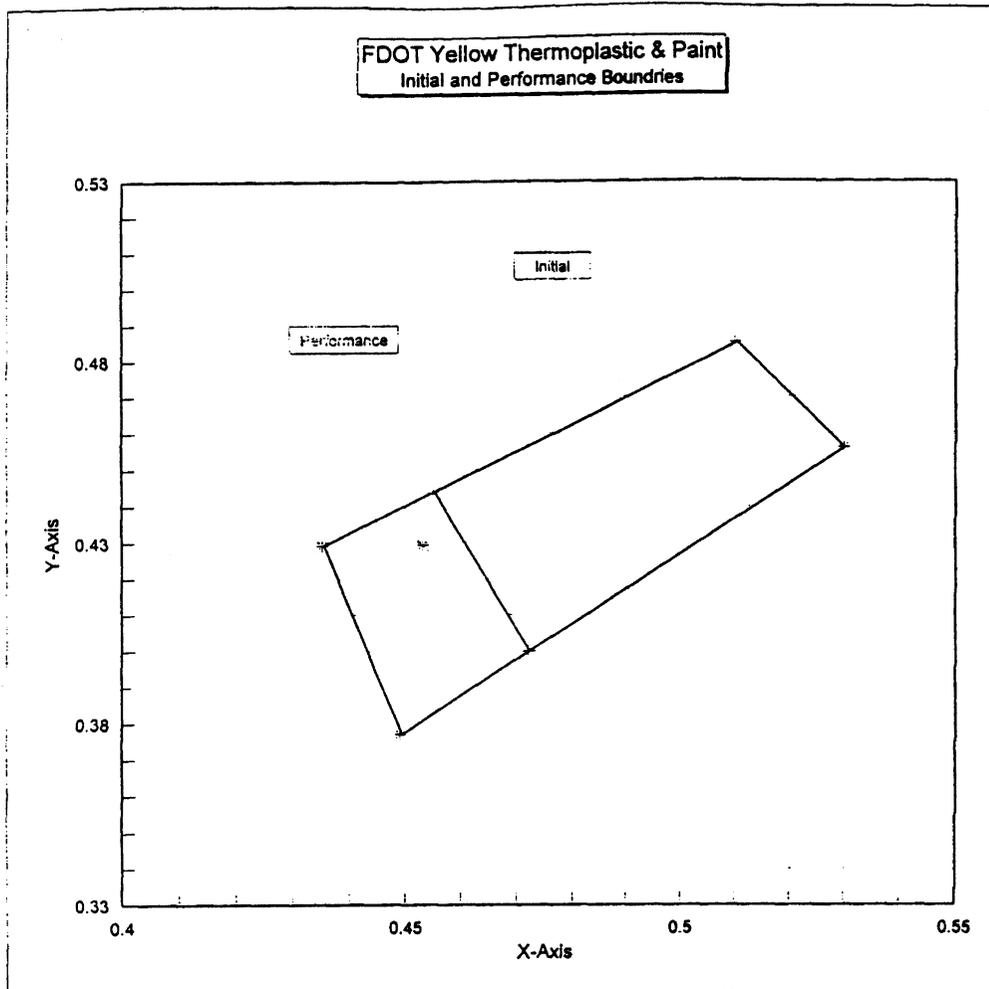
Figure - Yellow Thermo & Paint 97 (After August 1, Initial Color Box Day 1 thru Wk 2, Performance > Wk 2)

Table 97 - Yellow Thermoplastic and Paint, Chromaticity Test Results. August 1997

YELLOW	COORDINATE VALUES	
	x	y
Regulatory Value No. 1	0.4550	0.4440
Regulatory Value No. 2	0.5100	0.4850
Regulatory Value No. 3	0.4720	0.4000
Regulatory Value No. 4	0.5300	0.4560
Regulatory Value No. 5	0.4350	0.4290
Regulatory Value No. 6	0.4490	0.3770
Mean Of Three Tests	0.4531	0.4293
Test # 1	0.4536	0.4306
Test # 2	0.4518	0.4360
Test # 3	0.4540	0.4272

Notes: Tests results requested by UF School of Civil Engineering involve field testing of physical parameters for a test section. Material is a yellow thermoplastic with drop on beads installed on FC2 Asphaltic Cement. Testing was performed using a FDOT BYK portable chromaticity instrument on 11-5-97.

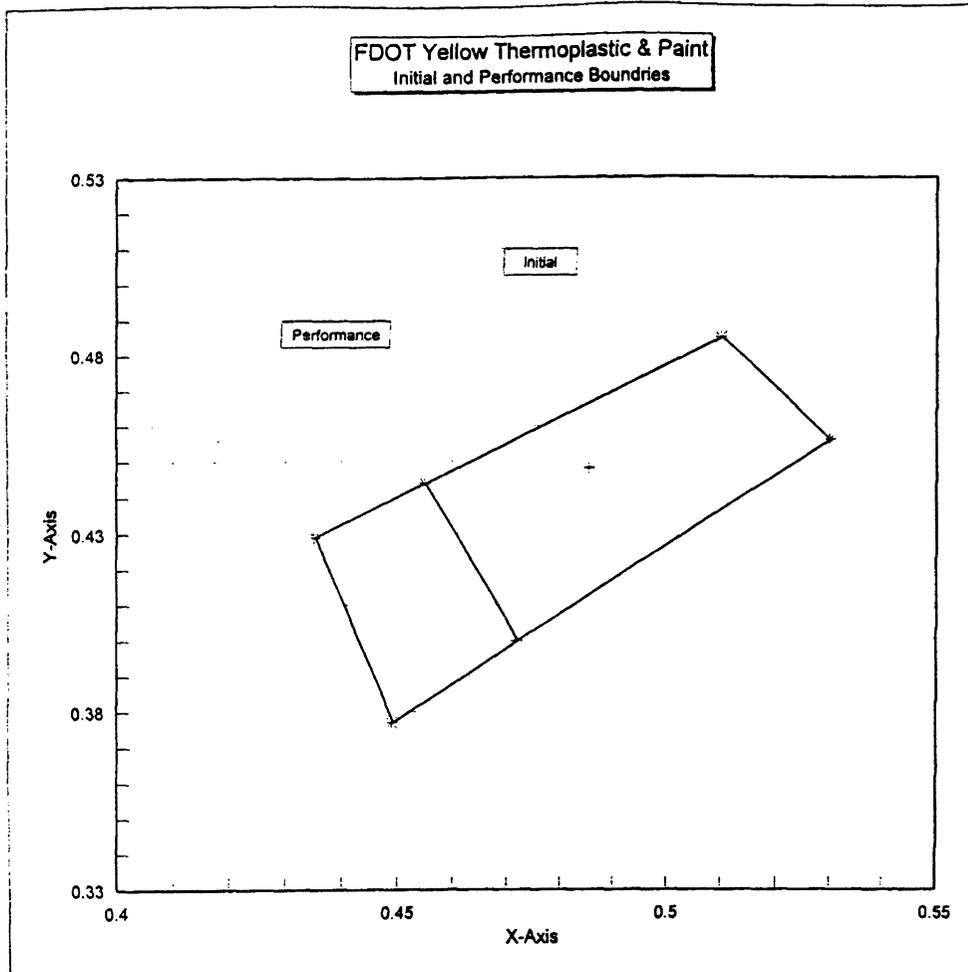
Figure - Yellow Thermo & Paint 97 (After August 1, Initial Color Box Day 1 thru Wk 2, Performance > Wk 2)

Table 97 - Yellow Thermoplastic and Paint, Chromaticity Test Results. August 1997

YELLOW	COORDINATE VALUES	
	X	Y
Regulatory Value No. 1	0.4550	0.4440
Regulatory Value No. 2	0.5100	0.4850
Regulatory Value No. 3	0.4720	0.4000
Regulatory Value No. 4	0.5300	0.4560
Regulatory Value No. 5	0.4350	0.4290
Regulatory Value No. 6	0.4490	0.3770
Mean Of Three Tests	0.4855	0.4481
Test # 1	0.4908	0.4480
Test # 2	0.4839	0.4504
Test # 3	0.4877	0.4455

Notes: Tests results requested by UF School of Civil Engineering involve field testing of physical parameters for a test section. Material is 3M yellow thermoplastic tape installed on FC2 Asphaltic Cement. Testing was performed using a FDOT BYK portable chromaticity instrument on 11-5-97.

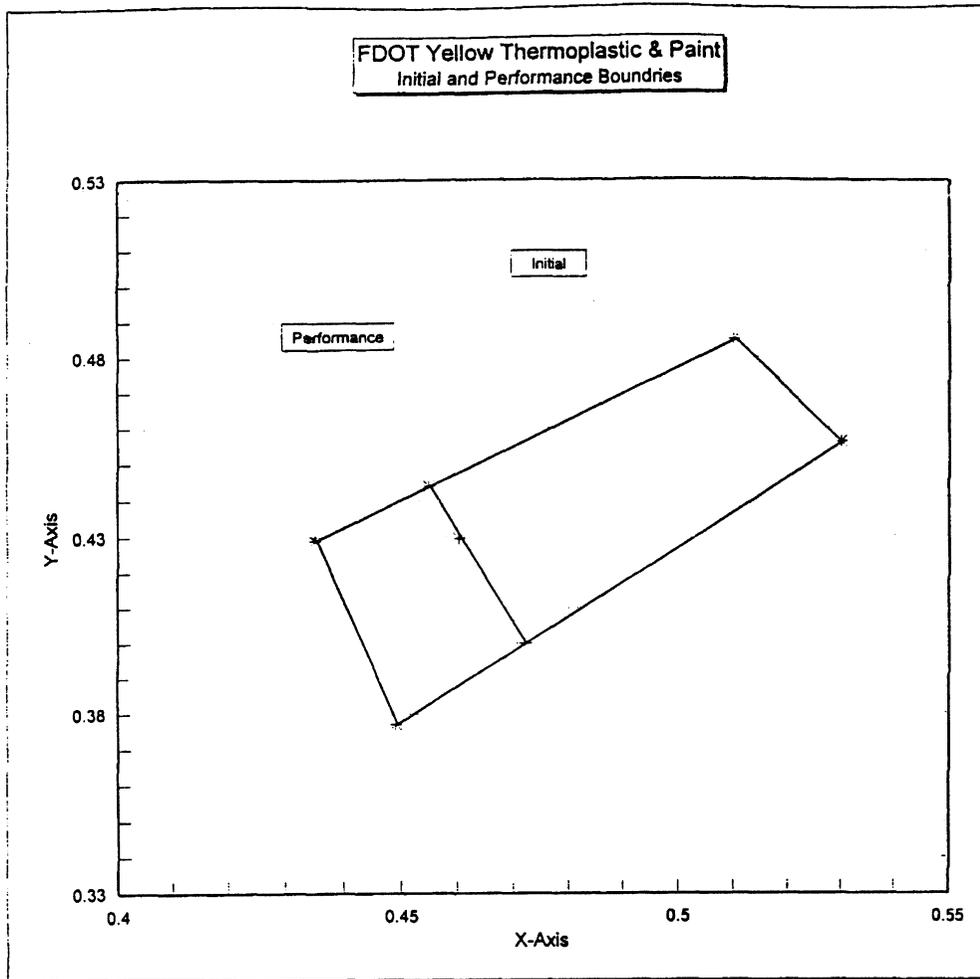
Figure - Yellow Thermo & Paint 97 (After August 1, Initial Color Box Day 1 thru Wk 2, Performance > Wk 2)

Table 97 - Yellow Thermoplastic and Paint, Chromaticity Test Results. August 1997

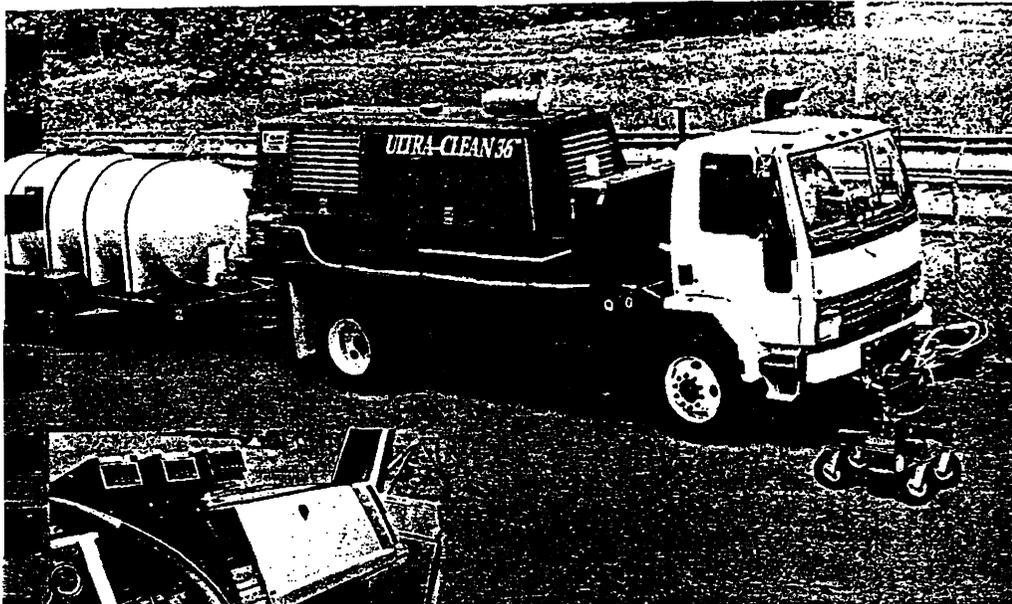
All STARJET™ system operating controls (above) are conveniently located in the truck cab.

Now there's a mobile ultra-high pressure water jet system that removes painted stripes and coatings from highways and parking decks in just minutes.

The STARJET™ system from NLB Corp. makes short work of permanent or temporary stripes... even thermal material. It won't damage concrete or asphalt, because it uses nothing but 36,000 psi (84 bar) water.

The ultra-high pressure water for the STARJET™ unit is provided by an NLB ULTRA-CLEAN 36<sup>®</sup> pump, mounted on the truck bed. The pump is rated up to 36,000 psi and 6 gpm (2,500 bar and 22.7 lpm). The truck pulls a 1,625-gallon (6,150 l) tank trailer, which supplies water to the pump via a transfer pump. A second water tank is recommended to ensure a continuous water supply.
