Evaluation of X-Box Pavement Markings at Railroad-Highway Crossings

Final Report

Prepared in cooperation with the
State of Florida Department of Transportation and the
U.S. Department of Transportation

January 2002

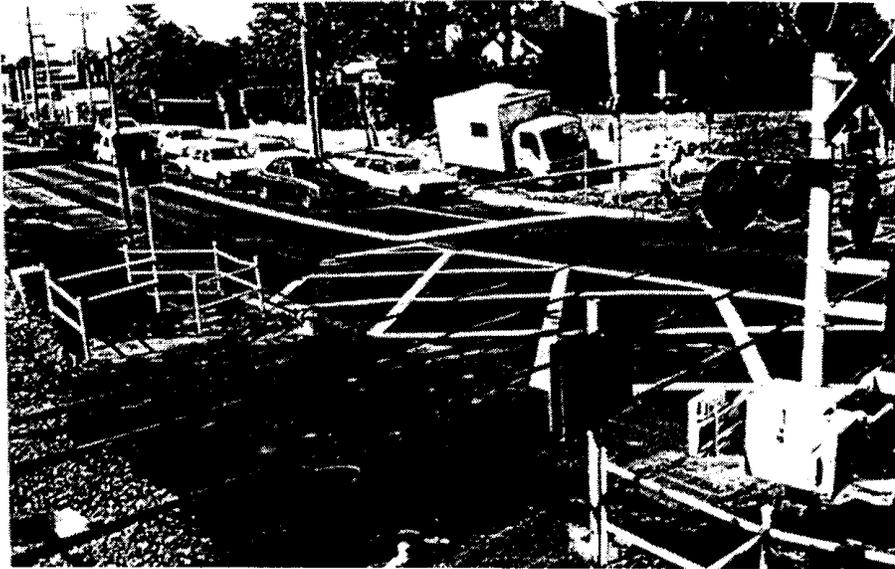
Figure 1-2. Crossing at Middleborough Road, Box Hill, Australia

markings on the near side of the crossing, as shown in figure 1-2, and yielded few encroachments onto the tracks. Although the study was very short in duration, it did show a significant reduction in the number of encroachments on or adjacent to the tracks, as can be seen in figure 1-3³.

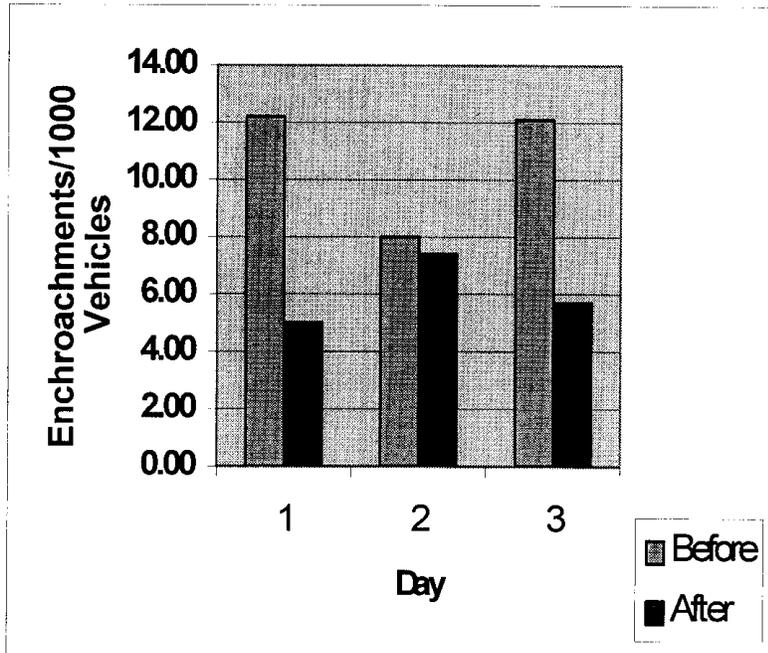
Figure 1-3. Comparison of Encroachments at Box Hill Grade Crossing

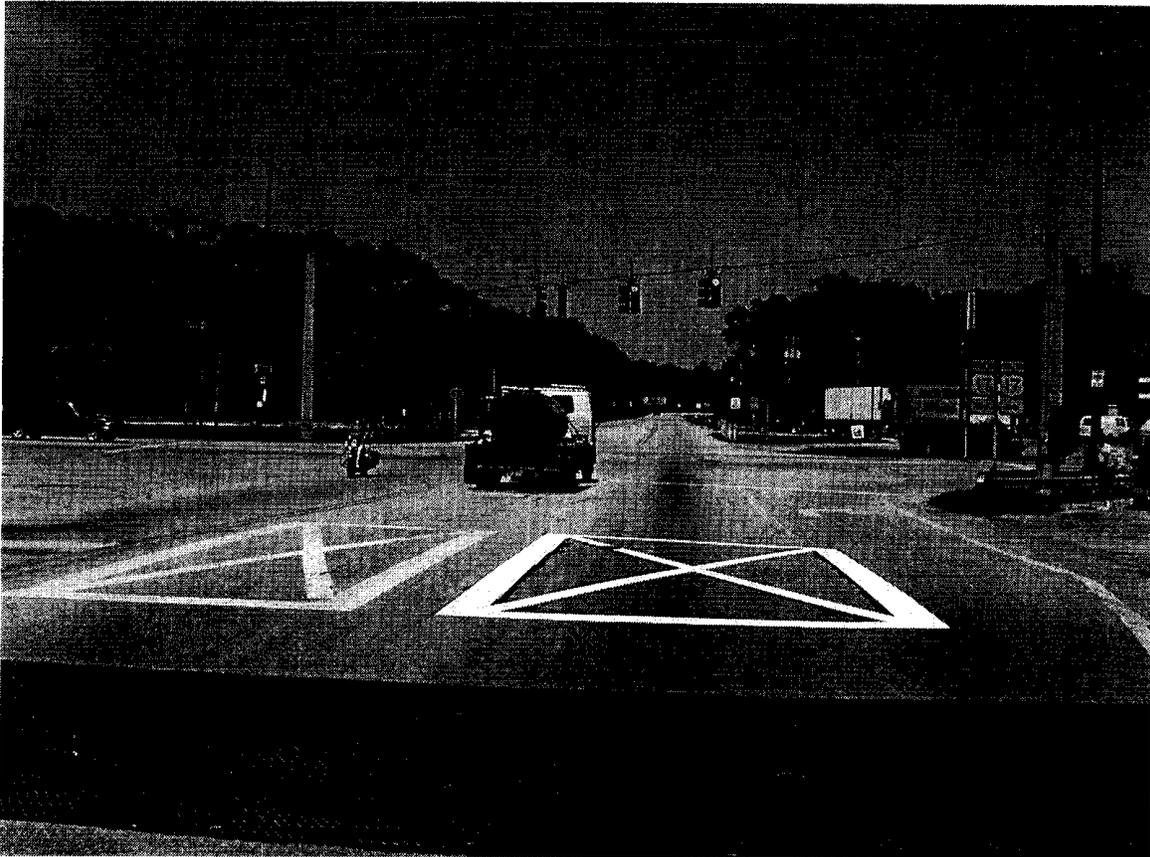
Figure 2-1. Barberville Crossing with European X Markings Installed

The evaluation plan was for three sites, one rural test site as shown in figure 2-1, and one urban test site as shown in figure 2-1, both of which involved the installation of the European X marking. The third site was an urban control site which was not treated. There was to be a suitable period in which "before data" could be collected so that direct comparisons of "after data" with similar traffic conditions would allow analysis of the potential safety performance at these locations once the markings had been installed by FDOT maintenance crews. It was attempted to locate two suitable locations for control sites, one rural and one urban, with each in close proximity to the test sites, where data could be collected during the same time periods when before and after data were collected at the treated sites. These controls were intended to determine whether there were changes in the study measures of effectiveness (MOEs) which were not directly attributable to the introduction of the experimental X markings, but instead to systemic changes in traffic characteristics, weather, public safety campaigns, etc., which could contaminate results of a simple "before-after" design. Only one suitable control site was found. If the sites had been selected because of their unusually high numbers of incidents (which was not considered in the selection for this study), this type of experimental design would help make corrections for regression-to-the-mean bias. The basic experimental design therefore is referred to as a before-after design with controls.

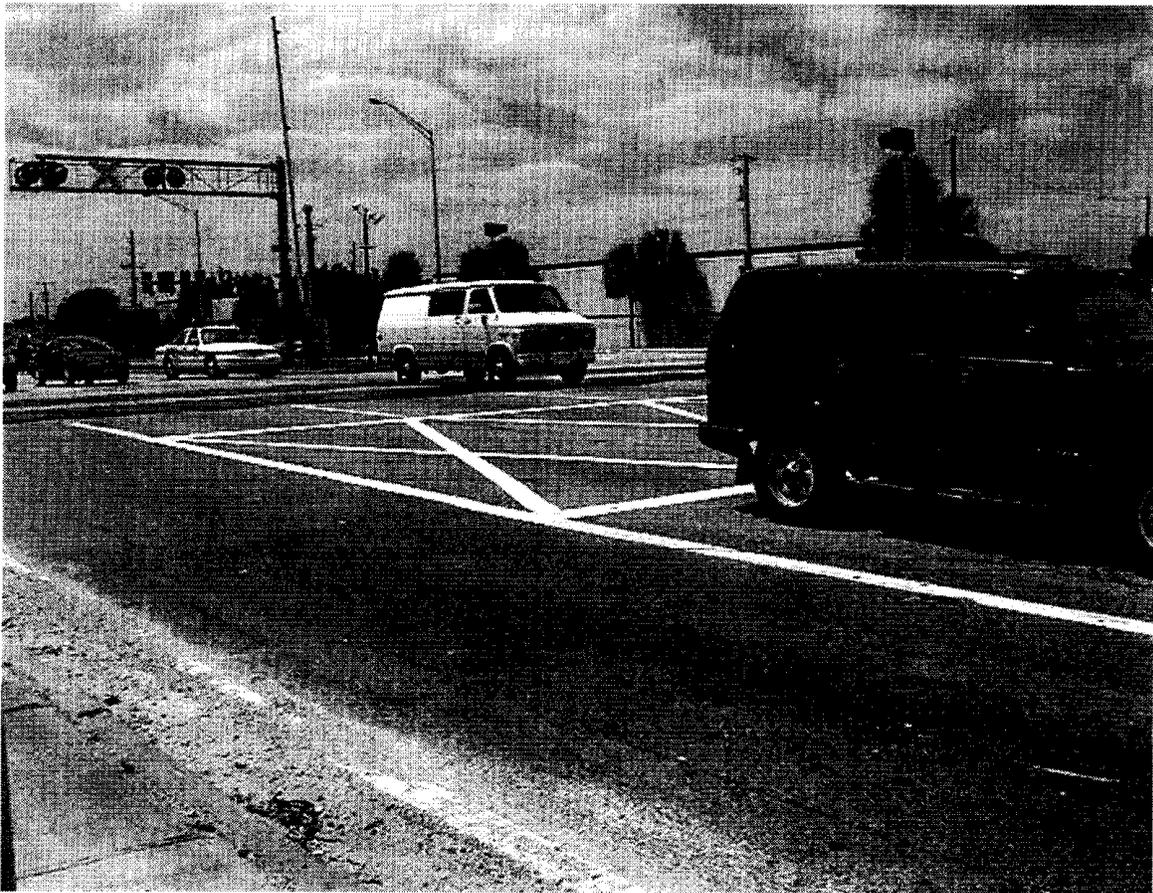
Figure 2-2. Commercial Blvd. Crossing with European X Markings Installed

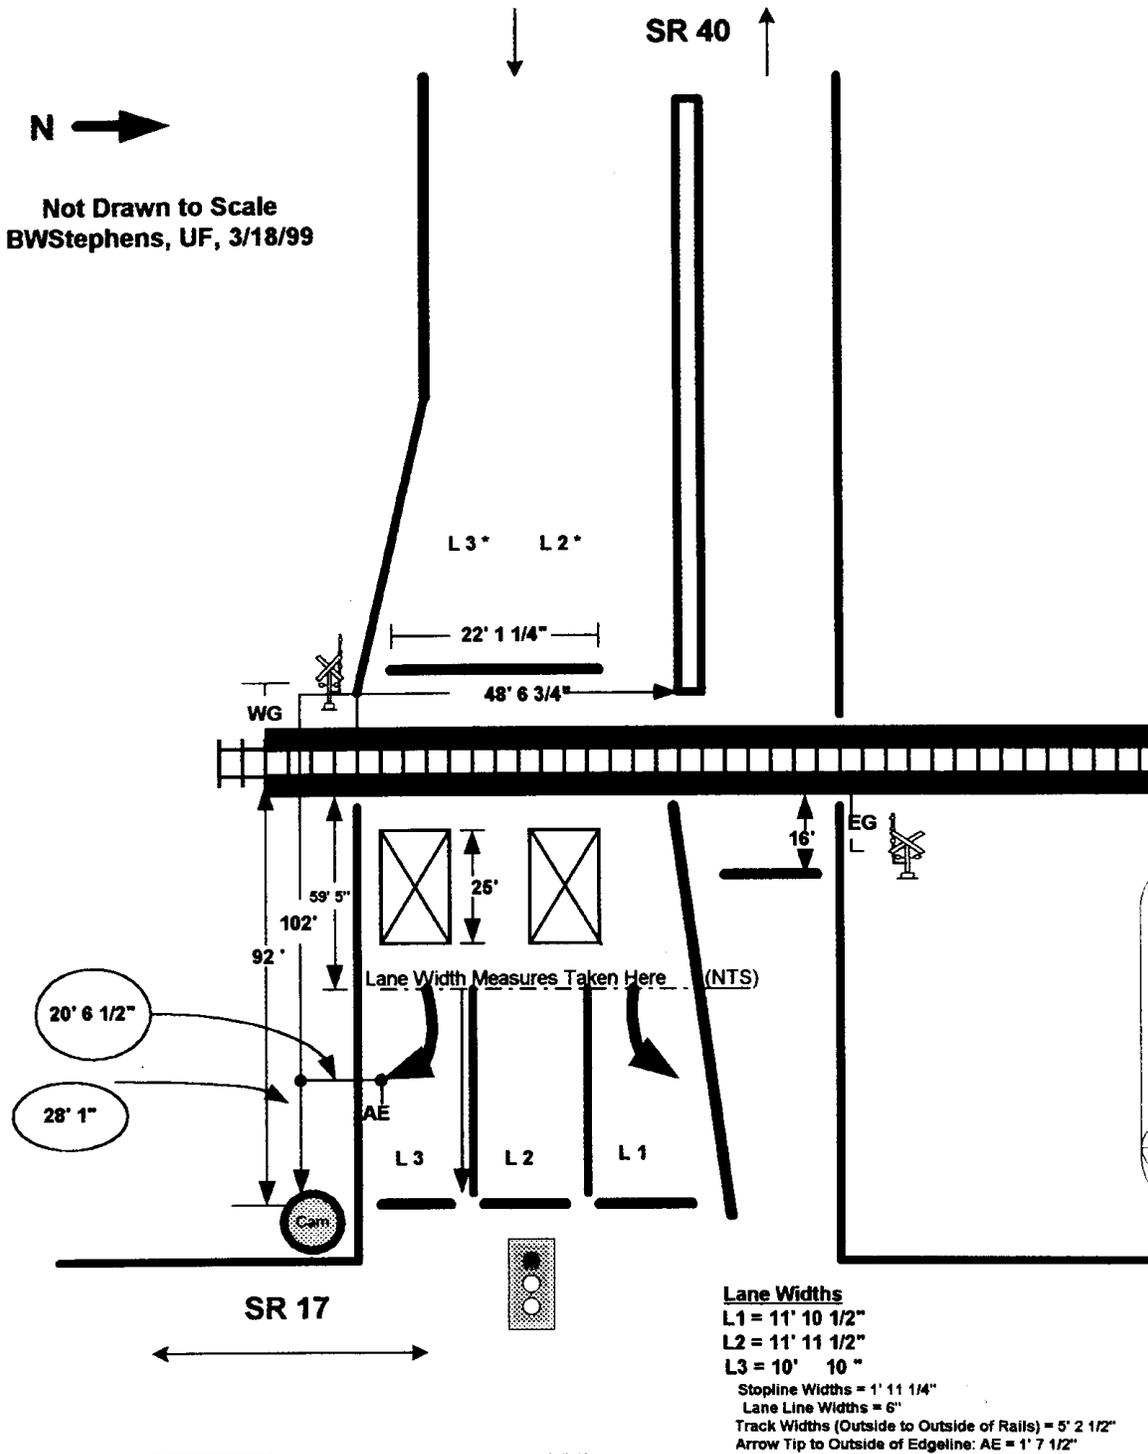
* Prior to track there is only lane marked. However traffic often uses the taper to effectively create 2 lanes. Research on "X" markings designates lanes 2 and 3.

Gate Distances: Gate Center to Outside of Track
 East Gate: EG = 11' 6"
 West Gate: WG = 9' 2"

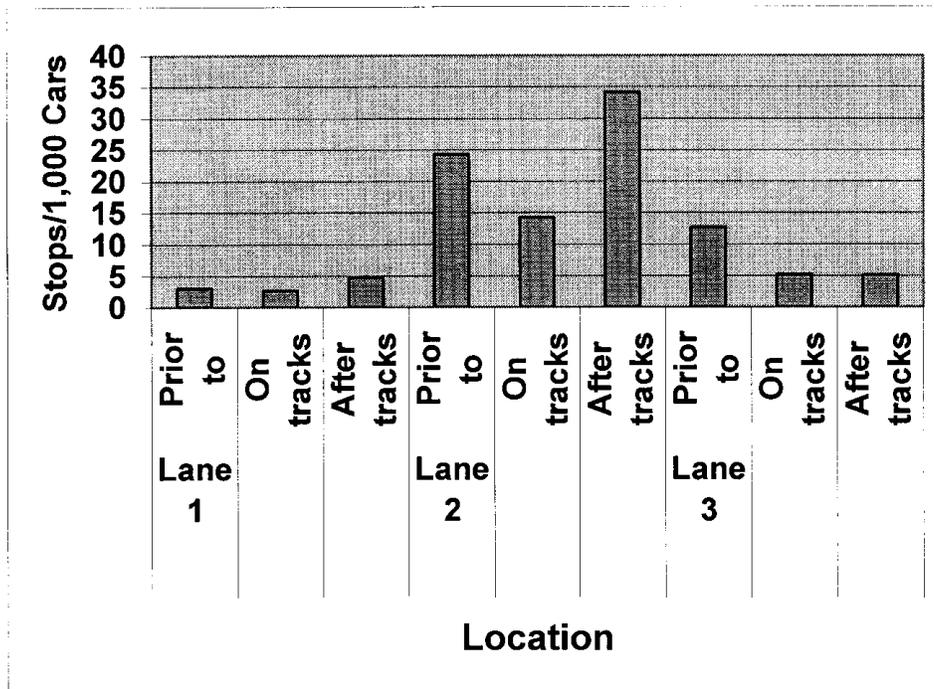
Figure 3-2. Stoppage Patterns for Barberville Labor Day Study Prior to Installation of European X Markings

3-2 and 3-3. When looking at these patterns for the pre- and post-installation conditions, similarities between the patterns can be observed, but the scale is different.

A dramatic reduction in stoppages of cars on or near the tracks occurred after the installation of the X-markings. The differences between stoppage rates within the designated X-area area were not significantly different. (See Appendix C for more

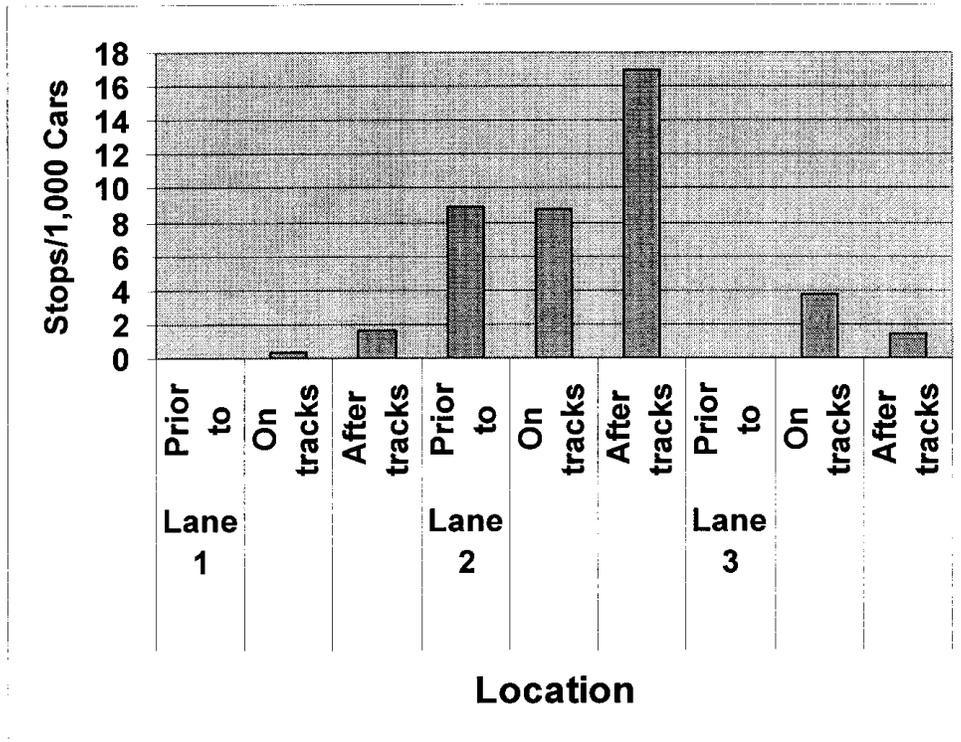
Figure 3-3. Stoppage Patterns for Barberville Labor Day Study After Installation of European X Markings

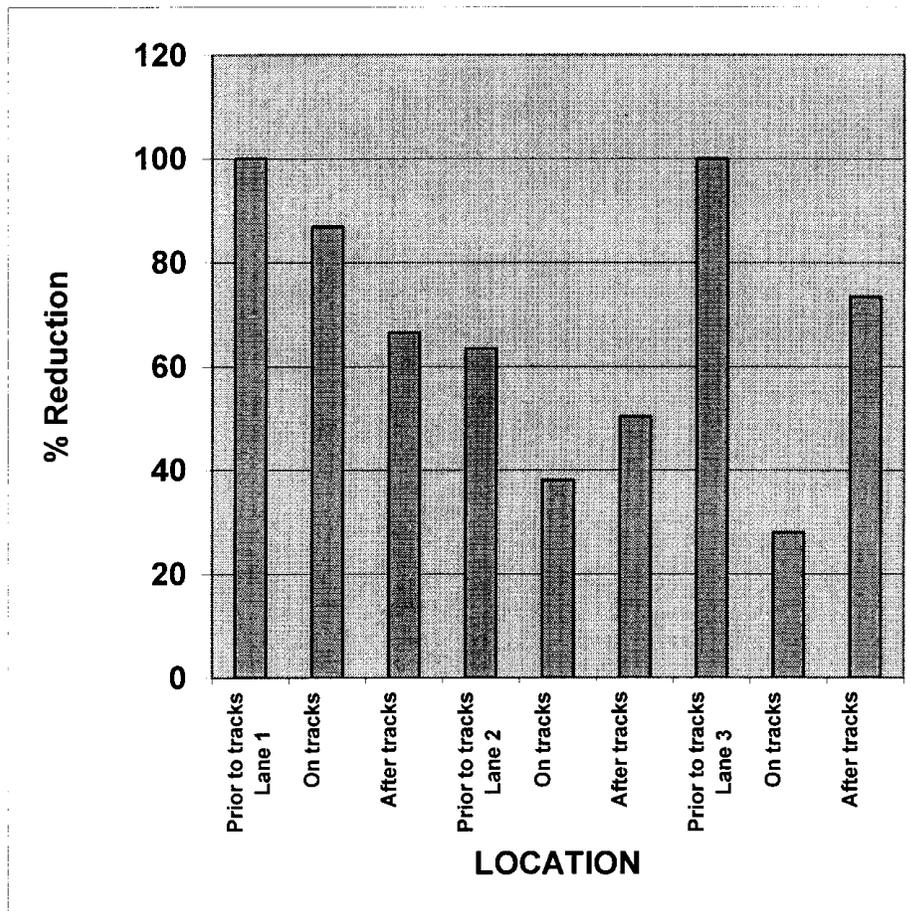
Figure 3-4. Percentage Reductions in Stops/1,000 Cars for Barberville Labor Day Study

information.) The percentage changes for each lane and each of the three zones on or near the tracks are shown in figure 3-4.

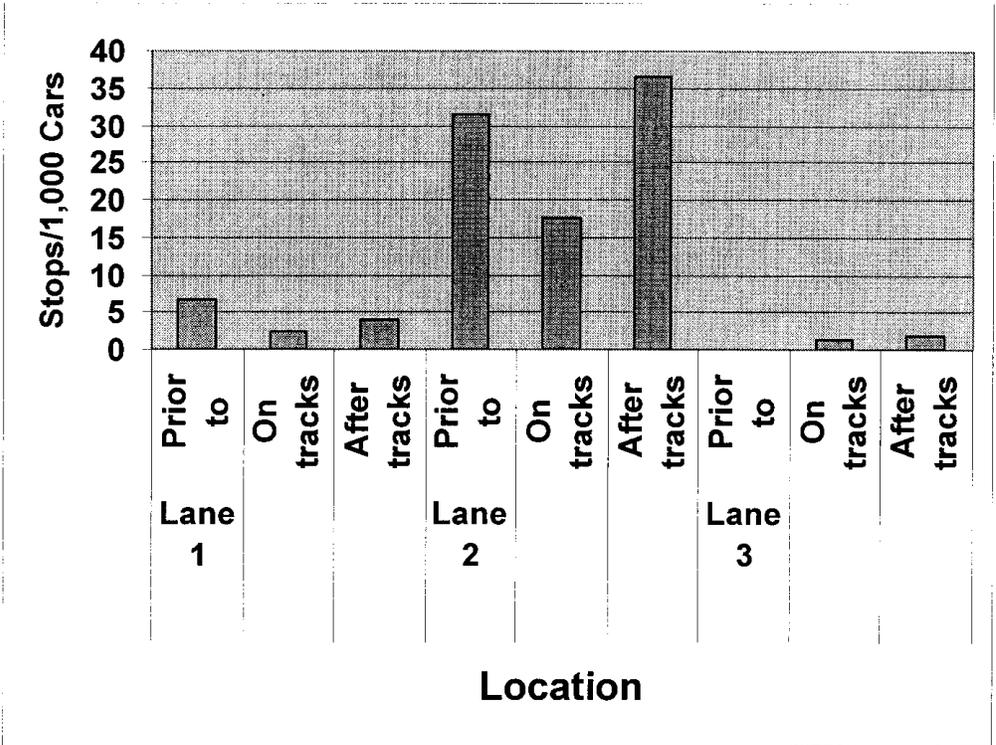
Figure 3-5. Stoppage Patterns for Barberville Spring Study Prior to Installation of European X Markings

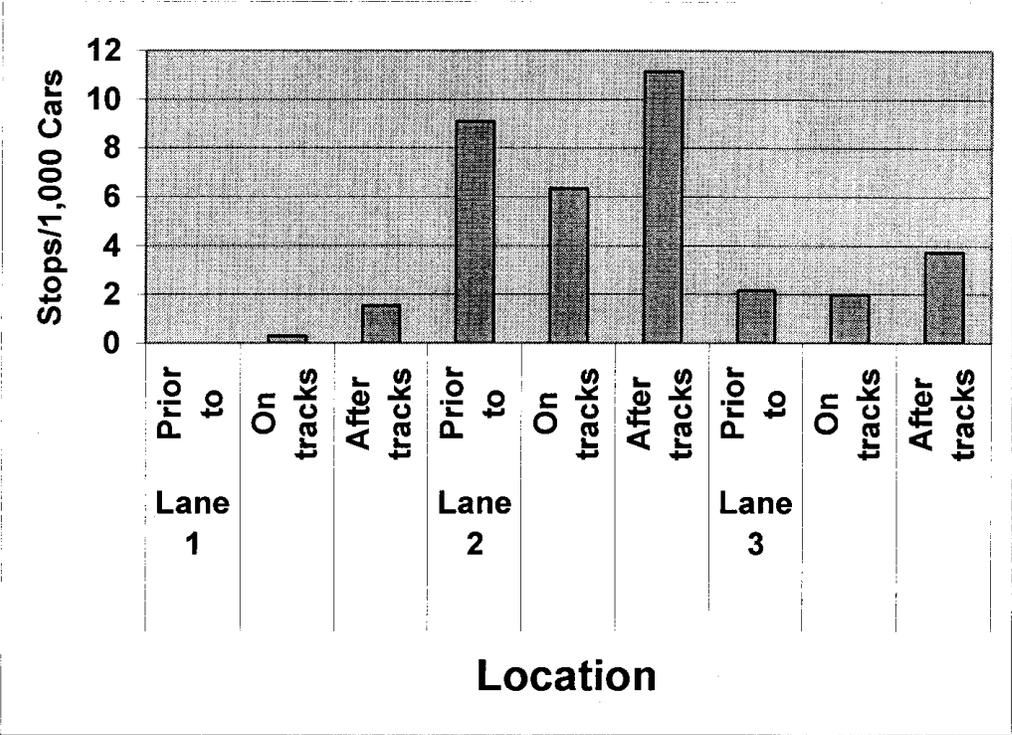
Figure 3-6. Stoppage Patterns for Barberville Spring Study After Installation of European X Markings

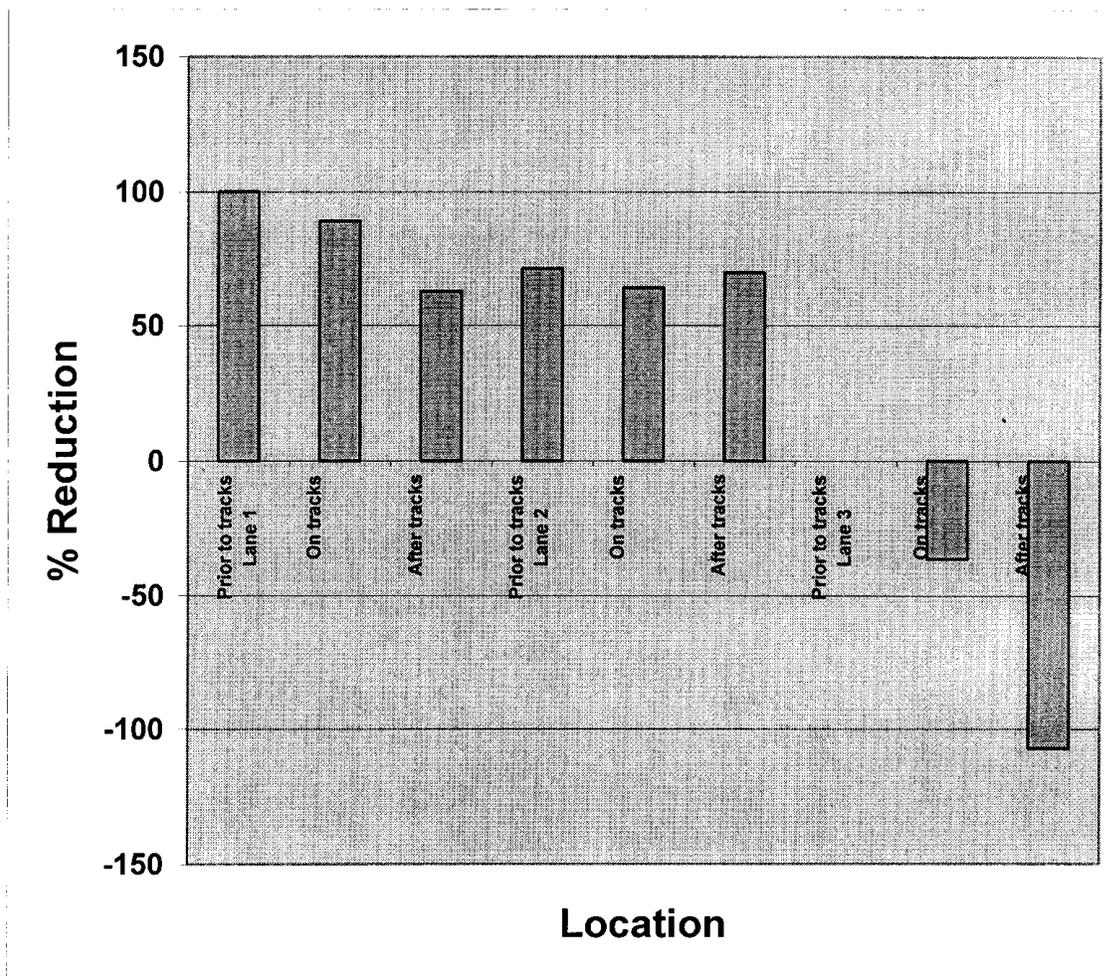
Figure 3-7. Percentage Reduction in Stops/1,000 Cars for Barberville Spring Study

As with the Labor Day study, the percentage changes between the stoppage rates for each of the Barberville lanes and the critical zones within the lanes were plotted as shown in figure 3-7. The picture that emerges is not as clean-cut as in the earlier analysis, in that there were increases in the stoppage rates in all zones for lane 3. Notwithstanding this situation, the overall rate still decreases dramatically because the relative stoppage rates are low for lane 3.

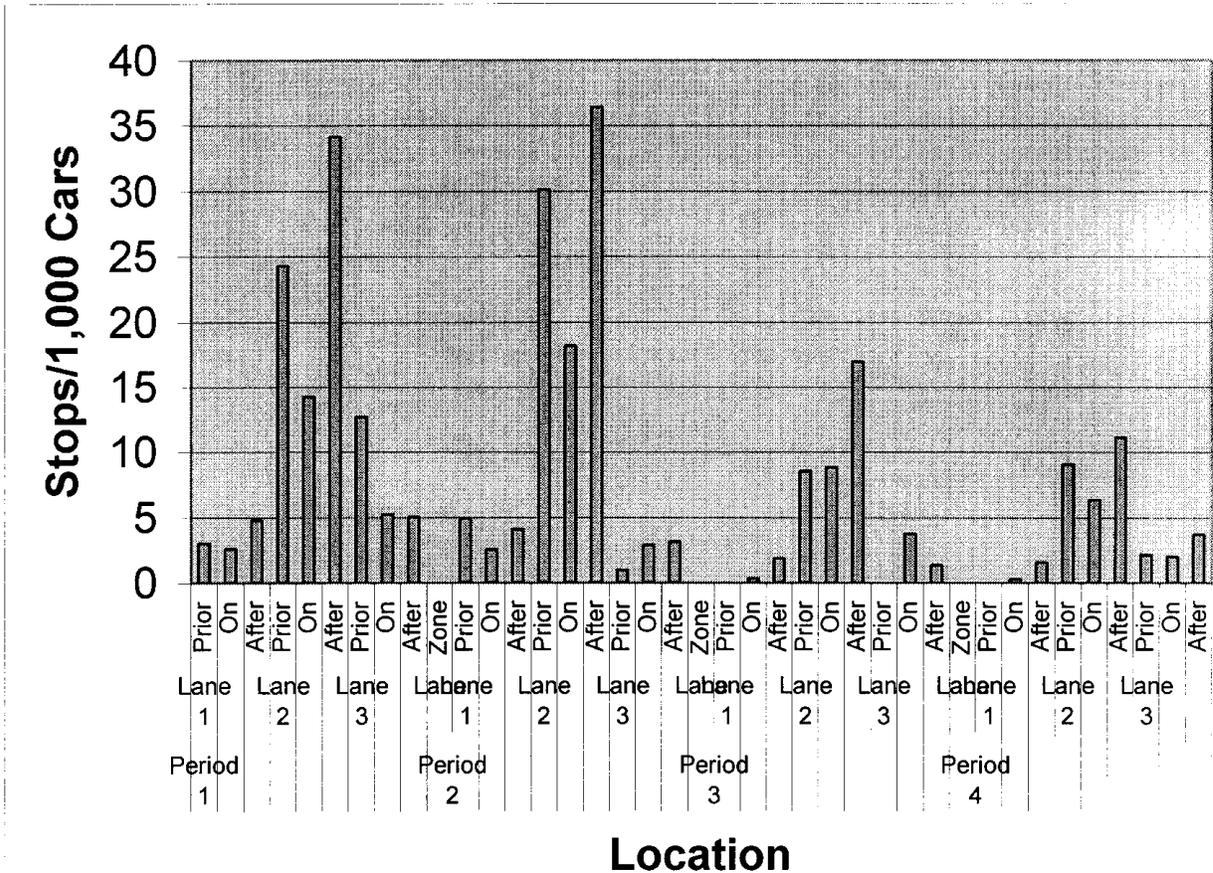
Figure 3-8. Stoppage Rate Over Four Study Periods for Barberville (1½ Year Duration)

Figure 3-8 shows the overall trend in stoppage rates at the Barberville site. Periods 1 and 2 are associated with pre-installation of the European X (September 1998 and Spring 1999). Periods 3 and 4 are post-installation (September 1999 and Spring 2000). Figure 3-8 includes all of the reduced data, including data not included in the prior analysis. Figure 3-9 compares the first and the last periods, suggesting a 68% overall reduction in stops across all lanes and critical zones (corresponding to an overall decrease in 7.75 stopped cars per thousand cars in the critical zones on and adjacent to the tracks).

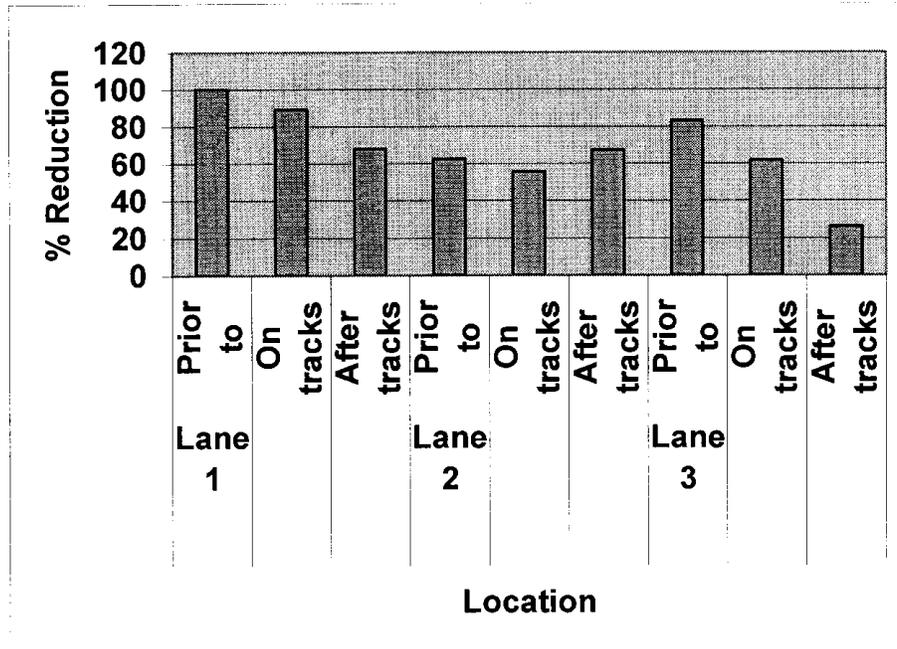
Figure 3-9. Percentage Reductions in Stops/1,000 Cars for Barberville Between First Pre-Installation and Last Post-Installation Periods

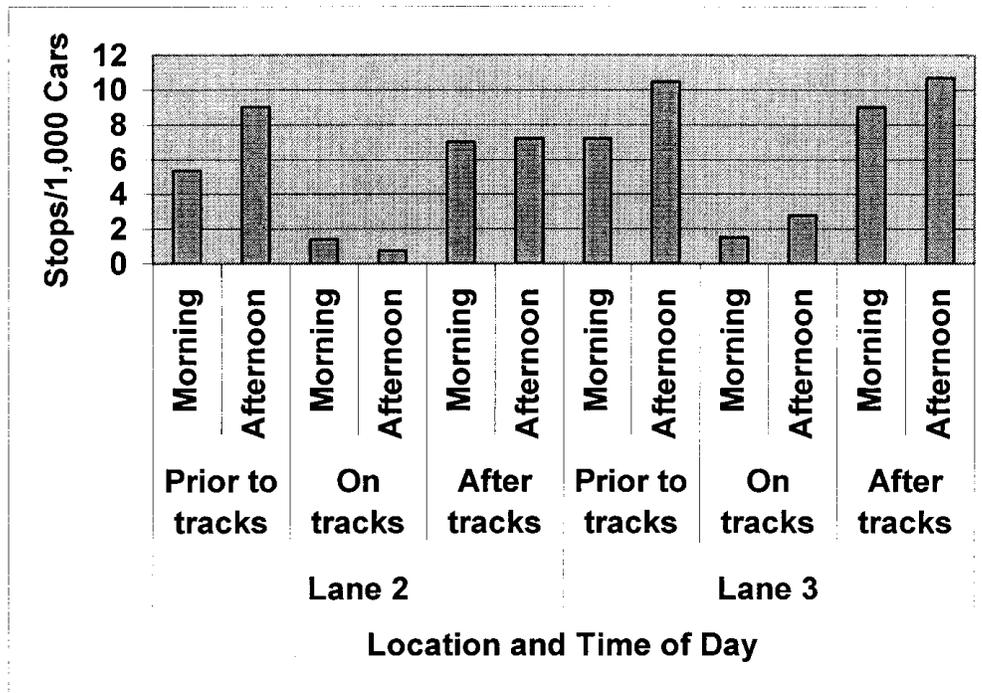
Figure 3-10. Stoppage Patterns for Inside Lanes on Commercial Blvd Before Installation of European X Markings

examined more closely for the inside lanes (i.e., lanes 2 and 3, which displayed the most stable improvements between the before and after periods). Figures 3-10 and 3-11 show the patterns of stoppage rates for the inside lanes at the Commercial Blvd crossing for the pre-installation and post-installation conditions, respectively. Although no further statistical analysis was conducted, it can be observed that the patterns are very similar for these two lanes, but show a difference in scale. In figure 3-12, it can be observed that there is consistency in the differences. The results suggest that the X-markings may have a positive effect on critical stoppage rates for the inside lanes, but no improvement on the exterior lanes, and an overall insignificant effect.

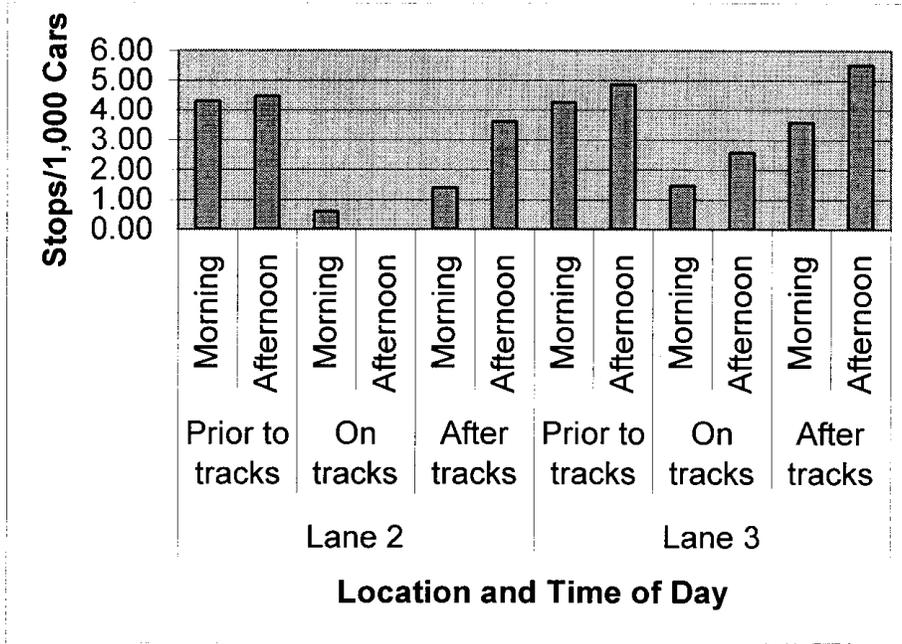
Figure 3-11. Stoppage Rate Patterns for Inside Lanes on Commercial Blvd After Installation of European X Markings

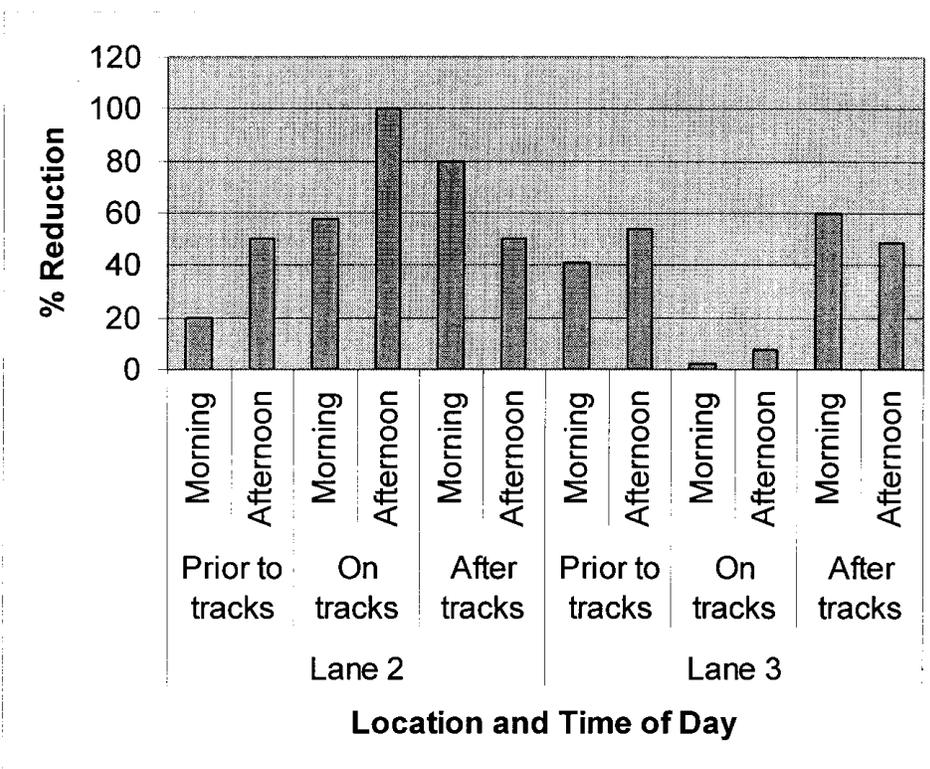
Figure 3-12. Percentage Reductions in Stops/1,000 Cars for Inside Lanes on Commercial Blvd

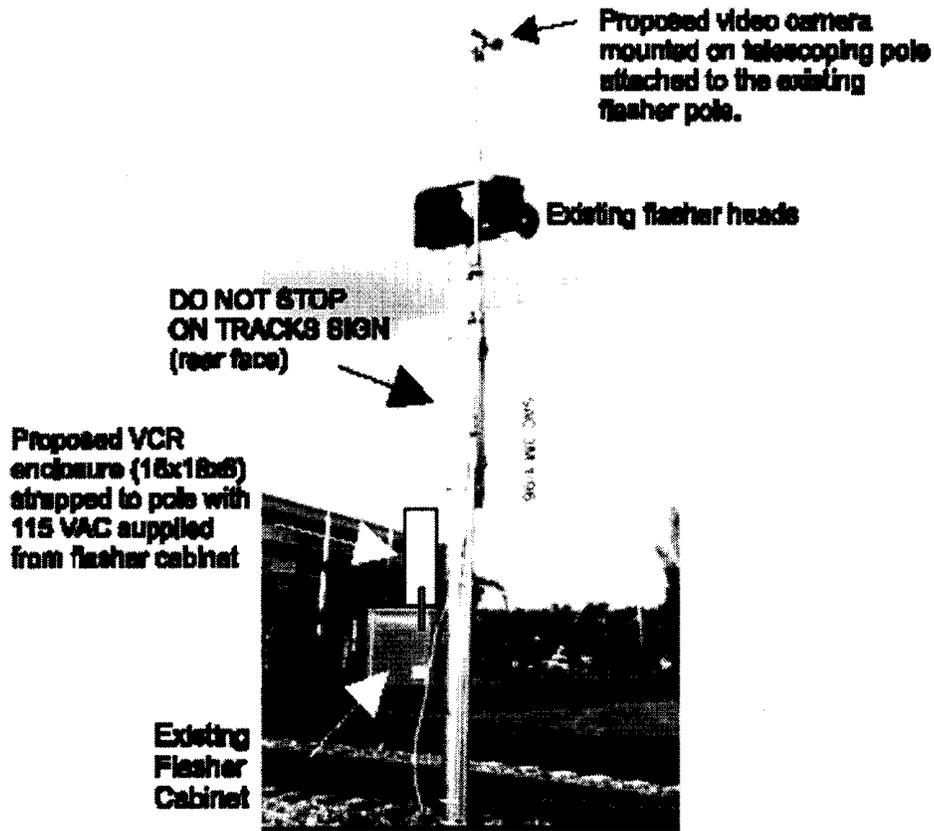
Figure A-1. Installation of Camera and Recorder Box at Commercial Blvd

The Ft. Lauderdale locations posed greater challenges for setting cameras and other equipment and are used to illustrate the installation procedures. The European X marking was deployed at the Commercial Blvd. railroad grade crossing as a test site, and the Oakland Park Blvd crossing was used as a control site. During the original planning, consideration was given to conducting another "before-after" study at another Broward County crossing; however, a suitable crossing with a workable video camera vantage point could not be found.

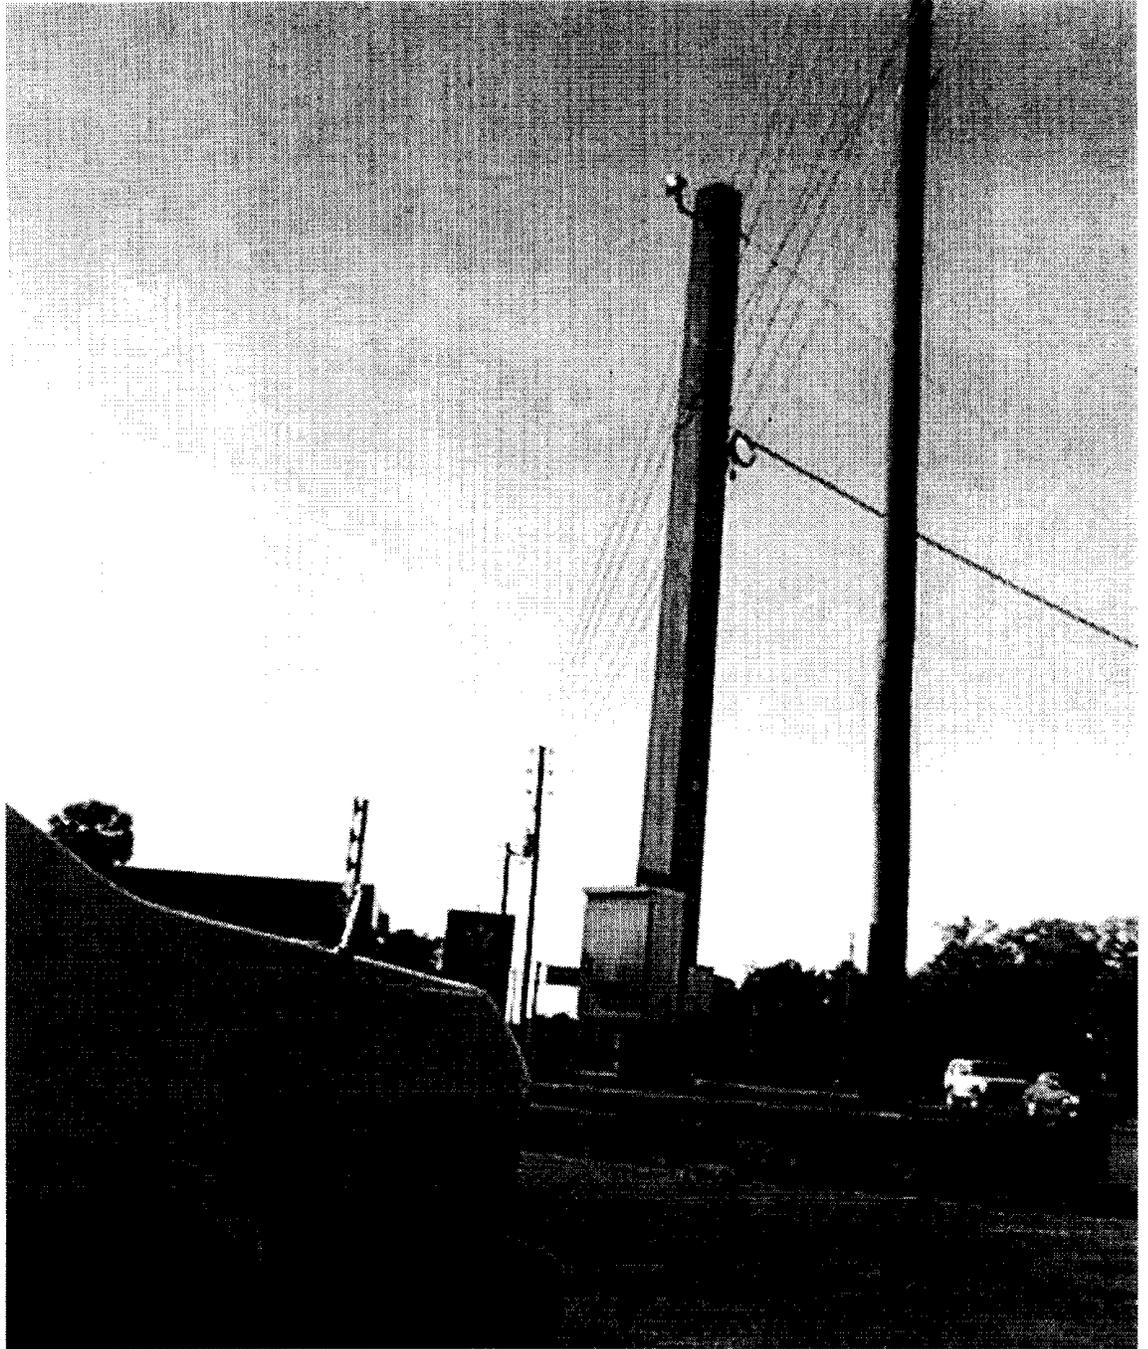
Figure A- 3. Camera Mounted at Barberville Highway-Railroad Crossing

The installation of the housing for the video recorder at the Barberville site was similar to the one at the Commercial Blvd location. The video camera, however, was mounted on a high existing pole as shown in figure A-3.

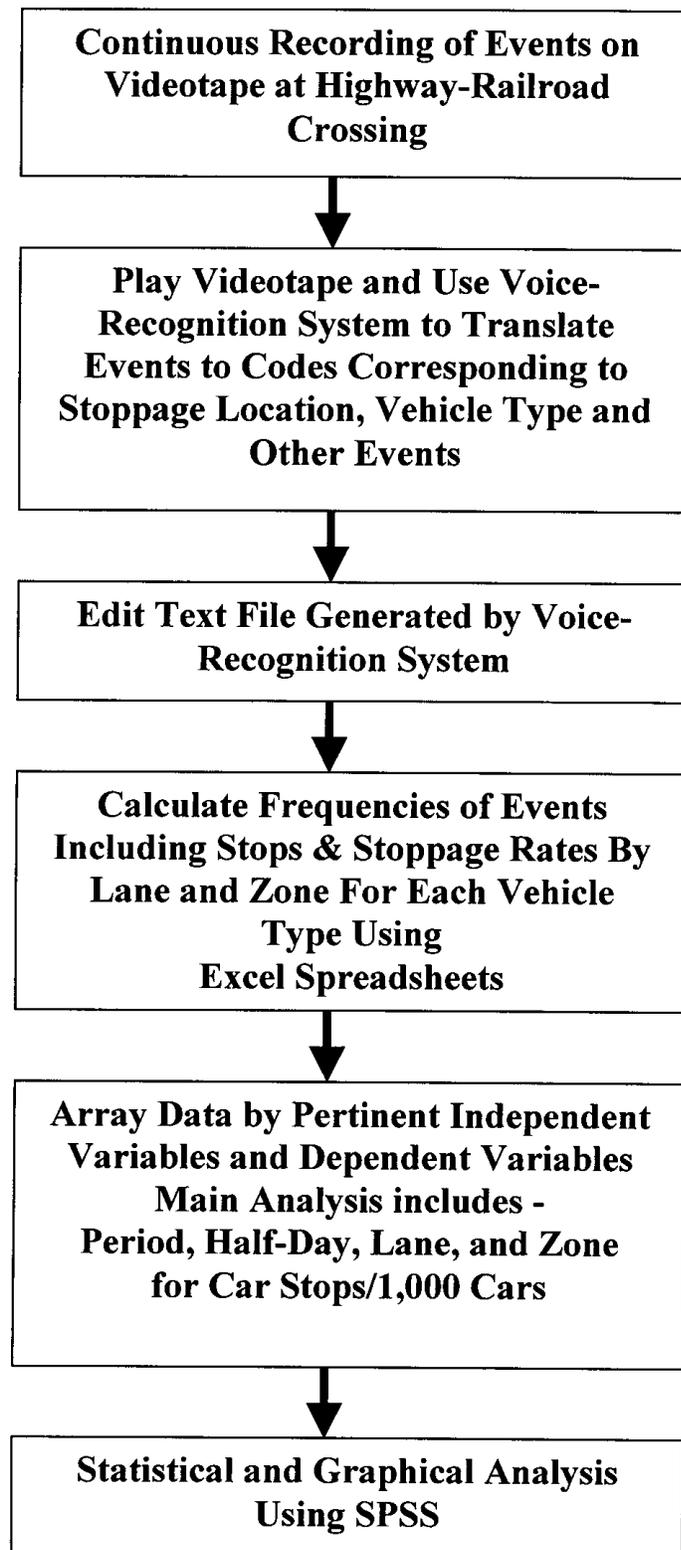
Figure B-1. Data Acquisition and Analysis Process

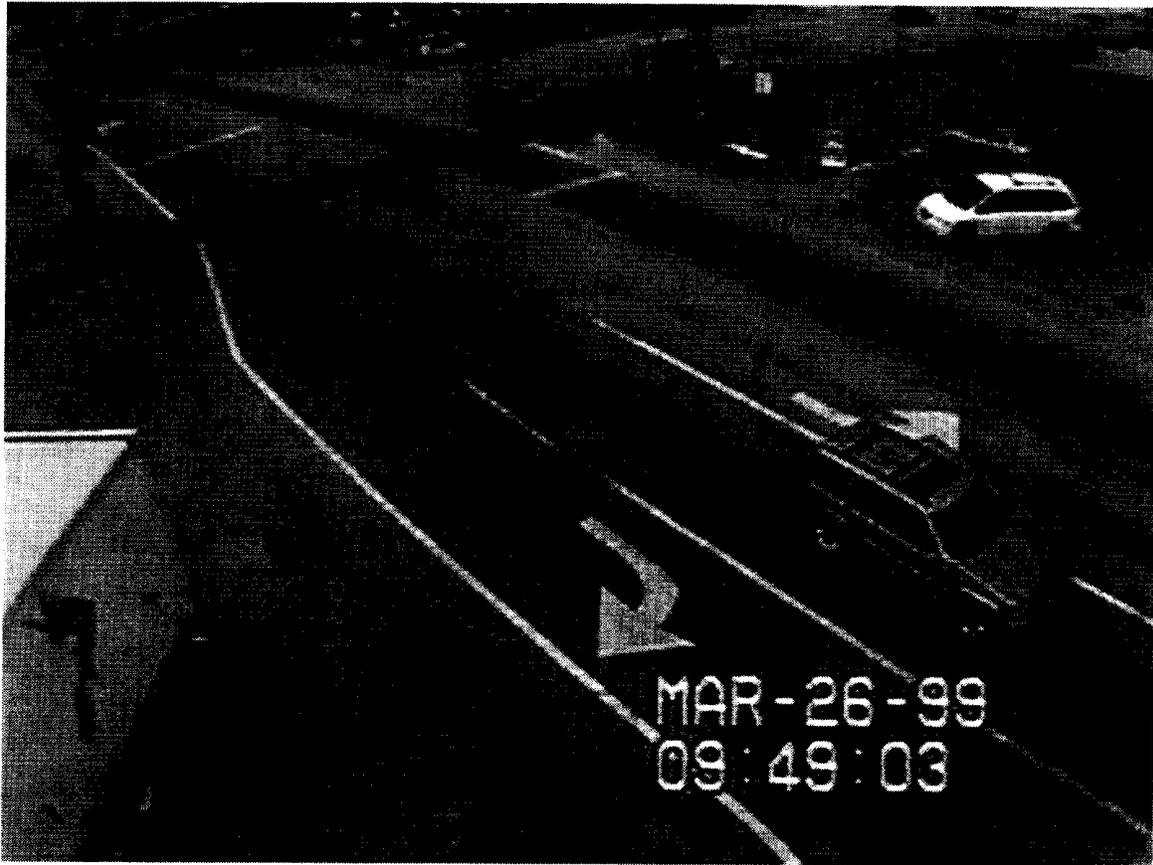
Figure B-2. Camera View of Barberville Highway-Railroad Crossing

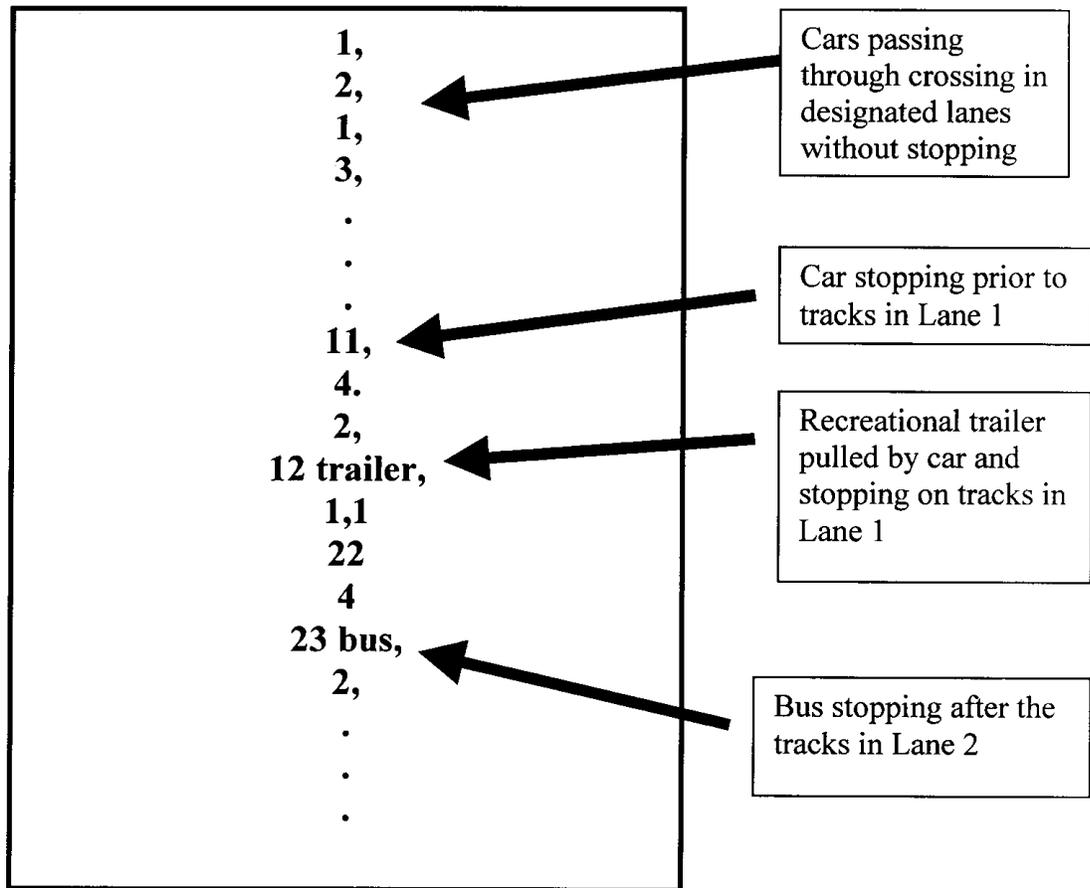
Figure B-3. Example of Coding

Counts of vehicles that did not halt within the designated areas were simply coded by a single digit, 1,2,3, or 4 corresponding to the lane. If the vehicle was a non-passenger car (e.g., truck, bus, school bus, vehicle pulling trailer, etc.) then the vehicle type was also designated. Figure B-3 illustrates the data recording sequence.

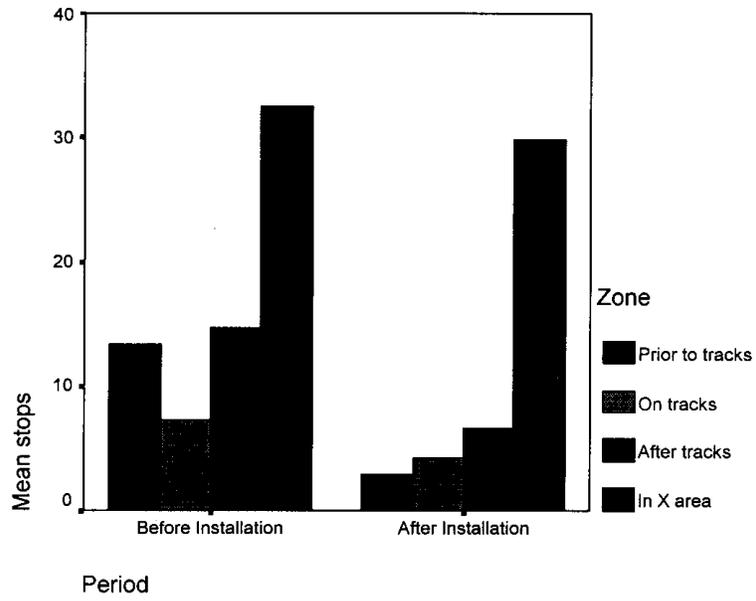
Figure B-10. Example of Graphical Analysis

The SPSS package also provides nested means and graphic capabilities that allow probing more deeply into the data. This facility was used to attempt to understand why the European X markings were successful at Barberville, but not at Commercial Blvd. This feature is illustrated in figure B-10.
