# **BICYCLE AND PEDESTRIAN CONSIDERATIONS AT ROUNDABOUTS**

## **Final Report**

**Florida Department of Transportation**

**Florida International University**

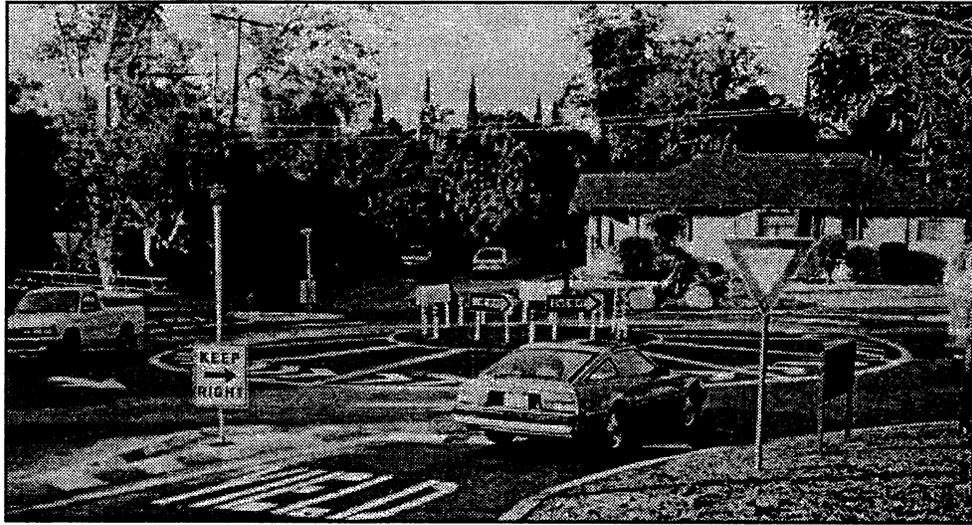
**Figure 2.12 - Santa Barbra Roundabout in California, 1992**

The first modern roundabout on the California State Highway System was installed by the City of Santa Barbara in 1992. The roundabout shown in **Figure 2.12** replaced an intersection of five two-lane streets regulated by stop signs. The old intersection averaged four accidents per year, while the roundabout averaged 2.1 accidents per year, with only five accidents in a 28-month period (Ourston and Bared, 1995).

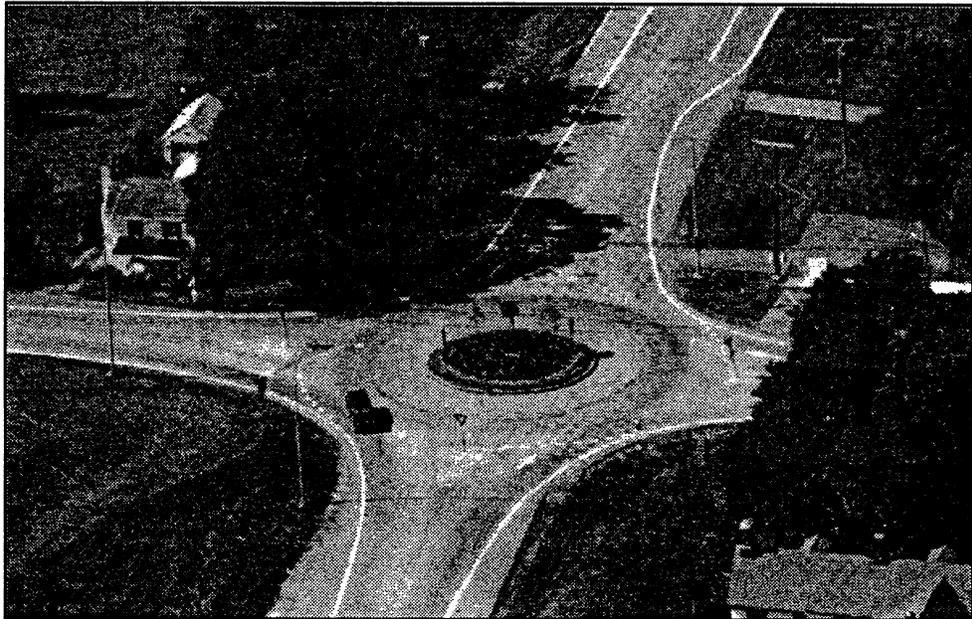
**Figure 2.13 - The First Roundabout in Lisbon, Maryland**

Maryland's first modern roundabout was built in 1993 in Lisbon (see **Figure 2.13**). The roundabout replaced a lightly traveled four-leg intersection regulated by a flashing beacon. The former intersection had averaged eight accidents with eight personal injuries per year. Two accidents occurred in the first three months after construction of the roundabout, resulting in two personal injuries. For the following 21 months, there were no reported accidents. By April 1993, roundabouts at approximately 25 intersections had been considered, and three were in the final design process. There have been no reported accidents at those intersections since the roundabouts were installed, and the community has been satisfied with the improvement (Myers, 1994).

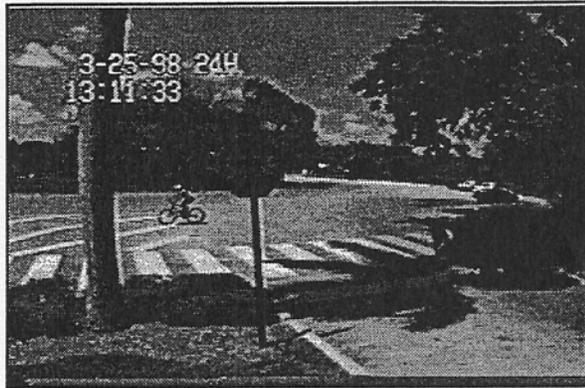
**Figure 4.4 - A Cyclist Going Opposite to Traffic on the Circulating Roadway**

Figures 4.2 to 4.6 were clipped from the video tapes for the Cartagena Plaza Circle. These figures show how pedestrians and bicyclists cross the approaches of the Circle, as well as the location of the main conflict points.

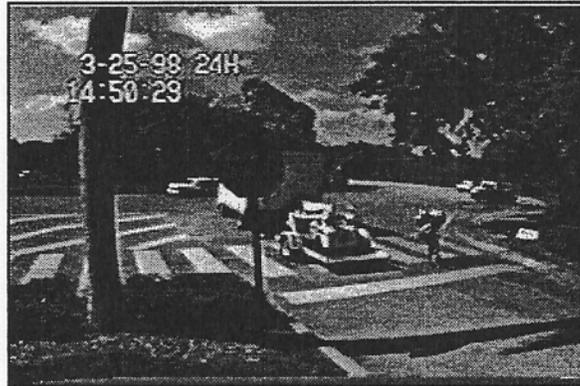
**Figure 4.6 - Cyclists are not Willing to Stop for Vehicles Already on the Crosswalk**
