**FINAL REPORT**

**Effect of Asphalt Cement Deficiency on Open-Graded Friction Courses**

Contract No. BB891, FM Number 403703

**Florida Department of Transportation**

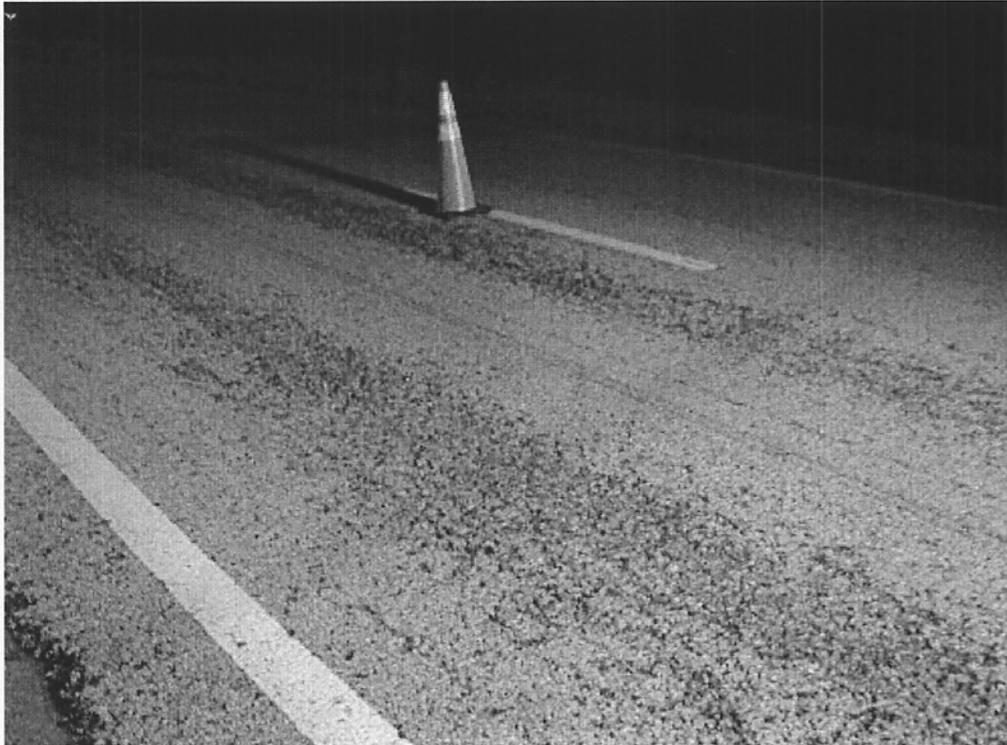
Figure 8. Section in state of advanced raveling on I-75

Figure 8 shows a heavily raveled location on Interstate 75 prior to the beginning of operations.

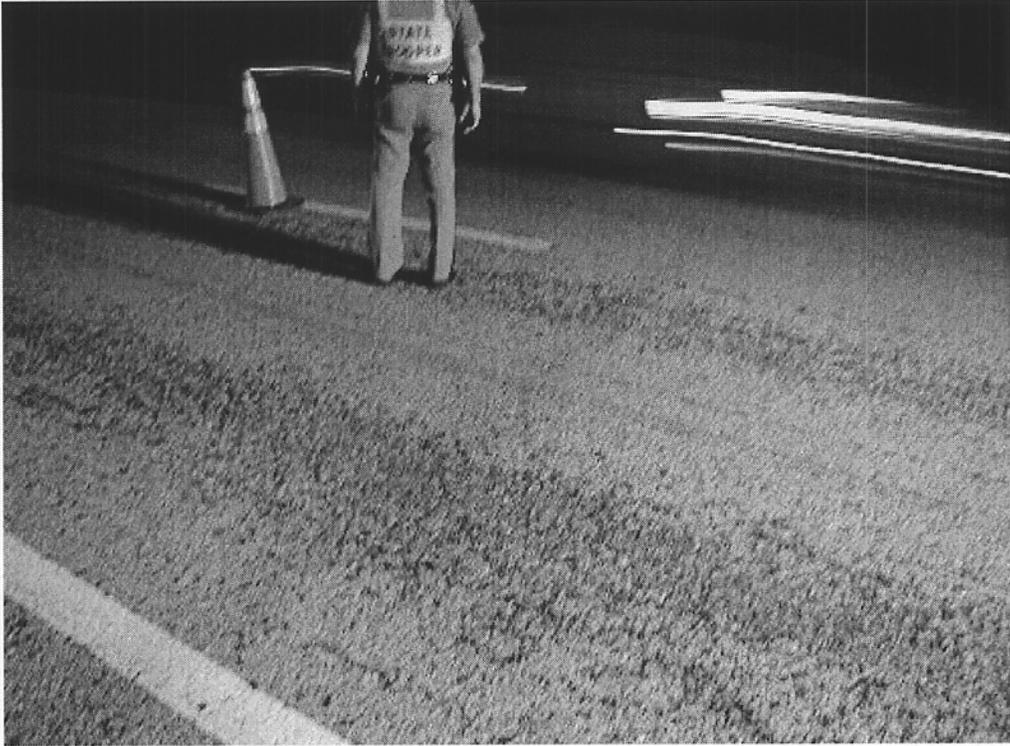
Figure 9. Preparing for MOT (maintenance of traffic) on I-75

The same I-75 location as it is being prepared for maintenance of traffic and safety before coring begins is shown in Figure 9.

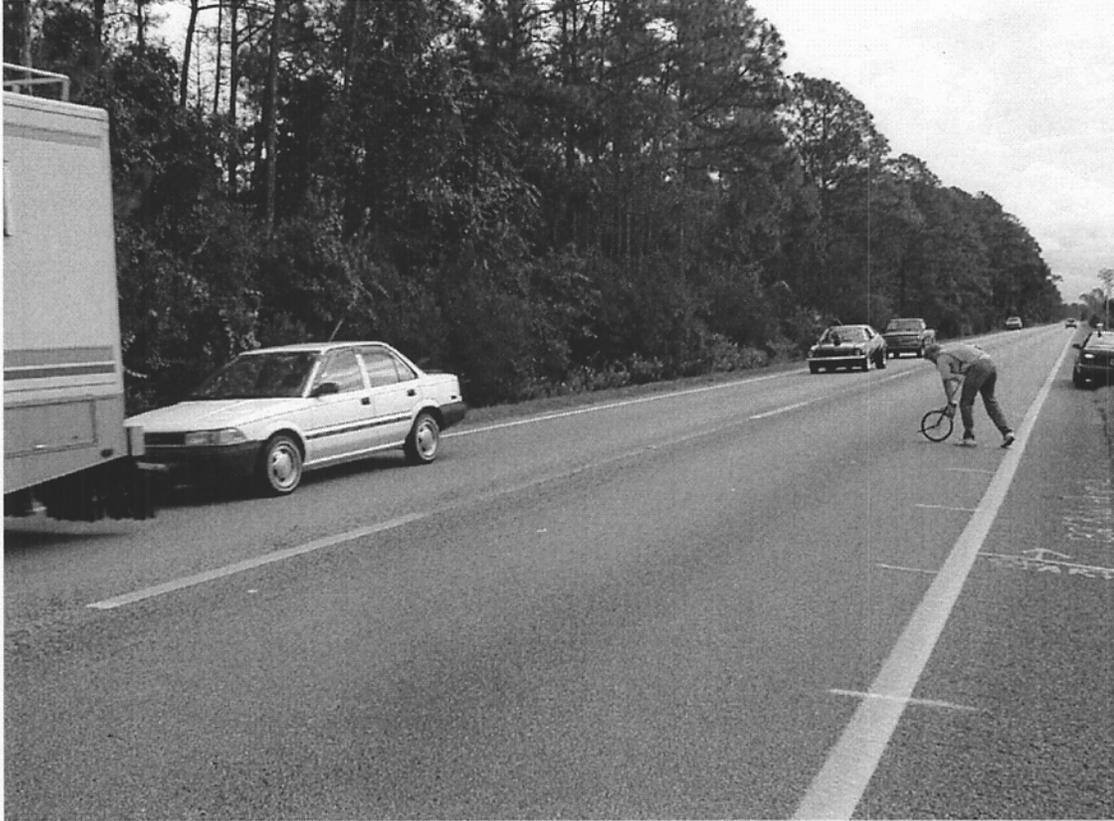
Figure 10. Preparing for coring: core layout on State Road  
40, in Volusia County

Initial layout of coring locations was prepared by the sub-  
contractor as shown in Figure 10.

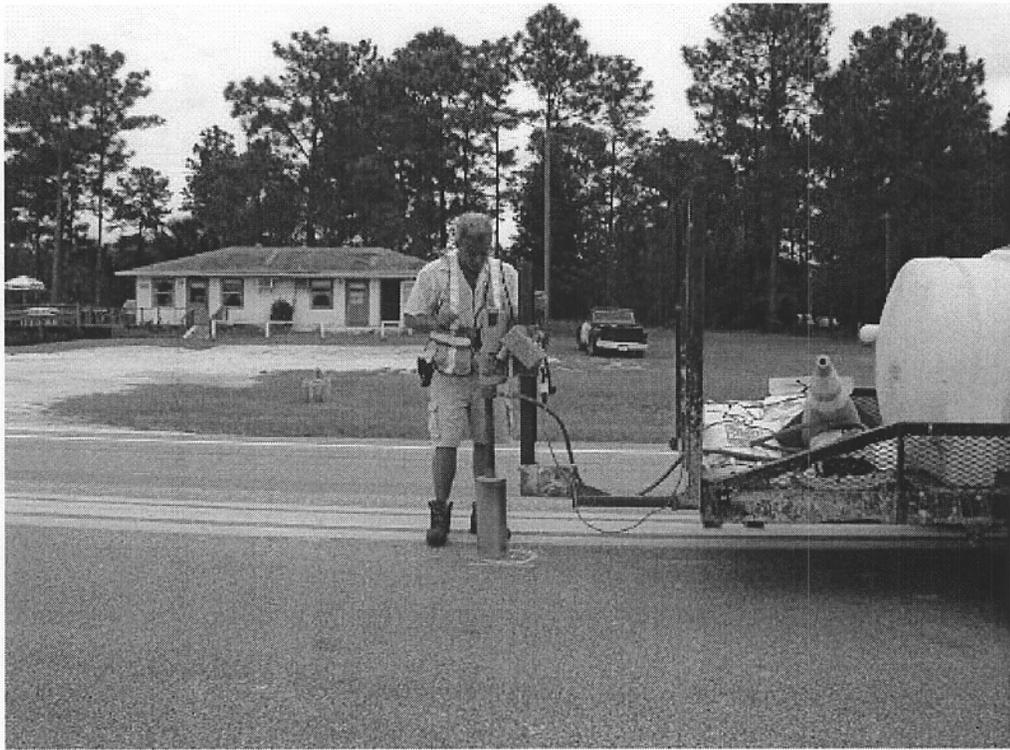
Figure 11. Beginning of coring on S.R. 40, in Volusia County

After the location is labeled (using orange spray marks), the coring machine is used to proceed with the operations, as shown in Figure 11.

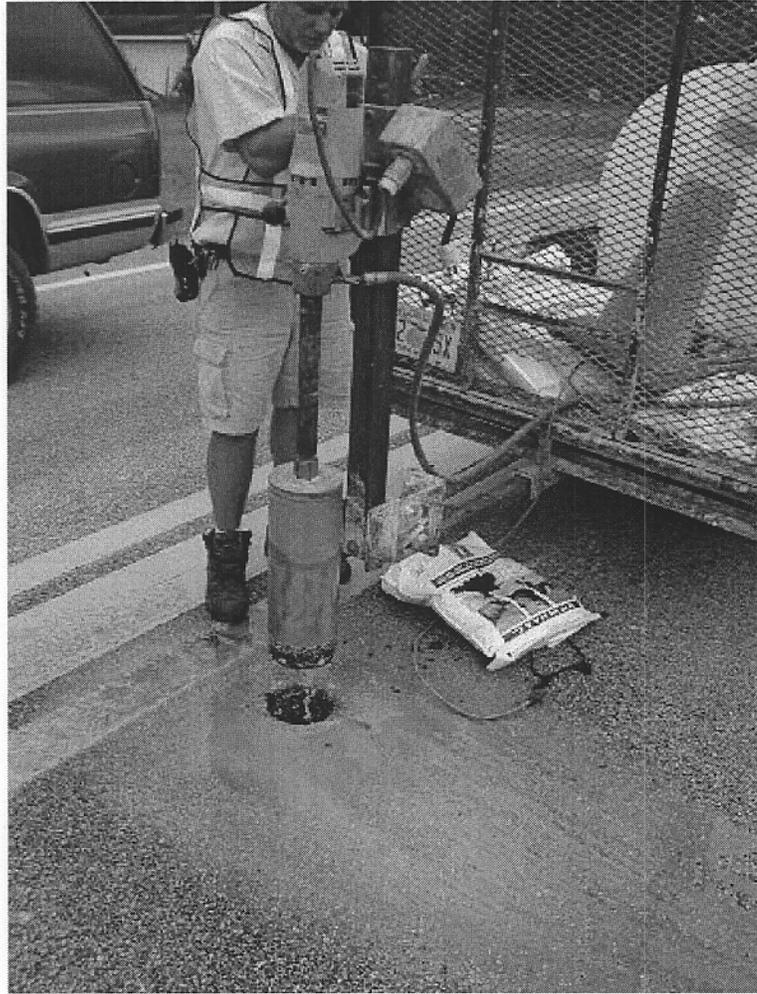
Figure 12. End of Coring: specimen to be removed from barrel (Location: S.R.40, Volusia County)

Finally, Figure 12 shows the completion of the coring operation. The specimen is about to be removed from the barrel. Cores were between 6 and 10 inches deep and measured 6 inches in diameter.

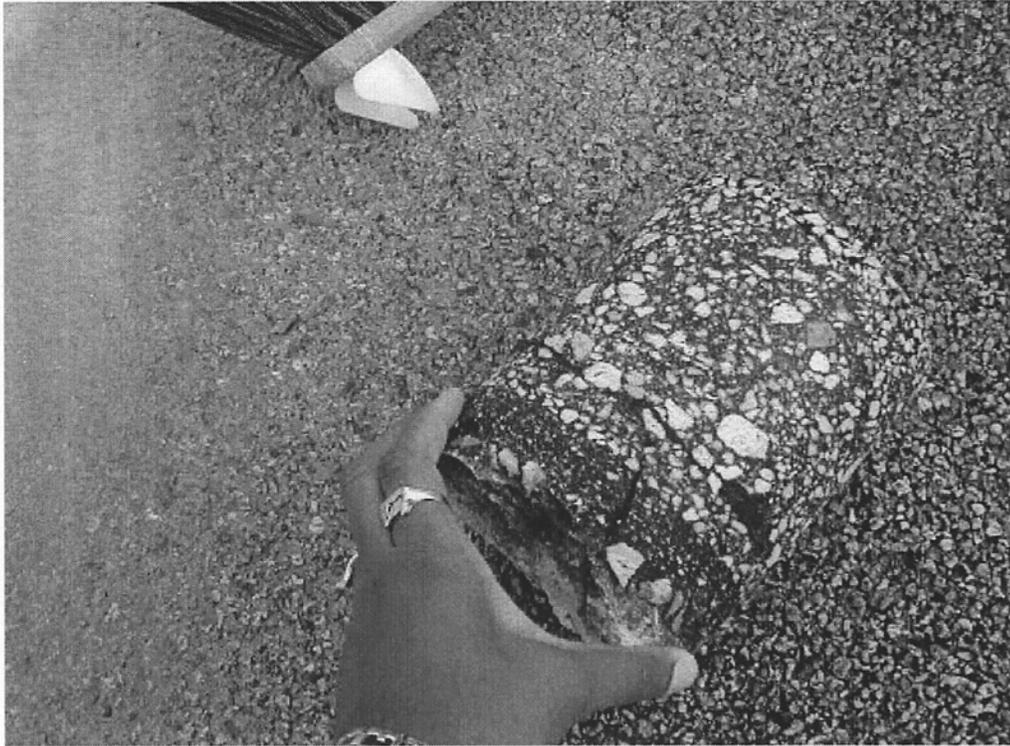
Figure 13. Core sample

Figure 13 shows a core sample after removal from the barrel. It is now ready for labeling, storage and then testing in the laboratory. Layer separations can be seen distinctly with different aggregate sizes and layer colors.

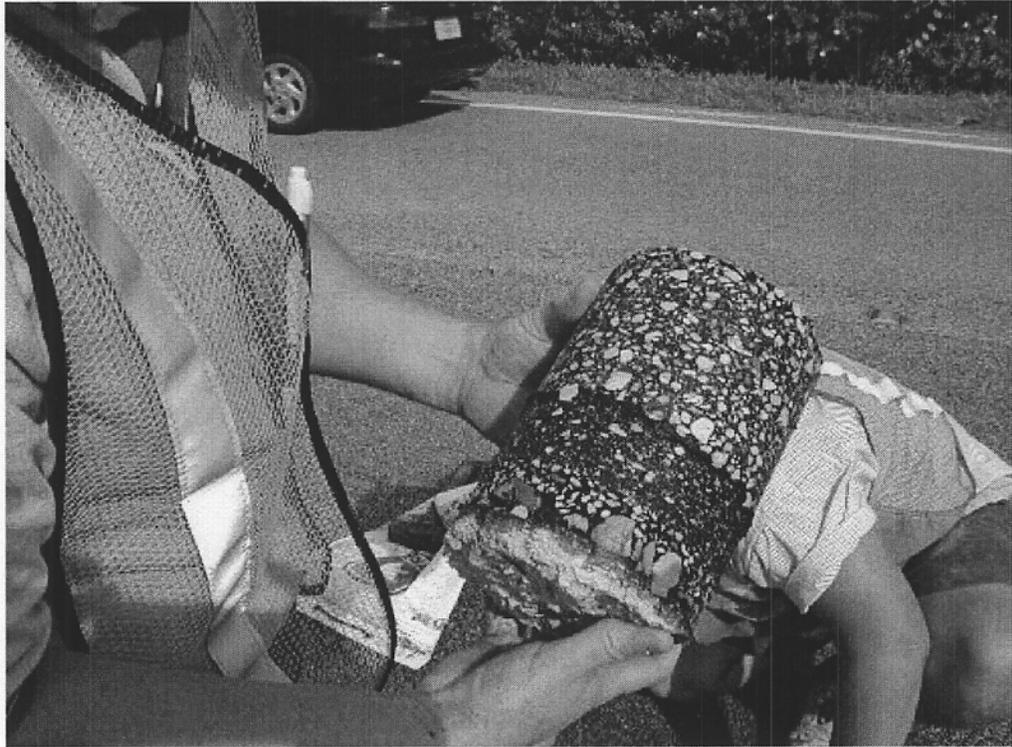
Figure 14. Core sample with visible pavement layers

Figure 14 shows another core where the layers can be easily recognized. The limerock base is also clearly visible.

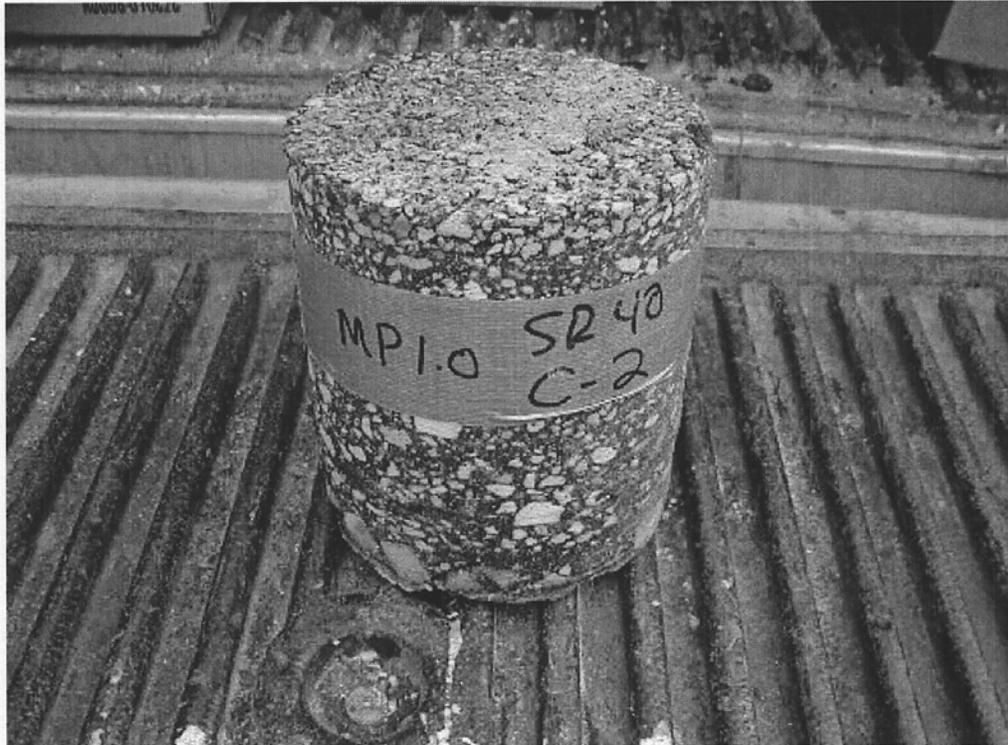
Figure 15. Labeled Core

After coring, the samples were cautiously labeled with the road name, milepost location and core number in Figure 15. They were then individually stored in plastic cylinders before being transported to the testing laboratory in Orlando.

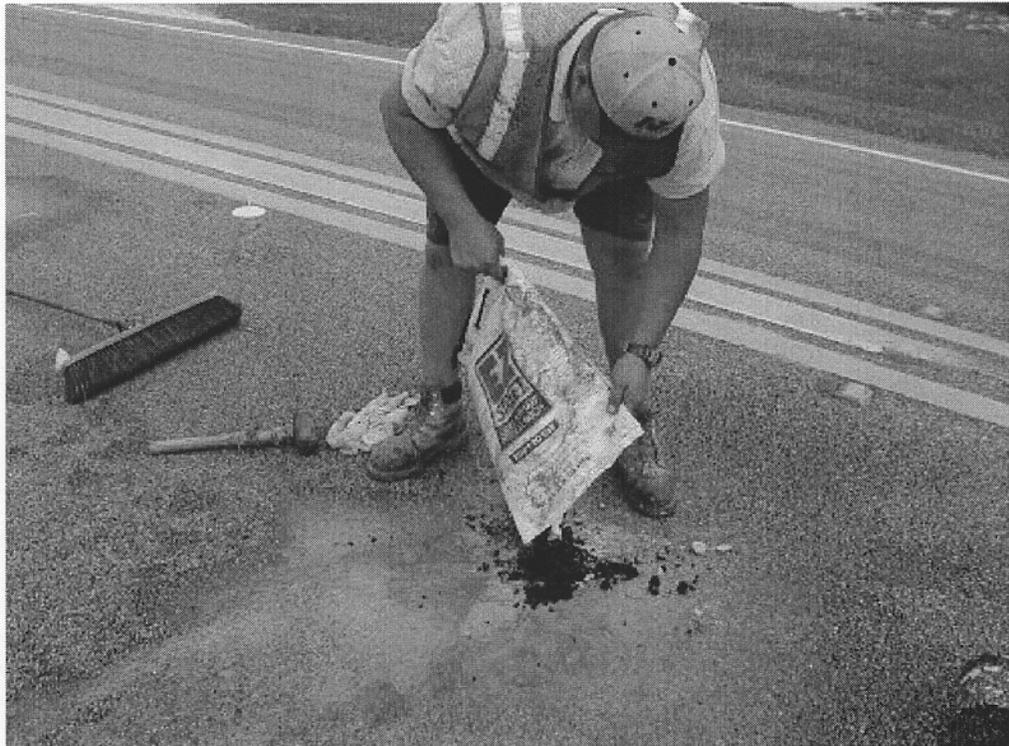
Figure 16. Patching a hole with cold-mix asphalt

The hole left after coring is completed must be filled to prevent accidents and accelerated localized deterioration of the pavement. EZ Street™, a cold-mix asphalt patch produced commercially was used in this project. The product is a polymer-enhanced permanent patching mix made by the Community Asphalt Corporation. Figure 16 shows the patching operation using cold-mix asphalt.

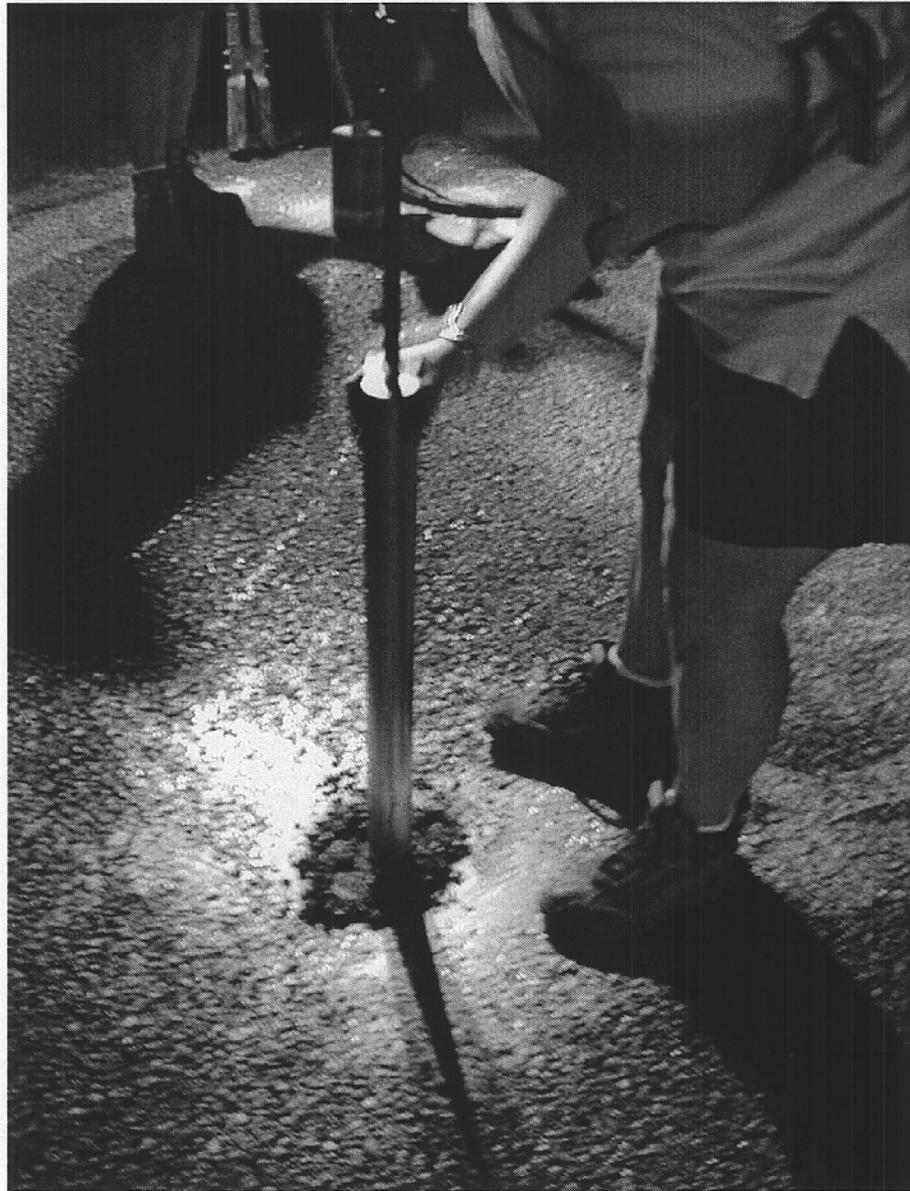
Figure 17. Compaction

The hole was filled in thirds of its depth and compacted after each stage using a compactor or a hammer, as shown in Figure 17.

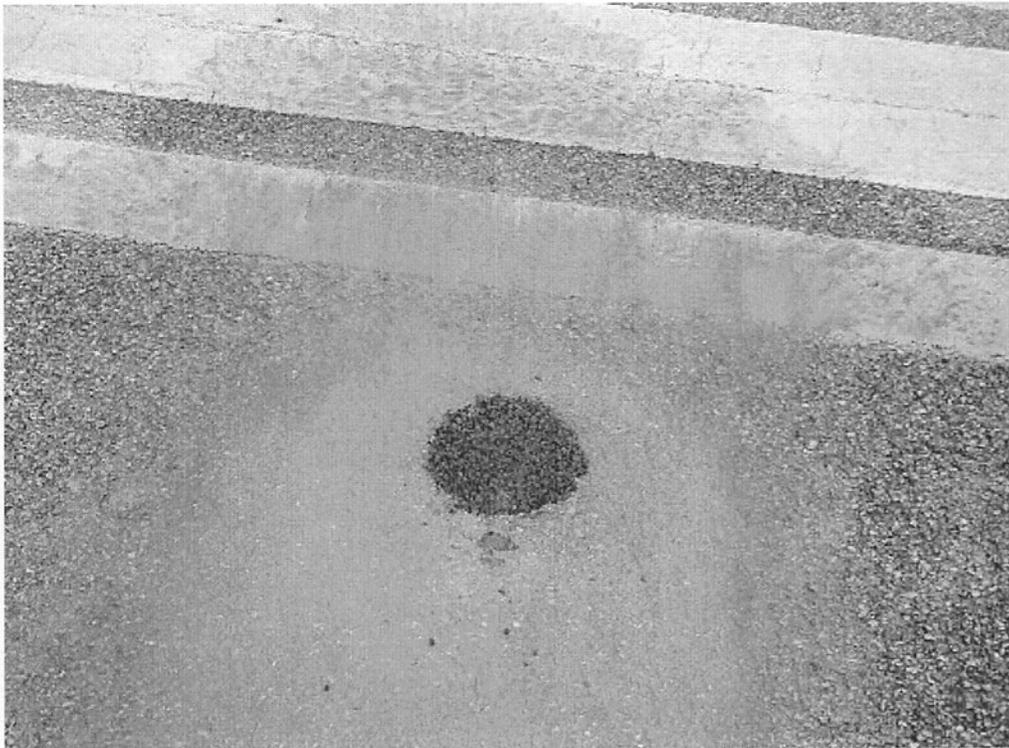
Figure 18. Patched hole after compaction and cleaning

The hole is then patched, compacted and cleaned as shown in Figure 18.

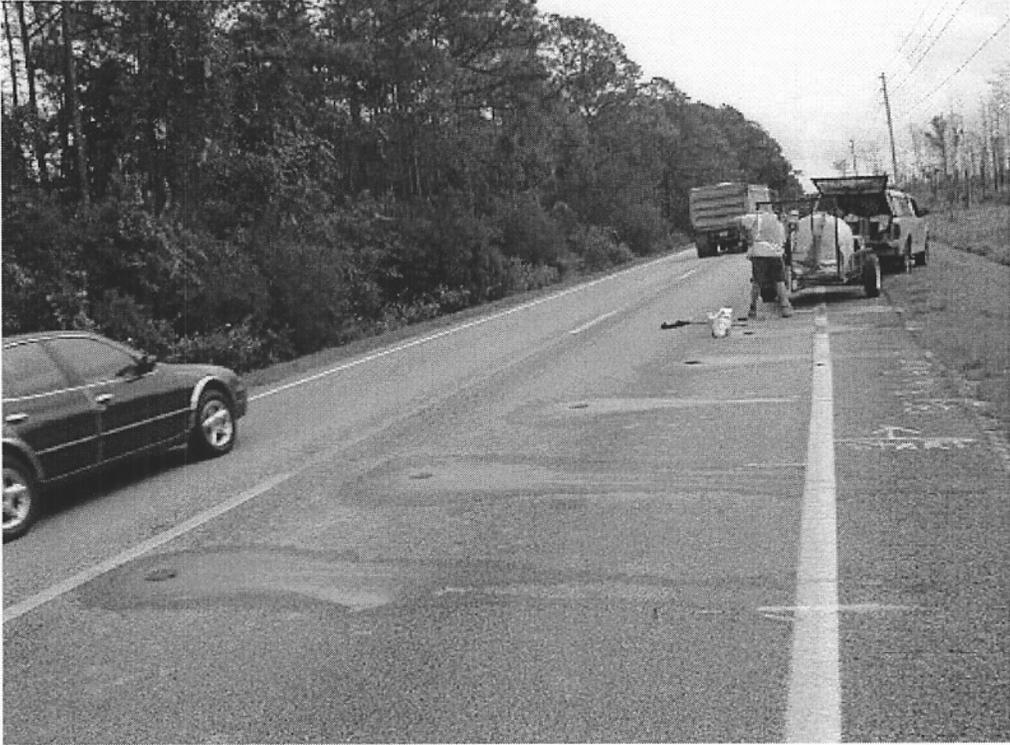
Figure 19. Cored, patched and cleaned section

Lastly, Figure 19 shows the pattern of core locations after they have all been completed and repaired.

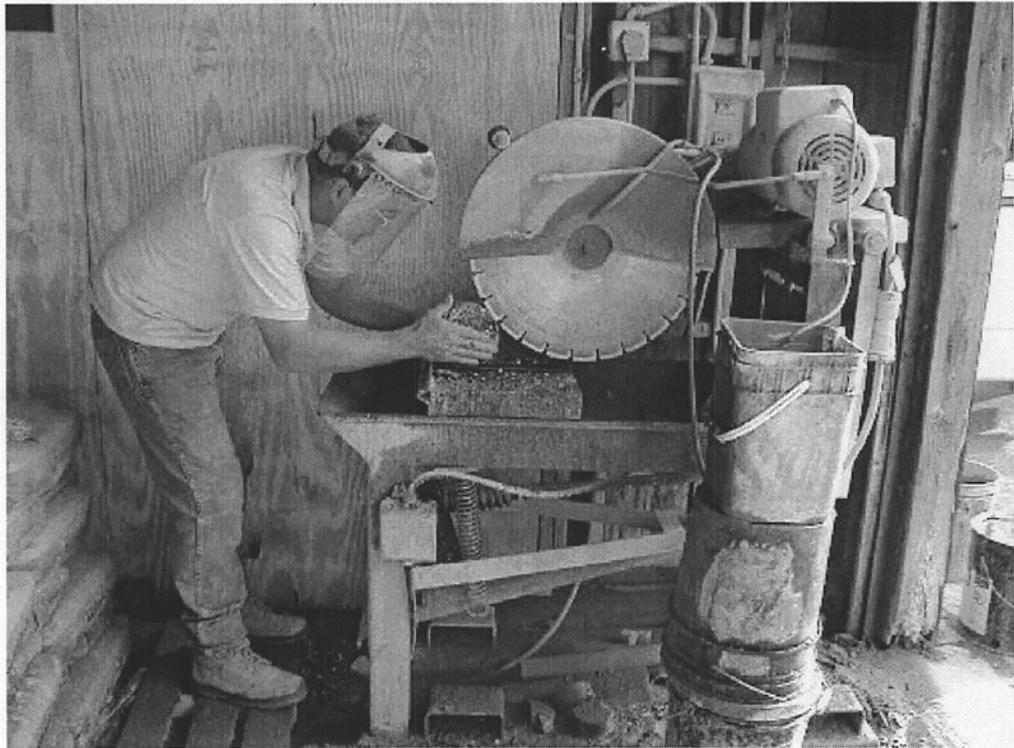
Figure 20. Cutting the friction course out of the core

The friction course layer was cut from the core sample by a technician using a hydraulic saw, as shown in Figure 20.

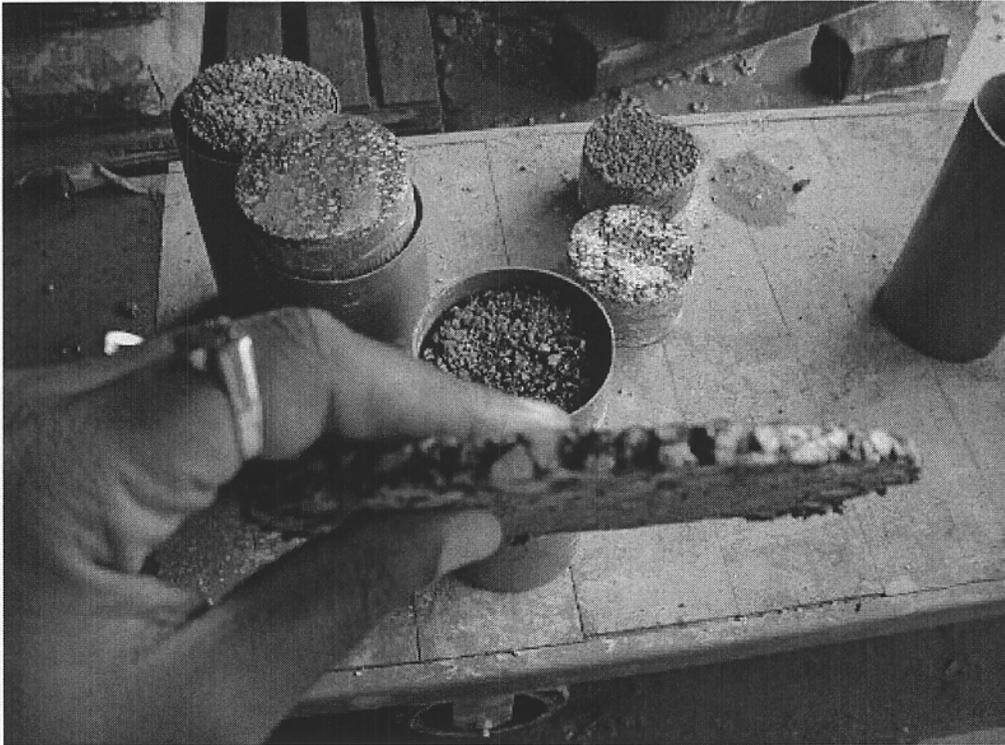
Figure 21. Friction course after cutting  
(approximately  $\frac{1}{2}$  " thick)

Next, the friction course was cut from the core. As shown in Figure 21, typically the friction course was about  $\frac{1}{2}$ " thick, which is expected.

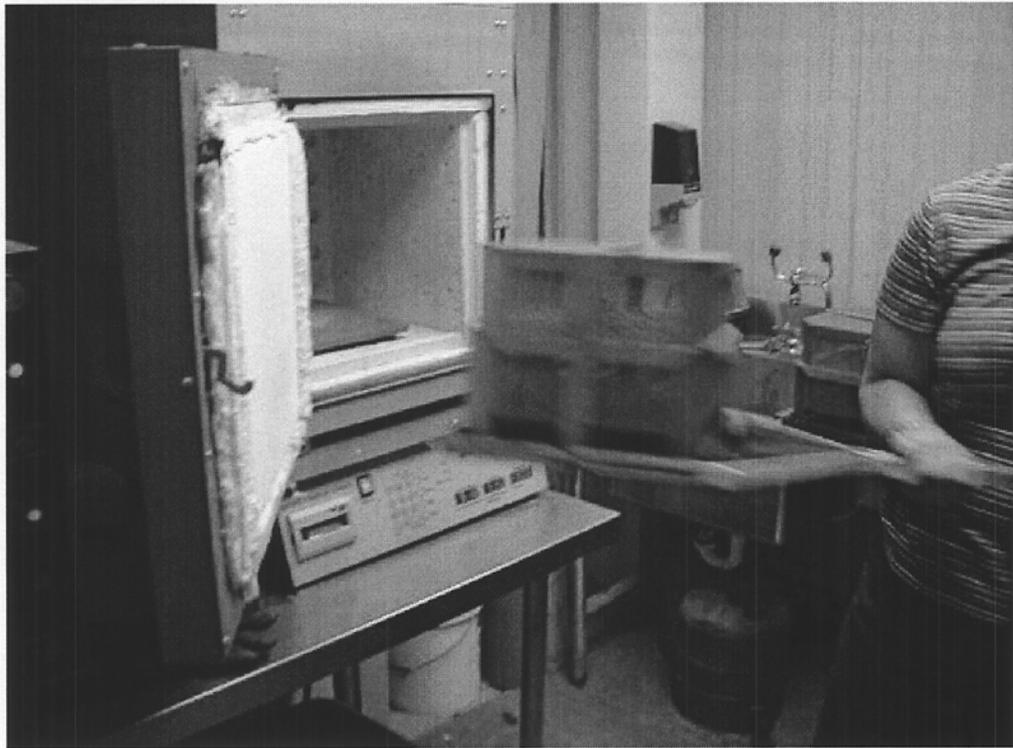
Figure 24. Sample in the NCAT Asphalt Content Tester

The NCAT tester is then warmed and the sample is ready to be heated as shown in Figure 24. The very high temperatures ( $538^{\circ}\text{C}$  or  $1000^{\circ}\text{F}$ ) allow for the HMA mix to completely break up, making it possible determine AC content and perform gradation tests.

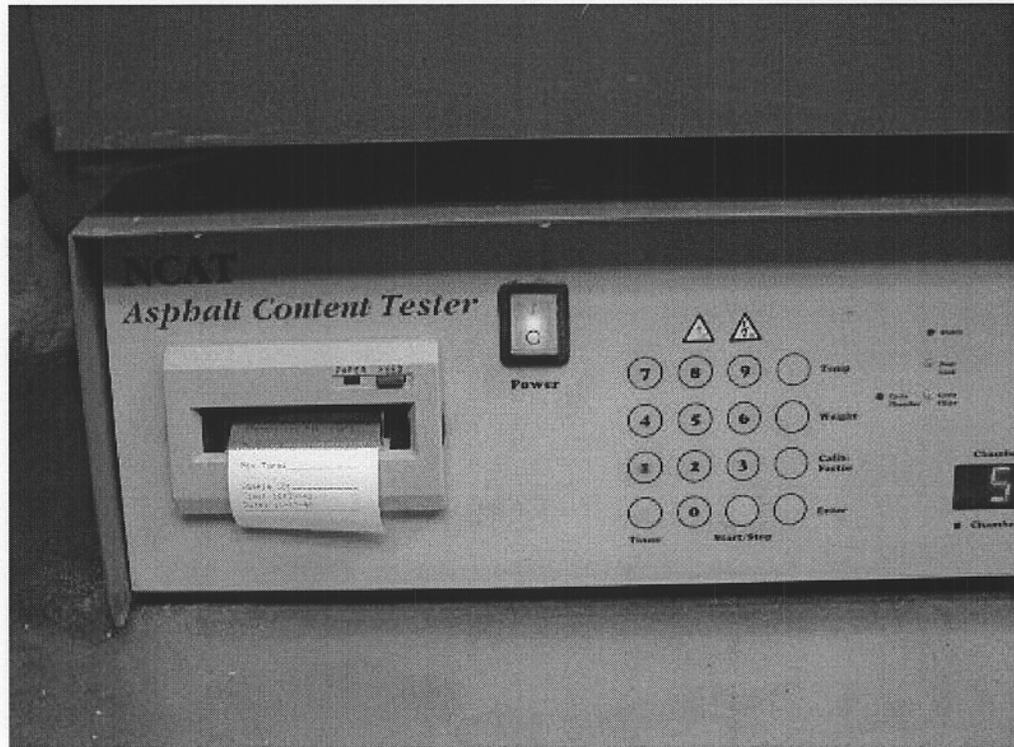
Figure 25. Output of the NCAT oven (AC%)

The NCAT Tester produces an output approximating the AC content of the sample that has undergone extraction testing. The printout from the AC Tester is shown in Figure 25.
