**Post Grouting Drilled Shaft Tips**  
*Phase II*

**Principal Investigator: Gray Mullins**

**June 2004**

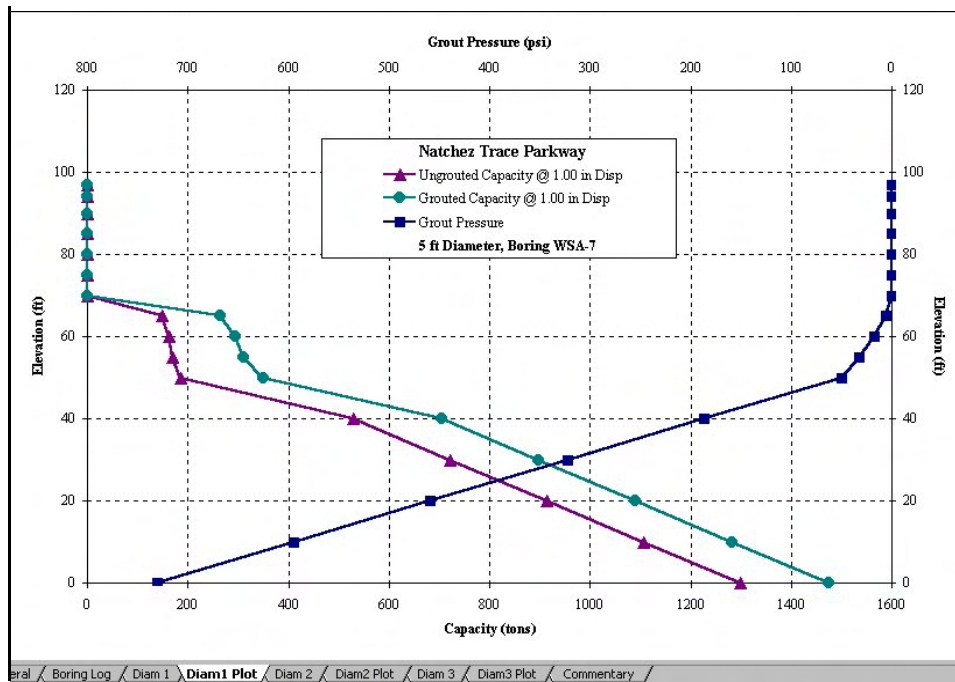
Figure 2-9 Shaft Capacity Design Curves.

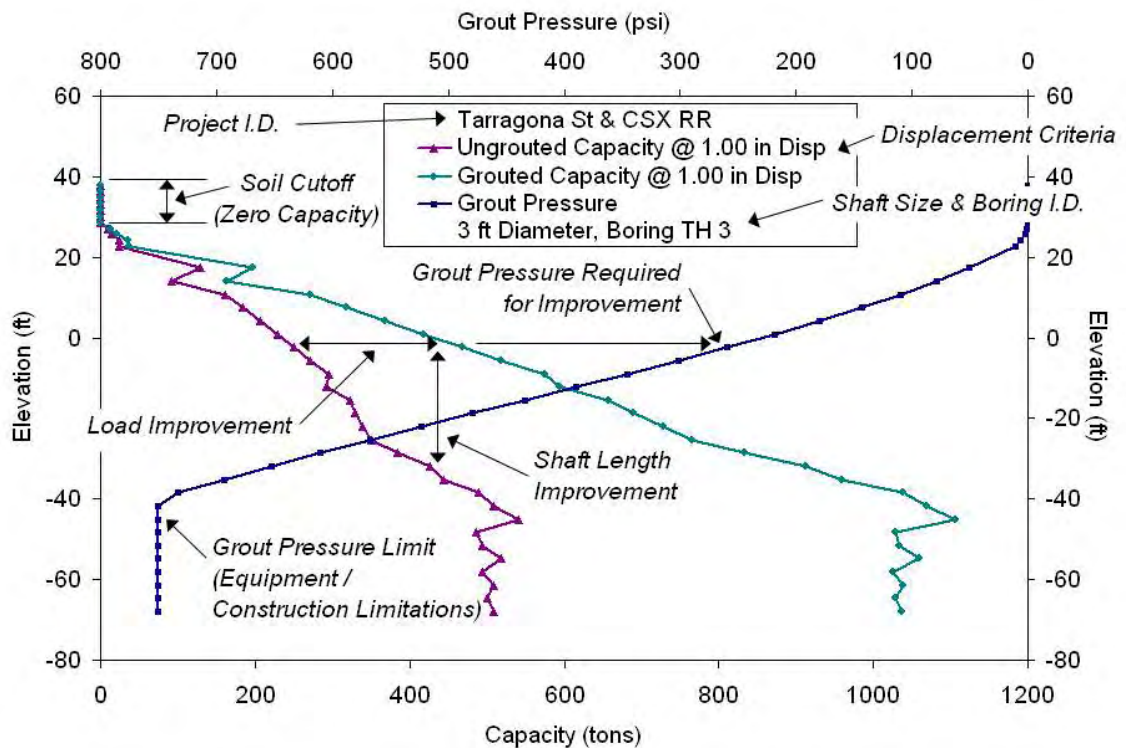
The performance improvement can be evaluated either on the basis of load carrying capacity at a specific depth or on the basis of shaft length reduction for a given load. Figure 3-1 shows a typical design curve annotated to show these comparisons. The un-annotated curve was generated from the design software and provided to the contractors.

Figure 3-1 Detailed shaft capacity and grout pressure design curves.

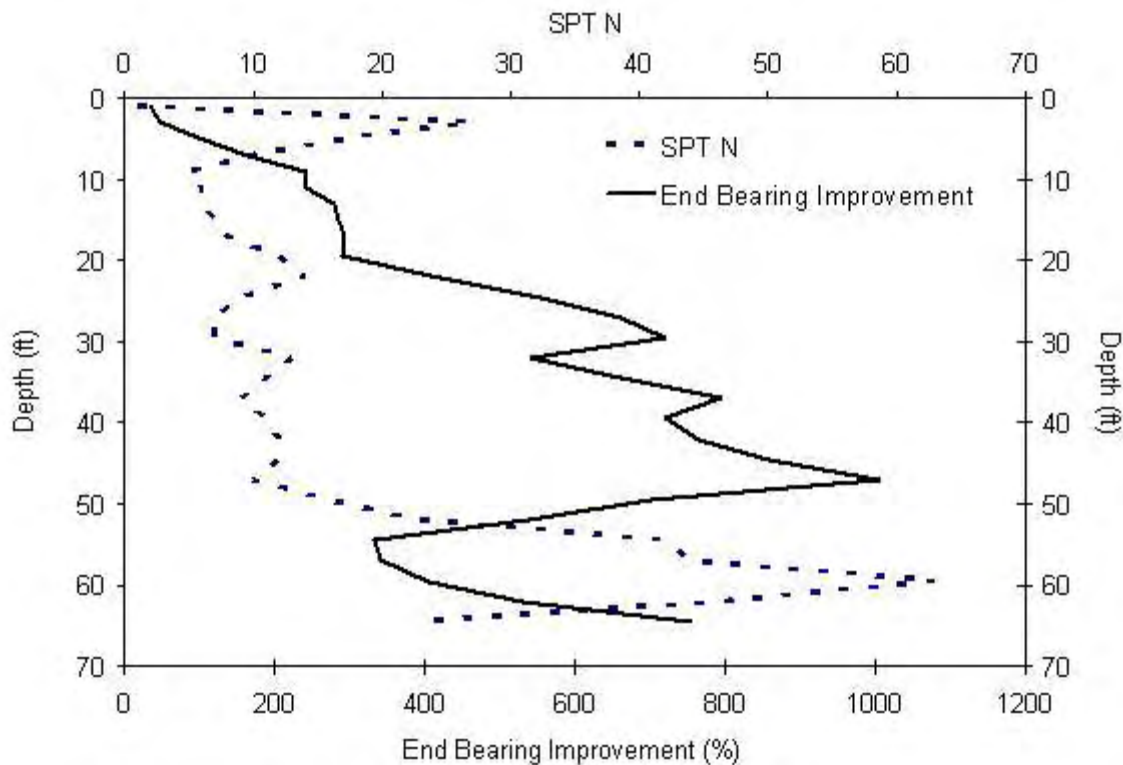
For each project reviewed, the average end bearing improvement is reported. This average was derived from all lengths of shaft reported in a given design curve. This improvement was calculated as the difference between the grouted and ungrouted end bearing divided by the ungrouted end bearing. However, this average value is not truly representative of the actual improvement that would be realized but is an indicator of general improvement in that soil type. The actual improvement is dependent on the attainable grout pressure which is directly related to available side shear. The deeper a shaft is embedded, the more available side shear capacity and hence higher attainable grout pressure. Further, loose sands are more improvable than dense sands. Figure 3-2 shows the improvement as a function of depth for Boring PGAB-1 from the PGA Blvd Project in West Palm, FL. In general, the end bearing improvement increases with depth and decreases inversely proportional to relative density.

Figure 3-2 End Bearing Improvement with respect to depth and SPT N value.

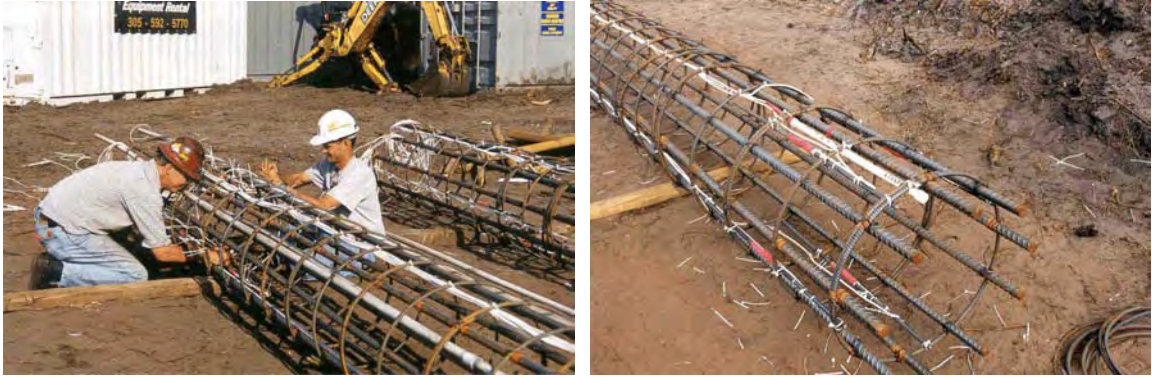
Figure 4-1 PGA Blvd: Installation of strain gages and toe accelerometer.

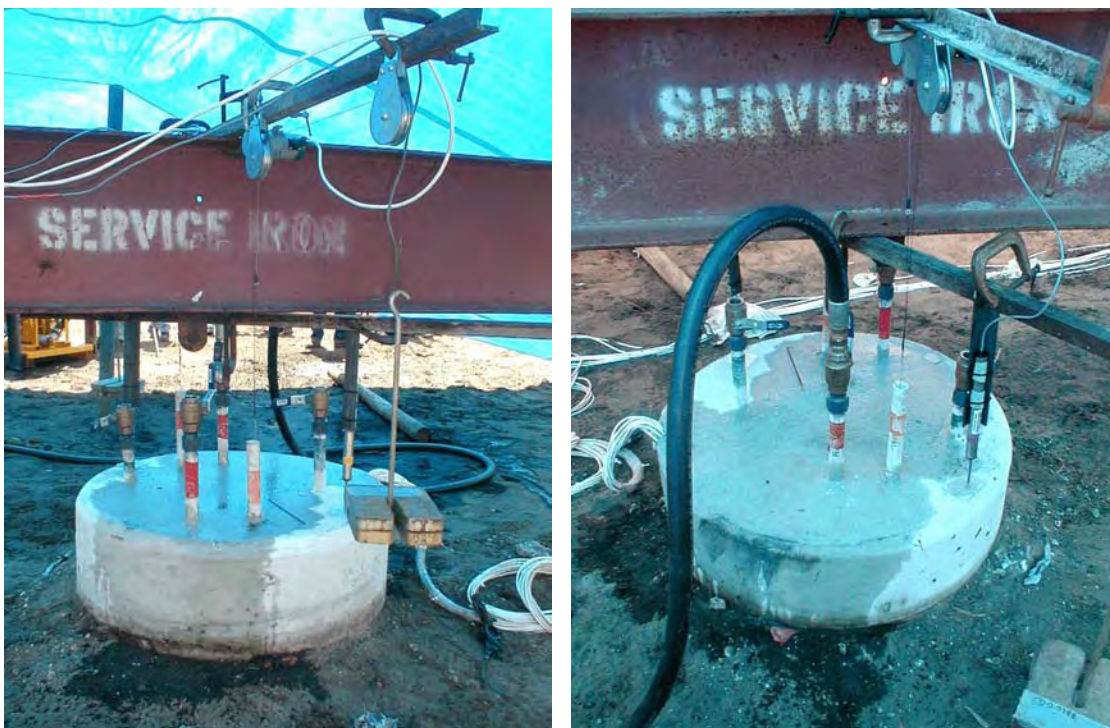
Figure 4-11 PGA Blvd: Post grout instrumentation setup.

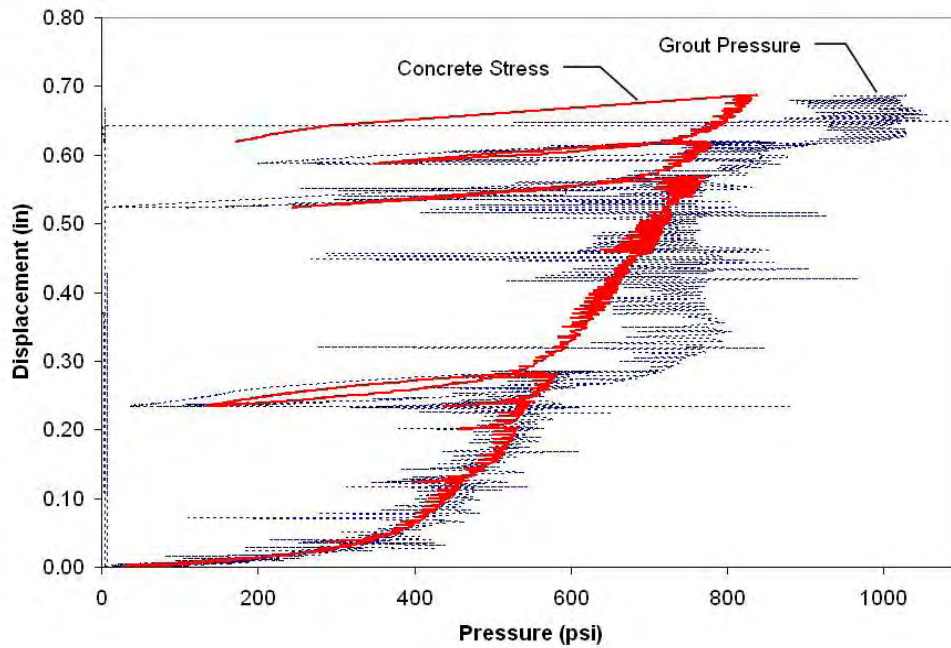
Figure 4-16 PGA Blvd: Shaft tip stress comparison with grout pump pressure.

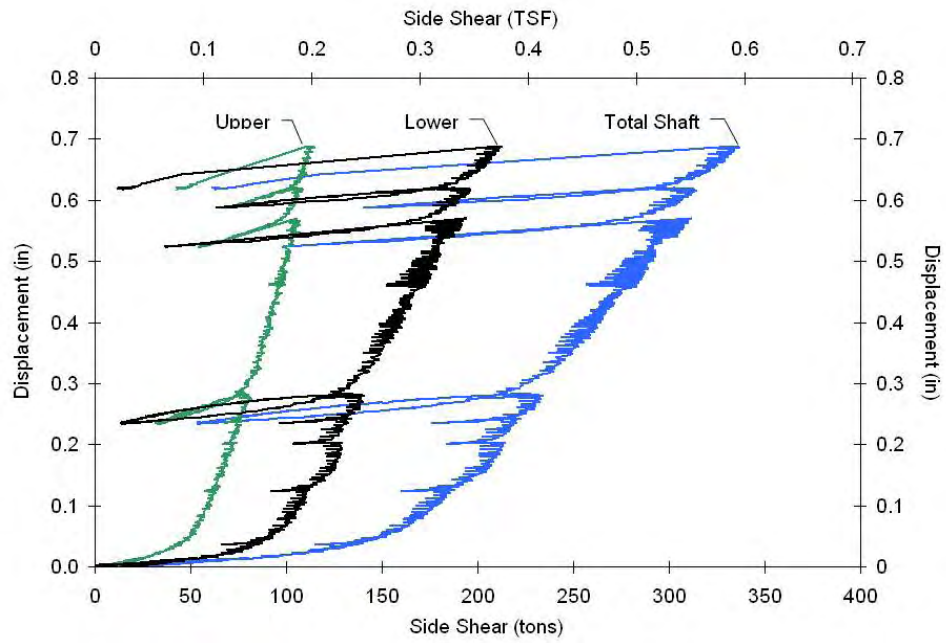
Figure 4-17 PGA Blvd: Side shear versus displacement during grouting.

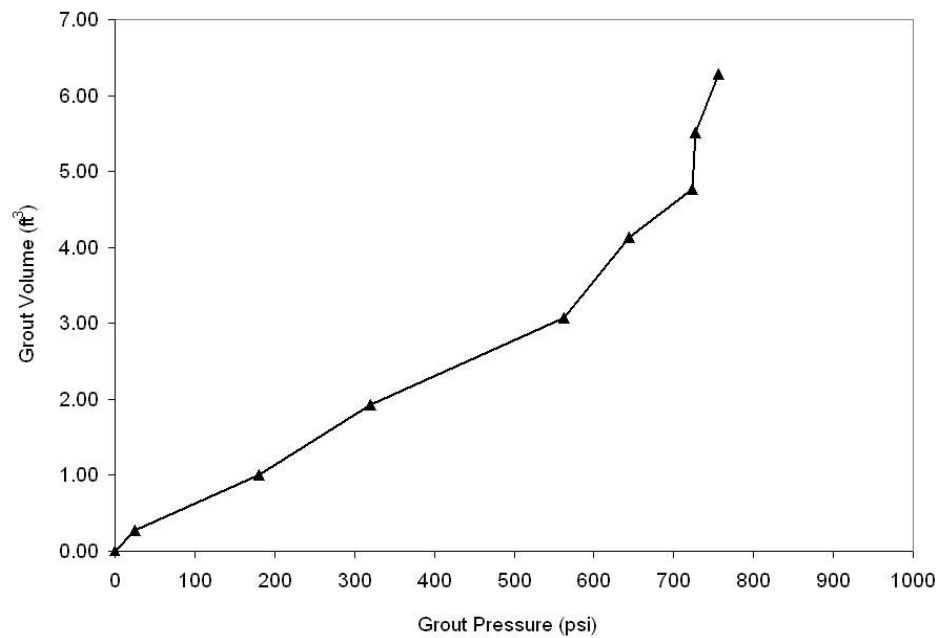
Figure 4-18 PGA Blvd: Grout volume versus grout pressure (LT-2).

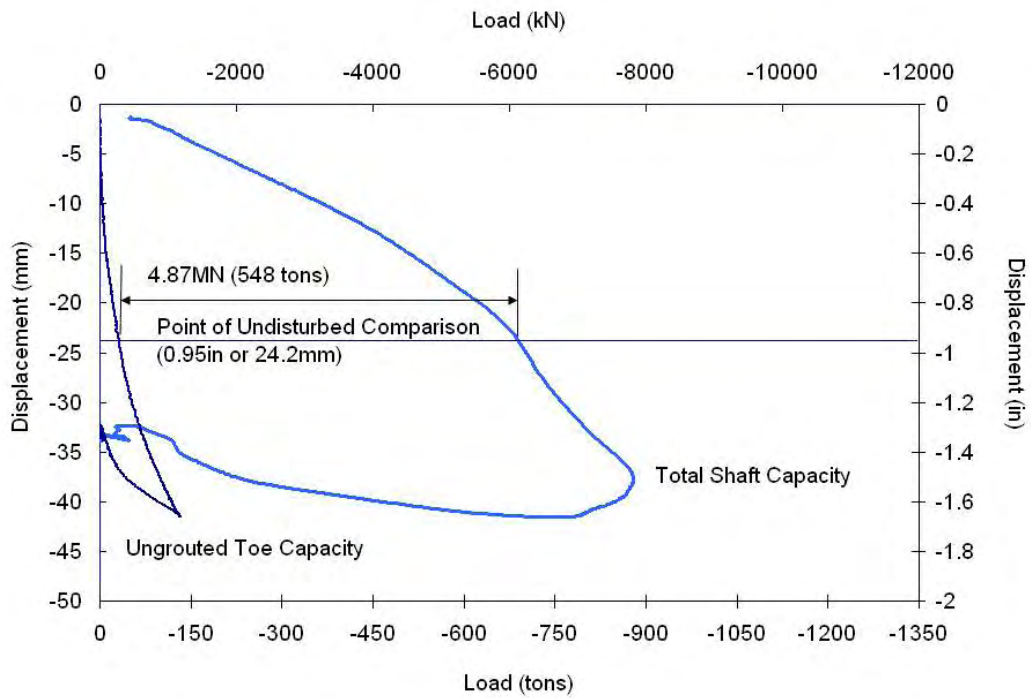
Figure 4-20 PGA Blvd: LT-1 total shaft and toe capacity curves.

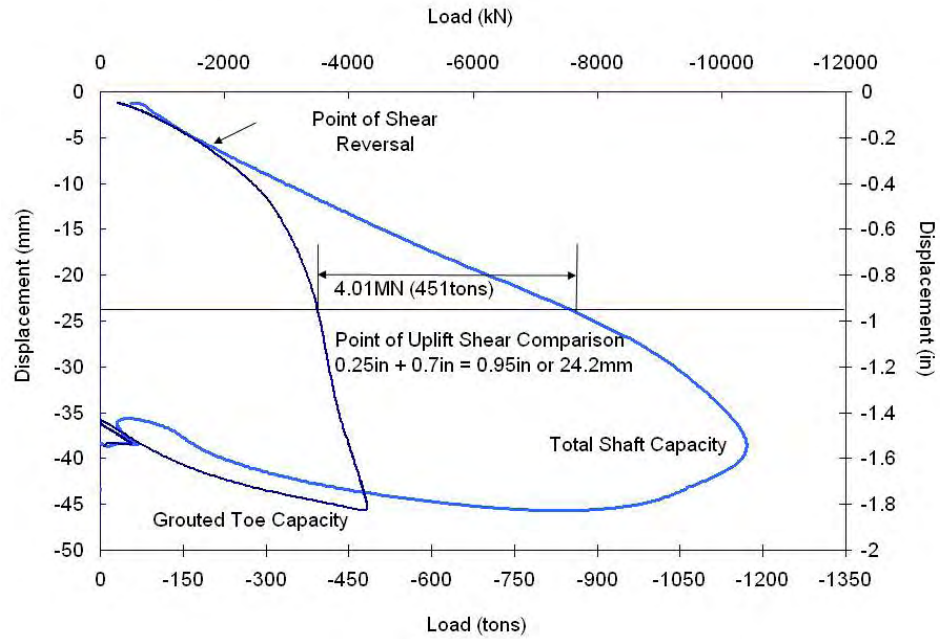
Figure 4-21 PGA Blvd: LT-2 total shaft and toe capacity curves.

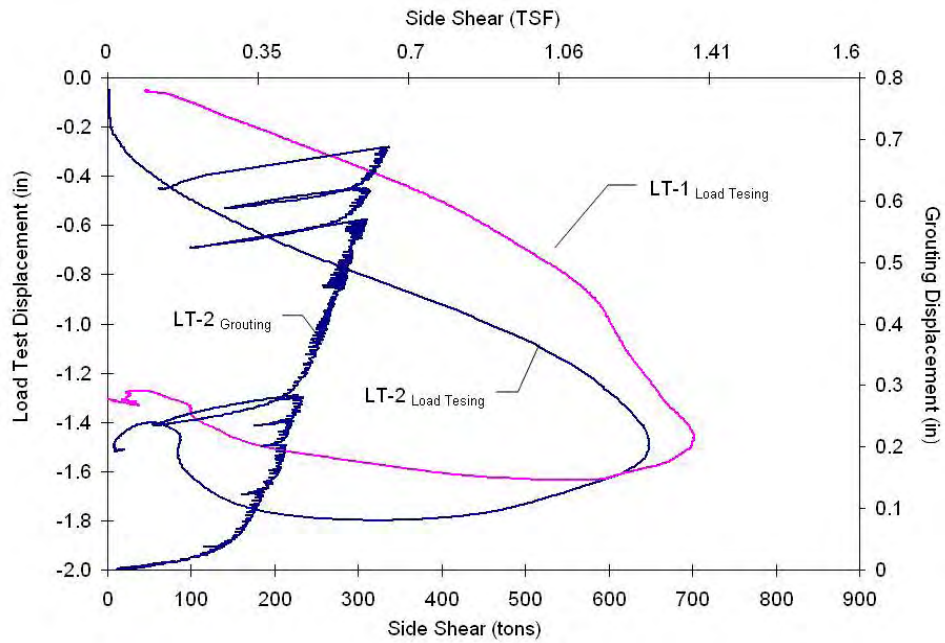
Figure 4-22 PGA Blvd: Side shear during load testing and grouting.

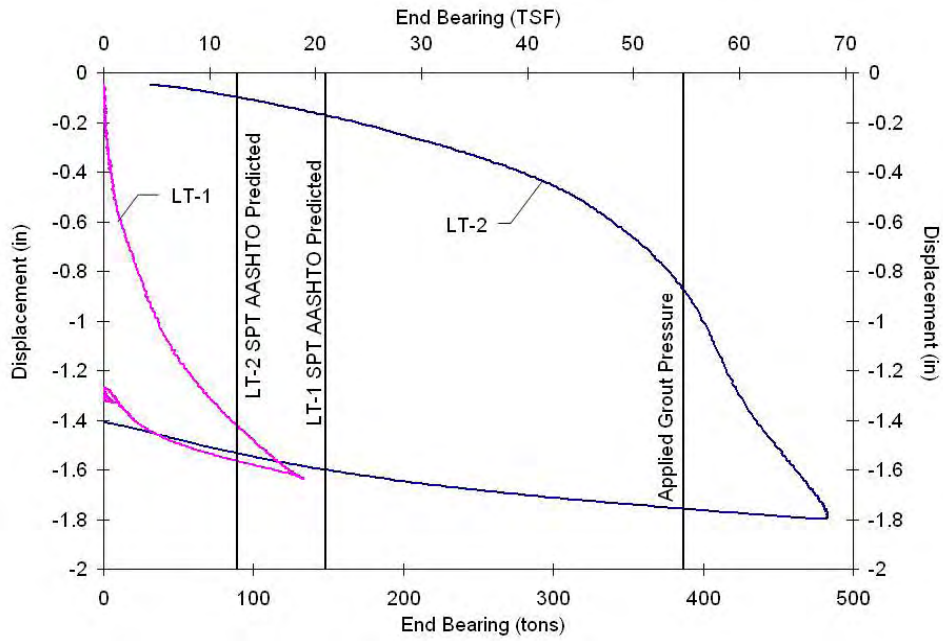
Figure 4-23 PGA Blvd: End bearing load plots with applied grout pressure and predicted AASHTO end bearing.

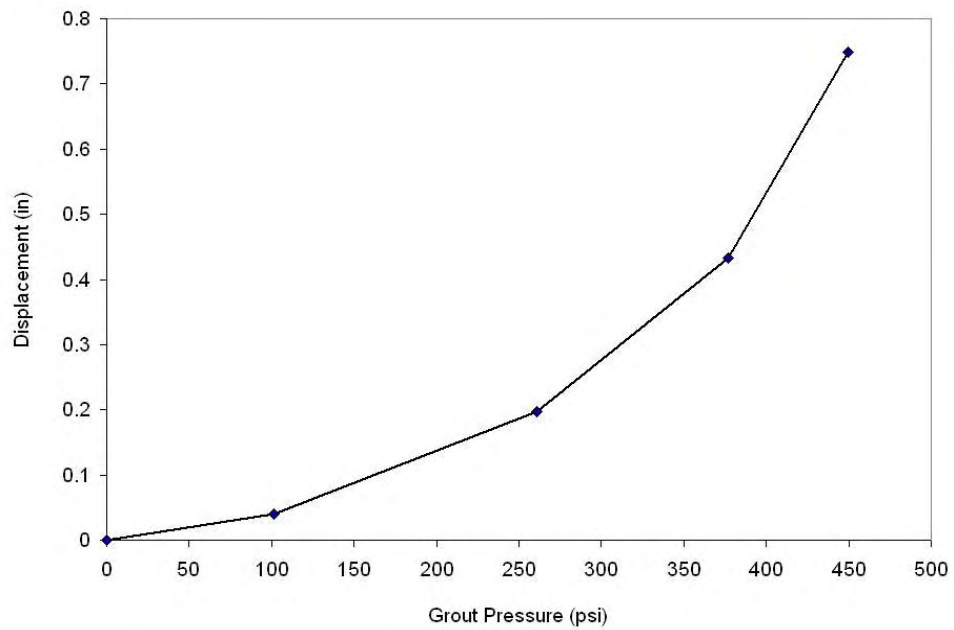
Figure 4-35 PGA Blvd: Typical grout pressure versus displacement from field grouting logs; Pier 2 / Footing 4 Right - Shaft 2.

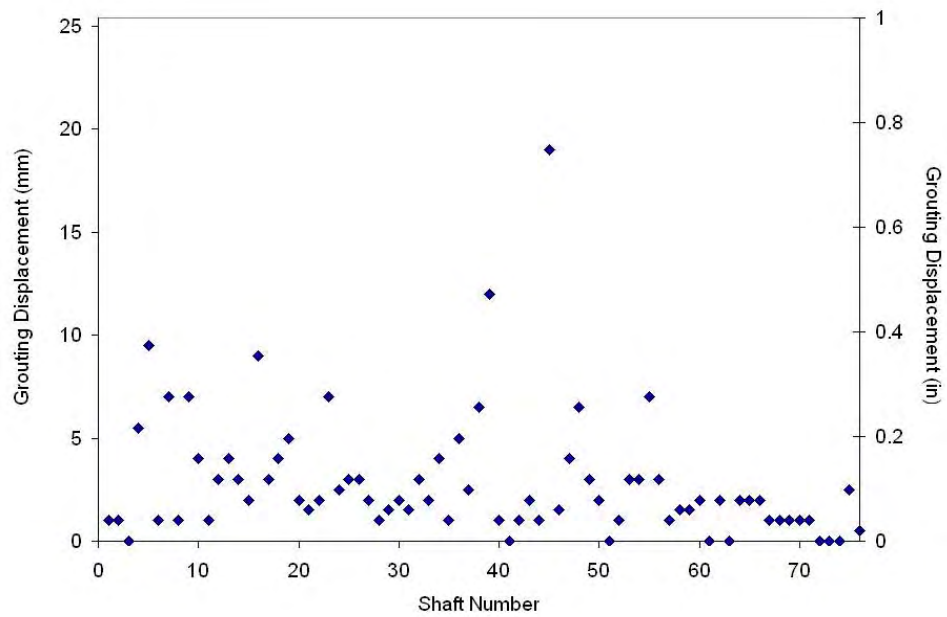
Figure 4-39 PGA Blvd: Phase I production QA data showing uplift for every shaft.

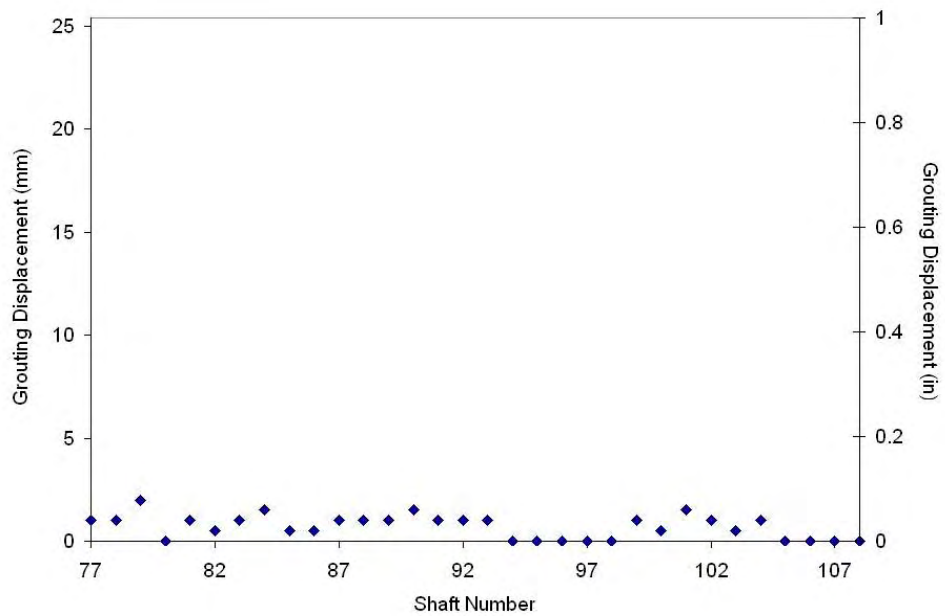
Figure 4-40 PGA Blvd: Phase II production QA data showing uplift for every shaft.

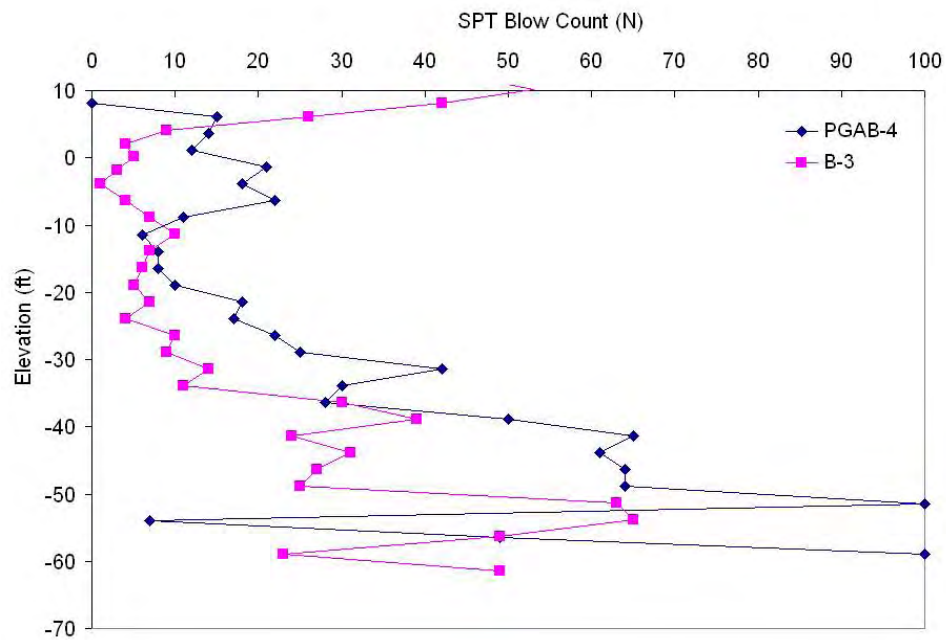
Figure 4-41 PGA Blvd: Variations in blow counts between manual and automatic hammers.

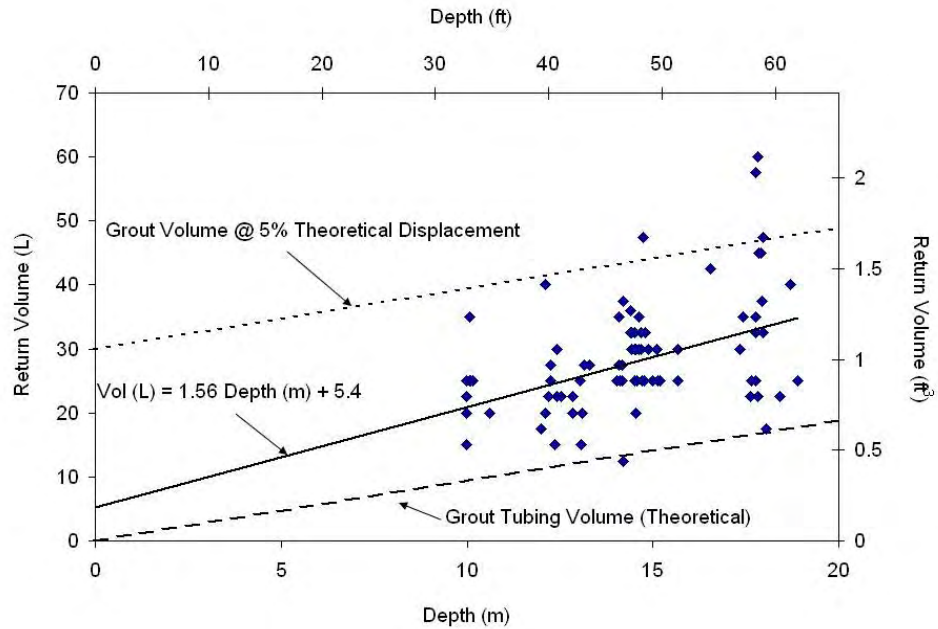
Figure 4-43 PGA Blvd: Volume of grout required to obtain return (no pressure).

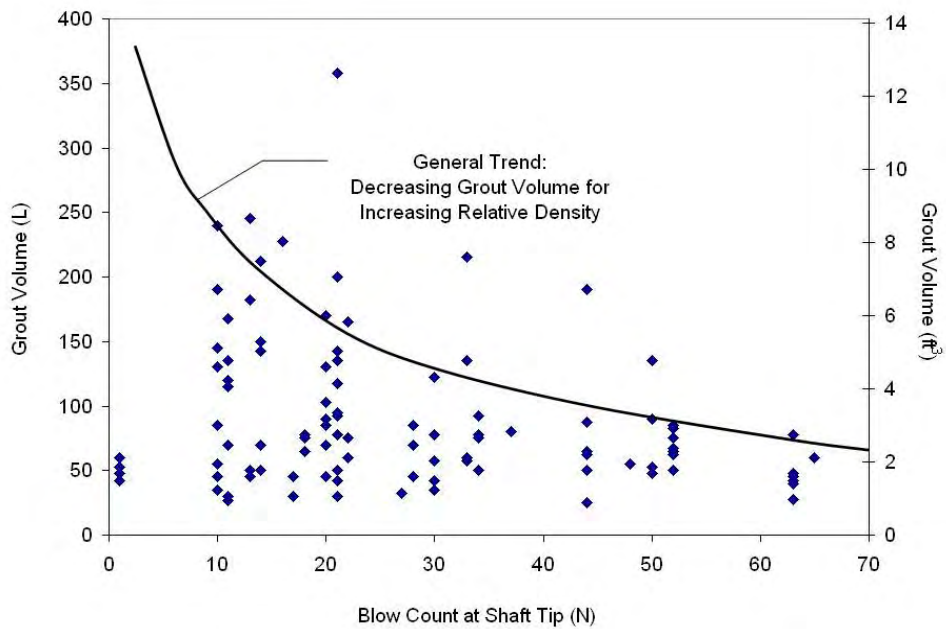
Figure 4-44 PGA Blvd: Net volume of grout placed beneath shaft tips.

with dense sand given the same side shear reaction. The difference lies in the amount of grout required to affect the soil modification to a similar density state. The dense sand beneath S-2 ( $N > 50$ ) and the net volume taken to grout ( $3 \text{ ft}^3$ ) are in line with that observed at the PGA Blvd project (Figure 4-44).

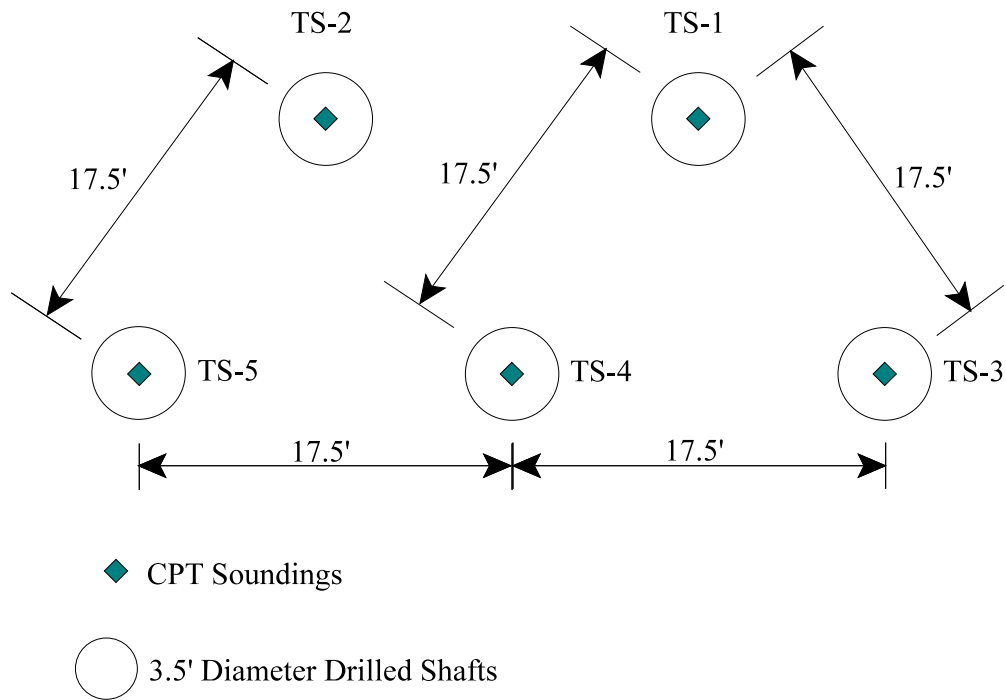
Figure 4-45 NGES Auburn test site layout.

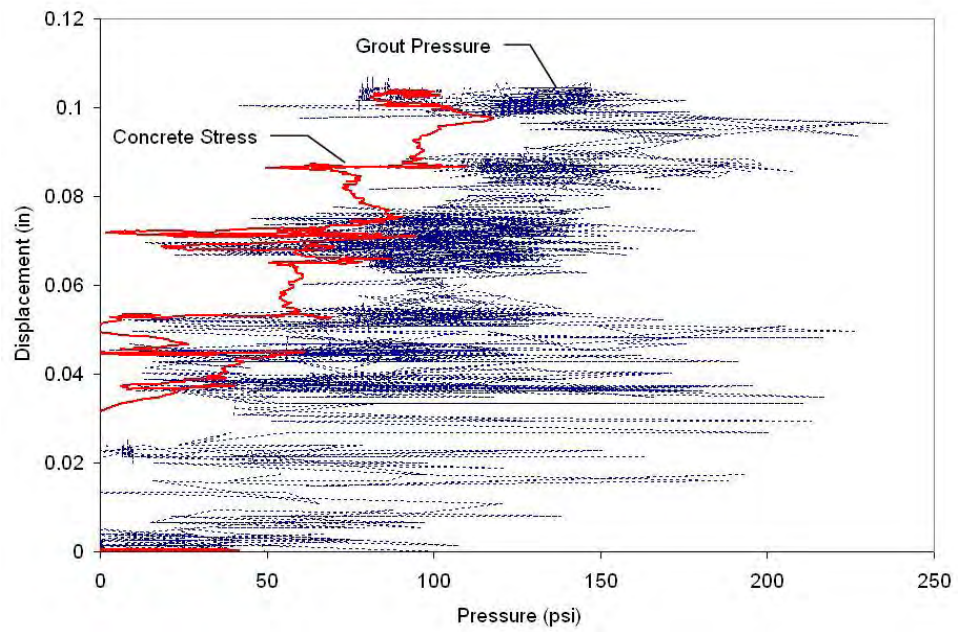
Figure 4-63 NGES Auburn: TS-1 grout pressure versus displacement.

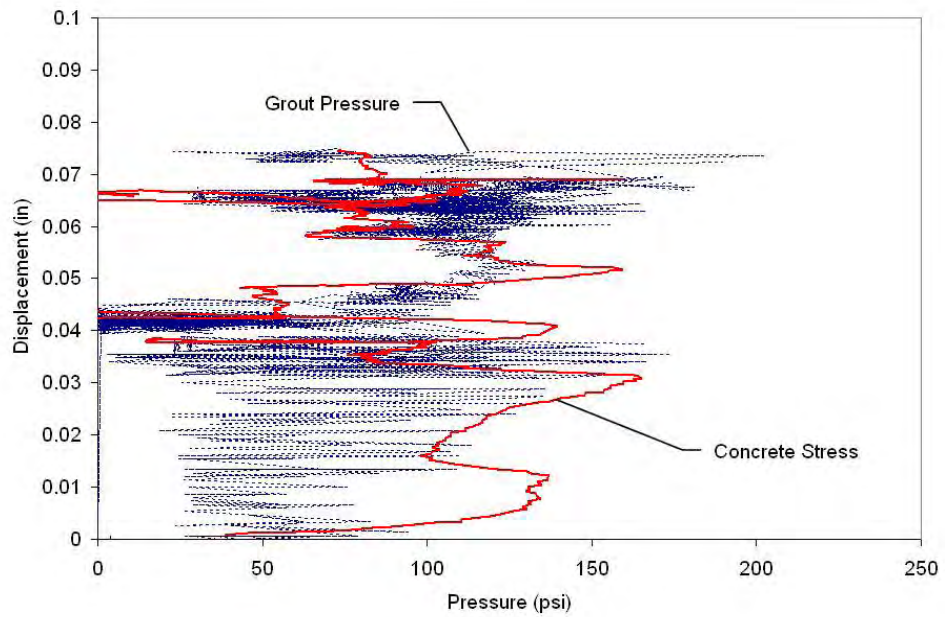
Figure 4-64 NGES Auburn: TS-2 grout pressure versus displacement.

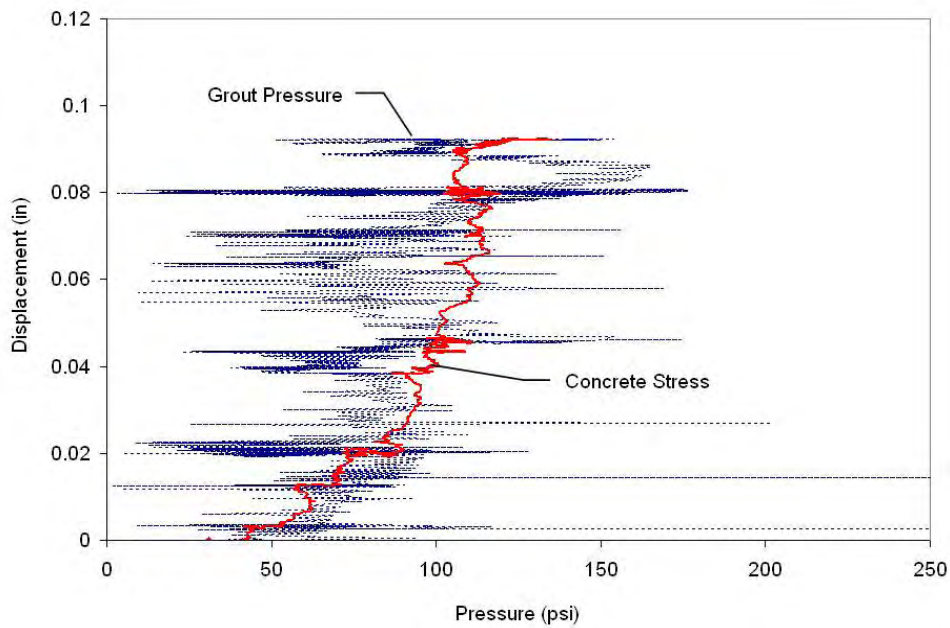
Figure 4-65 NGES Auburn: TS-3 grout pressure and concrete stress versus displacement.

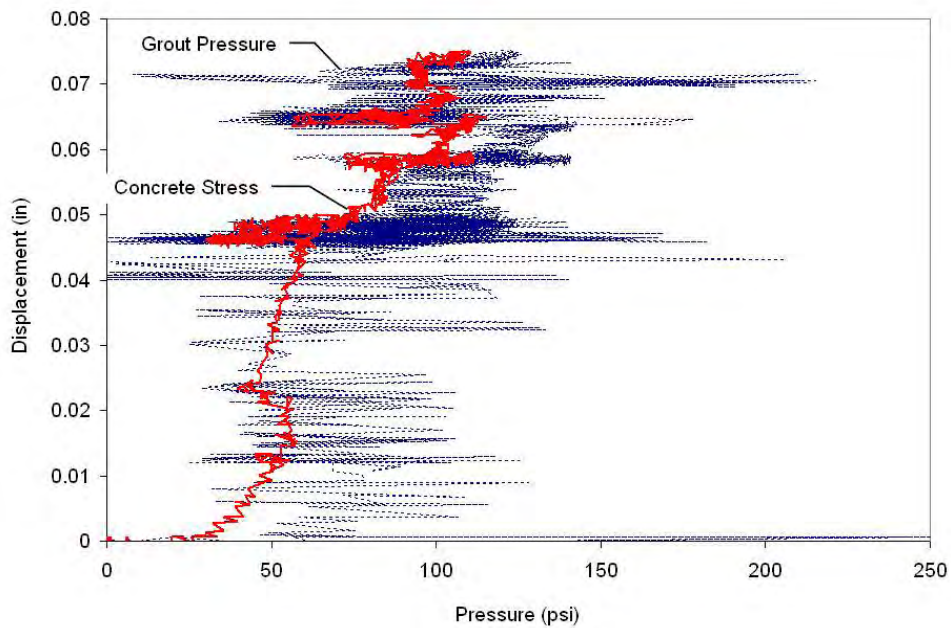
Figure 4-66 NGES Auburn: TS-5 grout pressure and concrete stress versus displacement.

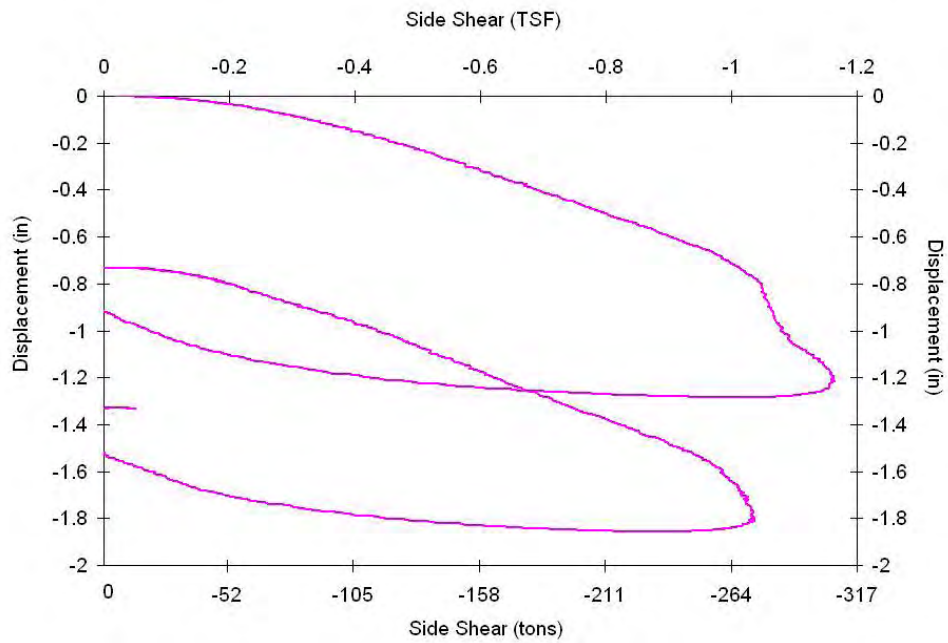
Figure 4-72 NGES Auburn: TS-4 Side shear plots during axial load testing.

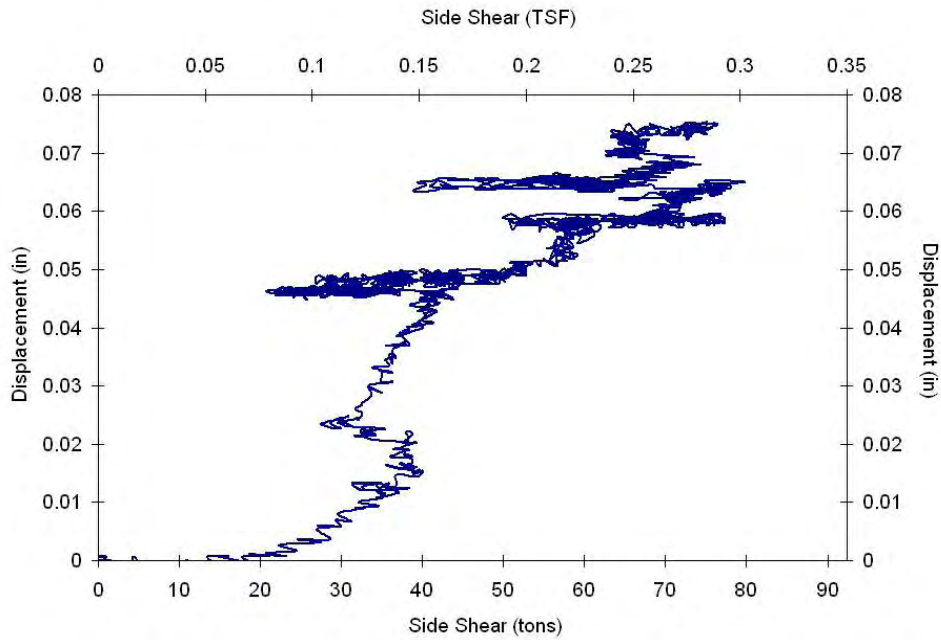
Figure 4-73 NGES Auburn: Side shear plot for TS-5 during grouting.

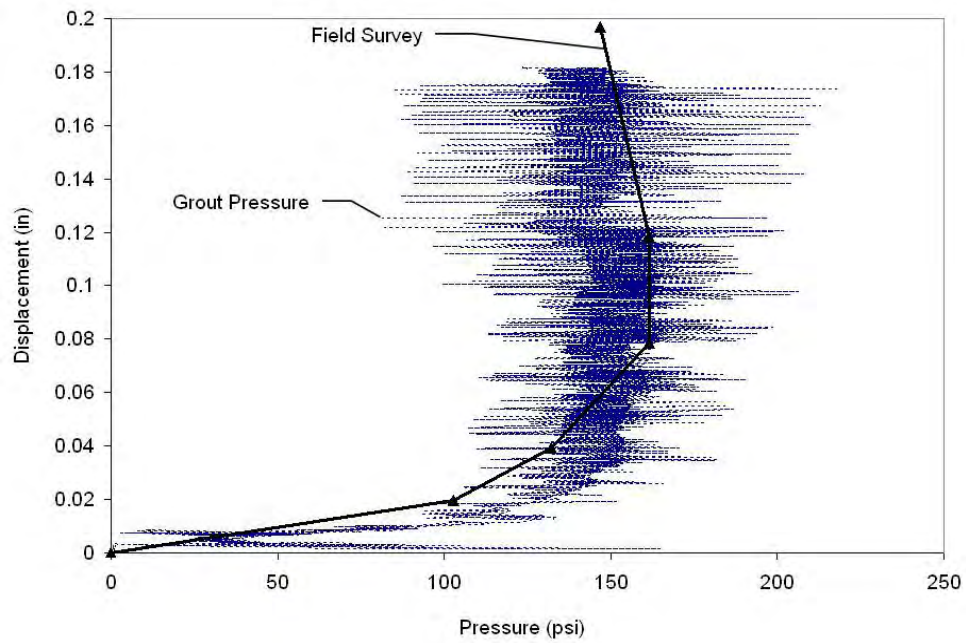
Figure 4-96 TexDOT Demo: Comparison between load test and production survey data (shaft C-2).

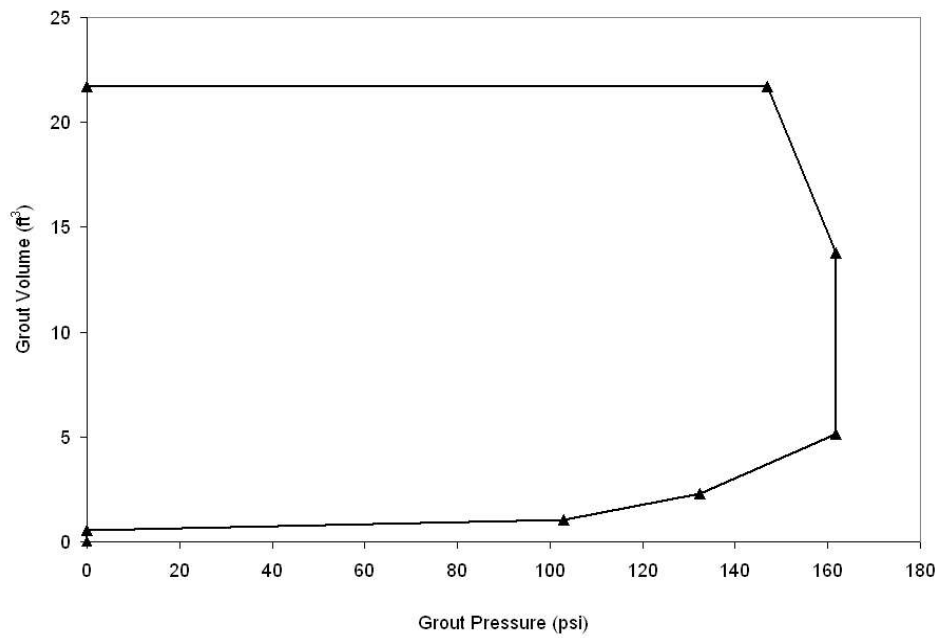
Figure 4-99 TexDOT Demo: C-2 grout volume versus grout pressure.

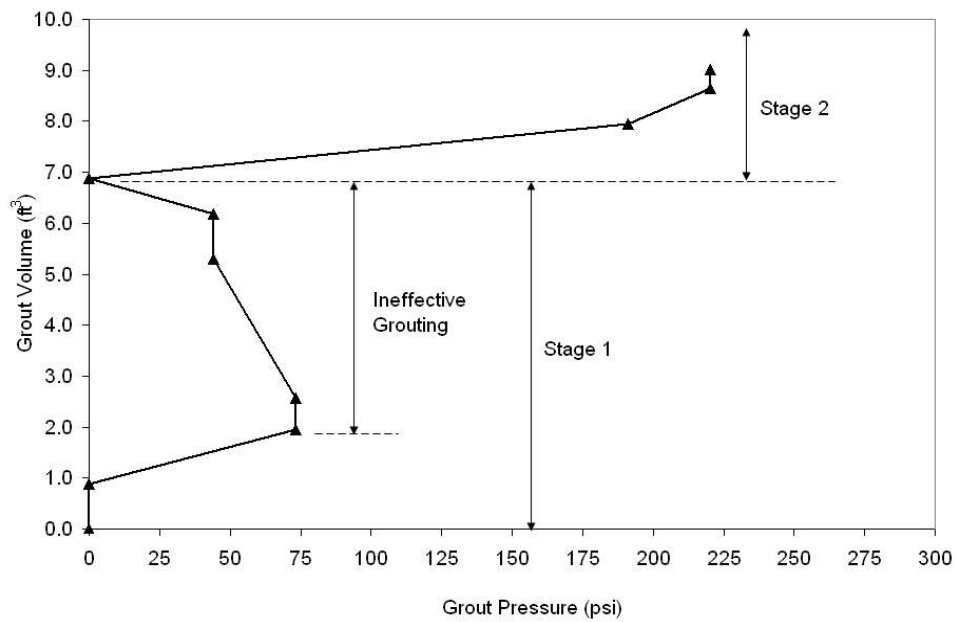
Figure 4-101 TexDOT Demo: S-2 grout volume versus grout pressure.

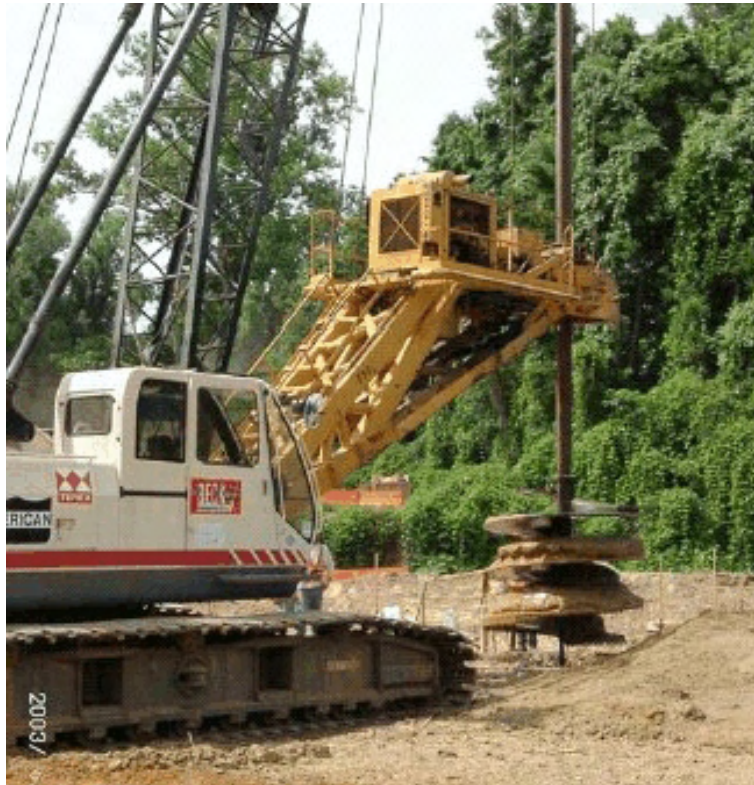
Figure 4-111 Natchez: Crane mounted drill rig.

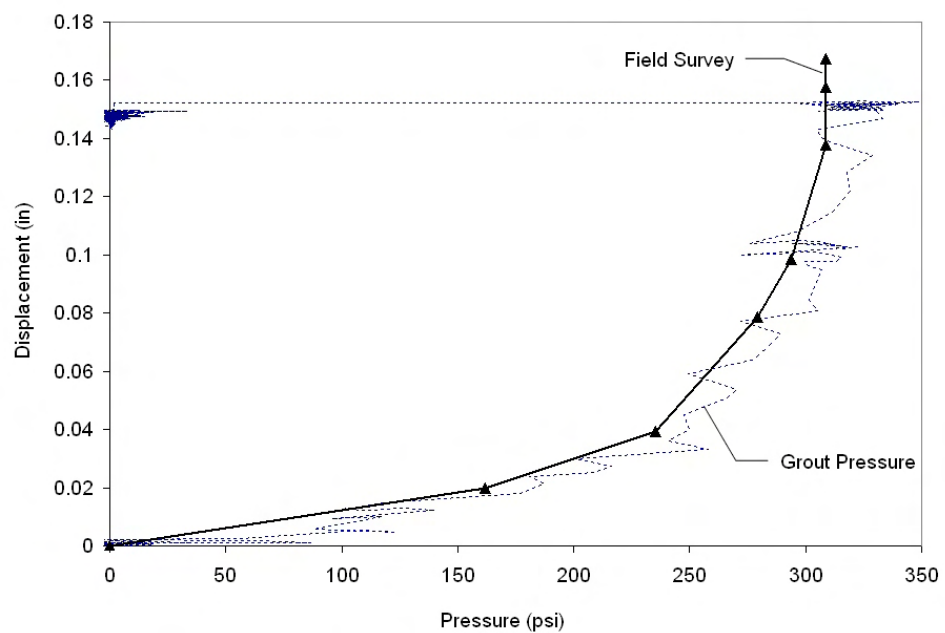
Figure 4-122 Natchez: Grout pressure versus displacement non-production test shaft.

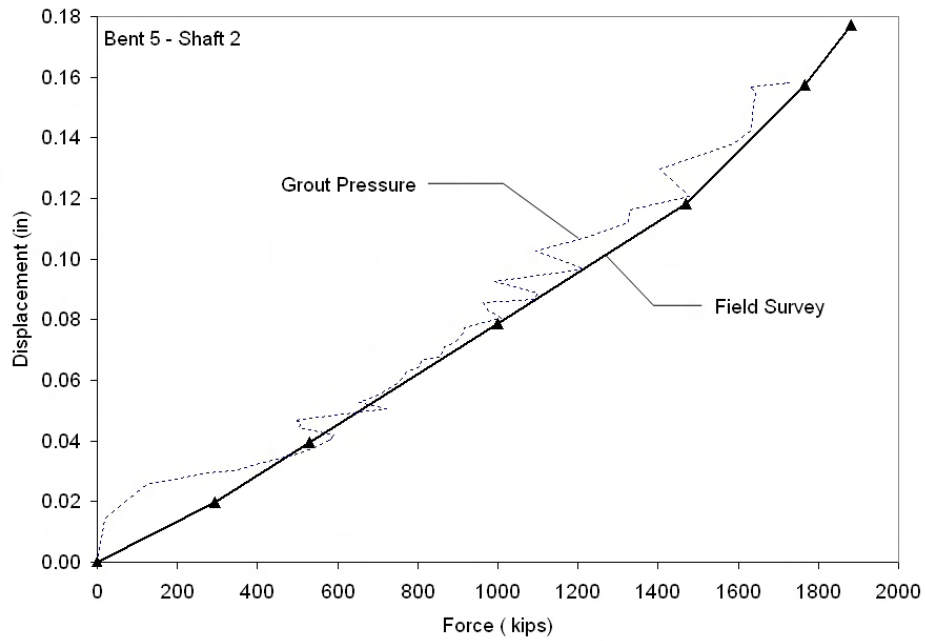
Figure 4-123 Natchez: Grout pressure versus displacement (instrumented production test shaft w/o isolation casing).

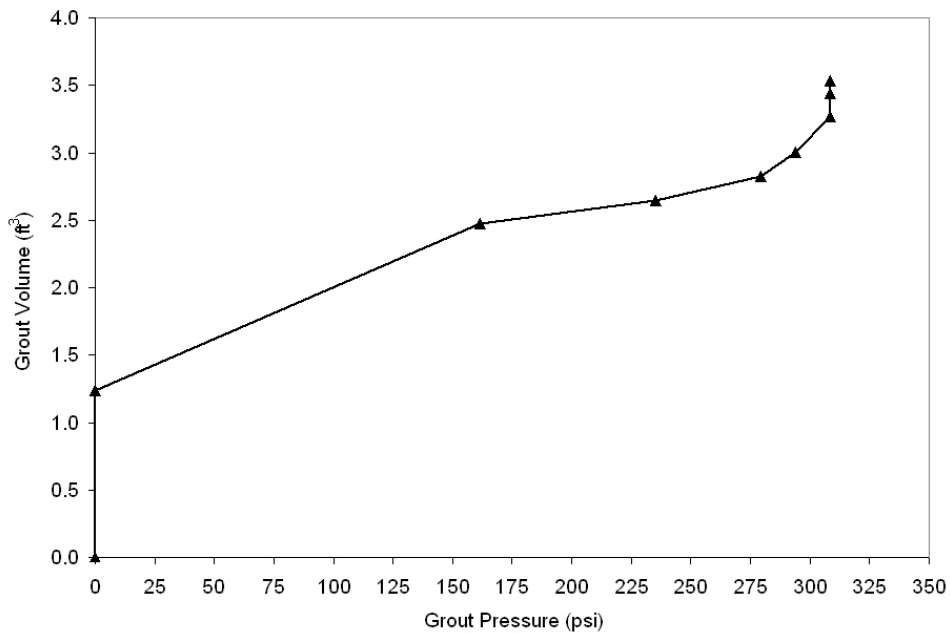
Figure 4-124 Natchez: Grout pressure versus grout volume (non-production test shaft).

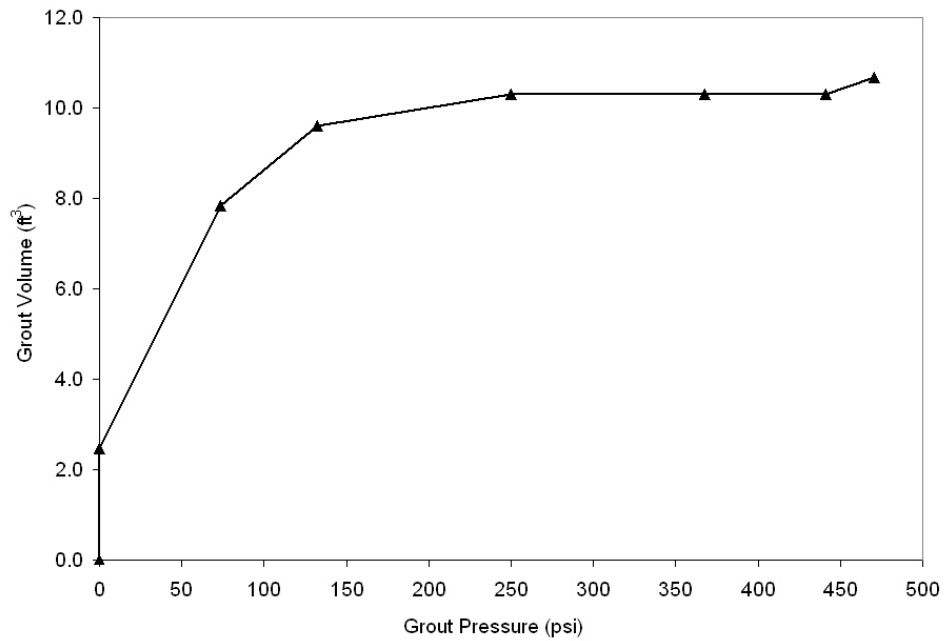
Figure 4-125 Natchez: Grout pressure versus grout volume (production test shaft).

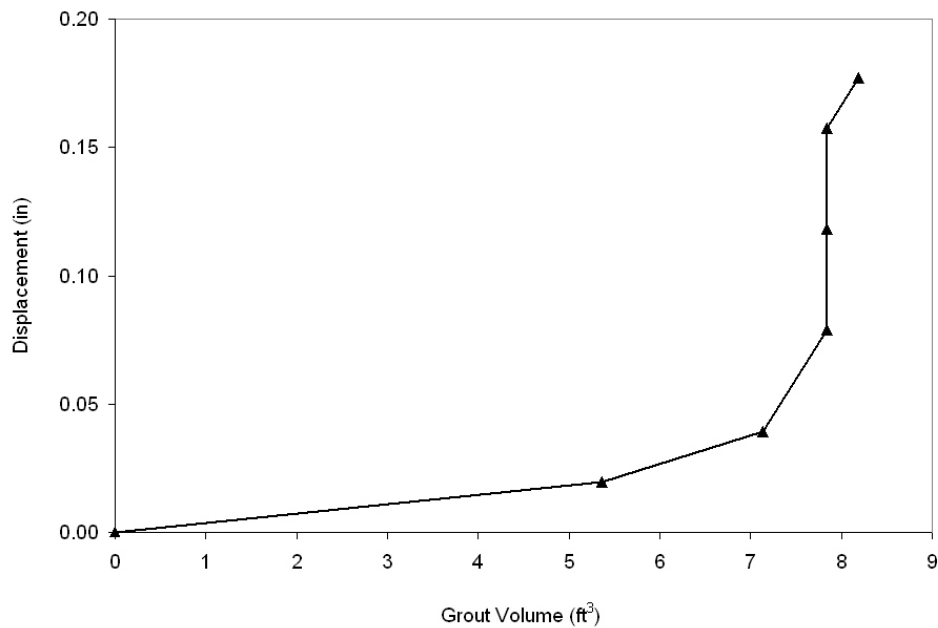
Figure 4-126 Natchez: Grout volume versus displacement (production test shaft).

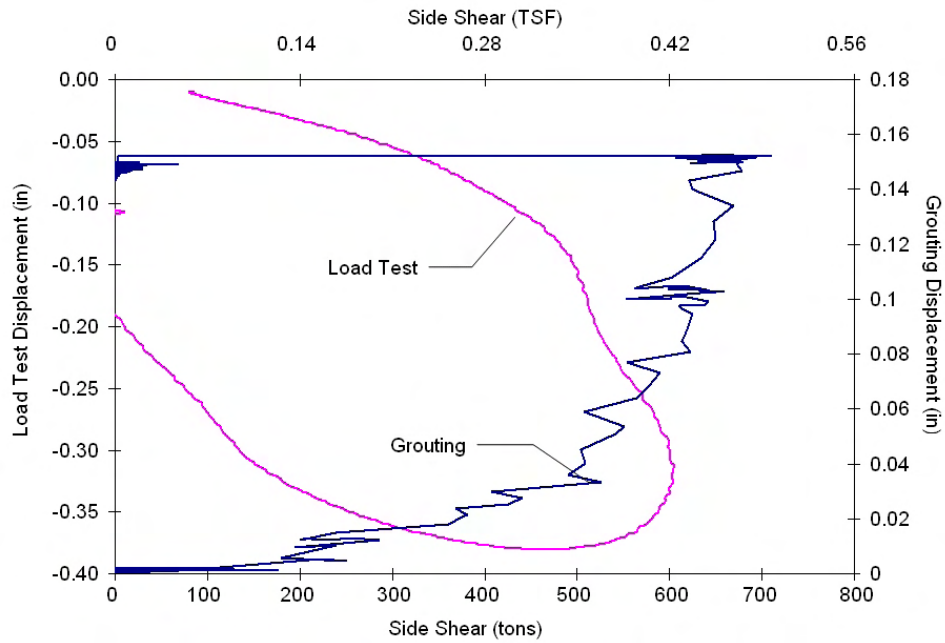
Figure 4-127 Natchez: Side shear for non-production test shaft with isolation casing.
