**Post Grouting Drilled Shaft Tips**  
*Phase II*

**Principal Investigator: Gray Mullins**

**June 2004**

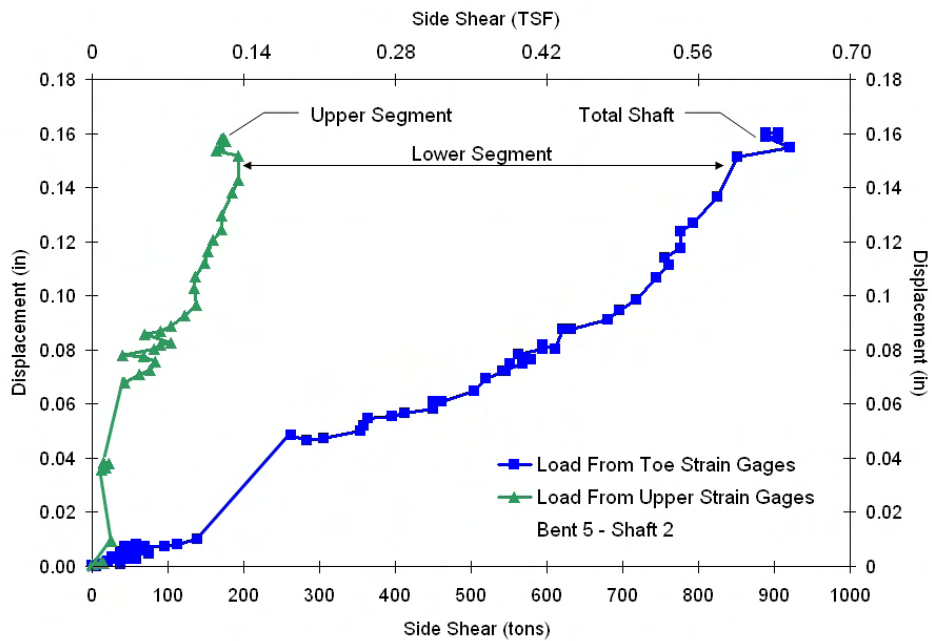
Figure 4-128 Natchez: Side shear for the instrument production shaft.

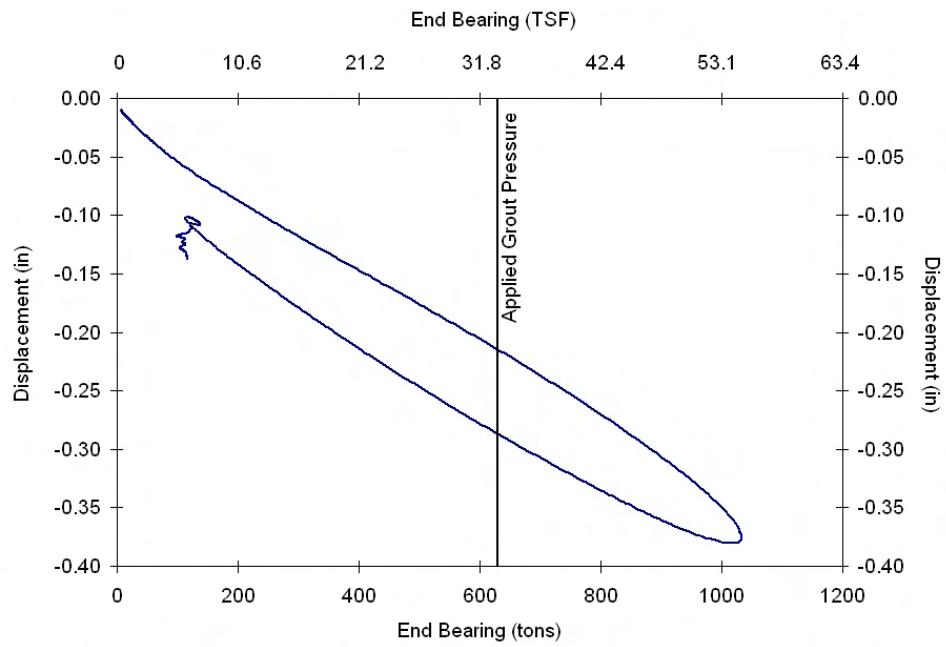
Figure 4-133 Natchez: End bearing (test shaft with isolation casing).

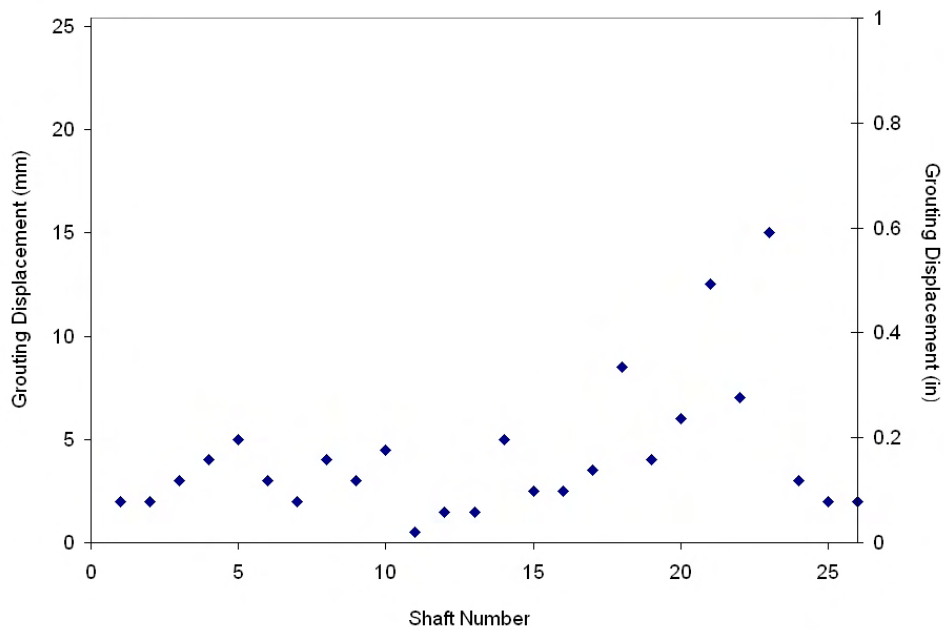
Figure 4-139 Natchez: Production QA data showing uplift for every shaft.

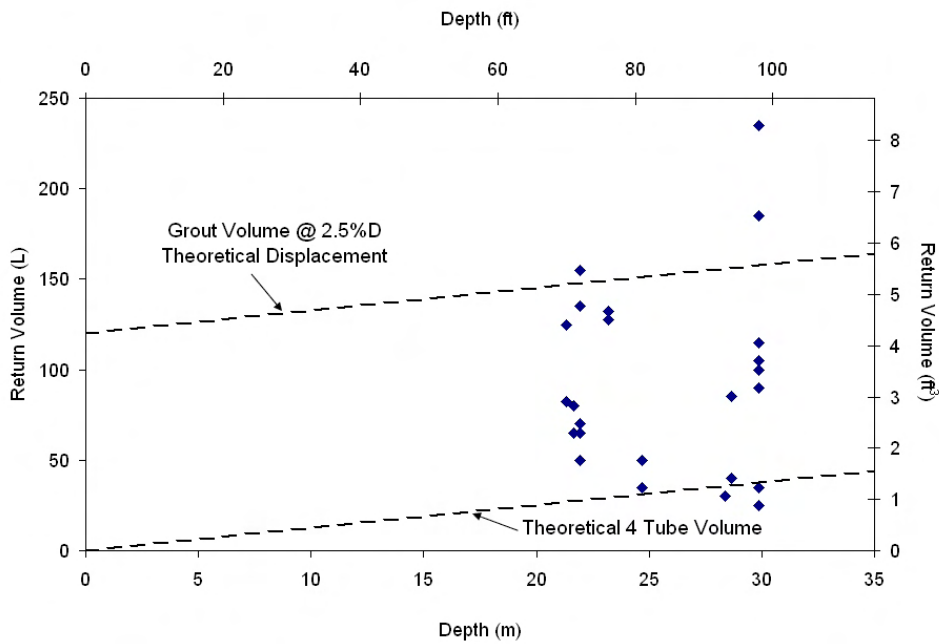
Figure 4-140 Natchez: Volume of grout required to obtain return (no pressure).

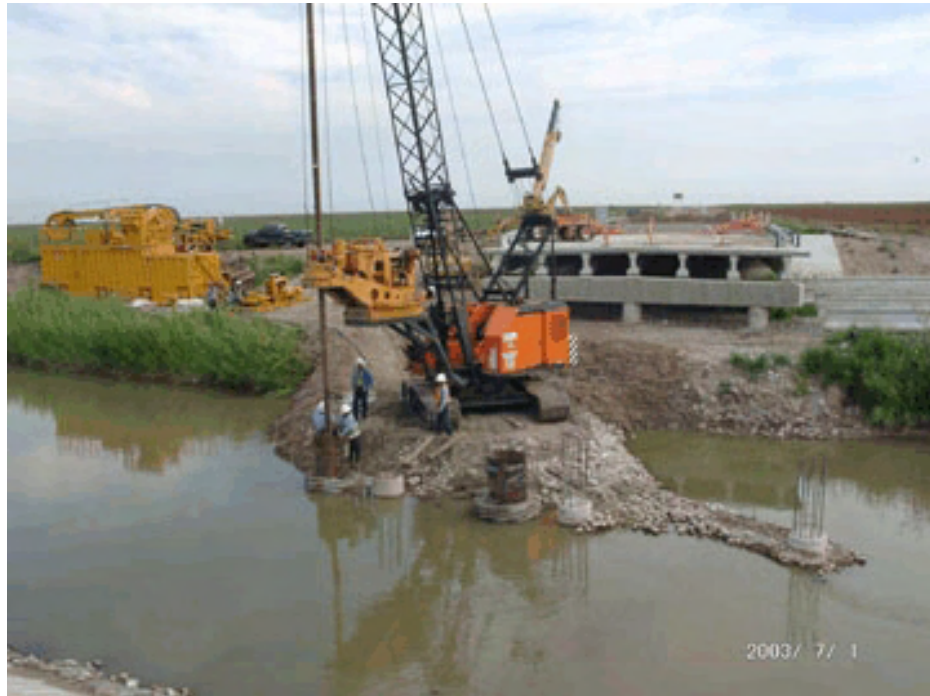
Figure 4-142 FM 507: Setup and drilling of the west shaft.

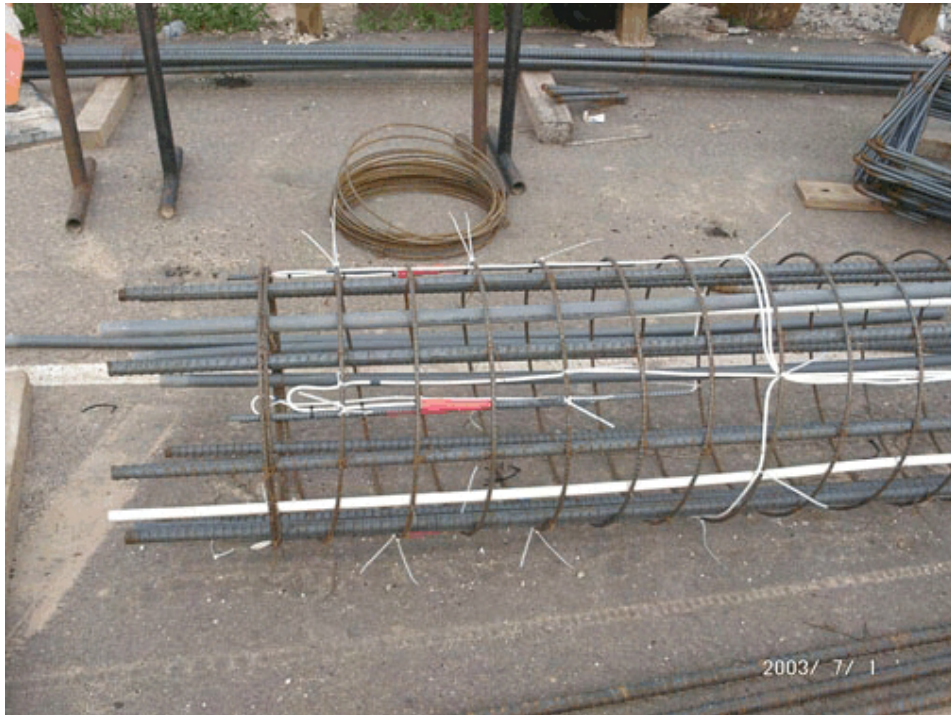
Figure 4-146 FM 507: Strain gages and telltale tubes installed.

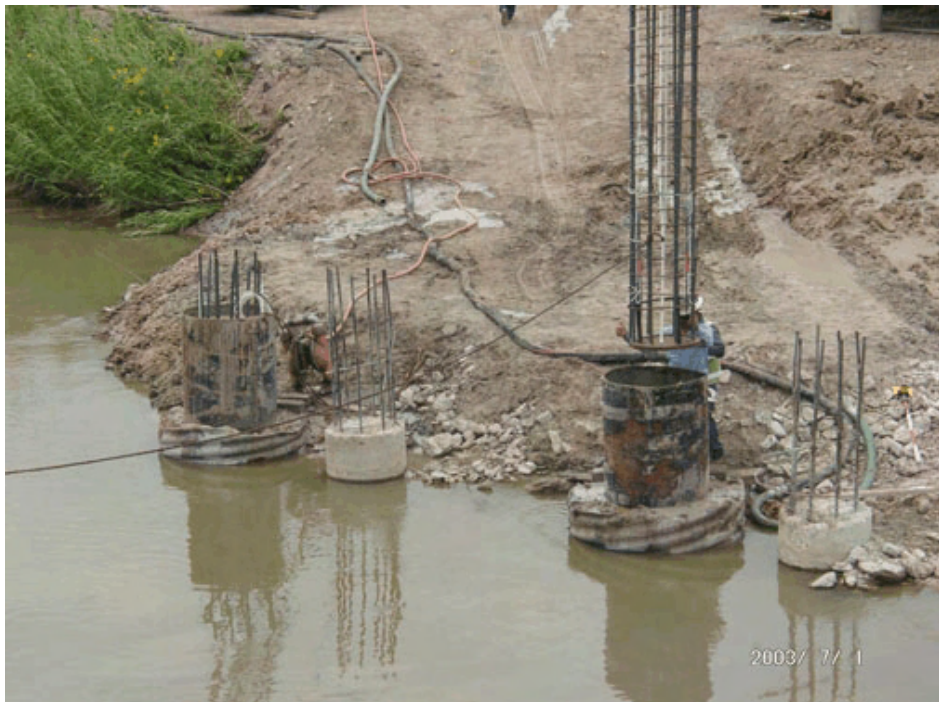
Figure 4-149 FM 507: East shaft cage placement.

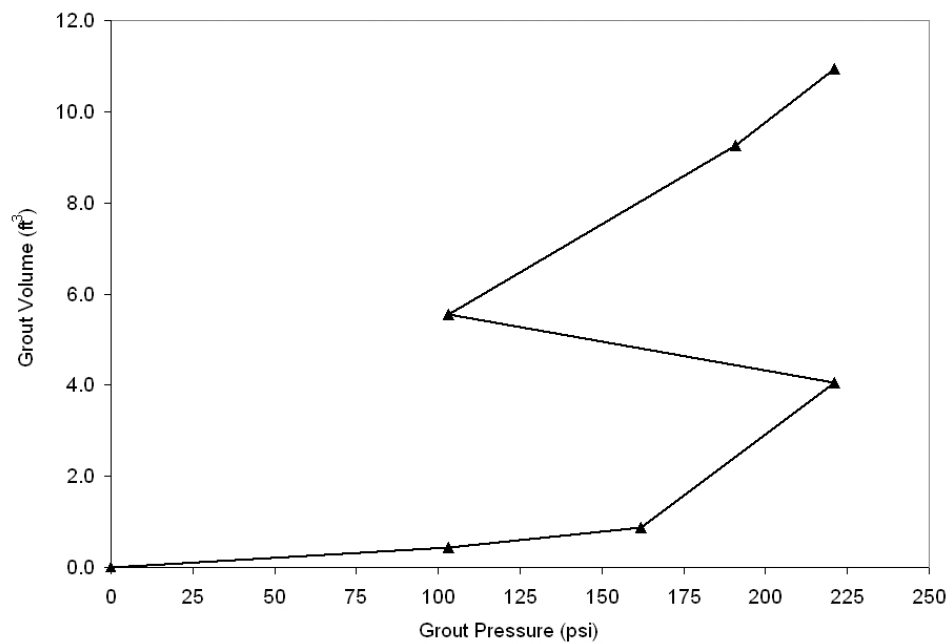
Figure 4-157 FM 507: West shaft grout pressure versus grout volume.

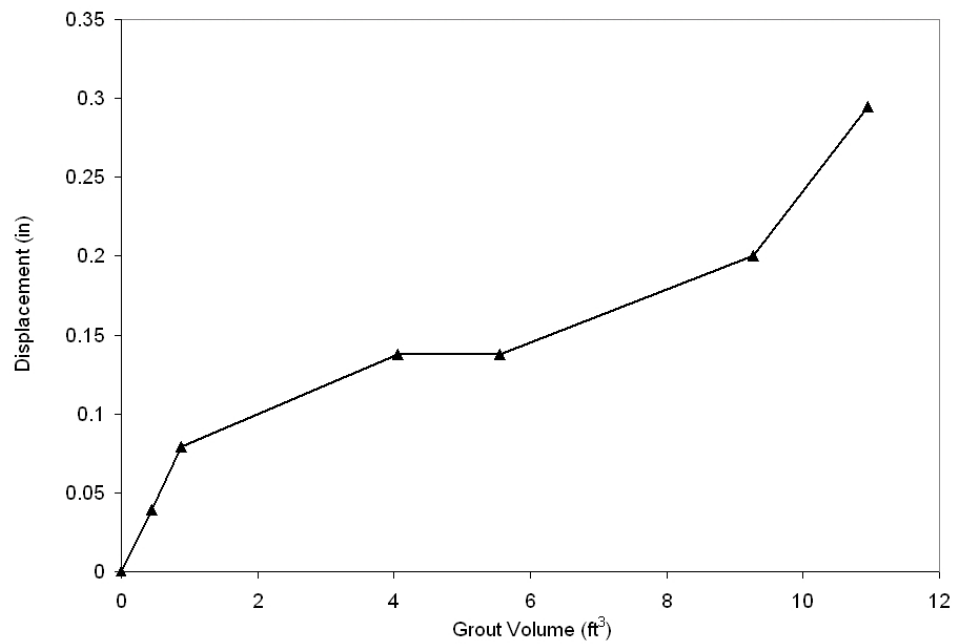
Figure 4-158 FM 507: West shaft grout volume versus displacement.

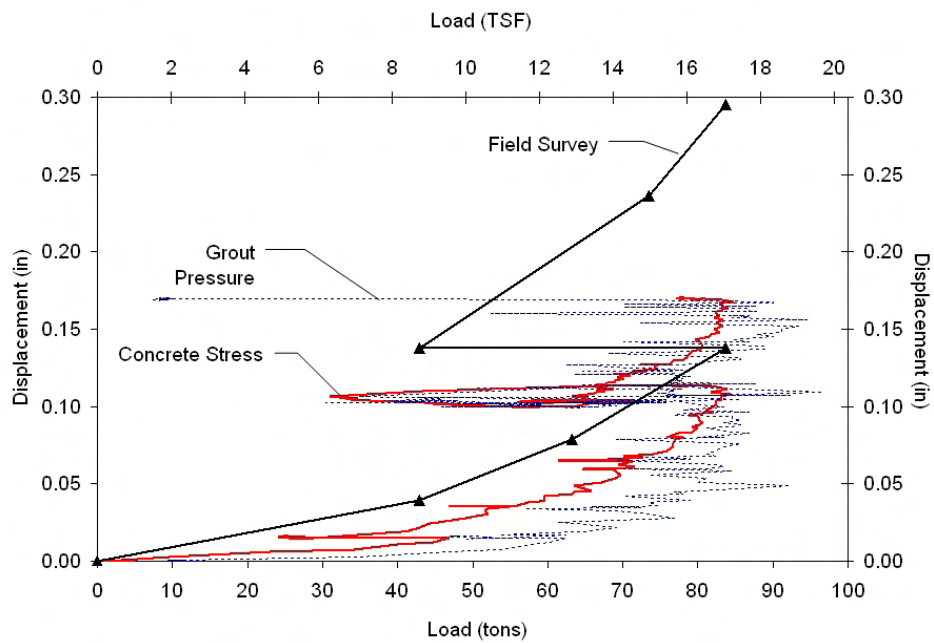
Figure 4-159 FM 507: West shaft load versus displacement.

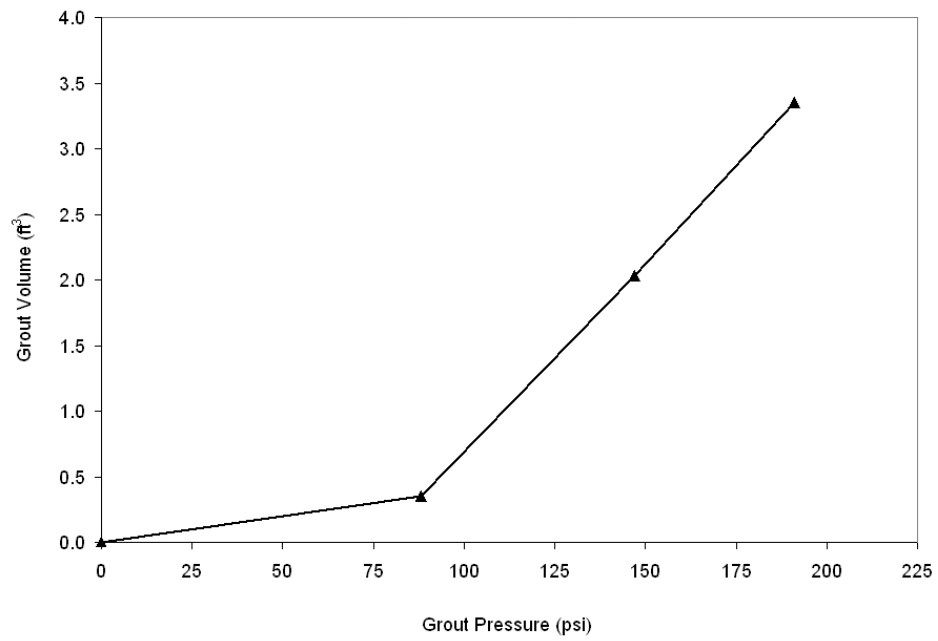
Figure 4-160 FM 507: East shaft grout pressure versus grout volume.

**East Shaft.** Similarly, the grout volume versus grout pressure obtained during grouting of the East shaft is shown in Figure 4-160. The maximum grout pressure was 191 psi at a grout volume of 4.9 cubic feet. The displacement - volume relationship is given in Figure 4-161. Figure 4-162 shows the displacement versus load during grouting. The maximum uplift of the shaft during grouting was 0.281 inches. The maximum load of 74 tons was calculated using a cross sectional area of 707 in<sup>2</sup> and a concrete modulus of 3420 ksi. The field record of grouting is shown in Appendix E.

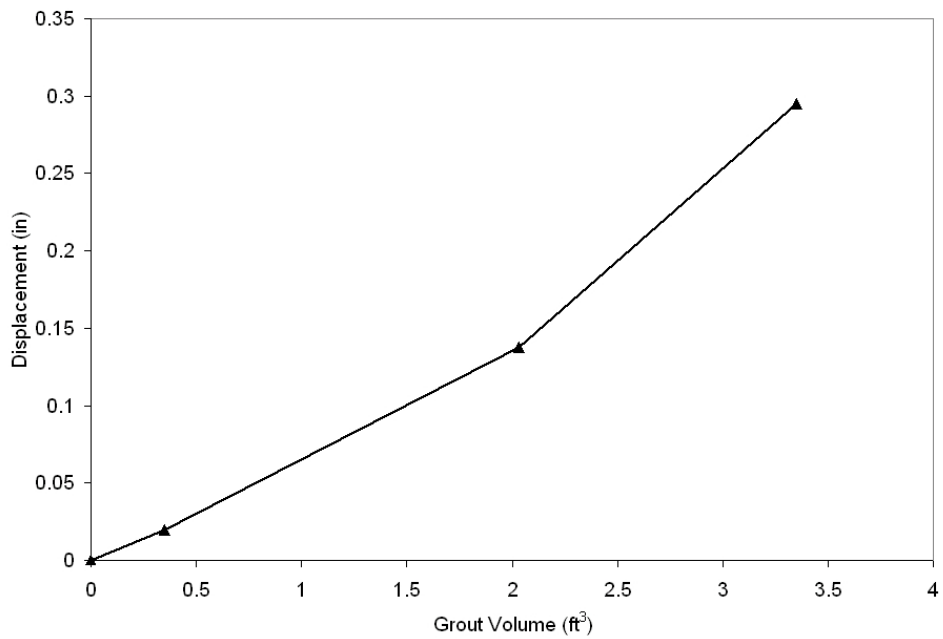
Figure 4-161 FM 507: East shaft grout volume versus displacement.

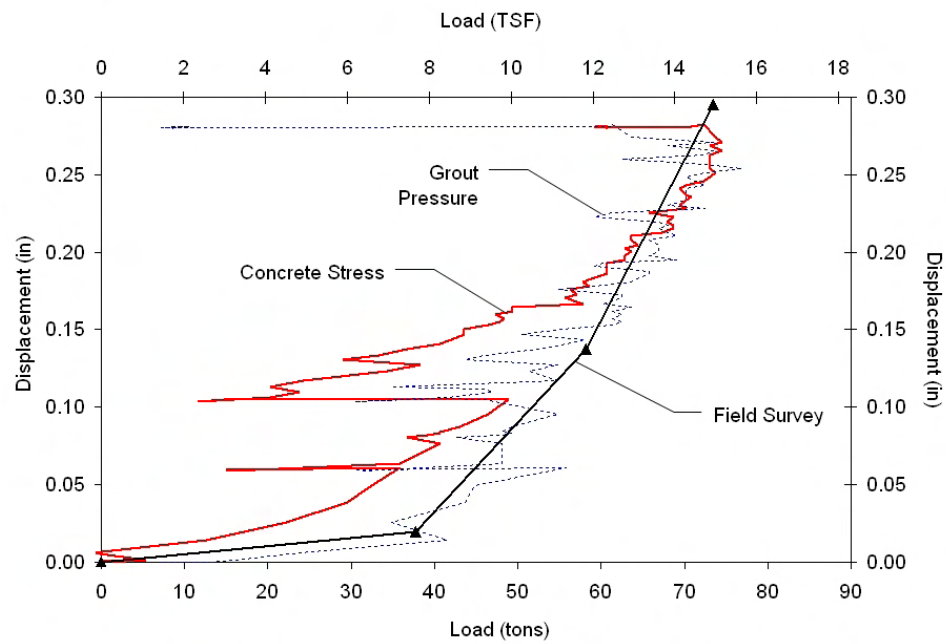
Figure 4-162 FM 507: East shaft load versus displacement.

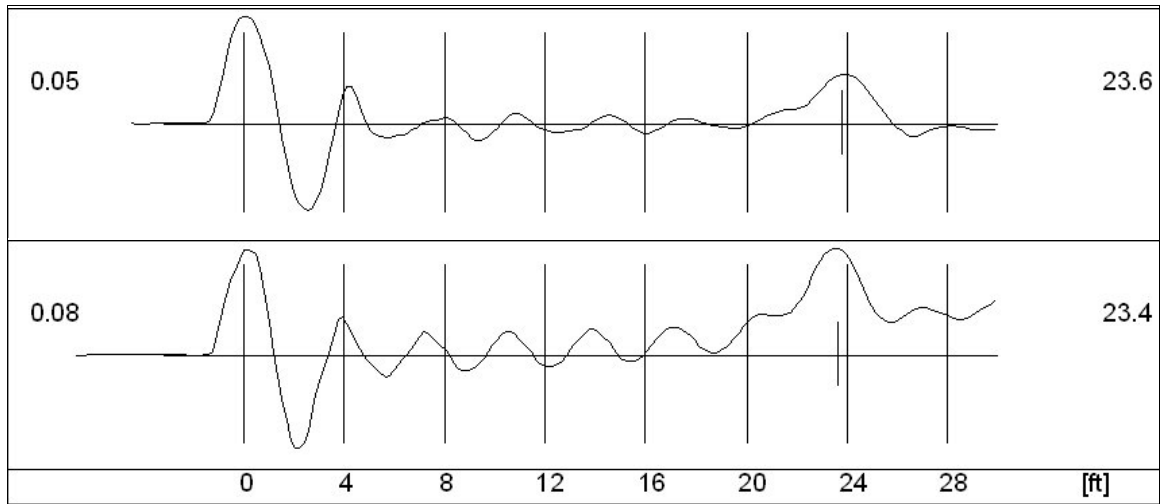
Figure 4-163 Auburn: SIT data for TS-1 before grouting (top) and after load testing (bottom).

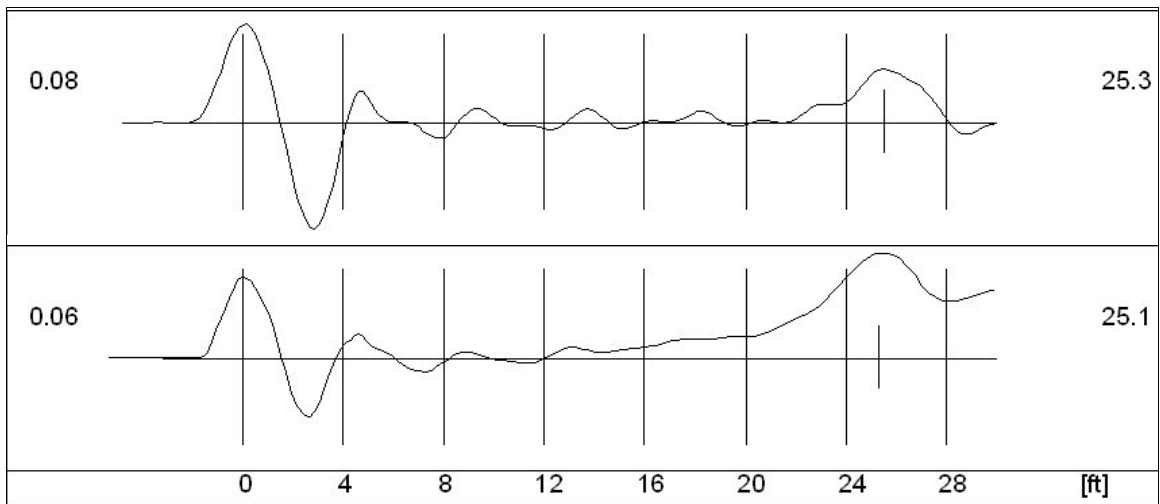
Figure 4-164 Auburn: SIT data for TS-2 before grouting (top) and after load testing (bottom).

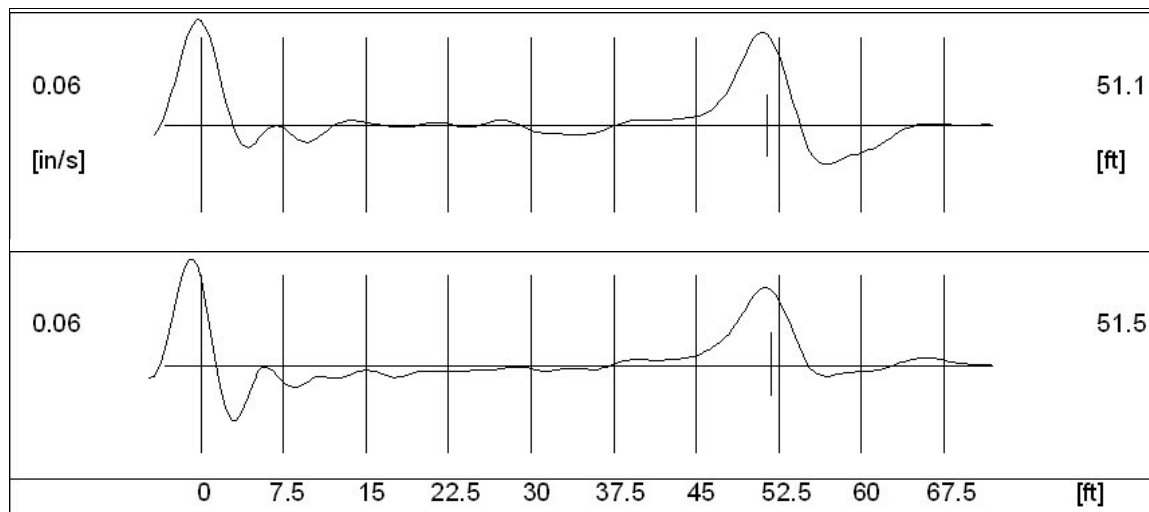
Figure 4-170 TexDOT Demo: SIT data for C-1 prior to grouting (top) and after load testing (bottom).

The other two test shafts at the Houston project were tipped in hard clay ( $N > 50$ ). These shafts showed the same change in echo response from before and after load testing. Figures 4-170 and 4-171 show these traces for test shafts C-1 and C-2, respectively.

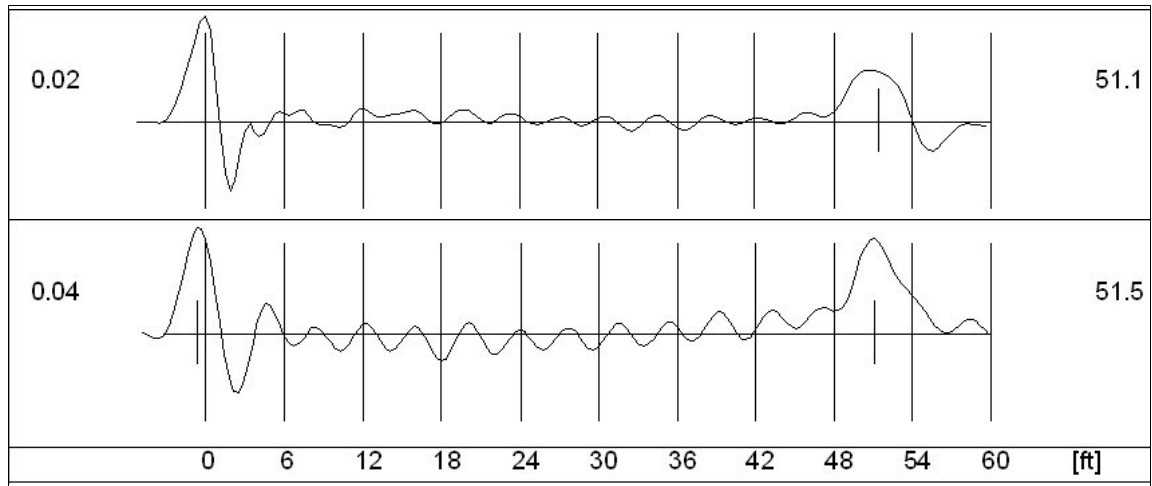
Figure 4-171 TexDOT Demo: SIT data for C-2 before grouting (top) and after load testing (bottom).

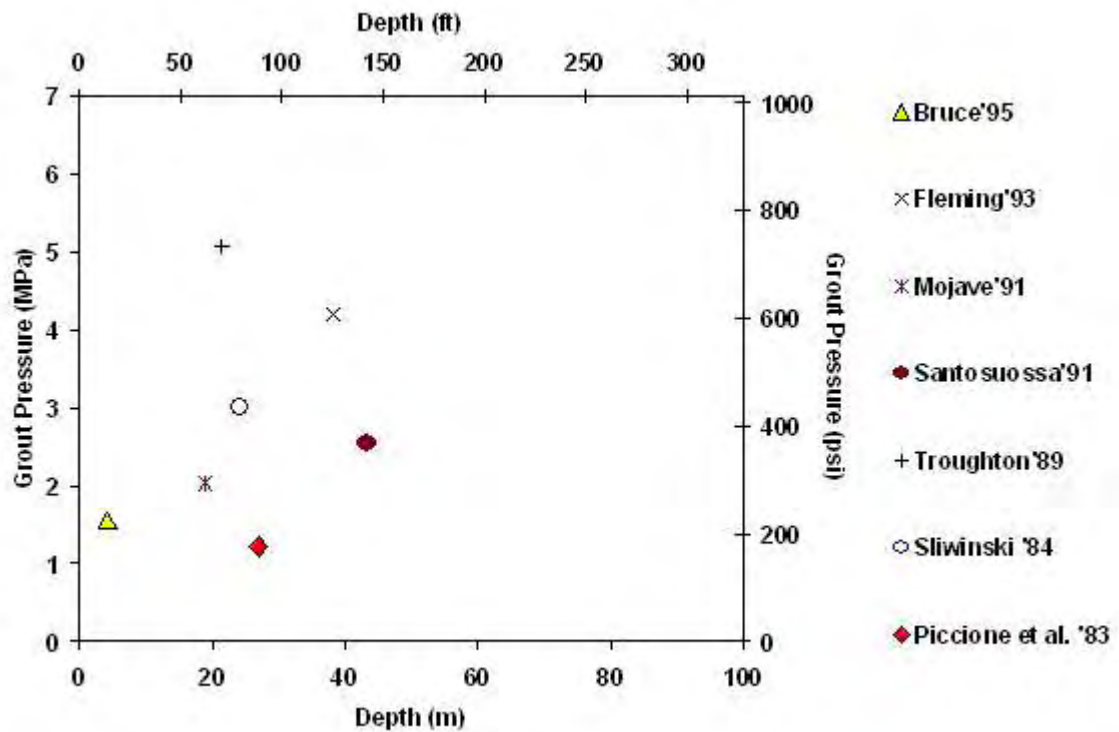
At the onset of this project post grouting drilled shaft tips to either mitigate construct debris (soft toe) or to improve the end bearing response had been documented in numerous publications dating back as far as the early 1960's. These citations indicated that end bearing could be improved for sands and clays with ultimate capacities as much as two to three times ungrouted shafts. However, numerical procedures to predict the improvement were not available. In some instances, details concerning the diameter of the shaft, depth to the tip, and grout pressure employed could be extracted. Figure 5-1 shows the field of cited experiences prior to this study.

Figure 5-1 Published grout pressure versus depth prior to this research program.

experimental and production experiences that significantly add to this trend. Figure 5-2 shows the same figure (Figure 5-1) updated with the latest available data. This includes all the case studies outlined in Chapter 4 as well as unpublished international experiences.

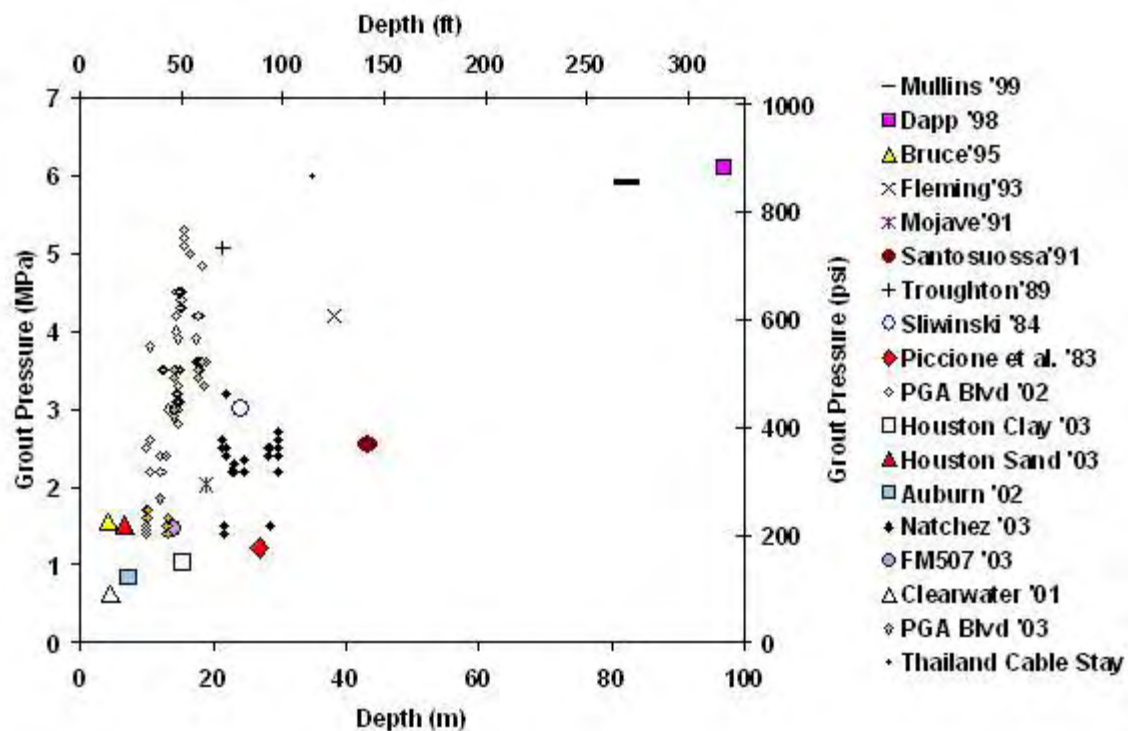
Figure 5-2 Grout pressure versus depth including Phase II data sets.

Using the side shear and L/D relationships rather than depth, Figures 5-2 and 5-3 are merged in Figure 5-4.

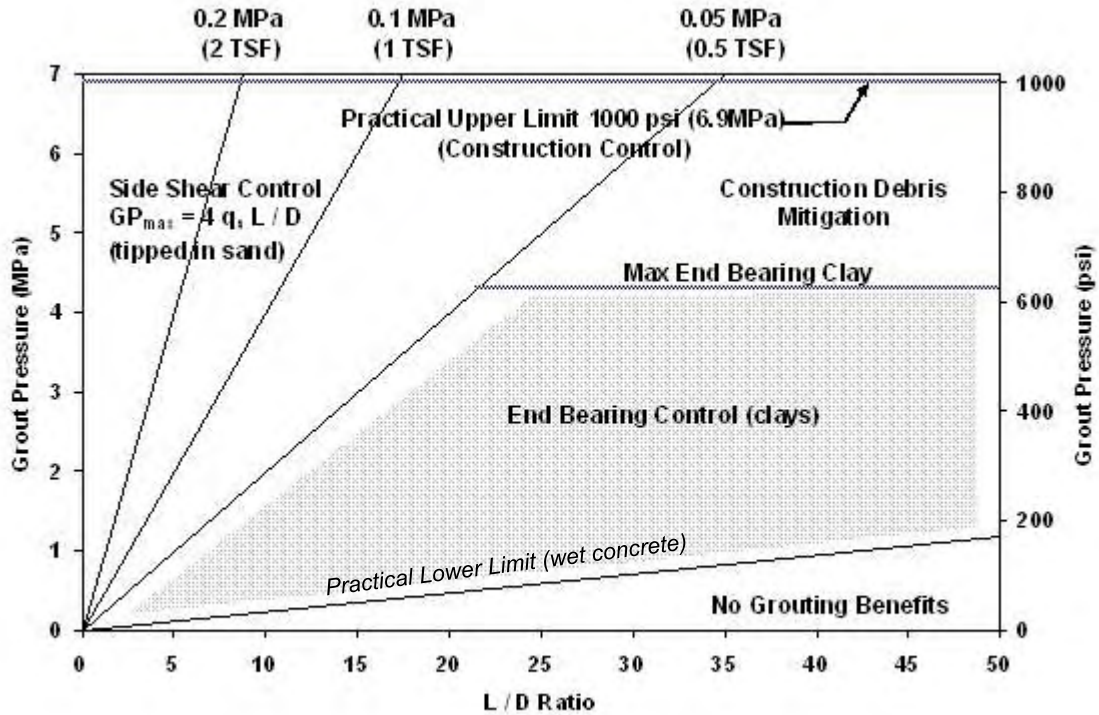
As the grout pressure is a function of tip area, unit side shear area, and shaft length, the expression for anticipated grout pressure can be simplified as follows:

Figure 5-3 Pressure versus depth concept graph.

$$GP_{\max} = \text{Side Shear Force} / \text{Tip Area}$$

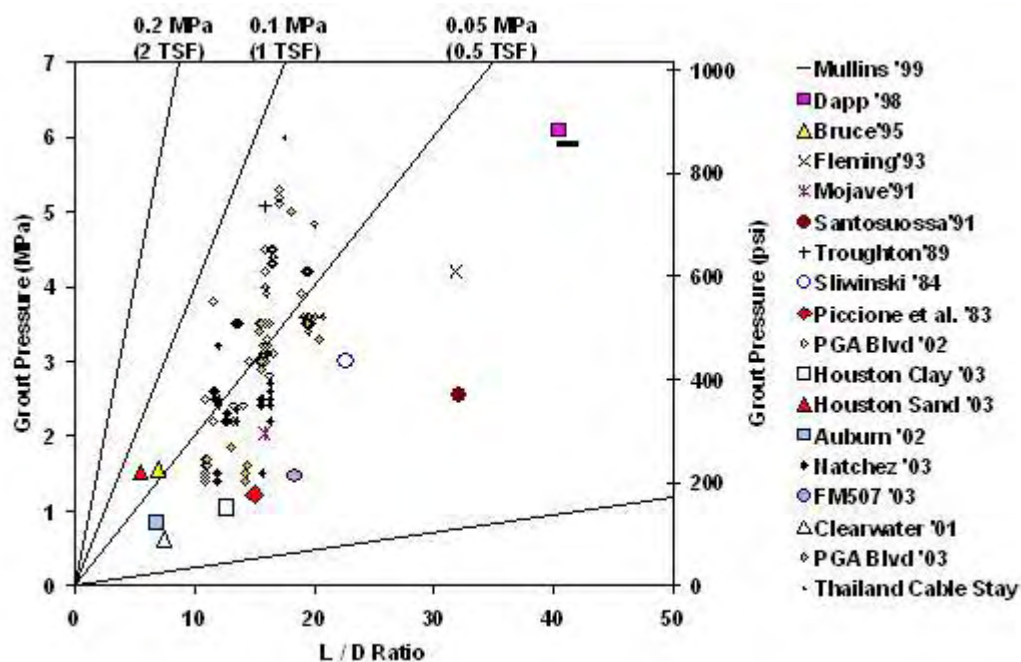
Figure 5-4 Grout pressures versus L/D ratio including Phase II data sets.

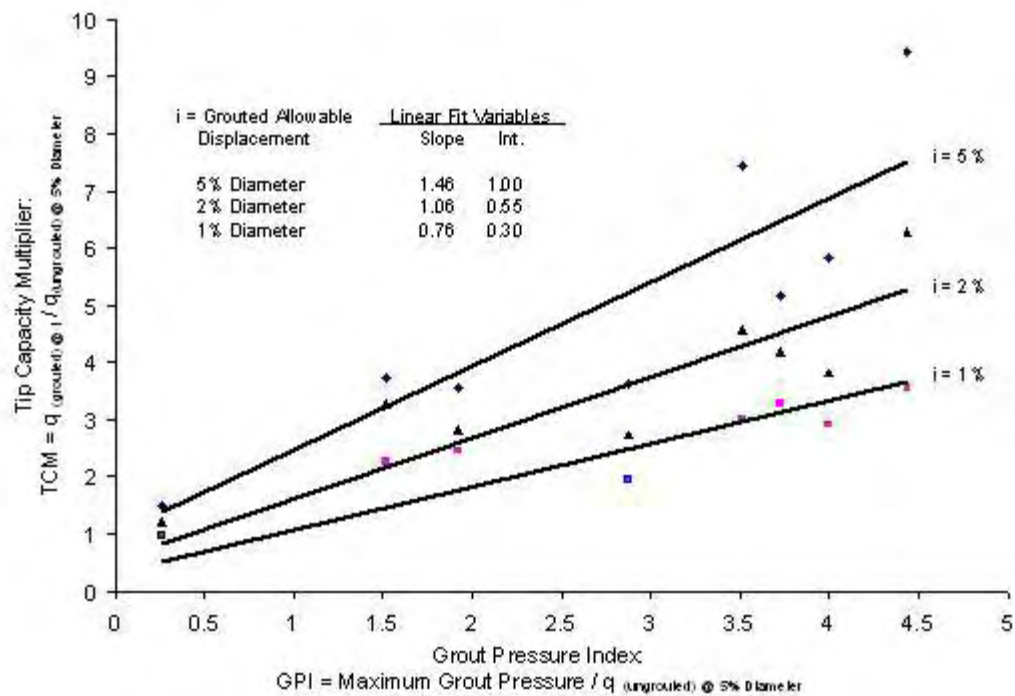
Figure 5-6 Phase I updated TCM and GPI 5% design graph for sand.

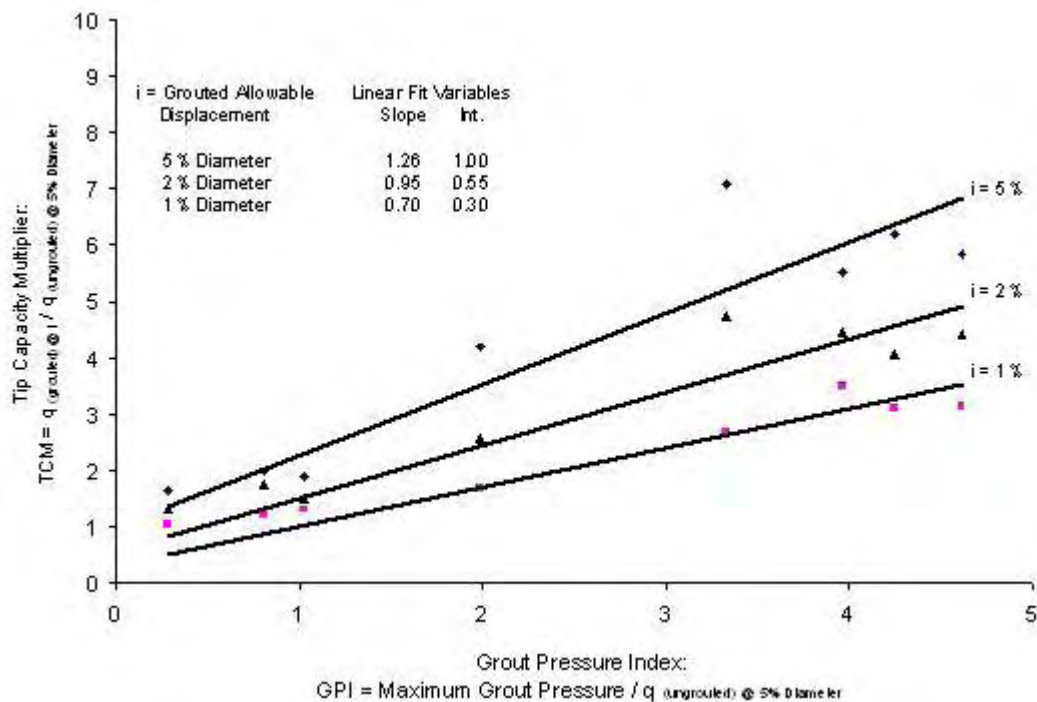
Upon re-evaluating the intercept values of the TCM curves, it became apparent that if the ungrouted shafts used to determine the relative improvement were artificially low, then the TCM values would be artificially high when applied to standard design values. This stems from the observation that most of the control shafts used in the study exhibited slightly lower end bearing values than the AASHTO predicted value of 0.6N (in tsf). Although the difference was slightly lower, it did not reflect the more usual observance that AASHTO predicted end bearing values are lower than measured. Further, ungrouted (conventional) shafts are more subject to large variations in end bearing associated with numerous construction techniques and mishaps. Conversely, grouted shafts tipped in sand will converge to a more reproducible end bearing based on the availability of adequate side shear. With this in mind, using the more exhaustive data set based on end bearing predicted by 0.6N would produce a more rational approach. This also allows more data sets to be included that do not have an ungrouted control shaft provided the soil boring data were available. Figure 5-7 shows a different TCM design curve based on the ratio of measured grouted end bearings and predicted end bearings. The revision affects the slope of the TCM curves but the intercepts are maintained reflecting the larger database presented by Reese and O'Neill (1988).

Figure 5-7 Phase II recommended TCM and GPI 5% design graph for sand.

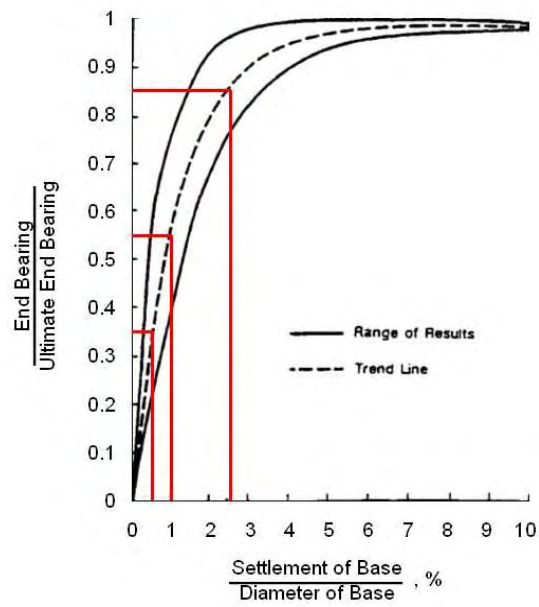
Figure 5-8 Phase II recommended intercepts for cohesive soils (after Reese & O'Neill, 1988).

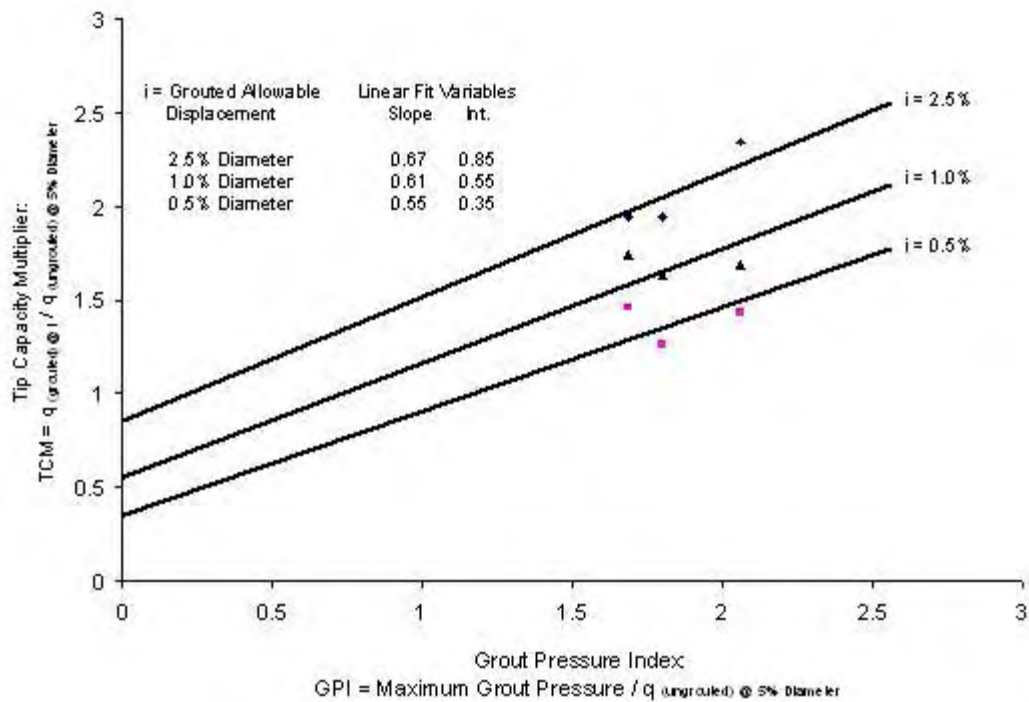
**Silt.** Designing for grouted tips in silty soils should not use sand criteria nor should it be restricted to clay criteria. The testing conducted in Phase II at the NGES for silty soils suggests that a TCM / GPI relationship may exist that could be used for design. Therein, silty soils are more free draining than clay and less than sands. The improvement in silts is more like clay than sand. The most notable difference between silt and clay is that the attainable grout pressure can be higher than the ungrouted end bearing. This is presumably due to the slight densification that is possible over the duration of the grouting. Figures 5-8 and 5-9 show a plausible design approach using a TCM approach. The limitation which has not been resolved at this time lies in defining an upper grout pressure limit.

Figure 5-9 Phase II recommended TCM and GPI 2.5% design graph for silt.

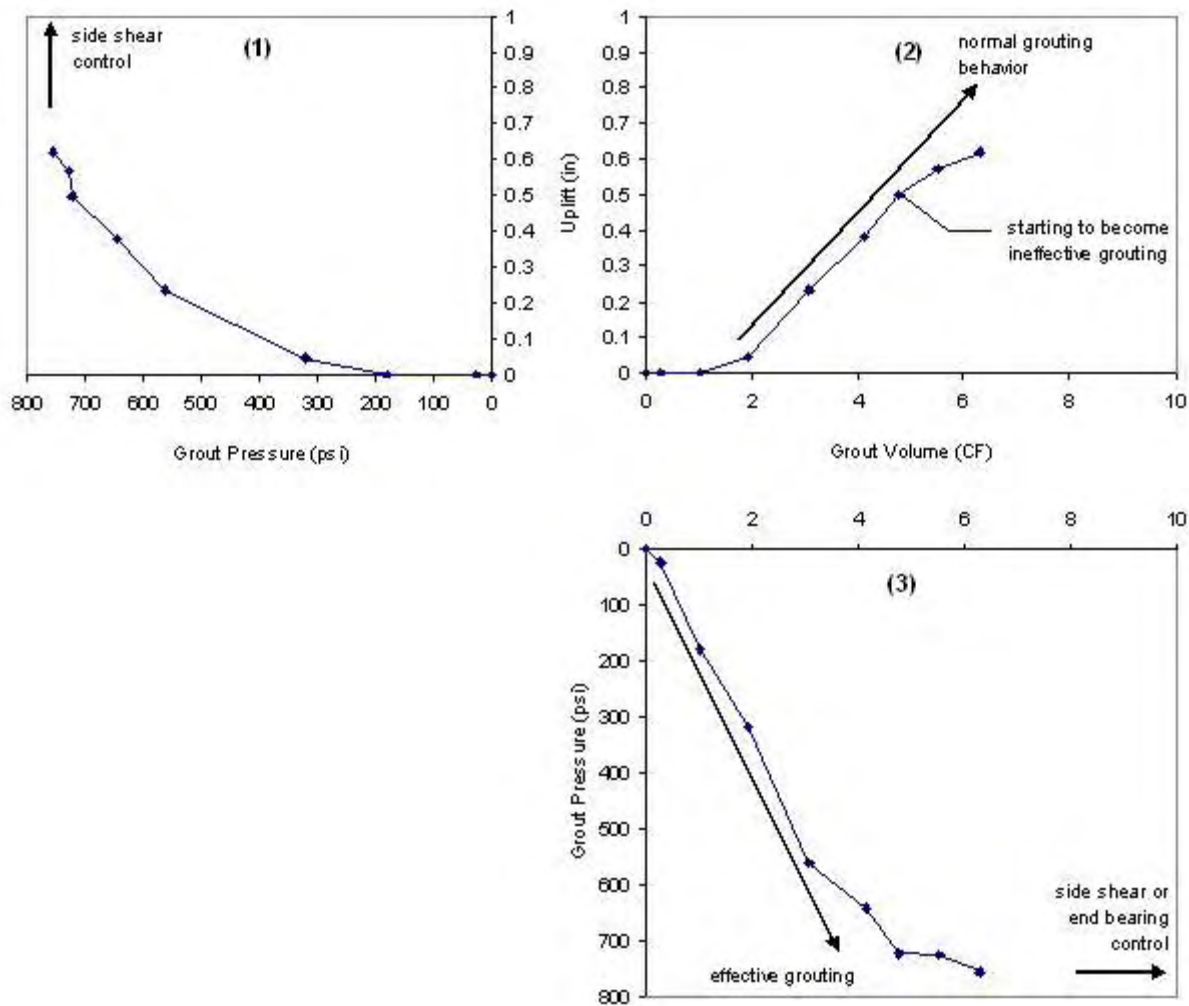
be monitored and recorded at intervals capable of clearly delineating the following relationships: (1) grout pressure vs. uplift displacement, (2) grout volume vs. uplift displacement, and (3) grout pressure vs. grout volume. Relationships (1) and (3) should appear similar in shape. Clear increases in displacement or volume without increase in pressure are an indication of ineffective grouting. Figures 5-10 and 5-11 show field measurements of two scenarios where these three relationships were monitored to show grouting effectiveness (side shear and end bearing control). In all instances, if grout pressure is still increasing, end bearing enhancement from grouting is still effective.

Figure 5-10 Normal behavior for side shear-controlled, post grouted shafts (sands).

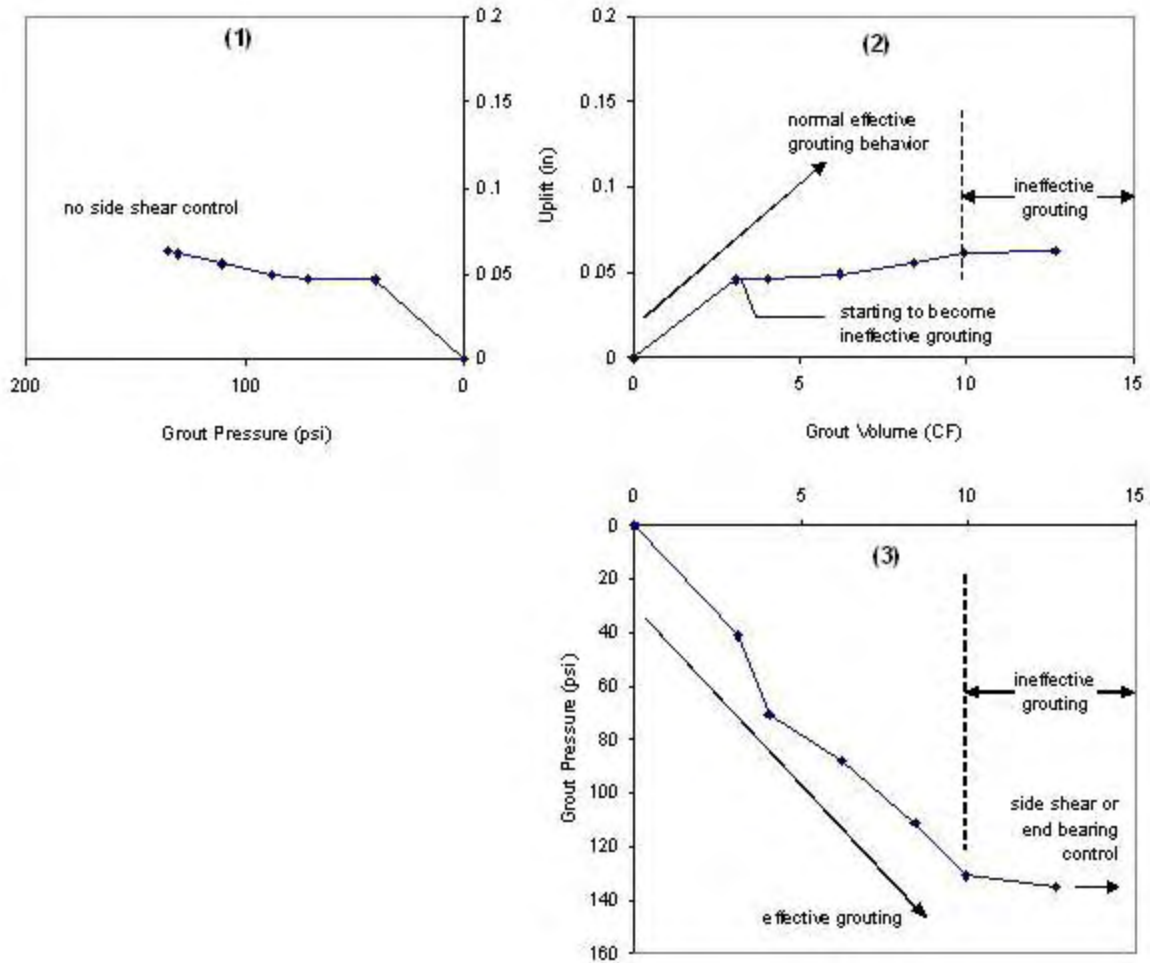
Figure 5-11 Normal behavior for end bearing-controlled, post grouted shafts (soft clays).

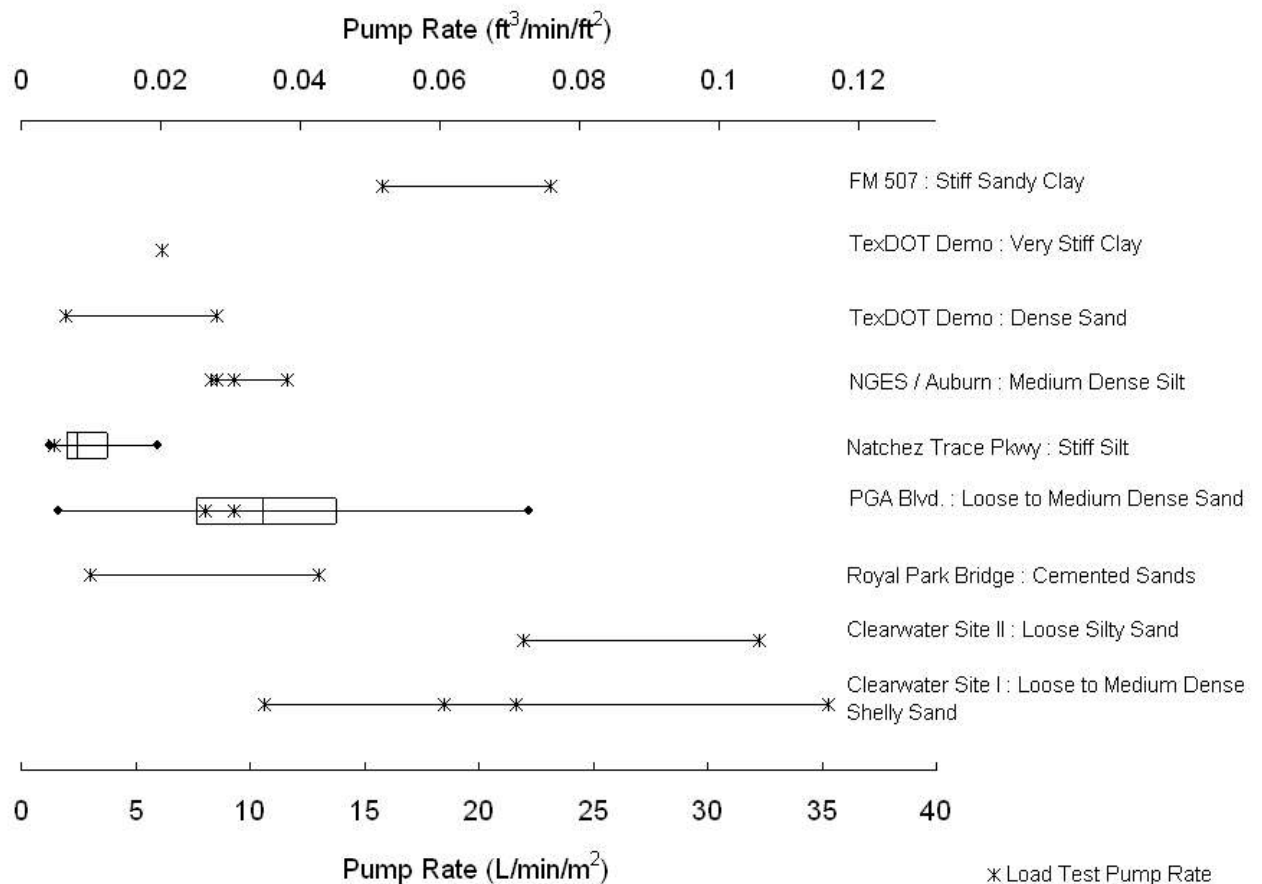
only supply upwards of 1 cu ft / min and do not pose a significant threat to the success of a post grouted shaft project.

Figure 5-12 Grout pumping rates successfully used during this project.
