FINAL REPORT

For the Florida Department of Transportation

**Constructability of Stabilized Subgrade Layer
Under High Groundwater Table**

FDOT Research Contract No.: BC-352-7

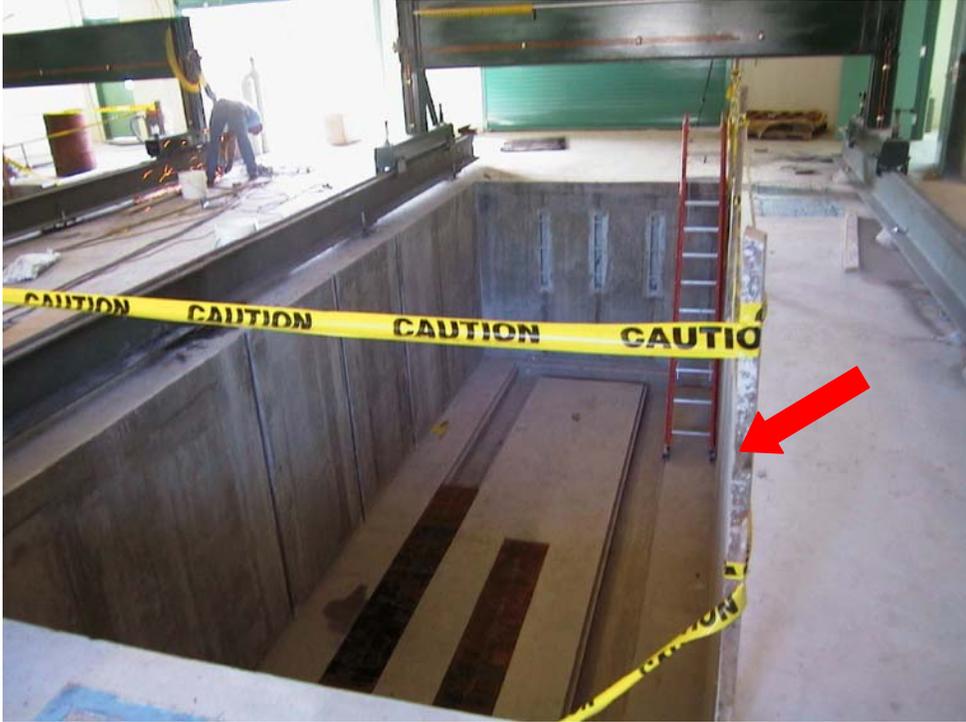
Figure 2.1 Overview of FDOT Test Pit

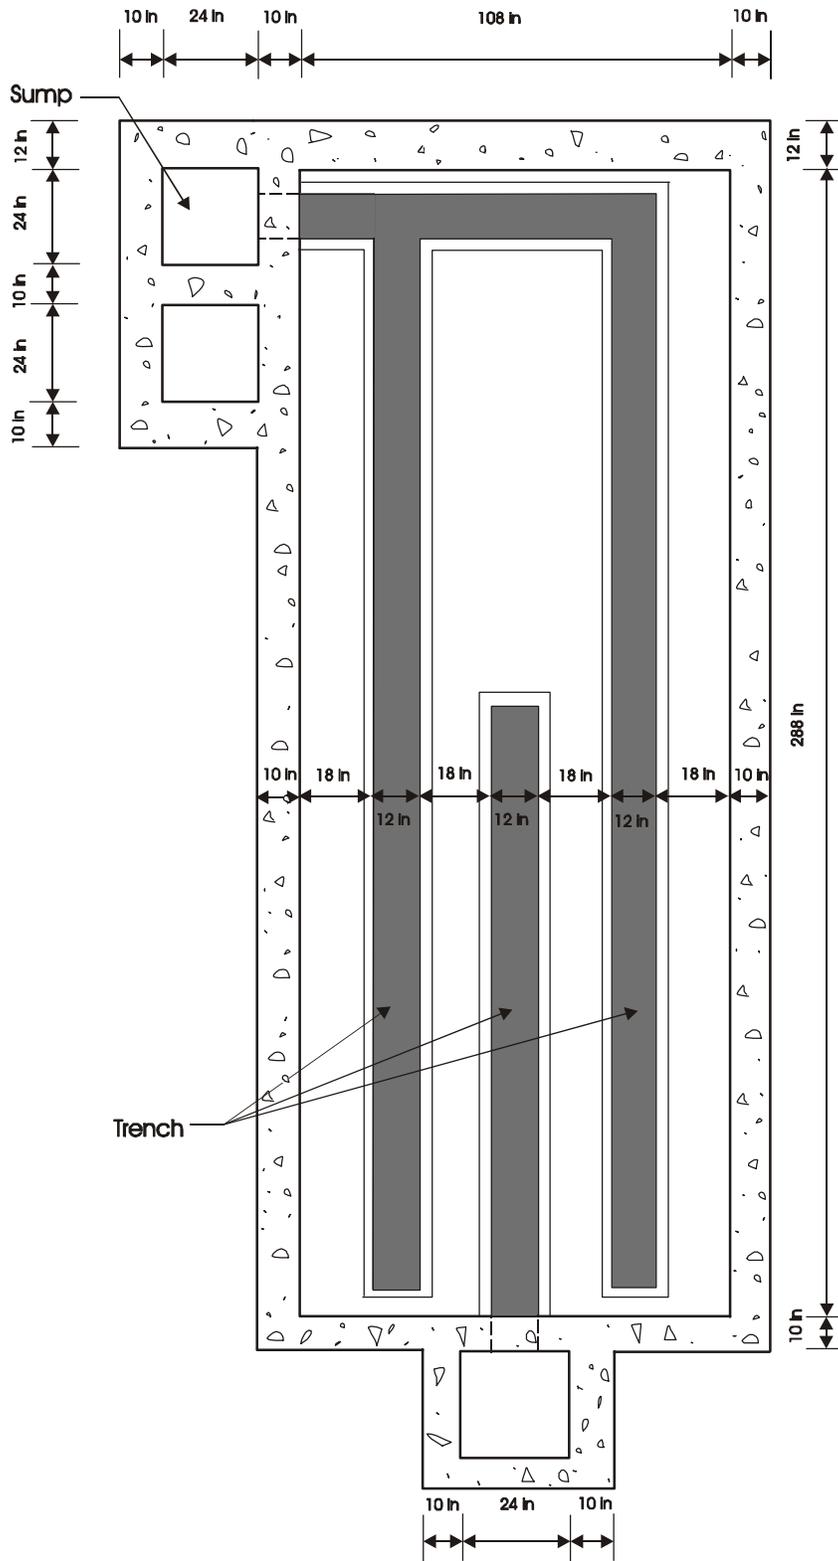
Figure 2.3 Plan View of Test Pit

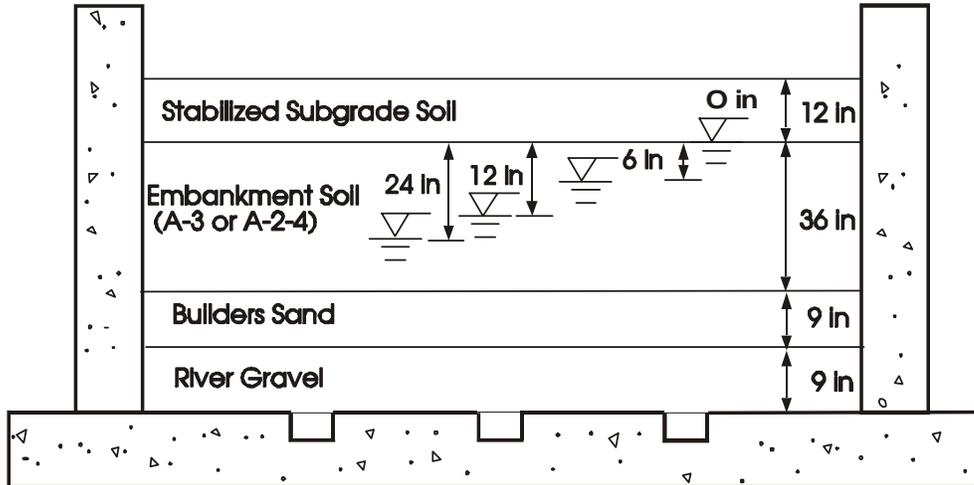
Water Level Condition:

Condition 1: 24 in. below the interface

Condition 5: 12 in. below the interface (drained)

Figure 2.4 Cross Sectional View of Test Pit Program

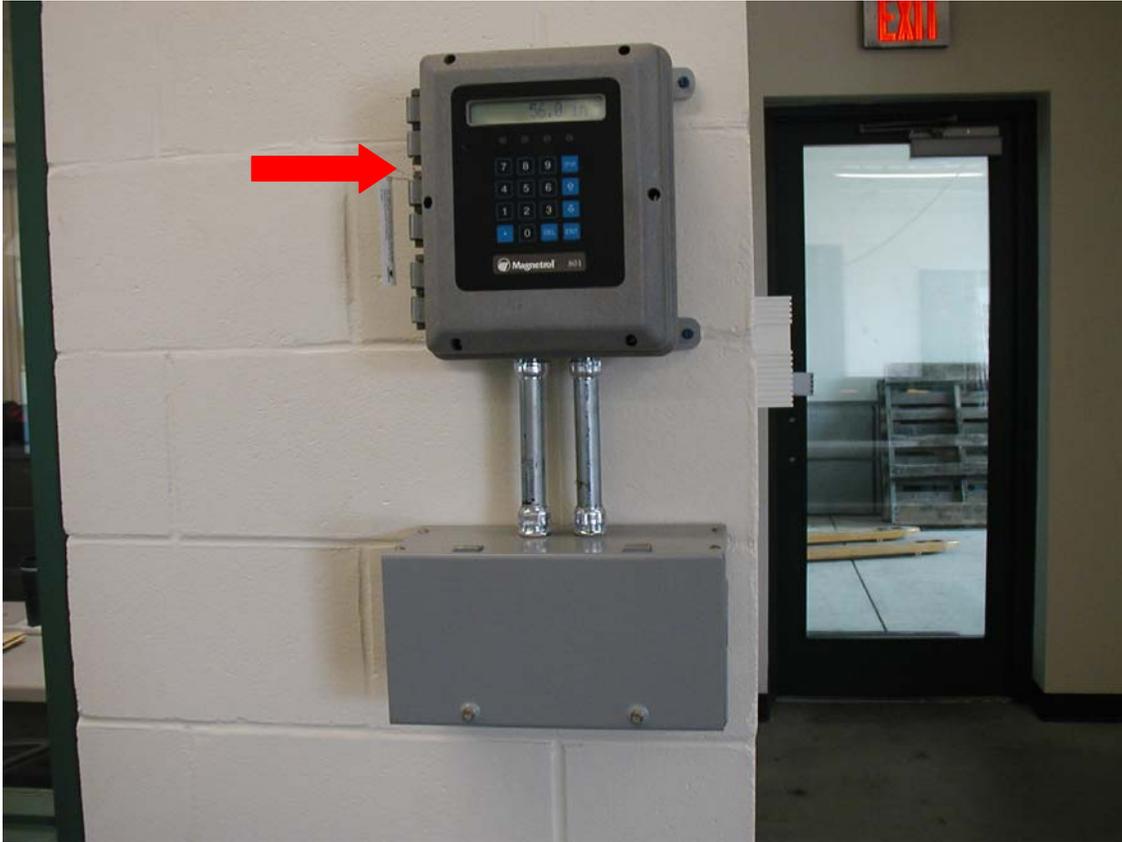
Figure 2.5 Instruments for Water Table Monitoring

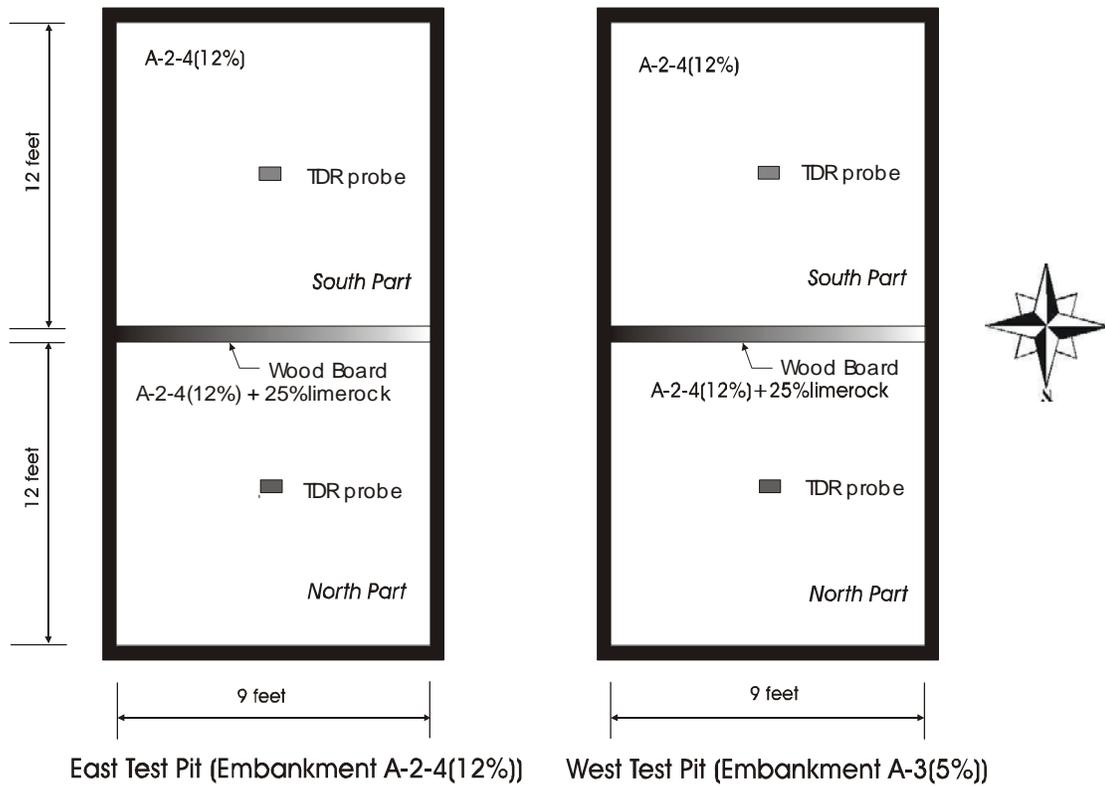
Figure 2.7 Layouts of Test Pit Experimental Program

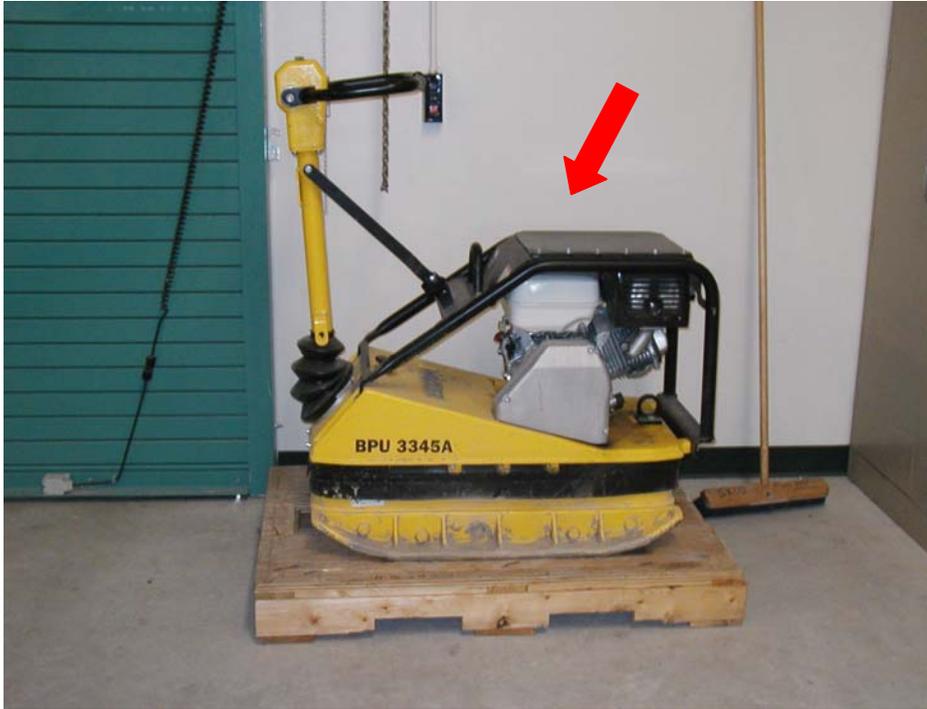
Figure 2.9 Plate Compactor (dynamic) used at Water Conditions 1, 2, 3, and 5

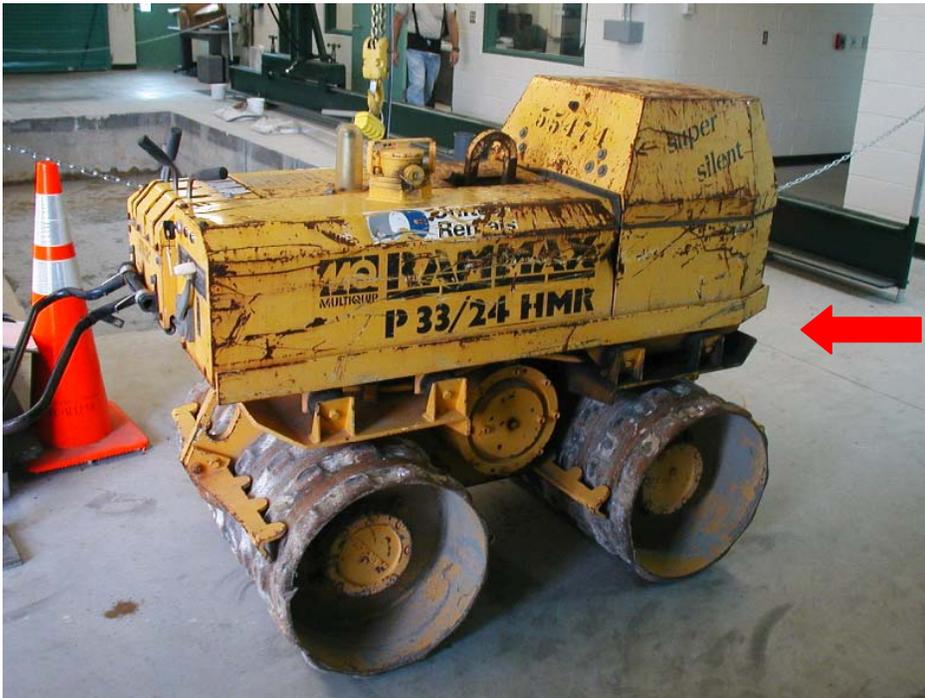
Figure 2.10 Sheepfoot Compactor (Vibratory) used at Water Condition 5

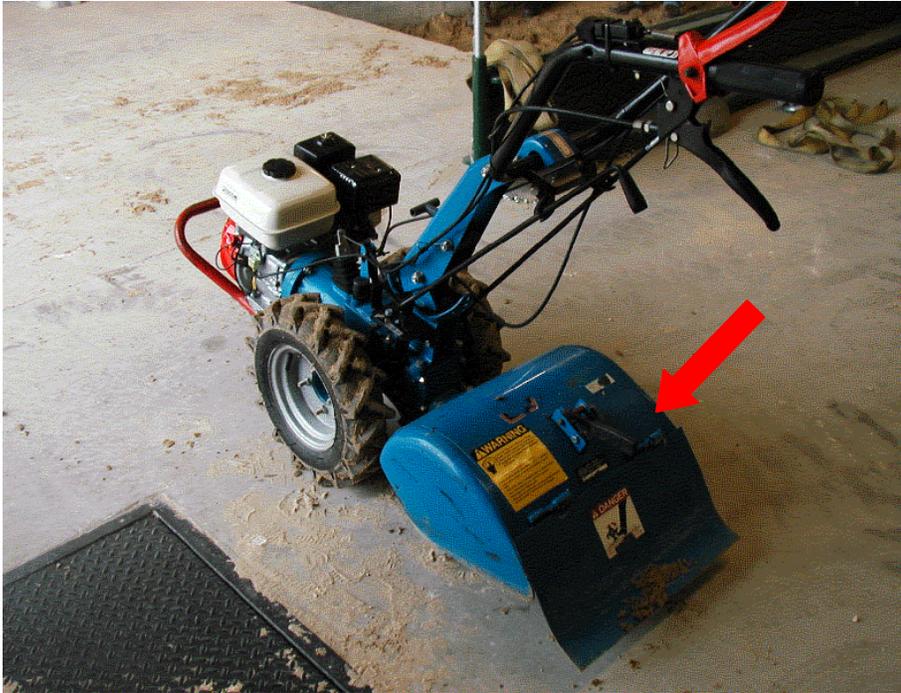
Figure 2.11 Dynamic Compactor (Vibratory) used at Water Condition 4

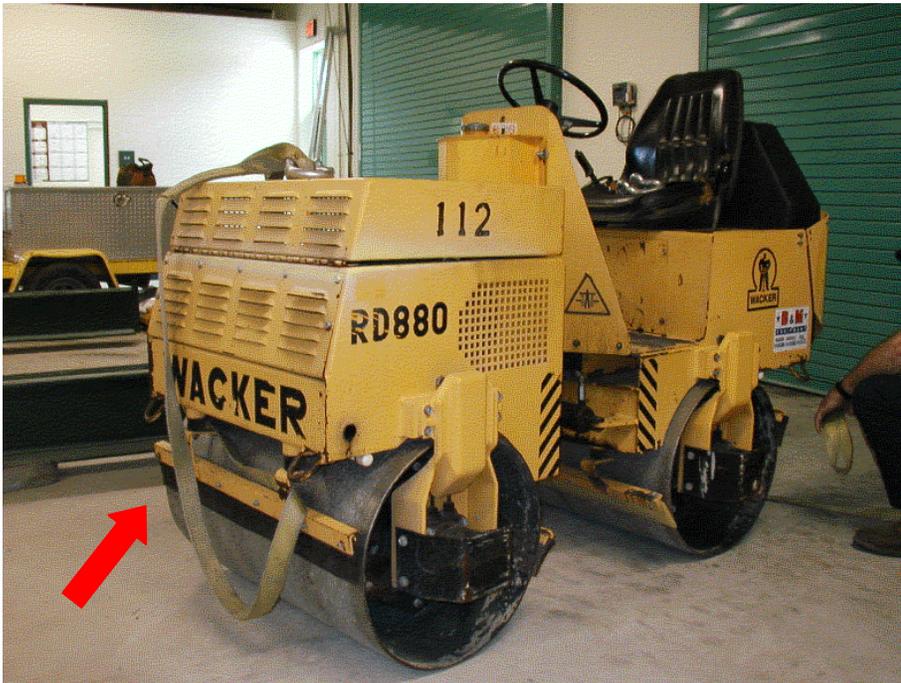
Figure 2.12 Roller Compactor (Static) used at Water Condition 4

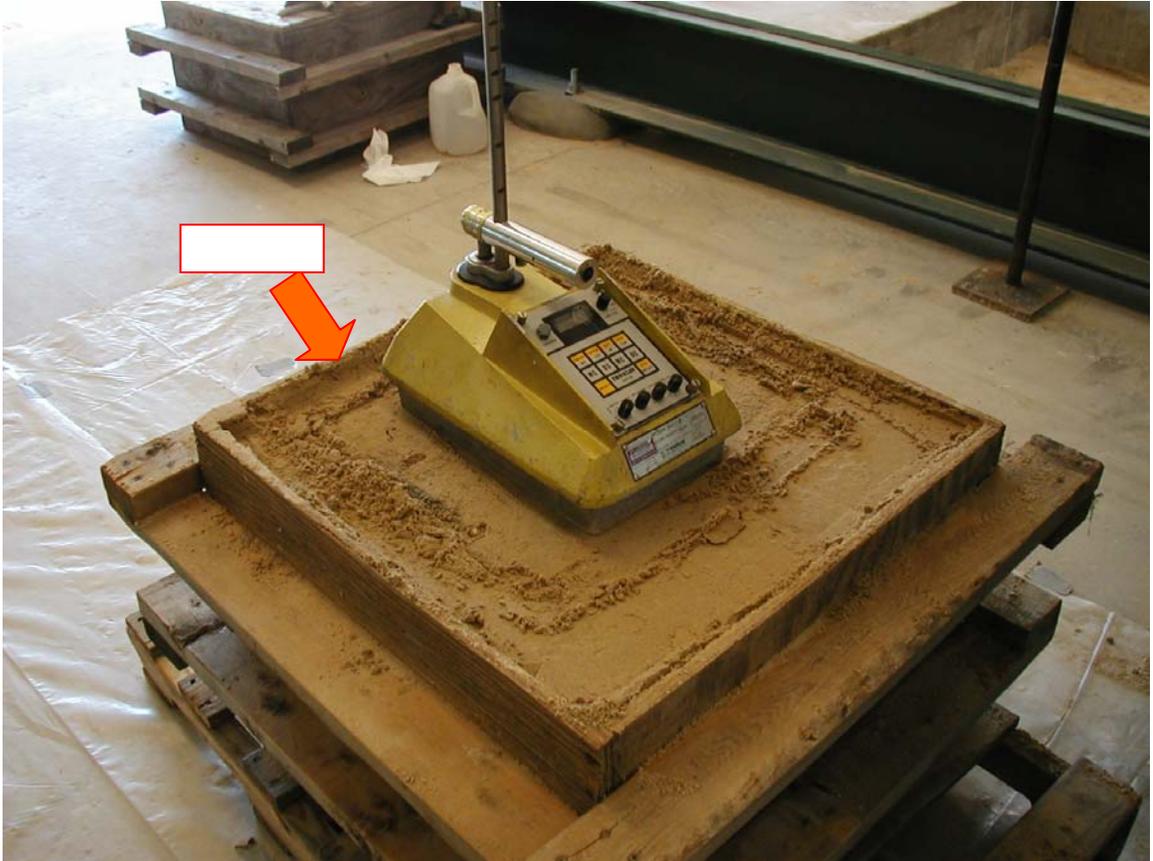
Figure 2.13 Soil Moisture Calibration Test

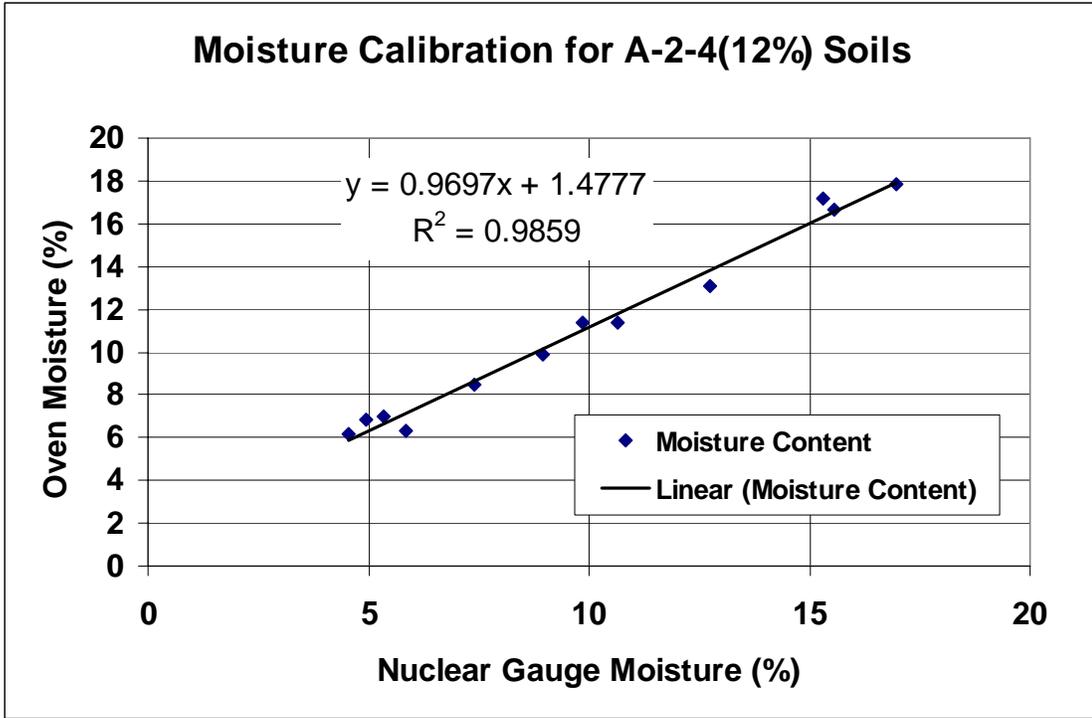
Figure 2.14 Moisture Calibration Curve for A-2-4(12%) Soils

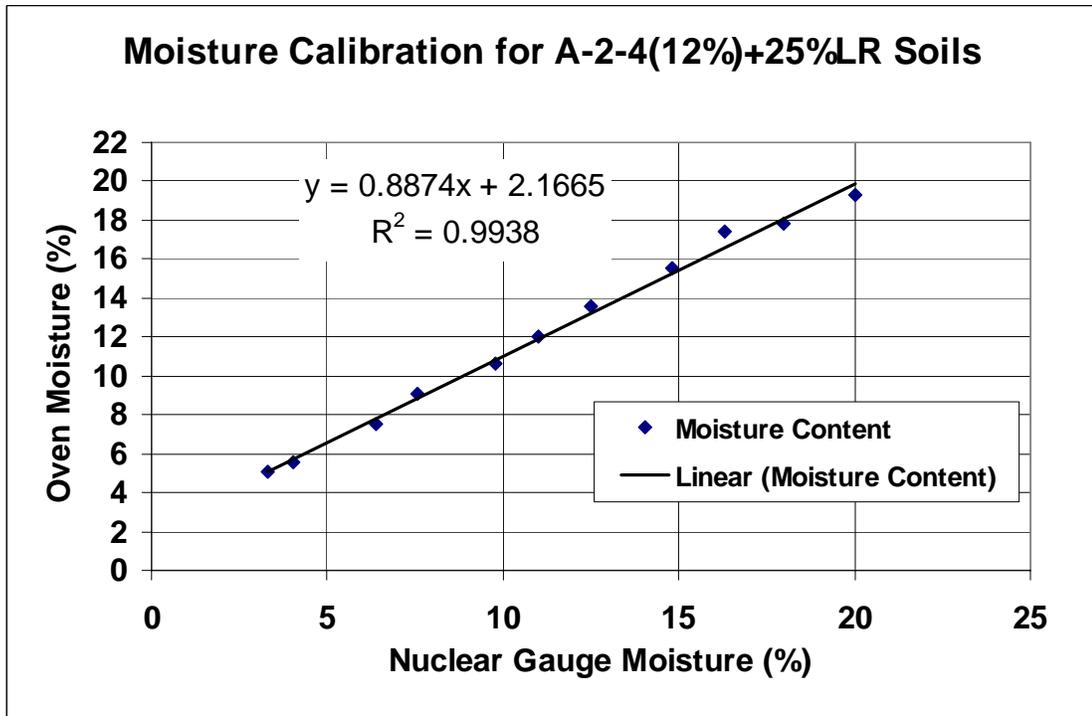
Figure 2.15 Moisture Calibration Curve for A-2-4(12%) +25% LR Soils

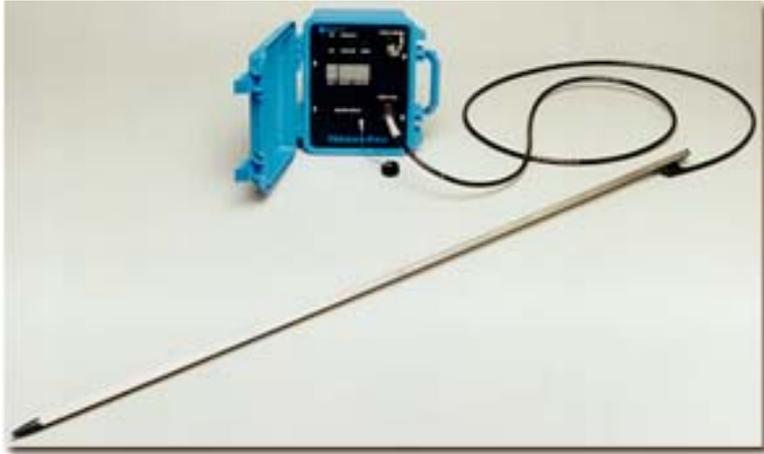
Figure 2.16 TDR Device used in the test

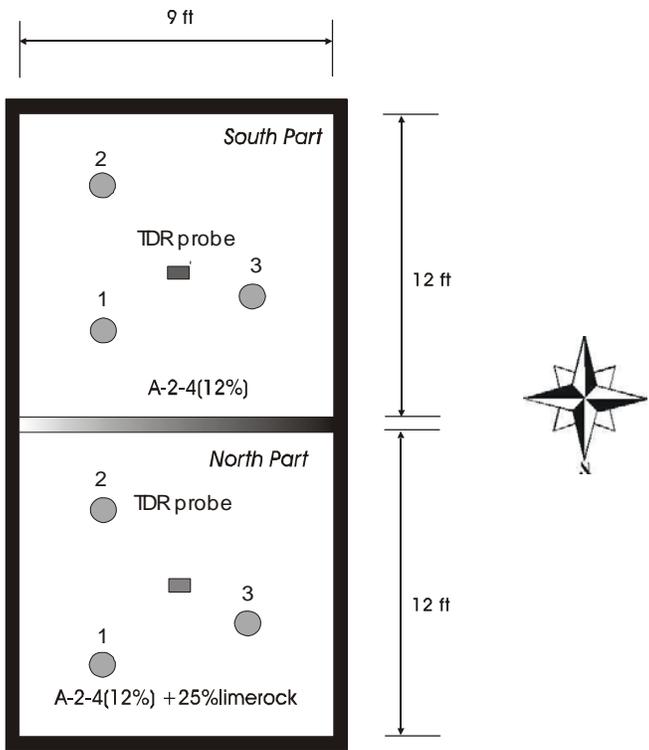
Figure 2.21 Relative Positions of TDR Probes and Nuclear Gauge Tests in the Test Pit for Condition 1

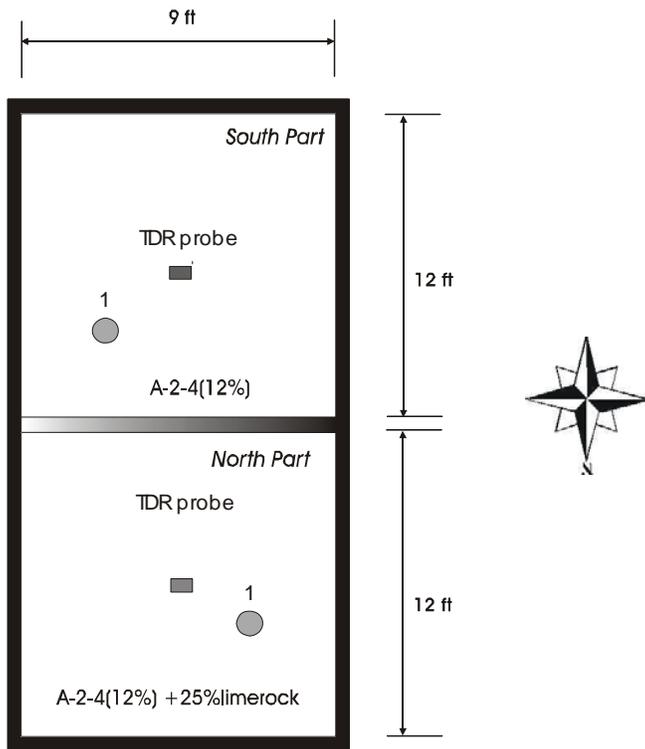
Figure 2.22 Relative Positions of TDR Probes and Nuclear Gauge Tests in the Test Pit for Conditions 1, 2, 3, 4, and 5

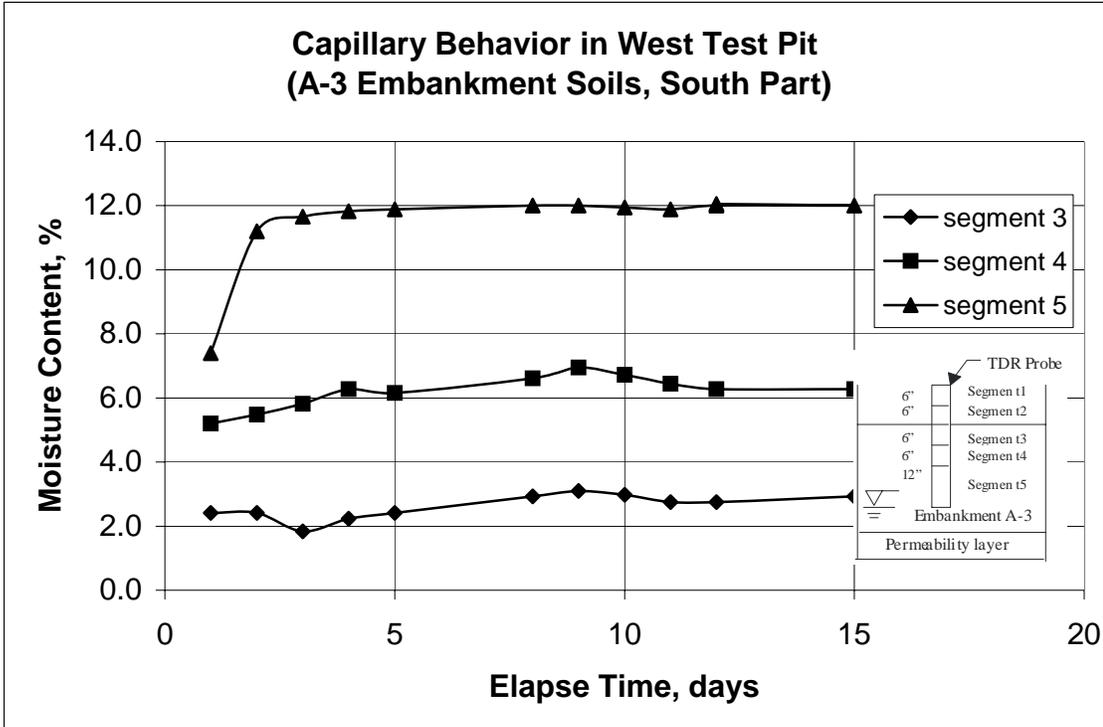
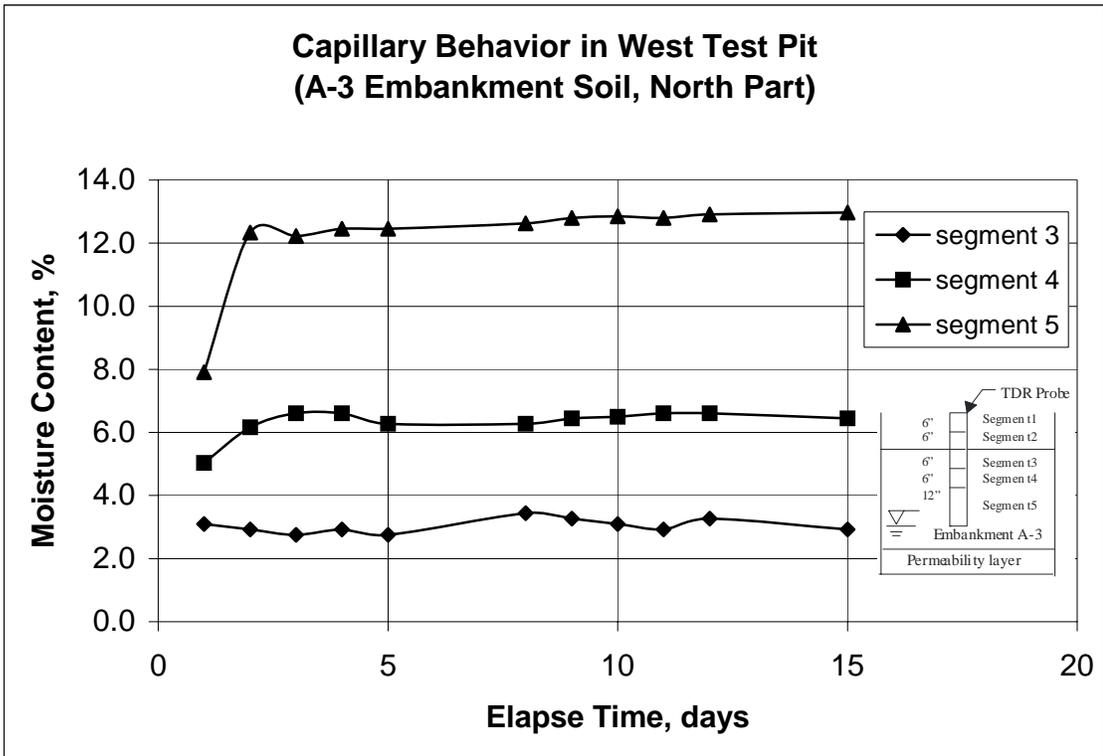
Figure 3.1 Capillary Rise Behavior at Water Level -24 inches (West Pit)

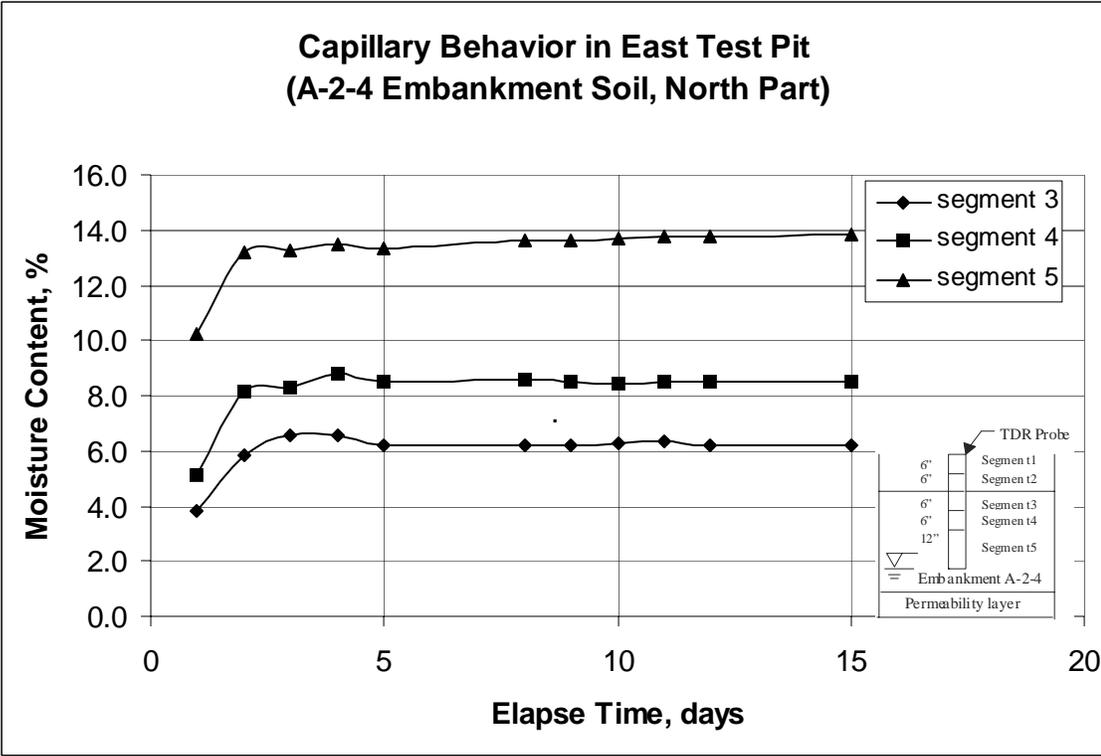
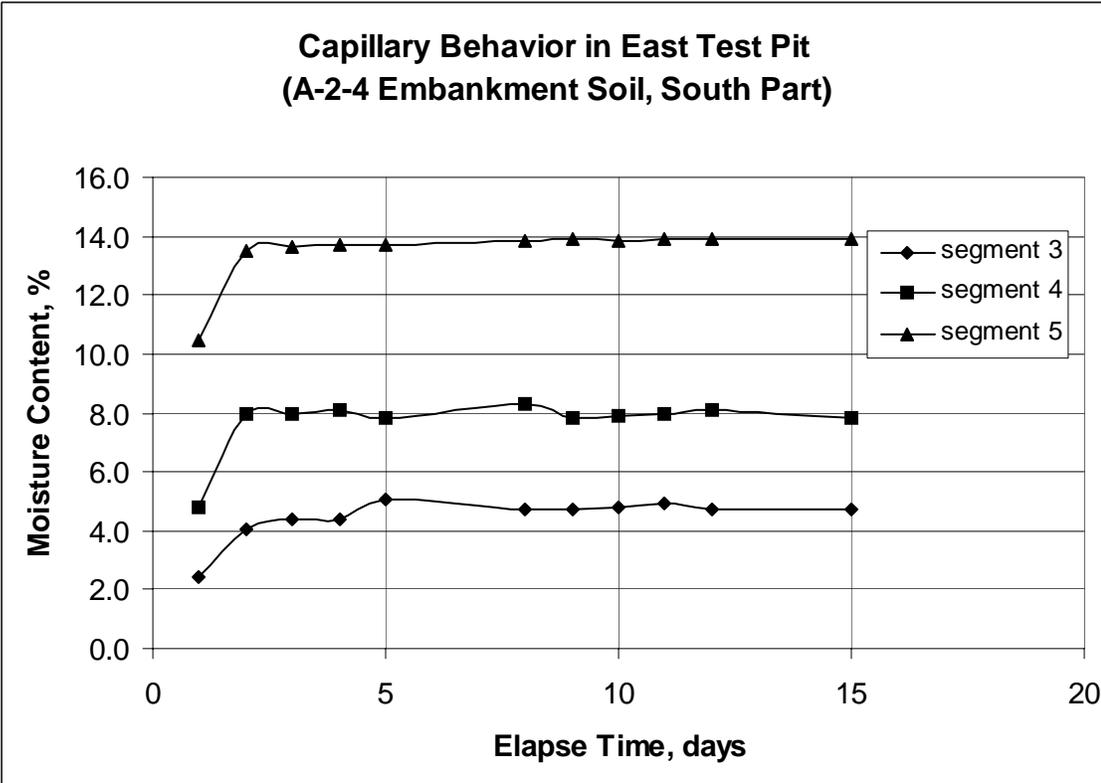
Figure 3.2 Capillary Rise Behavior at Water Level -24 inches (East Pit)

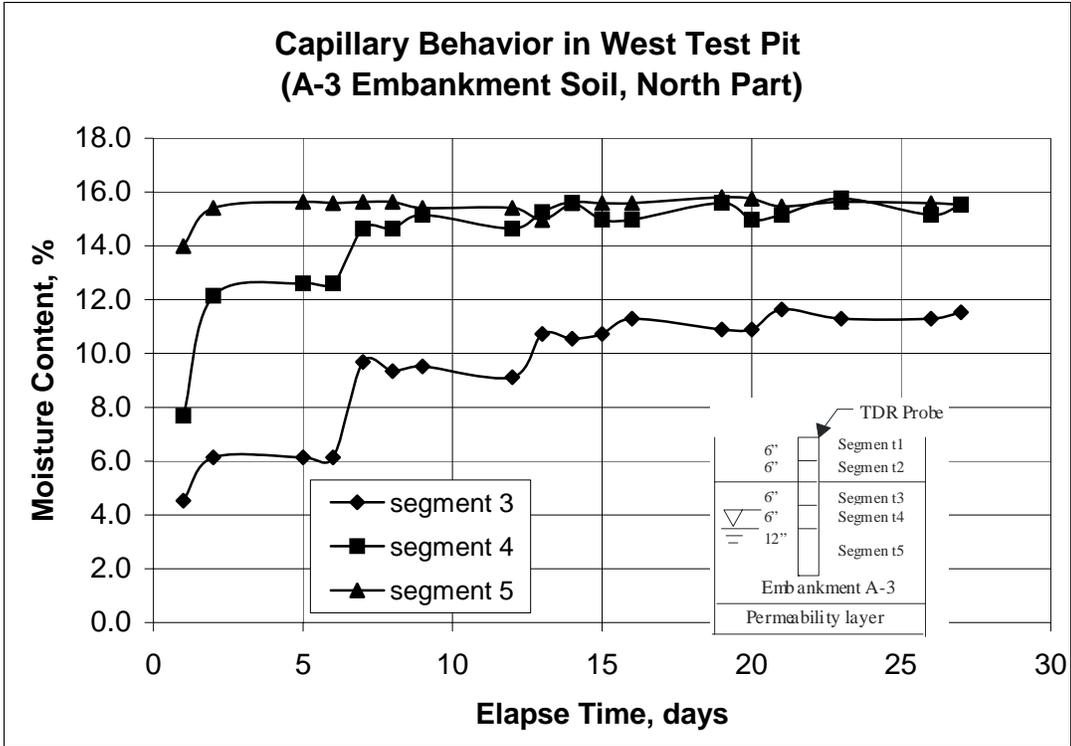
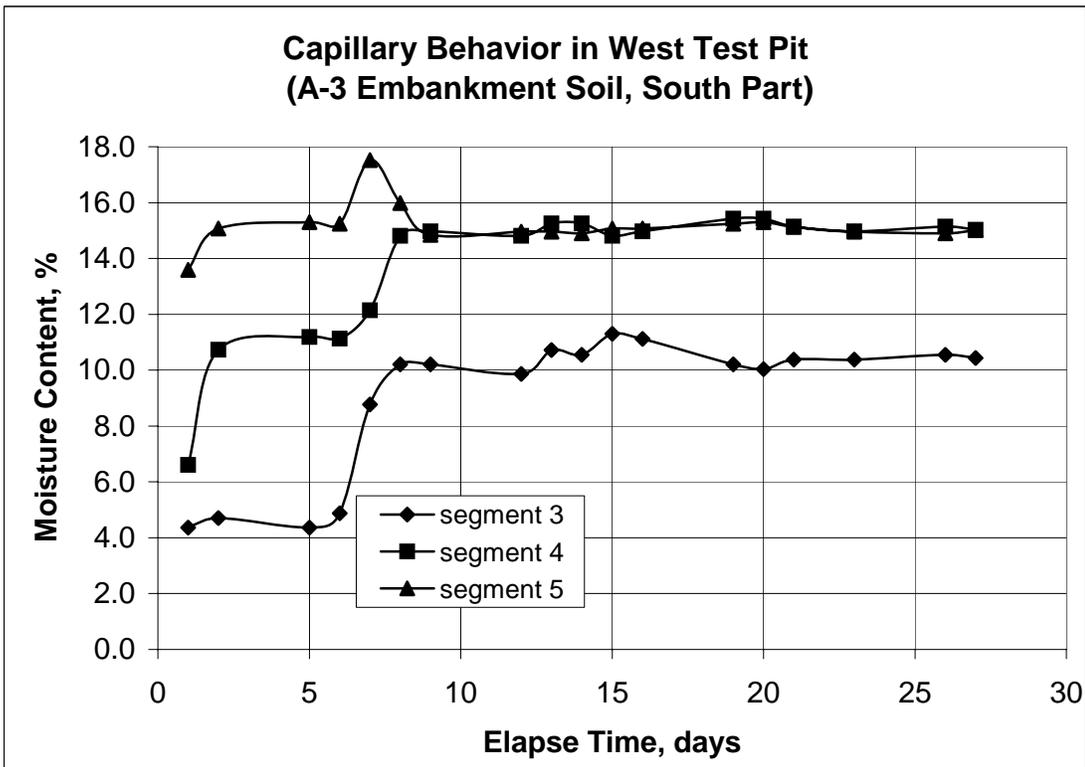
Figure 3.3 Capillary Rise Behavior at Water Level -12 inches (West Pit)

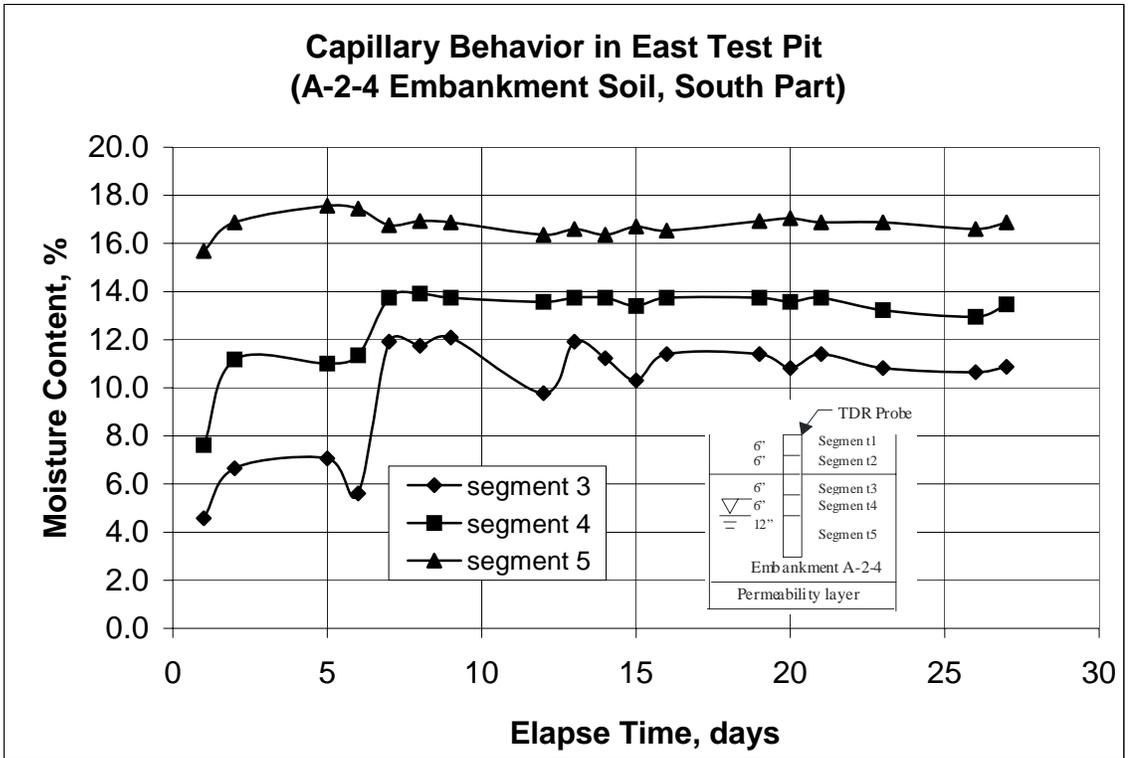
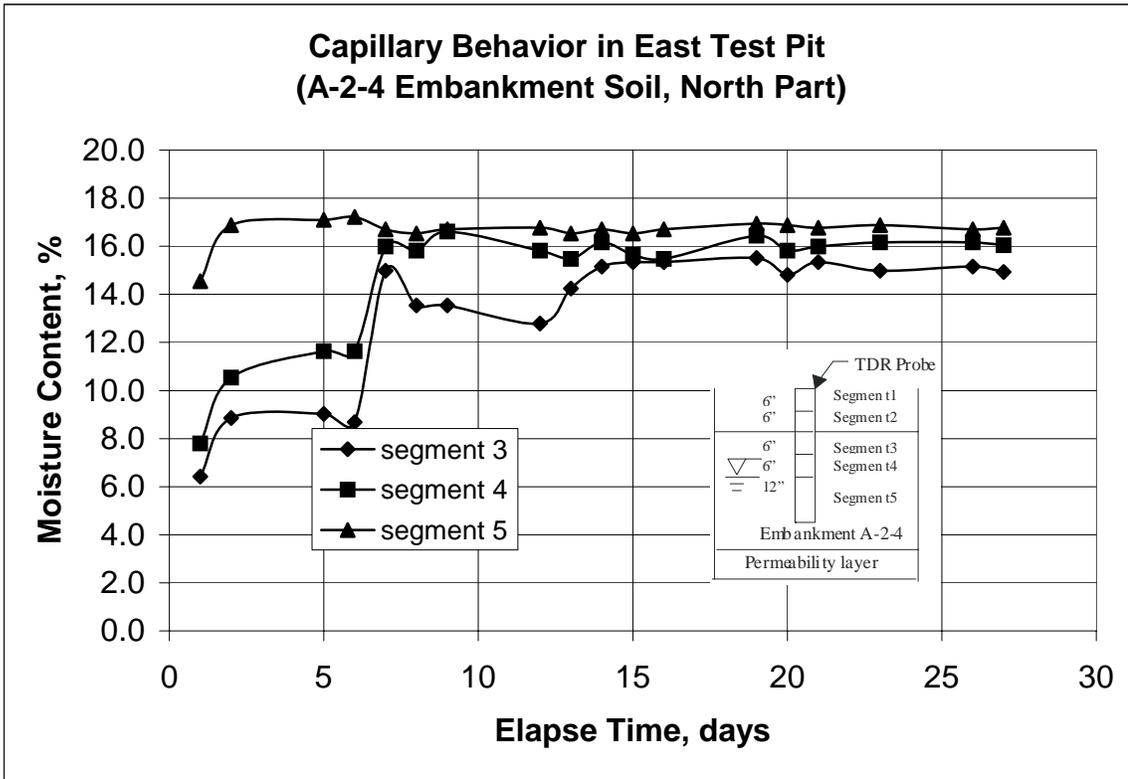
Figure 3.4 Capillary Rise Behavior at Water Level -12 inches (East Pit)

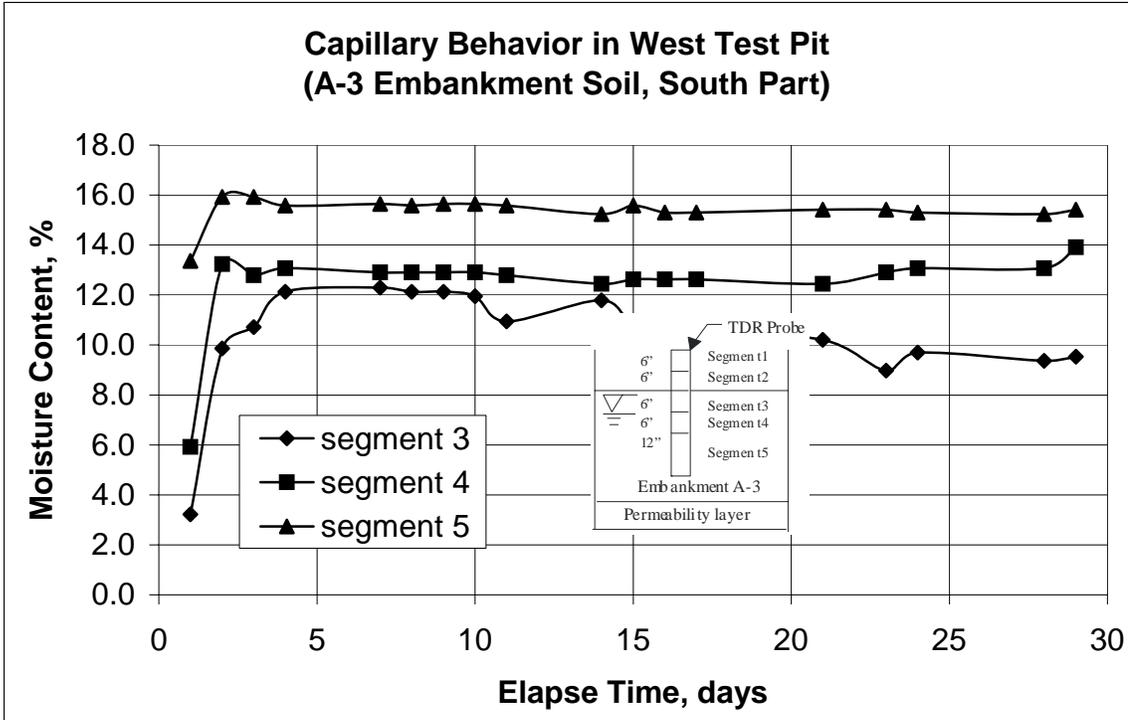
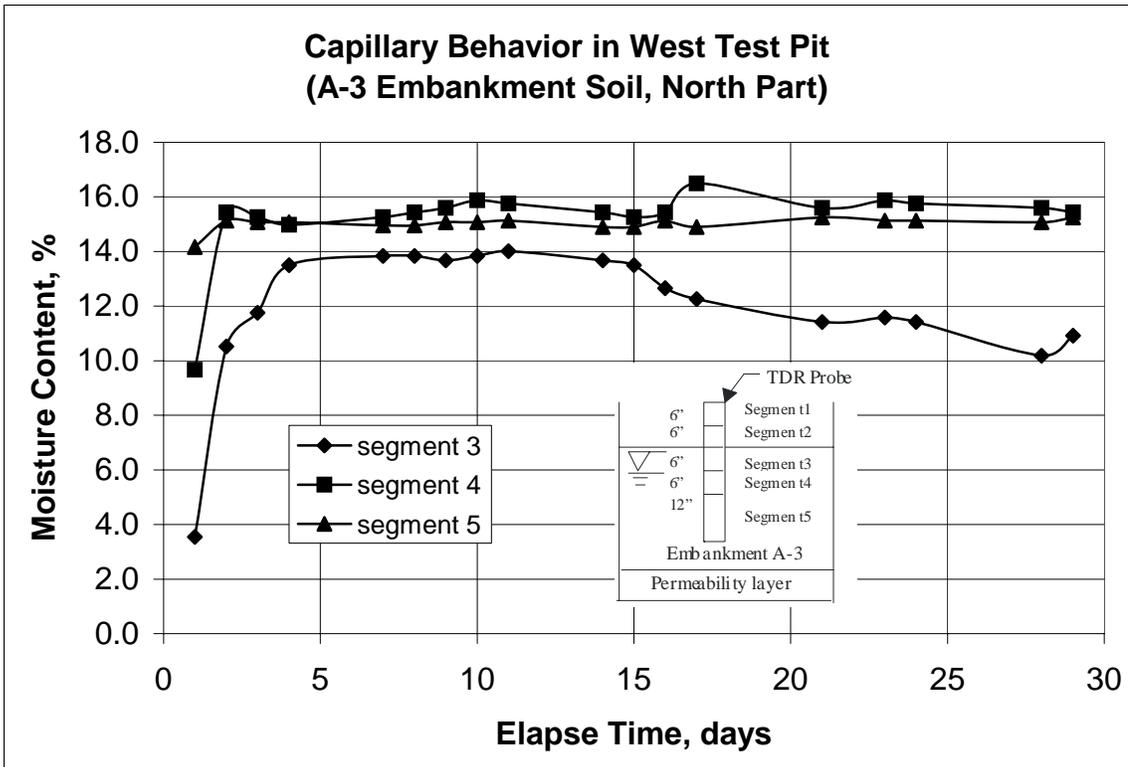
Figure 3.5 Capillary Rise Behavior at Water Level -6 inches (West Pit)

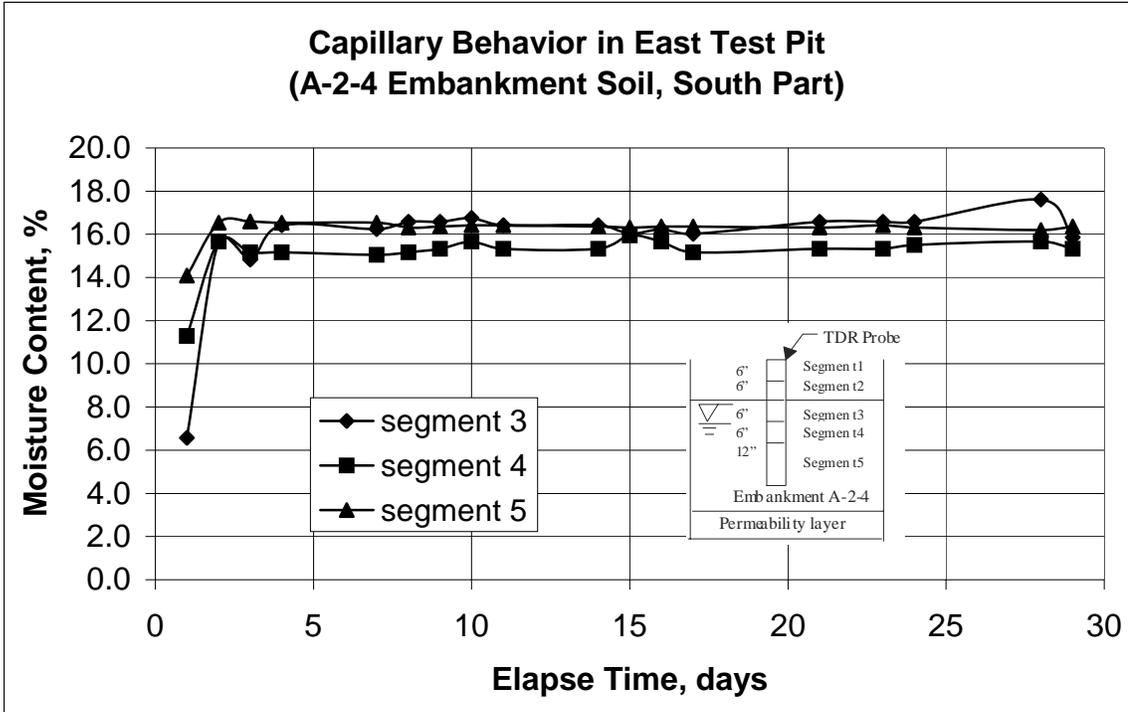
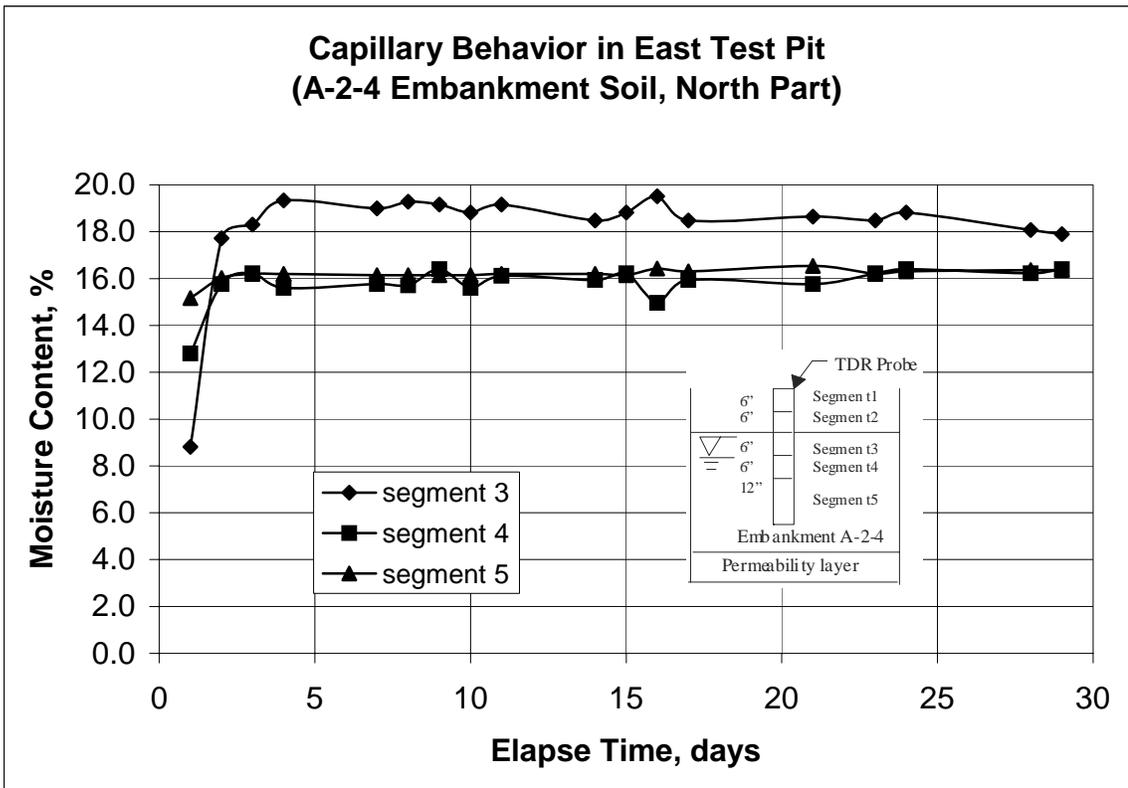
Figure 3.6 Capillary Rise Behavior at Water Level -6 inches (East Pit)

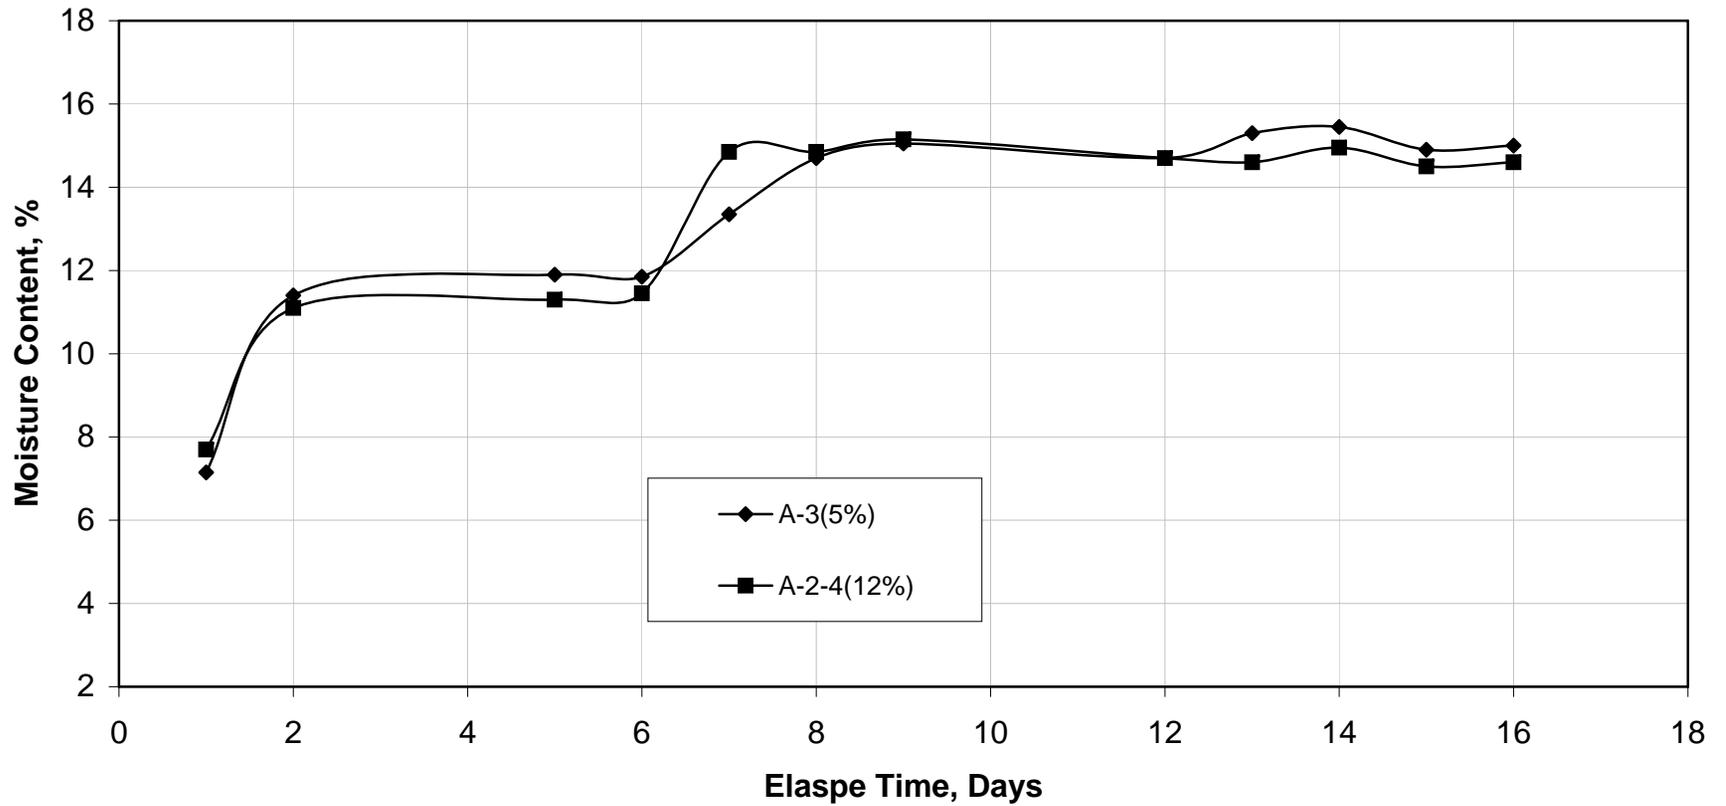
Figure 3.7 Comparison of Capillary Rise Rate at Water Level -12 inches
