FINAL REPORT

For the Florida Department of Transportation

**Constructability of Stabilized Subgrade Layer
Under High Groundwater Table**

FDOT Research Contract No.: BC-352-7

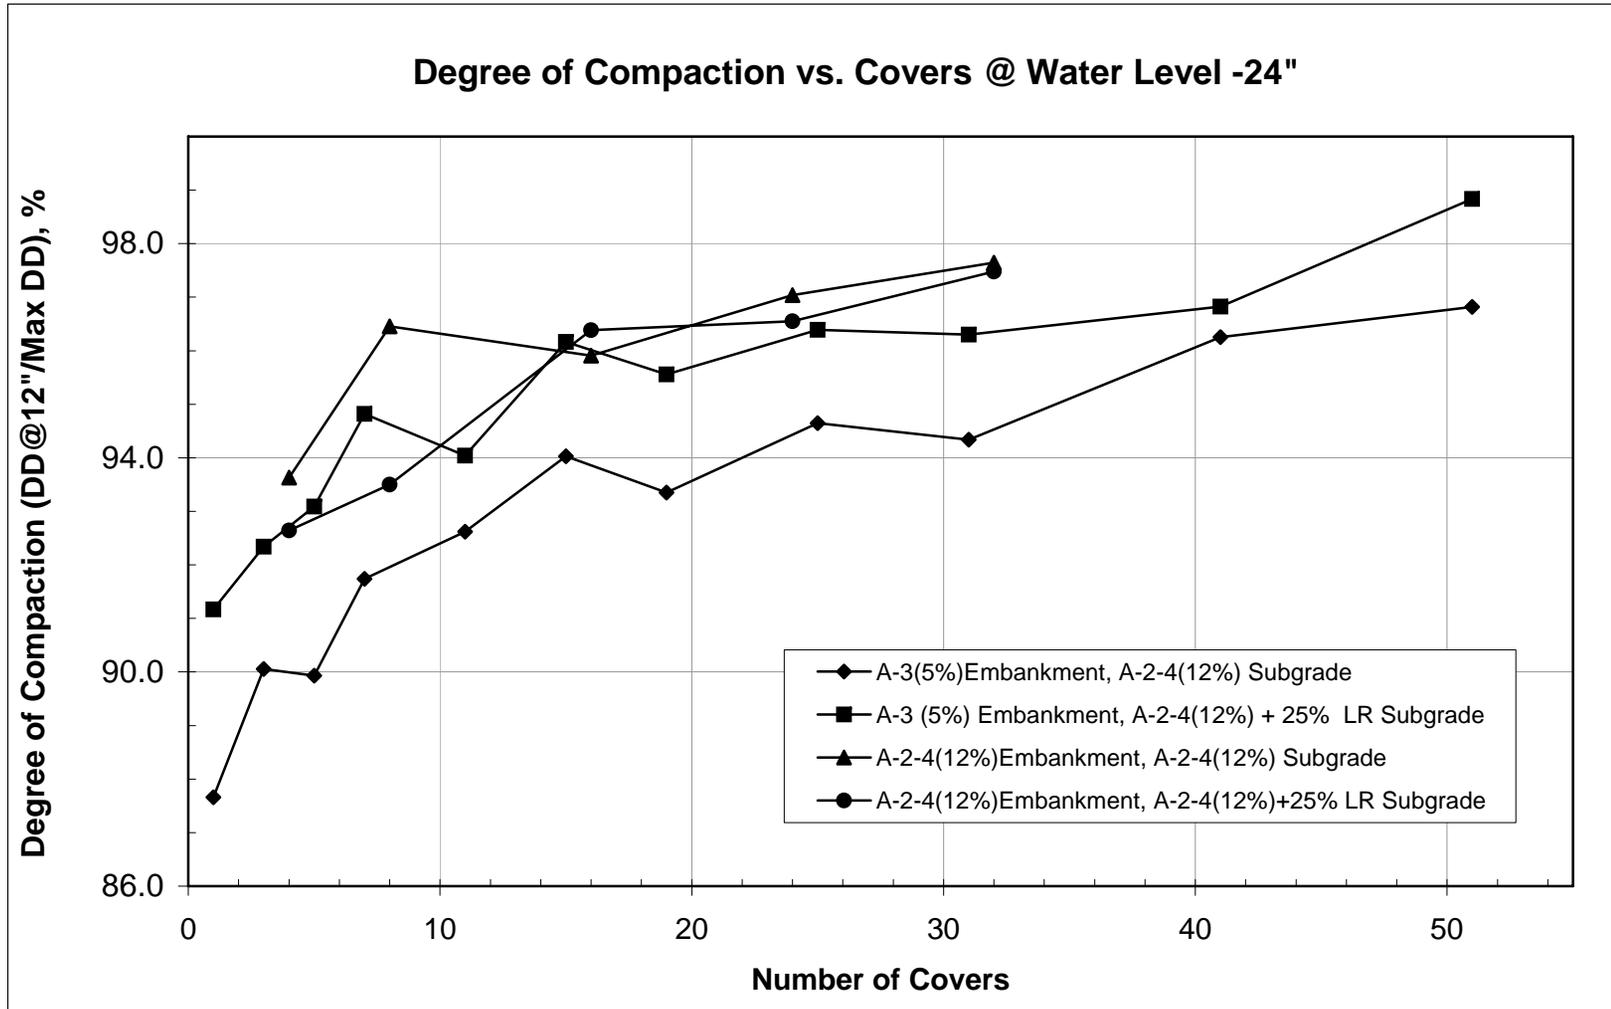
Figure 4.1 Degree of Compaction versus Number of Compaction Covers on Stabilized Subgrade for Water Level at -24 in. (Condition 1)

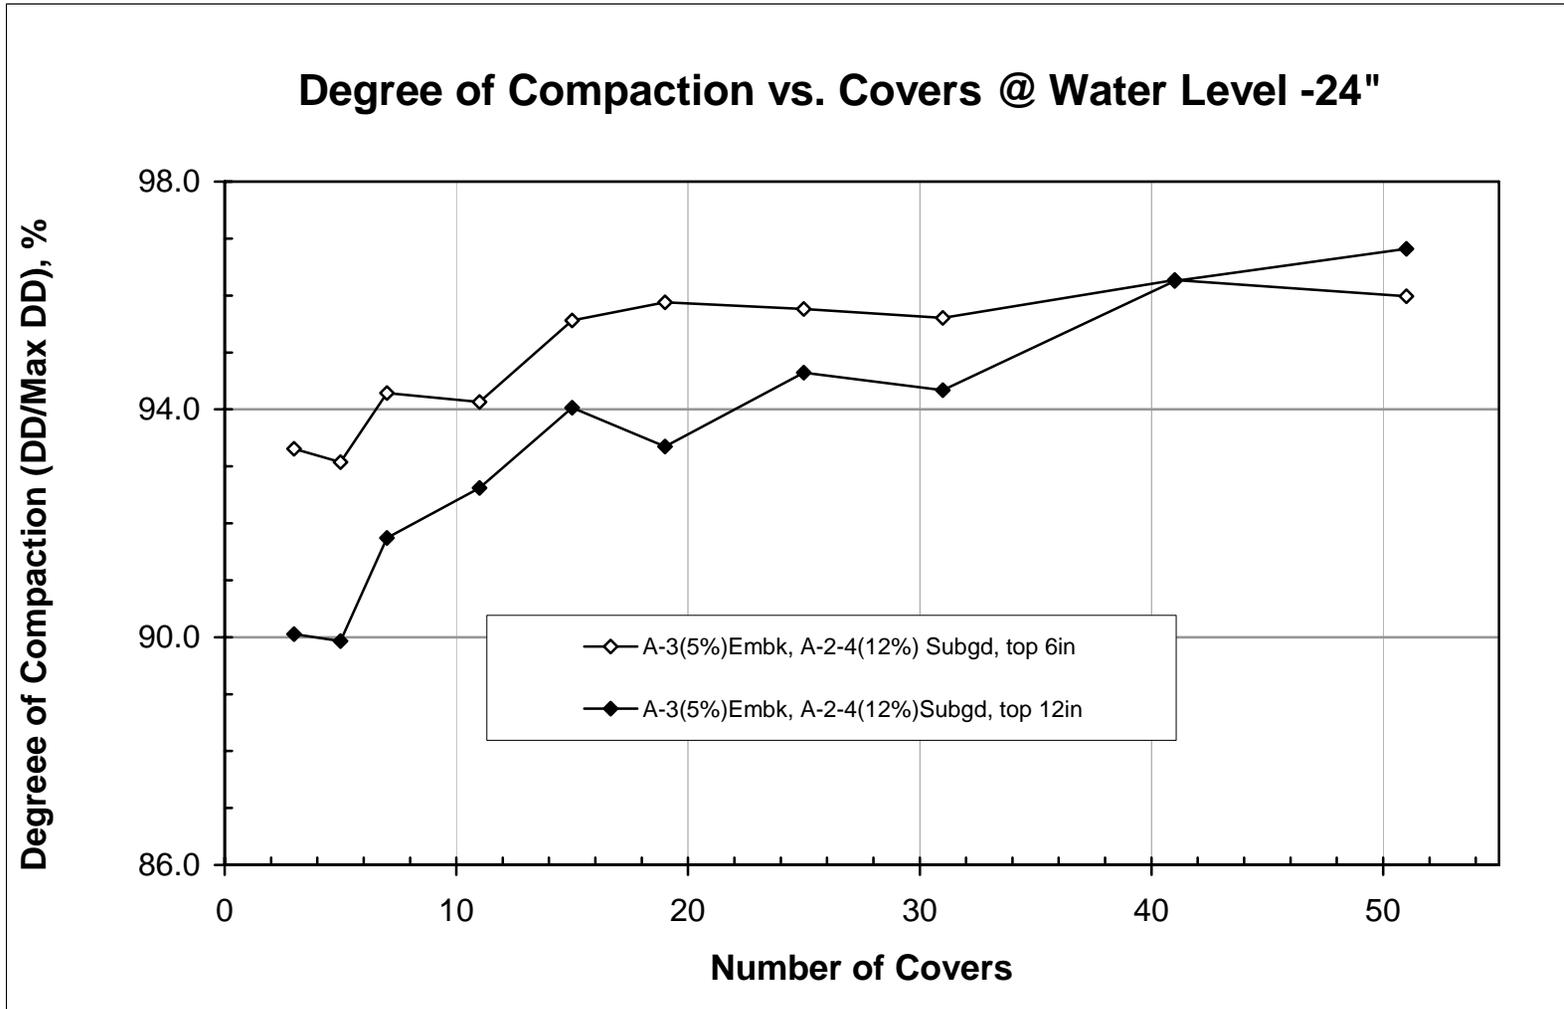
Figure 4.2(a) Comparison of Degree of Compaction for 6 in. and 12 in. Measurements (Condition 1, A-3 (5%) Embankment, A-2-4 (12%) Subgrade)

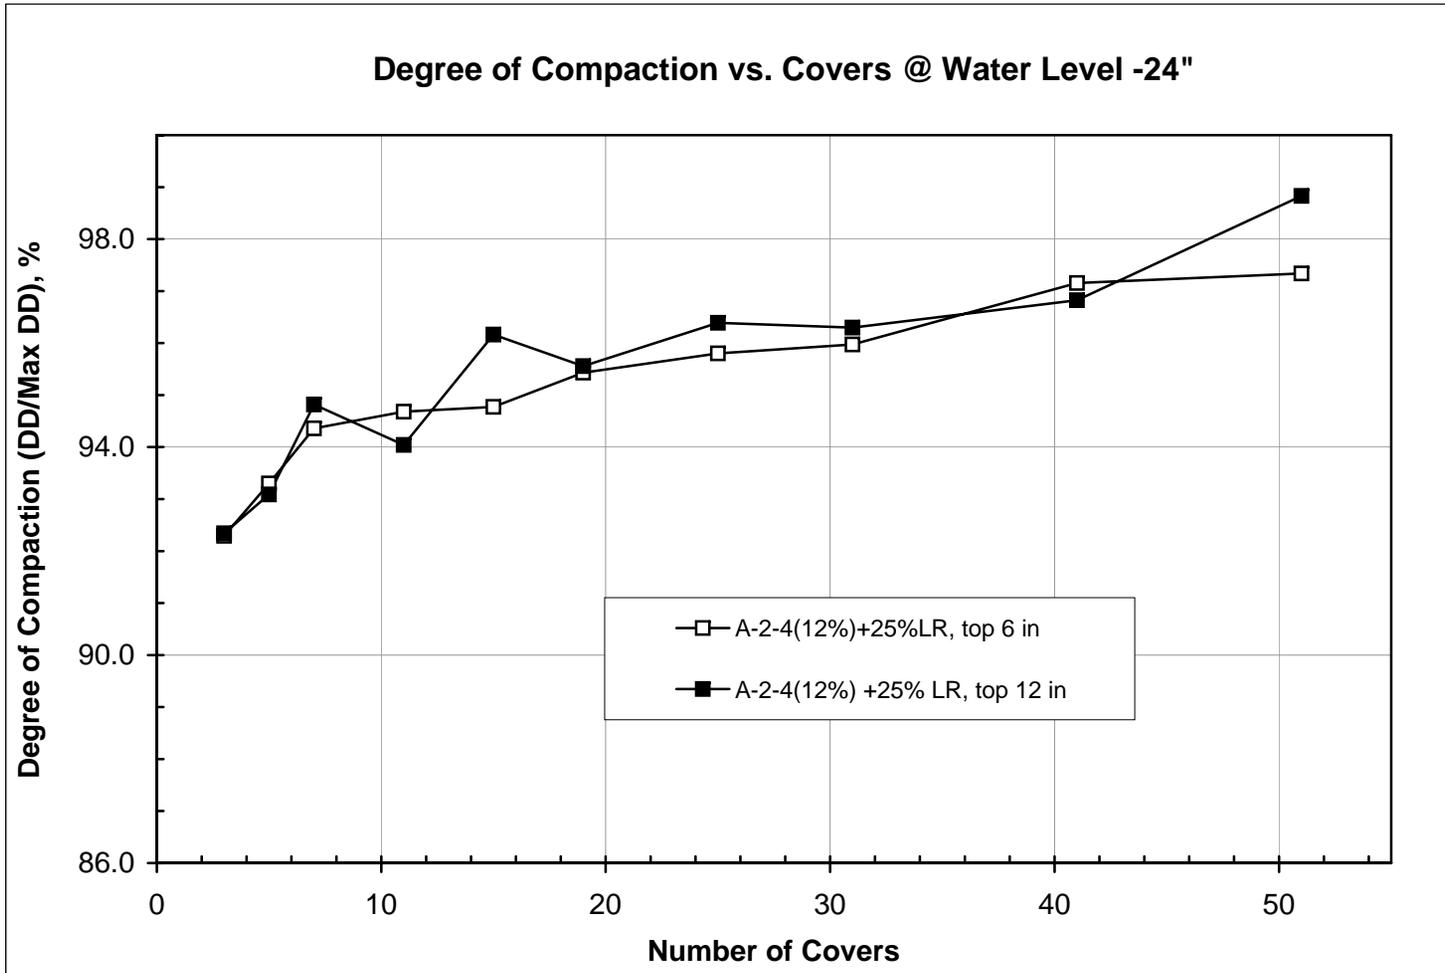
Figure 4.2(b) Comparison of Degree of Compaction for 6 inch and 12 inch Measurements (Condition 1, A-3 (5%) Embankment, A-2-4 (12%) +25% limerock Subgrade)

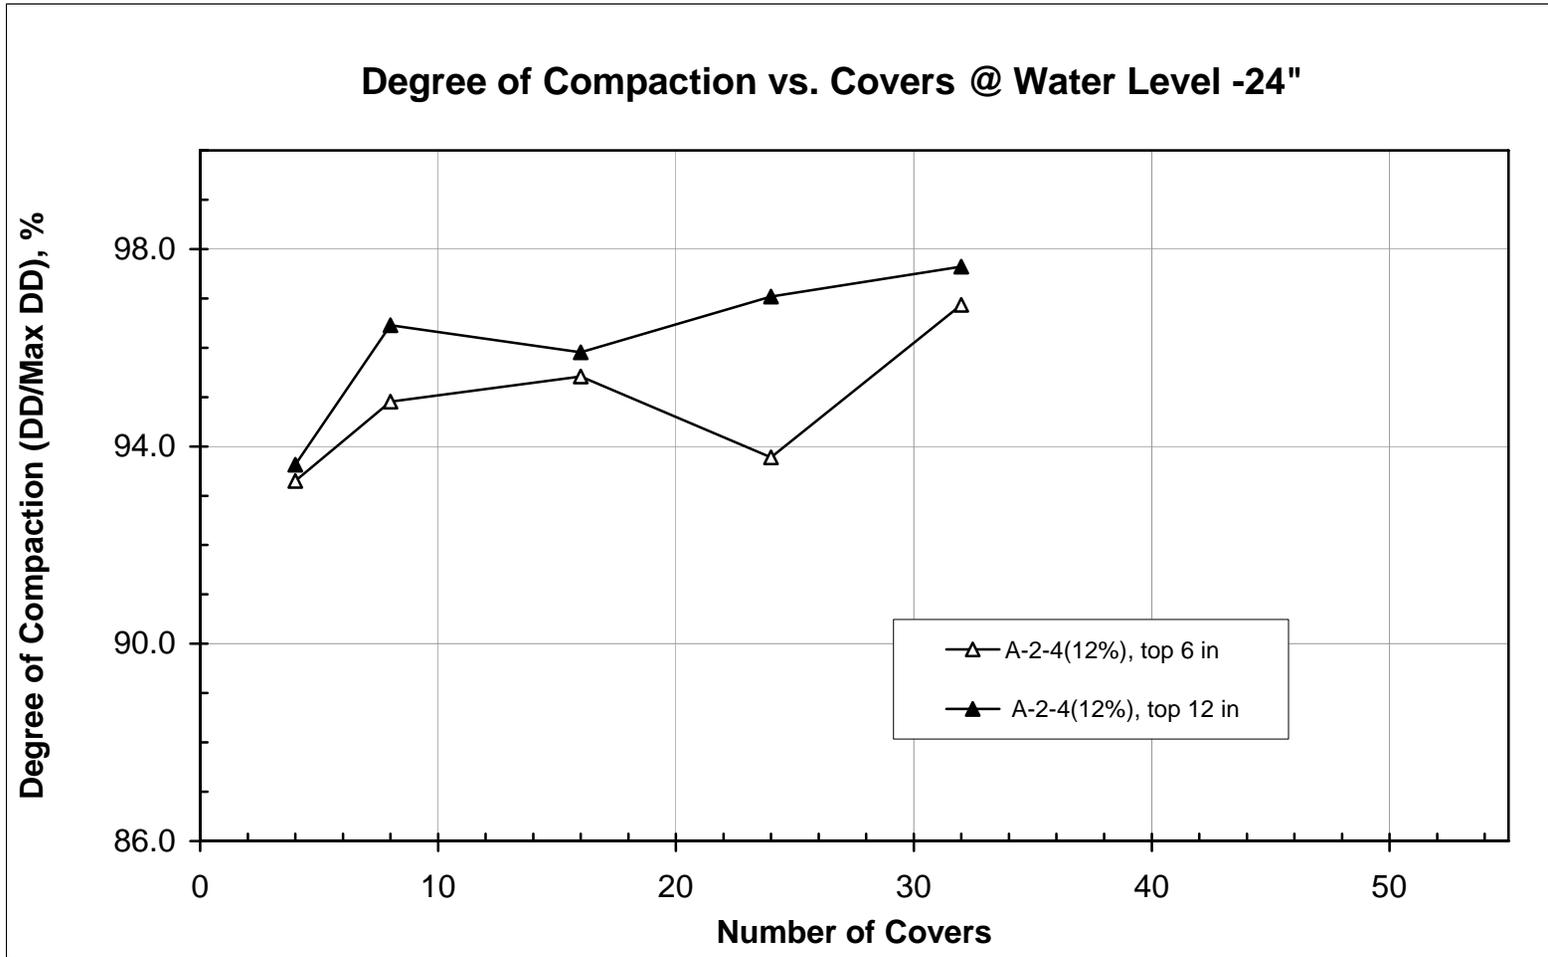
Figure 4.3(a) Comparison of Degree of Compaction for 6 in. and 12 in. Measurements (Condition 1, A-2-4 (12%) Embankment, A-2-4 (12%) Subgrade)

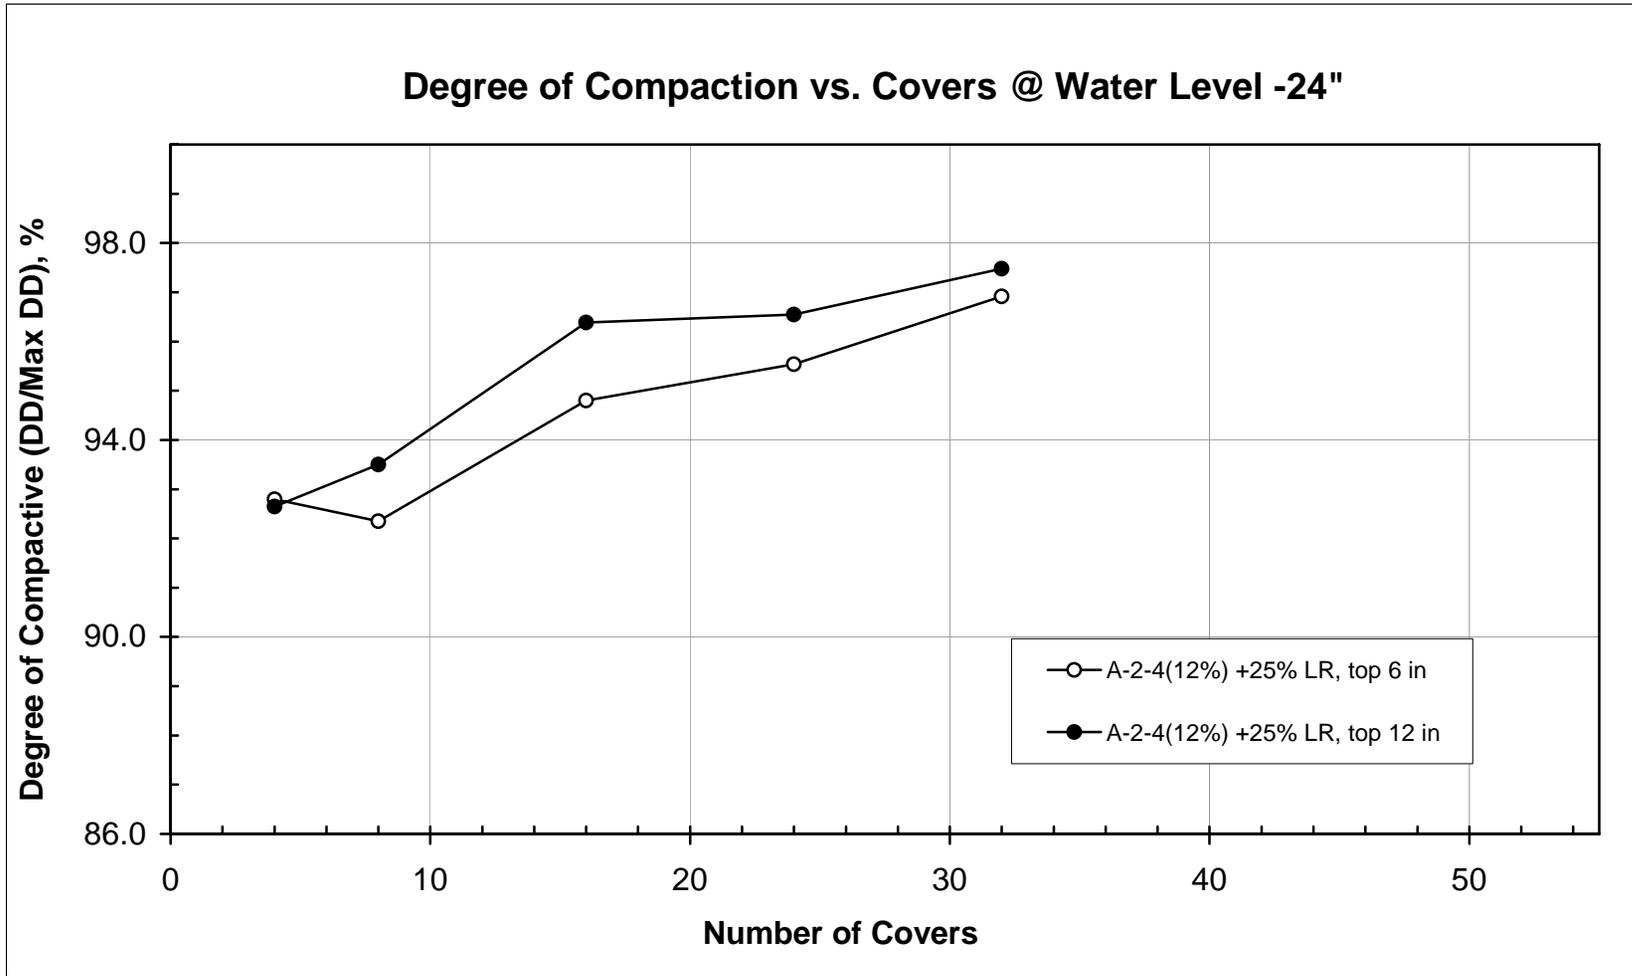
Figure 4.3(b) Comparison of Degree of Compaction for 6 inch and 12 inch Measurements (Condition 1, A-2-4 (12%) Embankment, A-2-4 (12%) + 25% limerock Subgrade)

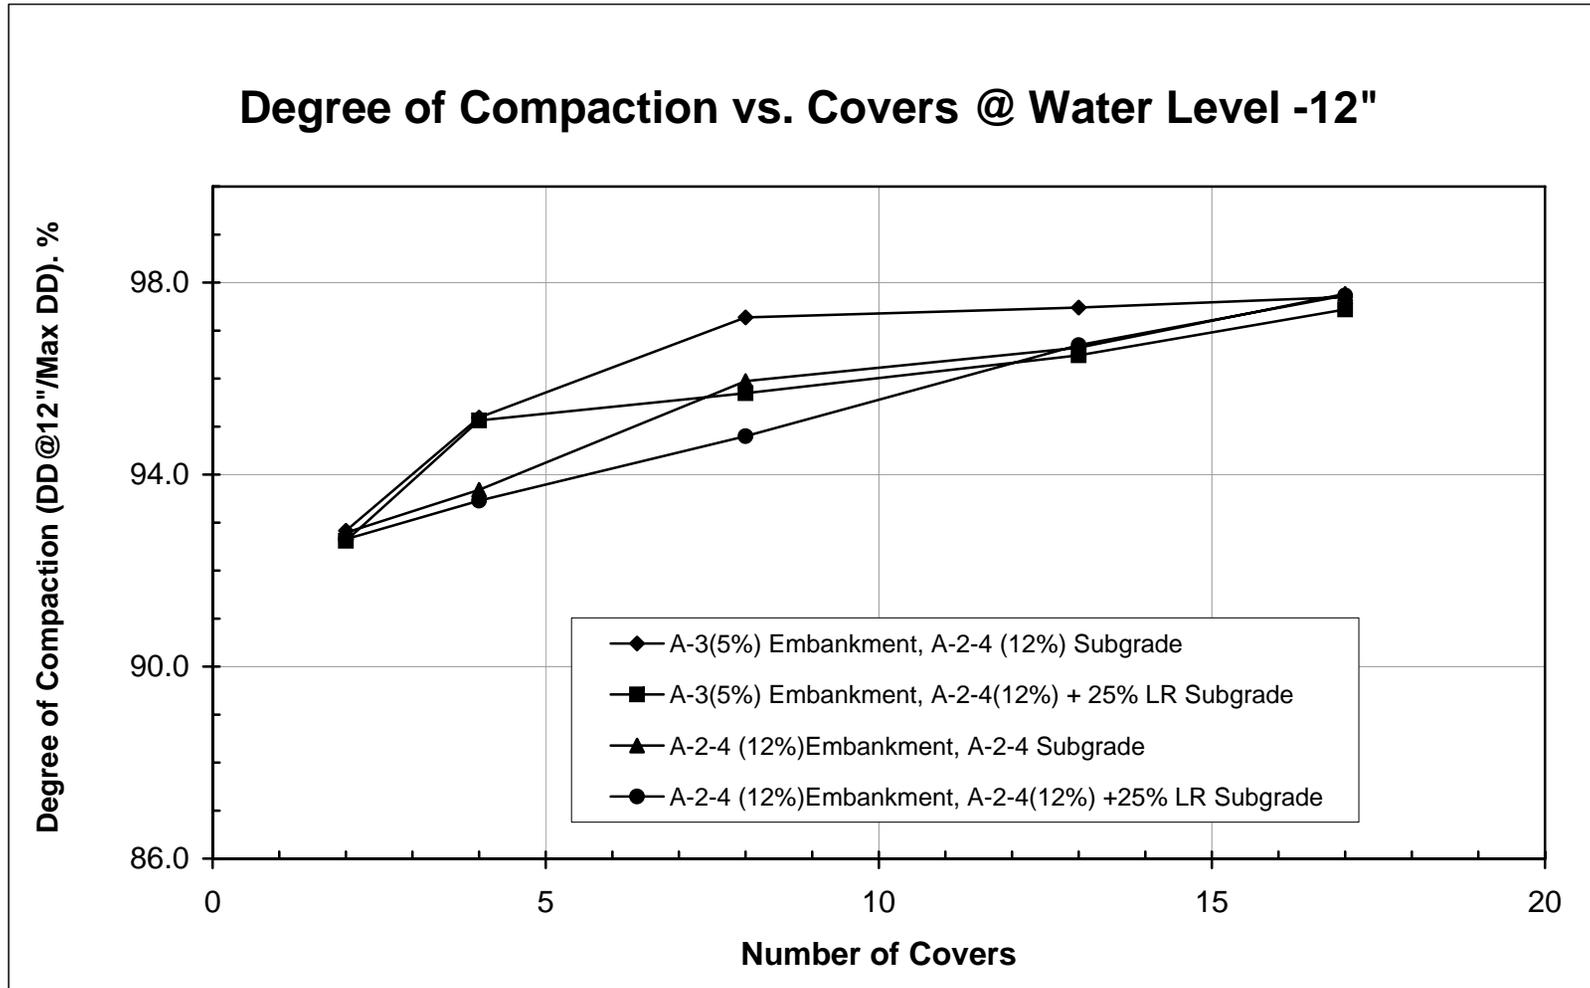
Figure 4.4 Degree of Compaction versus Number of Compaction Covers on Stabilized Subgrade for Water Level at -12 in. (Condition 2)

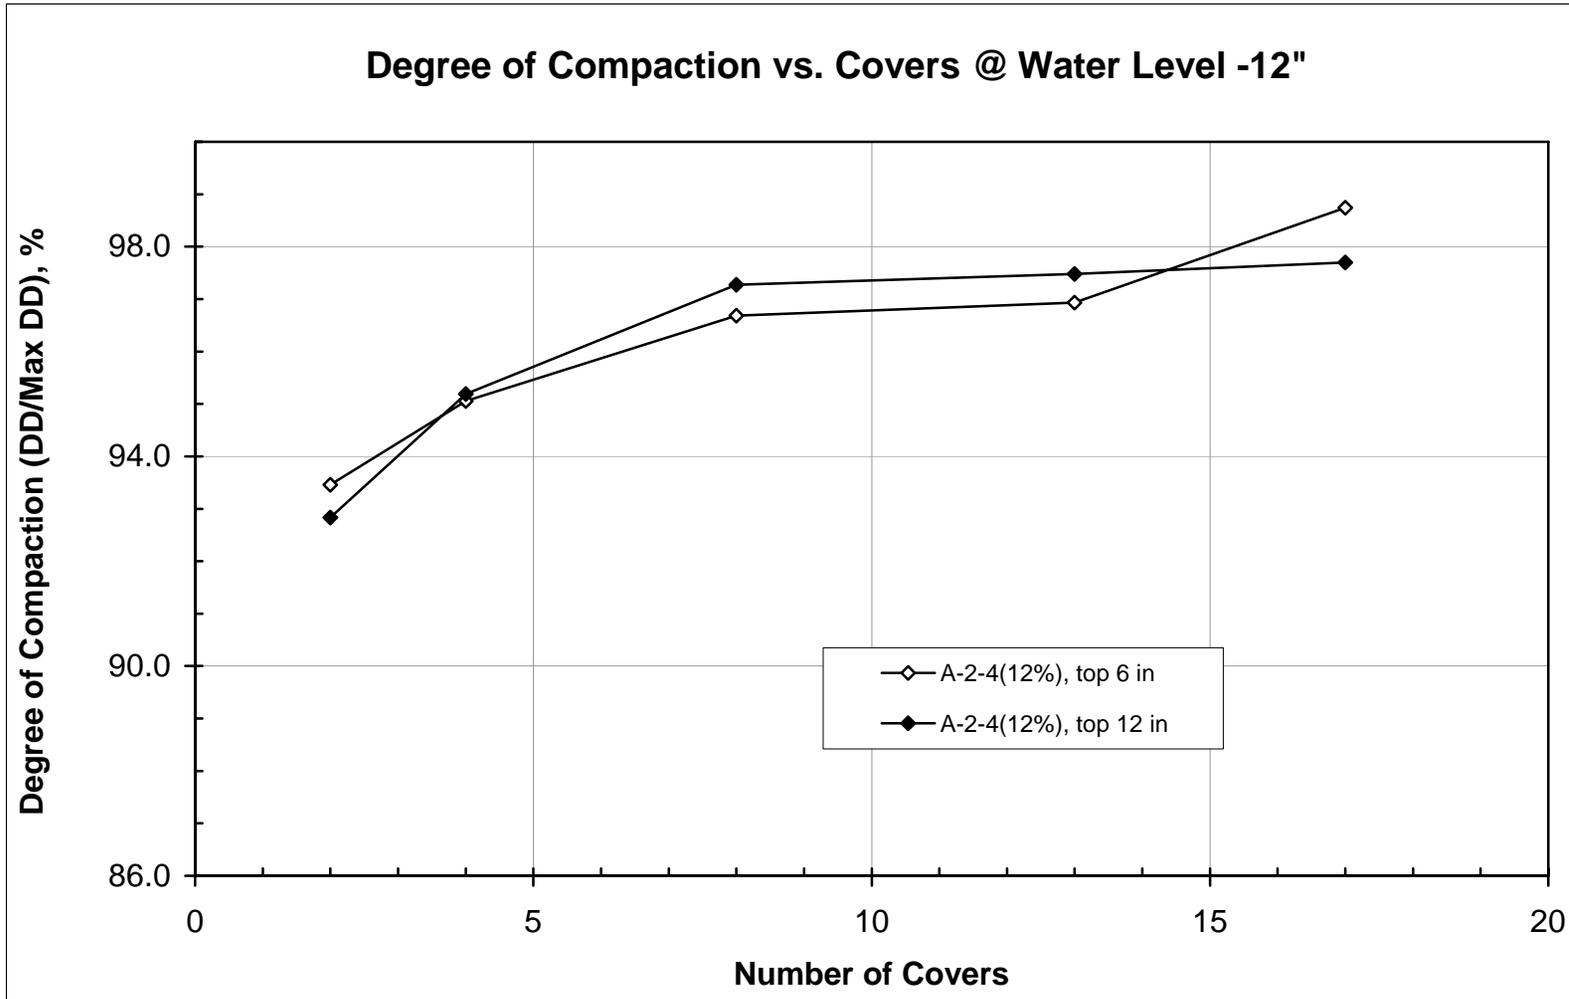
Figure 4.5(a) Comparison of Degree of Compaction for 6 in. and 12 in. Measurements (Condition 2, A-3 (5%) Embankment, A-2-4 (12%) Subgrade)

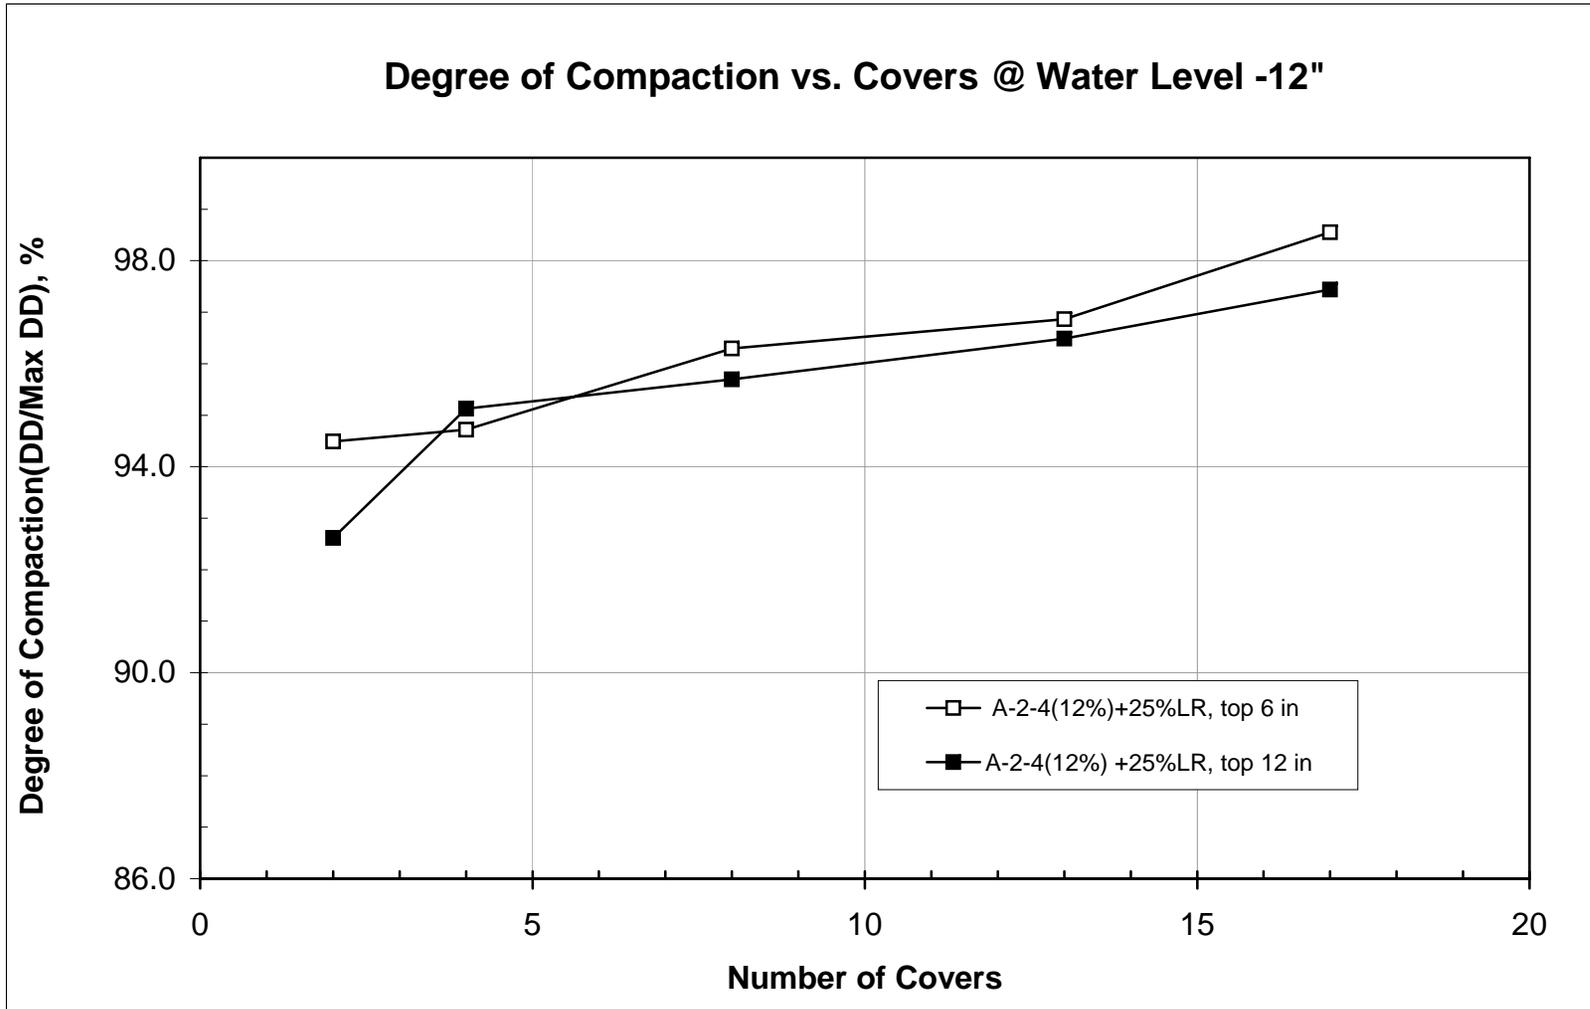
Figure 4.5(b) Comparison of Degree of Compaction for 6 inch and 12 inch Measurements (Condition 2, A-3 (5%) Embankment, A-2-4 (12%) + 25% limerock Subgrade)

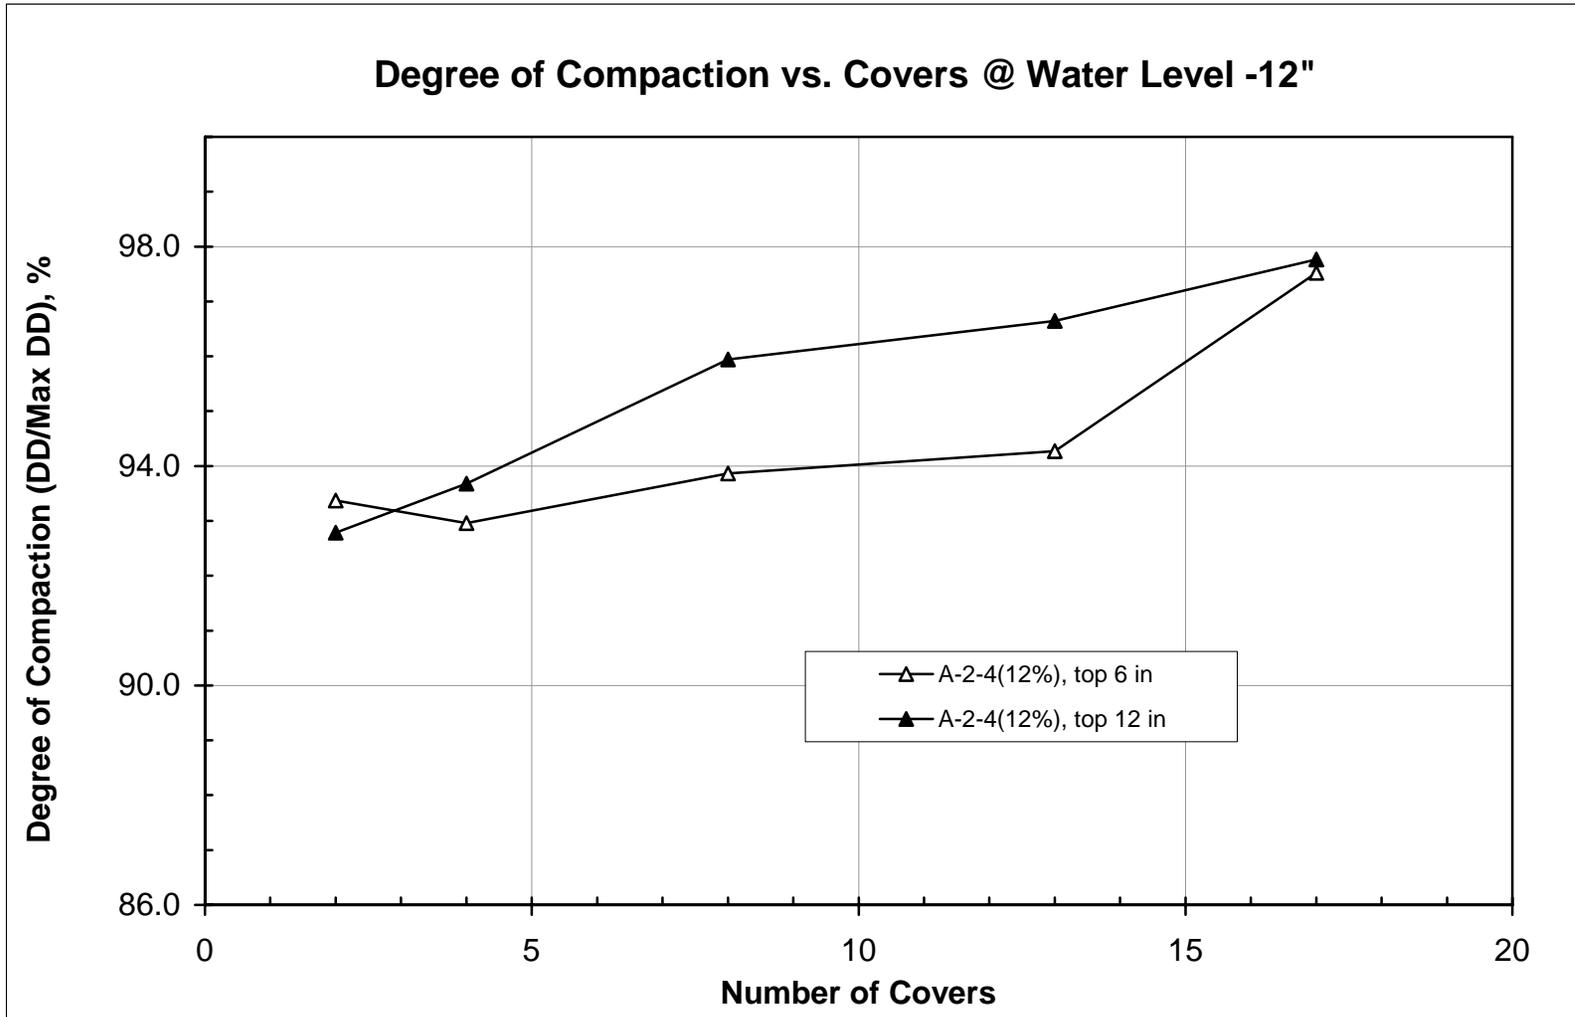
Figure 4.6(a) Comparison of Degree of Compaction for 6 in. and 12 in. Measurements (Condition 2, A-2-4 (12%) Embankment, A-2-4 (12%) Subgrade)

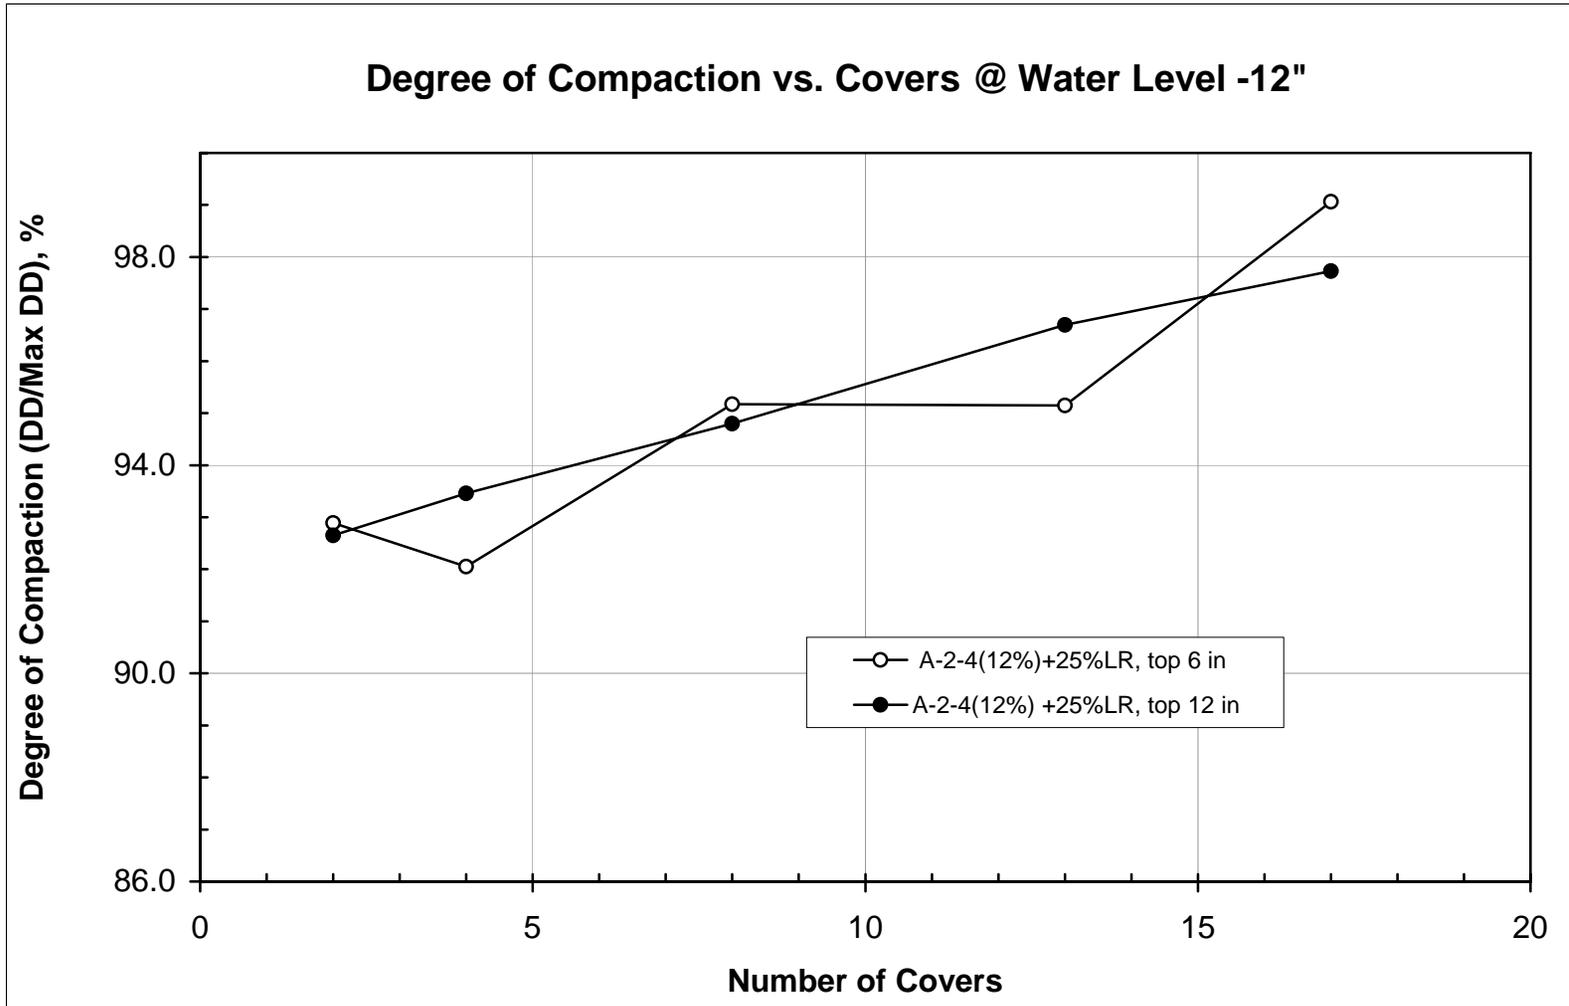
Figure 4.6(b) Comparison of Degree of Compaction for 6 inch and 12 inch Measurements (Condition 2, A-2-4 (12%) Embankment, A-2-4 (12%) + 25% limerock Subgrade)

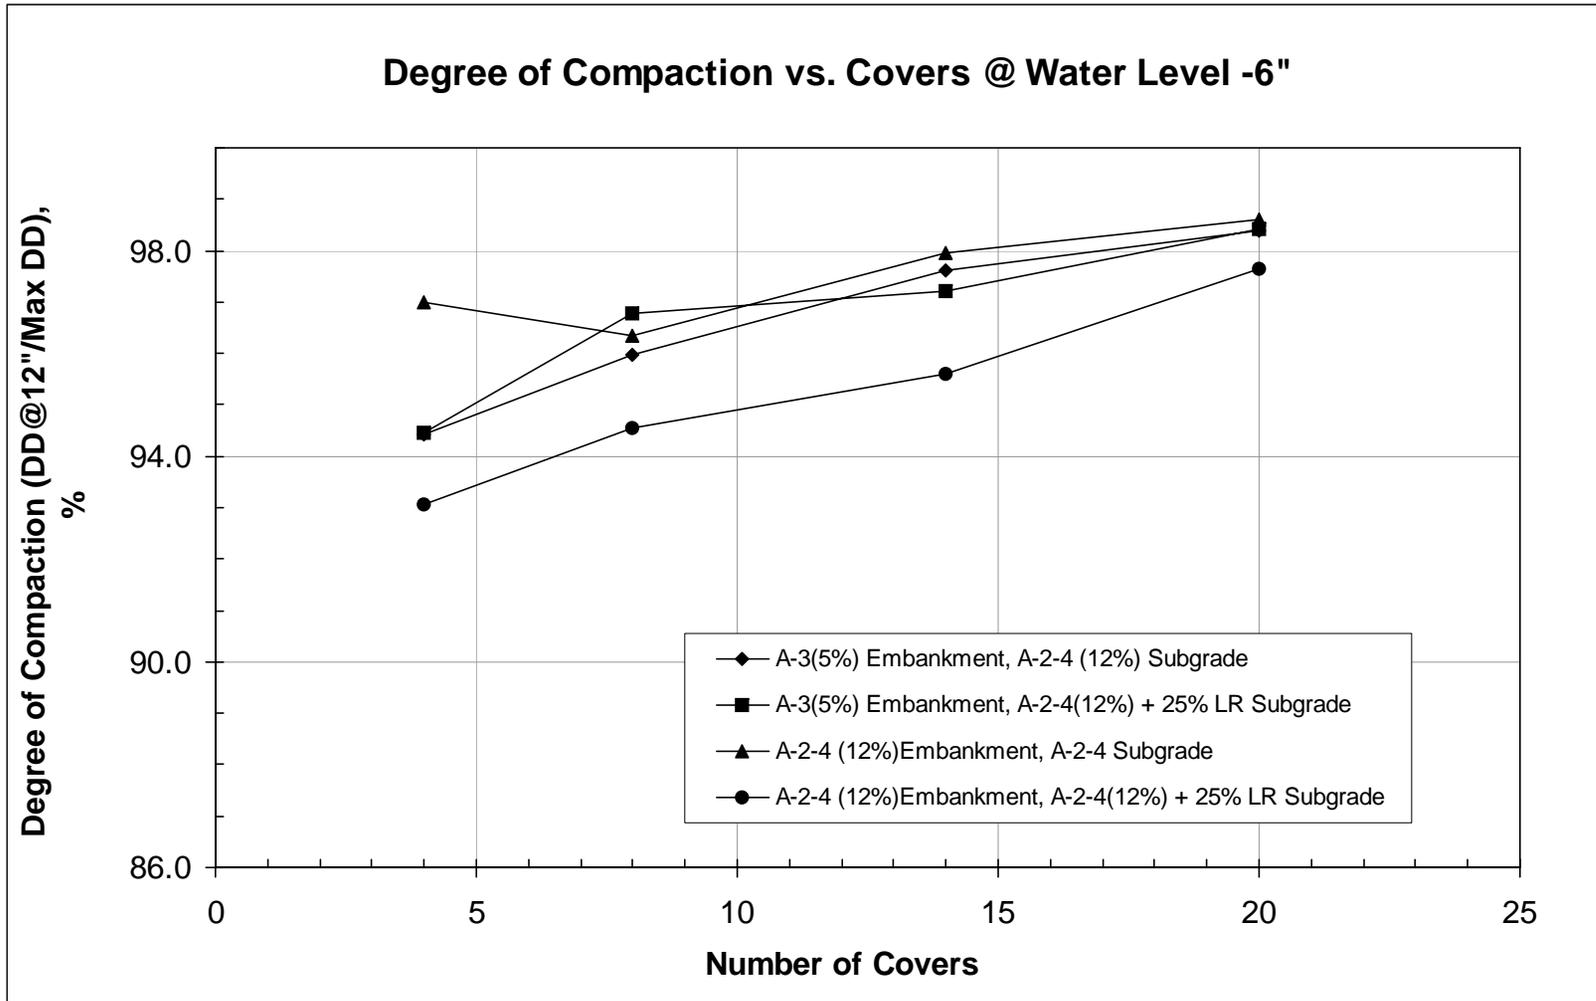
Figure 4.7 Degree of Compaction versus Number of Compaction Covers on Stabilized Subgrade for Water Level at -6 in. (Condition 3)

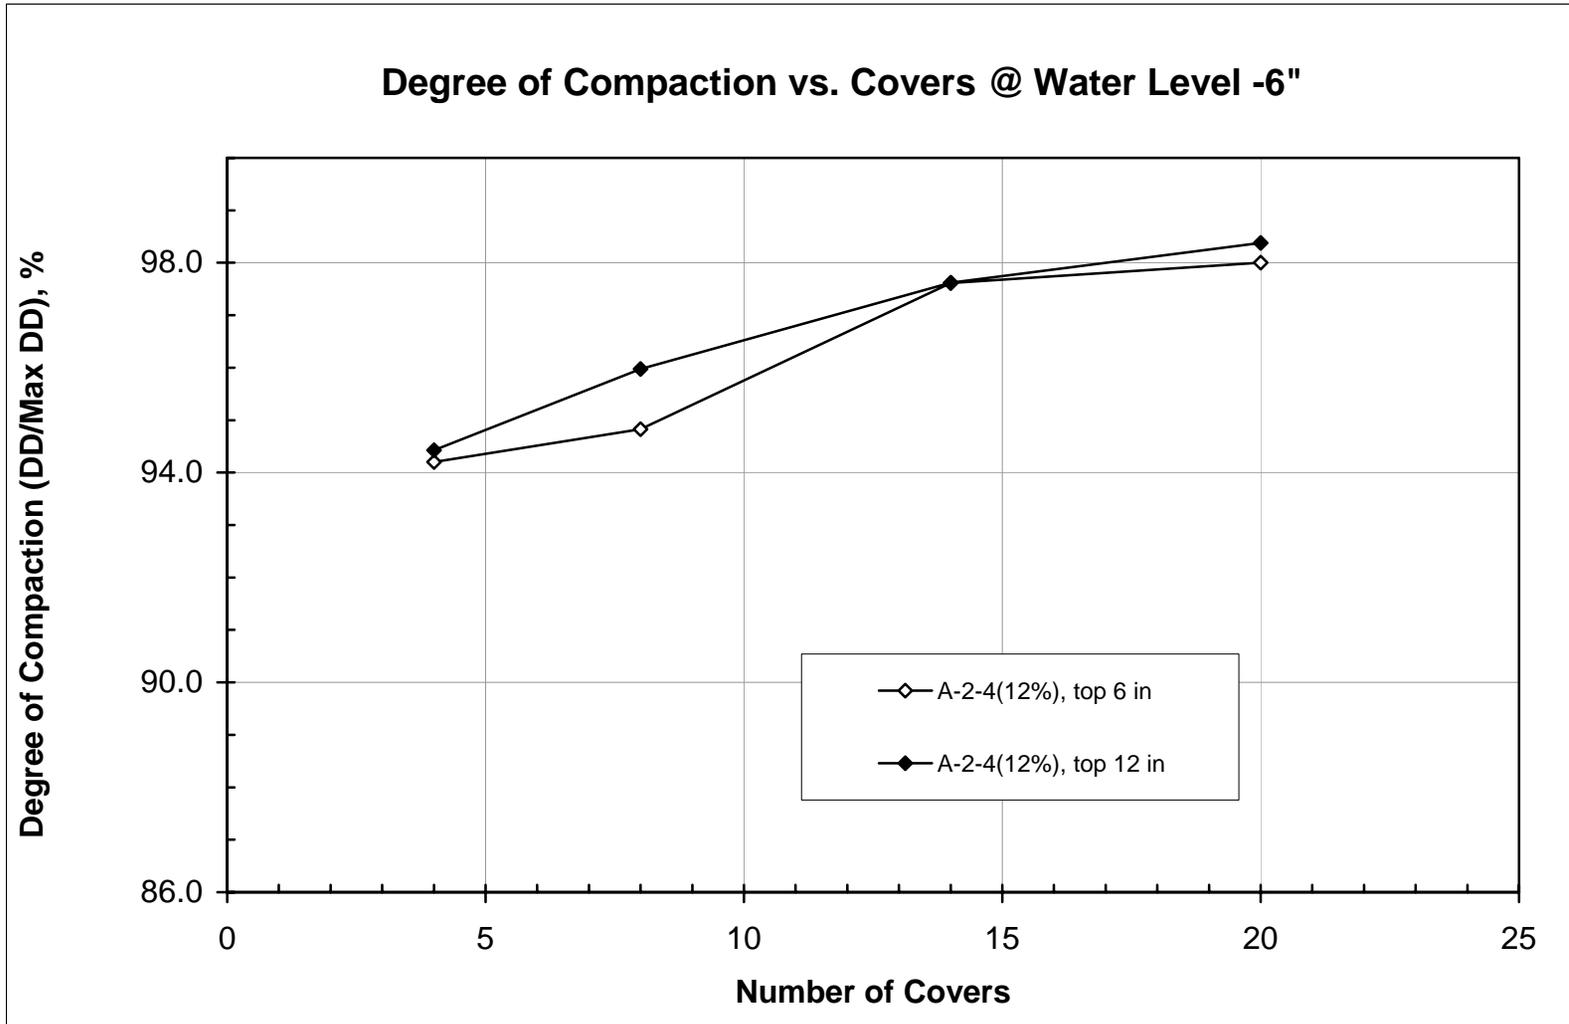
Figure 4.8(a) Comparison of Degree of Compaction for 6 in. and 12 in. Measurements (Condition 3, A-2-4 (12%) Embankment, A-2-4 (12%) Subgrade)

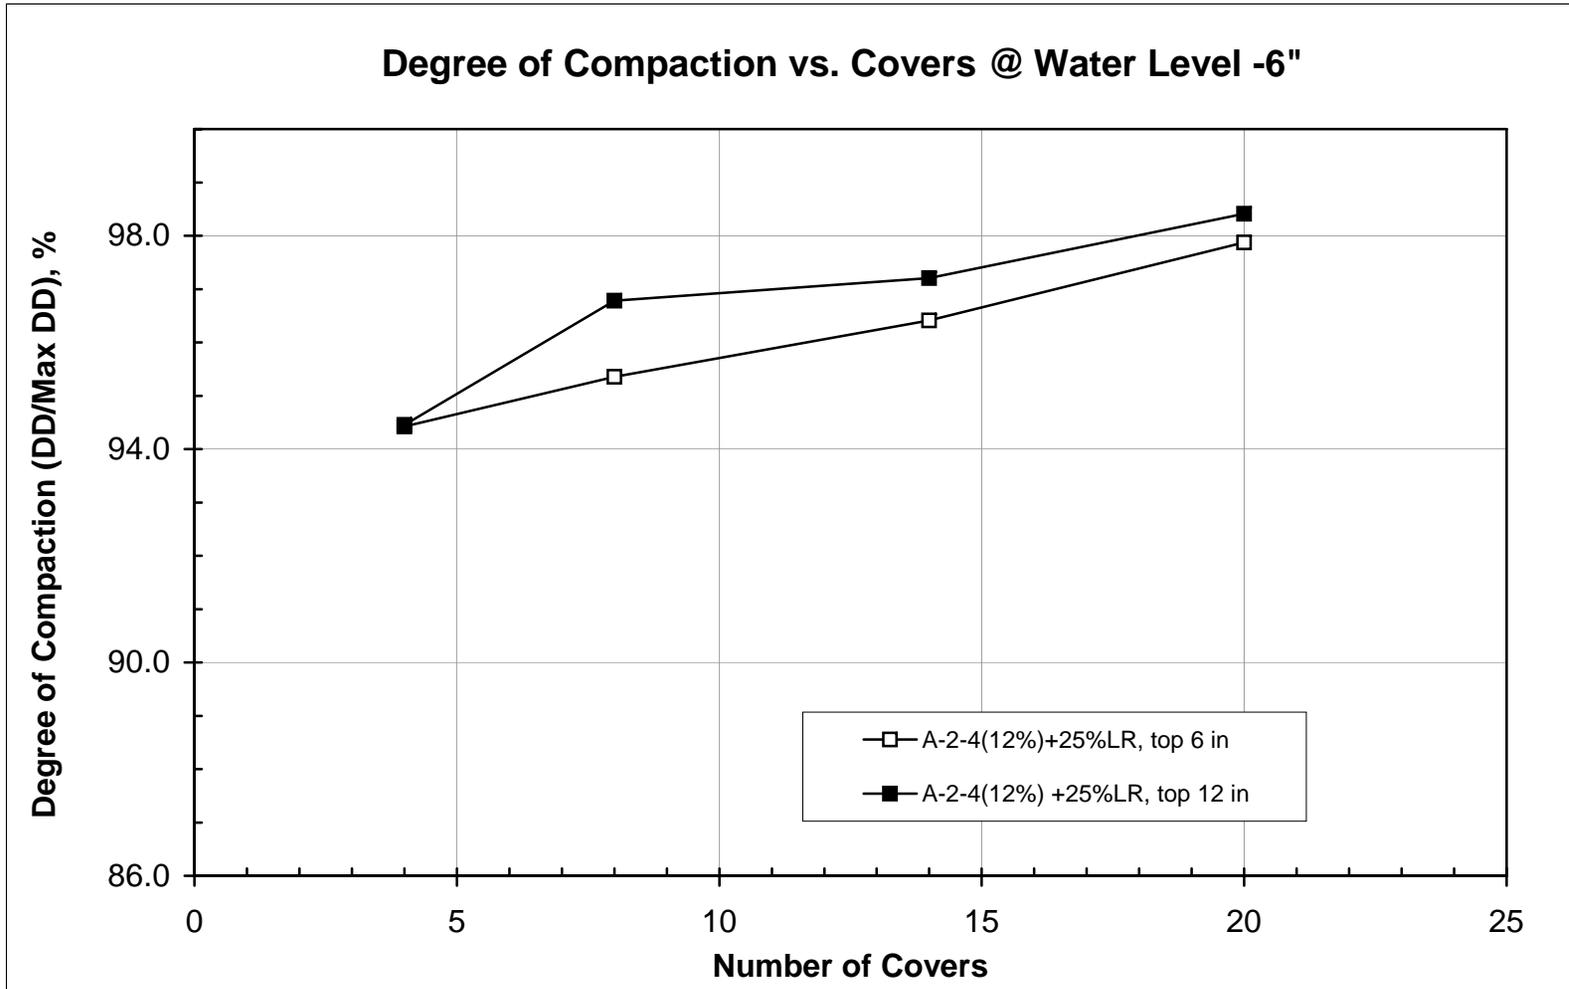
Figure 4.8(b) Comparison of Degree of Compaction for 6 inch and 12 inch Measurements (Condition 3, A-2-4 (12%) Embankment, A-2-4 (12%) + 25% limerock Subgrade)

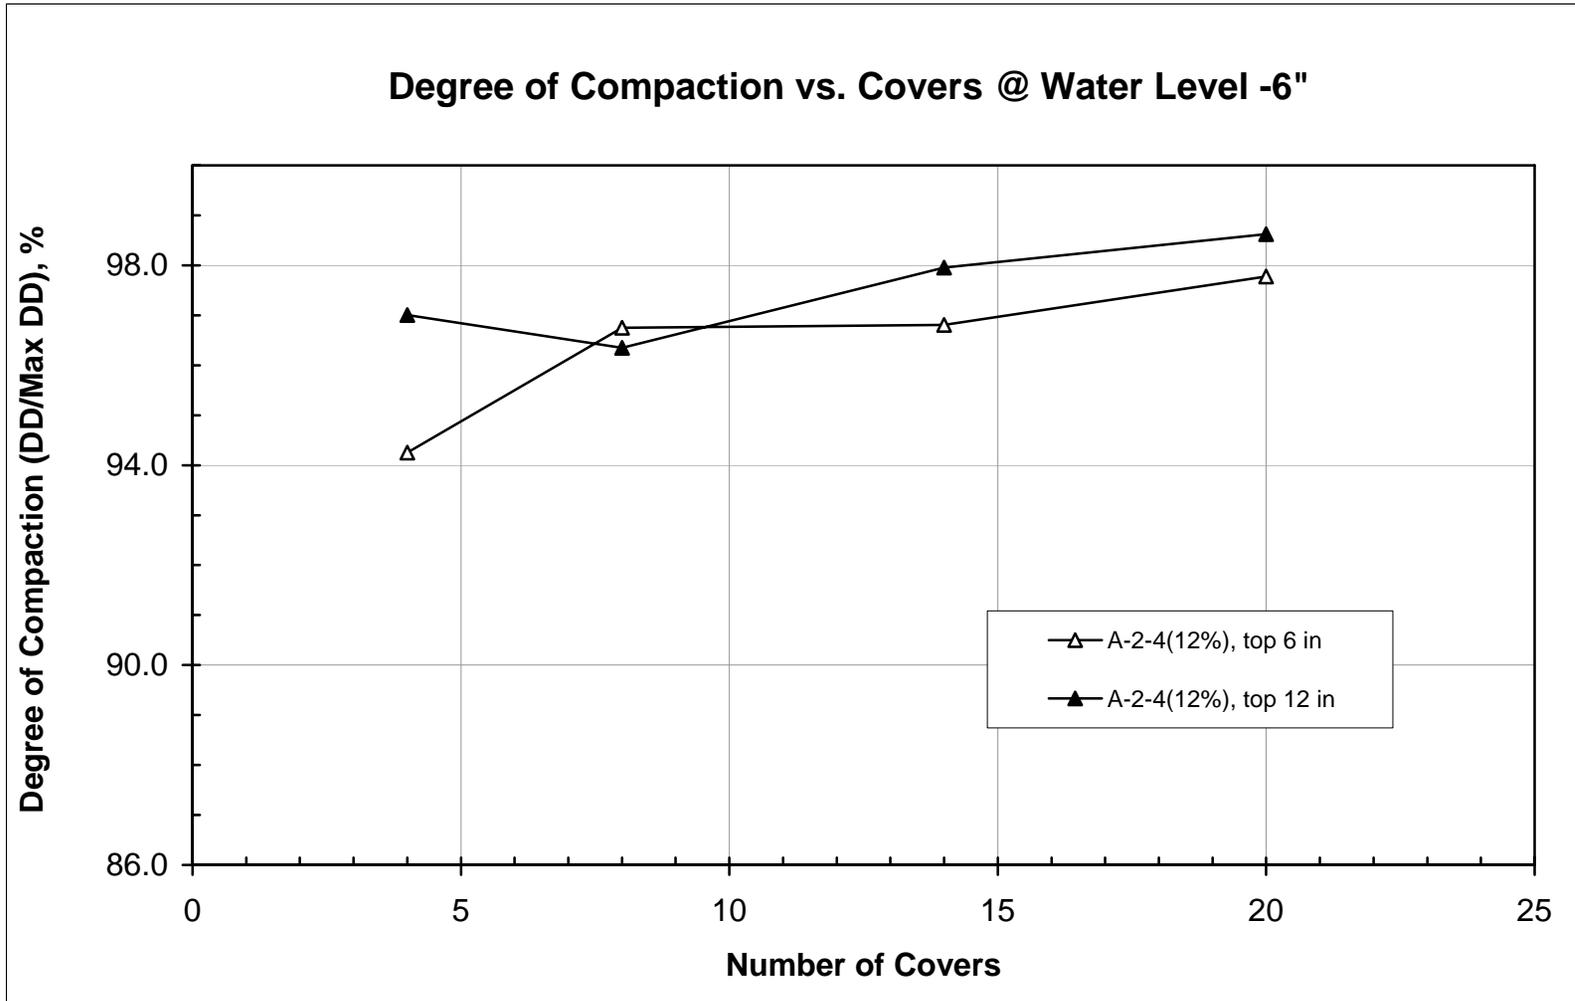
Figure 4.9(a) Comparison of Degree of Compaction for 6 in. and 12 in. Measurements (Condition 3, A-2-4 (12%) Embankment, A-2-4 (12%) Subgrade)
