FINAL REPORT

For the Florida Department of Transportation

**Constructability of Stabilized Subgrade Layer
Under High Groundwater Table**

FDOT Research Contract No.: BC-352-7

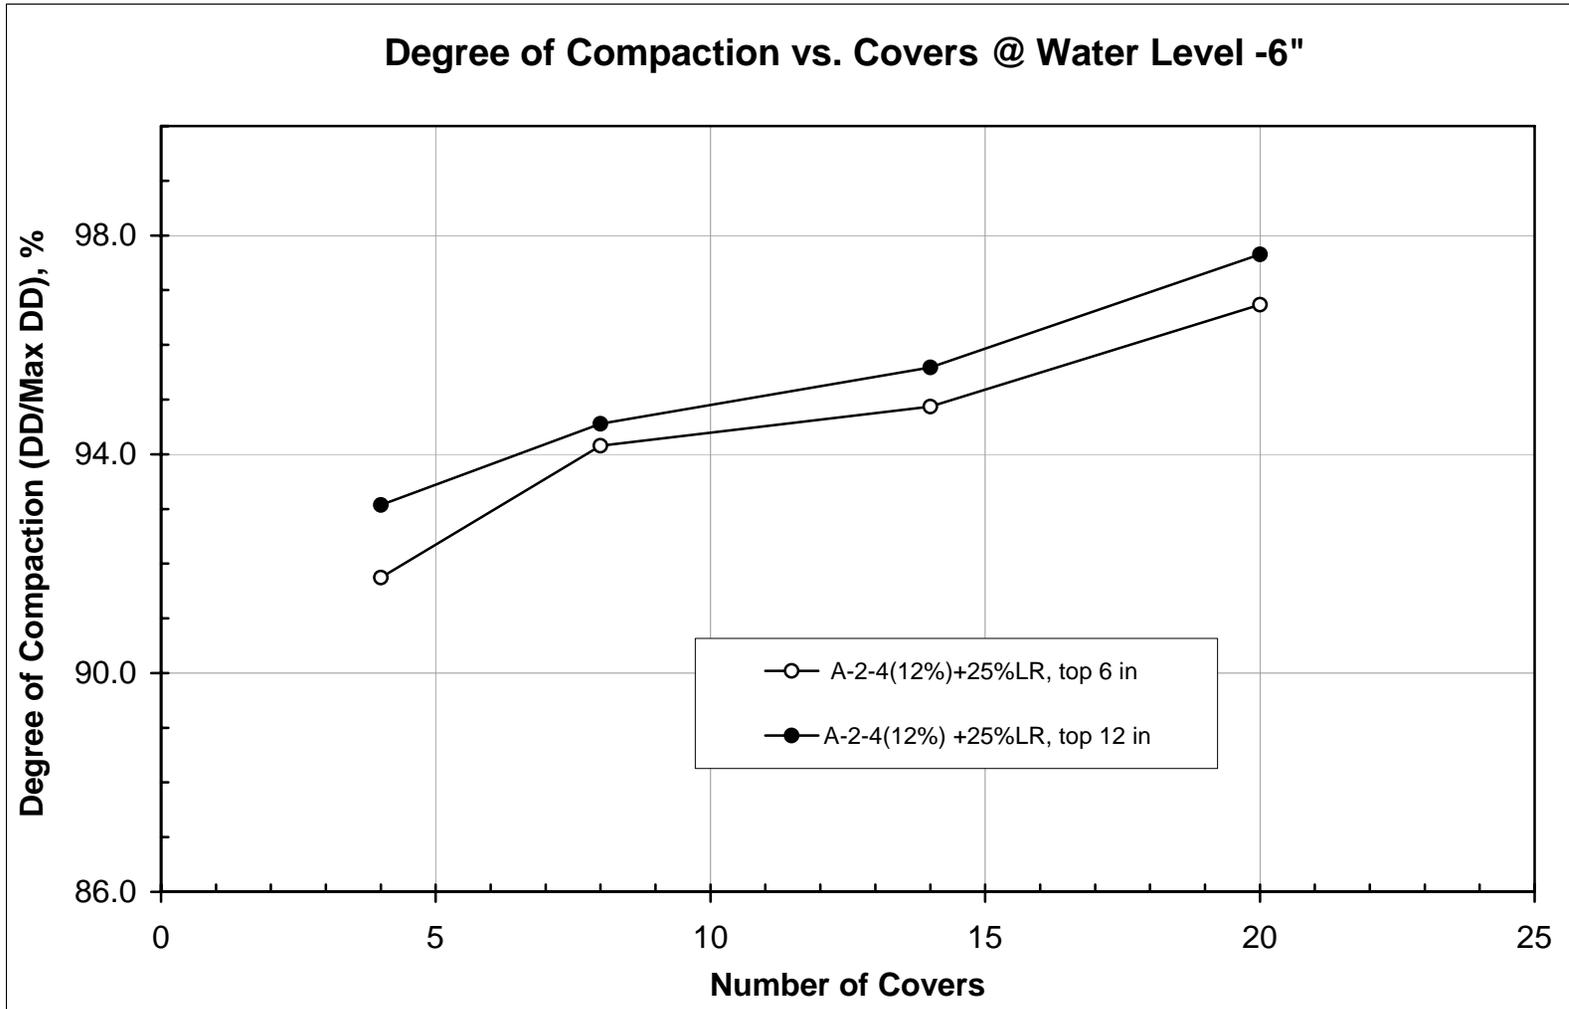
Figure 4.9(b) Comparison of Degree of Compaction for 6 inch and 12 inch Measurements (Condition 3, A-2-4 (12%) Embankment, A-2-4 (12%) + 25% limerock Subgrade)

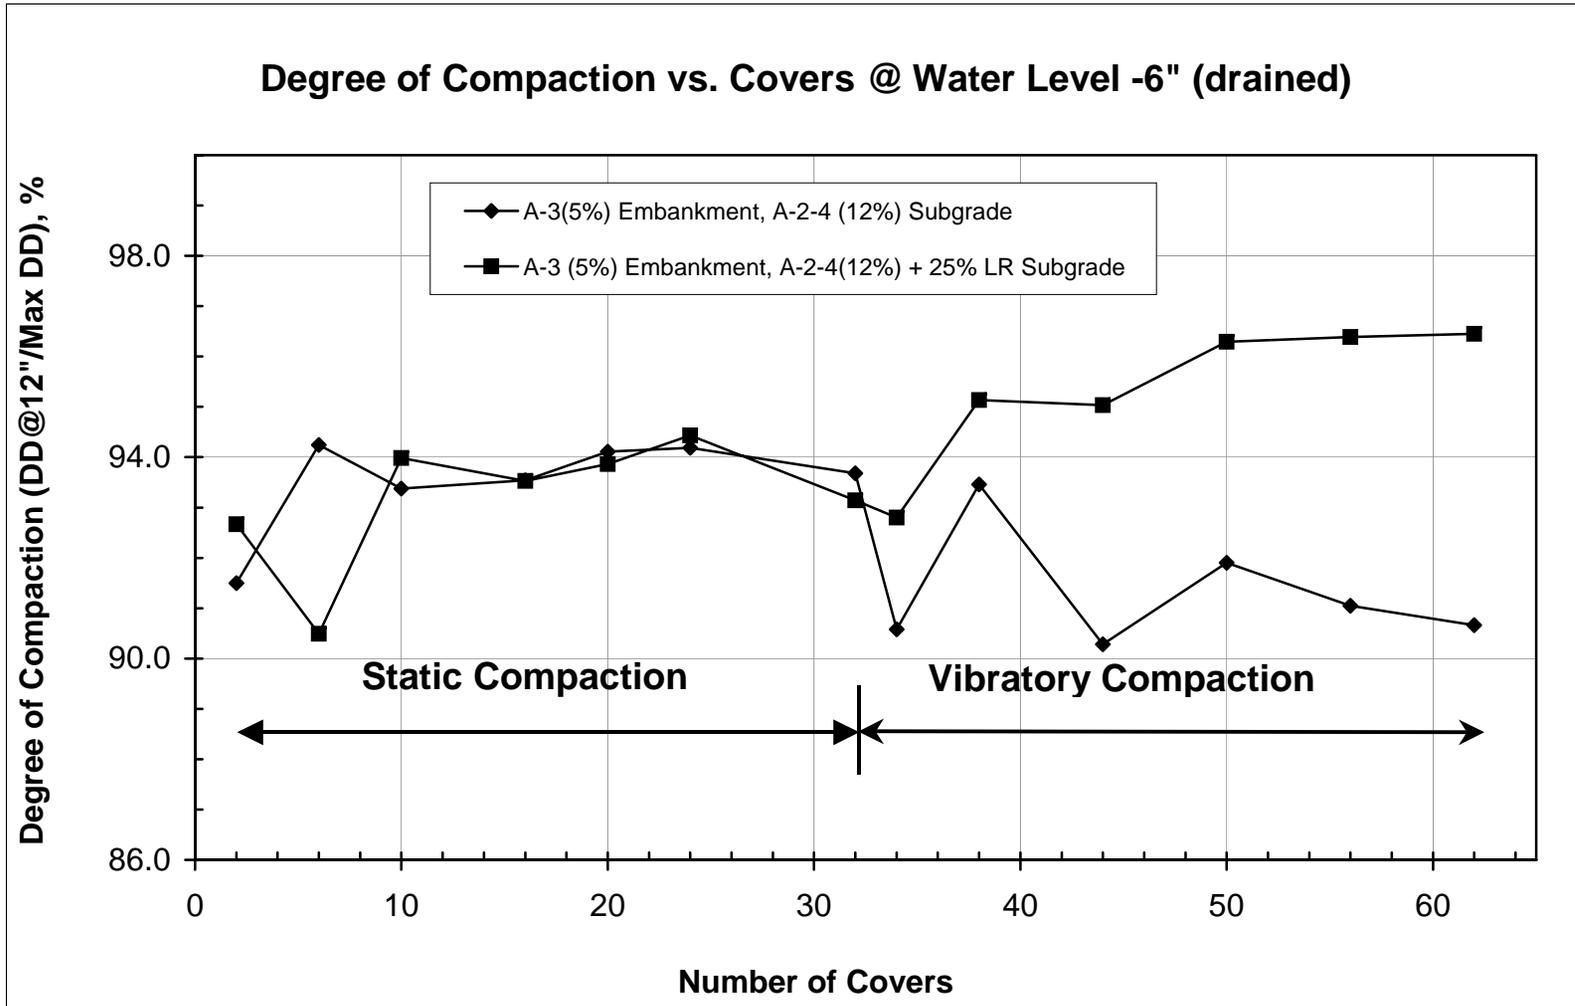
Figure 4.10 Degree of Compaction versus Number of Compaction Covers on Stabilized Subgrade for Water Level at -6 in. (drained) (Condition 4)

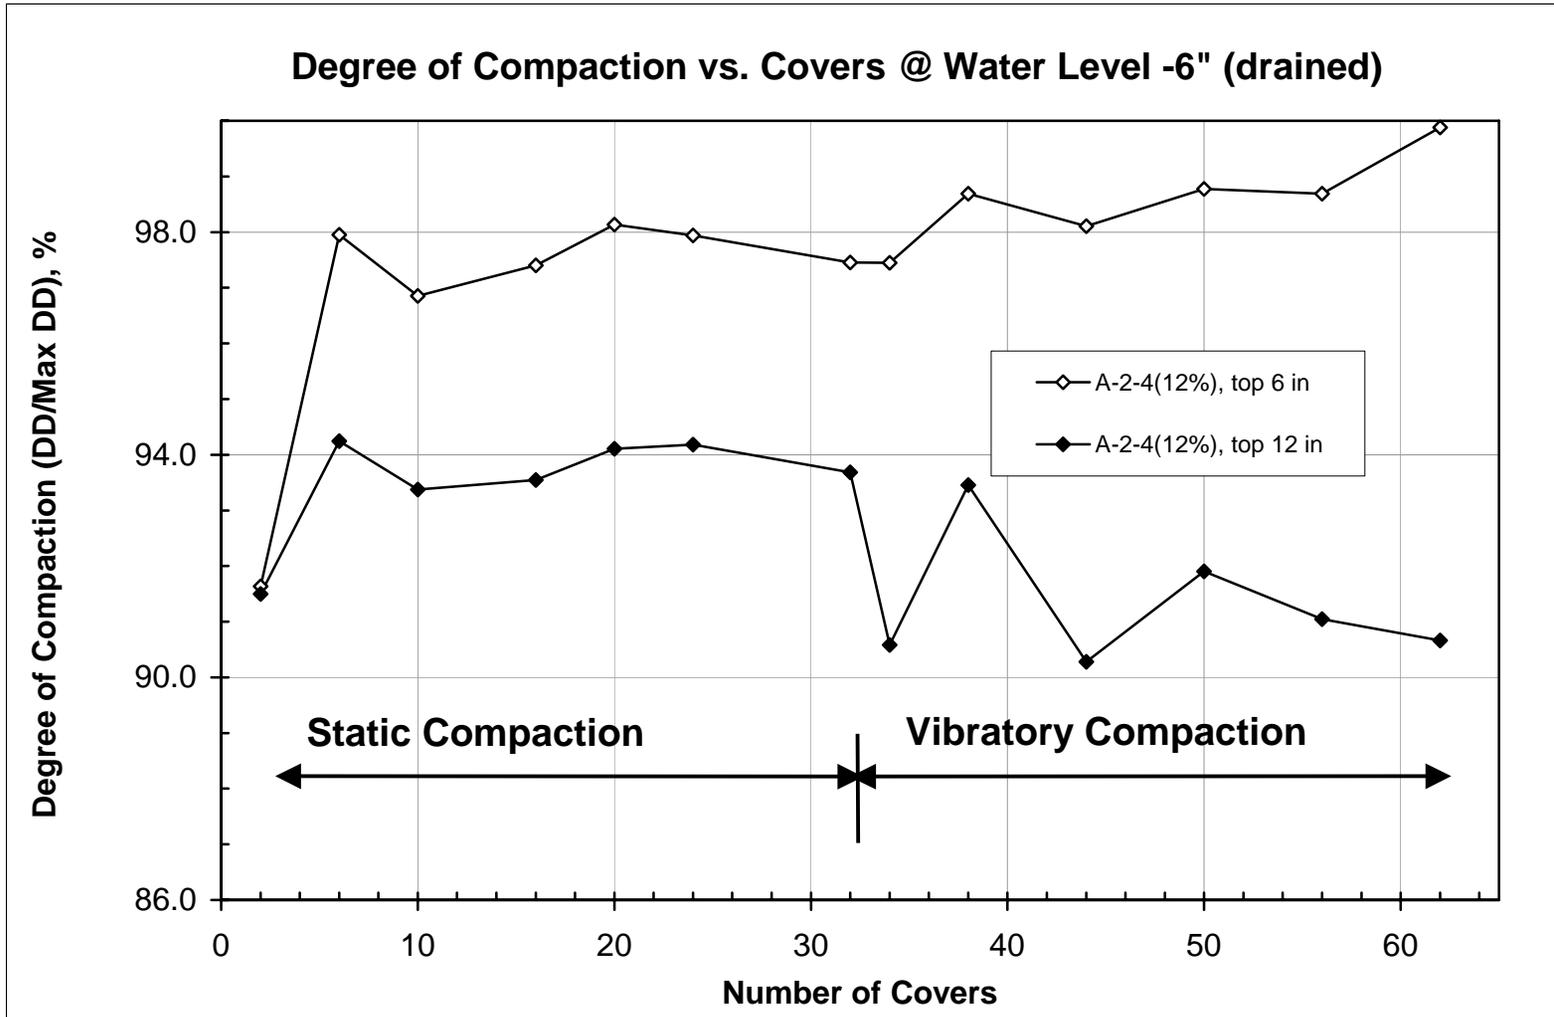
Figure 4.11(a) Comparison of Degree of Compaction for 6 in. and 12 in. Measurements (Condition 4, A-3 (5%) Embankment, A-2-4 (12%) Subgrade)

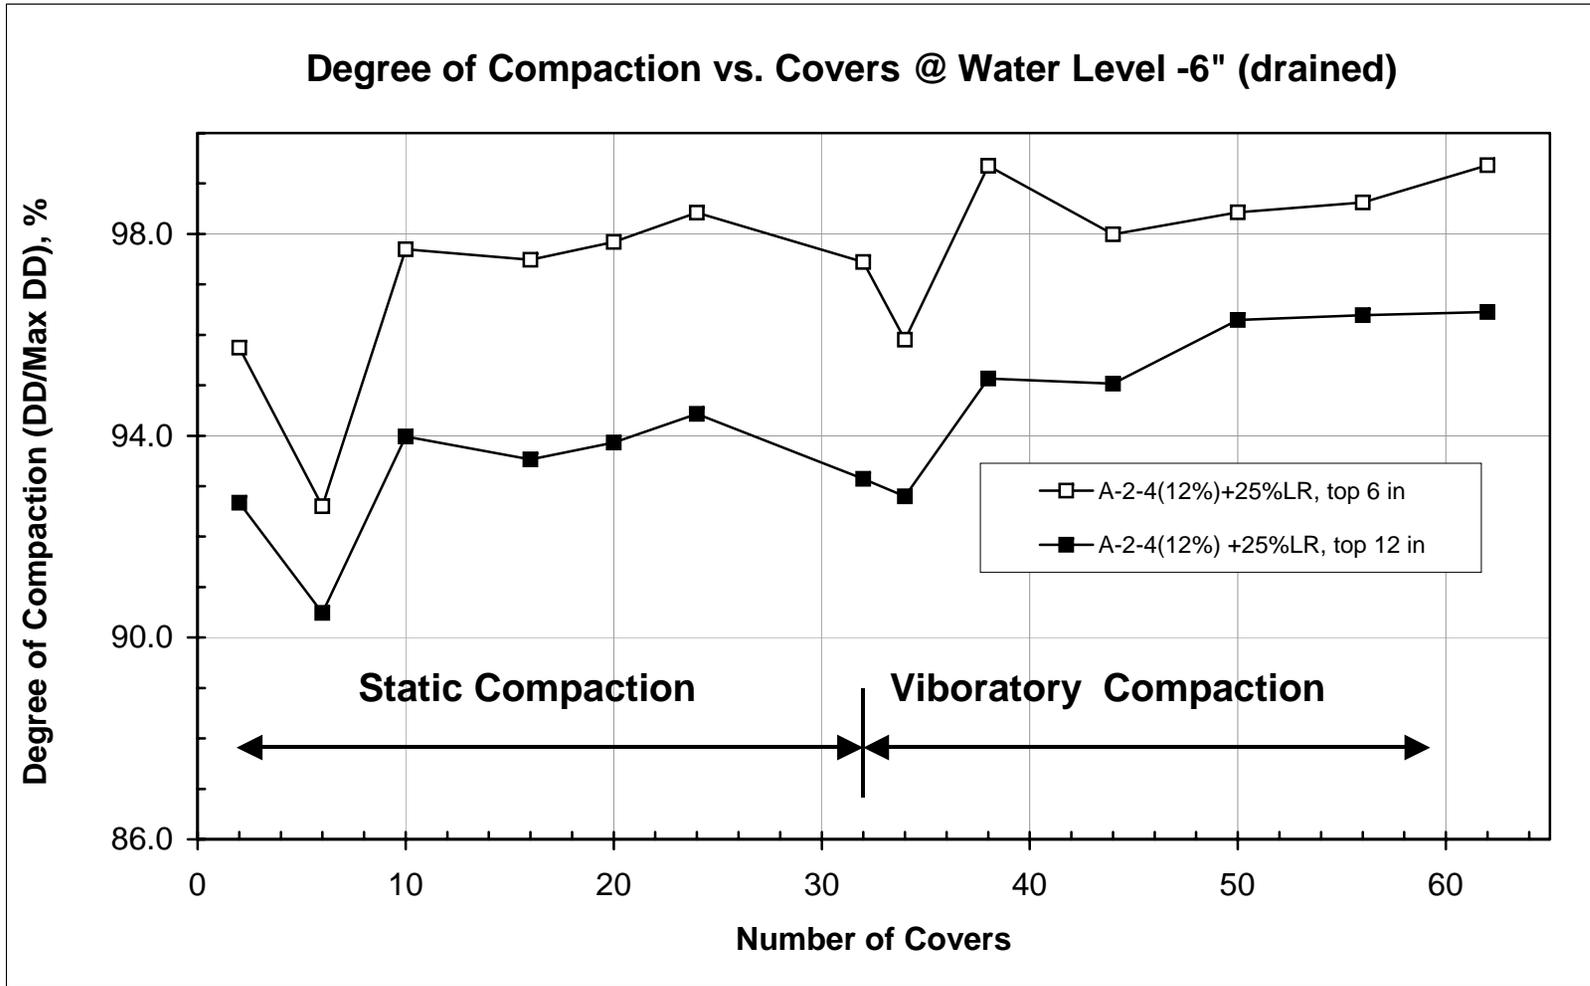
Figure 4.11(b) Comparison of Degree of Compaction for 6 inch and 12 inch Measurements (Condition 4, A-3 (5%) Embankment, A-2-4 (12%) + 25% limerock Subgrade)

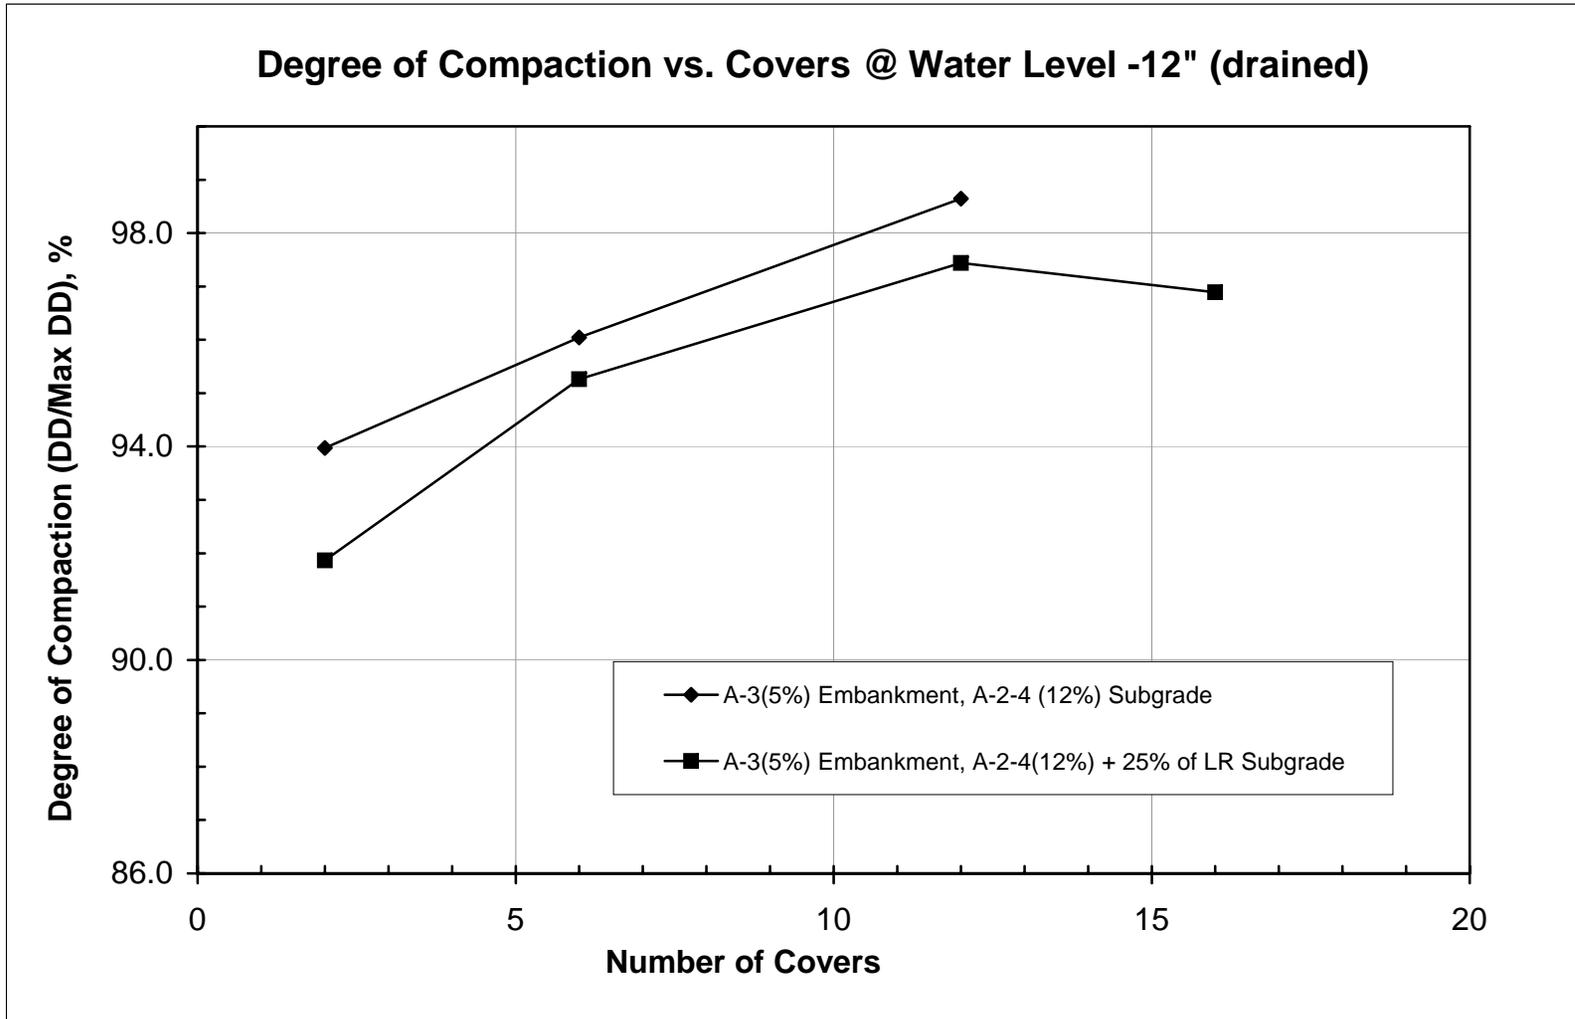
Figure 4.12 Degree of Compaction versus Number of Compaction Covers on Stabilized Subgrade for Water Level at -12 in. (drained) (Condition 5)

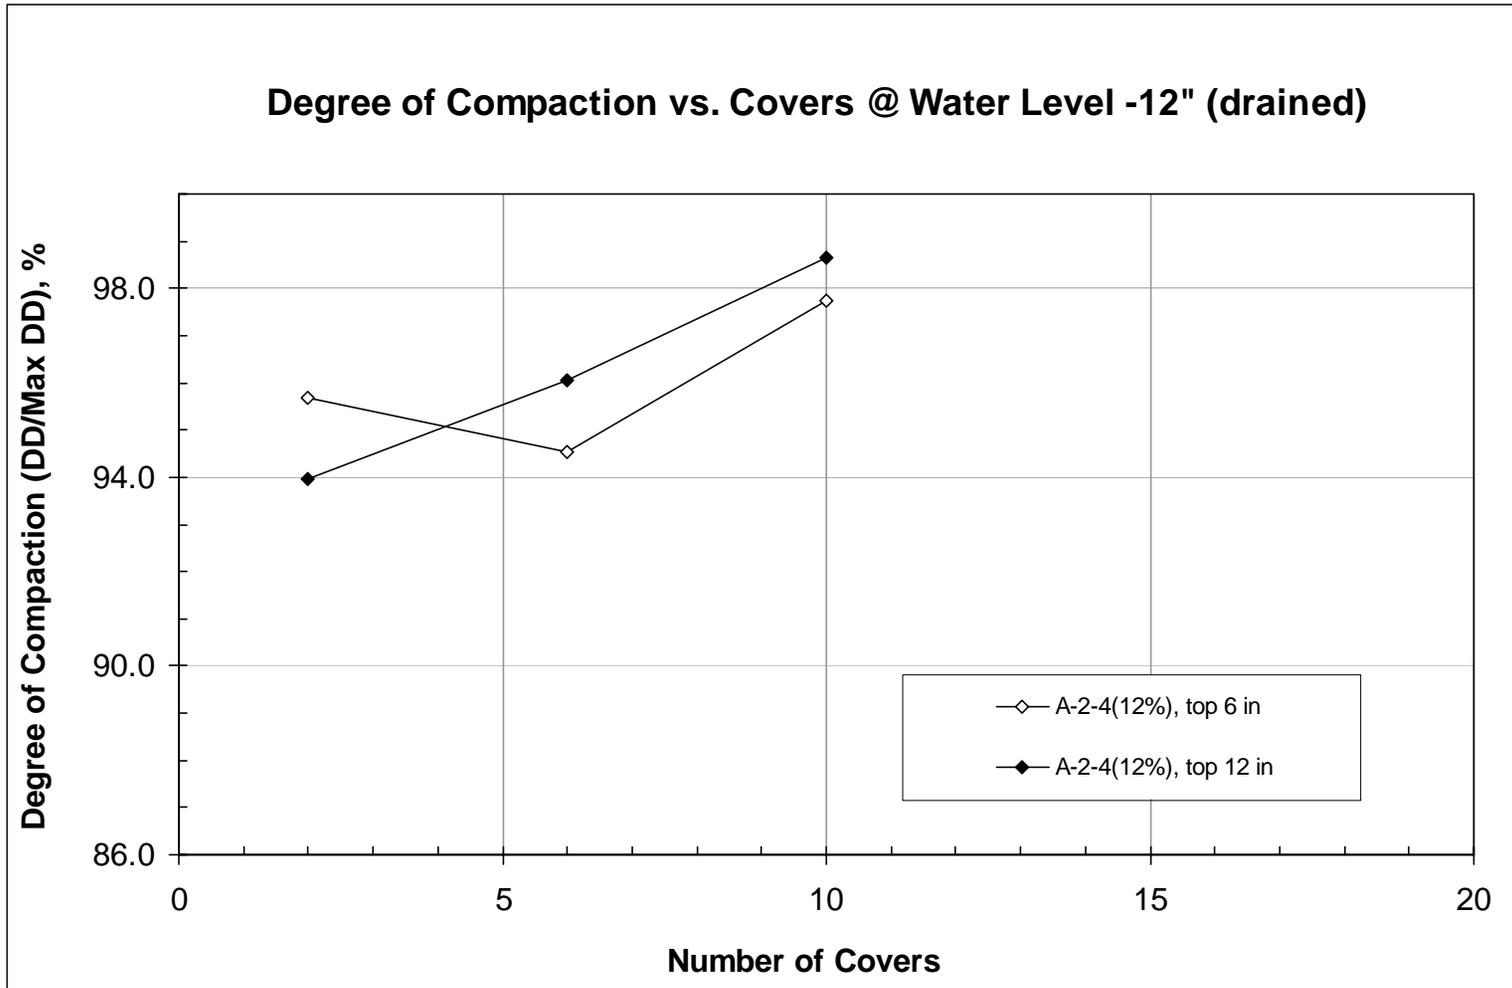
Figure 4.13(a) Comparison of Degree of Compaction for 6 in. and 12 in. Measurements (Condition 5, A-3 (5%) Embankment, A-2-4 (12%) Subgrade)

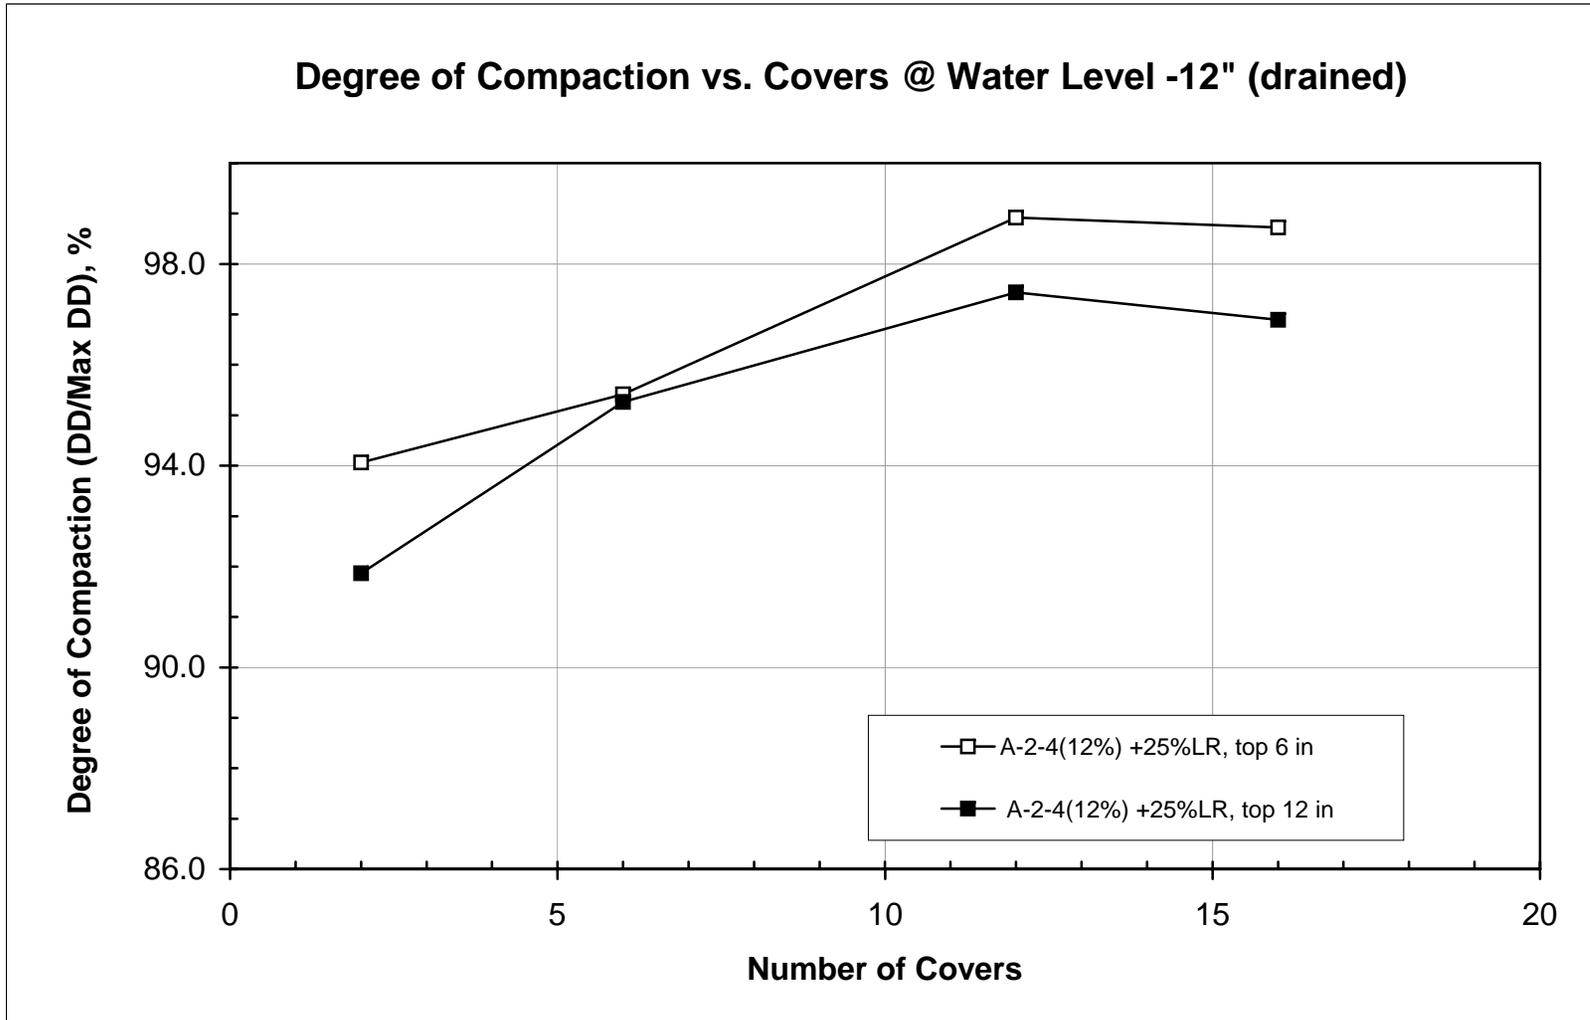
Figure 4.13(b) Comparison of Degree of Compaction for 6 inch and 12 inch Measurements (Condition 5, A-3 (5%) Embankment, A-2-4 (12%) + 25% limerock Subgrade)

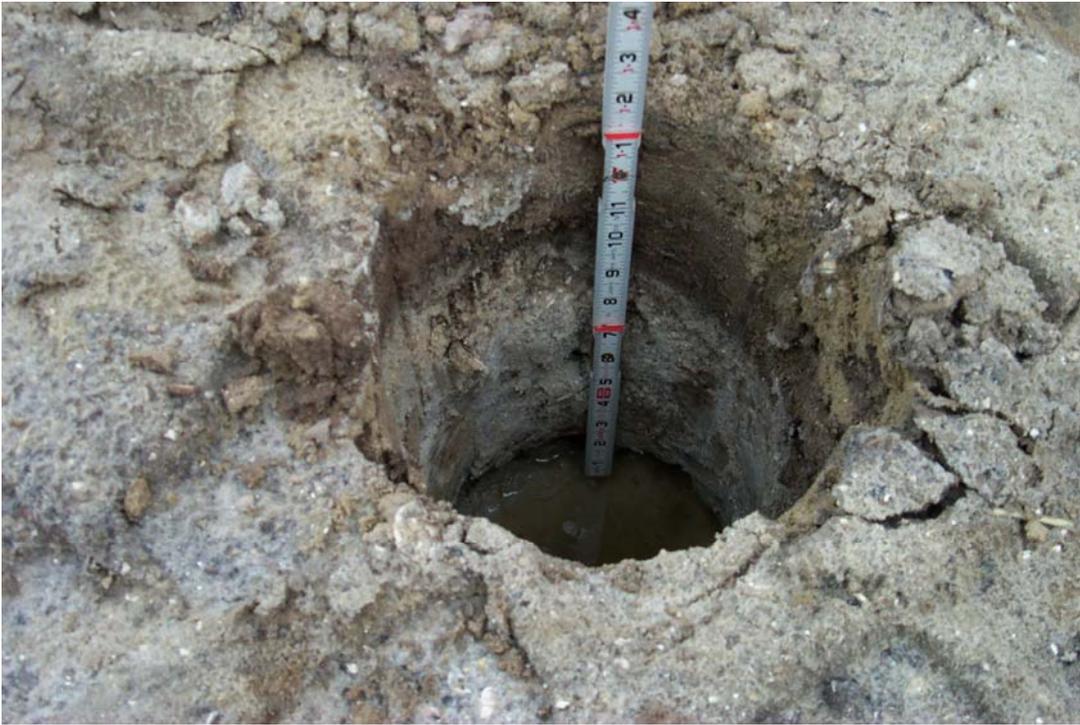
Figure 5.4 Measuring Ground Water Level at -12 in. below surface (Lake Worth Site)

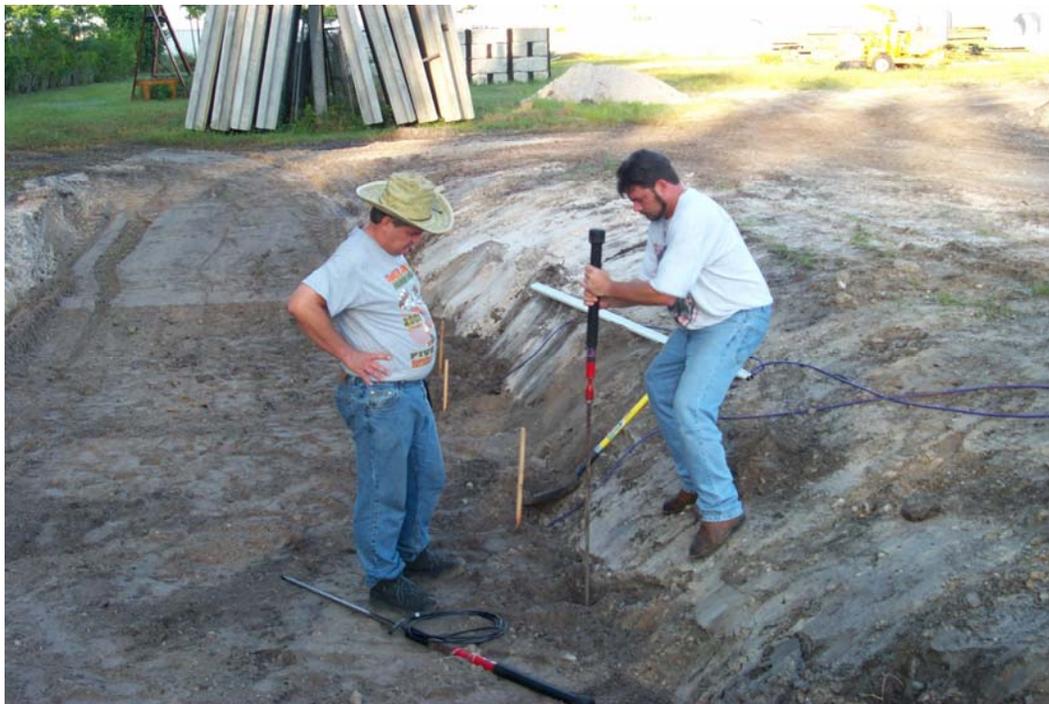
Figure 5.9(a) Installing the TDR Moisture Sensor (Lake Worth Site)

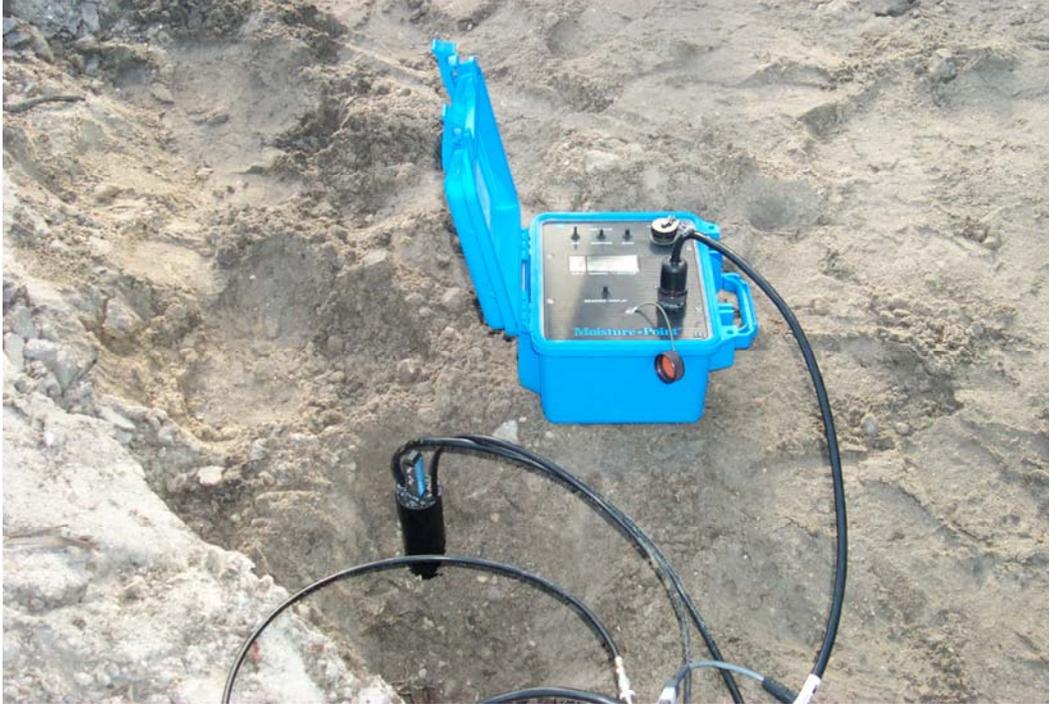
Figure 5.9 (b) TDR Moisture Measurement (Lake Worth Site)

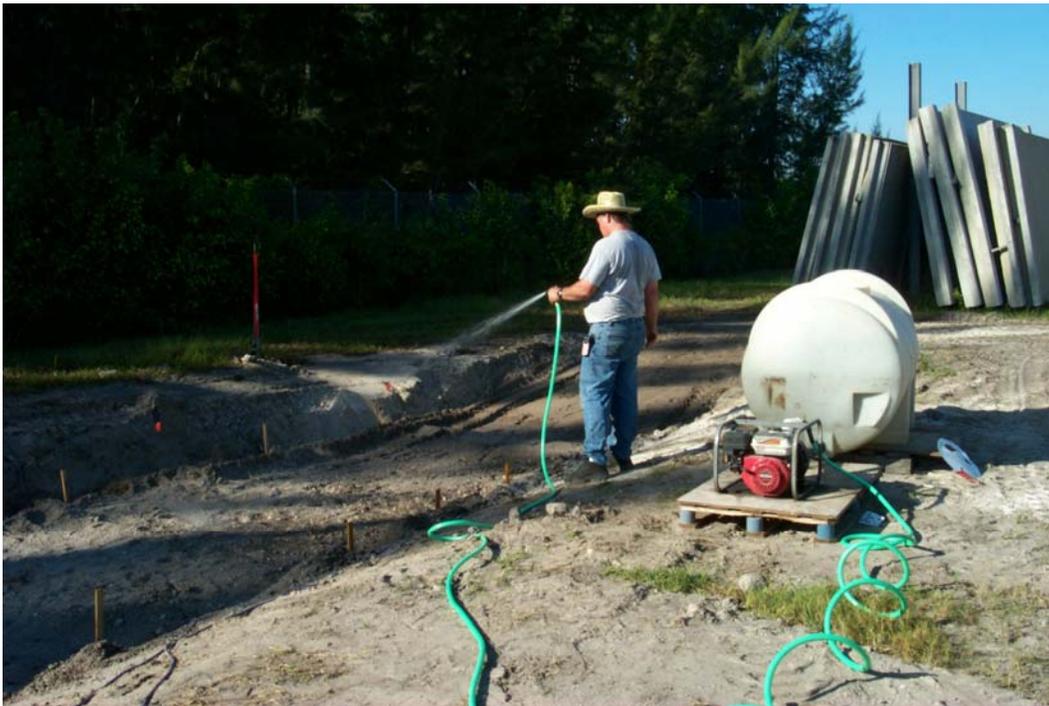
Figure 5.10 Adding Water to the Testing Soil Layer to Meet the Optimum Moisture Content (Lake Worth Site)

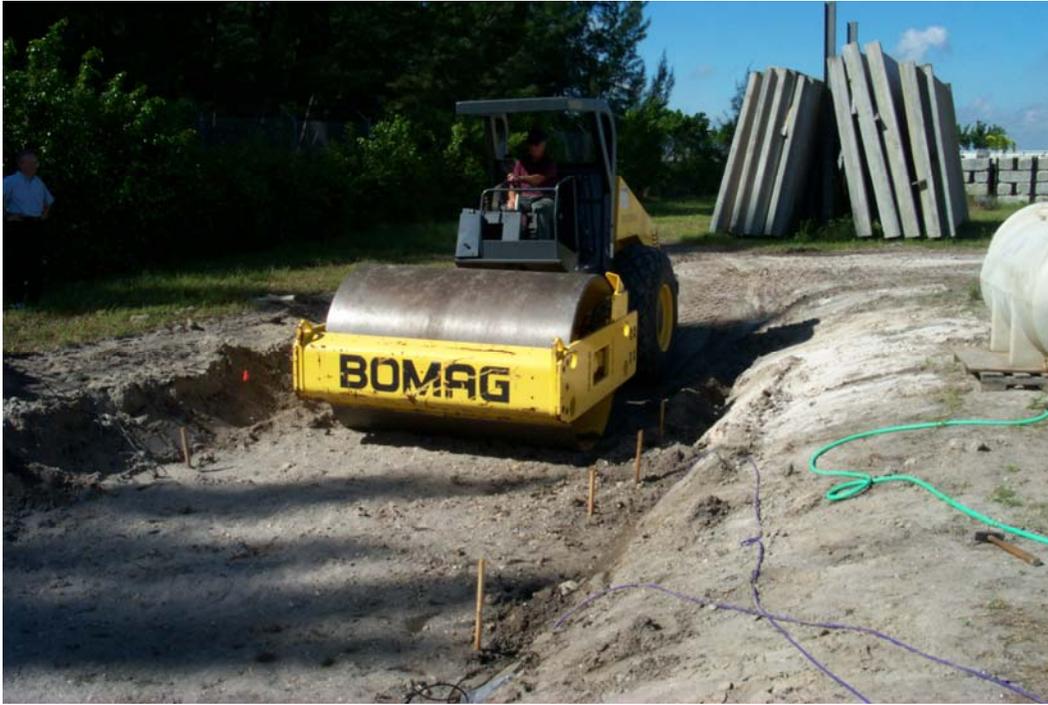
Figure 5.11 Starting Compaction with BOMAG Compactor (Lake Worth Site)

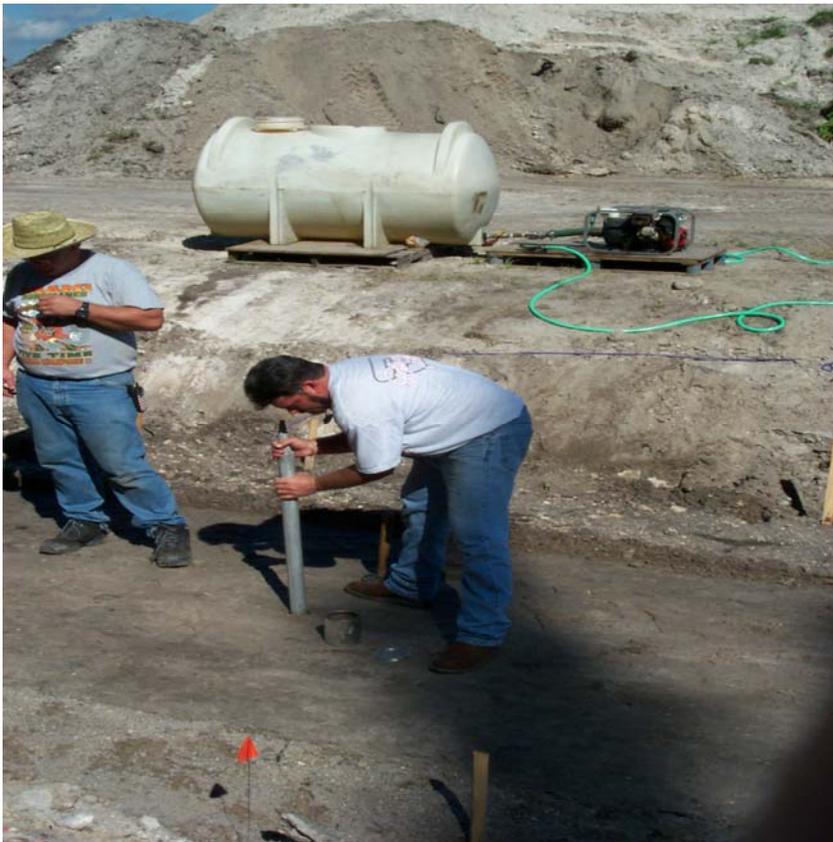
Figure 5.16 Sampling the Soil Moisture Content (Lake Worth Site)

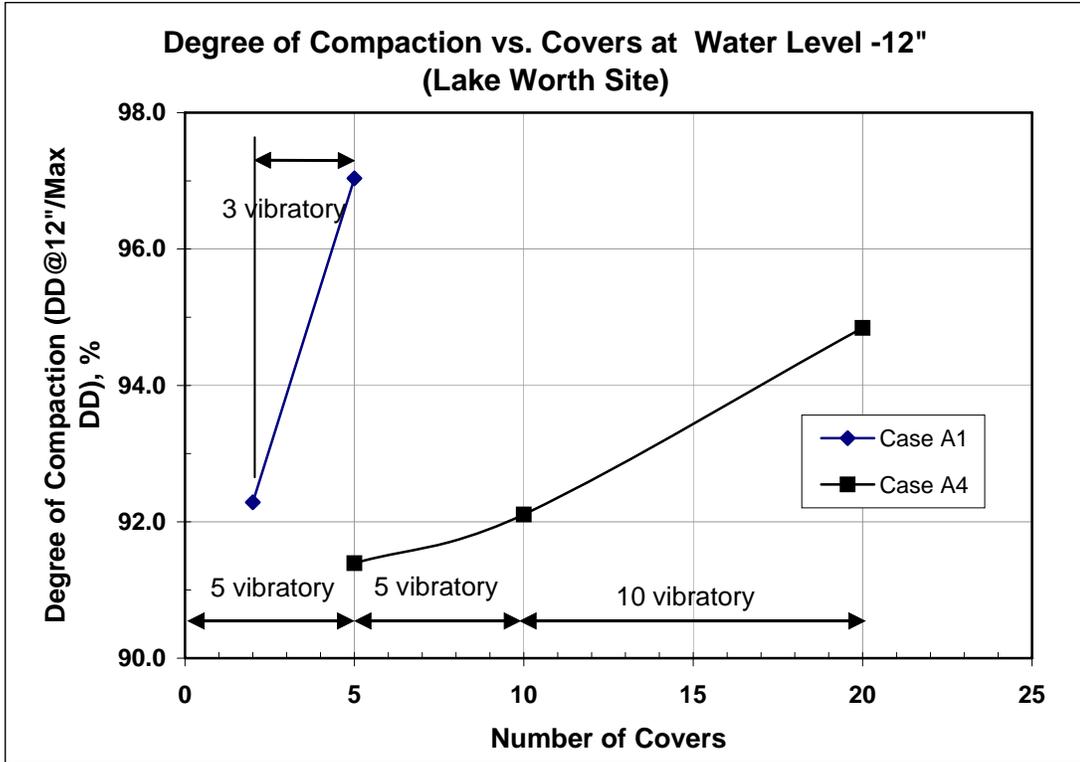
Figure 5.17 Degree of Compaction versus Number of Covers on Stabilized Subgrade for Water Level at -12 inches (Lake Worth Site)

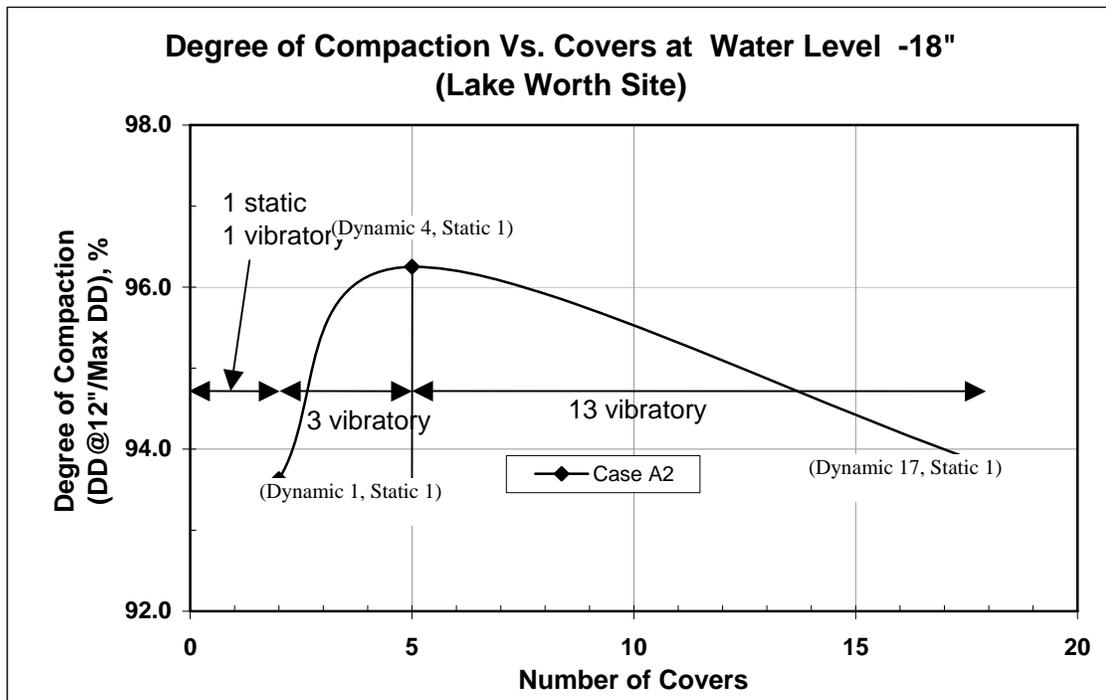
Figure 5.20 Degree of Compaction versus Number of Covers on Stabilized Subgrade for Water Level at -18 inches (Lake Worth Site)

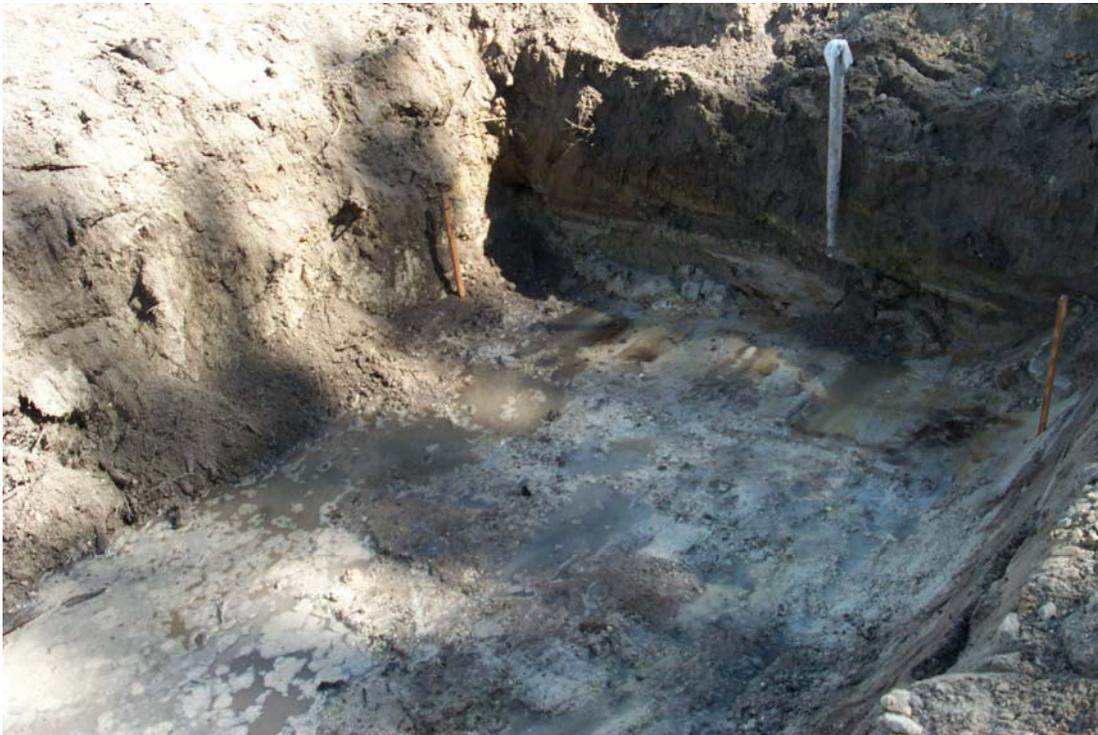
Figure 5.24 Digging to the Groundwater Level (Lake Worth Site)

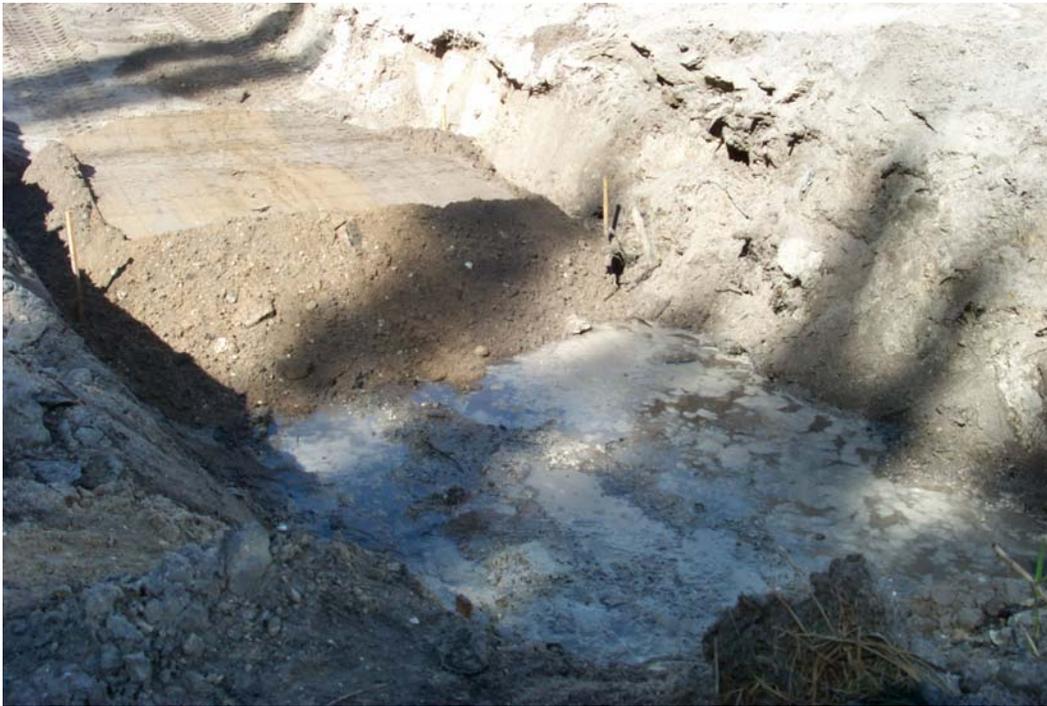
Figure 5.25 Placing Loose Material at 0" Groundwater Level (Lake Worth Site)

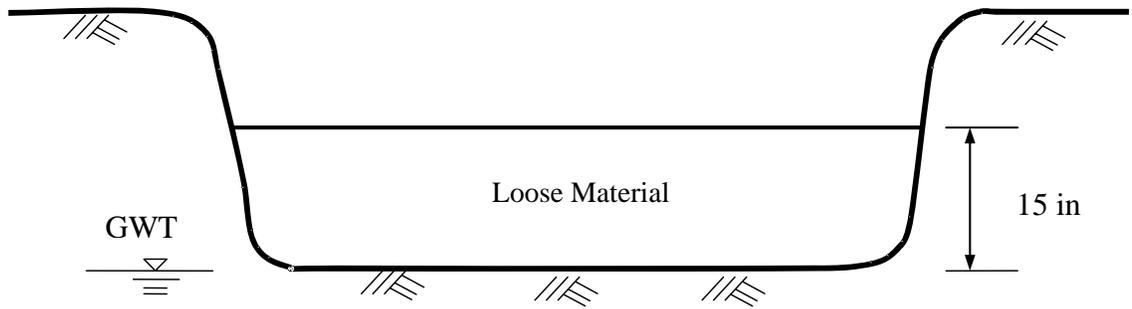
Figure 5.26 Schematic Site Plan for Compaction of Case A5 (Lake Worth Site)

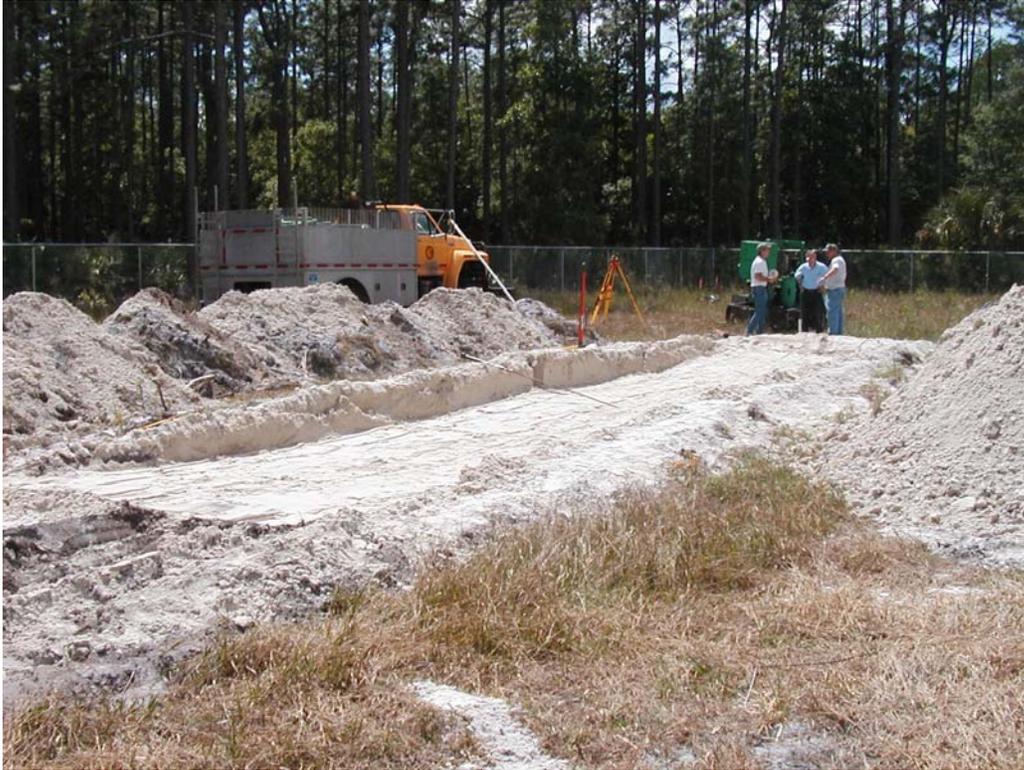
Figure 5.29 UCF Field Test Site (about 50 ft x 10 ft)

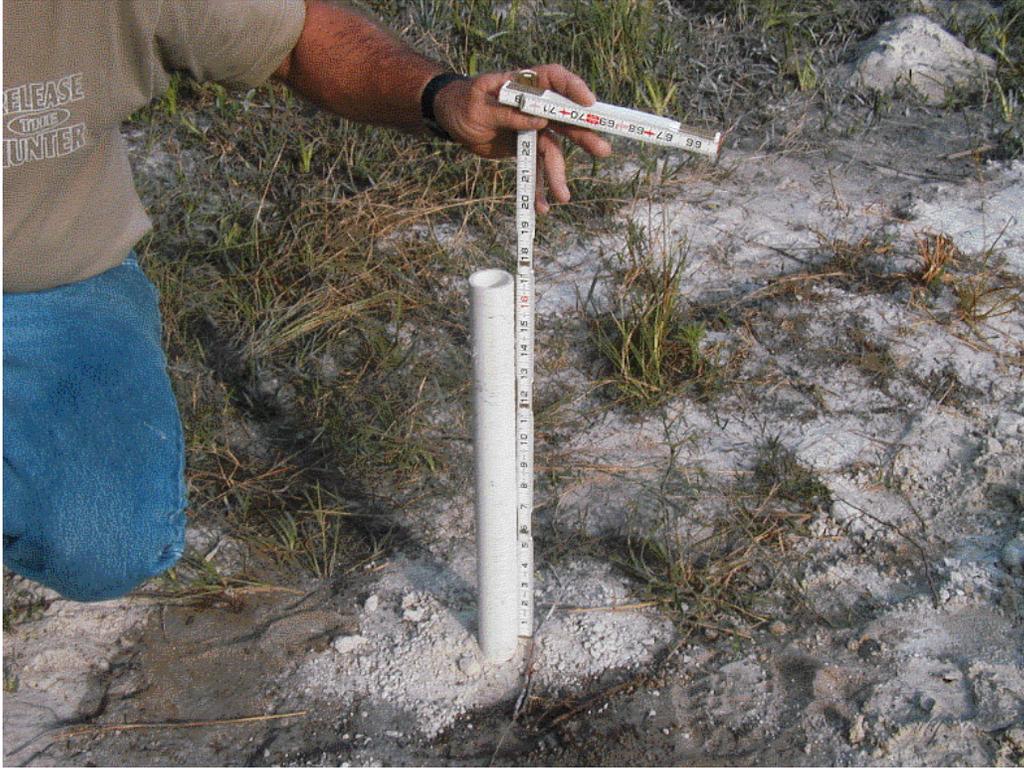
Figure 5.31 Dewatering Pipe to Control the Water Table Level (UCF Site)

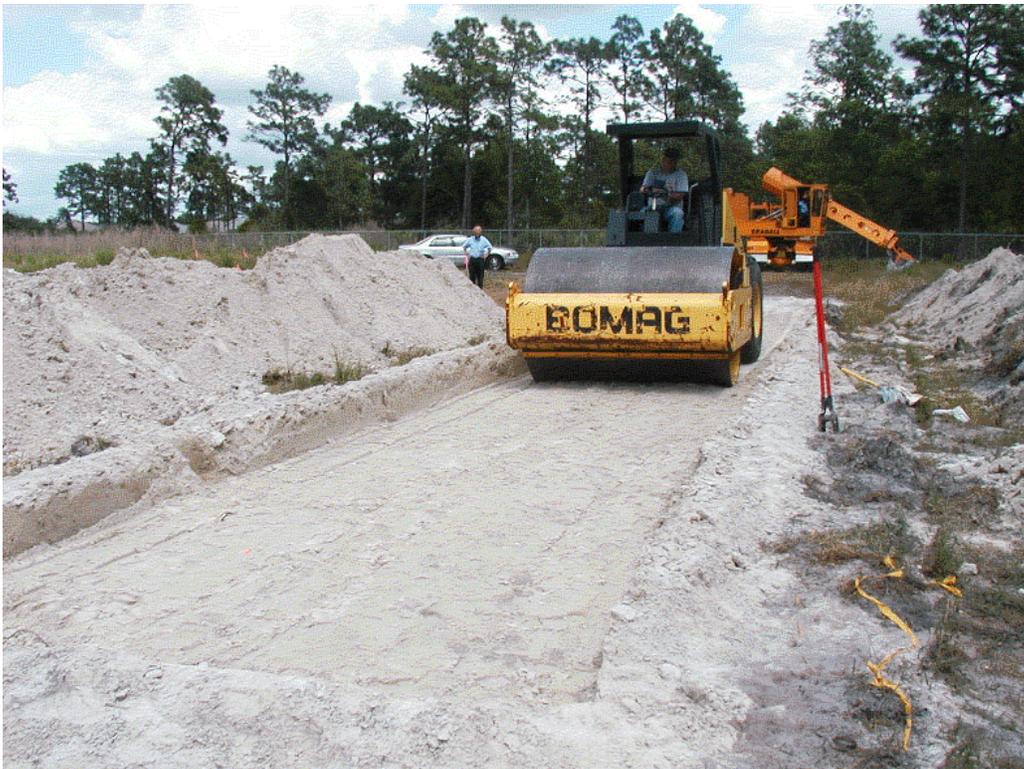
Figure 5.32 Static/Dynamic Drum Compactor (UCF Site)

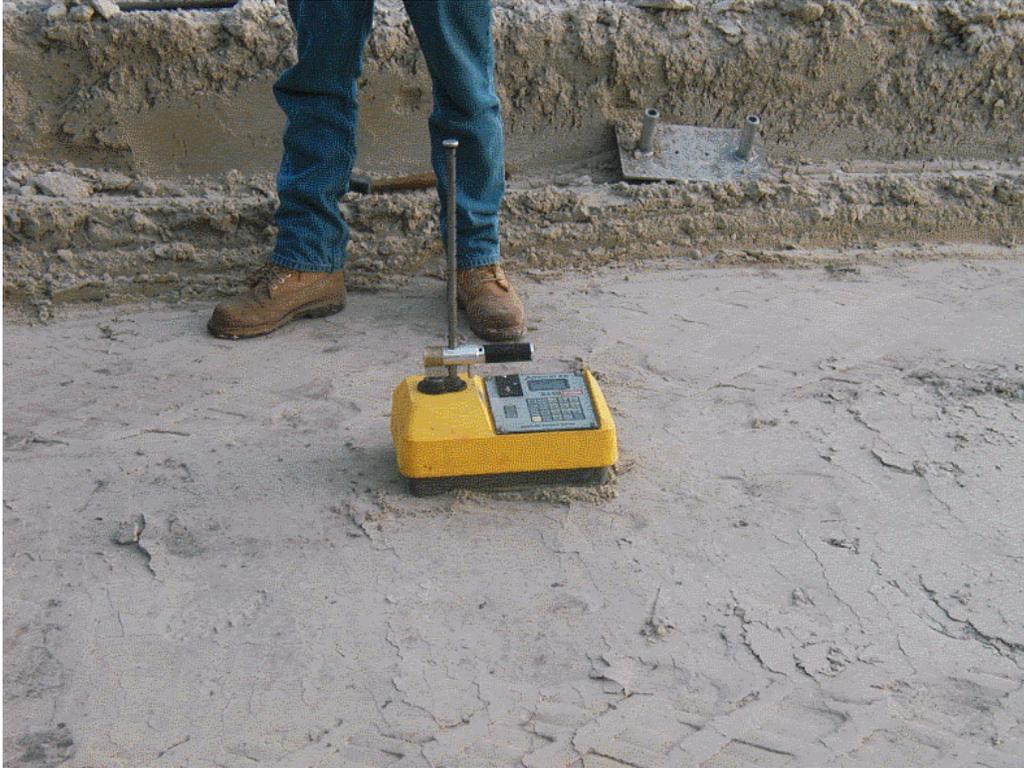
Figure 5.33 Nuclear Density Meter to Measure Soil Wet Density (UCF Site)
