FINAL REPORT

For the Florida Department of Transportation

**Constructability of Stabilized Subgrade Layer
Under High Groundwater Table**

FDOT Research Contract No.: BC-352-7

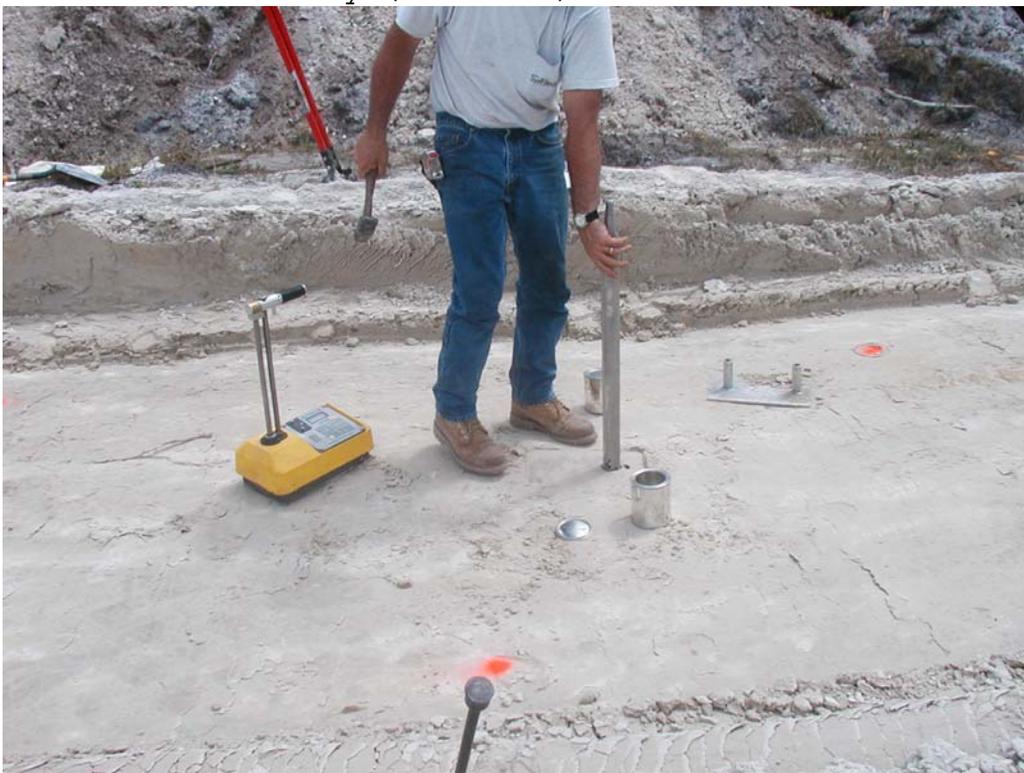
Figure 5.34 Taking Soil Sample for Measuring Speedy and Oven Moisture Content (UCF Site)

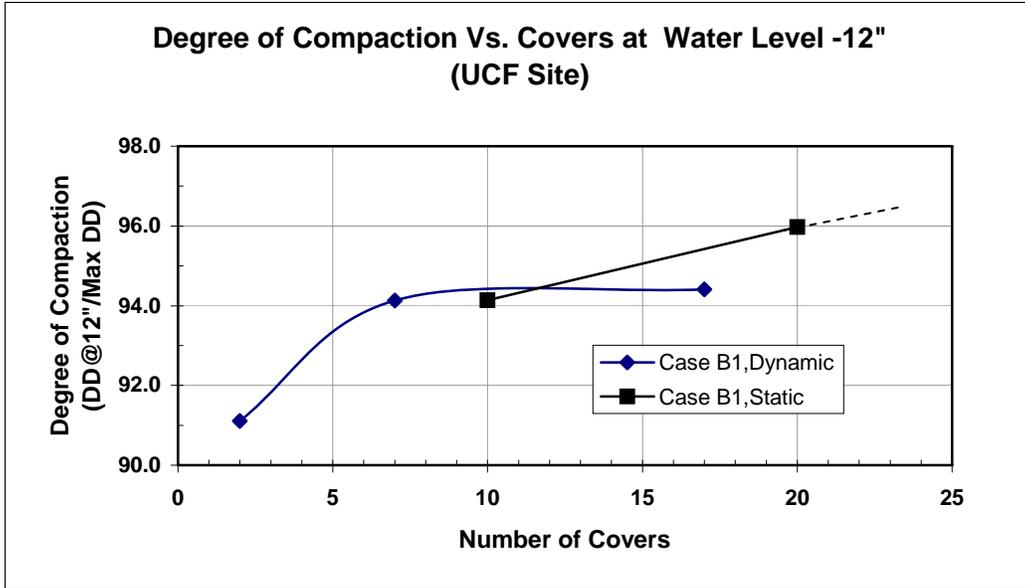
Figure 5.35 Degree of Compaction versus Number of Covers on Stabilized Subgrade for Water Level at -12 inches (UCF Site)

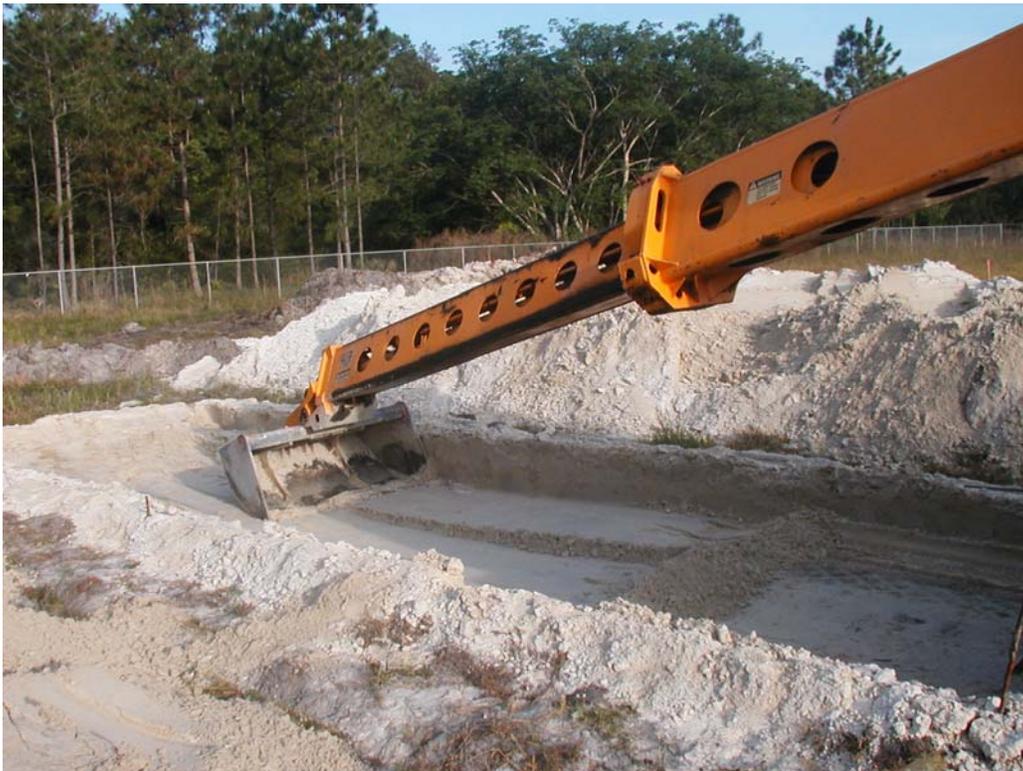
Figure 5.36 Equipment Used to Dig Out and Dump Soil (UCF Site)
