**CORROSION OF  
POST-TENSIONING STRANDS**

**Contract No. BC353 RPWO#33  
Final Report to Florida Department of Transportation**

**A. A. Sagüés  
Principal Investigator  
Department of Civil and Environmental Engineering**

University of South Florida  
Tampa, FL, 33620  
November 1, 2005

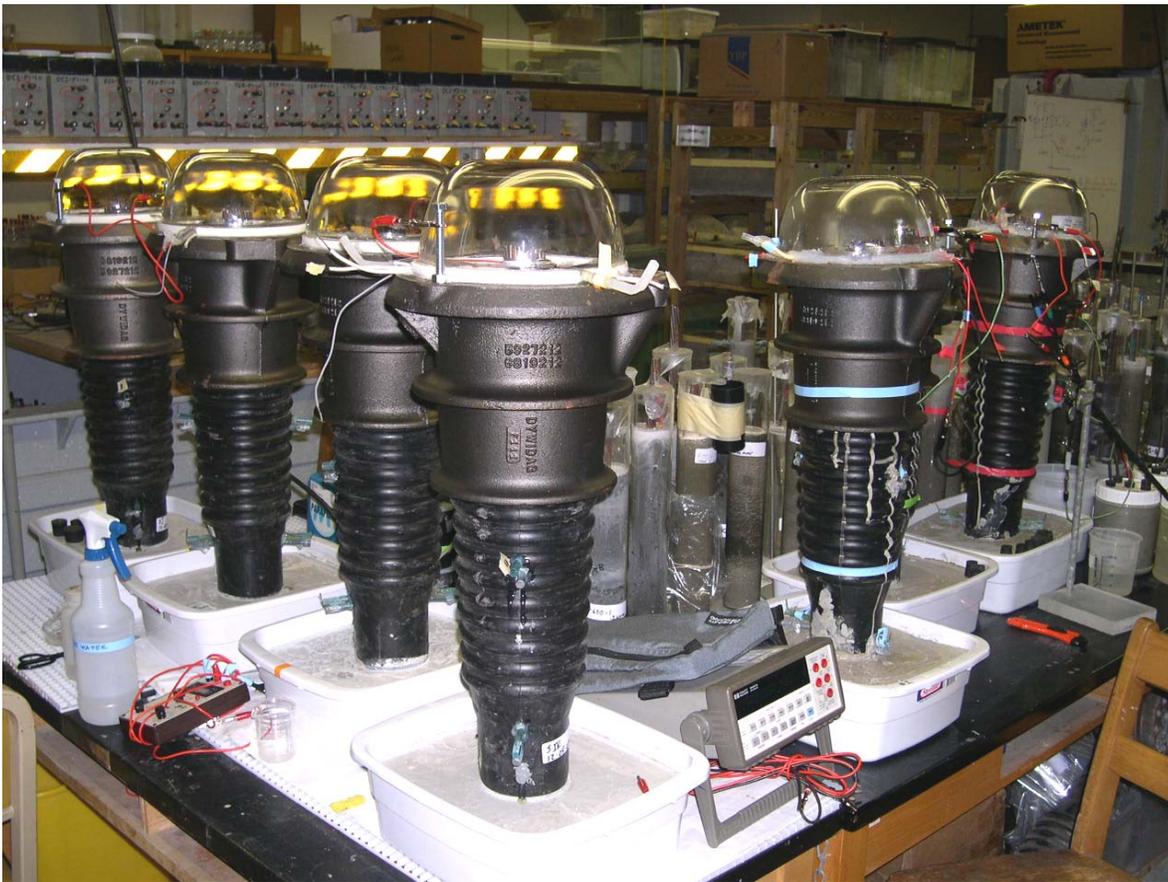
Figure 3b. Anchor test assemblies.

Two series of similarly configured mock-up PT anchorage assemblies (7 total) were constructed using actual anchorage bodies and PT strand. Figures 3a and 3b and Tables 1 to 3 detail configuration details and other system properties.. Series P (assemblies P1 to P3) used a plain cement grout with addition of a commercial, aluminum based expansion agent similar to the grout identified as PN in the next section " Grout Properties and Steel Polarization". This grout represented materials used in earlier construction practice which were found to cause bleed water voids. Series S (S1 to S4) used a new-generation commercial low-bleed grout representative of materials used at present (this grout is from a different batch but otherwise the same product as that designated "A" in the next Section. Unless otherwise indicated the grouts were prepared using de-ionized water and mixed in 5 gallon buckets using a "Jiffy" paddle at ~2500 rpm per procedure suggested by the commercial grout manufacturer and described in more detail in the next subsection. The three Series P assemblies were fastened together on a FMC Syntron VP86C1™ vibrating table operated at its lowest power setting continuously for four hours after casting the grout, simulating vibration that may be encountered in field operations and that may induce bleed water formation. In these assemblies the grout expanded ~5 cm near the top of the assembly and resulted in a ~1.5 cm deep bleed water accumulation on the upper surface that was absorbed/evaporated during the next 2 to 10 days after casting (Table 3). Prior tests showed that no significant bleed water accumulation developed on the A grout upon vibration, so the S-assemblies were not vibrated and, as expected, showed no visible bleed water accumulation.

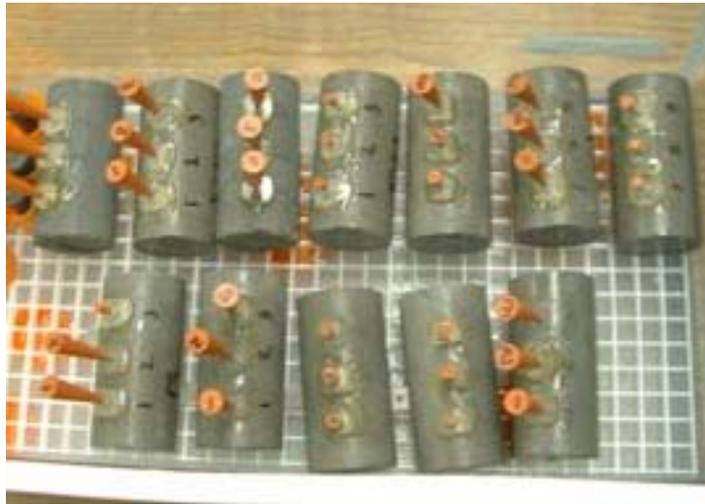
Figure 5d. ISL test specimens in 100% RH chamber for determination of pore water pH.
