## **USE OF FRP FOR CORROSION MITIGATION APPLICATIONS IN A MARINE ENVIRONMENT**

*Gray Mullins, Ph.D., P.E. and Rajan Sen, Ph.D., P.E.*

OCTOBER 2005

| 16. Abstract<br><br>This report presents results of laboratory and field studies to evaluate the role of fiber reinforced polymers in repairing corrosion damaged piles in a marine environment. Both CFRP and GFRP were evaluated in laboratory testing and in field demonstration studies using instrumented piles.<br><br>The focal point of the laboratory study was to determine whether a FRP wrap reduced corrosion in prestressed specimens when the chloride threshold level was exceeded. Results from exposure tests under ambient and accelerated conditions convincingly showed that the FRP was effective in slowing down the corrosion rate. In both exposures, identical wrapped and unwrapped specimens were subjected to simulated tidal cycles under ambient or nominal 140F temperature. For ambient exposure, the reduction in strand weight loss in newly fabricated CFRP and GFRP wrapped specimens was only 50% that in unwrapped controls. In the hot water exposure the increase in strand metal loss in unwrapped specimens initially pre-corroded to a targ

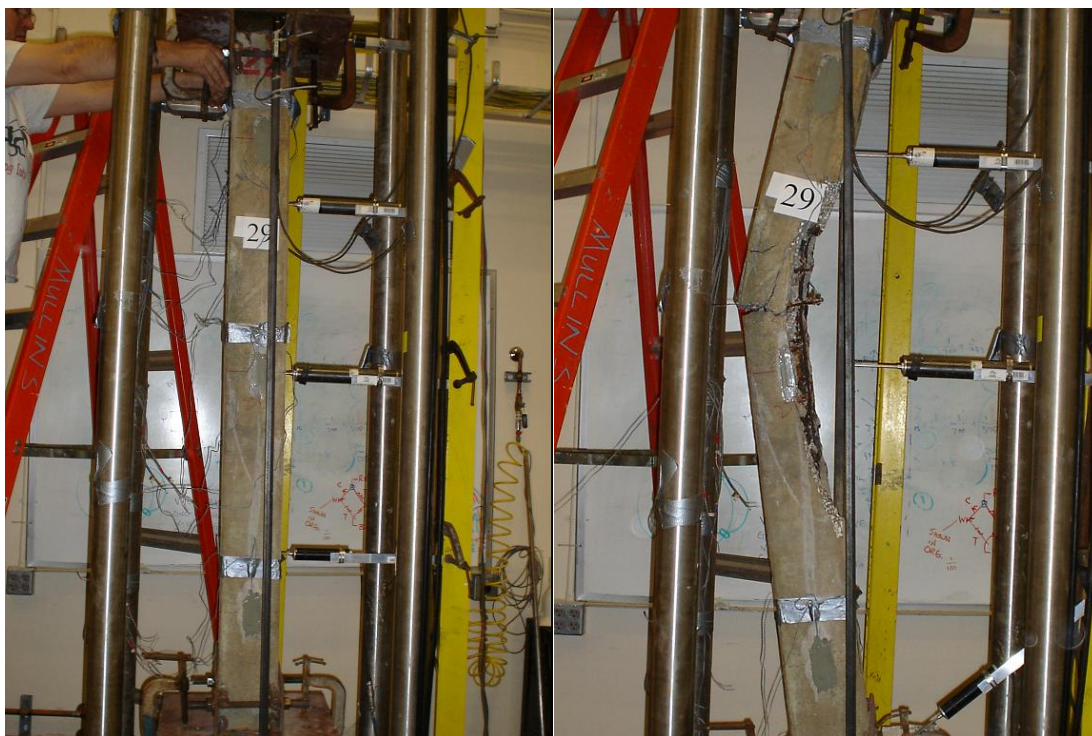
**Figure 7.23** Failure of Unwrapped Control #29

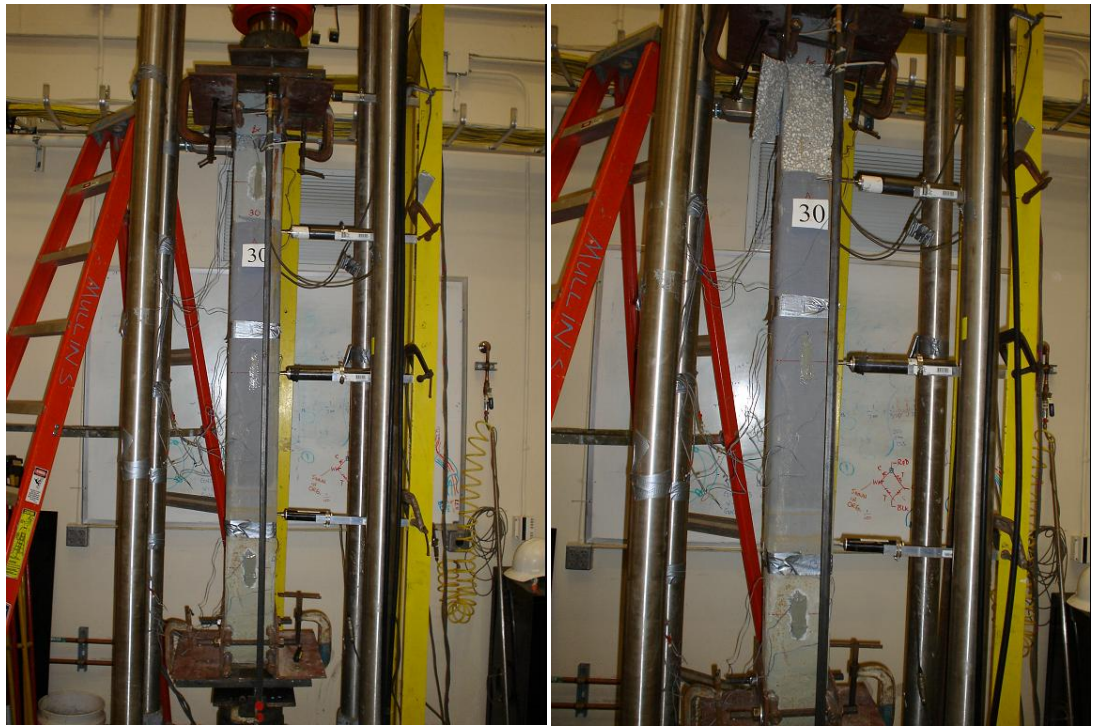
**Figure 7.25** Failure of Specimen #30 (Full Repair, 36 in Wrapped, Sealed)

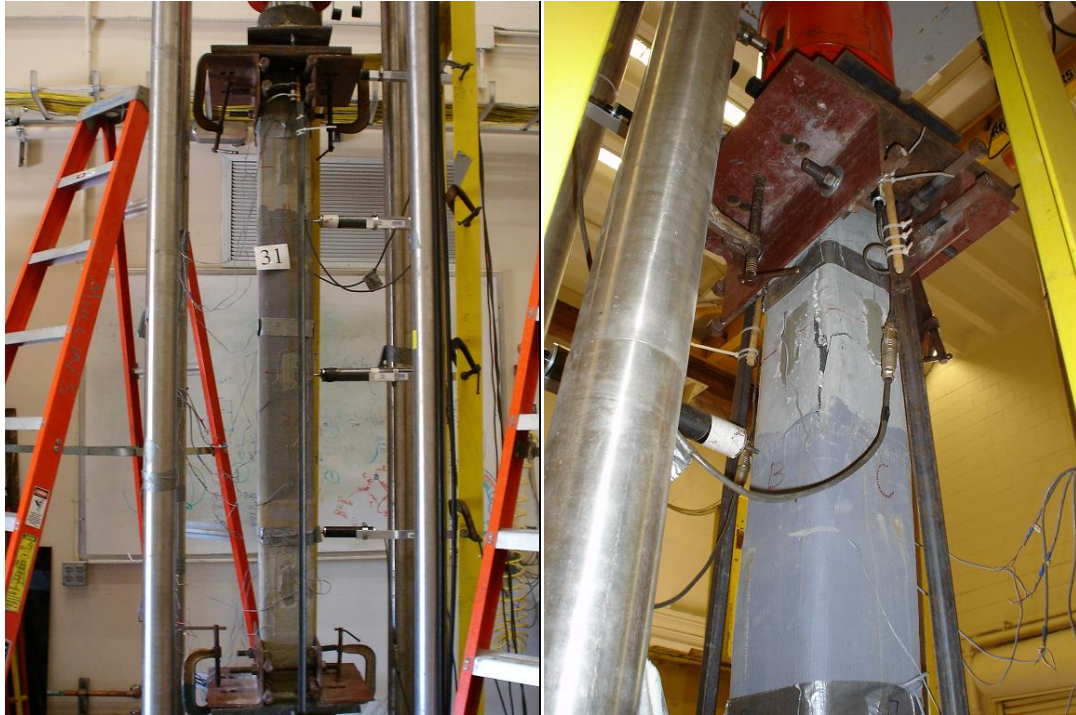
**Figure 7.26** Failure of Specimen #31 (Full Repair, 36 in. Wrapped, Sealed)

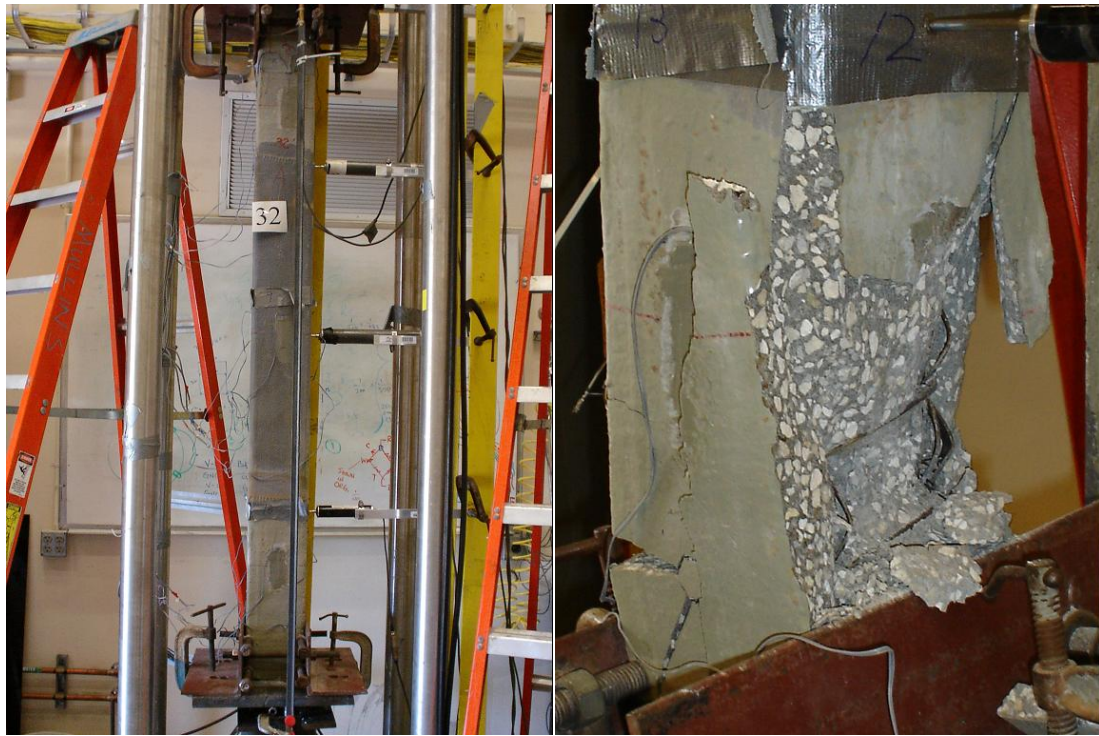
**Figure 7.28** Failure of #32 Specimen (Minimal Repair, 36 in Wrap, Seal)

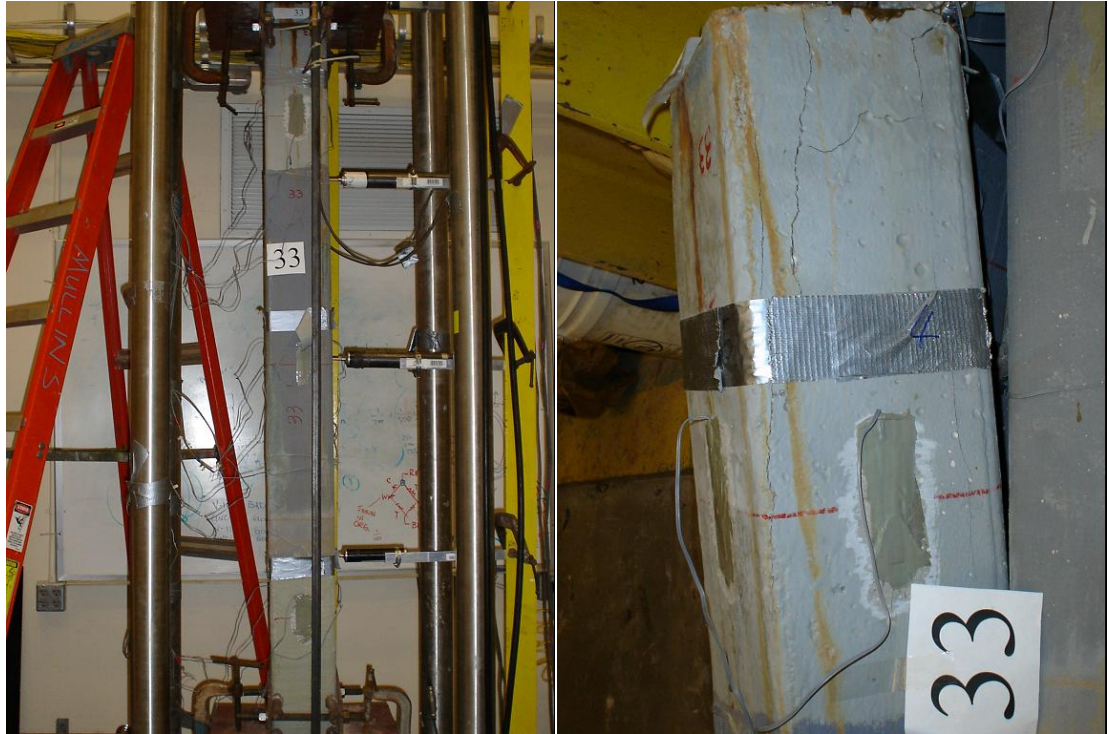
**Figure 7.29** Failure of #33 Specimen (Minimal Repair, 36 in Wrap, Seal)

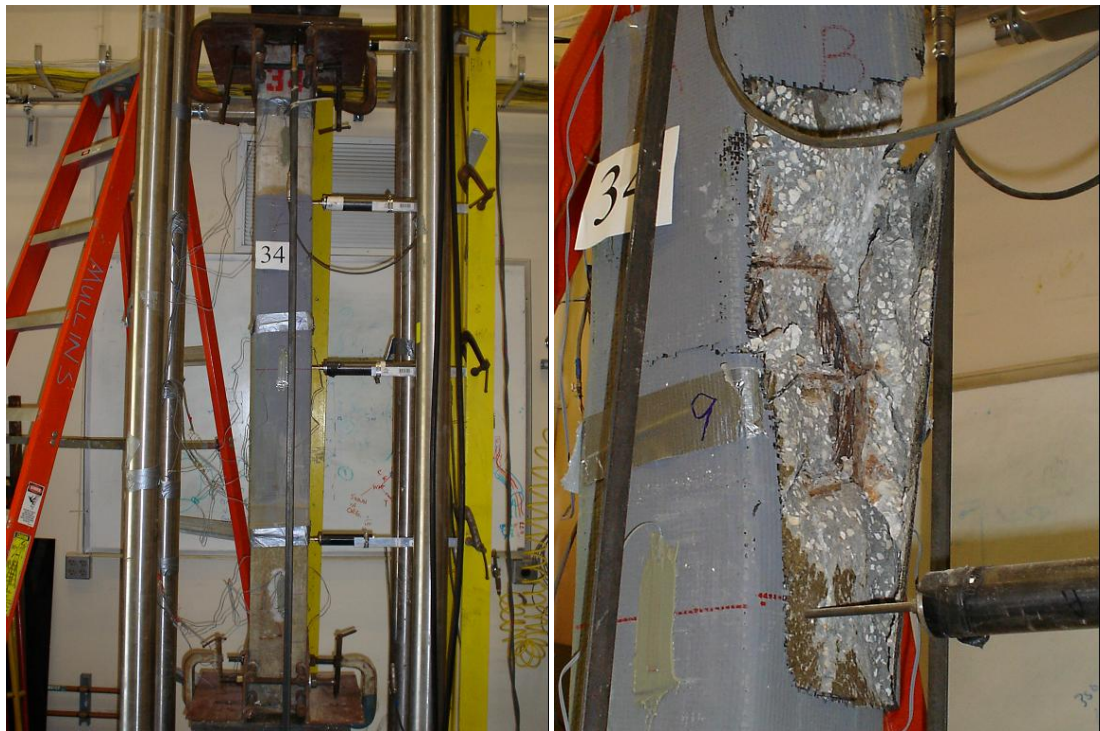
**Figure 7.30** Failure of #34 Specimen (Minimal Repair, 36 in Wrap, Unseal)

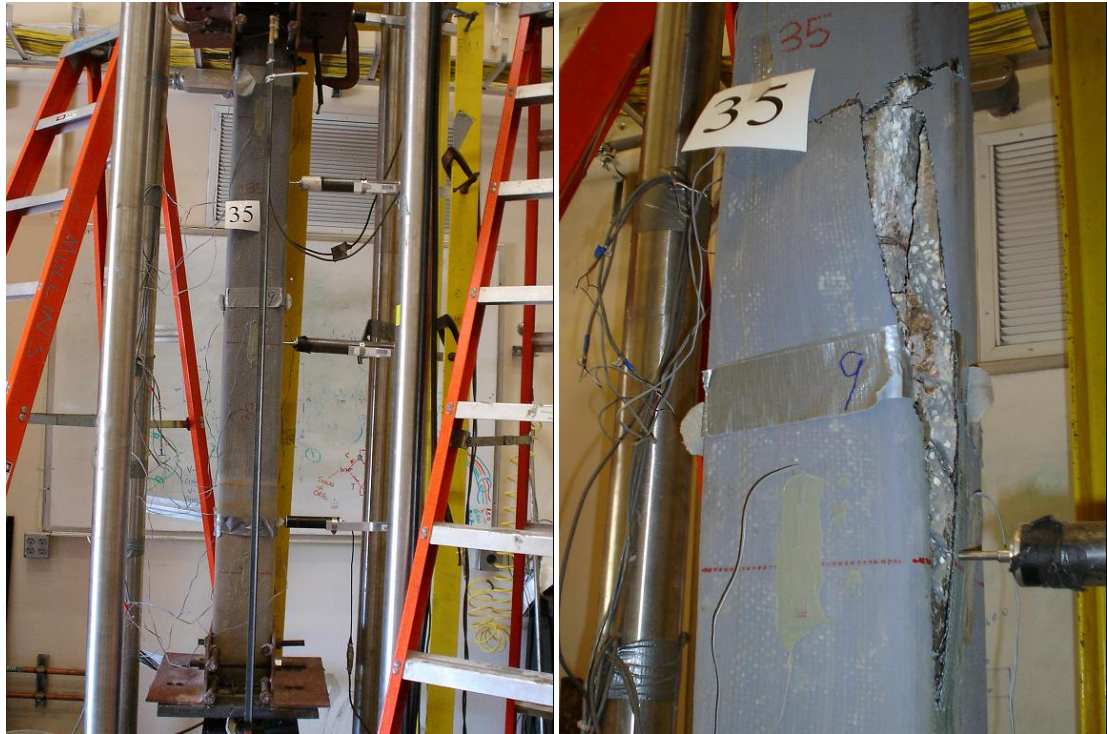
**Figure 7.32** Failure of #35 Specimen (Minimal Repair, 72 in Wrap, Seal)

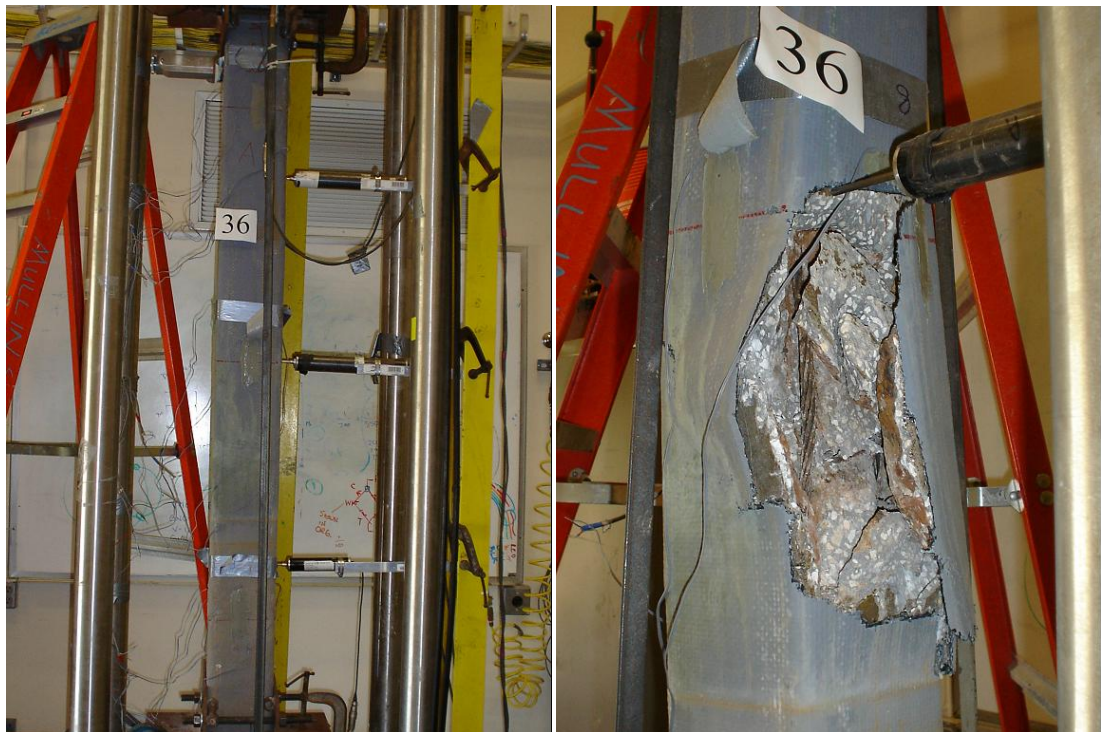
**Figure 7.33** Failure of #36 Specimen (Minimal Repair, 72 in Wrap, Seal)

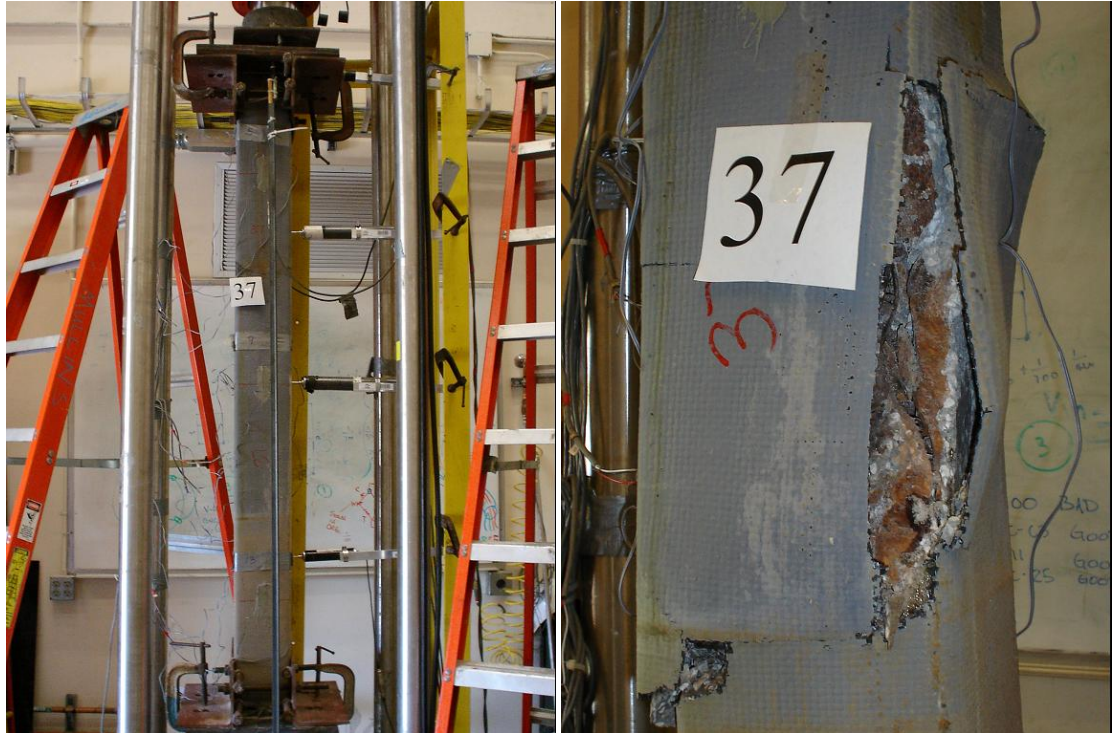
**Figure 7.34** Failure of #37 Specimen (Minimal Repair, 72 in Wrap, Unseal)

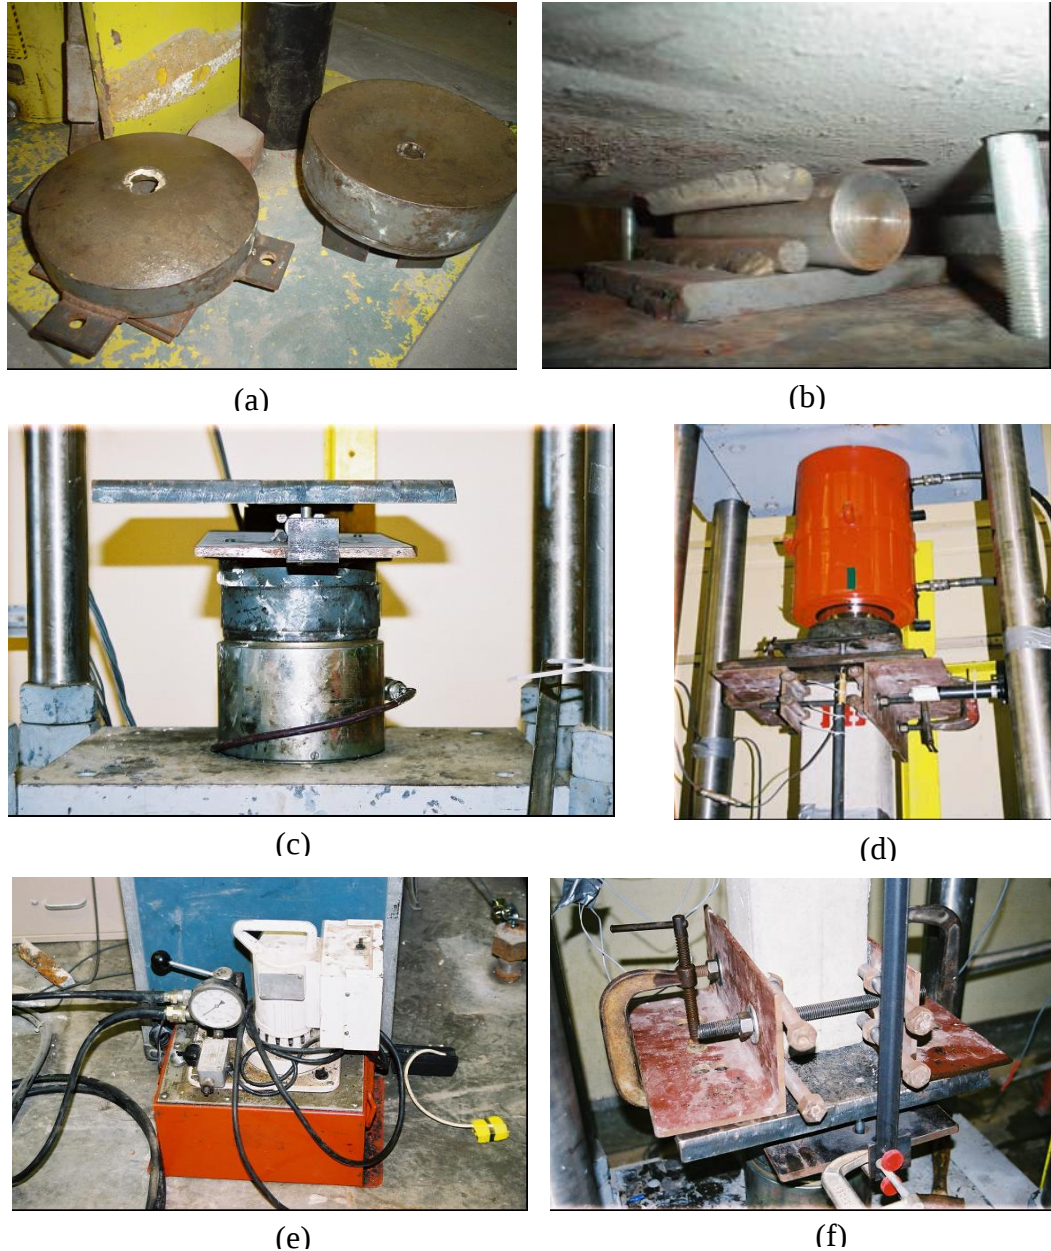
**Figure 8.14** (a) Steel Swivel; (b) Roller Assembly; (c) Roller-Swivel Assembly; (d) Hydraulic Cylinder; (e) Hydraulic Jack; (f) Setting up at the Bottom

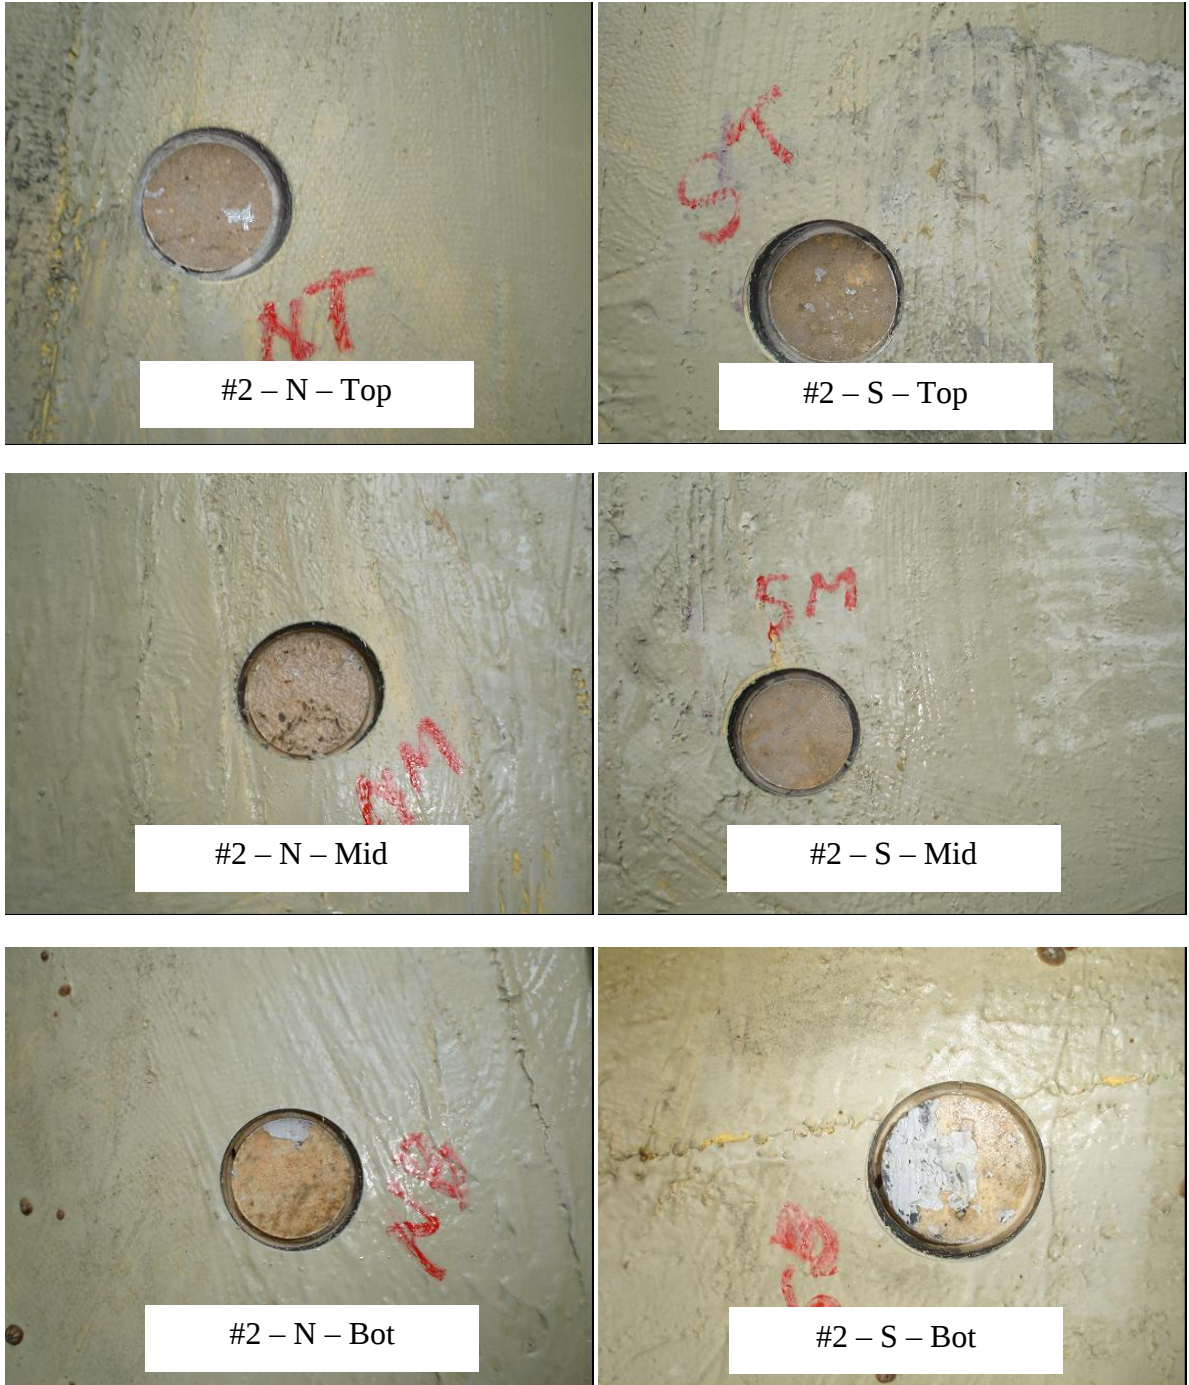
**Figure 10.28** Bond Test on Pile2 (all epoxy failure)
