FINAL REPORT

**Contract Number BC-354**

## FINAL REPORT

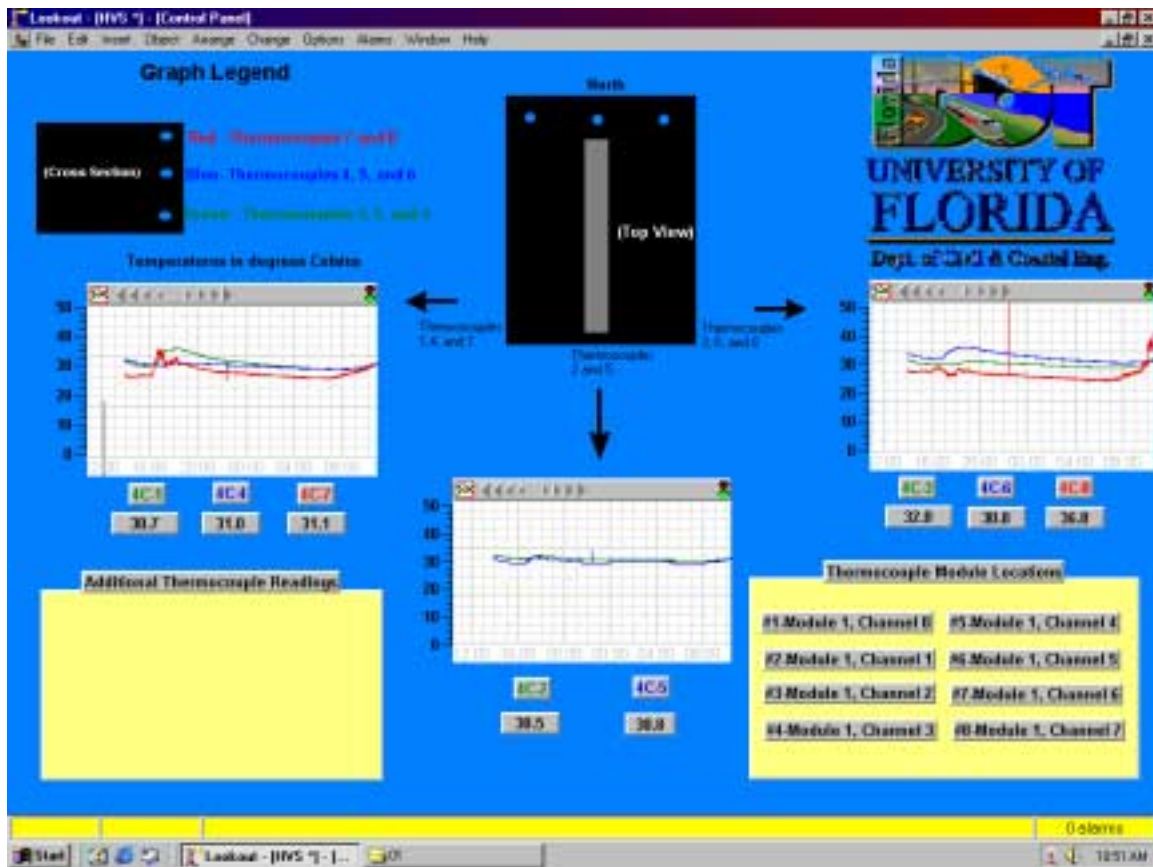
Fig. 3- Panel Display

Because of the hardware changes made to the Fieldpoint modules, adjustments to the Lookout software were also necessary. These consisted of changing the addresses referenced by the various displays within the Lookout panel. Aliases were created for each thermocouple, specifically Thermo 1 – 7. Displays on the display panel were referenced back to the thermocouple aliases. Thus, changing the locations of the thermocouples on the thermocouple modules no longer required the panel displays to be reconfigured, but rather just the thermocouple aliases. Temperature indicators were also added for the two surface thermocouples.

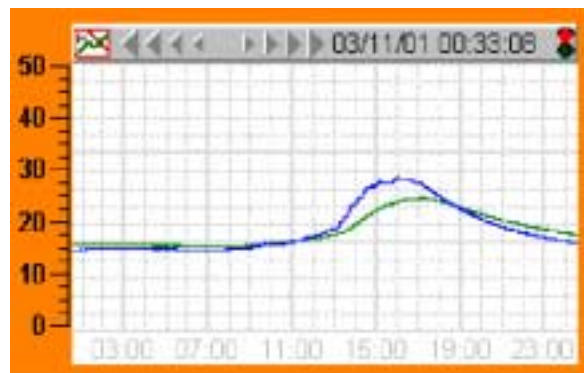
Figure 5: Example of Thermocouple Data

During operations, the installed thermocouples worked properly. A daily plot of the data, as it appears on the DAQ screen is shown below.

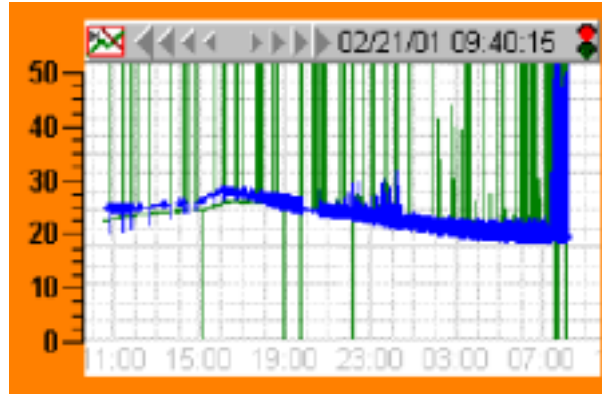
Figure 6: Example of Noise in Thermocouple Data

However, when electrical noise was present, the graphs of the data became filled with “spikes,” - data points that are the extreme values of the thermocouple. Since thermocouples voltage data is measured in millivolts, even a small amount of noise can create vastly erroneous data.

When the data acquisition system was initially installed, there was no noise and the entire data appeared as shown in Figure 6. After a period of time however, spikes began appearing during the evening hours. Eventually, the spikes occurred during the course of the entire day. The cause of this noise generation was baffling and great lengths were taken to: a. determine its source, and b. eliminate the noise. Because it is virtually impossible to eliminate all the noise from a field-installed system – especially one in which 480 VAC permeates the surrounding environment, the basic goal of this process was to create data reliable enough so that the spreadsheet data was not compromised. Fortunately, through the following process, the majority of the noise was virtually eliminated from the data.

When spikes were first seen, they only occurred during the evening hours. These times corresponded very closely to the times when the high voltage outdoor lighting system was activated at the Materials Office. Therefore it was thought that the noise could be originating from electrical noise produced from the sodium vapor lamps. However, this theory was disproved when the spikes re-occurred on a night when the lighting system was purposely left off.

Once the corrupted data began occurring at all hours, several alternative ideas were brought up as possible reasons. Among these was that the thermocouples were acting as strain gages, as the HVS wheel passed over the particular sensor. However, it was felt that the magnitude of the voltage output was too high to be created by the straining of the twisted pairs of thermocouple wires. A more likely scenario was that of static electricity. This theory was further enhanced because as cooler weather materialized, the spikes worsened. The HVS testing program started during the Fall when the relative humidity was high – typical of Florida’s atmospheric conditions. The spikes began to worsen as cooler weather moved in.

To test these ideas, the HVS wheel was run along the track at full load, and then using ever-decreasing wheel loads. Eventually it was found that the spikes always occurred when the tire was directly over the affected thermocouples, and that they occurred regardless of the load on the tire. In fact, the spikes occurred even when the tire was run over the thermocouples, without being in contact with the ground. Therefore, it was concluded that the noise was generated from static electricity build up on the tire itself. The spikes did not occur early on in the testing program because the relative humidity outside was sufficient to attenuate electron discharge from the tire to the thermocouple. As winter arrived, the humidity would drop during the night at first and hence the spikes only were evident during that time. However, eventually the RH was low enough during the entire day. In fact, a recommendation was made to install a weather station at the test facility to monitor RH, air temperature and rainfall.

Once the cause of the spikes was identified, effort focused on two areas: grounding protection for the thermocouples and/or static removal. Because the AC power to the Fieldpoint hardware was running from an outlet located on the HVS, it was not clear if a ground loop was created. Therefore, a large copper-grounding rod was inserted in the ground near the system and connected to the data acquisition unit. The channels displaying noise were then each grounded to this common point. This setup improved the data significantly. In addition, a separate AC power source running from the control room to the DAC hardware was installed which further enhanced the data.

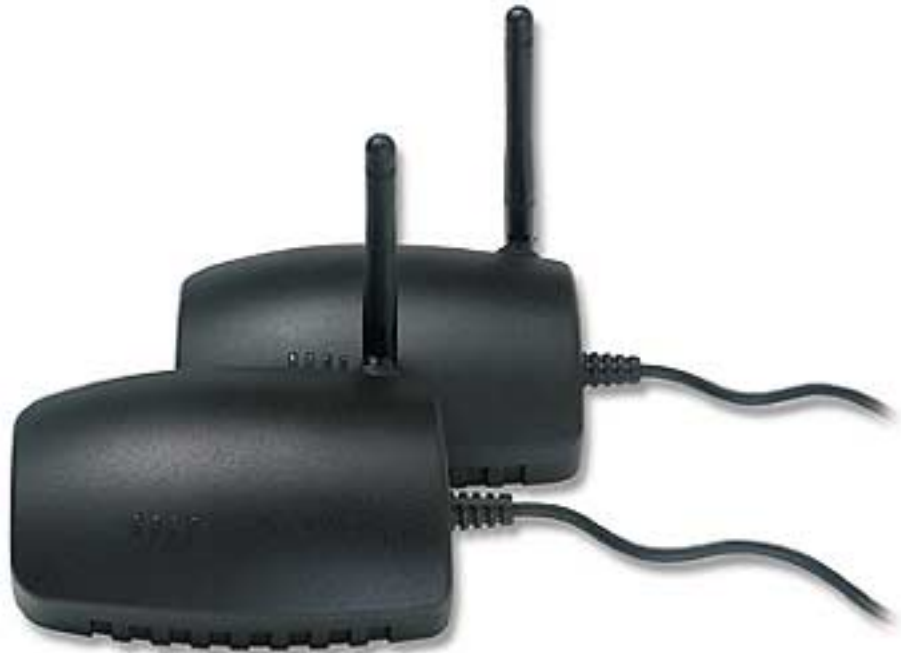
Fig. 7- ConnexLink Units

The thermal heating system software required a serial connection between a computer and the heating unit. Using a 100 ft cable would have been unfeasible due to the mobility of the HVS. Therefore, it was concluded that a wireless serial link would be necessary. Different techniques of achieving this goal were considered and a Aerocomm ConnexLink system was purchased. This system operates with two small transceivers that allow a bidirectional RS-232 link for up to 1000 feet.

The installation of this wireless radio link between the HVS and monitoring computer, for the Heating System, took longer than originally anticipated. The Aerocomm modems were not designed to be exposed to the elements. Therefore, a sealed box had to be designed and constructed to house them. This task was conducted by FDOT personnel. Following completion of the sealed housing, it was discovered that the heating system supplied an RS-485 connection. The Aerocomm radio modems only connect via a standard RS-232 connection. Thus a converter was purchased to allow for their use with the HVS. Unfortunately, successful operation of the Aerocomm radio modems was never properly achieved with the new converter. Originally suspecting the fault to lie with the RS-485 converter, the heating system manufacture was contacted. Eventually a new wiring diagram was supplied that would allow for the communications port on the heating system to be wired for RS-232 communication directly. This too, proved ineffective. The radios themselves were considered the next problem. The original Aerocomm radio modems were then replaced with Maxstream radio modems. These new modems operate at 900 MHz rather than 2.4 GHz, and have a line of site range of 10 miles. In addition, unlike the previous Aerocomm units, these modems are packaged in a metal casing, which makes them considerably more durable, and less affected by

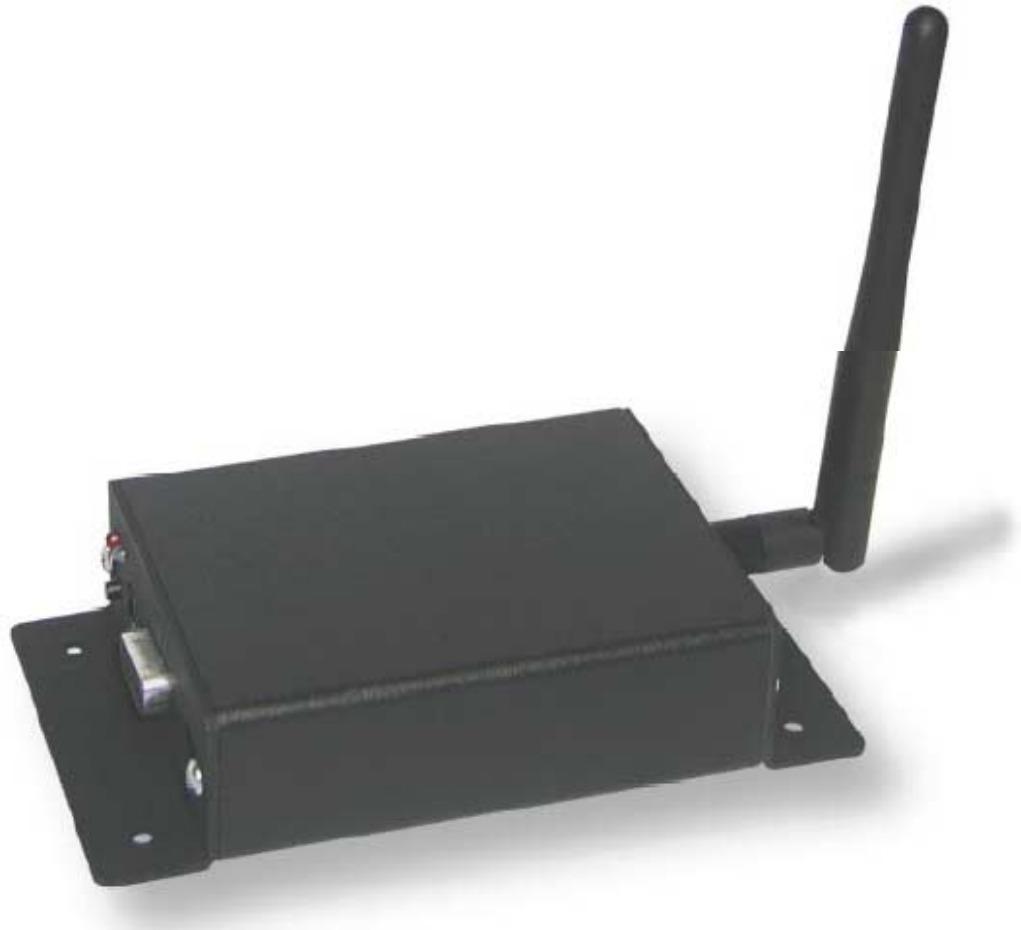
Fig. 8 Maxstream Unit

inclement weather and conditions. Finally these new modems contained all necessary cables and null modem adapters to properly install them. After several hours of installation and setup, the new Maxstream modems enabled a connection, and the HVS heating system finally became truly wireless.

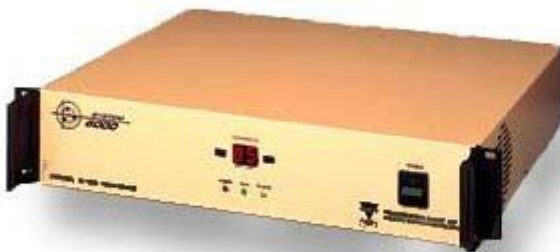
manufactures this strain/deformation hardware. The hardware consists of a Model 6100 Scanner, Model 6101 PCI Interface Card and Cable, seven Model 6010A Strain Gage Input Cards, and five Model 6040A LVDT Input Cards. In addition to the hardware, the

These various input cards are installed within the 6100 Scanner. This scanner then connects to the DAQ Computer using the PCI Interface Card. Finally, using the StrainSmart software the FDOT will be able to take the various measurements and readings with the Strain Gages and LVDT's attached to the input cards.
