Structures Research Report No. 922
Final Project Report

June 2004

**CFRP REPAIR OF IMPACT-DAMAGED BRIDGE
GIRDERS VOLUME I – STRUCTURAL EVALUATION
OF IMPACT DAMAGED PRESTRESSED CONCRETE I
GIRDERS REPAIRED WITH FRP MATERIALS**

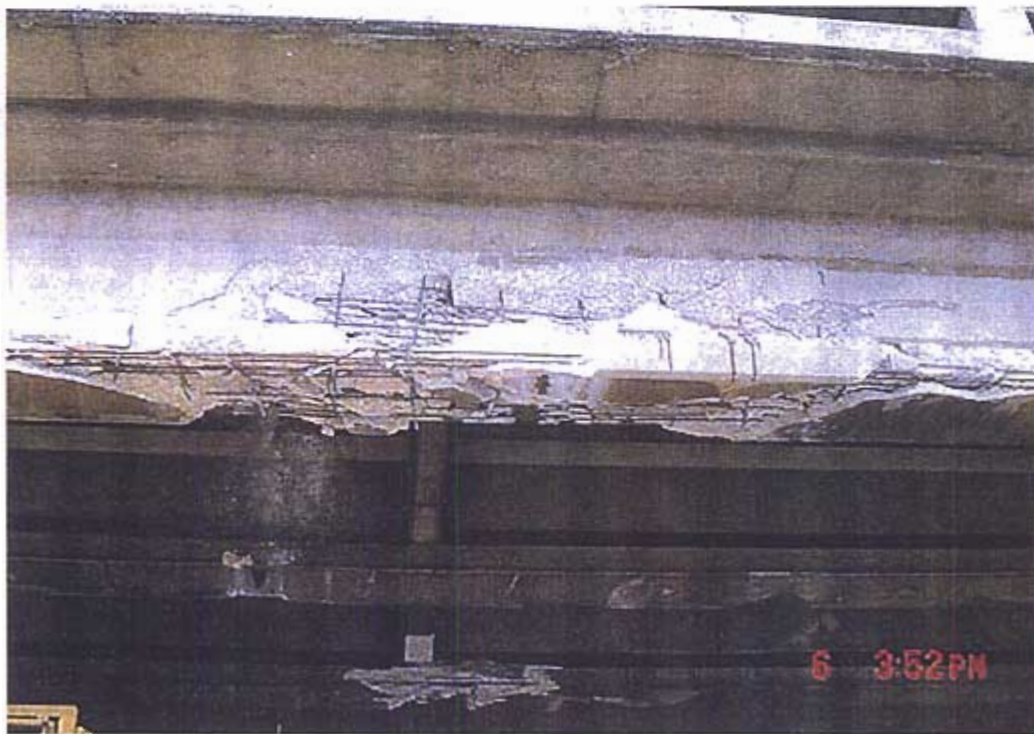
Figure 1-4: Close-up of Damage on the West Fascia Girder in the Vicinity of the Diaphragm

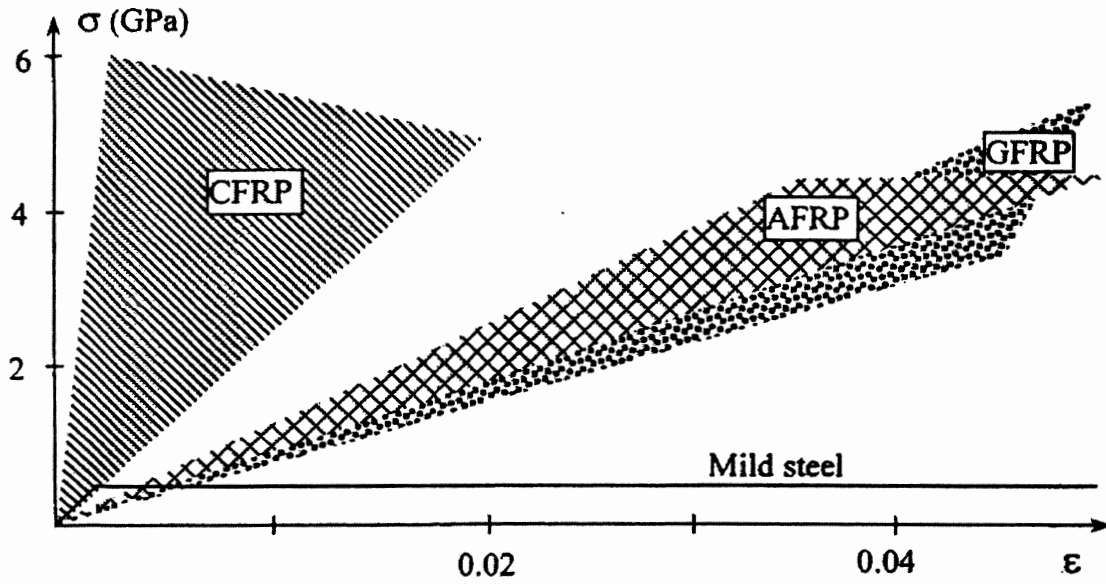
Figure 2-1: Stress-Strain Diagrams for Mild Steel and Carbon, Glass, and Aramid Fiber Reinforced Polymers (FIB 2001)

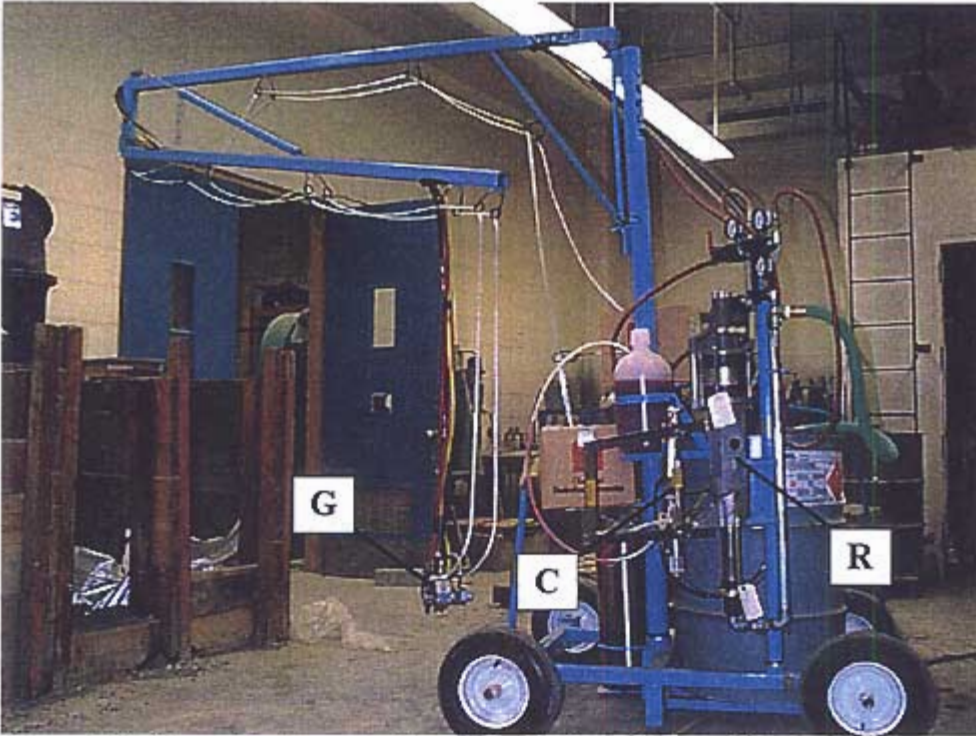
Figure 3-9: Spray Equipment: Gun (G), Catalyst (C), and Resin (R)

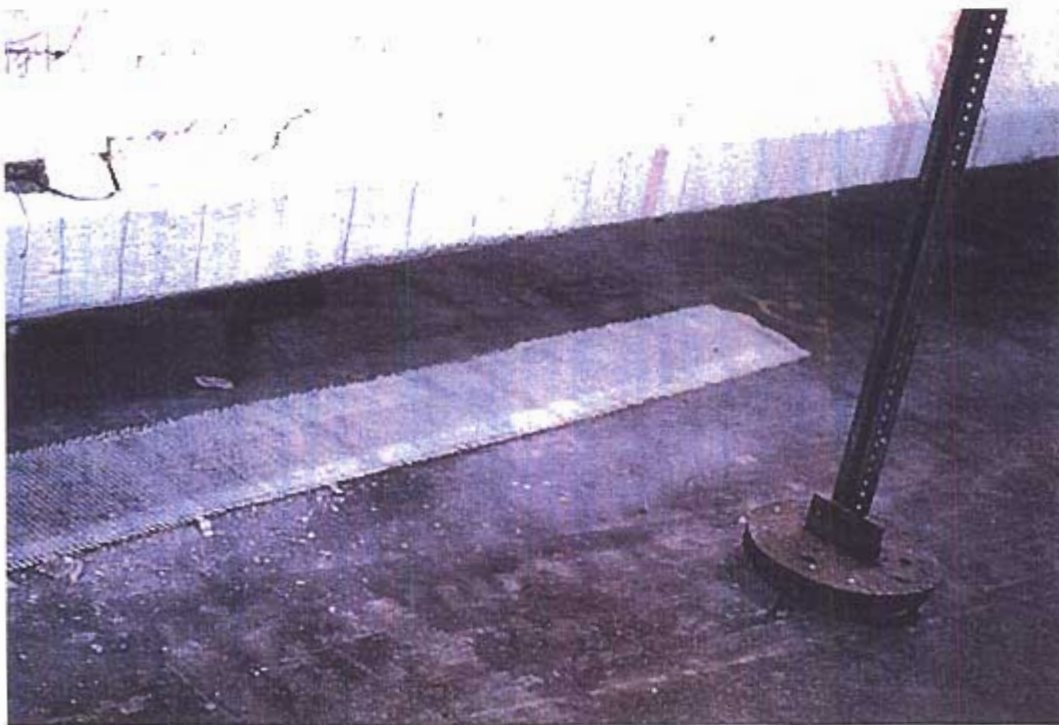
Figure 4-28: Test Specimen 4 at Failure Showing Separation of FRP

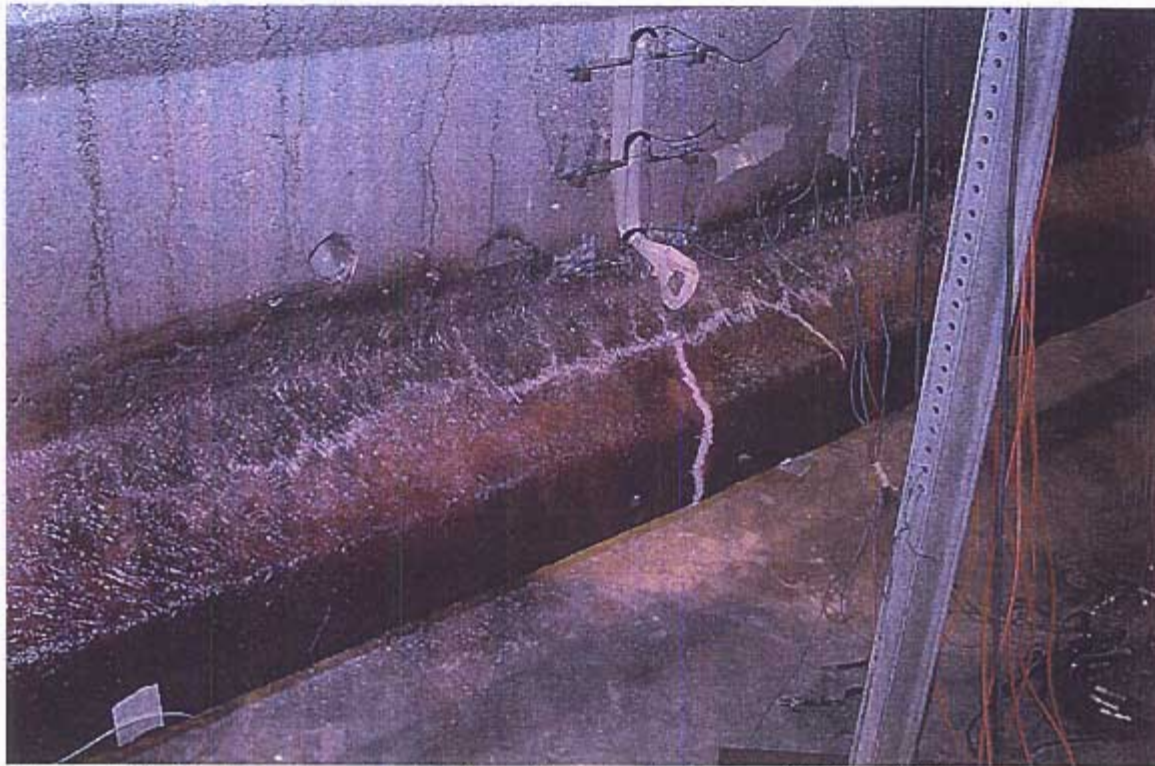
Figure 4-36: Test Specimen 5 at Failure Showing Rupture of FRP at Midspan

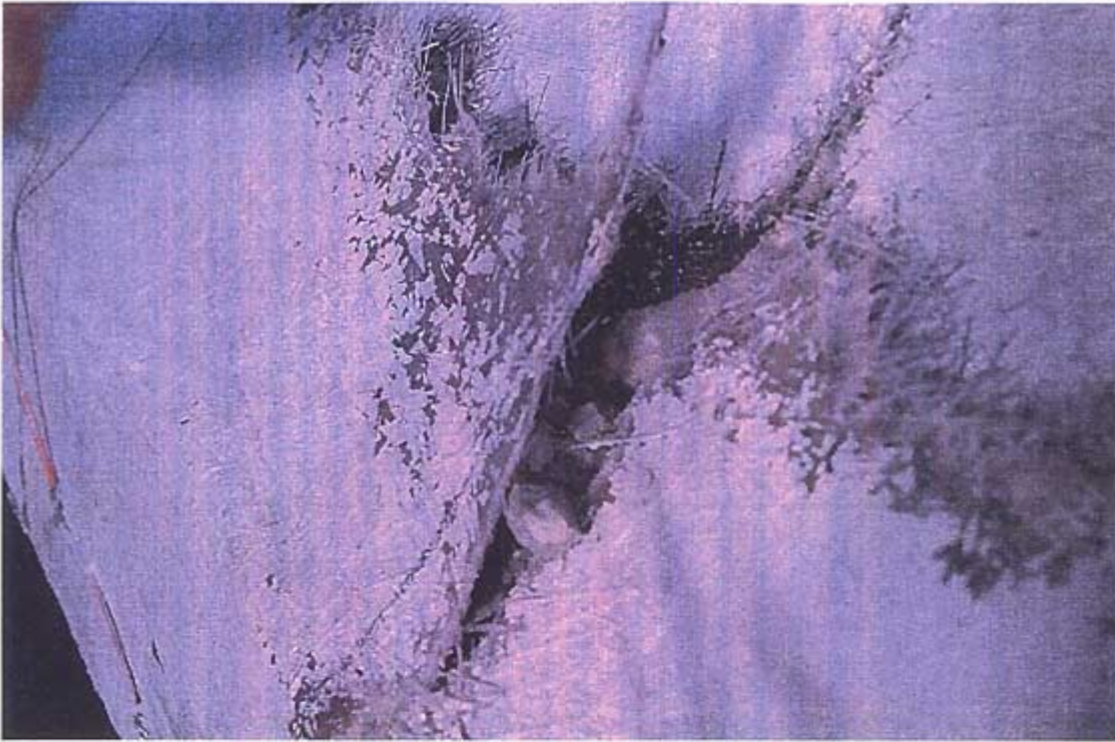
Figure 4-37: Test Specimen 5 at Failure Showing Rupture of FRP at Midspan on Tensile Face of Girder

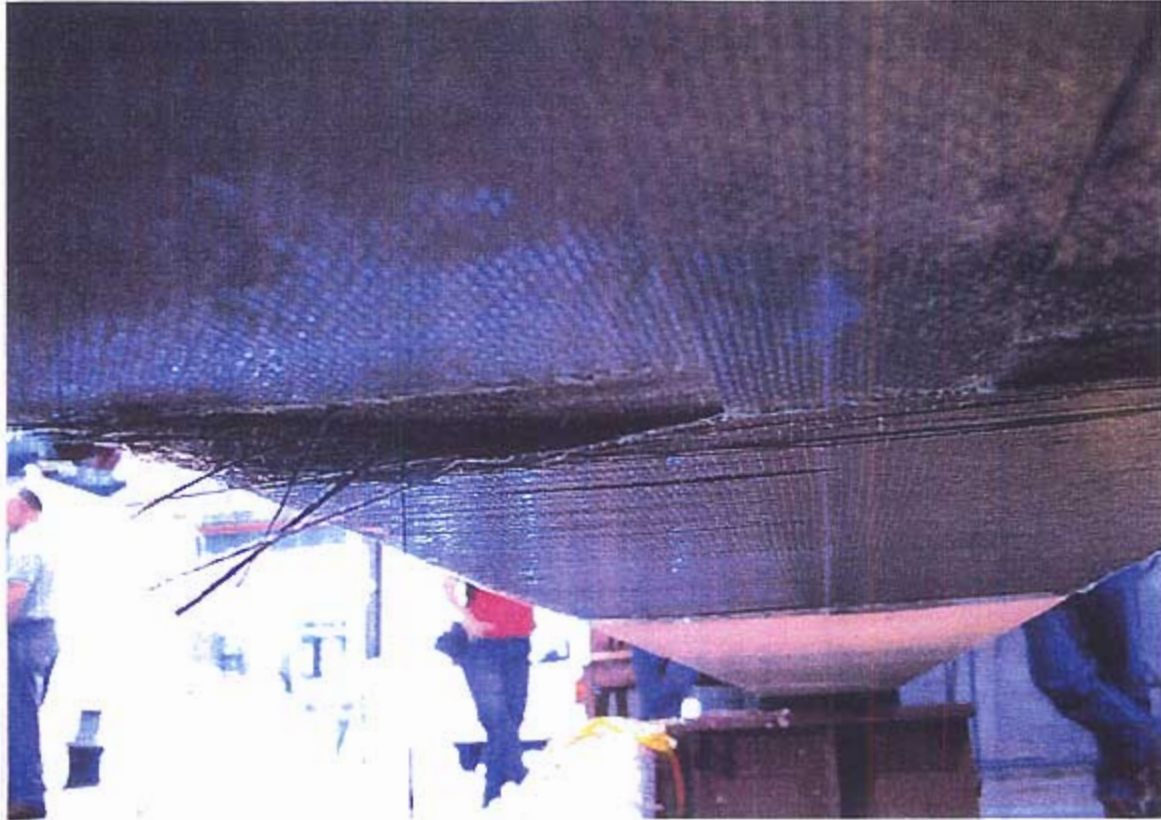
Figure 4-45: Test Specimen 6 at Failure Showing Anchorage Slip
