**DEVELOPMENT OF A RATIONAL METHOD FOR PREDICTING CORROSION
RATES OF METALS IN SOILS AND WATERS**

Contract No. BD497

Final Report to Florida Department of Transportation

**University of South Florida
Tampa, FL 33620
October 31, 2009**

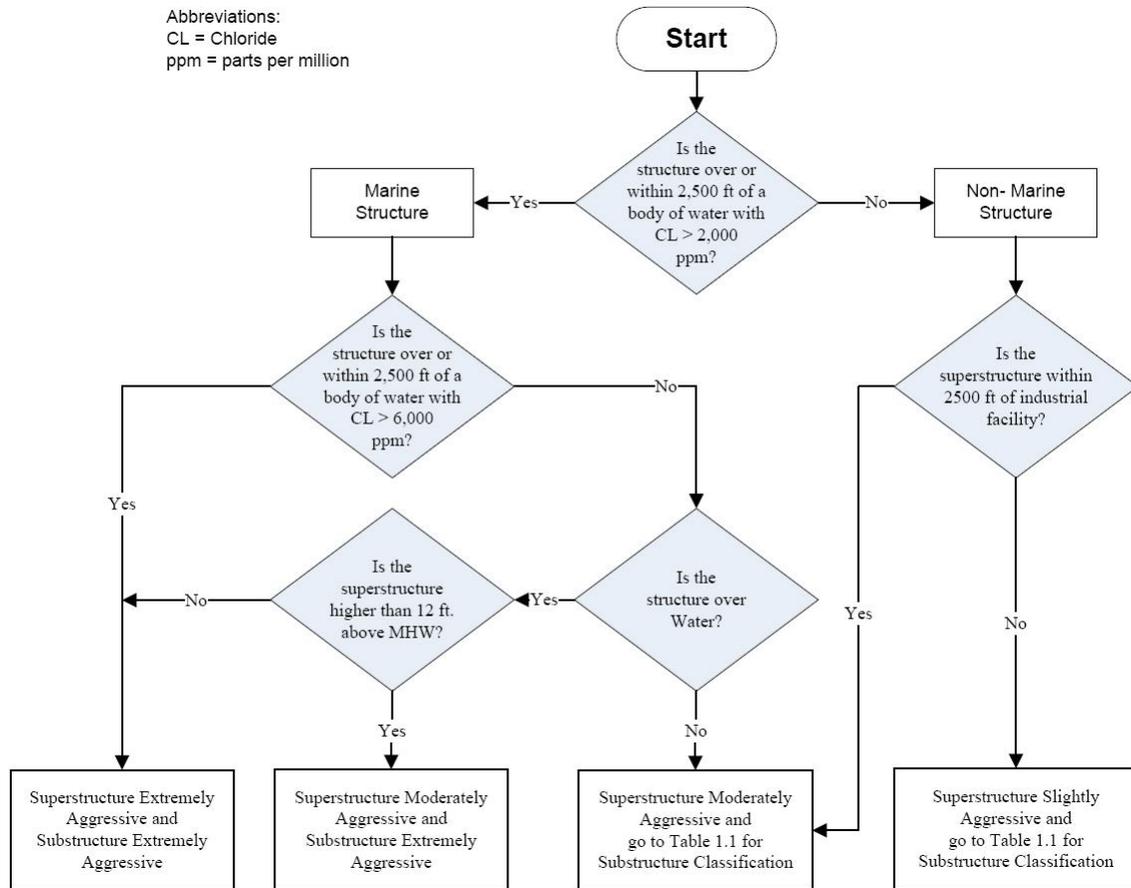
Figure 2.1 FDOT flow chart for definition of environmental classification for bridge structures from the 2009 Structural Design Guidelines Manual (FDOT 2009b). Table 1.1 in the flow chart is reproduced as Table 2-5 of the present report, which is customized for substructures only and excludes reinforced concrete.

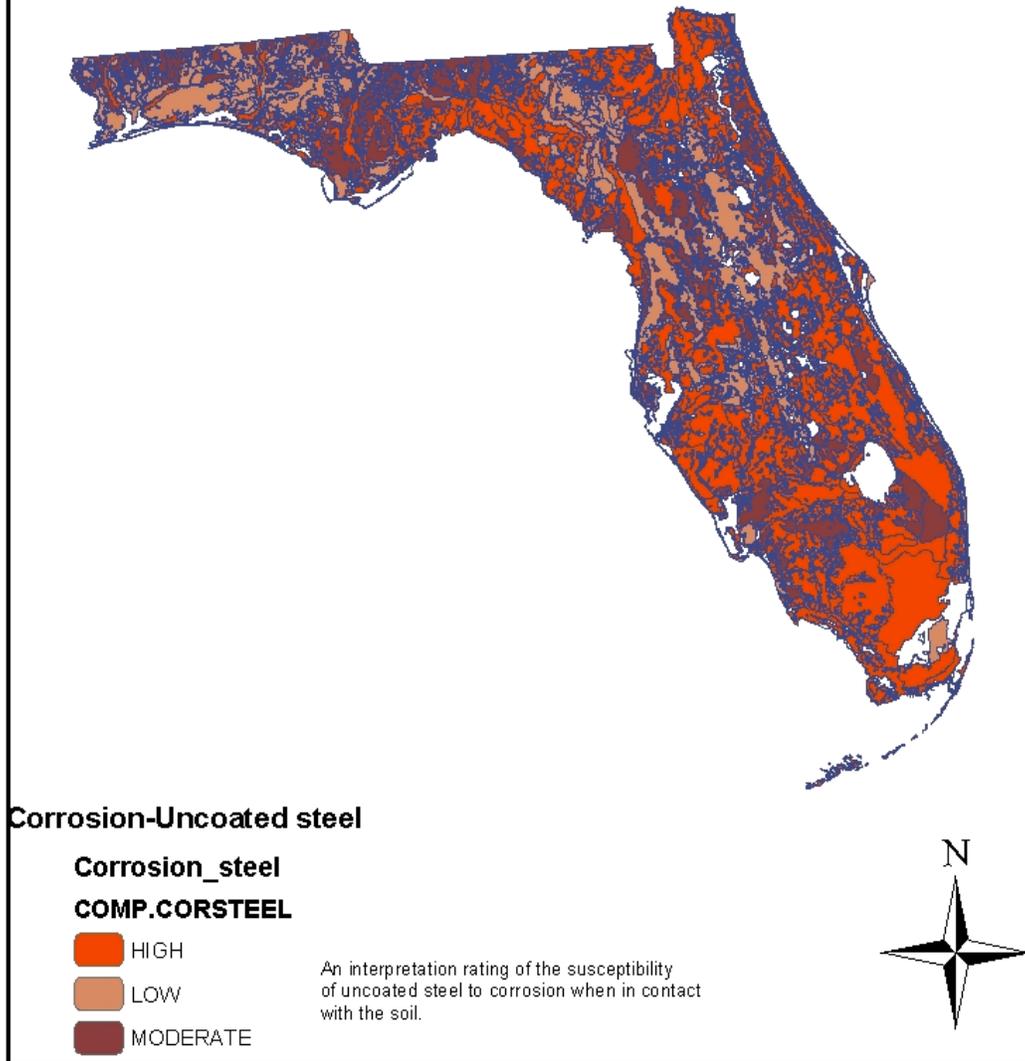
Figure 2-2. Corrosion potential for steel in Florida soil. This spatial plot was prepared from soil property data from the SSURGO database with Geographical Information Systems (GIS) software.

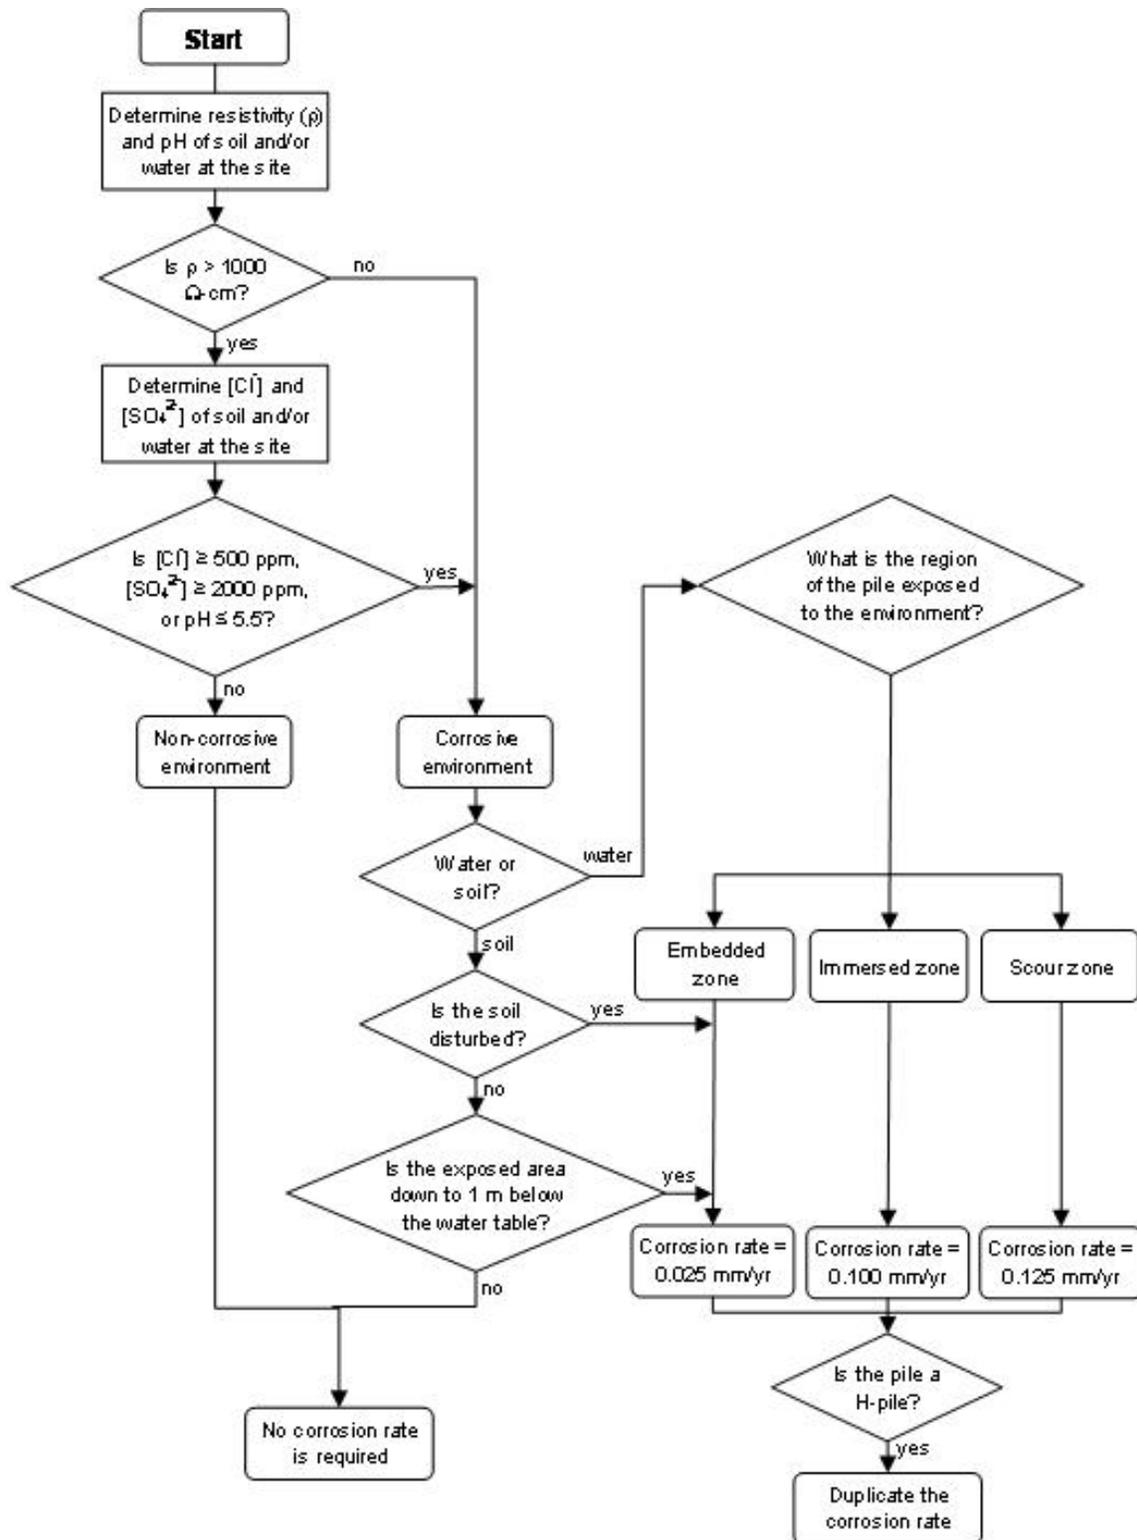
Figure 3-2. Flowchart to determining the environmental classification and the corresponding corrosion rates per CALTRANS (CALTRANS, 2003).

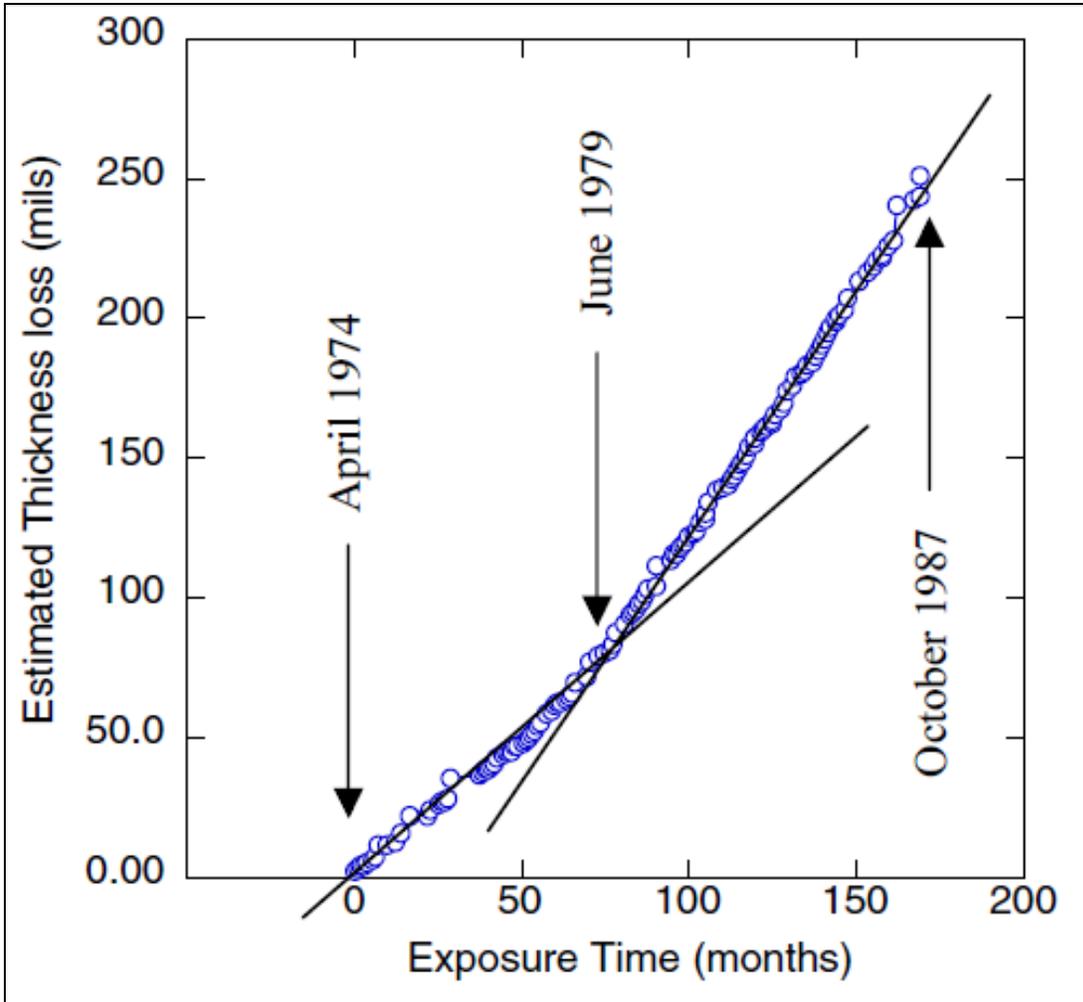
Figure 3-3. Estimated thickness loss as a function of time from April 1974 to October 1987 derived from dissolved oxygen measurements made near the Burlington Northern Bridge in Duluth-Superior Harbor (Marsh et al., 2005).

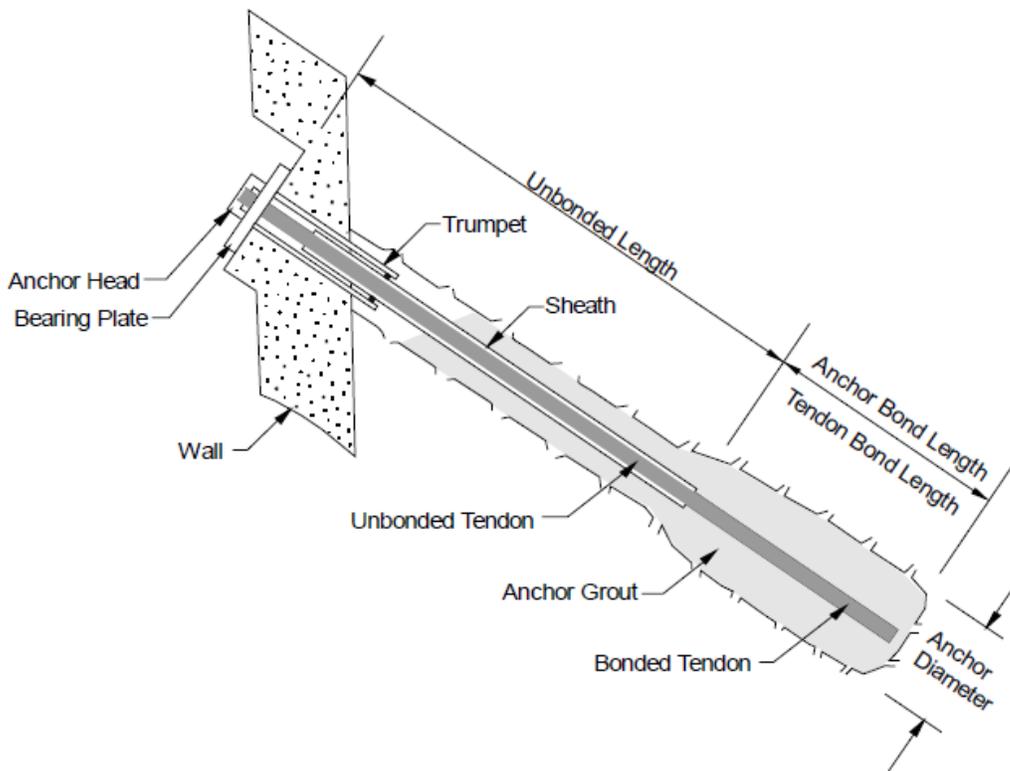
Figure 3-4. Components of a ground anchor (Sabatini et al., 1999).

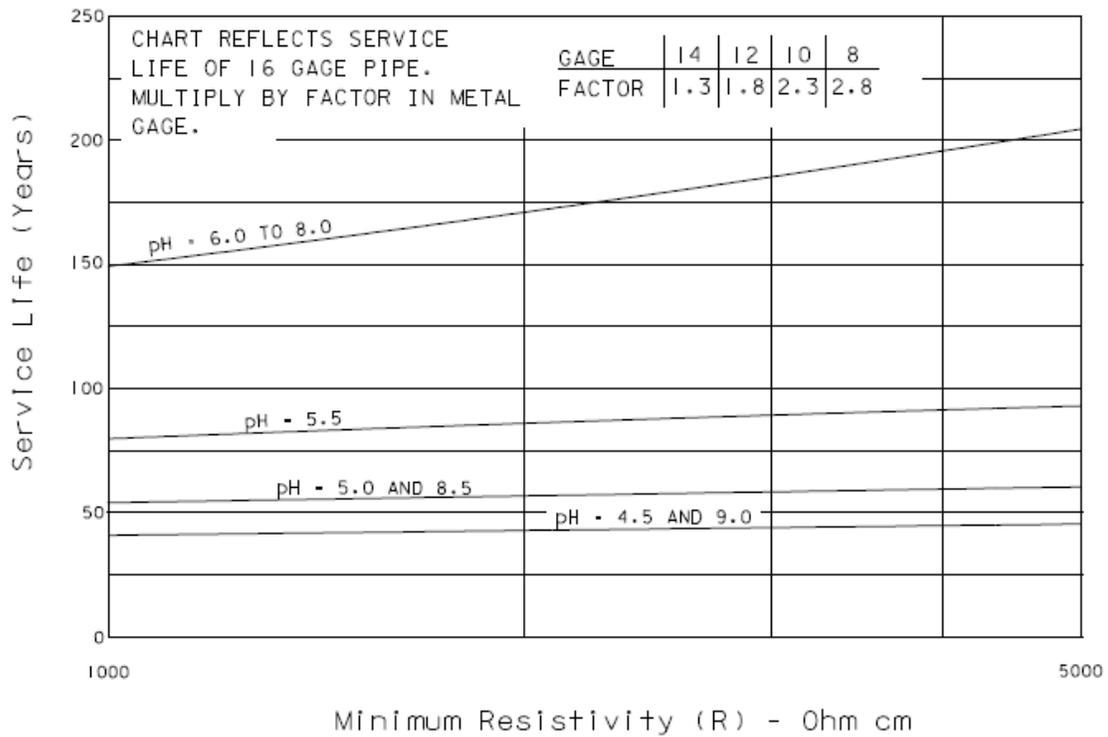
Figure 4-1. Estimated service life versus pH and resistivity for 1.52-mm (16-gage) clad aluminum (FDOT, 2008).

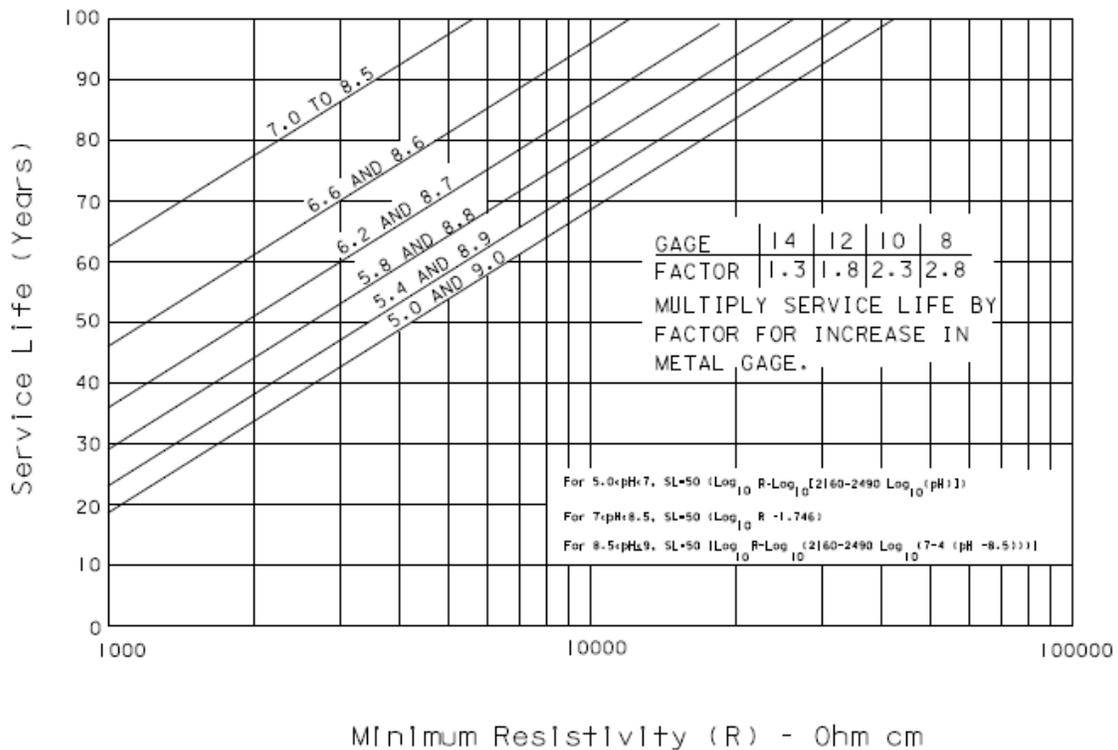
Figure 4-3. Estimated service life versus pH and resistivity for 1.52-mm (16-gage) aluminized steel type 2 (FDOT, 2008).

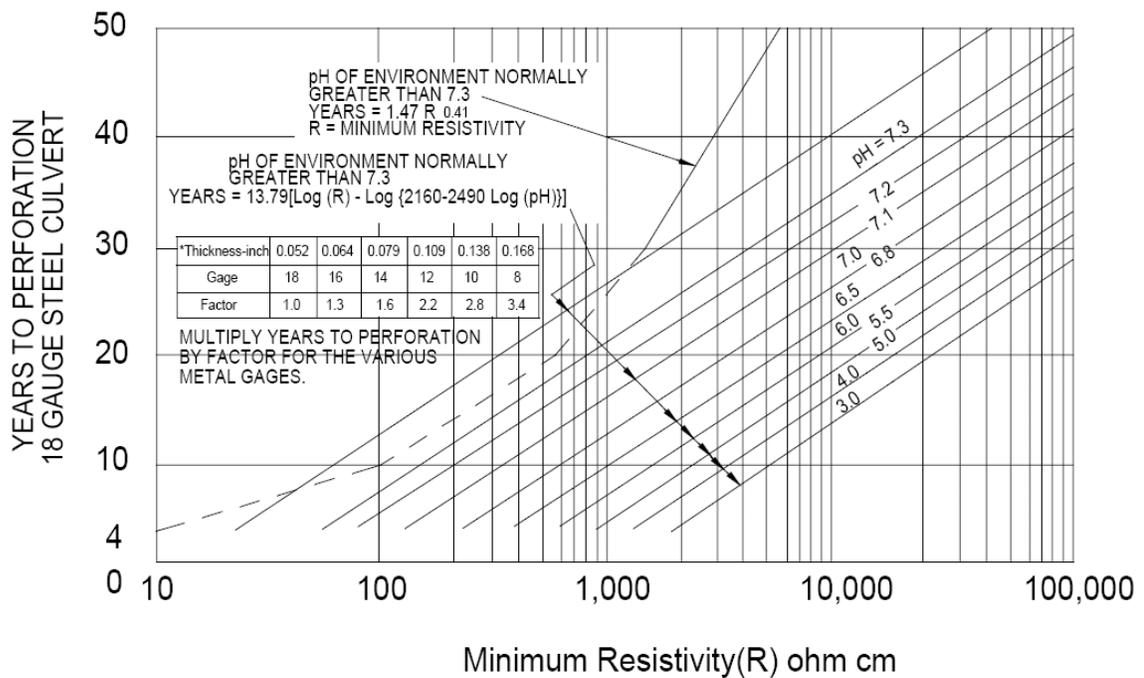
Figure 4-4. Refined California method chart for estimating years to perforation of 1.21-mm (18-gauge) galvanized culvert pipe (California Test 643, 1999).

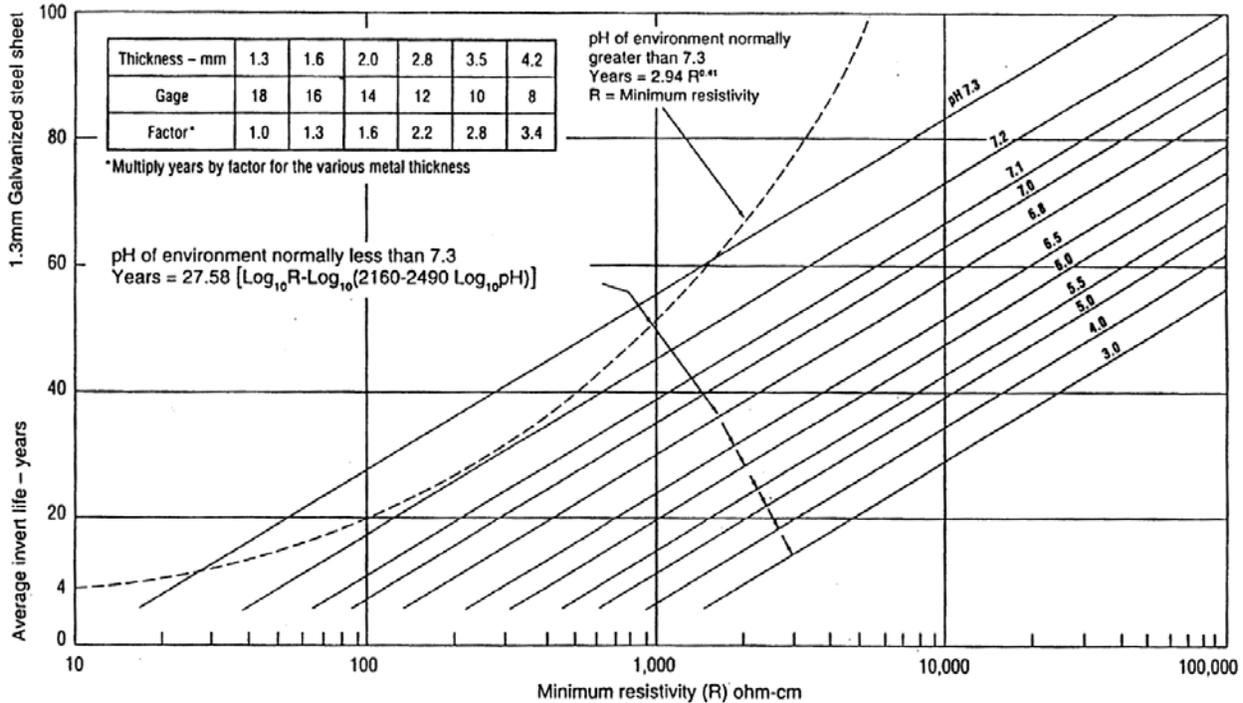
Figure 4-5. The AISI method chart for estimating years to perforation of galvanized steel pipes of 1.21-mm (18-gage) culvert pipe. Computing service life is the same as in the refined California method (AISI, 1994).

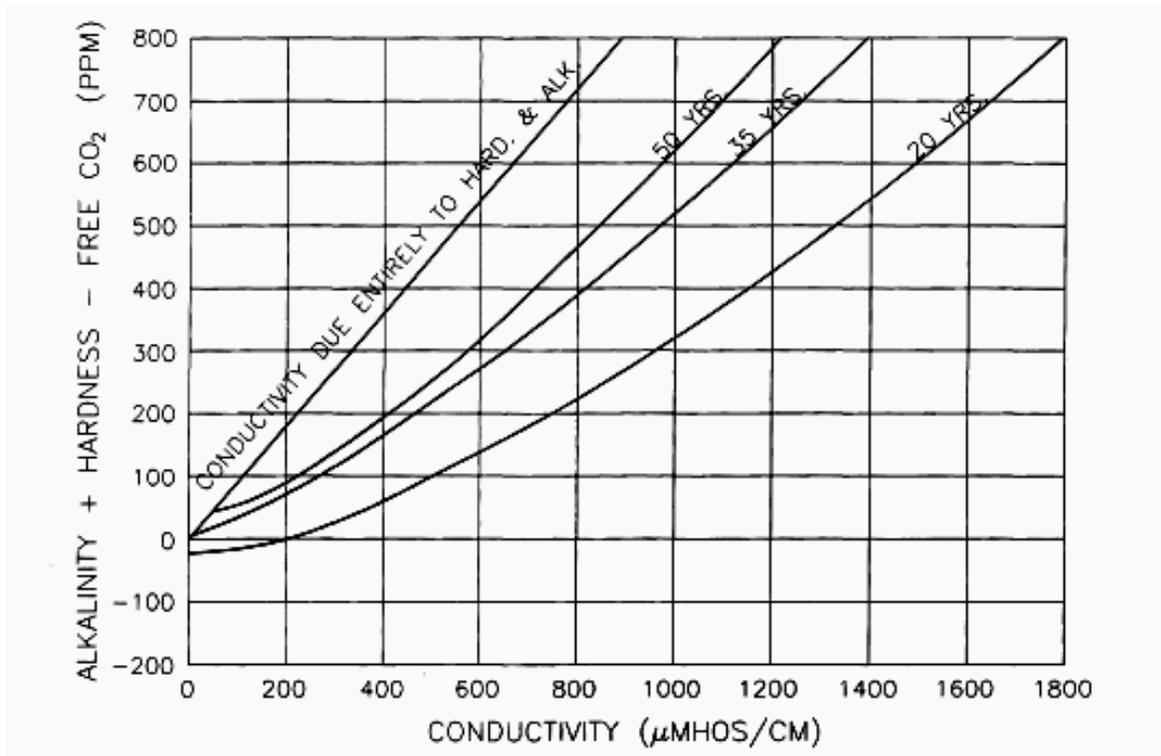
Figure 4-7. The AK Steel method chart for estimating service life of 14-gage galvanized and aluminized steel type 2 culvert pipes (Bednar, 1989).

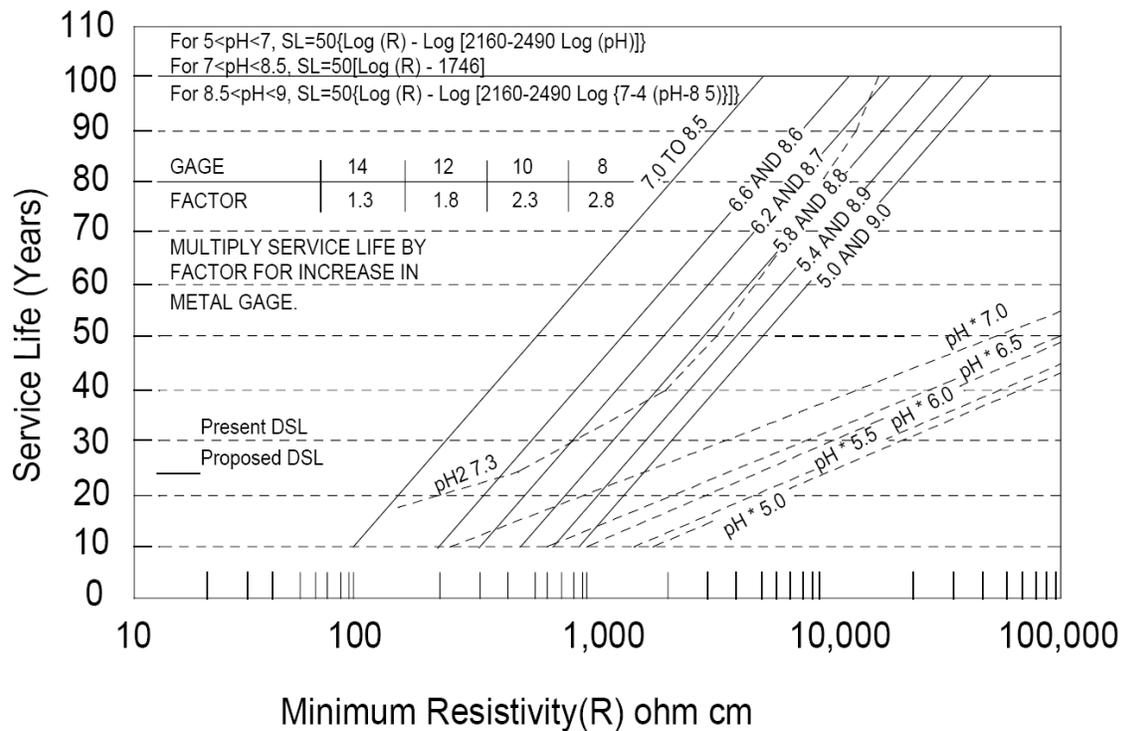
Figure 4-6. The FDOT chart for estimation years to perforation of 16-gage aluminized steel type 2 culvert pipes (solid lines) (Cerlanek and Powers, 1993). Dashed lines correspond to service life estimation using the refined California method for galvanized steel.

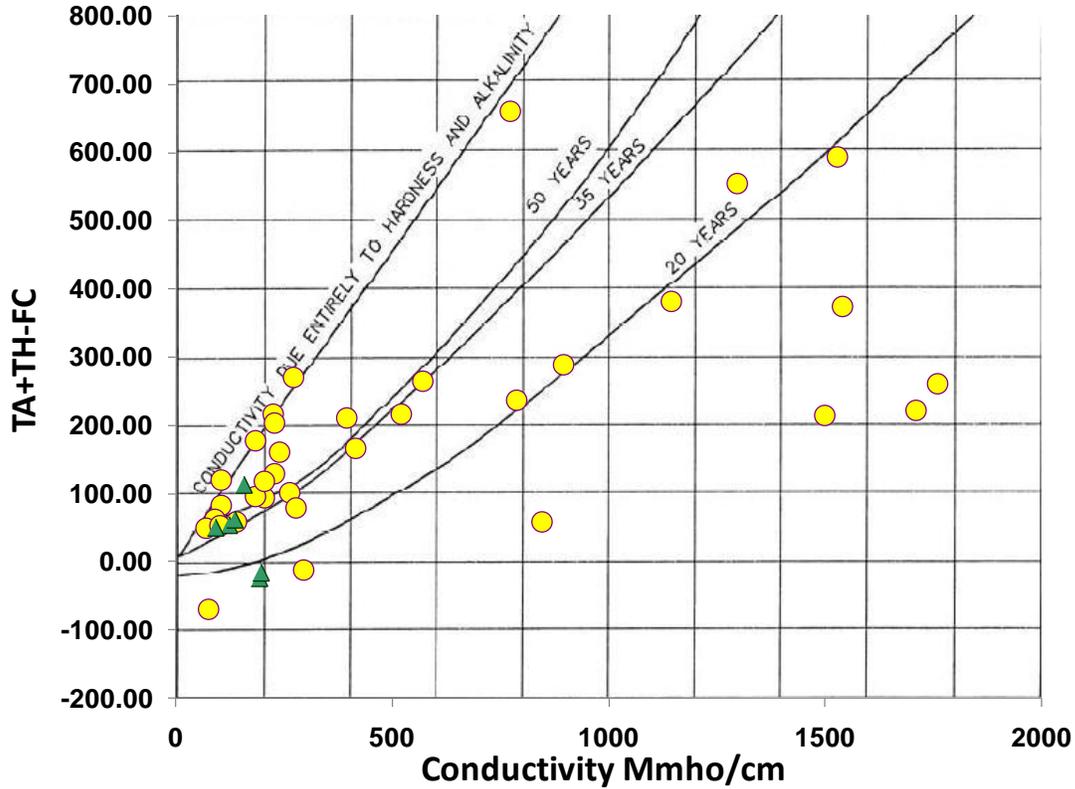
Figure 5-1. Alternative scaling index durability projection (Bednar 1989; Morris 1998) using water data from St. Cloud (triangles) and other Florida fresh waters (circles).

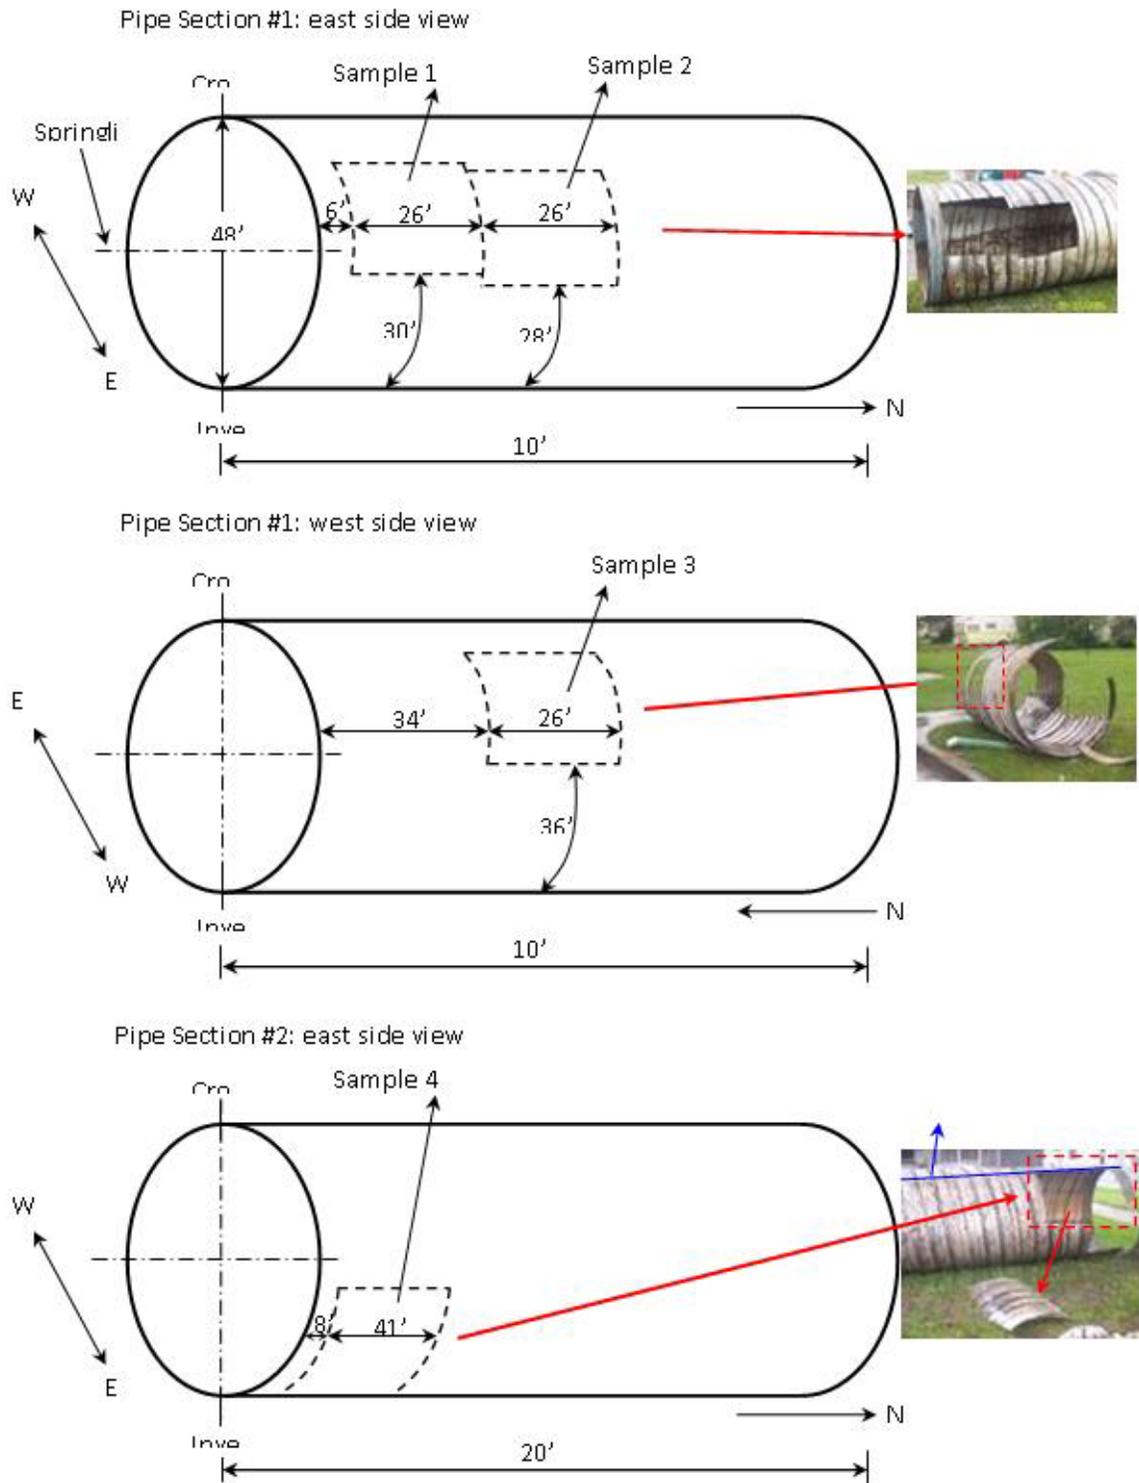
Figure 5-2. Schematic and pictures of the metal coupons taken from sections of aluminized steel type 2 culvert piping removed from service in St. Cloud, Florida.

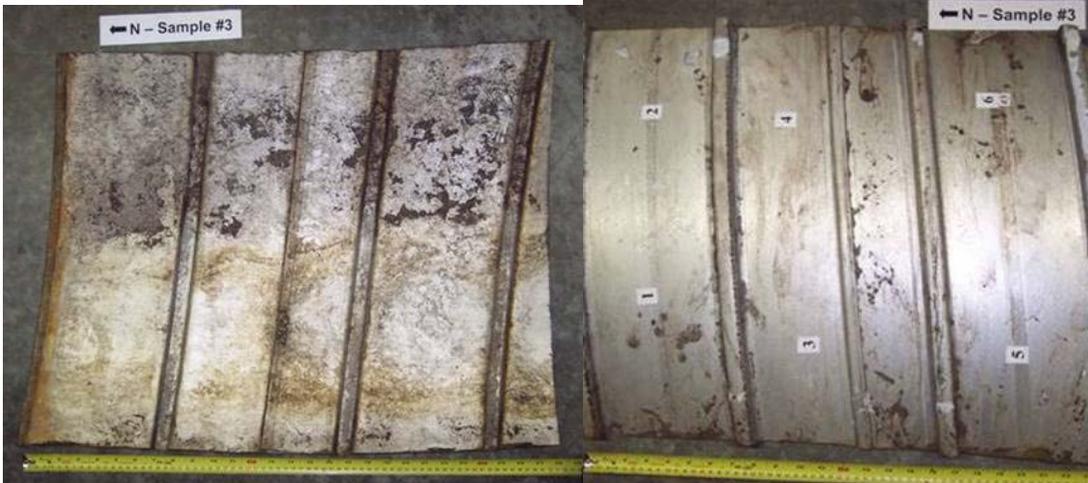
Figure 5-3. Coupon #3 corrosion before cleaning on water side (left) and soil side (right).

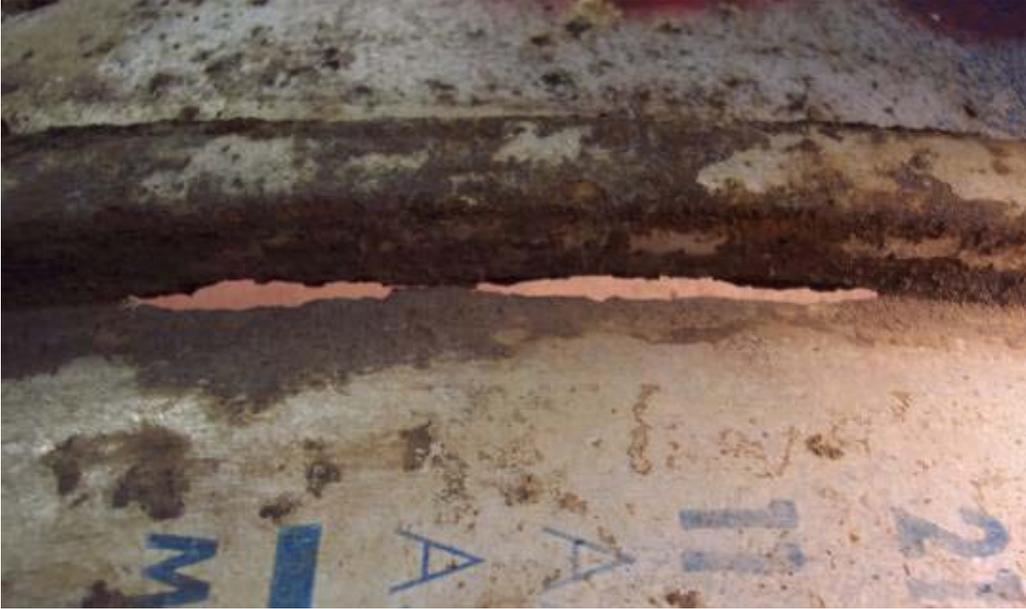
Figure 5-4a. Coupon #1 outer rib after cleaning.

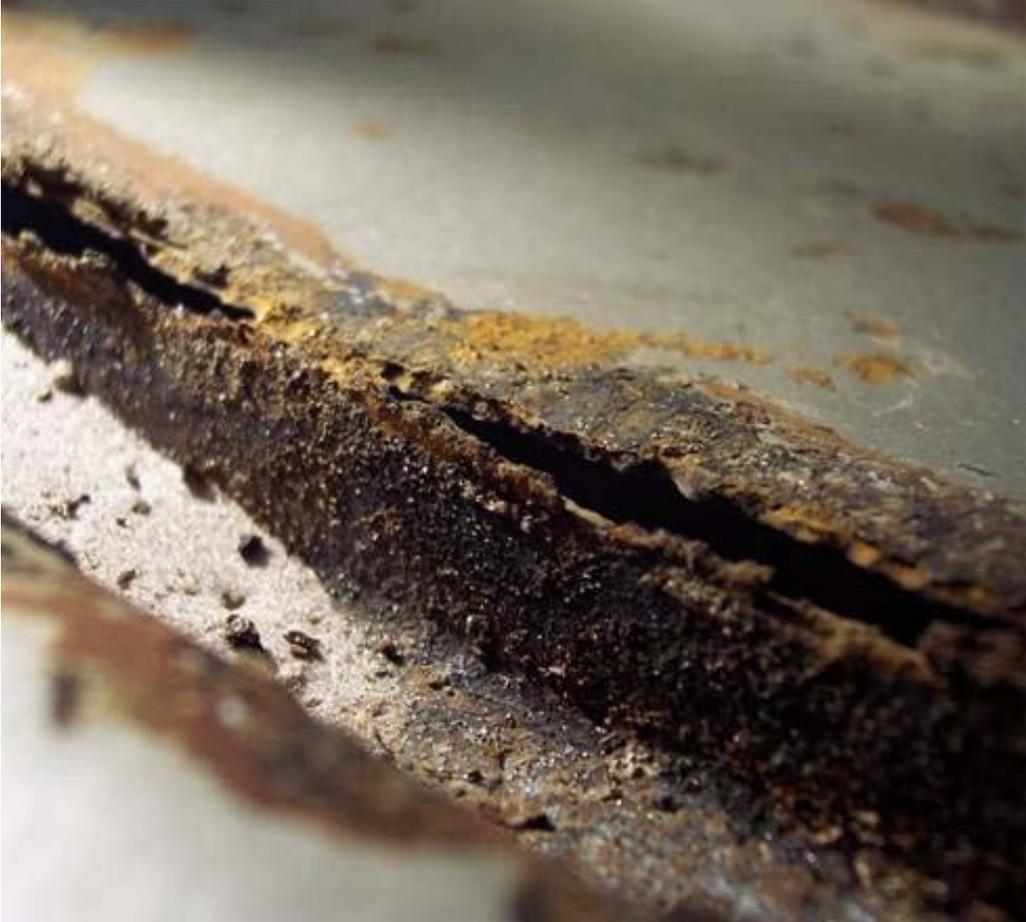
Figure 5-4b. Coupon #1 inside rib before cleaning.

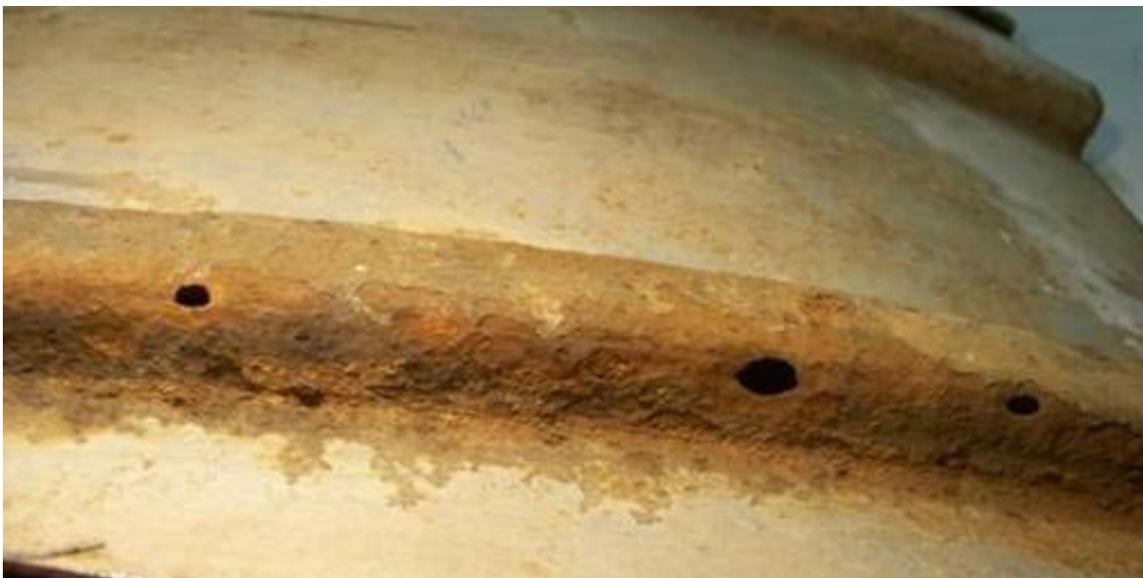
Figure 5-5. Coupon #4 outer rib after cleaning.

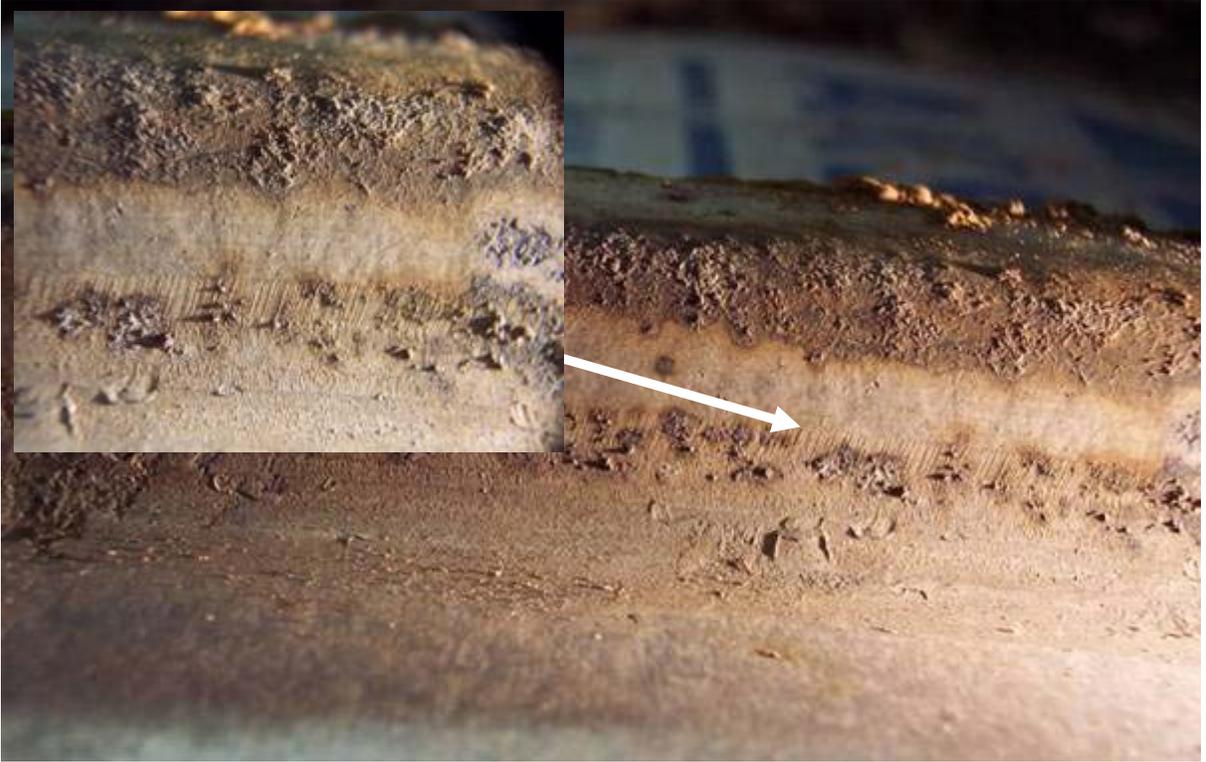
Figure 5-6. Coupon #1 close-up view of an outer rib.

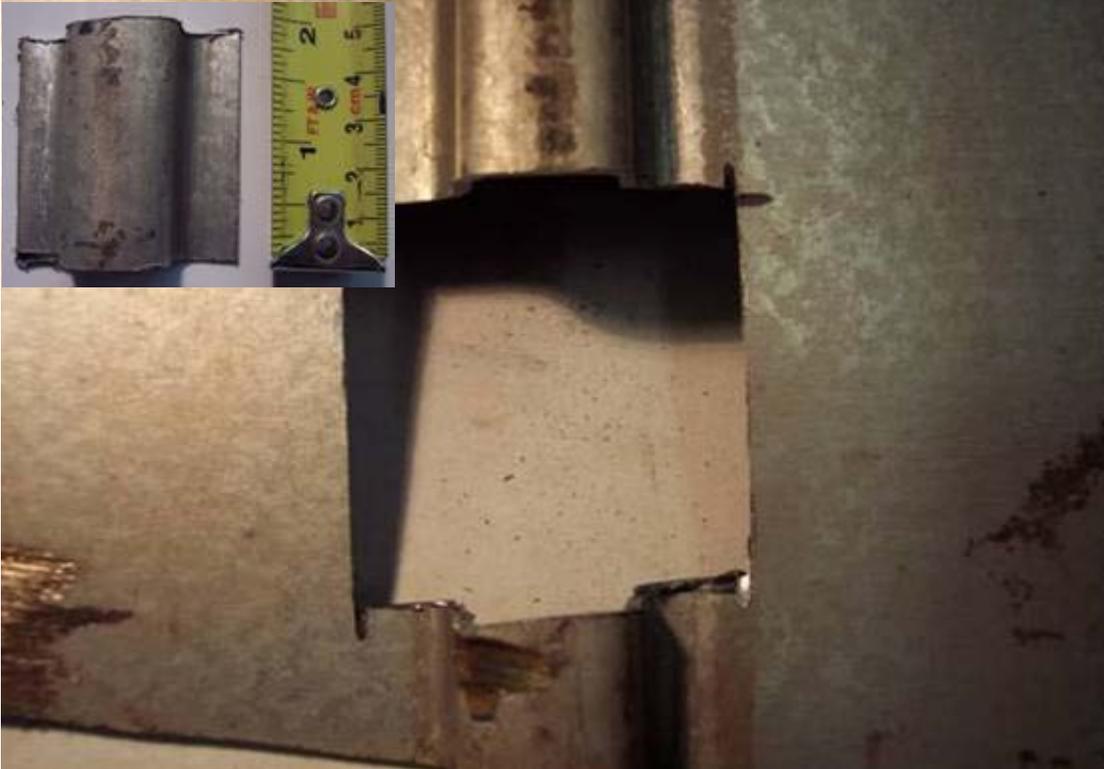
Figure 5-7. Spiral rib sample cut out from coupon #3 used for metallographic analysis.

Two ~5 to 7 cm wide and 10 cm long metal pieces (one obtained at a spiral rib and the other at a lock seam) were cut out of coupon # 3 (see Figure 5-7 and 5-8) for metallographic analysis. Each metal piece was then transversely cut into three samples and mounted in epoxy. The samples were polished down to 0.05 micrometers, cleaned with ethanol and etched with Nital solution.

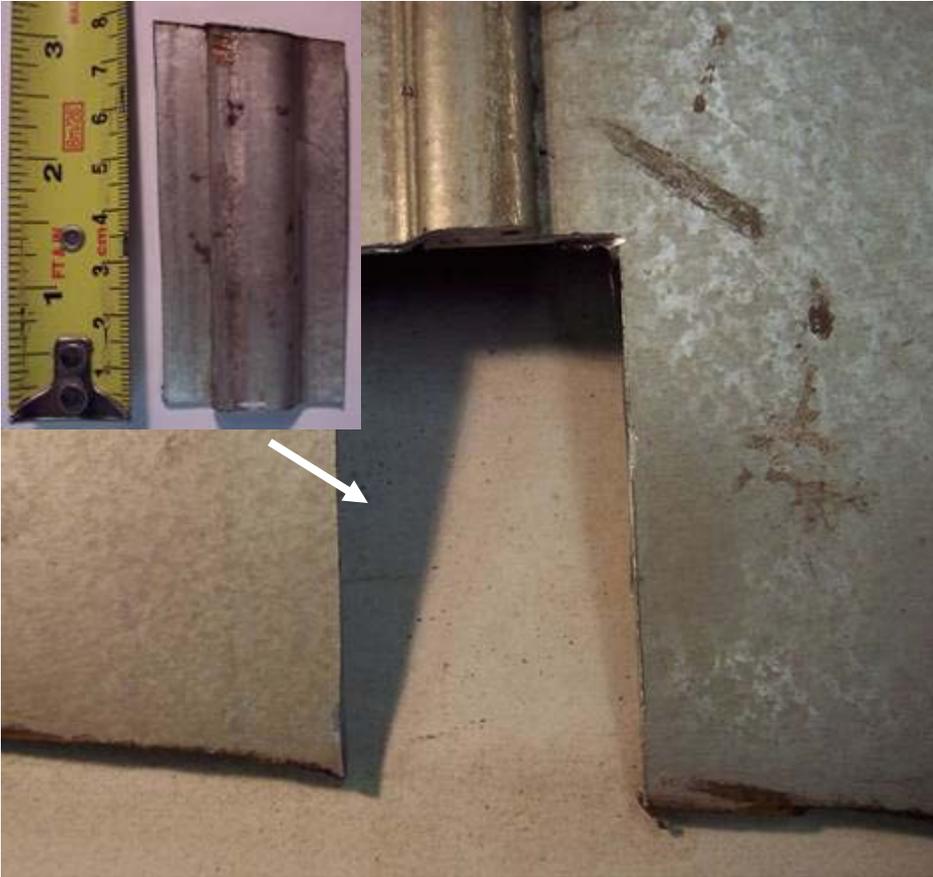
Figure 5-8. Lock seam sample cut out from coupon #3 used for metallographic analysis.

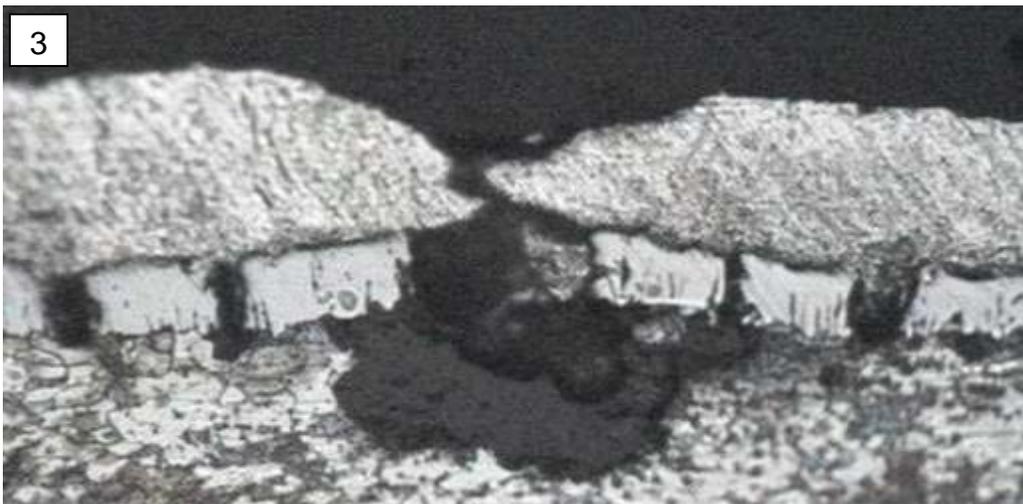
Figure 5-9b. Cross sections for features 1 to 3. Inner layer is ~10 μm thick.

Microscopic examination of the samples showed a nearly uniform outer coating ~ 15 to $20 \mu\text{m}$ thick and an inner intermetallic layer $\sim 10 \mu\text{m}$ thick, consistent with normally produced aluminized steel type 2. However, the outer layer was missing at several locations at the rib and seam bends as shown in Figures 5-9 and 5-10. There was no conclusive evidence as to whether the missing outer layer was missing because of corrosion during service or if it was absent beforehand.

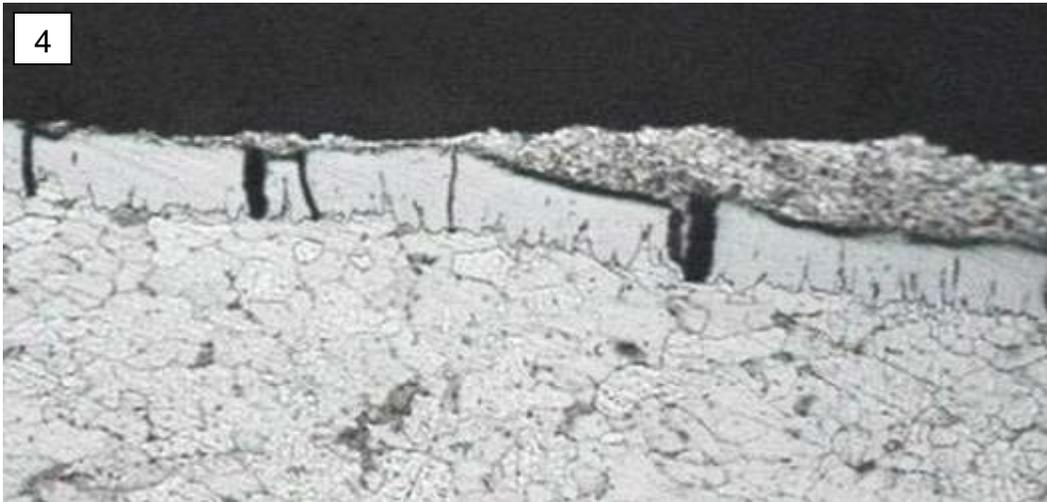
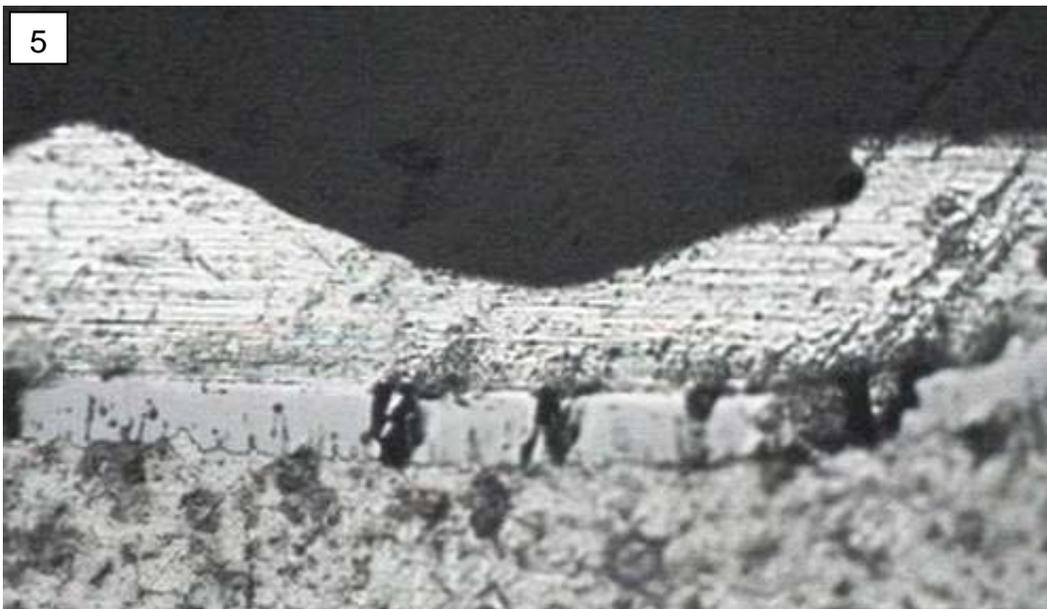
Figure 5-9c. Cross section for features 4 and 5. Inner layer is $\sim 10 \mu\text{m}$ thick.

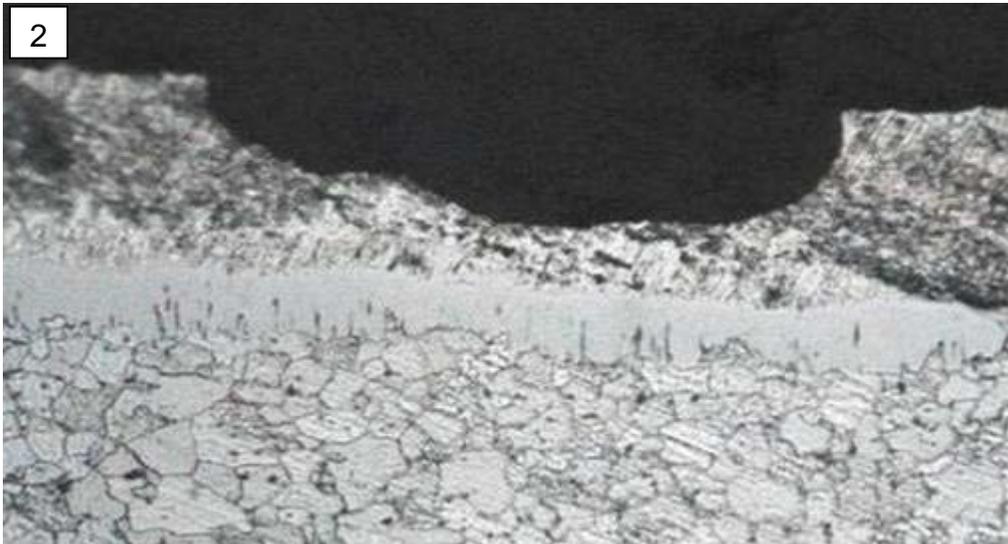
Figure 5-10b. Cross sections for features 1 to 3. Inner layer is $\sim 10 \mu\text{m}$ thick.

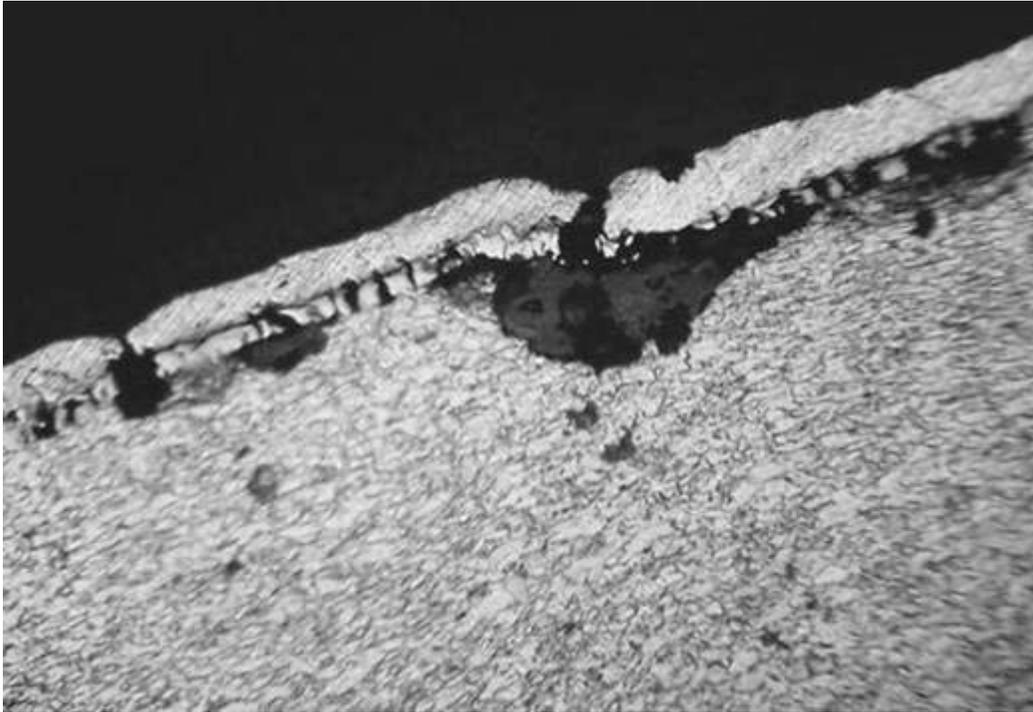
Figure 5-11. Microstructure of a sample cut out of coupon #3 inside rib bend. Inner layer is ~10 μm thick.
