**DEVELOPMENT OF A RATIONAL METHOD FOR PREDICTING CORROSION
RATES OF METALS IN SOILS AND WATERS**

Contract No. BD497

Final Report to Florida Department of Transportation

**University of South Florida
Tampa, FL 33620
October 31, 2009**

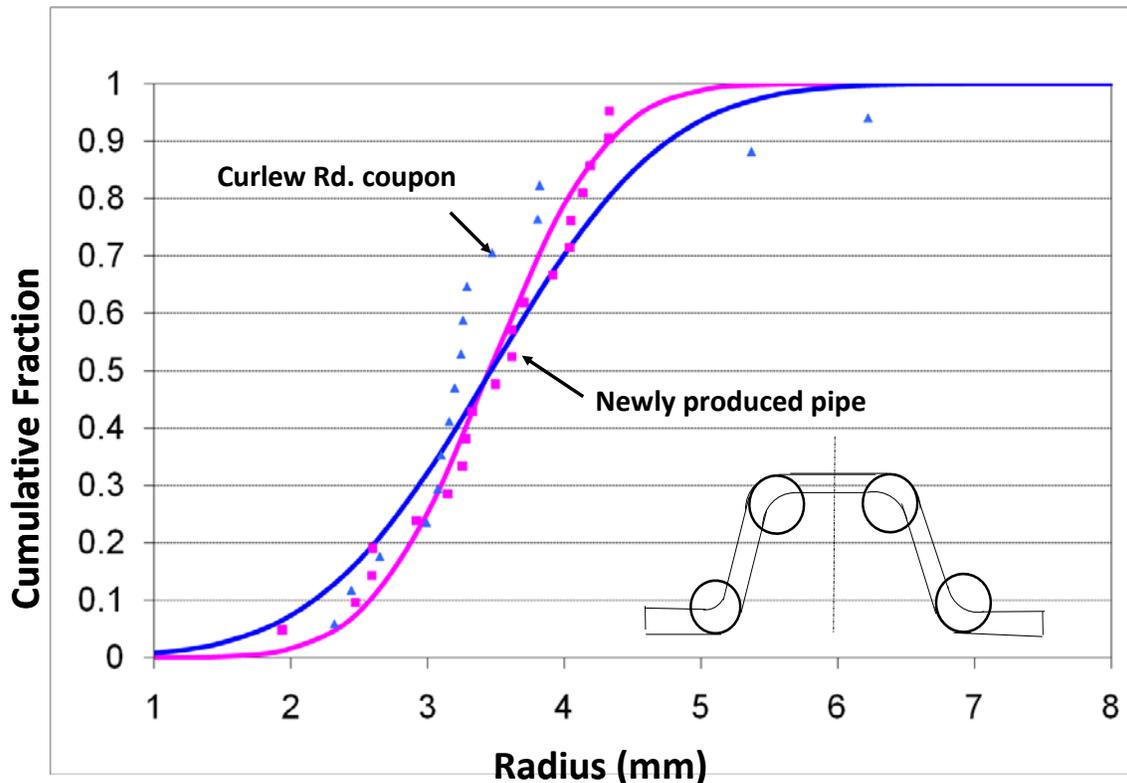
Figure 5-12. Comparison of cumulative distributions of rib outer radius of curvature (mm) between samples from a newly produced aluminized steel type 2 pipe and from a pipe once installed at the Curlew Road site. The schematic shows the position of the circles fit to each bend for each cross section.

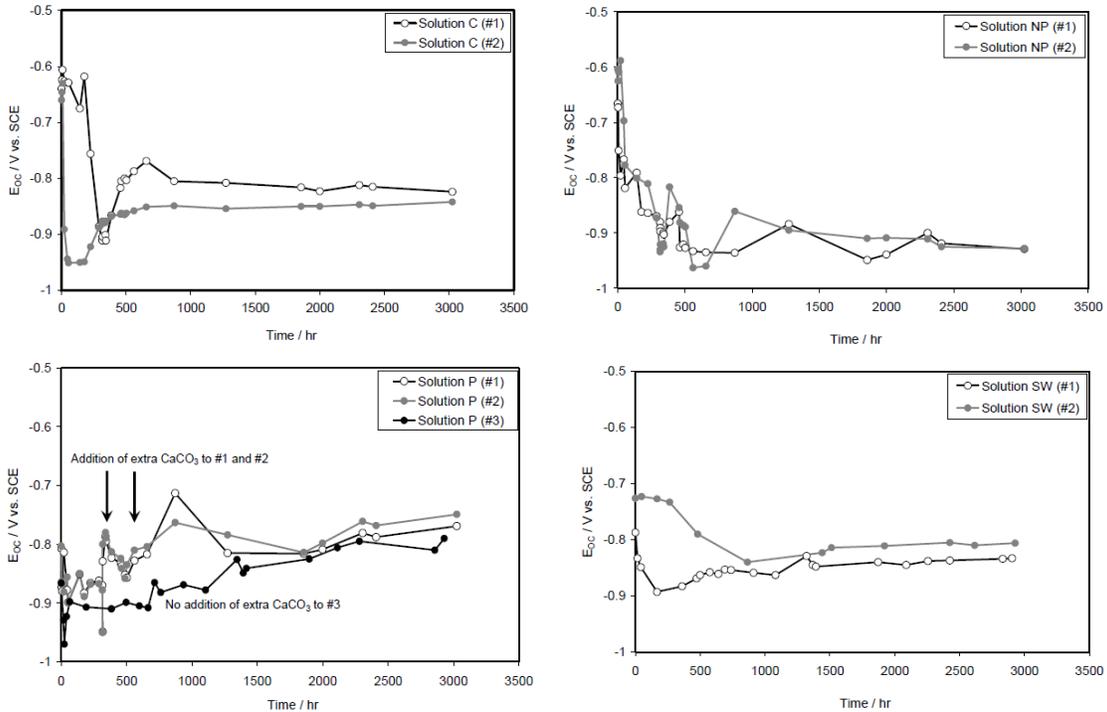
Figure 6-4. Eoc evolution of as-received aluminized steel type 2 replicate specimens in solution C (top left), solution NP (top right), solution P (bottom left) (arrows indicate two CaCO₃ additions to test cells #1 and #2), and solution SW (bottom right). Exposure ended at the time that the last datum was taken.

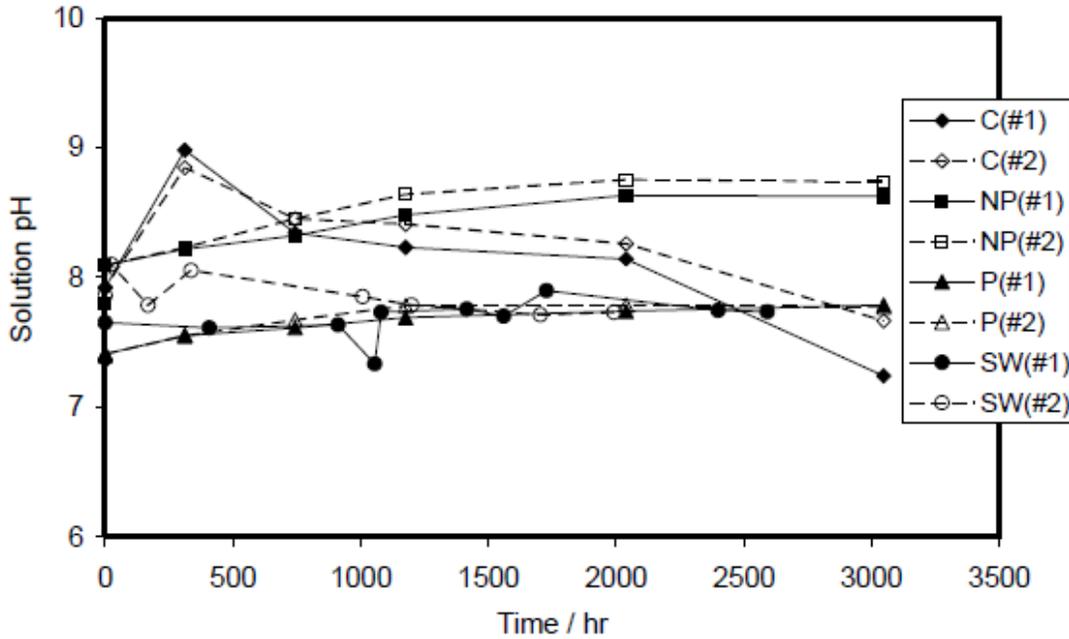
Figure 6-5. Evolution of the solution bulk pH for as-received aluminized steel type 2 specimens exposed to waters with varying scaling tendencies.

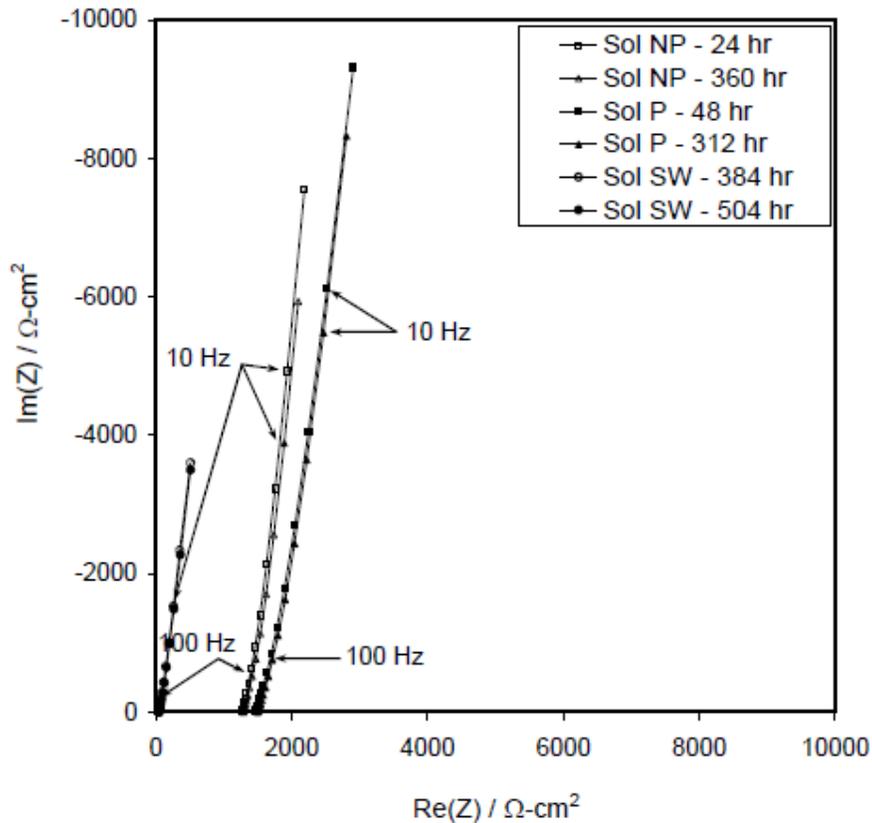
Figure 6-6. Typical electrochemical impedance spectroscopy (EIS) plot of the high-frequency limit for solutions NP, P, and SW.

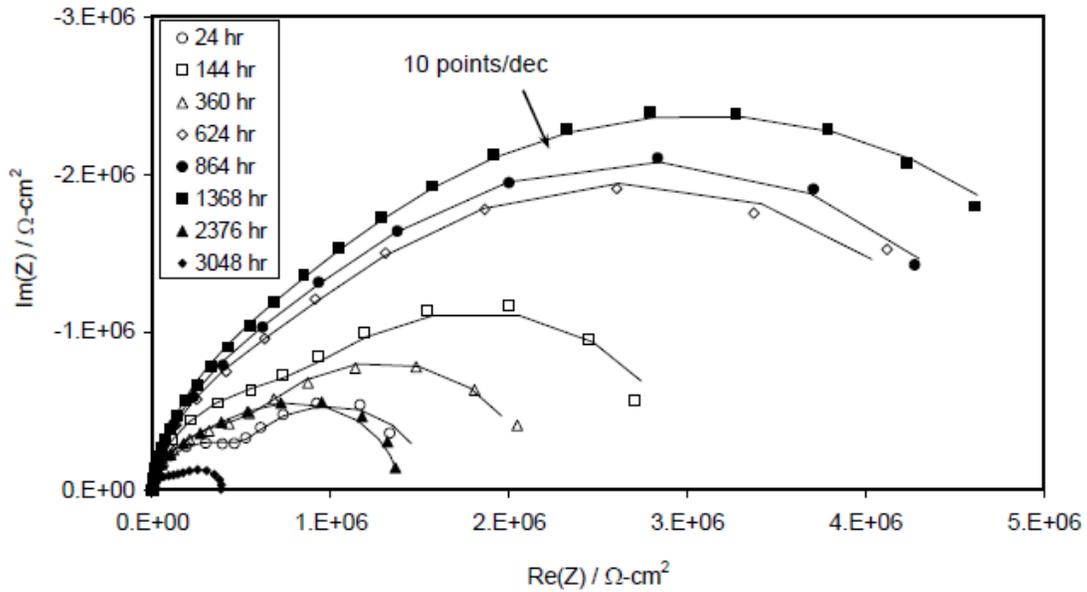
Figure 6-7. EIS behavior of as-received aluminized steel type 2 specimen #1 in solution NP (100 KHz-1 mHz - 5 points/decade unless indicated otherwise).

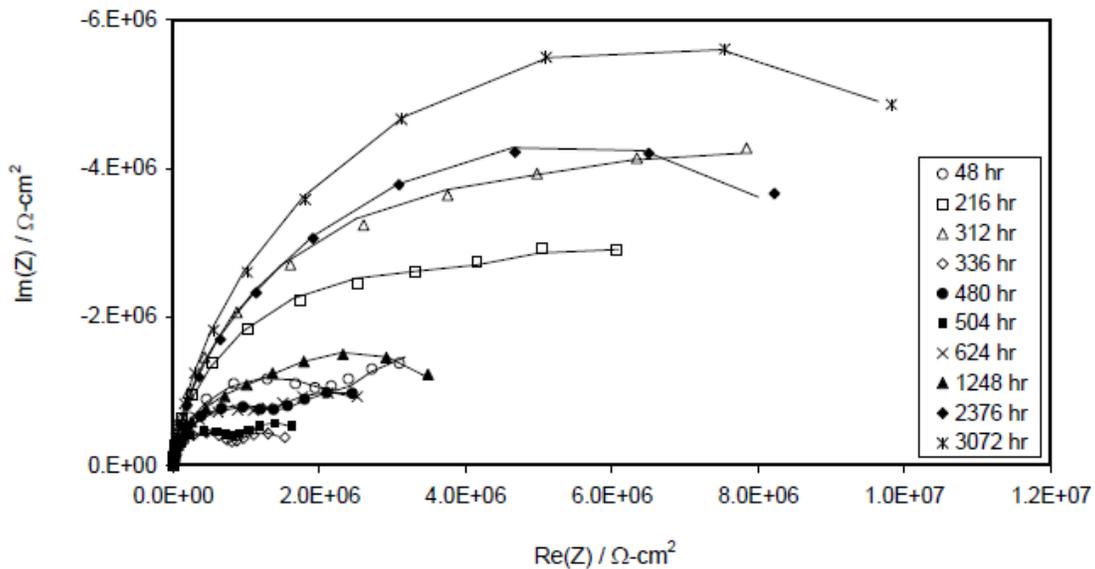
Figure 6-8. EIS behavior of as-received aluminized steel type 2 specimen #1 in solution P (100 KHz - 1 mHz – 5 points/decade).

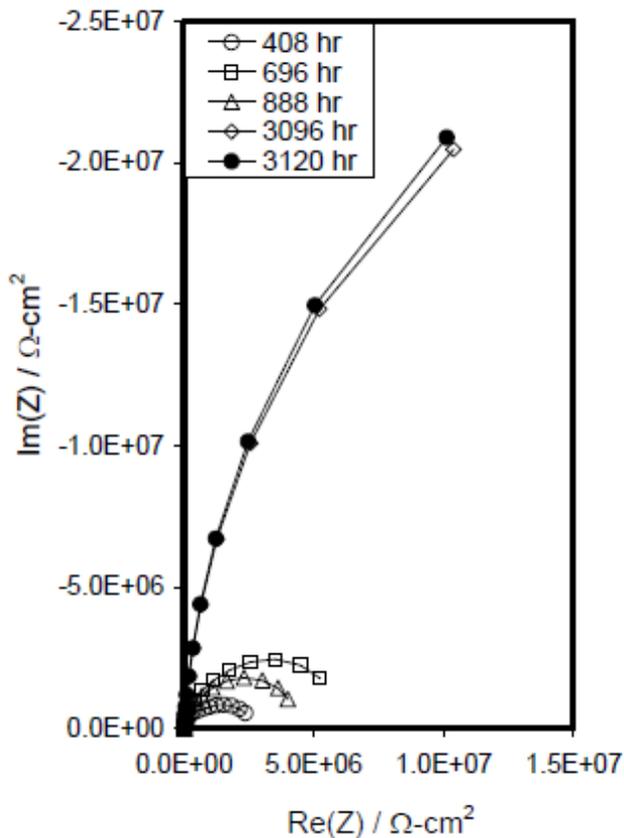
Figure 6-9. EIS behavior of as-received aluminized steel type 2 specimen #3 in solution P (100 KHz - 1 mHz – 5 points/decade).

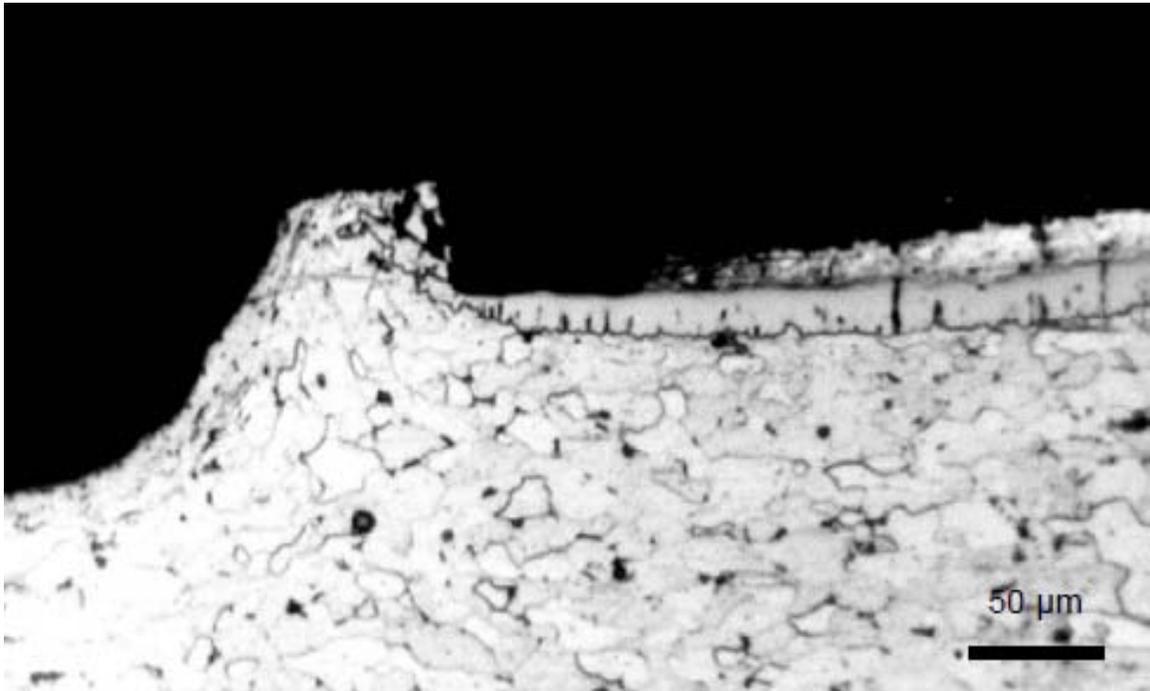
Figure 6-12. Cross section of blemished aluminized steel type 2 LCB specimen #1 exposed to solution NP showing complete outer coating loss surrounding the exposed steel.

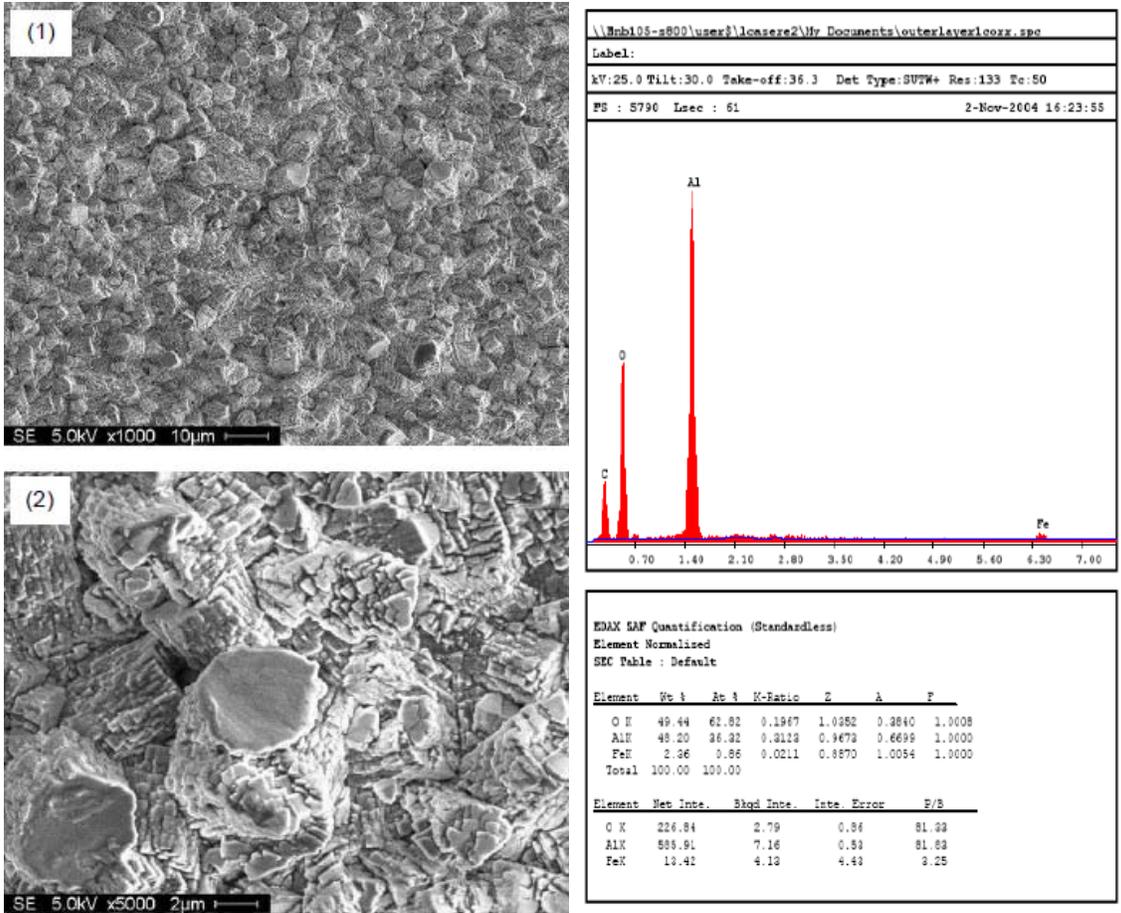
Figure 6-13. SEM image (left): (1) 1000x magnification and (2) 5000x magnification of the surface morphology of blemished aluminized steel type 2 LCB specimen #1 in solution NP taken after the end of exposure. SEM-EDS analysis (right) of corrosion deposits on the aluminized surface.

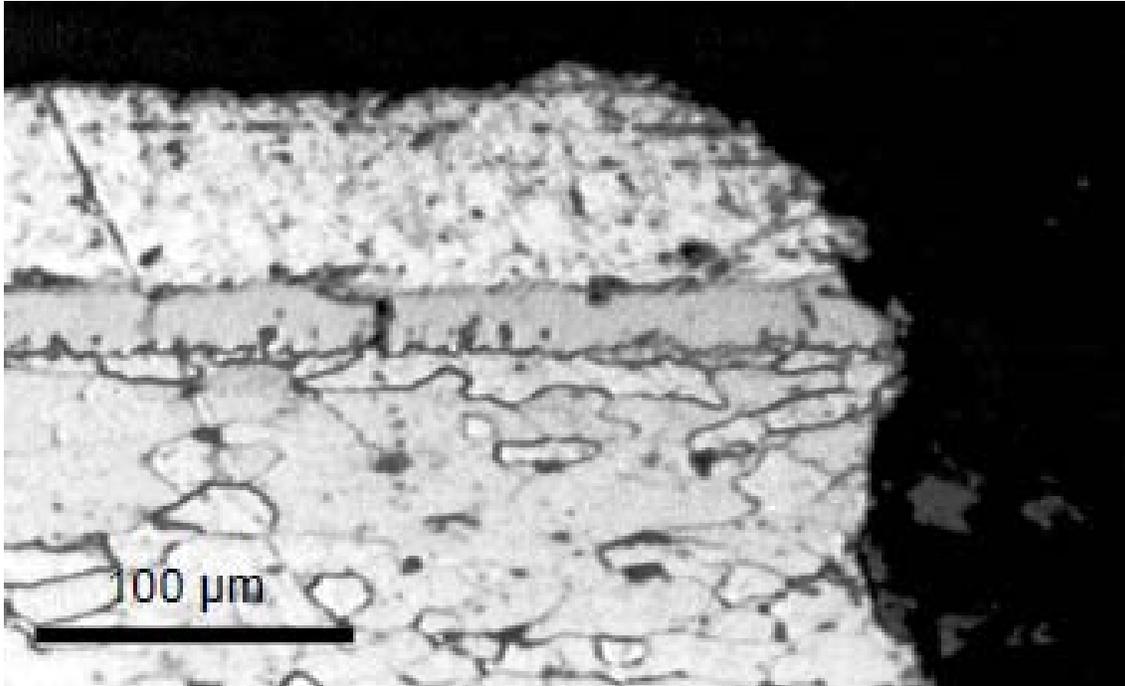
Figure 6-14. Cross section of the LCB specimen #1 exposed to solution SW near the edge of the exposed steel.

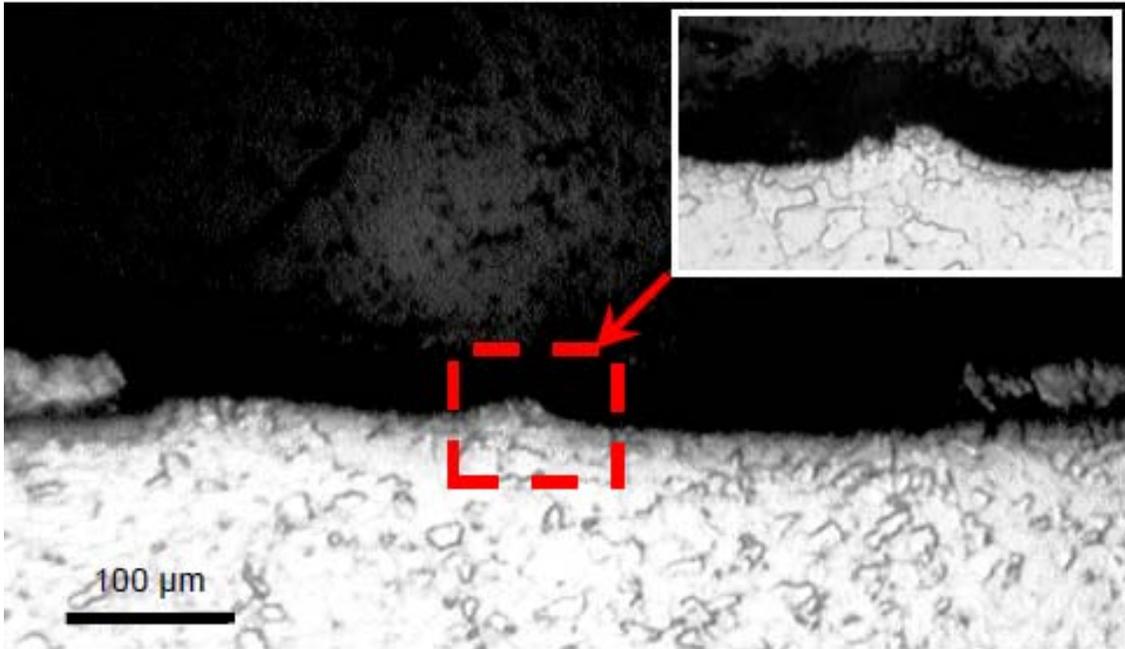
Figure 6-15. Cross section of the blemished aluminized steel type 2 SCB specimen #1 exposed to solution C showing that a pit ~0.5 mm diameter that reached the underlying steel.

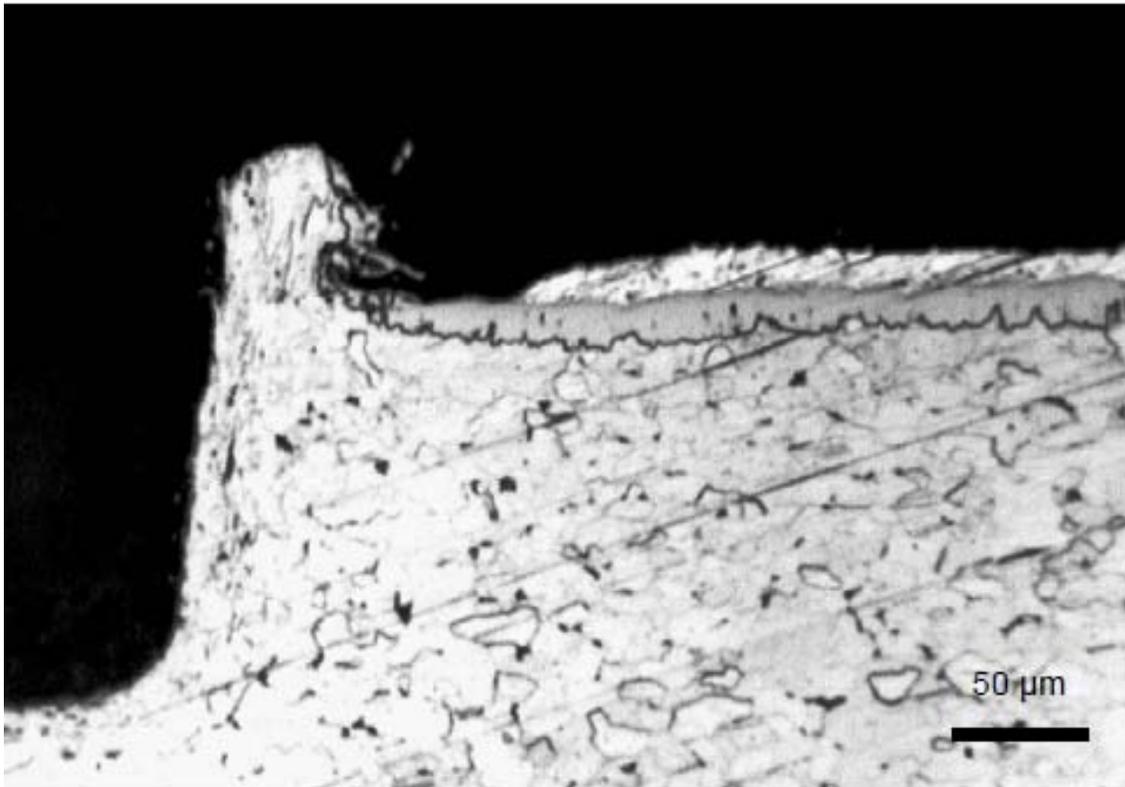
Figure 6-16. Cross section of blemished aluminized steel type 2 SCB specimen #1 exposed to solution NP showing complete outer coating loss surrounding the exposed steel.

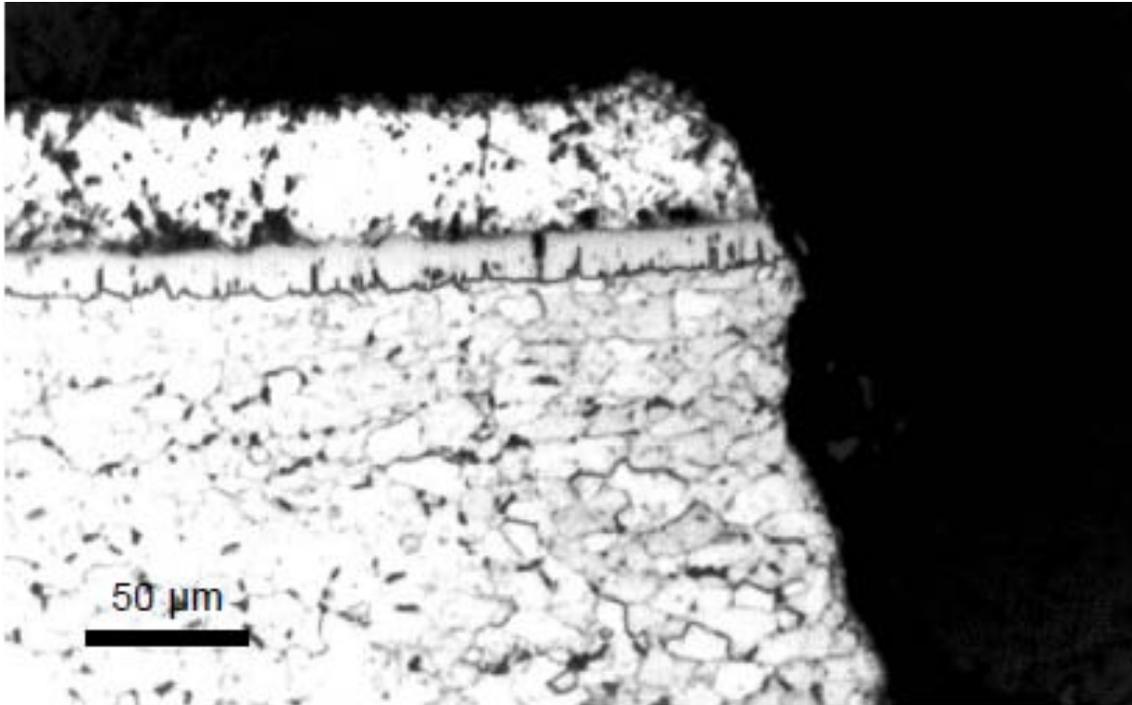
Figure 6-17. Cross section of of blemished aluminized steel type 2 SCB specimen #1 exposed to solution SW near the exposed steel region.

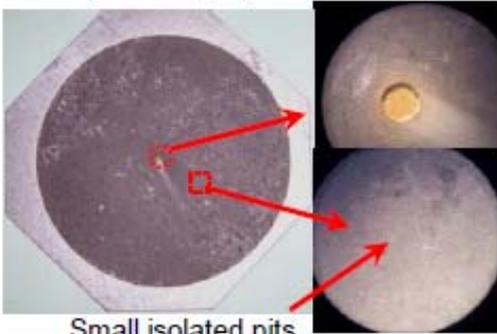
SCB specimen (#1) in Sol NP

Figure 6-18. Post-exposure photographs of selected blemished aluminized steel type 2 specimens.

The exposed steel of the SCB specimens in solution C showed corrosion in only one (#1) of the triplicate specimens, an early formation of a thin reddish scale (likely rich in Fe^{2+}) that later developed to form a layer ~<300 μm thick on top of the steel. No signs of corrosion were observed in either replicate #2 or #3, where the steel spot remained bright over the entire test period. The replicate individual steel specimens in solution C showed early formation of corrosion deposits distributed over the entire surface of similar appearance to that noted in the SCB specimen #1. The exposed steel of the SCB specimens in solution SW was bright and free of corrosion scale throughout the entire exposure, and there was only very light steel discoloration with no corrosion deposits of the LCB specimens in solution SW. Selected photographs of the LCB and SCB specimens taken after exposure and after cleaning are shown in Figure 6-18.

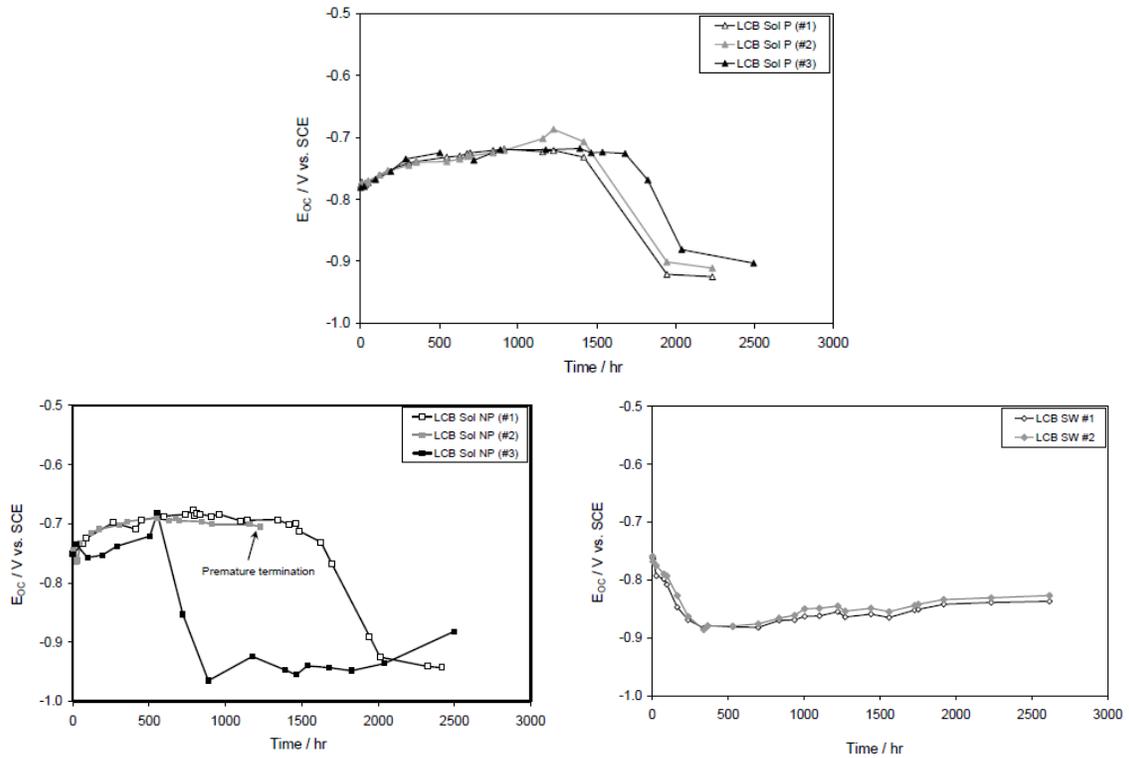
Figure 6-19. E_{OC} evolution in blemished aluminized steel type 2 LCB specimens in solution P (top), solution NP (bottom left), and solution SW (bottom right). Exposure ended at the time that the last datum was taken.

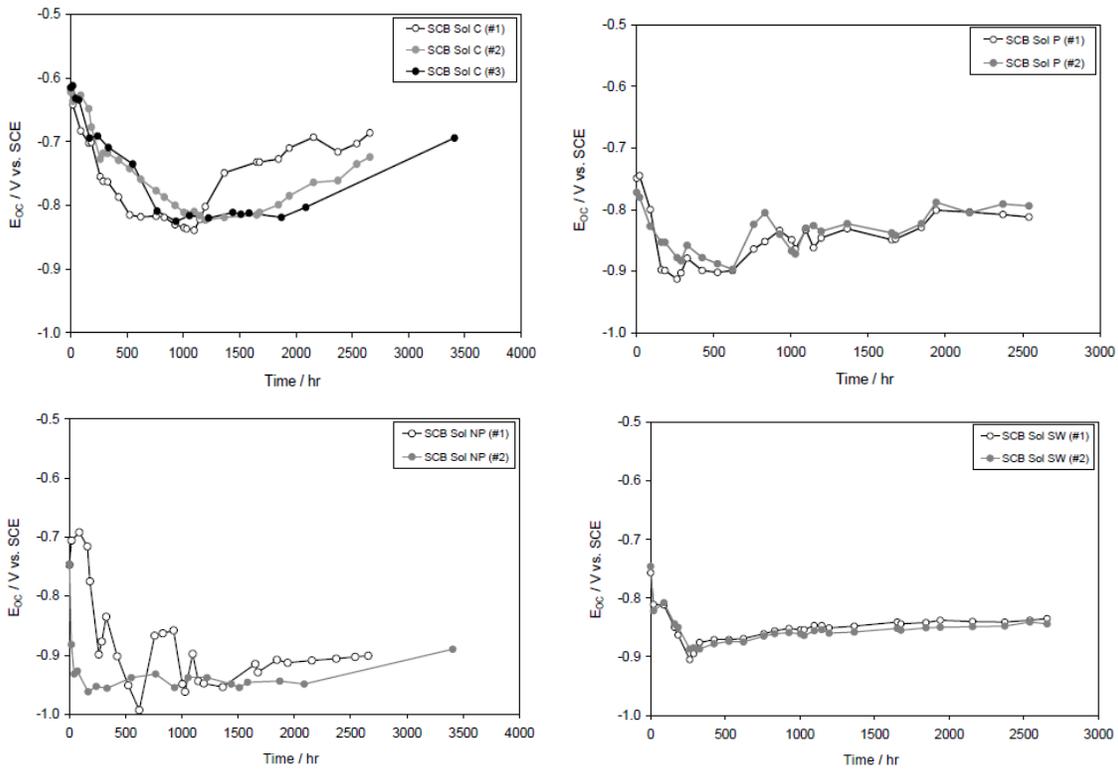
Figure 6-20. E_{OC} evolution as a function of time in blemished aluminized steel type 2 SCB specimens exposed to solution C (top left), solution P (top right) (test exposures were terminated ~450 hr after the last datum), solution NP (bottom left), and solution SW (bottom right). Exposure ended at the time that the last datum was taken, except as noted.

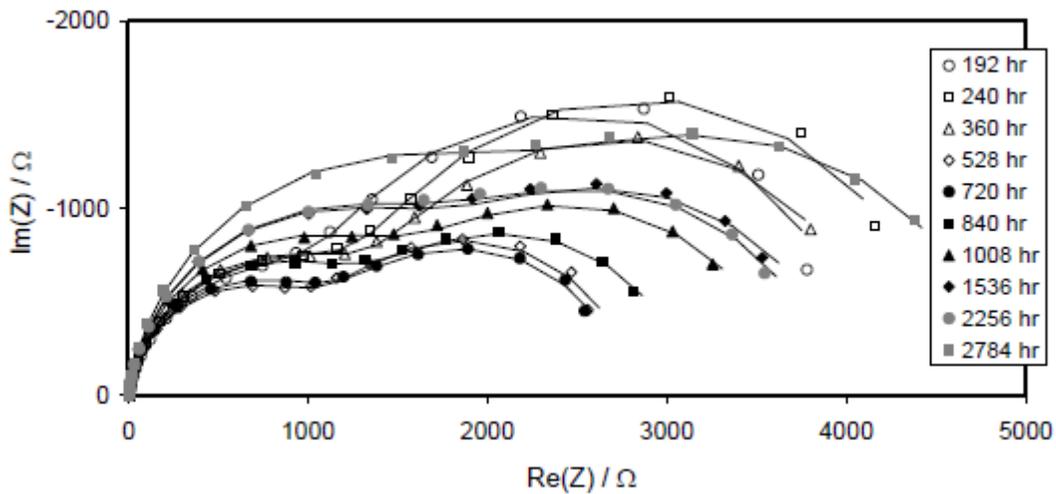
Figure 6-25. Nyquist plot of the impedance response of the LCB specimen #1 in solution SW (100 KHz - 1 mHz - 5 points/decade).

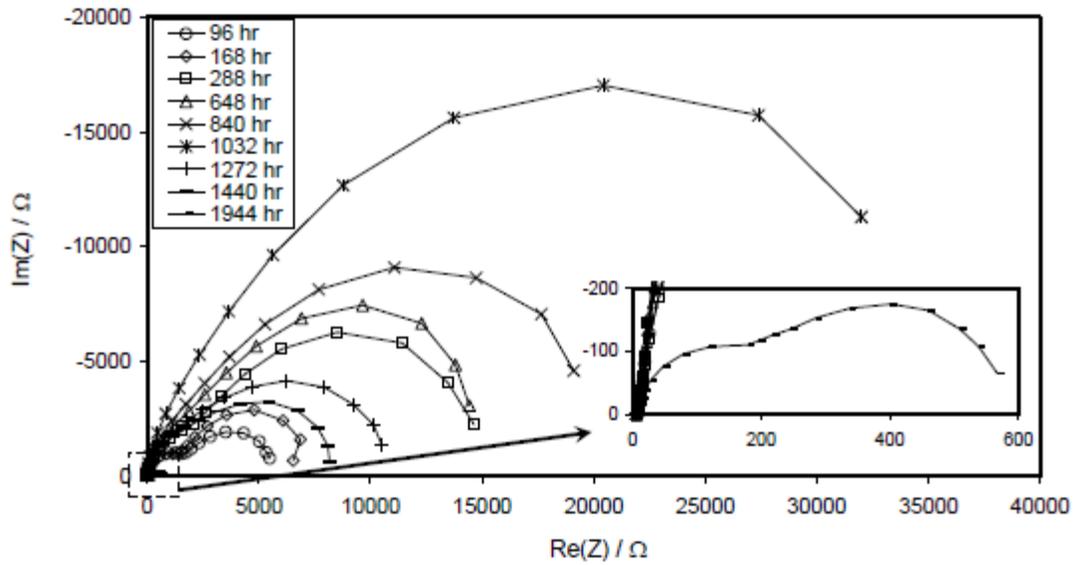
Figure 6-26. Nyquist plot of impedance response for blemished aluminized steel type 2 SCB specimen #1 in solution NP (100 KHz - 1 mHz - 5 points/decade).

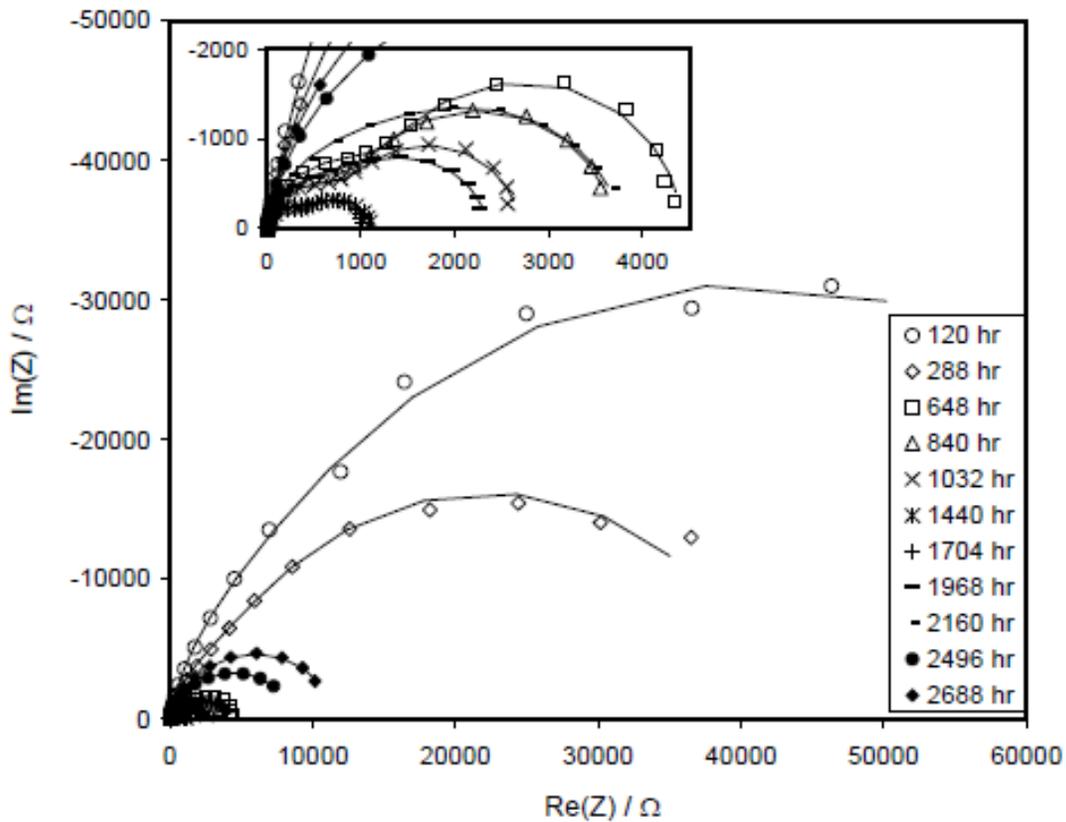
Figure 6-30. Nyquist plot of impedance response for blenished aluminized steel type 2 SCB specimen #2 in solution C (100 KHz-1 mHz - 5 points/decade).

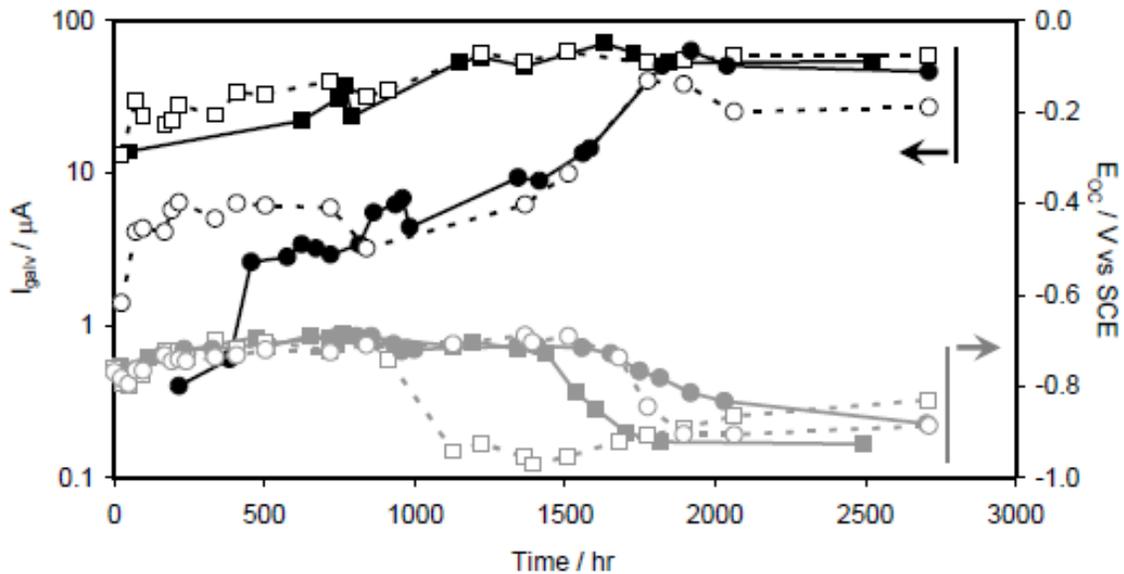
Figure 6-31. E_{oc} and galvanic current I_{galv} measurements for the macrocell assemblies exposed to solutions P (circles) and NP (squares). The steel components were always net cathodes.

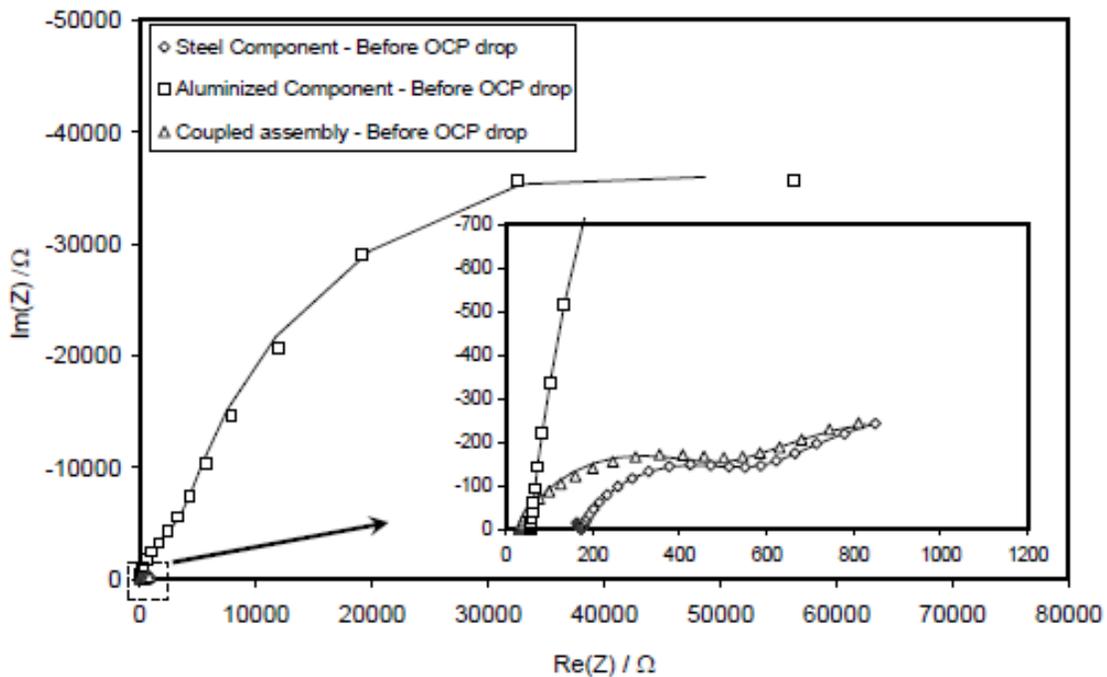
Figure 6-32. Nyquist plot of the impedance response of the macrocell assembly and the individual components exposed to solution P (100 kHz–1 mHz, 5 points/decade) before ($\sim 900 \text{ hr}$) the E_{OC} drop.

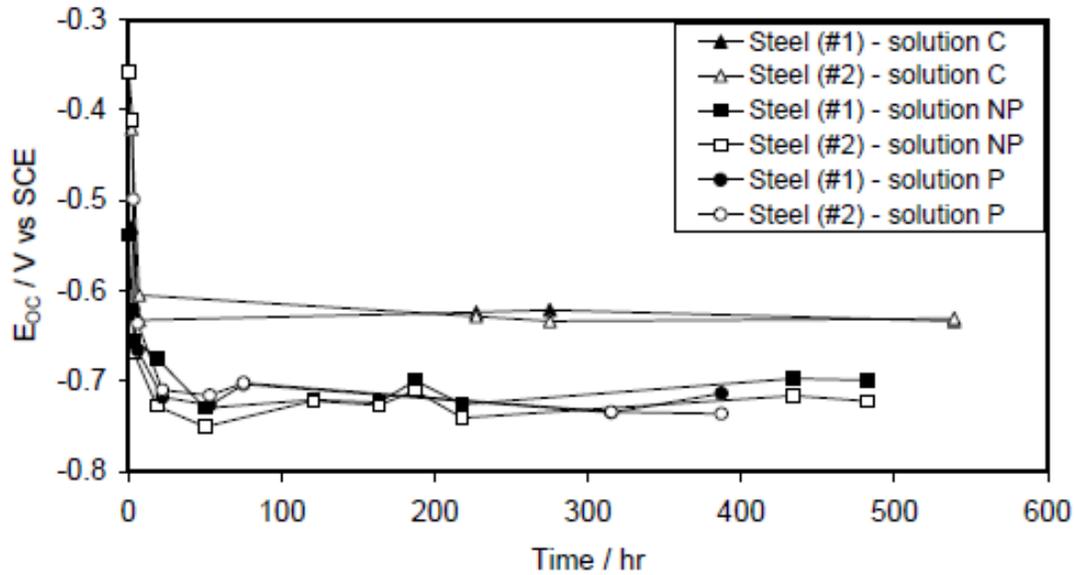
Figure 6-36. E_{OC} evolution as a function of time of in macrocell replicate uncoupled steel specimens. Exposure ended at the time that the last datum was taken.

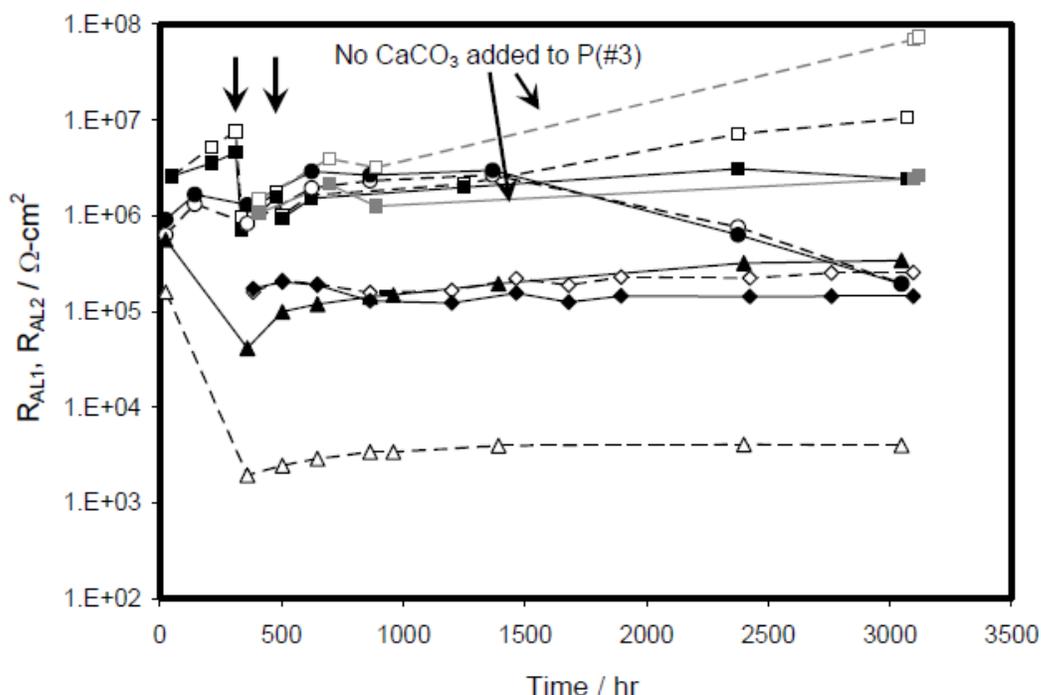
Figure 6-41. Evolution of the resistive components as a function of exposure time for for as-received aluminized steel type 2 specimens #1 in solutions NP (circles), P (squares), C (triangles), and SW (diamonds) (--- R_{AL1} , — R_{AL2}). Arrows indicate CaCO_3 additions to solution P (#1).

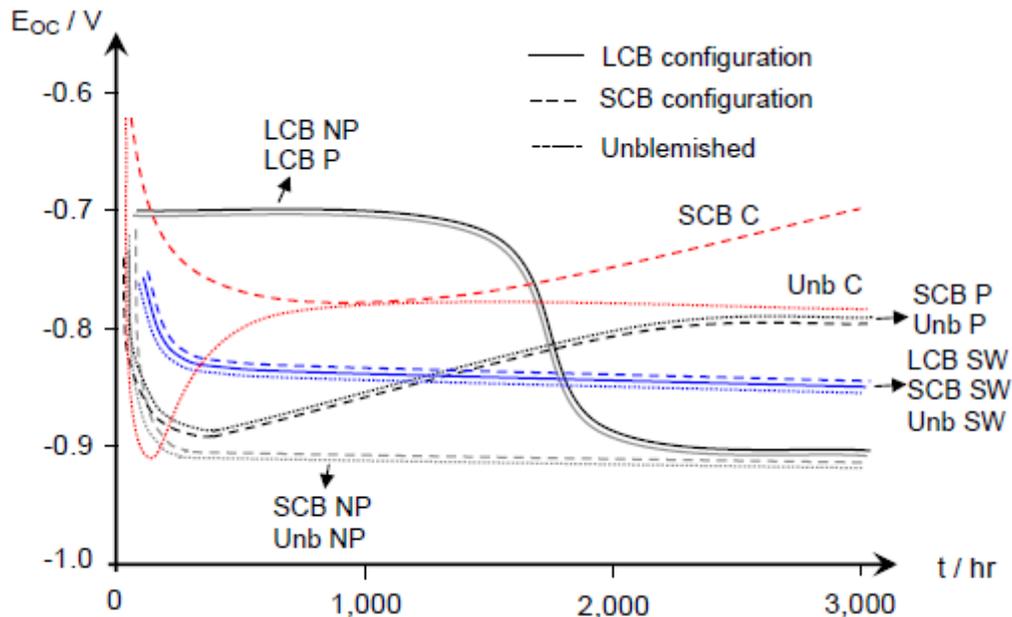
Figure 6-43. Schematic of the E_{OC} trends shown in Figures 6-23 through 6-29.

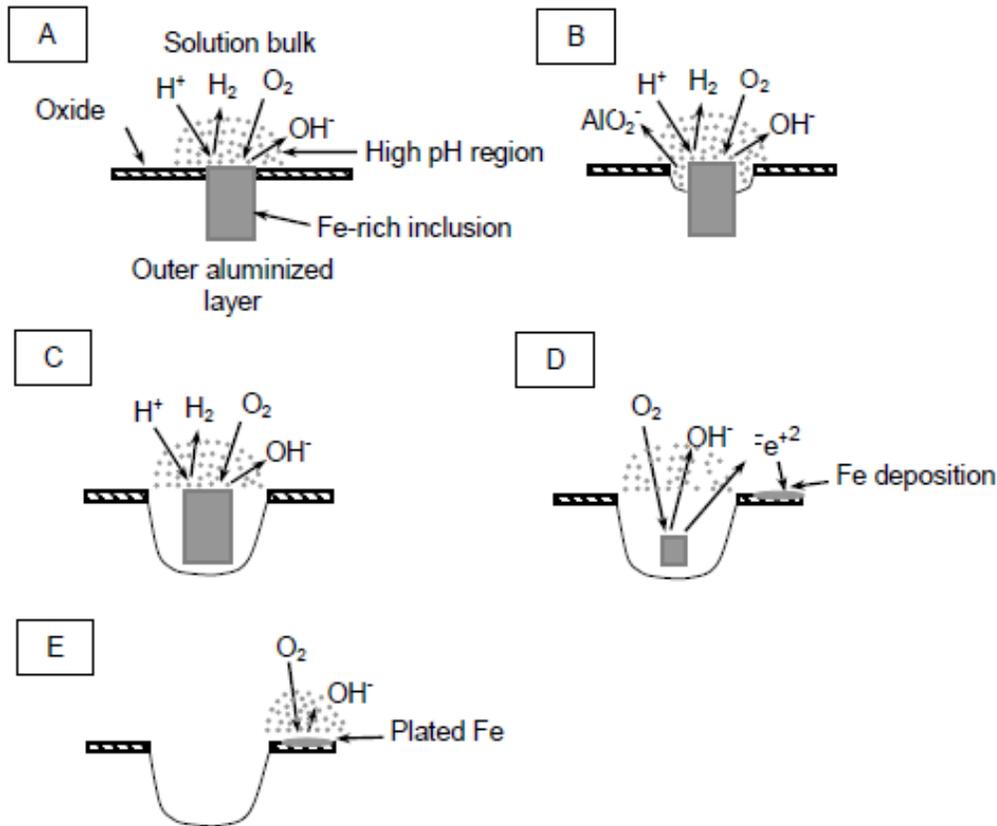
Figure 6-44. Schematic description of the corrosion mechanism of aluminized steel around the Fe-rich inclusion present in the outer aluminized layer: (A) development of high pH region around the inclusion due to the cathodic reaction, (B) corrosion initiation of the surrounding aluminum exposing larger inclusion area with consequent enhancement of the cathodic reaction, (C) detachment of the inclusion as a free particle from the aluminum matrix, (D) dissolution of the free particle and plating of Fe on aluminized surface, (E) development of a high pH region around the plated Fe (after Vukmirovic et al. (2002)).

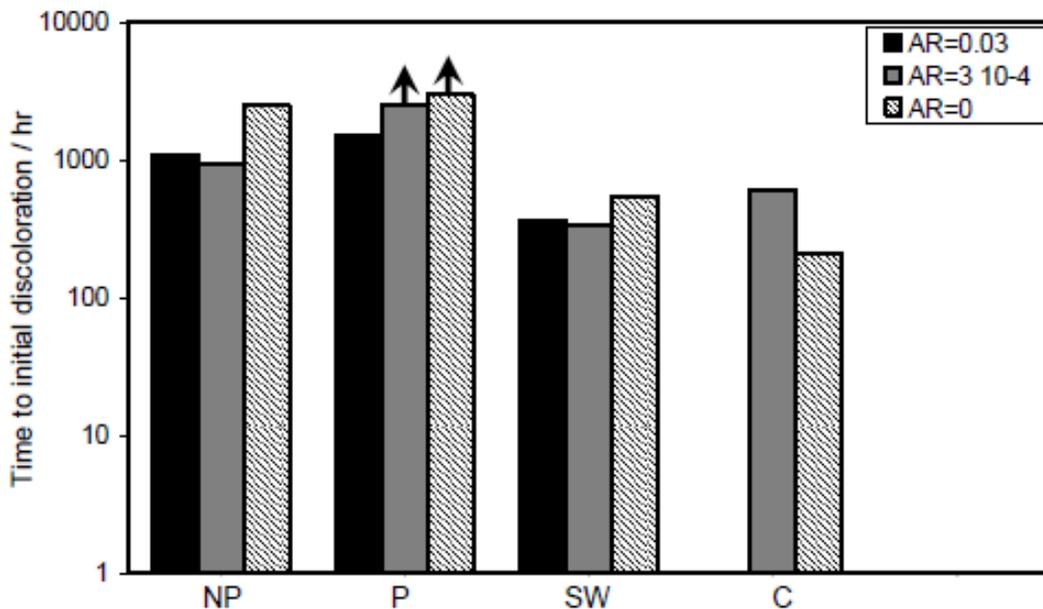
Figure 6-47. Average of the time to initial discoloration of blemished aluminized steel type 2 replicate specimens as a function of A_R . Results for $A_R = 0$ and $A_R = 3 \times 10^{-4}$ in solution P are minimum values as indicated by the arrows.

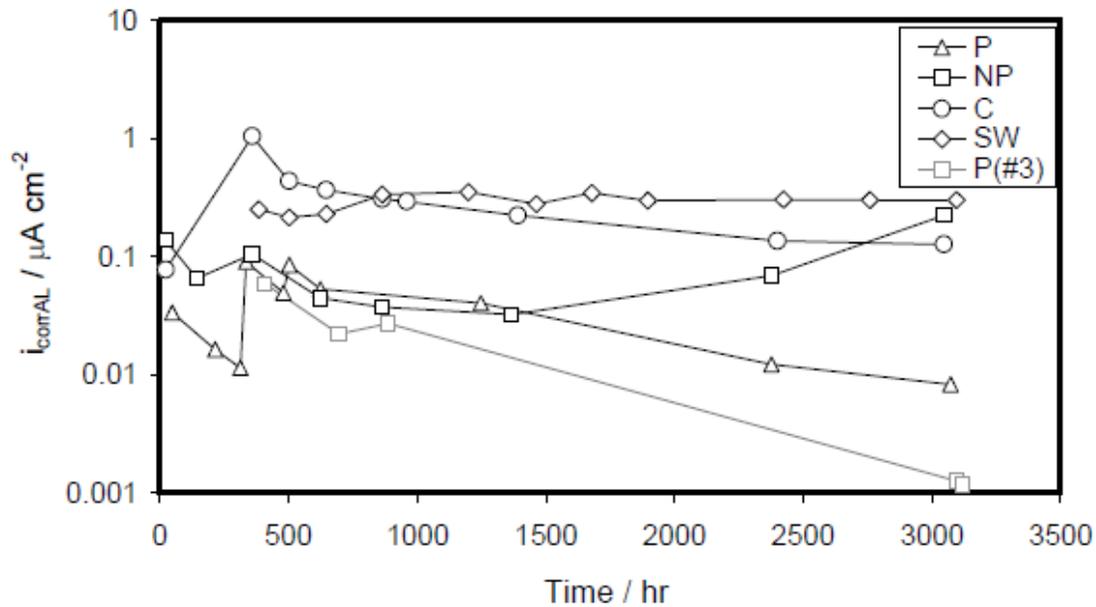
Figure 6-48. Nominal corrosion current density evolution for as-received aluminized steel type 2 specimens (#1) in all media. No extra powdered CaCO_3 was added to the triplicate specimen in solution P (#3).

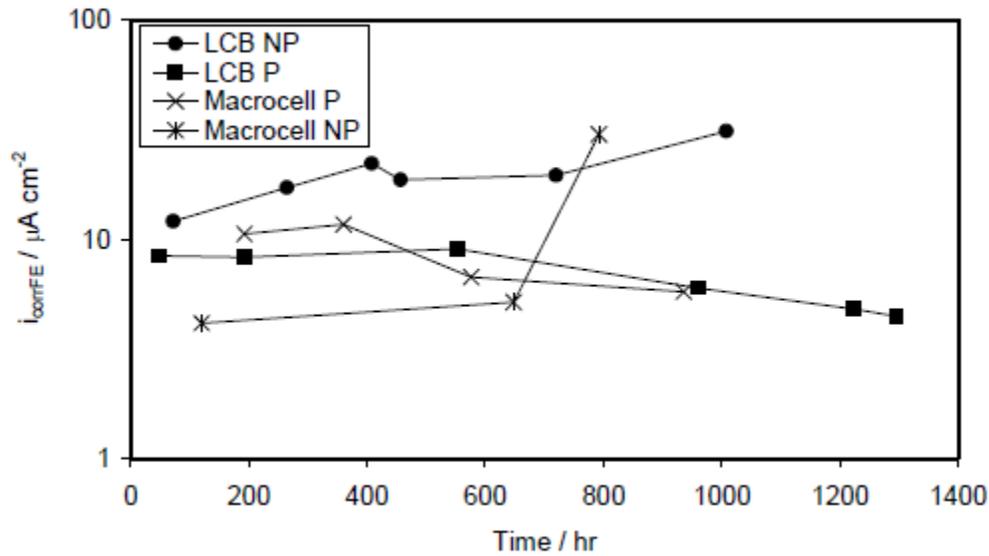
Figure 6-49. Evolution of i_{corrFE} of the exposed steel portion for the LCB specimens (#1) in solutions NP and P obtained per analog equivalent circuit shown in Figure 6-46A and the steel component in the macrocell assemblies obtained per the upper branch of the analog equivalent circuit in Figure 6-45.

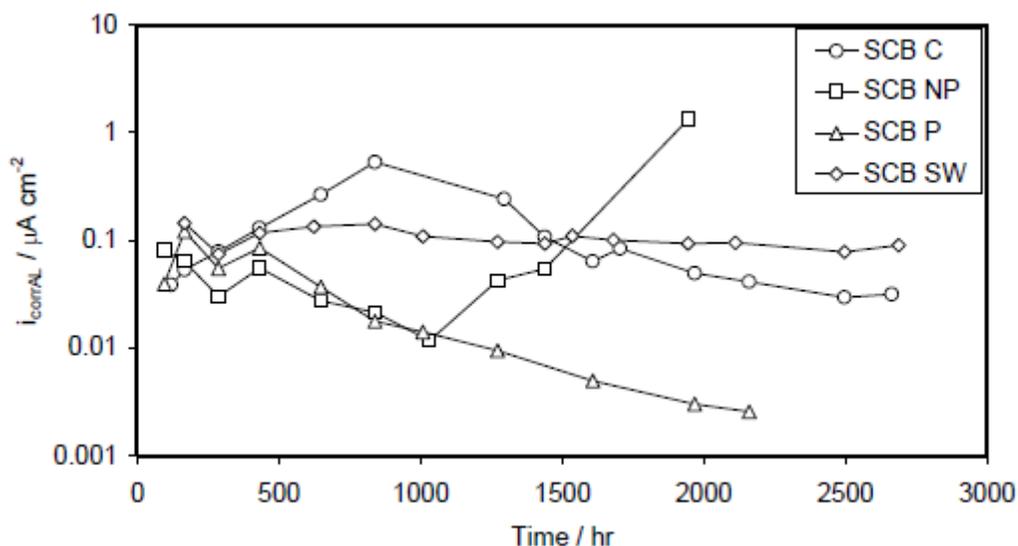
Figure 6-51. Evolution of i_{corrAL} of the aluminized portion for the SCB specimens (#1) obtained using the analog equivalent circuit shown in Figure 6-46B.
