**DEVELOPMENT OF A RATIONAL METHOD FOR PREDICTING CORROSION
RATES OF METALS IN SOILS AND WATERS**

Contract No. BD497

Final Report to Florida Department of Transportation

**University of South Florida
Tampa, FL 33620
October 31, 2009**

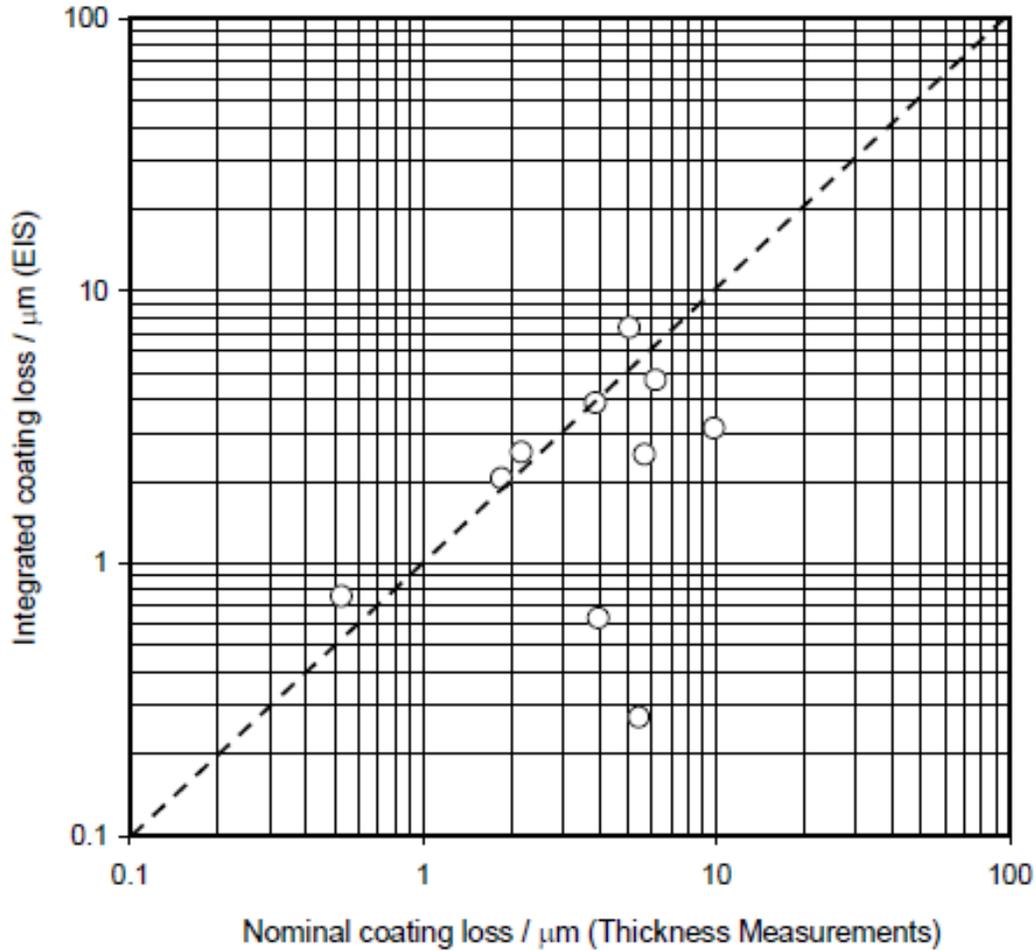
Figure 6-52. Correlation between the integrated coating loss obtained by EIS and the nominal coating thickness loss determined by magnetic coating thickness measurements for selected specimens shown in Table 6-4.

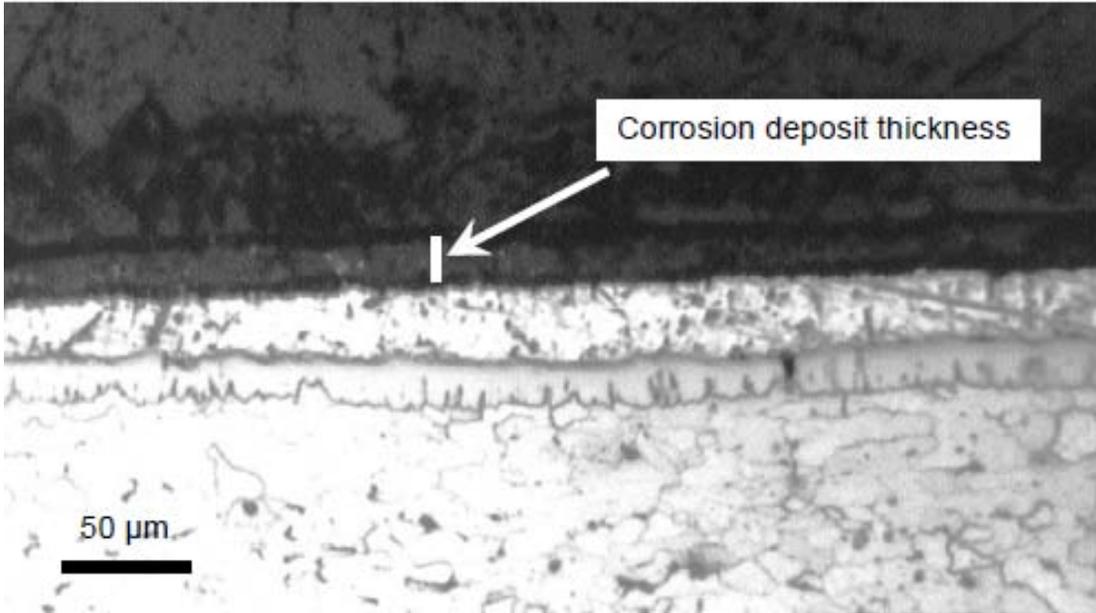
Figure 6-53. Cross section of the LCB specimen #1 exposed to solution NP. The dark outer layer covering the entire outer aluminized coating layer corresponds to corrosion deposits of ~10-15 μm thick.

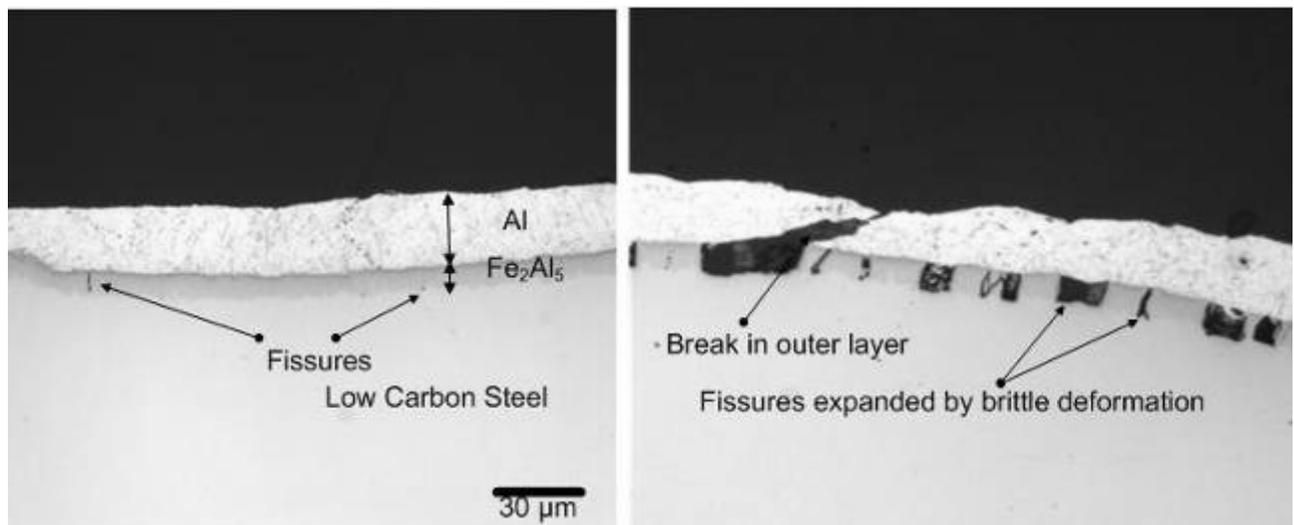
Figure 7-1. Flat specimen (left), bent specimen (right).

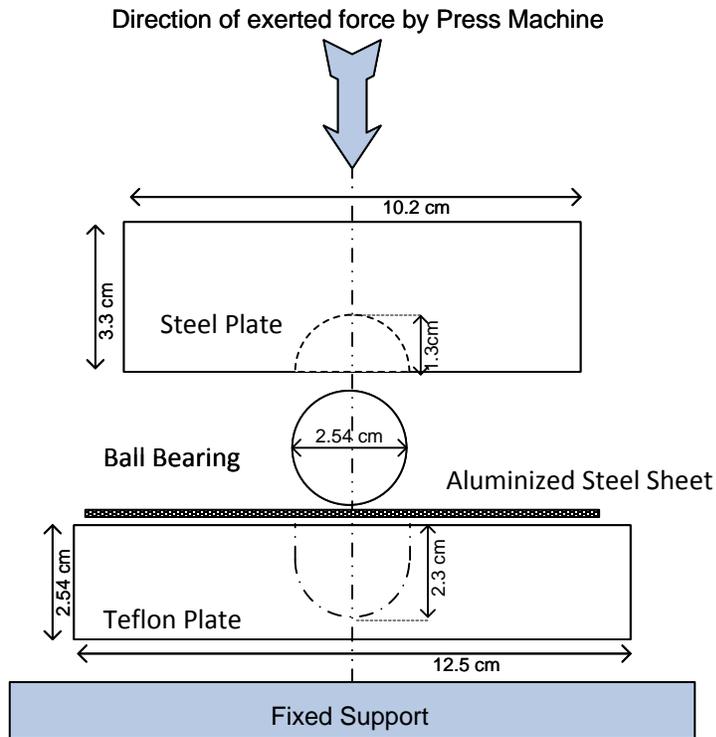
Figure 7-2. Schematic of indentation arrangement (not to scale).

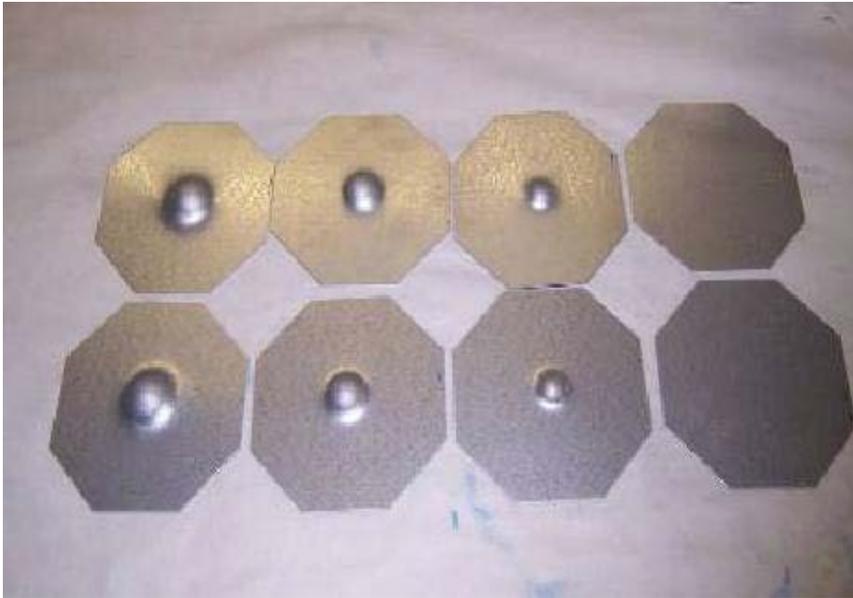
Figure 7-3. Duplicate specimens indented to (left to right) 2.54 cm (1 in), 1.90 cm, (3/4 in), 1.43 cm (9/16 in), and flat.

The specially prepared specimens were made of octagonal portions of 1.52-mm (16-gage) aluminized steel sheet with minimal as-received surface distress. These specimens were indented at the center to a roughly hemispherical dimple shape using steel ball-bearing balls with diameters of 2.54 cm (1 in) , 1.90 cm (3/4 in), and 1.43 cm (9/16 in) (Figure 7-2). The indentation was made by pressing the bearing ball, socketed in a steel plate, into the initially flat specimen. Guide rods in the press assembly assisted in centering the indentation. An indented Teflon plate was used to protect the convex face of the sample until nominally full hemispheric penetration was achieved. Figure 7-3 shows the

appearance of the dimpled specimens. The convex face was the one later exposed to the test solution. After forming, the specimens were cleaned with ethanol and acetone, and stored in a desiccator prior to immersion exposure to the test solution with a circular exposed area of 82 cm^2 (12.6 in^2) centered on the dimple. The dimple configuration with flat surroundings permitted placement in the test cell with a flat gasketed joint that avoided leaking and minimized risk of crevice corrosion at an unevenly sealed joint. Control flat specimens without surface indentation and similar exposed surface area were used for comparison. Specimens were tested in duplicate.

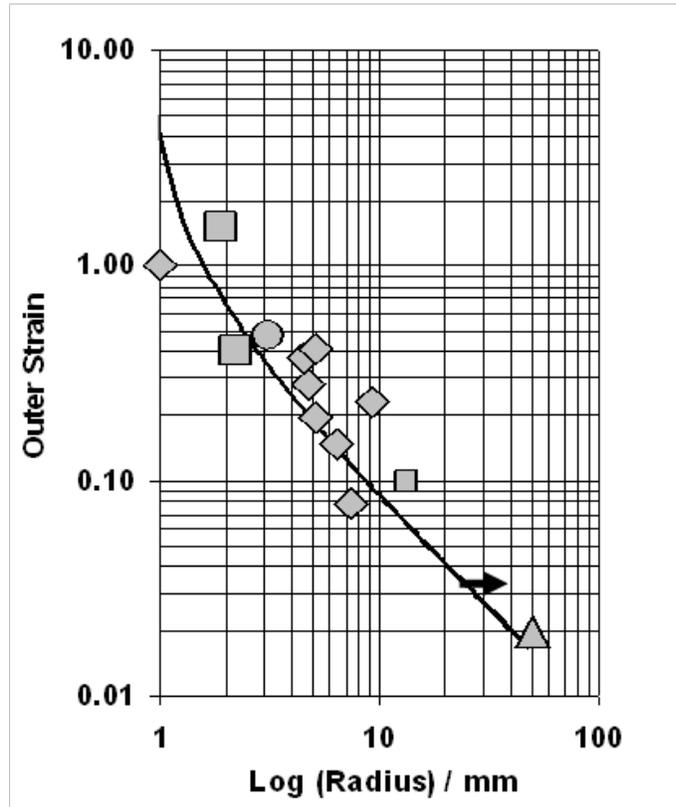
Figure 7-5. Outer strain ϵ_l (per Equation 7-1) (solid line) and ϵ_M per micrographic analysis of intermetallic layer gaps (symbols) as a function of radius of curvature for several samples.

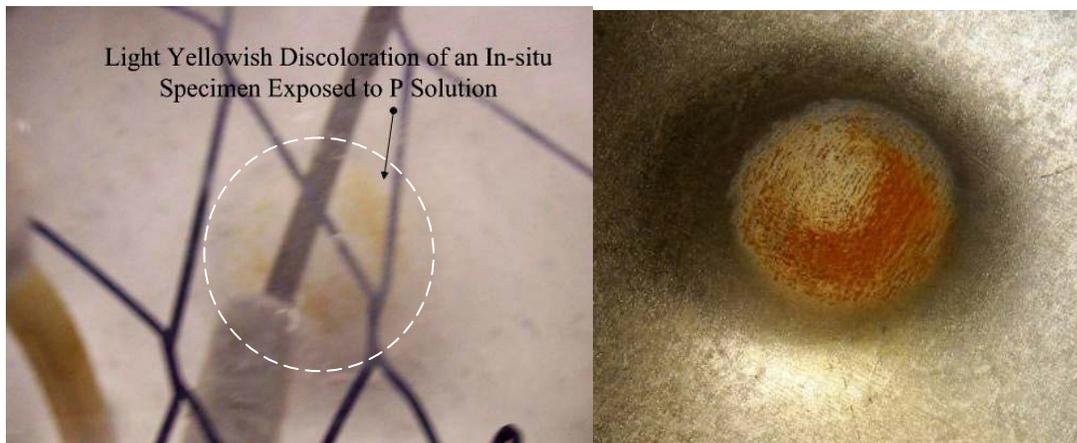
Figure 7-6. Light corrosion on a 2.54-cm (1-in) convex dimple immersed in solution P after 21 days of exposure (left) and severe corrosion on a 2.54-cm (1-in) convex dimple immersed in C solution after 19 days of exposure (right).

Visual examination of the specimen surfaces in solution P (high total alkalinity with carbonate precipitation) showed early appearance of light yellowish discoloration uniformly distributed over the convex indentation surface in all dimpled specimens tested, indicative of some corrosion (Figure 7-6, left). Symptoms were more severe in solution C (low alkalinity and no precipitating tendency), where appearance of strong reddish discoloration was first noted early on in the exposure around the convex indentation of all dimpled specimens, and gradually propagating covering the entire indentation surface (Figure 7-6, right). Corrosion appeared to be more intense for the 2.54-cm (1-in) diameter indentation specimens, although it is noted that the affected area was greatest for those even though maximum local strain may have been less severe than for the smaller radius indentation specimens. In both solutions, corrosion of the surrounding aluminized surface was minimal, suggesting little disruption of passive behavior there during the test interval sampled. Correspondingly, no sign of corrosion was observed in any of the flat surface specimens exposed to both solutions, suggesting good corrosion performance to date in those cases. Clearly, for the time being any galvanic protection from the aluminized portion

was insufficient to avoid initiation of active corrosion of the exposed steel especially in the C solution, in agreement with the results reported in Chapter 6 for specimens with machined coating breaks (Cáseres and Sagüés, 2006).

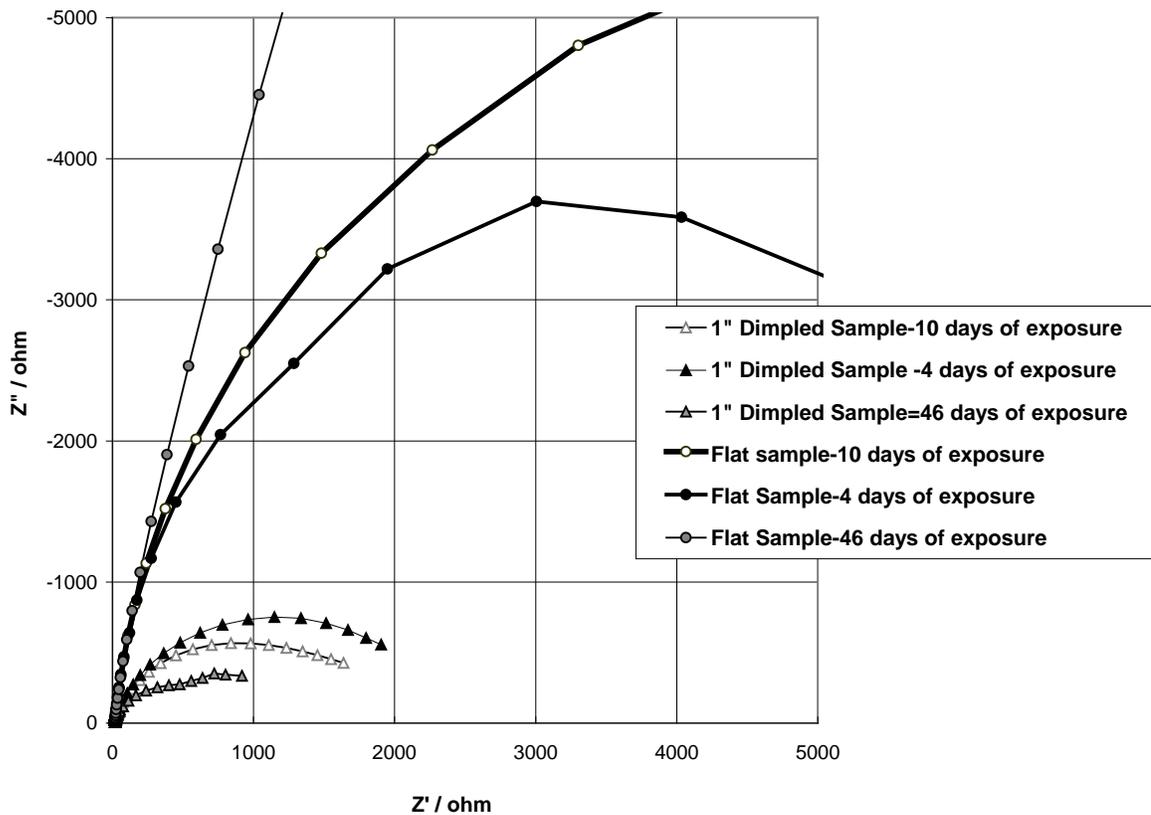
Figure 7-7. EIS results of the flat and 2.54-cm (1-in) indentation specimens exposed to solution C.

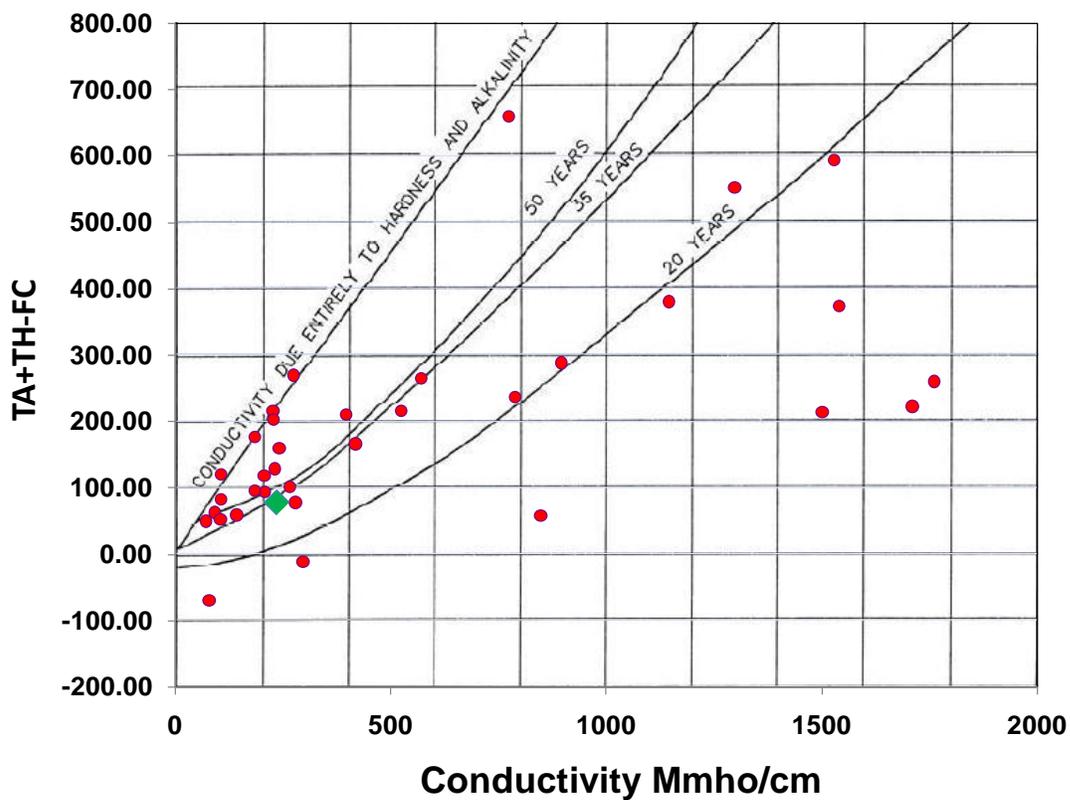
Figure 7-9. Alternative scaling index durability projection (Bednar 1989; Morris 1998) using water data from experimental solution (diamond) and other Florida fresh waters (circles). Diamond: Properties of Solution S.

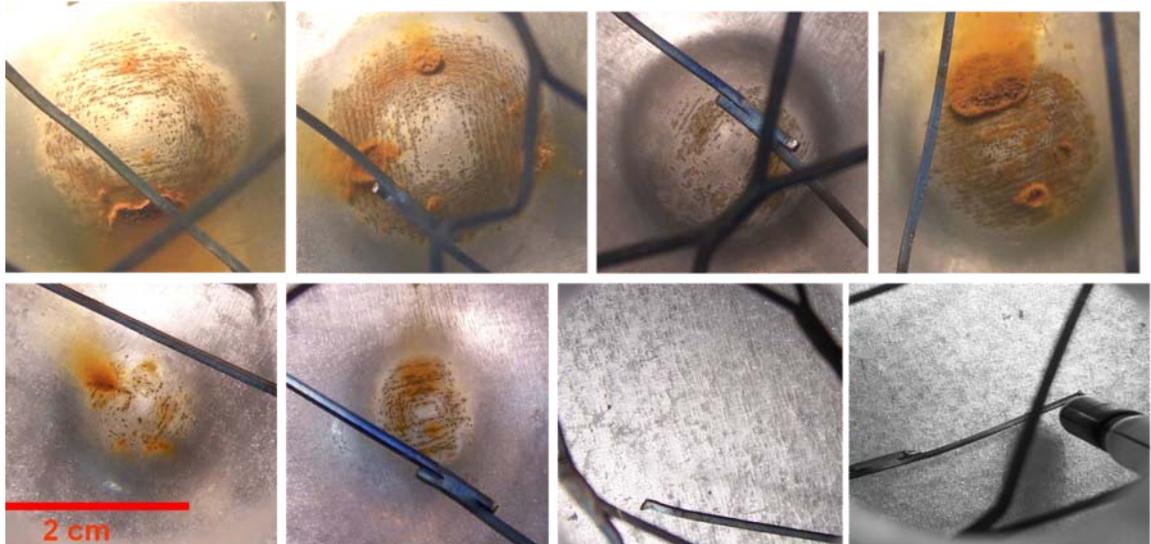
Figure 7-11. Visual comparison of corrosion development in formed and flat specimens immersed in Solution S at 26 days of exposure. Top row: from left to right, duplicate specimens with 2.54 (1-in) and 1.90 cm (3/4 in) dimples respectively. Bottom row: duplicate specimens with 1.43 cm (9/16 in) dimple and flat condition respectively.

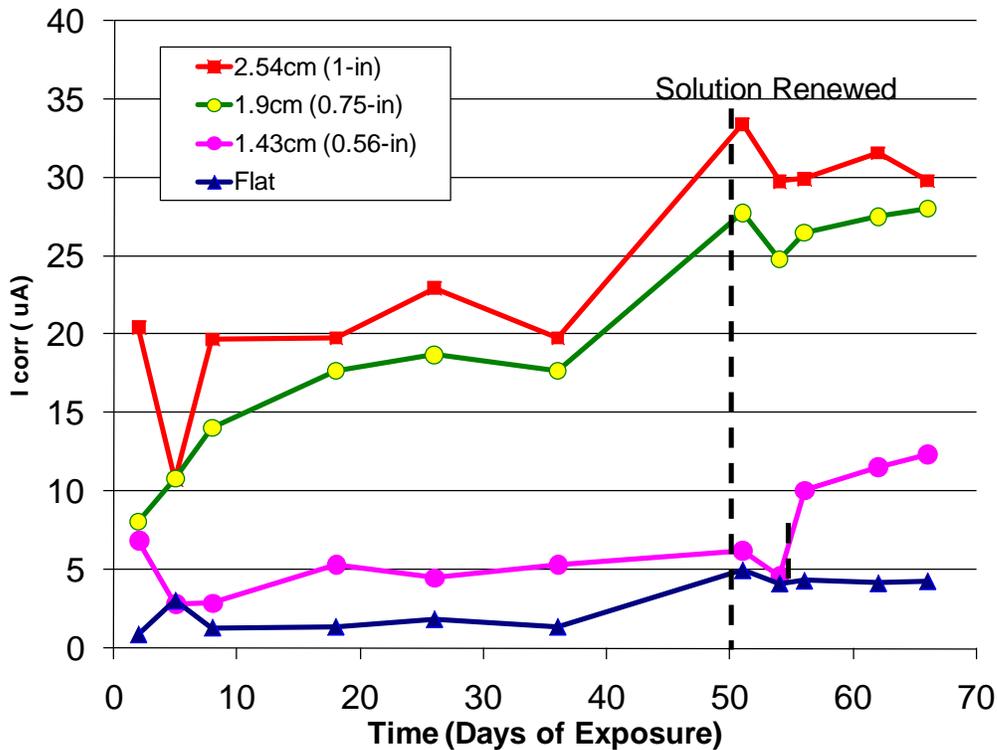
Figure 7-12. Corrosion rates over time for dimpled specimens. Solution S. Average of duplicate specimens.

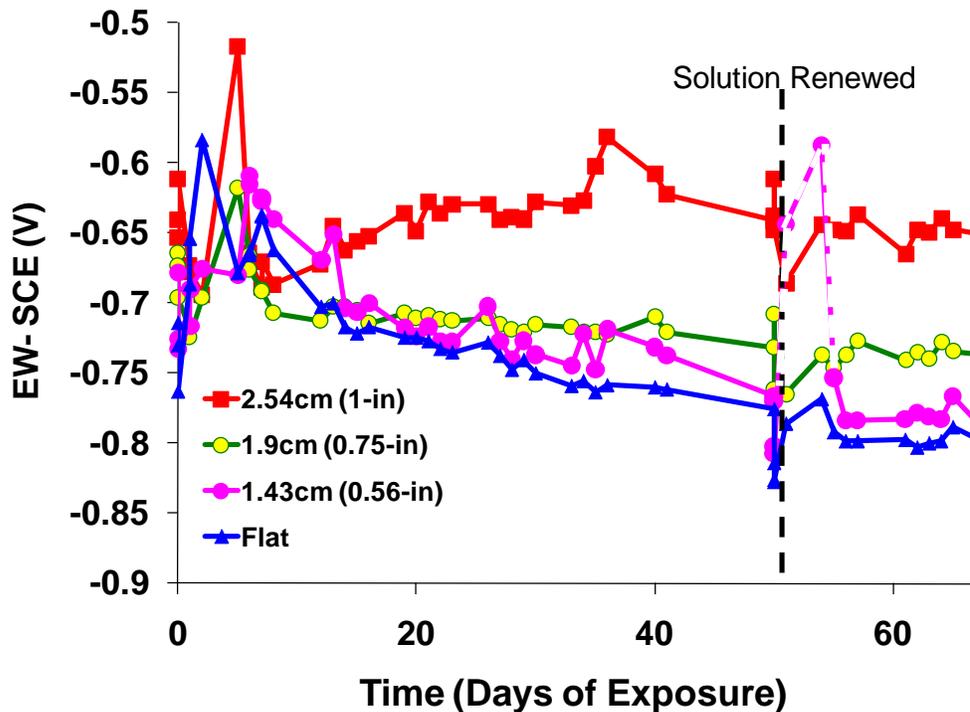
Figure 7-13. Open-circuit potentials of formed specimens over time. Averages of duplicate specimens. Solution S.

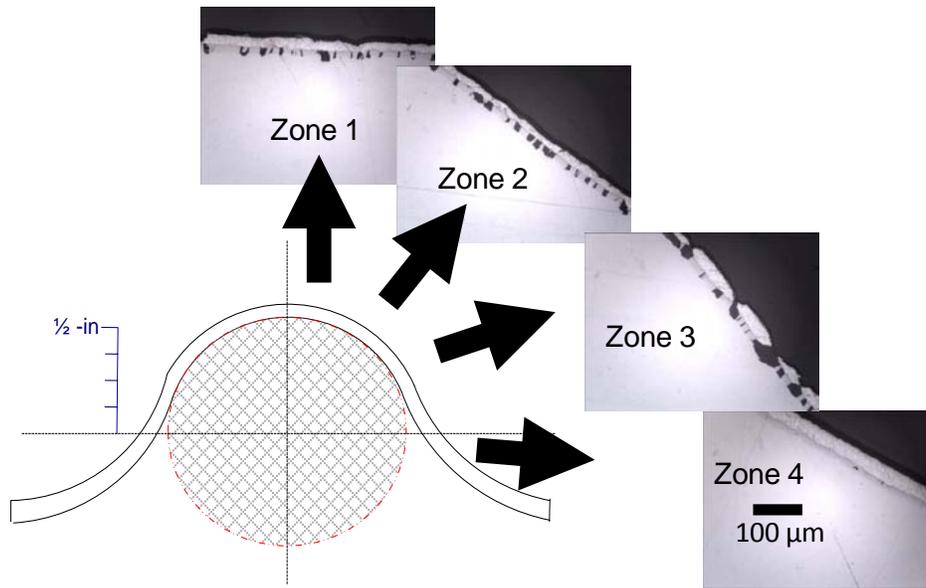
Figure 7-14. Coating damage due to deformation of an aluminized steel type 2 specimen was determined metallographically in the cross-section of a 2.54-cm (1-in) dimple.

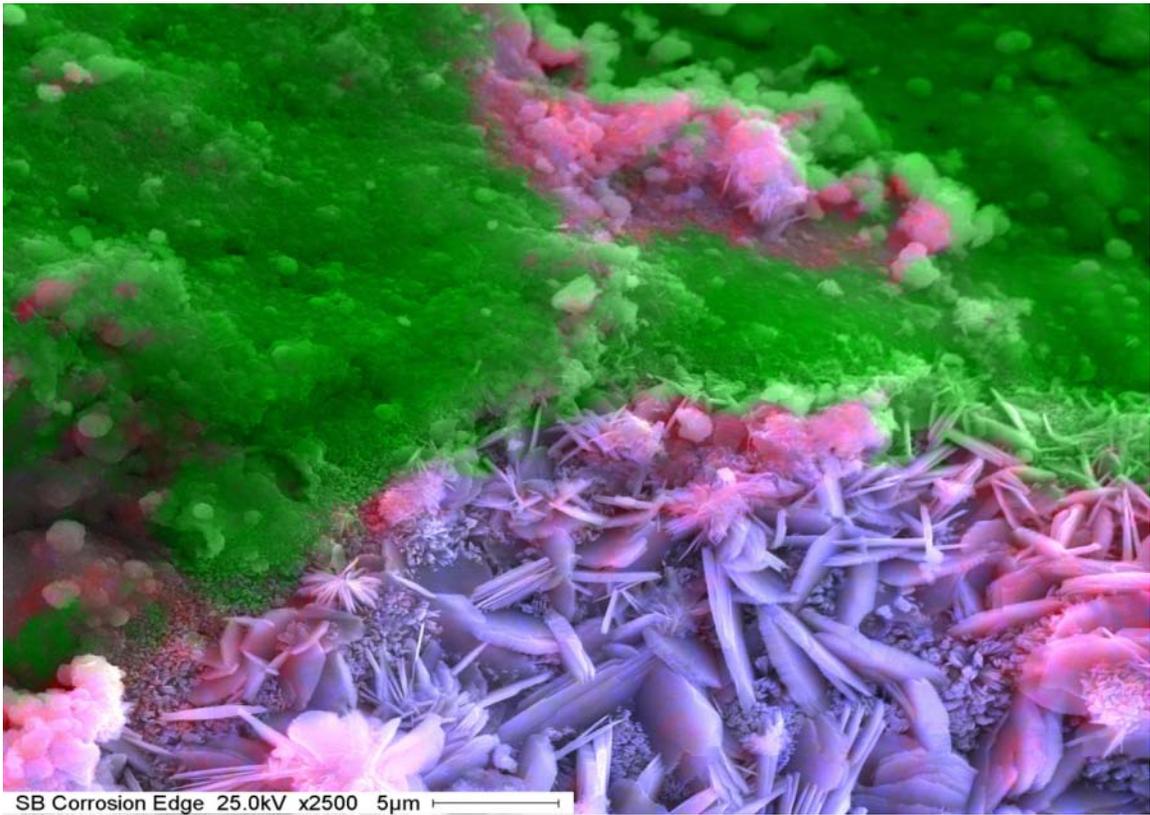
Figure 7-17. SEM photo: Looking at a crack region exposed to the solution, corresponding to a sharp-bend specimen with inner radius of 1.6 mm exposed to Solution S. (Color key: aluminum rich, green; oxygen-rich, pink; iron-rich, purple).

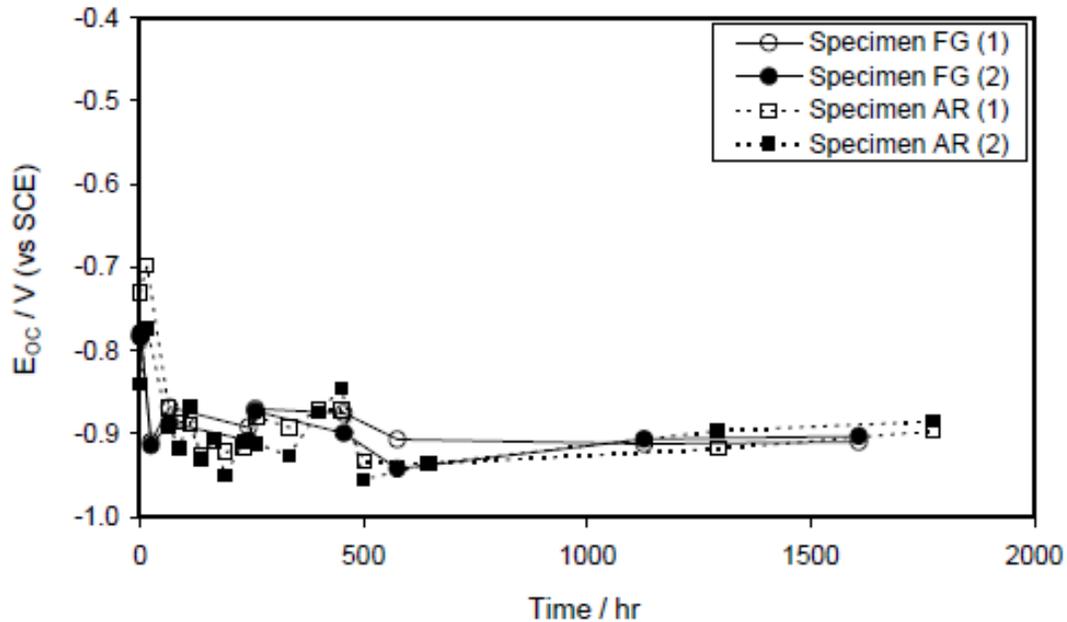
Figure 9-2. Eoc evolution of as-received (AR) and finely ground (FG) surface conditions. Specimen number is denoted in parenthesis.

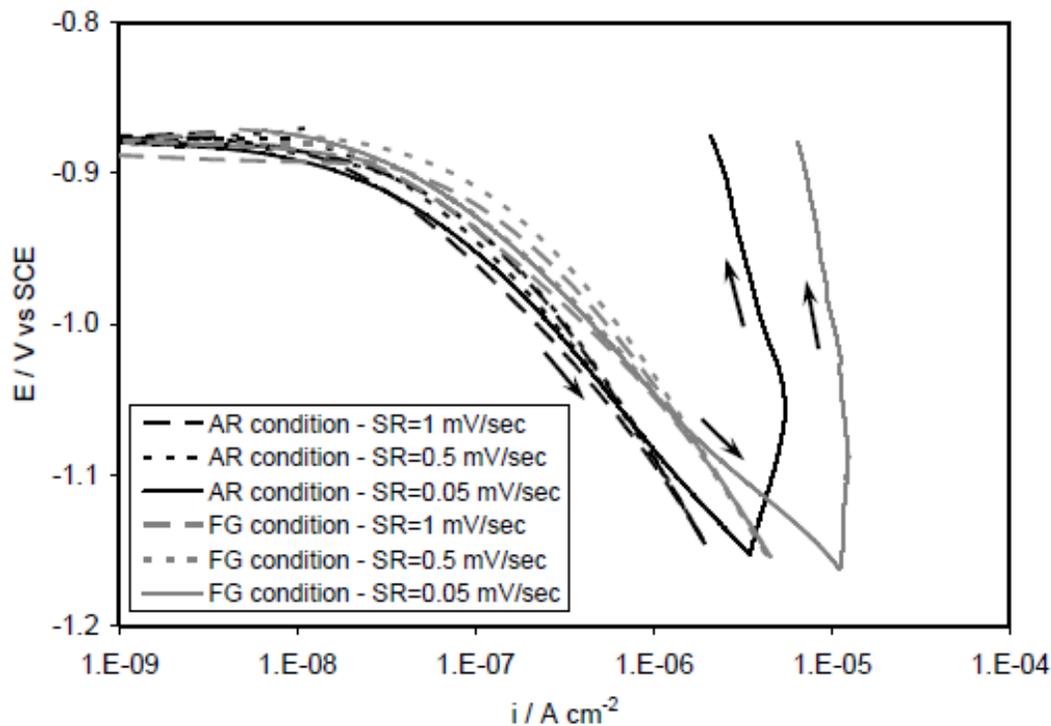
Figure 9-3. Cyclical cathodic polarization of as-received (AR) and finely ground (FG) surface conditions in unstirred naturally aerated solution at 408 hr of exposure. Return scan current was always greater than for the forward scan as exemplified by arrows.

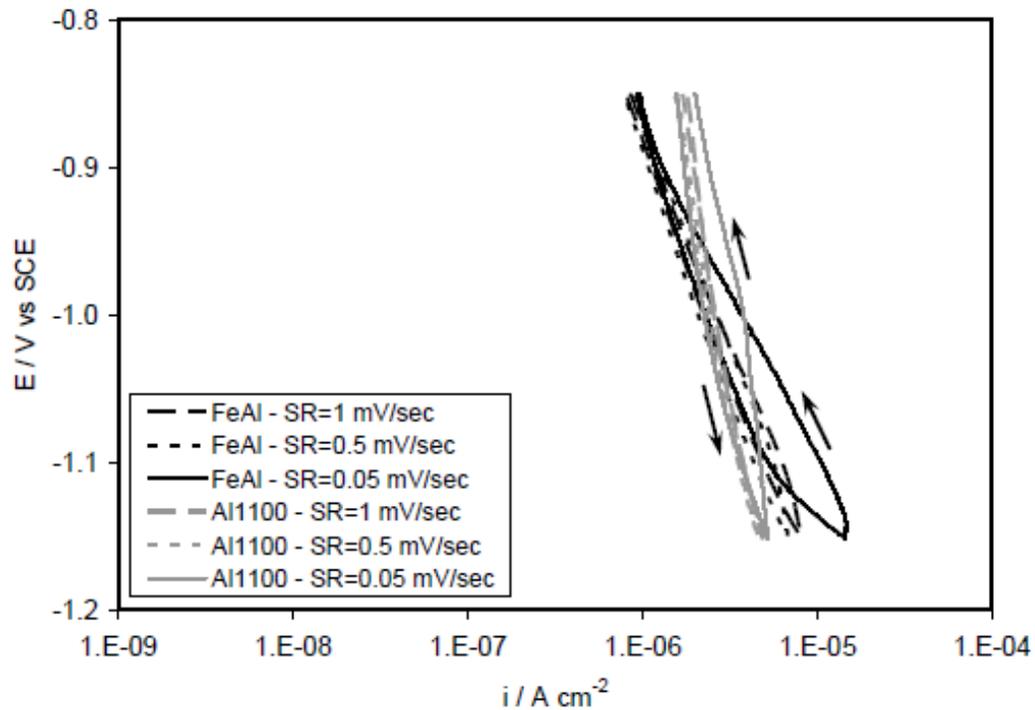
Figure 9-4. Cyclical cathodic polarization of the FeAl and Al1100 alloys in unstirred naturally aerated solution at 408 hr of exposure. Return scan current was always greater than for the forward scan as exemplified by arrows.

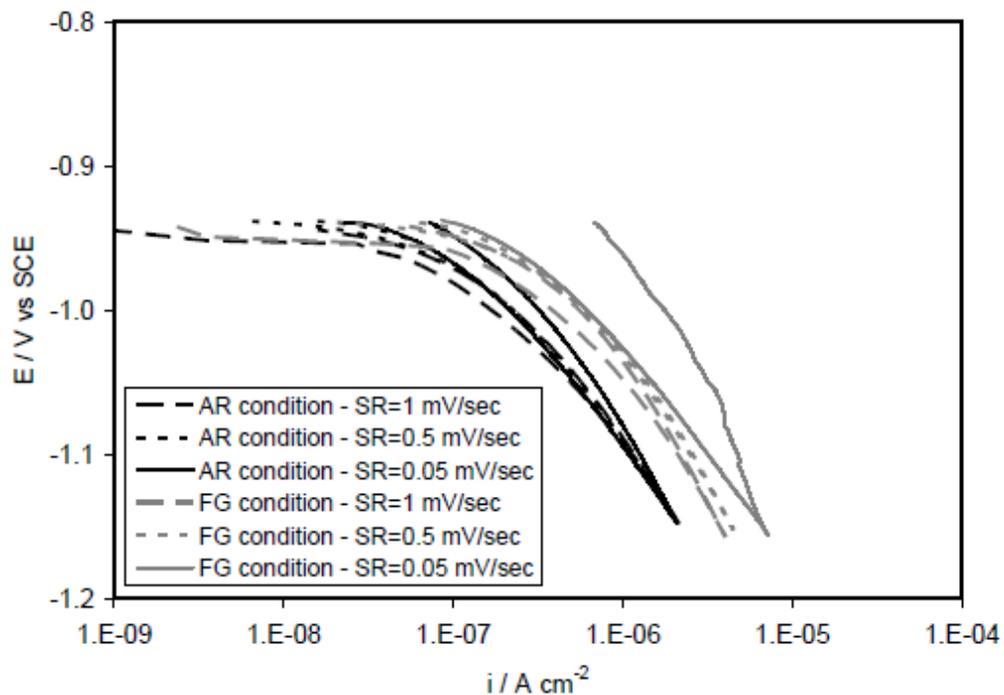
Figure 9-5. Cyclical cathodic polarization of the as-received (AR) and finely (FG) surface conditions in unstirred deaerated solution after 650 hr of exposure.

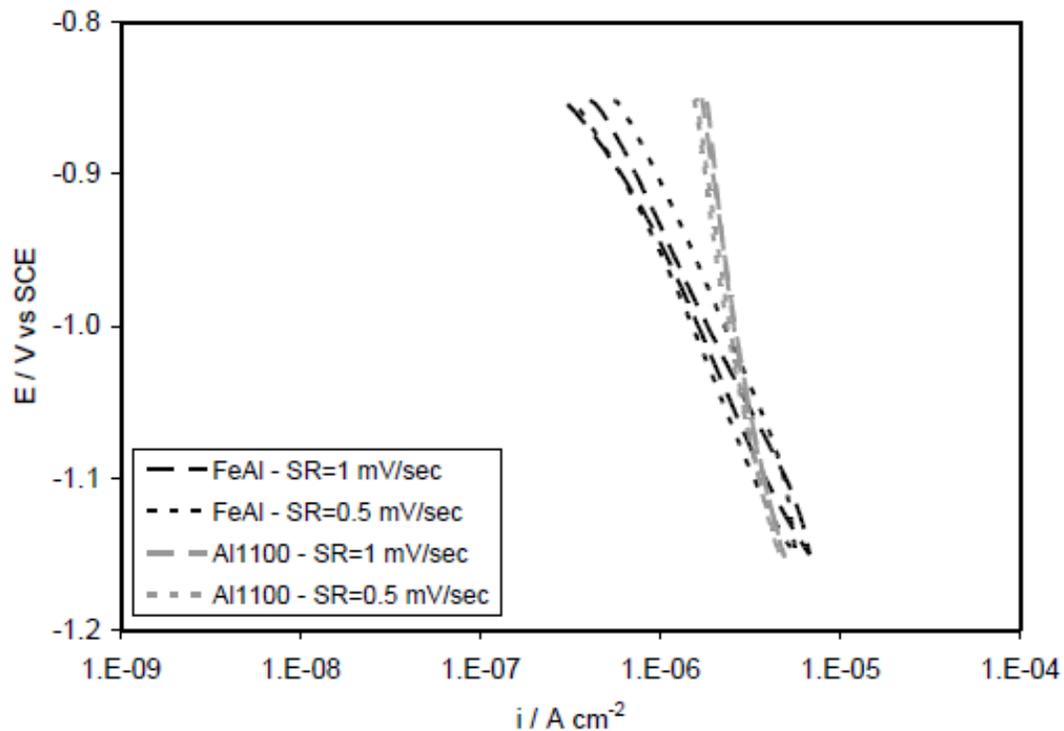
Figure 9-6. Cyclic cathodic polarization of the FeAl and Al1100 alloys in unstirred deaerated solution after 650 hr of exposure.

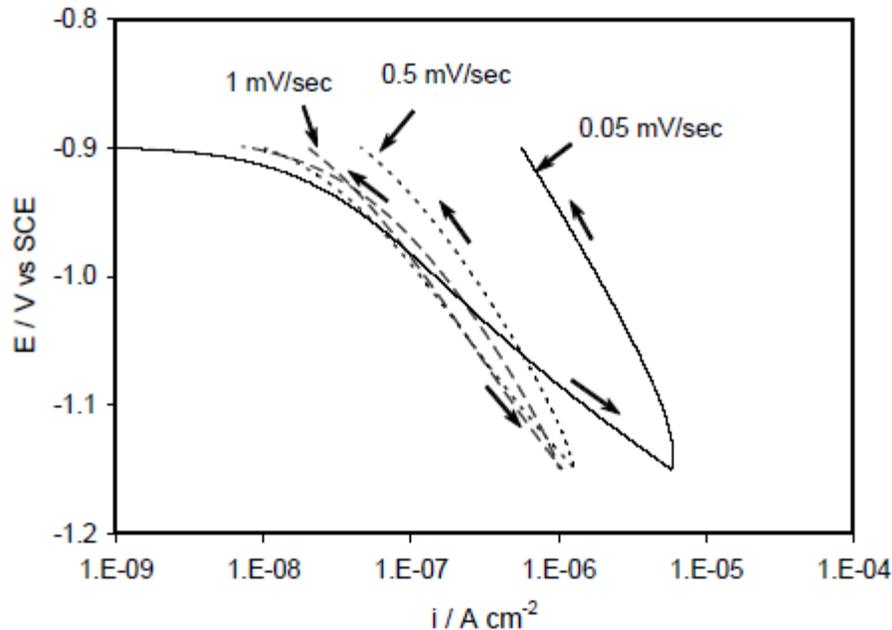
Figure 9-7. Model results for the as-received (AR) surface condition in the aerated solution.

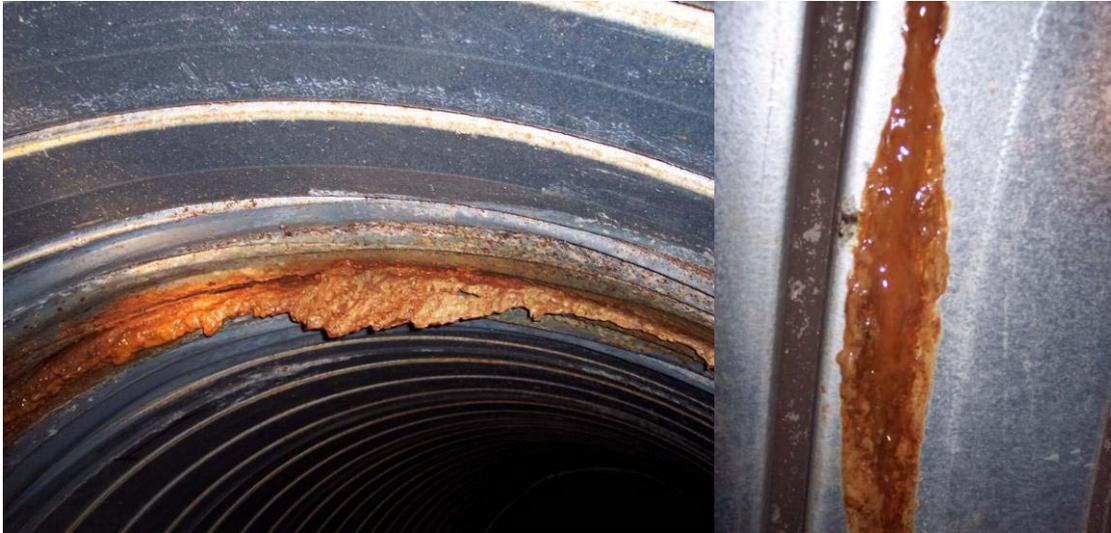
Figure 10-1. Possible bioslime oozing from damaged seam (left) and on inside wall (right) of in-service aluminized steel type 2 culvert piping.

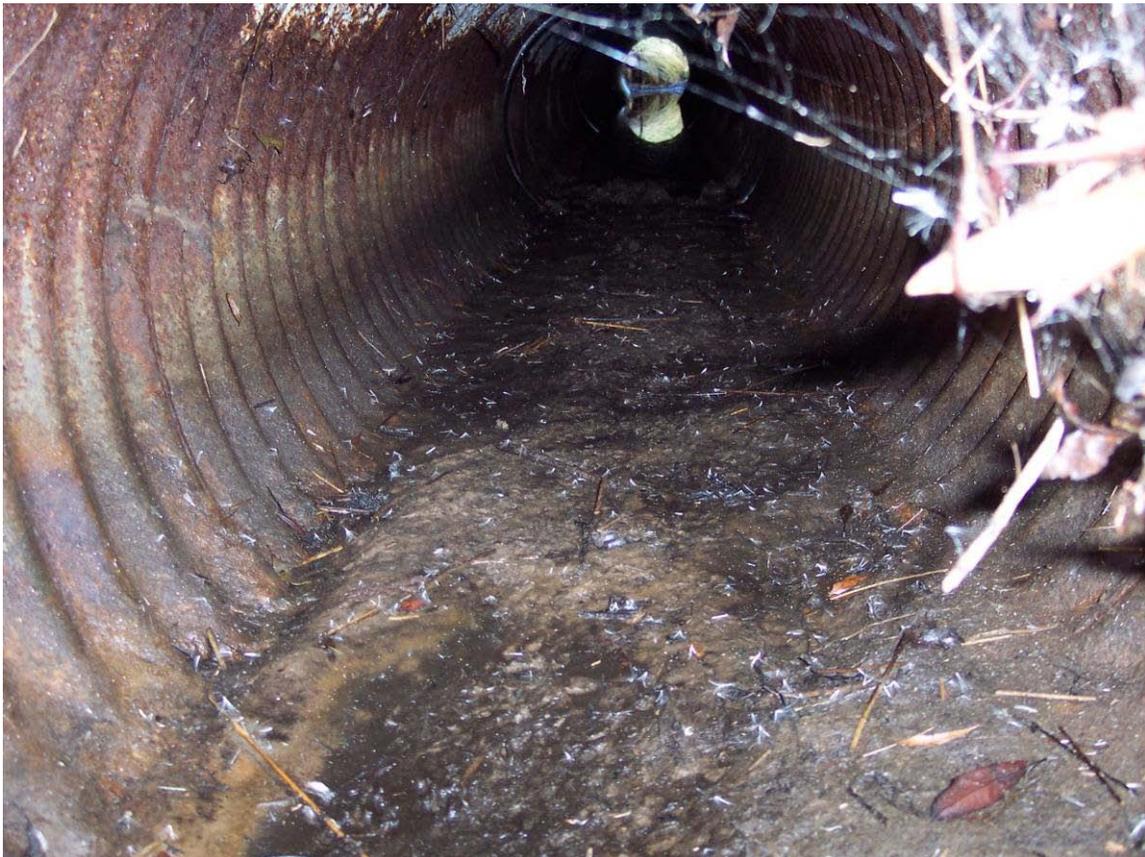
Figure 10-2. Corrosion is evident in an aluminized steel type 1 culvert pipe after 7 yr of service.
