FINAL REPORT

ELECTRICAL ENGINEERING SUPPORT FOR TELEMETERED TRAFFIC MONITORING SYSTEMS

FDOT Contract No. BD-543-3

March 2009

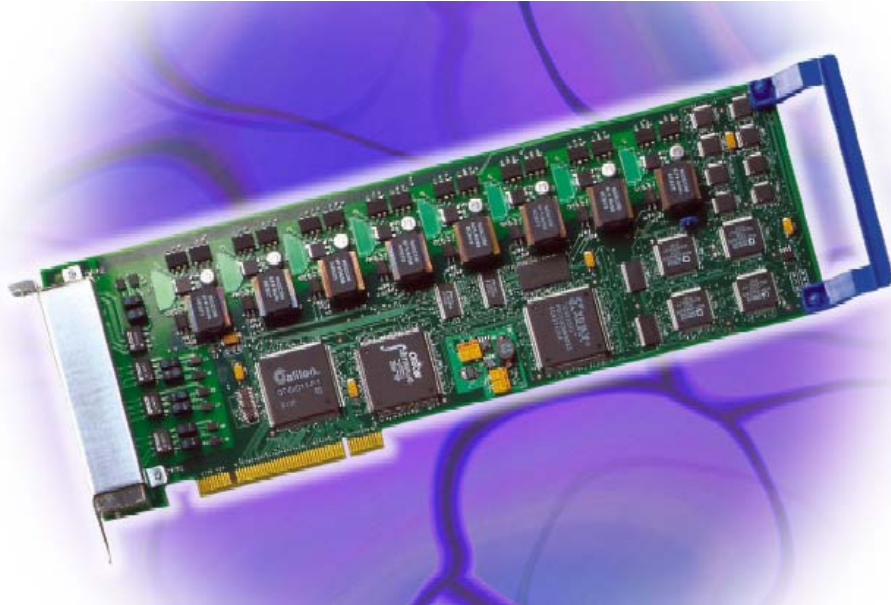
Figure 1. The Digi AccelePort RAS PCI Board

The Digi AccelePort RAS 8-modem PCI board (see Figure 1) is an internal computer card intended for personal computers or workstations based on Windows, Linux or UNIX operating systems. The card allows the computer to establish 8 simultaneous modem connections. The modems are capable of up to 56K rates using the V.90 or K56Flex standards. It is compatible with the modem speeds and standards used by the FDOT for TTMS installations. A data sheet for the Digiboard is included in Appendix A.

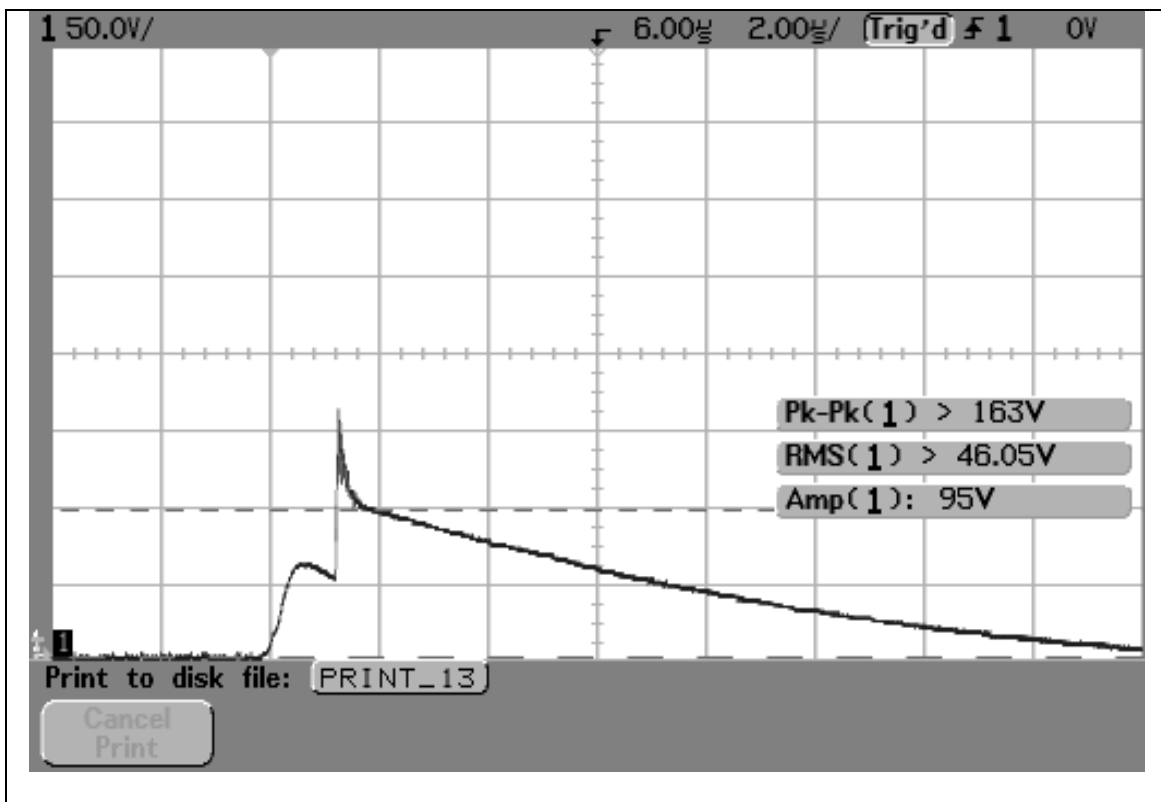
Figure 6. CITELE BP1-06 at 1000A

Since each suppressor yielded similar results, the BP1-06 will be taken into consideration for this analysis. Figure 6 depicts the response of the BP1-06 suppressor at 1000A.

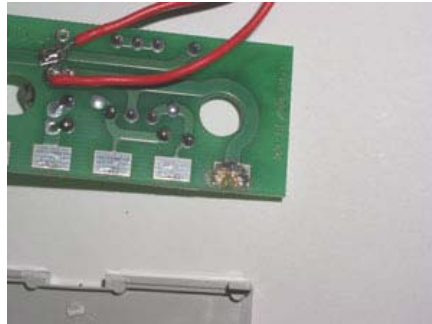
Figure 8. CITEL BP1-06 Endurance

pressing on an etched contact on the circuit card. The large surge currents through this relatively small contact area result in the deterioration of the pad on the circuit card. Eventually, there was no direct contact remaining and the surges arced between the metal bar and the circuit card causing even more damage. The damage from the endurance testing is illustrated in Figures 8 and 9. The damage was obvious after roughly 1100 to 1500 surges (at 6 KA), as the current began to arc.

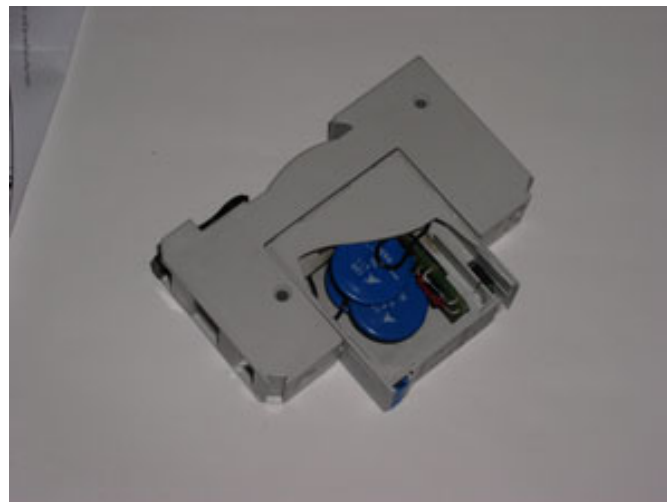
Figure 12. Damage to CITEL DS210-12VDC Suppressor

Endurance testing was conducted on the CITEL DS210-12VDC suppressor. The suppressor was tested at 2000A (maximum discharge current allowance) for an extended period of time. After roughly 155 hits at 15-second intervals, the impulse started to arc at the input and eventually the suppressor buckled under pressure. Figure 12 illustrates the outcome of the endurance test.

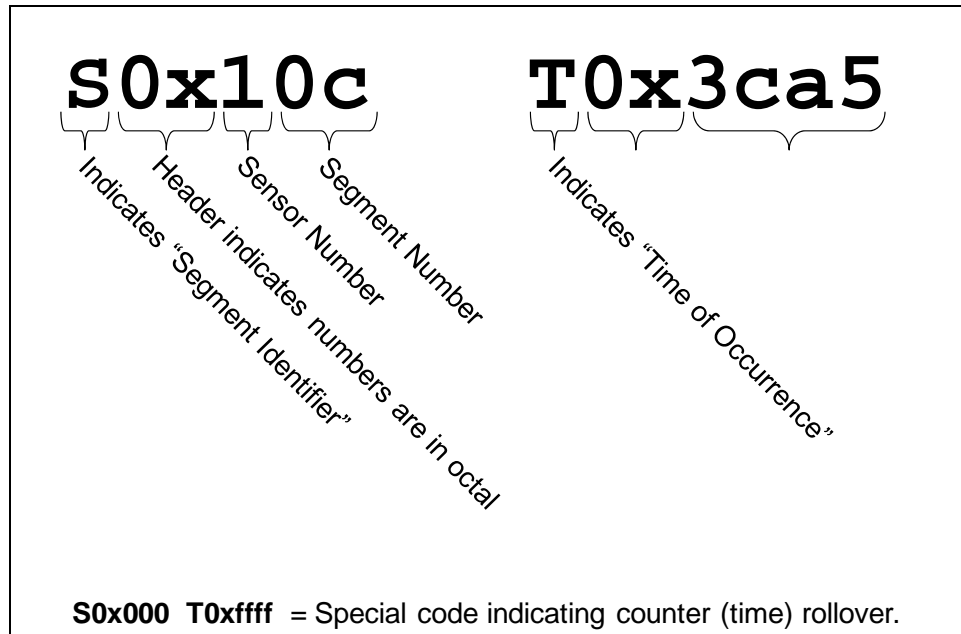
Figure 8. Format of Interface Electronics Output

The example output in Figure 8 is a report of a closure on segment C of sensor 2 at a time of 3ca5 milliseconds in hex (15,525 milliseconds). Whenever the millisecond clock rolls over to zero, a special code is transmitted with the maximum clock count.
