August 25, 2008
Miami-Dade Pedestrian Safety Project: Phase II
FINAL IMPLEMENTATION REPORT AND EXECUTIVE SUMMARY

Pedestrian Safety Engineering and Intelligent Transportation
System-Based Countermeasures Program for Reduced Pedestrian Fatalities,
Injuries, Conflicts and Other Surrogate Measures: Miami-Dade Site

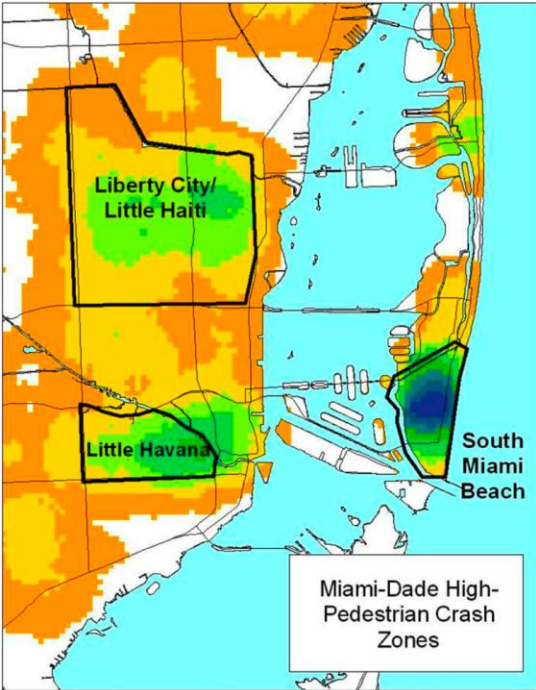
Figure 1.1 Miami-Dade High Pedestrian Crash Zones

Miami-Dade County has the highest incidence of pedestrian injuries and fatalities in the State of Florida, which ranked within the top two states in number of pedestrian crashes as well as per capita pedestrian crashes during the baseline period. In recent years the pedestrian crash rate had remained relatively steady prior to the implementation of the NHTSA and FHWA Pedestrian projects. During the nine years prior to the FHWA project there were a total of 15,472 pedestrian crashes in the DHSMV Miami-Dade County, which included 670 fatal crashes (4.2 percent). Figure 1.1 shows the geographic distribution of pedestrian crashes during the baseline period as a crash density map. High crash zones are represented by darker colors. Figure 1.2 shows the Crash map for South Miami Beach. South Miami Beach has the highest crash density in Miami-Dade County.

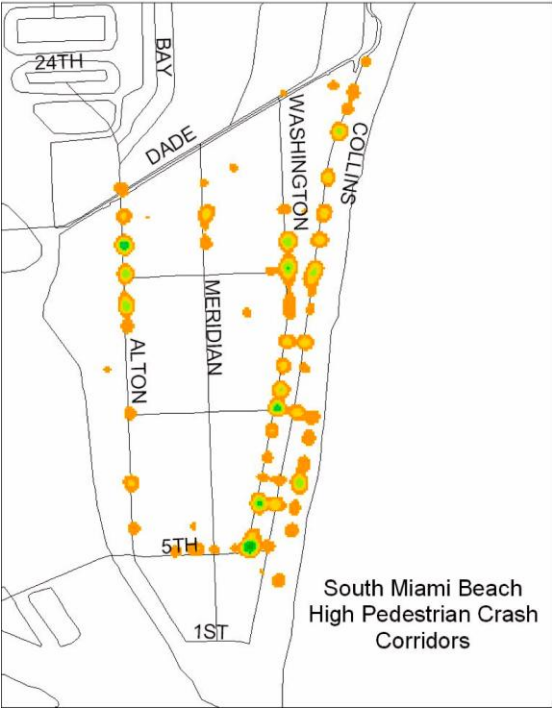
Figure 1.2 South Beach High Pedestrian Crash Corridors

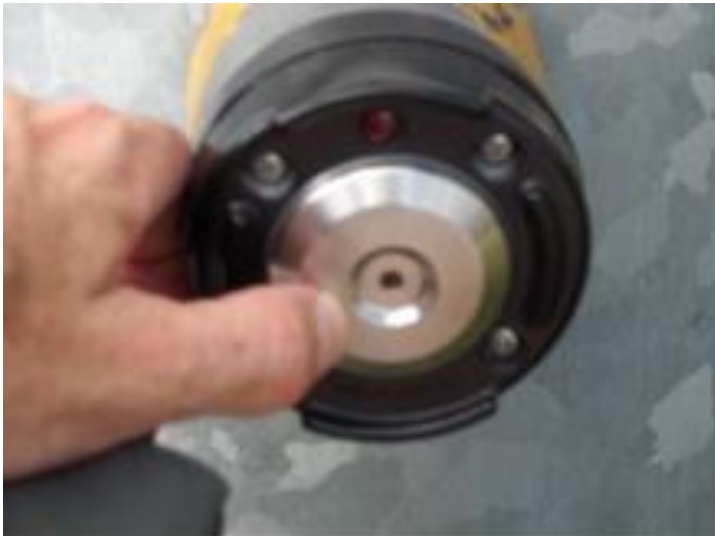
This treatment consists of a pedestrian stainless steel push button with a piezo driven solid state switch that provides two types of feedback when the push button is pressed. First, the button is illuminated with a 1200 mcd red light emitting diodes (LED) for 0.1 s (Momentary LED Model) and second, a 2.6 kHz tone is sounded simultaneously with the LED flash when the button was pressed and a 2.3kHz tone was sounded when the button was released. The device could also be modified so the light remained on until the onset of the “WALK” indication. These buttons were installed at 17 intersections, typically with 2 buttons per intersection.

Figure 3.1 Picture of Pedestrian Push Button That Confirms Press

Notes: It was difficult to see the LED light in bright Florida sunlight. It appeared that the auditory feedback was more critical to the efficacy of the device. In areas with less bright sunlight the pilot light might be more salient. These buttons might also be of useful to visually impaired pedestrians because they confirm the button press. However, accessible call buttons with a locator tone would be preferred when taking into account the needs of visually impaired pedestrians.

These devices seem reliable and durable and are associated with minimal maintenance needs. Because these push buttons provide feedback when they are pressed we observed fewer multiple presses, which could extend the life of the buttons, reducing maintenance costs over conventional buttons.

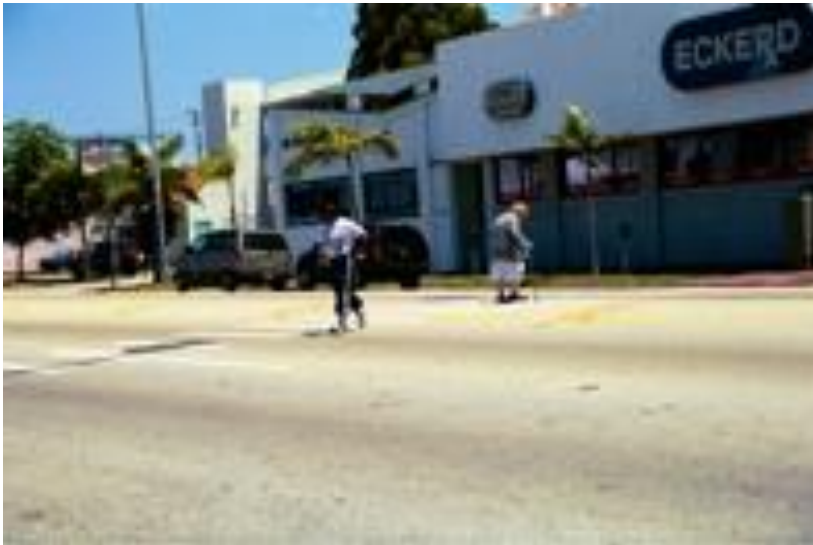
This treatment was installed at mid-block traffic signals. It required the signal to be operated in isolation mode (non synchronous timing). The minimum green time was reduced to decrease pedestrian wait time and increase compliance with the signal. Three of these treatments were installed as indicated in table nine. Prior to the start of the study both signals were run in synchronous mode, and the cycle length was 130 s between 8 am and 8 pm at the Alton Road crosswalk and varied from 90 s to 120 s at the crosswalk on SW 8th Street. Minimum green time was evaluated at 30 s, 1 minute and 2 minutes at both crosswalks. The speed limits at these locations were 35 mph on Alton Rd. and 30 mph on SW 8th St.

Figure 3.2 Picture of Midblock Crossing with Reduced Minimum Green Time

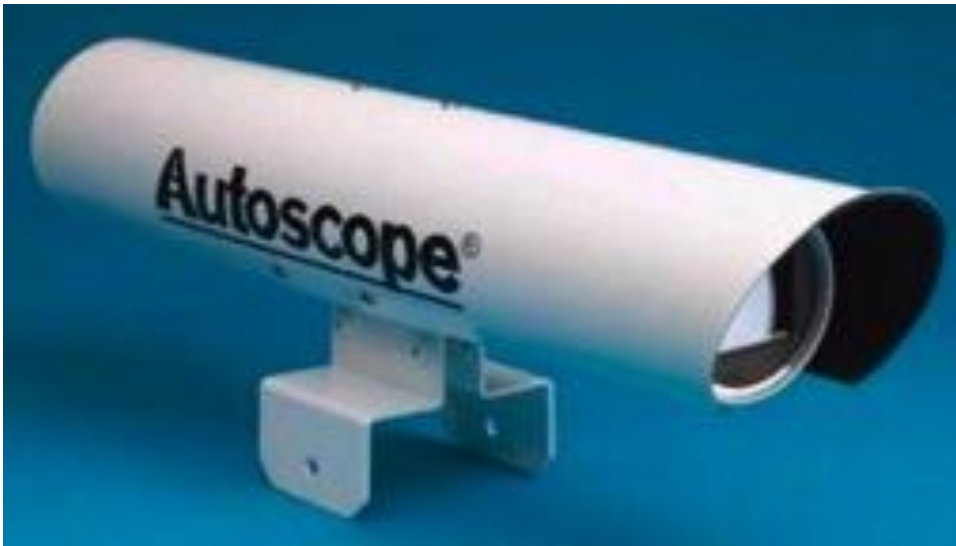
This device uses video detection technology to detect the pedestrian and put in a call for a mid-block traffic signal. An Autoscope Solo Pro was used for pedestrian detection in this study. The processor was included in the camera. The camera sent compressed video via twisted pair. Two rectangular zones were set up on the sidewalk approaching the curb; the pedestrian had to cross both zones to trigger the device. The device could determine direction of movement by the order in which the zones were crossed. With this method the pedestrian only put in a call when entering the crosswalk. This system was installed at one midblock traffic signal on Alton Road.

Figure 3.3 Picture of Device Used For Pedestrian Detection

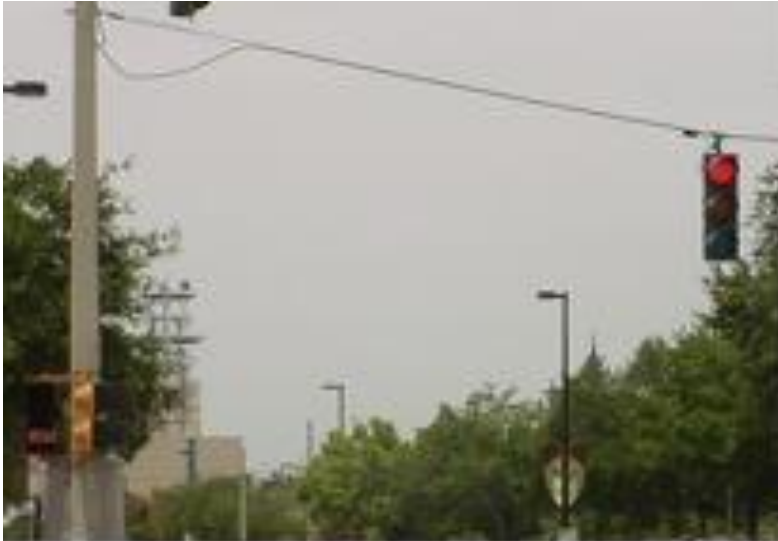
The purpose of this device was to give a head start for pedestrians over left and right turning vehicles at the start of the WALK. Pedestrians crossing the main line receive a 4 second exclusive pedestrian phase while all vehicle signals remained in the all red phase. These vehicles lost 4 seconds of green time in order to give the pedestrians a 4 second exclusive pedestrian phase. This treatment provides the best protection from vehicles turning left and provides less protection from vehicles turning right because they may still turn right on red.

Figure 3.4 Picture of Leading Pedestrian Phase

Notes: This treatment was effective at increasing yielding by drivers turning left but was not effective at improving the behavior of drivers turning right. Prohibiting right turn on red at the start of the WALK when a pedestrian pushed the call button should greatly improve the efficacy of this countermeasure.

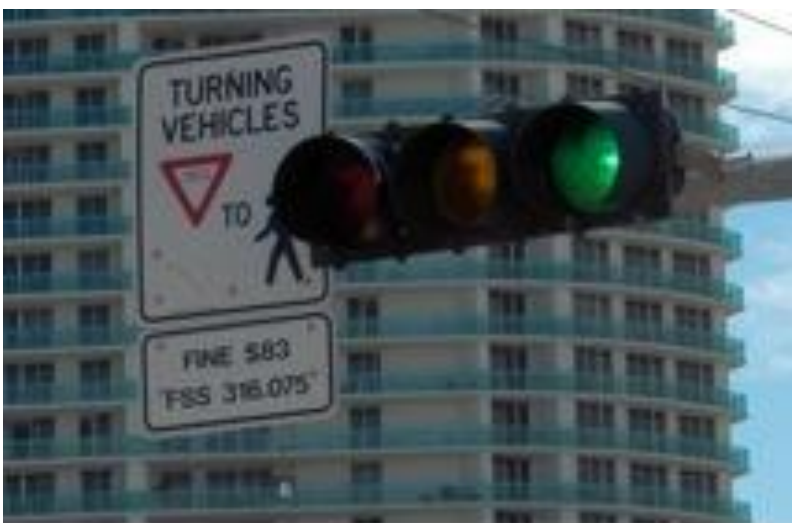
This treatment was a symbol version of the “Turning vehicles must yield to pedestrians” text sign. This sign retained the text message “Turning vehicles” and “to” and substituted the yield symbol for the word “yield” and the pedestrian symbol for the word “pedestrian”. The purpose of using this sign in place of the text message sign was to make the sign more comprehensible to tourists that were not native speakers of English and to increase recognition distance.

Figure 3.5 Picture of “Turning Vehicles Yield to Pedestrians” Symbol Sign

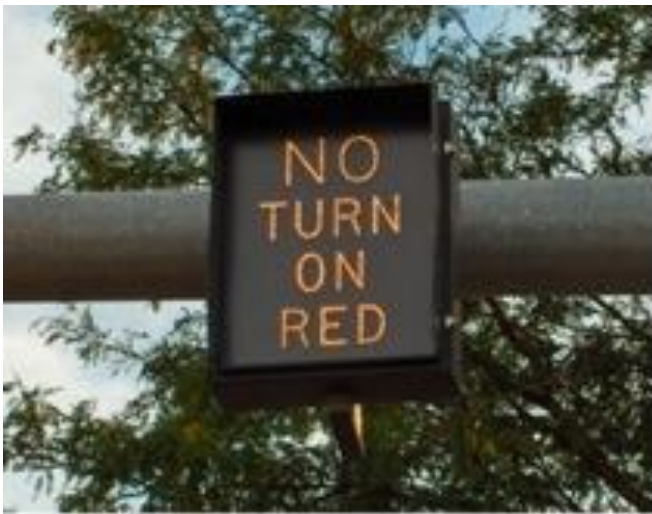
This sign was illuminated when right turn on red was not permitted. The sign was installed on the mast arm in the same location that the static “No turn on red when pedestrians in crosswalk” sign and the “No turn on red” sign were installed. This allowed a direct comparison of all three signs.

Figure 3.6 Picture of Electronic No Turn on Red Sign

Notes: The electronic NRTOR sign reduced the percentage of motorists turning right-on-red when a pedestrian was present over that produced by the two static signs and reduced the percentage of conflicts between vehicles turning right on red and pedestrians crossing within the crosswalk over the other two signs. However there were many violators during all conditions. The electronic sign had an even larger effect on increasing the percentage of violators coming to a complete stop

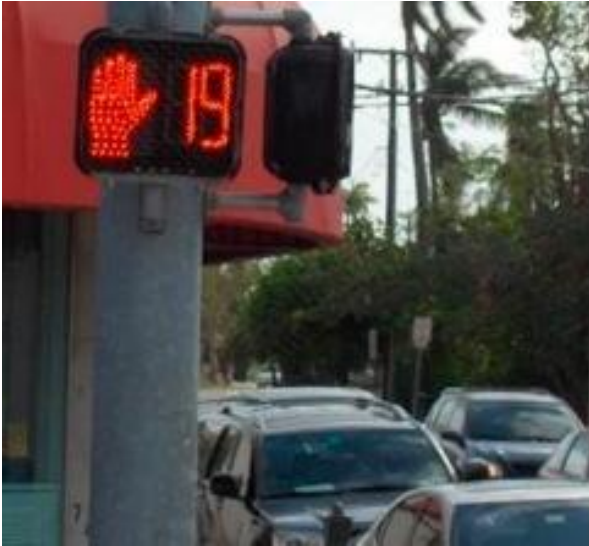
This treatment was a countdown pedestrian signal that displayed a walking person symbol during the "WALK" indication, counted down the seconds in the clearance phase along with the flashing hand display, and displayed the solid hand during The "DON'T WALK" indication which began during the all red phase. These signals were

programmed to begin the countdown at the start of the pedestrian clearance (flashing hand) phase and counted down to 0 at the end of the yellow phase.

Figure 3.7 Picture of a Pedestrian Countdown Signal

Notes: The countdown displays decreased the percentage of pedestrian in the crosswalk during the all red phase and were associated with an increase in the percentage of pedestrians that pressed the call button as well as the percentage of pedestrians that pressed the call button that then waited for the WALK indication.

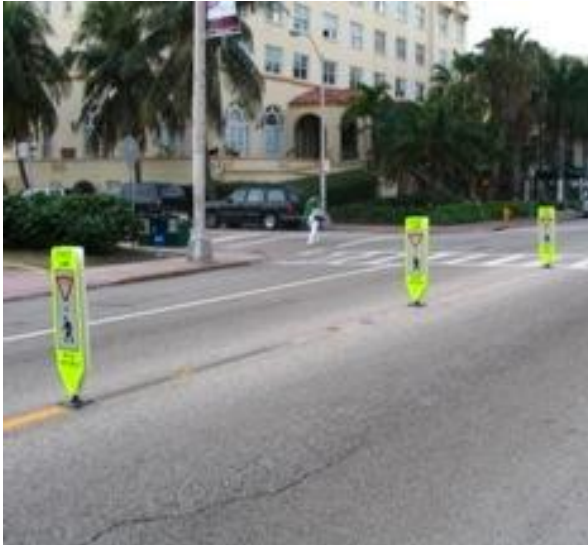
In-Street Pedestrian Signs are intended for use at uncontrolled (not signalized) crosswalks to remind drivers of laws regarding pedestrians’ right-of-way. They are more noticeable than roadside signs and may also exert a minor traffic-calming effect by effectively narrowing the inside lanes slightly. Dimensions and color: 12” x 44”, fluorescent yellow green diamond sheeting with 10” x 24” white high intensity sheeting inserts. Overall height is 47 inches. The signs can be installed with either a portable or fixed base.

Figure 3.8 Picture of In-street “Yield to Pedestrians” Signs

Notes: These signs were effective but had a very short lifespan. The streets were narrow and did not have a median island to protect the signs. We found that using three signs on each approach was no more effective than using one.

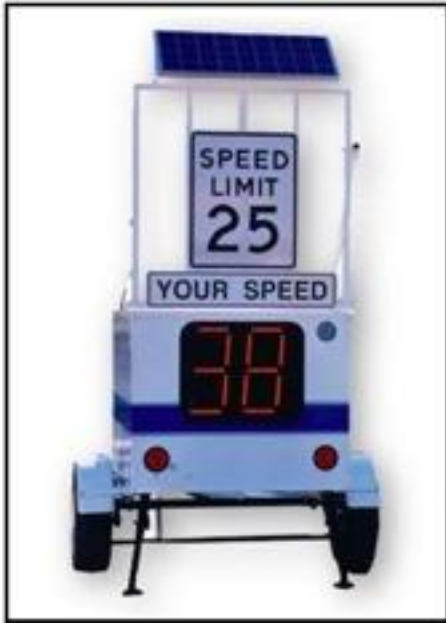
Portable Changeable Message Speed Limit Signs, also known as “radar speed trailers,” are used to deter speeding. These devices can be installed along the side of the road; typically in parking areas, and display the speed of each approaching vehicle and can flash LEDs when the approaching vehicle is speeding. A speed limit sign is included on the trailer. Above a user-selected maximum, the sign “blanks out” to avoid enticing drivers into exhibitions of speed. A computer within the device recorded speed data.

Figure 3.9 Picture of a Speed Trailer

Notes: These signs reduced braking for pedestrians but had little effect on vehicle speed. One reason why the sign was ineffective in reducing vehicle speed was most vehicles were already driving within the speed limit.

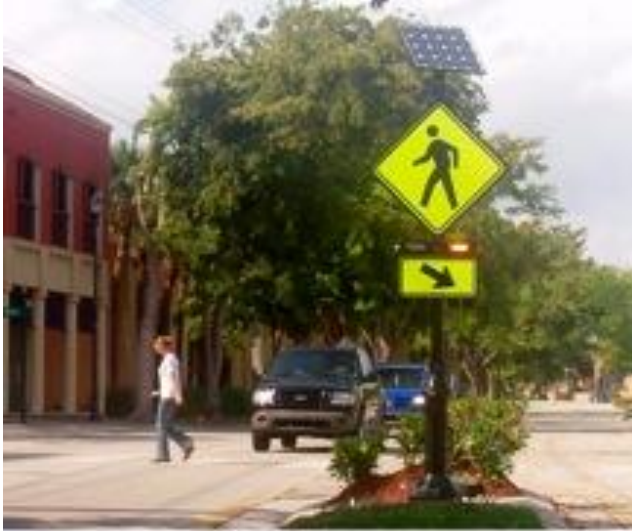
This treatment was the standard pedestrian warning sign with two LED flashers attached (see Figure 1). The LED flashers were each 6 inches wide and 2.5 inches high placed 9 inches apart. Each unit was dual indicated (LED's on front and back). Each side of the LED beacon flashed in a wig-wag flashing sequence (left, then right) the 2 large LED's in combination flashed 76 times in the wig-wag flashing sequence during a 30 second cycle. Of the 2 large LED's, the Left LED, flashed 2 times (in a slower type of a rapid flash) each time it was energized followed by the Right LED, which flashed in a very fast rapid 3 flash volley when energized. The total number of flashes in this combination was 190 total flashes per 30 second cycle. Four signs along with beacons were installed at each crosswalk. The devices were linked by radio frequency transponders so a depression of any of the pedestrian call buttons immediately activated the flashers on all four signs. At the South Bayshore Drive crosswalk a sign was placed on the left side of each approach and on the right side of each approach at the median island. At the NW 67th Street site a sign along with beacons was placed on the left side of each approach and on the right side at a median just after the crosswalk on the northbound approach and before the

crosswalk on the southbound approach. A LED facing the pedestrian flashed to indicate to pedestrians that the system was operating. The system also presented an audible message instructing pedestrians that the light flashing across the street indicates that the device was operating, and instructing them to wait for cars to stop before crossing. Signal duration was timed assuming a crossing speed of 3.5 feet per second.

Figure 3.10 Picture of Rectangular LED Rapid Flashing Beacons

These devices seem very reliable. The primary maintenance issue would be the repair or replacement of a unit if a vehicle strikes it.

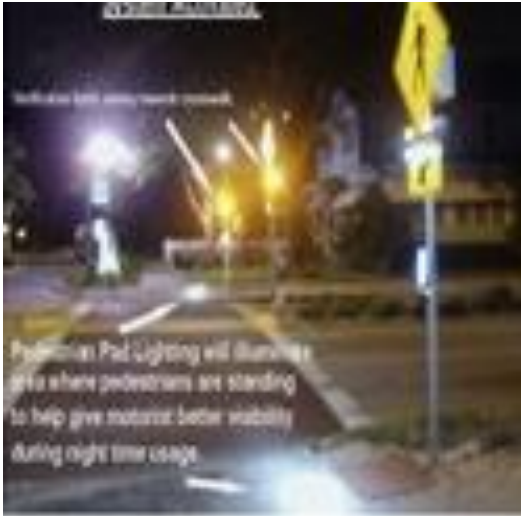
This treatment was used in conjunction with the rectangular LED rapid flashing beacons treatment described above. When a pedestrian pressed the call button to activate the beacon at night, the device was activated and LED white lighting illuminated the departure portion of the curb face and the first 4 feet of the crosswalk. This dynamic pad lighting consisted of four 2.5 by 1.25 inch housings each containing 3 LEDs.

Figure 3.11 Picture of Dynamic Lighting

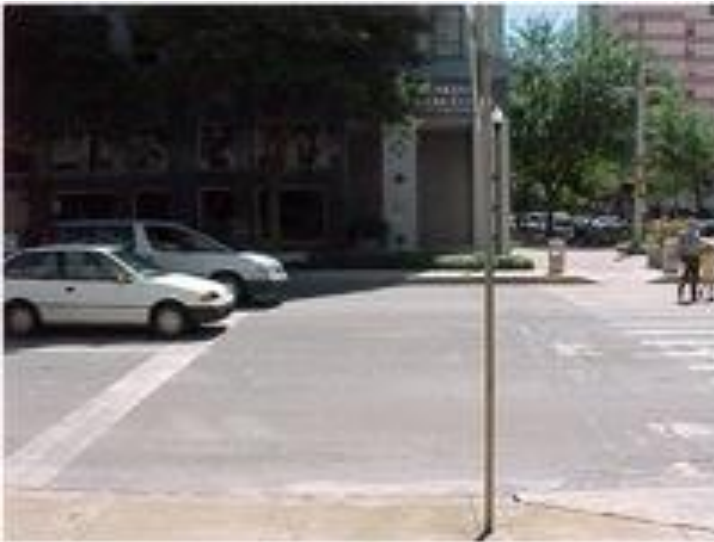
This treatment involved installing stop bars 20 feet in advance of the crosswalk rather than the minimum distance of 4 feet in advance of the crosswalk. Studies have shown that offset and setback stop bars can reduce vehicle/pedestrian conflicts. Setting back stop bars has also been shown to add .75 s to intersection clearance time and can reduce turning vehicle threats by increasing intersection visibility.

Figure 3.12 Picture of Offset Yield Lines

Notes: This treatment is easier to install on fresh pavement.

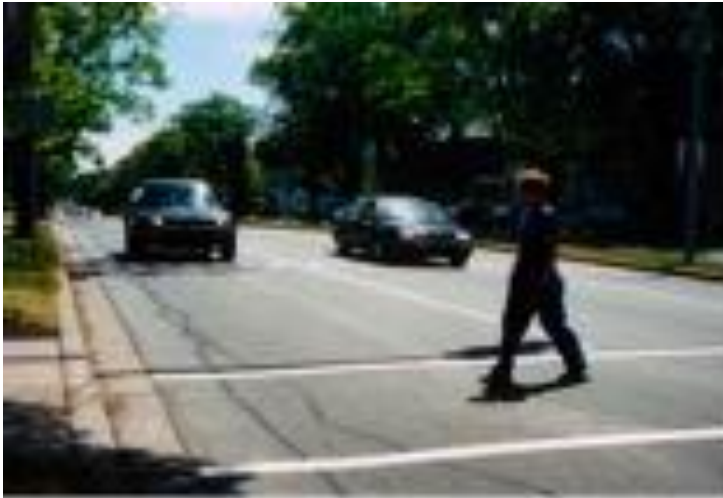
Advance yielding markings may be installed in advance of crosswalks at uncontrolled locations. Previous work has shown that advance yield markings placed 30 feet in advance of the crosswalk increases the distance that drivers yield in advance of the crosswalk. Advance yield markings were only installed at one site because the sign size specified in the 2003 manual was much smaller than the sign used in the research that supported the introduction of this marking into the manual.

Figure 3.13 Picture of Advance Yield Markings

Notes: This treatment is designed to reduce multiple threat conflicts and therefore has been installed at the two multilane locations with the rectangular LED rapid flash beacon.

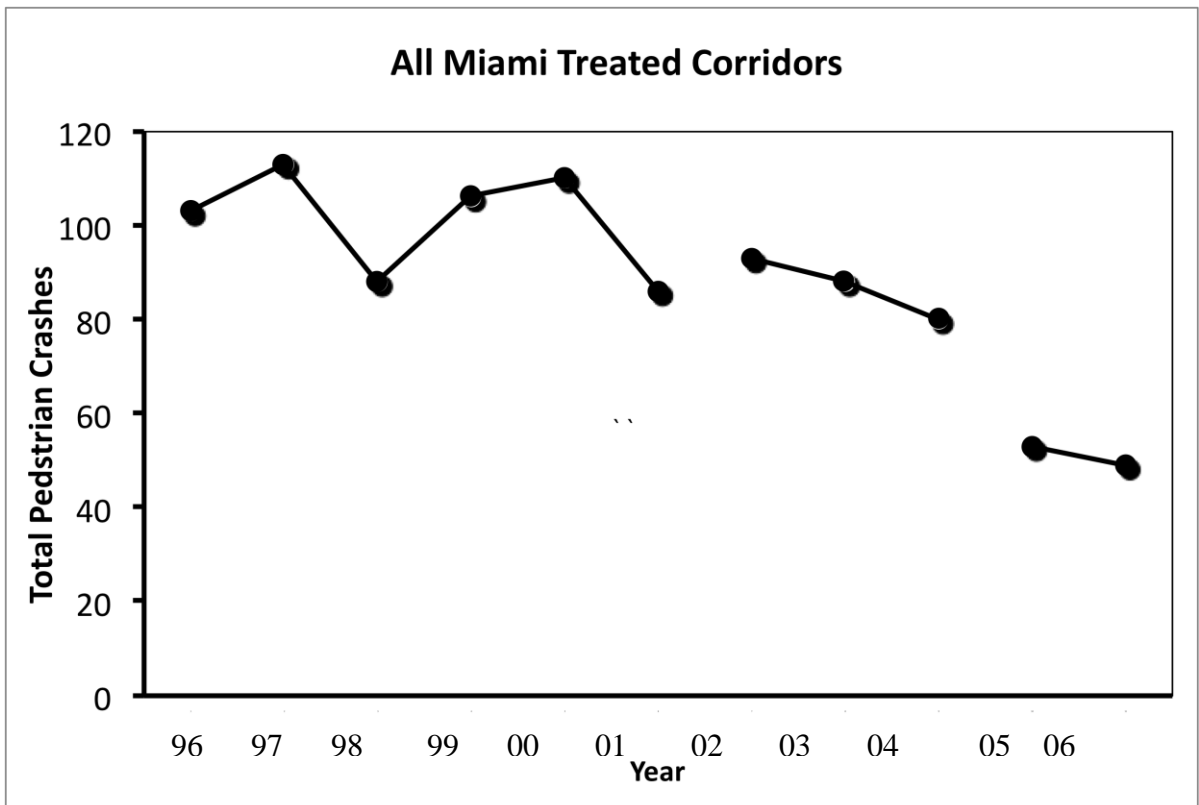
Data were collected for each corridor for 6 years prior to the introduction of the NHTSA project, for the 3 years that the NHTSA project was implemented, and for an additional 2 years that the FHWA project was implemented. This provides a total of 11 years of crash data along these high crash corridors. Figure 4.2.1 shows the crash rate for all eight treated corridors remained reasonably stable with a slight downward trend during the 6 years prior to the introduction of the NHTSA project. The introduction of the NHTSA project appeared to lead to a small decrease in pedestrian crashes from a mean of 101 during the baseline period to a mean of 87 (a decrease of 11.5%) during the three years that the NHTSA project was in effect. The installation of the engineering countermeasures on top of the NHTSA education and enforcement efforts lead to a further reduction to an average of 51 crashes per year. This represents a 50% reduction over the baseline level and a 41% reduction from the NHTSA project levels. It is interesting to note that during the 9 years prior to the FHWA project there were 15,472 pedestrian crashes in Miami-Dade County. Of these 46% occurred on State and County Roads for a total of 7,117 crashes or 791 crashes per year. Around 100 per year or nearly 13% of these crashes occurred along the treated corridors.

Figure 4.2 Crashes per Year for All Eight Crash Corridors from 1996-2006

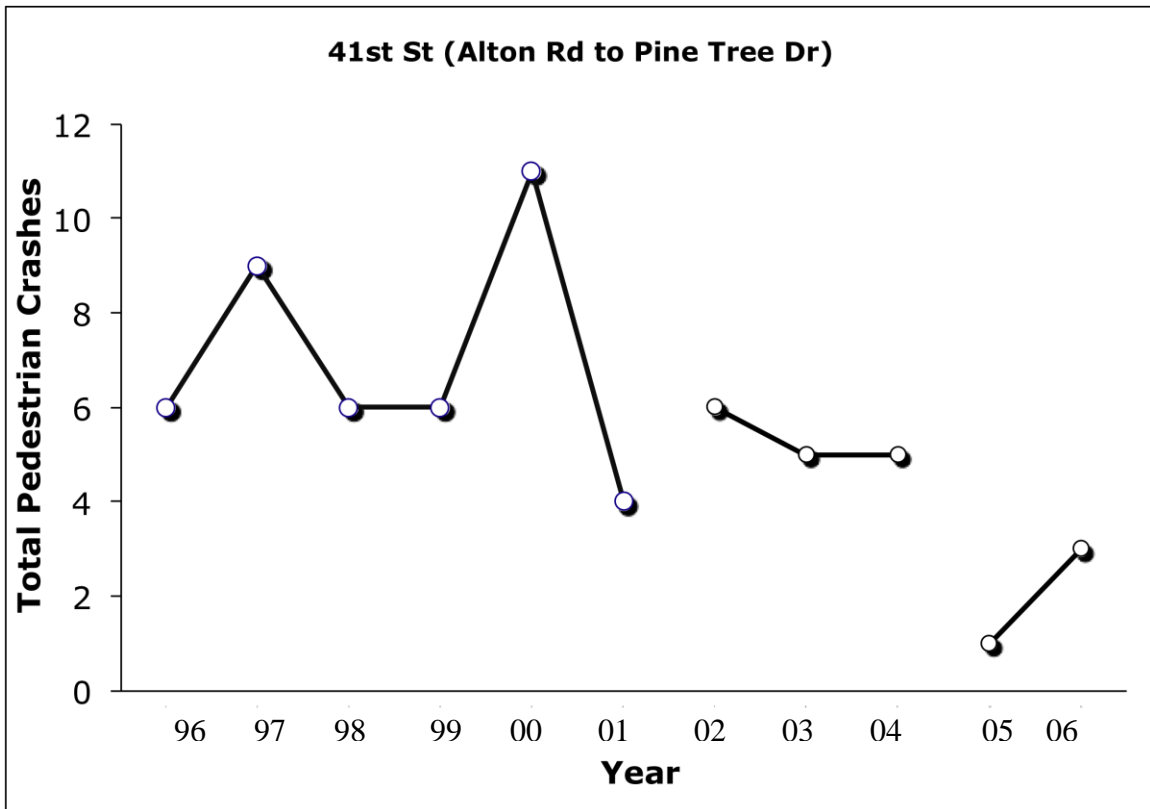
It is interesting to note that crashes declined in each of the eight crash corridors. Data from each corridor is presented below. One corridor that was not particularly responsive to the NHTSA treatment but very responsive to the FHWA engineering treatments was 41st Street; Alton Road to Pine Tree Drive. This corridor had the highest percentage of daytime pedestrian crashes of all eight corridors (81%). The results for this location are presented in Figure 4.2.2. Crashes averaged 7 per year during baseline, 5.3 per year during the NHTSA program, and 2 per year during the FHWA program. This corridor received a large number of countdown timers, push buttons that confirmed the press, the no right turn on red electronic sign, and the prohibited permissive left turn treatment. Data for this corridor are presented in Figure 4.3.

Figure 4.3 Crashes per Year for 41st St.; Alton Rd. to Pine Tree Dr. 1996-2006

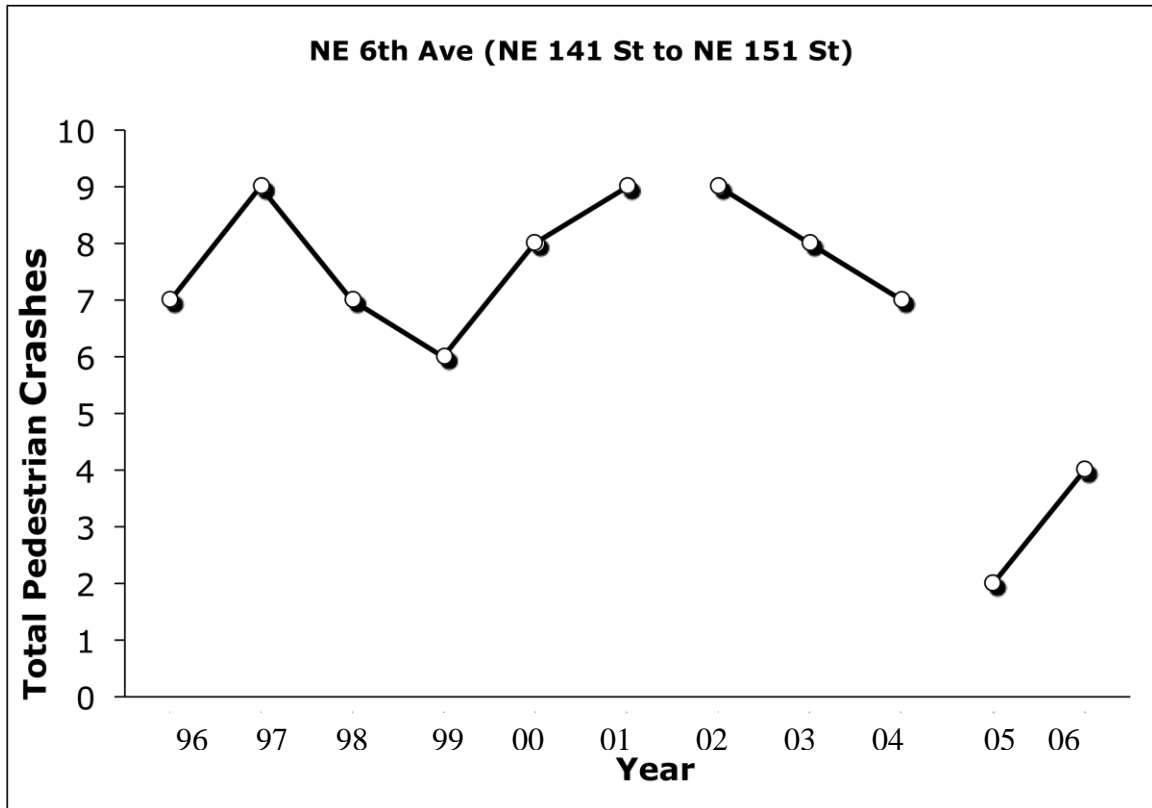
Another corridor that responded well to the engineering treatments was NE 6th St. (NE 141st St. to NE 151st St.). Many of the pedestrians struck in this corridor were children who were hit in crosswalks near the school. This corridor

had the highest percentage of crashes involving children and youth (34%) and the highest percentage of crashes involving African American pedestrians (73%). During baseline crashes averaged 7.7 per year at this site and maintained at 8.0 during the three years of the NHTSA project. The FHWA project was associated with a reduction in crashes to 3 per year. This site also received countdown timers and push buttons that confirmed the press at high crash intersections and a large number of pedestrian zone signs. Data from this site are presented in Figure 4.4.

Figure 4.4 Crashes per Year Along NE 6th St. (NE 141st St. to NE 151st St.) from 1996 to 2006

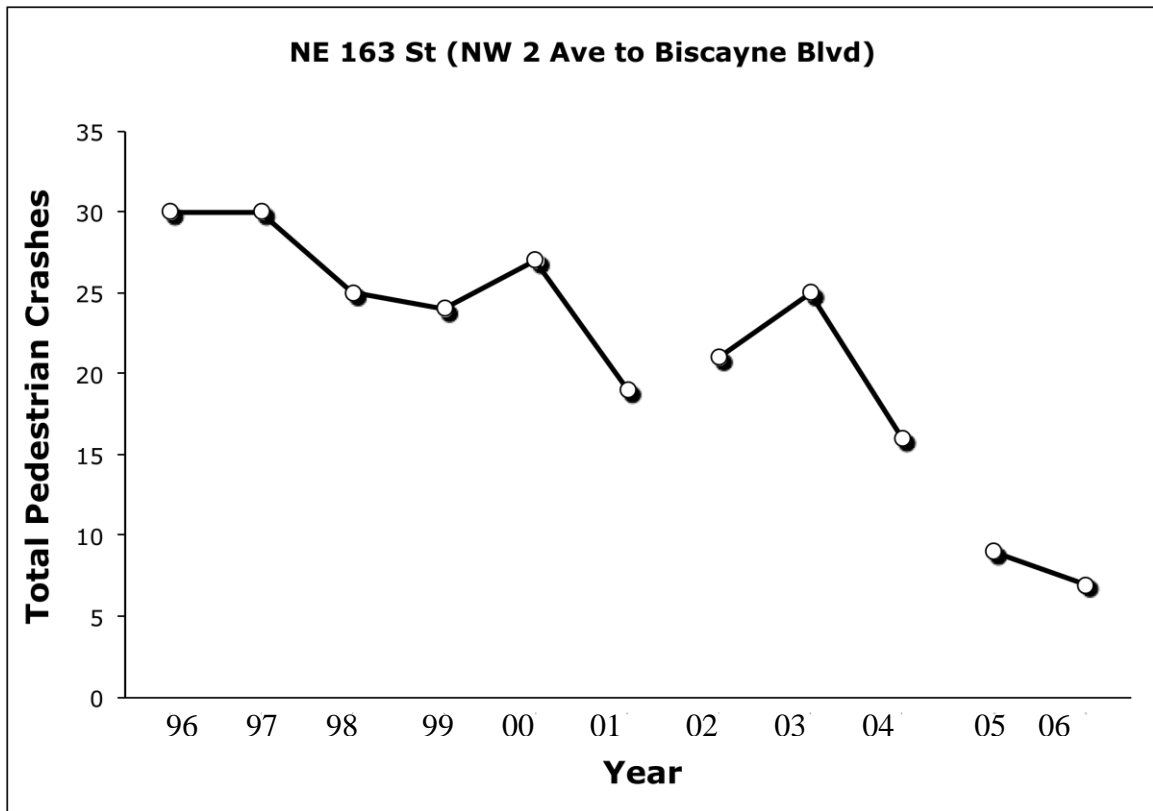
The corridor that showed the largest improvement also had the highest number of crashes per year during baseline, the second highest percentage of African American pedestrians struck during baseline (41%), and the second highest percentage of senior pedestrians struck during baseline (28%). Baseline data show a downward trend during the baseline period. This corridor had the second highest percentage of pedestrian crashes involving turning vehicles (60%). This large corridor along NE 163rd St. had 25.8 crashes per year during baseline, crashes declined to 20.7 crashes per year during the NHTSA project and declined further to 8 per year during the FHWA project. This corridor also received the largest number of countermeasures. This corridor had a large number of countdown pedestrian signals and push buttons that confirmed the press installed. This site also received "Turning Vehicles Yield To

Pedestrians” symbol signs, and a large number of offset stop lines. Data for this corridor are presented in Figure 4.5.

Figure 4.5 Crashes per Year NE 163rd St. (NE 2nd Ave to Biscayne Blvd.) from 1996 to 2006

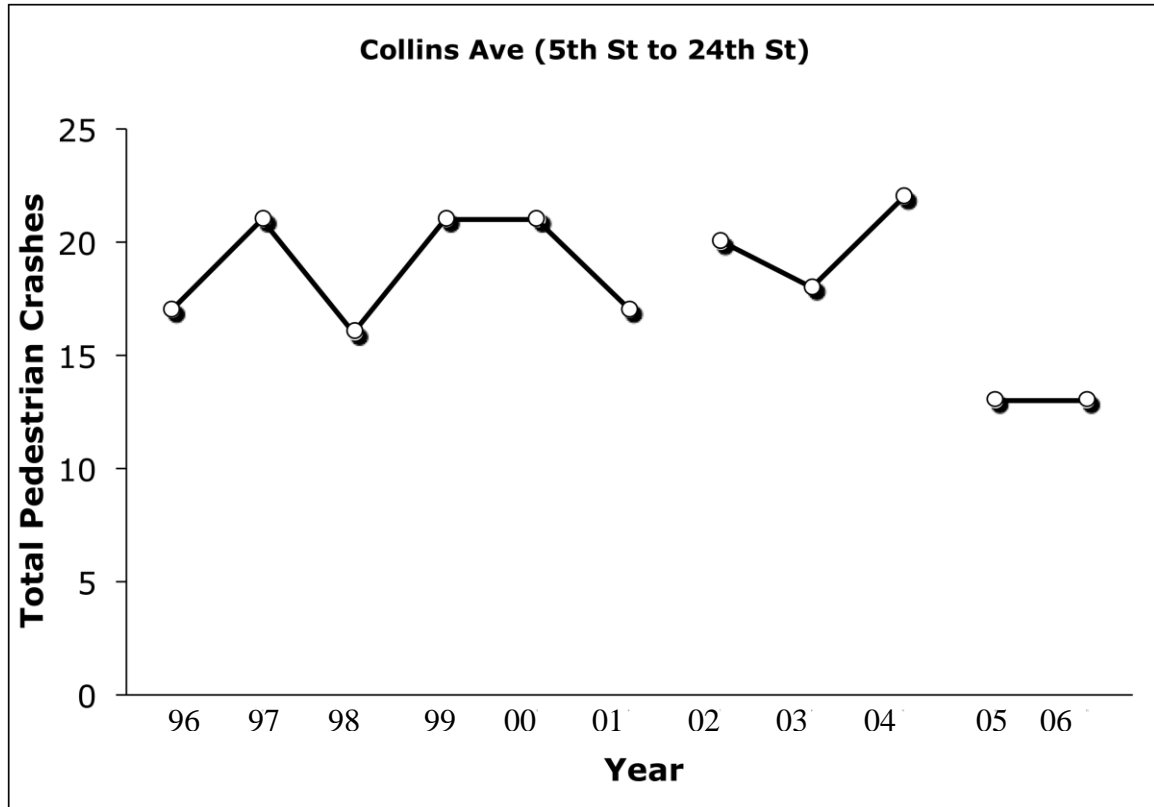
This corridor on Collins Ave. between 5th St. and 24th St. was in the middle of the South Beach recreational area. Therefore it is not surprising that this corridor had the highest percentage of nighttime crashes of all eight corridors (55%). During baseline there were 18.8 pedestrian crashes per year along this corridor. During the NHTSA project there were 20 crashes per year. The introduction of the FHWA project was associated with a decline in crashes to 13 per year. One of the treatments that was effective along this corridor was the in street pedestrian signs. Unfortunately these signs did not stand the test of time and were only in effect for a relatively short period of time. This corridor also received a couple of lead pedestrian intervals, a large number of “Turning vehicles yield to pedestrians” symbol signs, some pedestrian zone signs, and one advance yield marking. Crash data are presented in Figure 4.6.

Figure 4.6 Crashes per Year Collins Ave. (5th Street to 24th St.) from 1996 to 2006

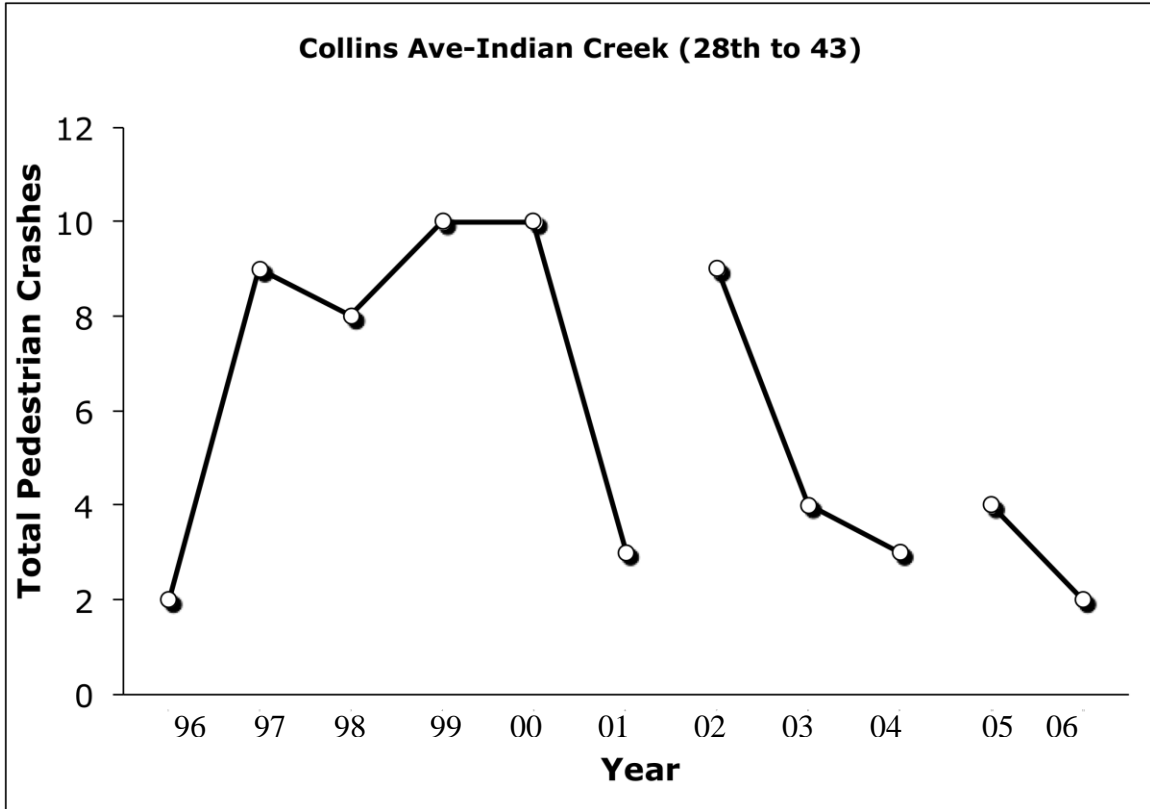
This corridor is immediately adjacent to the Collins Ave (5th to 24th St.) corridor. Treatments installed along this corridor included “TURNING VEHICLES YIELD TO PEDESTRIANS” symbol signs, and the use of the speed trailer. Crashes averaged 7 per year during the baseline period along this corridor, 5.3 per year during the NHTSA project and 3 per year during the FHWA project. The graph of the yearly crash data is shown in Figure 4.6. Although the average number of crashes is lower during the FHWA study there are too few crashes and too much overlap to conclude much about the efficacy of the treatment at this location.

Figure 4.7 Crashes per Year Collins Ave. (Indian Creek 28th St. to 43rd St.) from 1996 to 2006

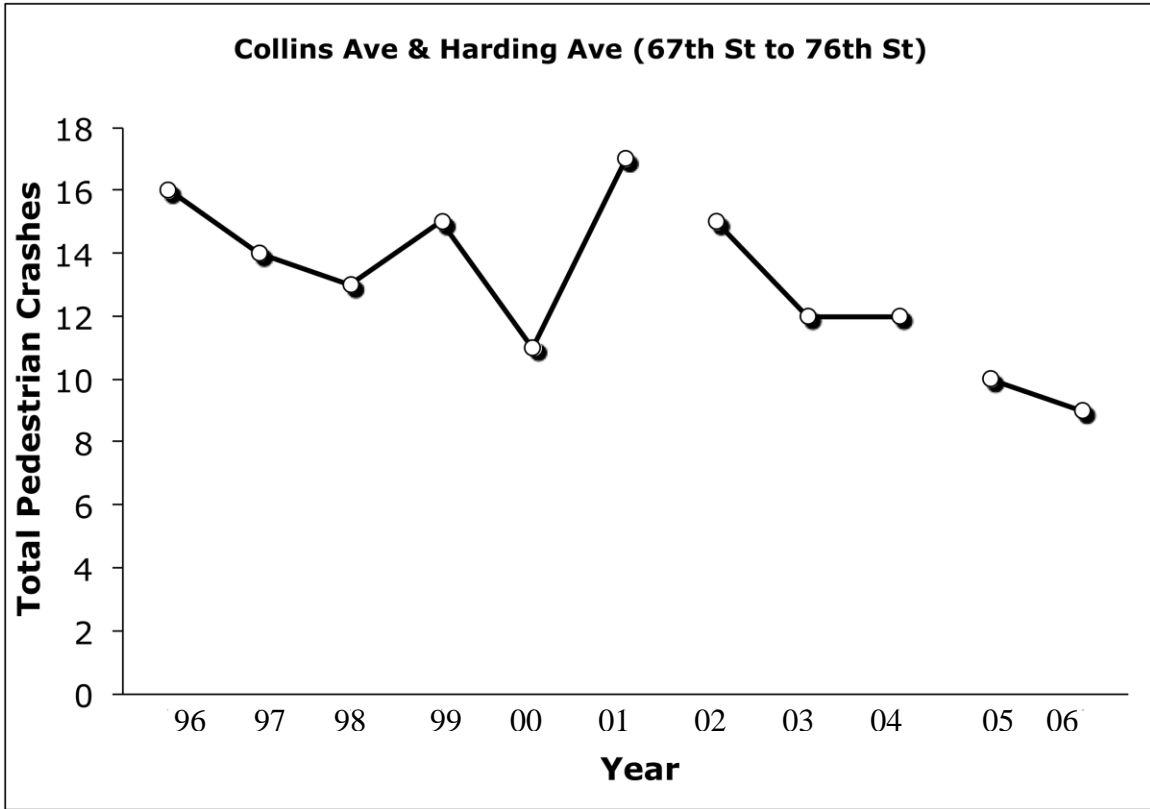
This crash corridor had the highest percentage of crashes involving turning vehicles during baseline of all of the selected corridors averaging 80% and the highest percentage of pedestrians struck over the age of 65 years (49%). Treatments installed along this corridor included “Turning vehicles yield to pedestrians” symbol signs, pedestrian zone signs, and the speed trailer. During the baseline condition the number of crashes per year averaged 14.3, during the NHTSA project crashes averaged 13 per year and during the FHWA project they averaged 9.5 per year. Overall it appeared the treatments were only moderately effective at this site. A graph of the yearly crash data is shown in Figure 4.8.

Figure 4.8 Crashes per Year Collins Ave. and Harding Ave. (67th St. to 76th St.) from 1996 to 2006

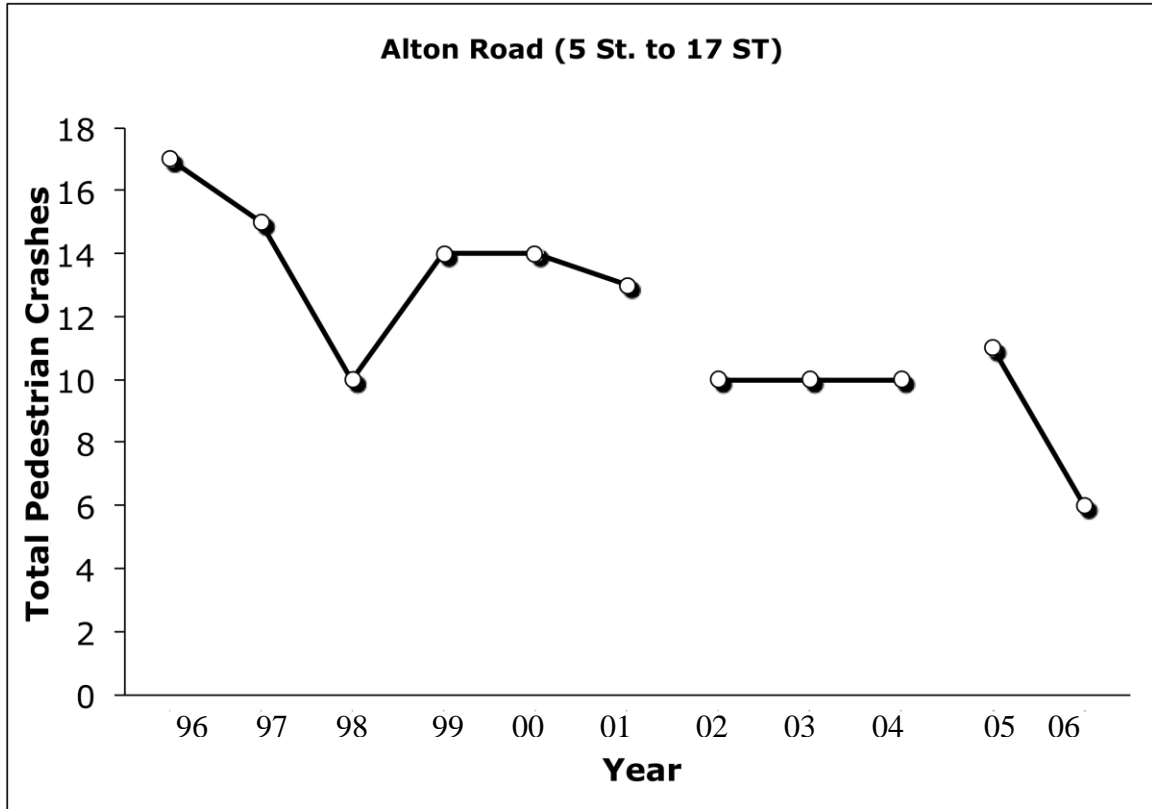
The corridor along Alton Road between 5th St. and 17th St. averaged 13.8 crashes per week during baseline. This corridor had the second highest percentage of daytime crashes (74%) and 42% of crashes occurred at intersections. Alton Rd. received a number of treatments. A large number of push buttons that confirmed the press and countdown pedestrian signals were installed along this corridor. The video detection system was installed at a midblock signalized crosswalk. Three intersections received a leading pedestrian interval, and one intersection received the “Turning vehicles yield to pedestrians” symbol sign treatment. The introduction of the NHTSA project was associated with a decline in crashes to 10 per year and the FHWA project was associated with a further small decline to 8.5% crashes per year. A graph of these data is shown in Figure 4.9.

Figure 4.9 Crashes per Year on Alton Rd. 5th St. to 17th St.) from 1996 to 2006

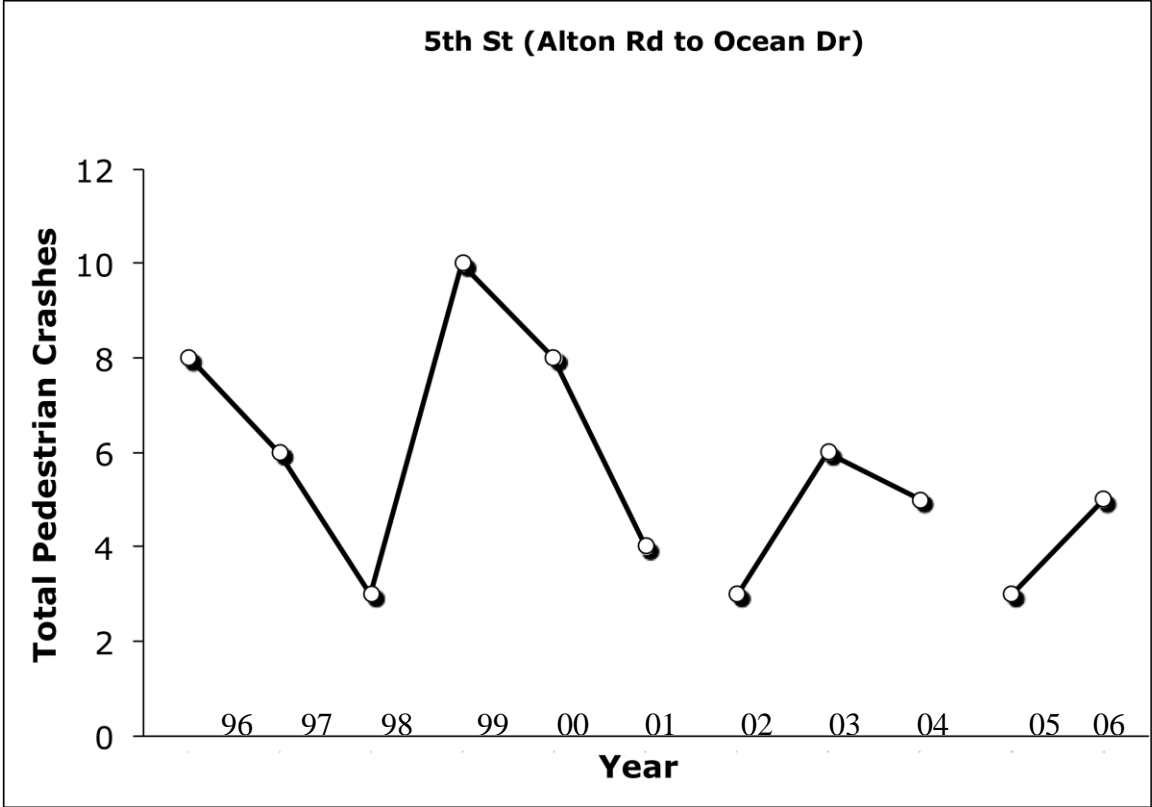
The final graph shows the number of crashes occurring on 5th St. between Alton Rd. and Ocean Drive. More than half the crashes along this corridor occurred at night and only 23% involved turning vehicles. Treatments installed along this corridor included push buttons that confirmed the button press, and “Turning vehicles yield to pedestrians” symbol signs. During the baseline condition pedestrian crashes averaged 6.5 per year. After the NHTSA program was introduced these crashes declined to 4.7 per year and following the introduction of the FHWA project crashes declined to 4 per year. Figure 4.10 shows crashes at this site. Overall there were not a large number of crashes along this corridor and it is difficult to determine whether the treatments had an effect.

Figure 4.10 Crashes per Year on 5th St. Between Alton Rd. and Ocean Dr.) from 1996 to 2006
