**TIME RATE OF LOCAL SCOUR
AT COMPLEX BRIDGE PIERS
FIELD AND LABORATORY ANALYSES**

FDOT CONTRACT NO.: BD 545 RPWO 19

APRIL 2009

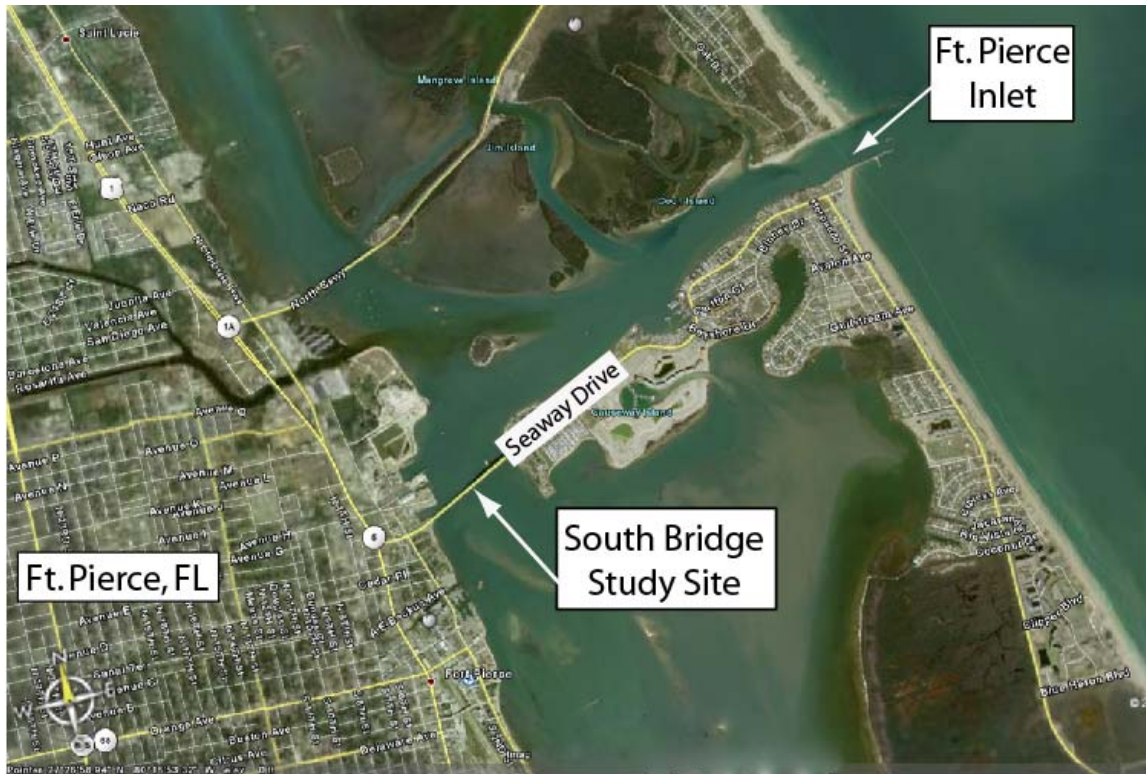
Figure 2 Aerial photograph showing test pier location relative to Fort Pierce Inlet.

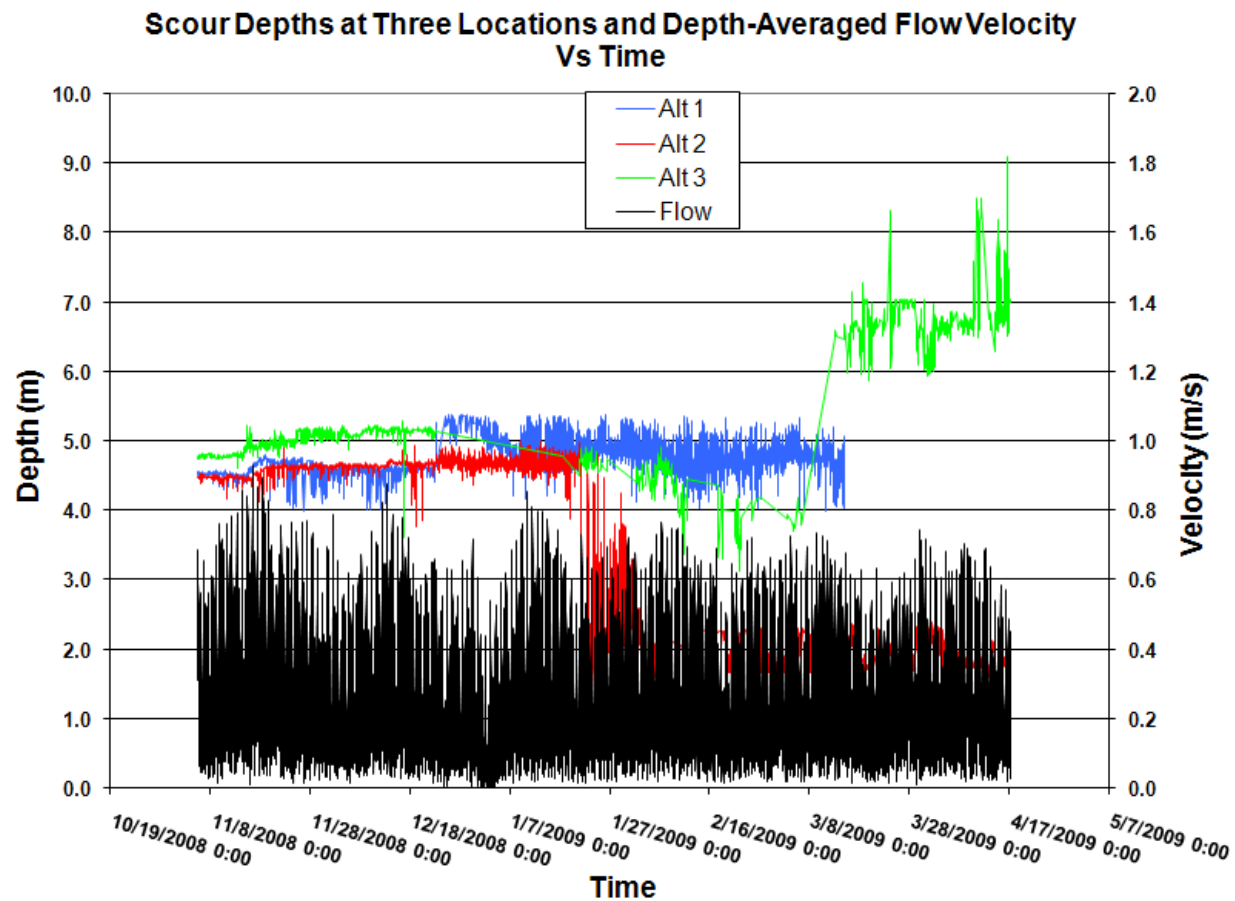
Figure 6 Scour depth and depth-averaged flow velocity versus time.

Data collection began November 5, 2008 and for the purposes of this report ended April 17, 2009, a total of 164 days. Plots of the data are presented in Figures 5-9. Note that the water depth and flow velocity measurements did not experience any problems over the duration of the study (Figure 5). The scour depth instruments provided good data for the majority of this period, but altimeter 2 started having problems around January 21, 2009 and altimeter 3 around February 8, 2009. Altimeter 1 provided good data until March 14, 2009. The dive crew has been waiting until the decision was made regarding the extension of the measurement period to repair/removed the instruments.

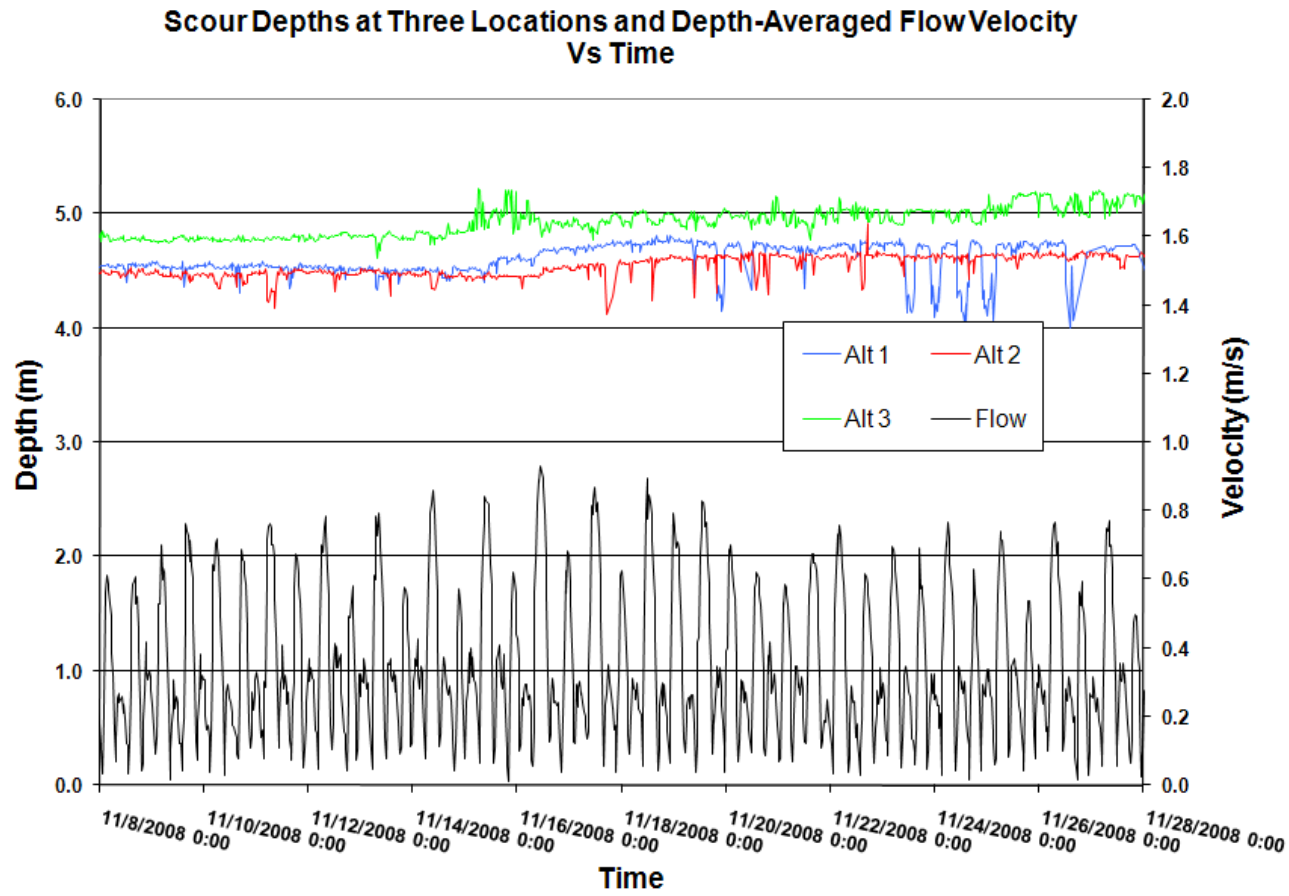
Figure 7 Scour depth and depth averaged flow velocity versus time for a 20 day interval.

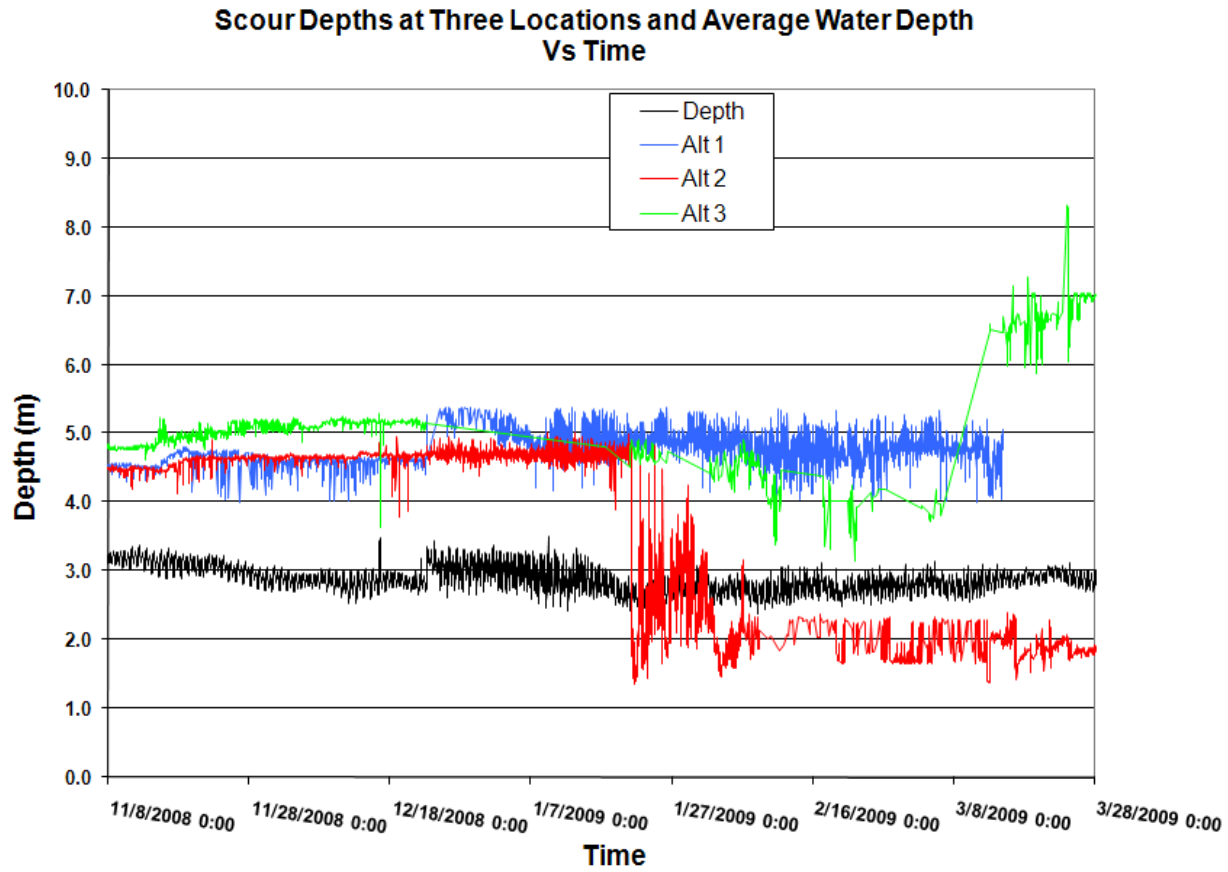
Figure 8 Scour depth at three locations and water depth seaward of the pier versus time.

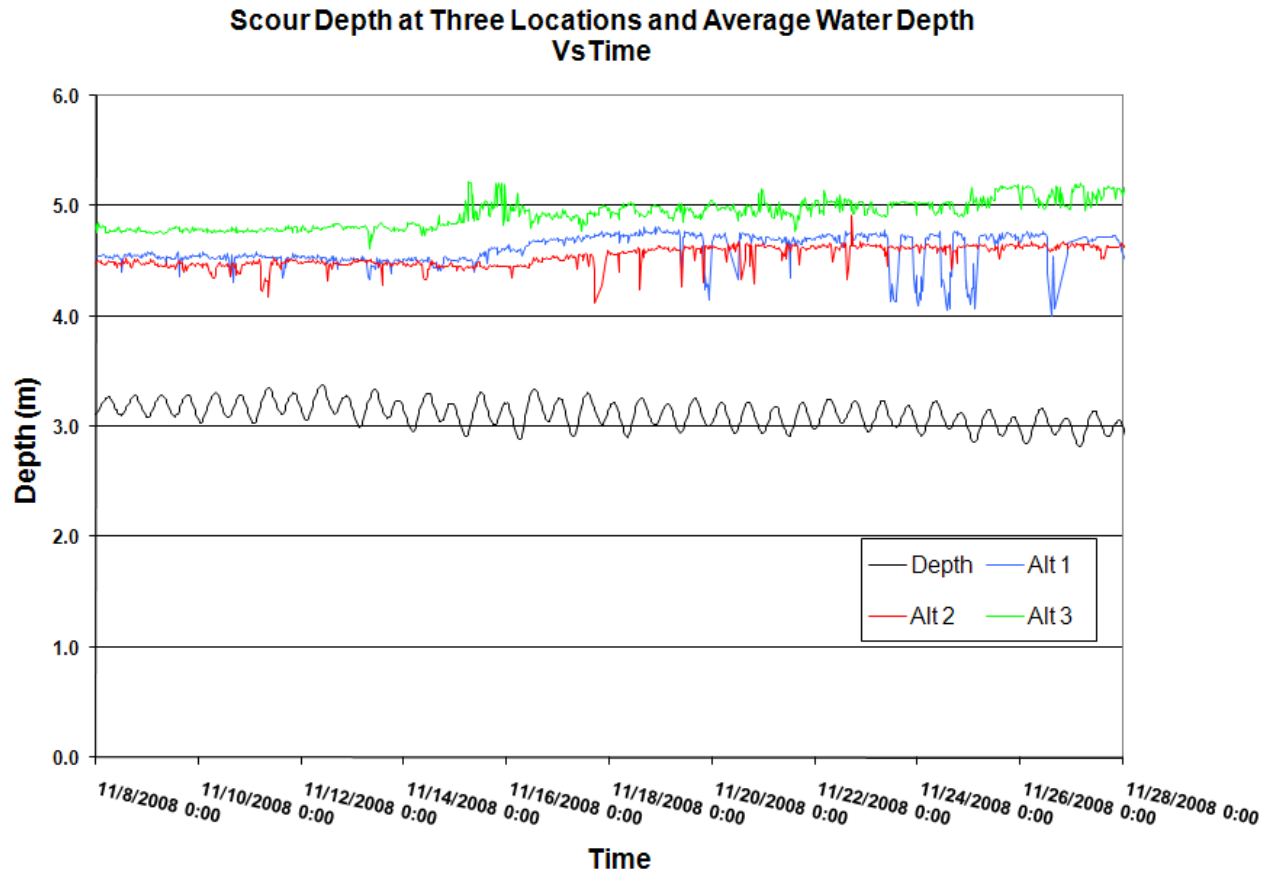
Figure 9 Scour depth at three locations and water depth seaward of the pier versus time for a 20 day time interval.

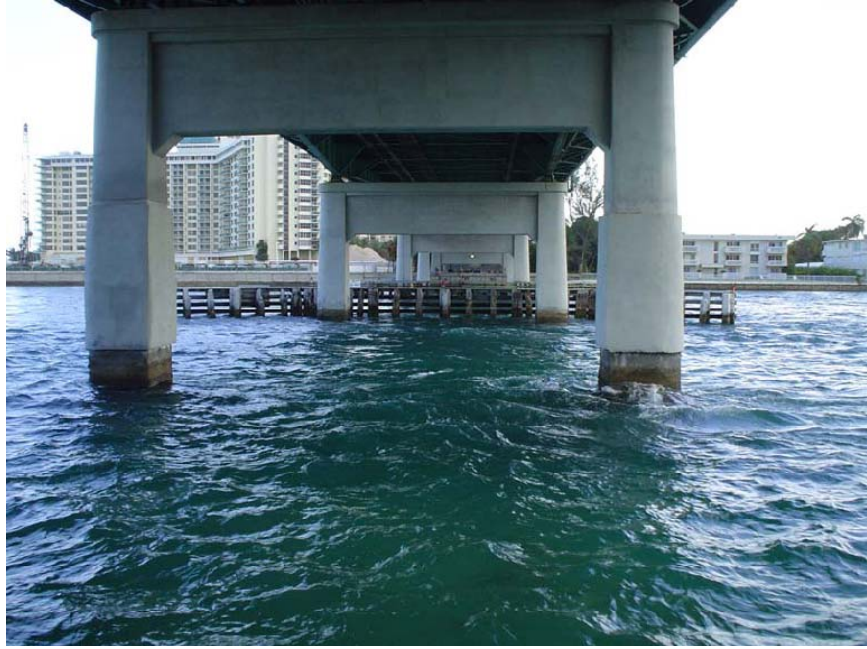
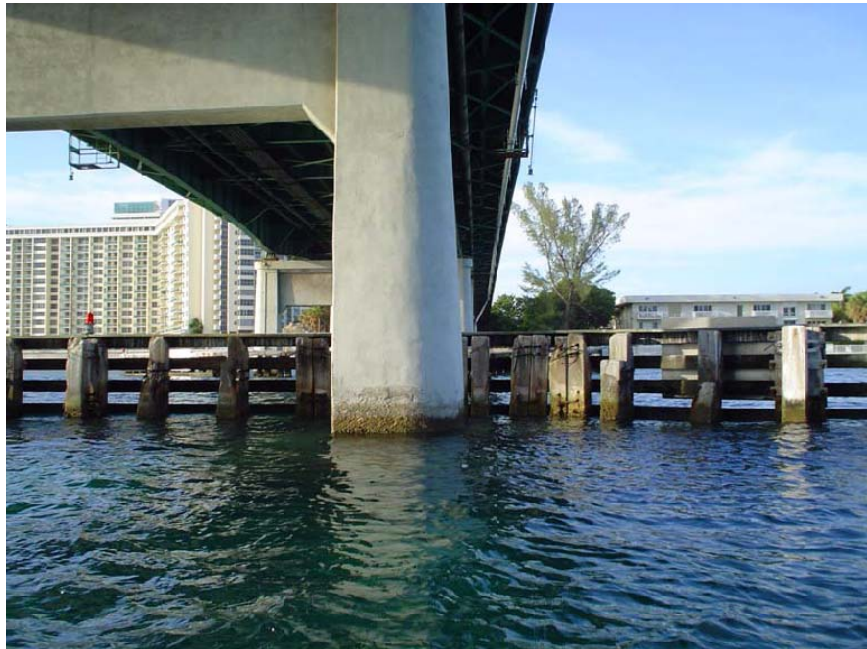
Figure B 1 Photographs of Bakers-Haulover Bridge piers.

Upon initially arriving at the sight it was discovered that all eight of the piers supporting the bridge were placed on top of pile caps. Sand probes revealed that the sand layer thickness varied from more than 2' to exposed rock.

Piers 1 & 2 were located in a bedding environment that consisted of mostly sand with few breaches of bedrock and several larger detached rock pieces which appear to have been exposed in the scour hole and provided a very small amount of non-uniform armoring. Due to the local scour within the channel, the pile caps of both piers were exposed. The existing scour conditions of Pier 2 were that of a width of up to 16' on either side of the pile cap and 12' forward of the oncoming flow. The scour depth at Pier 2 was found to be 9' below the existing bed level. Due to the close proximity of the two piers, their individual scour holes overlapped to a great extent creating a fairly large scoured area encompassing both piers. In many place around the Pier 2 pile cap (mainly the leading and side edges) the scour depth has reached a depth in excess of 6"-10" beyond the pile cap.

Piers 7 & 8 contained the largest amount of exposed bed rock, covering roughly 50% of the scoured area. However, Piers 7 & 8 also showed the deepest scour hole, with Pier 7 having scour more than 1' below the pile cap on its leading edge (scour depth being further punctuated by a dozen lobster living beneath the edge). As before, the two scour holes of Piers 7 & 8 overlapped into each other.
