FINAL REPORT

DEVELOP METHODOLOGIES/PROTOCOLS TO ASSESS CRACKING
POTENTIAL OF ASPHALT MIXTURES USING ACCELERATED
PAVEMENT TESTING

Contract No.: BD545-49

Florida Department of Transportation
605 Suwannee Street
Tallahassee, FL 32399

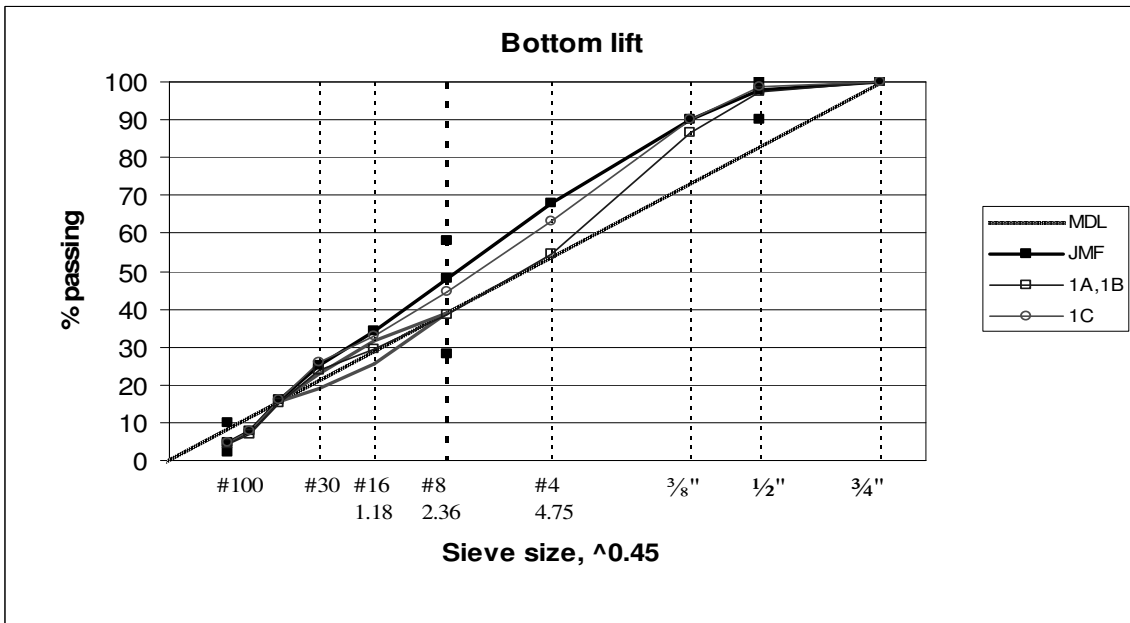
Figure 2.3 Bottom lift gradations

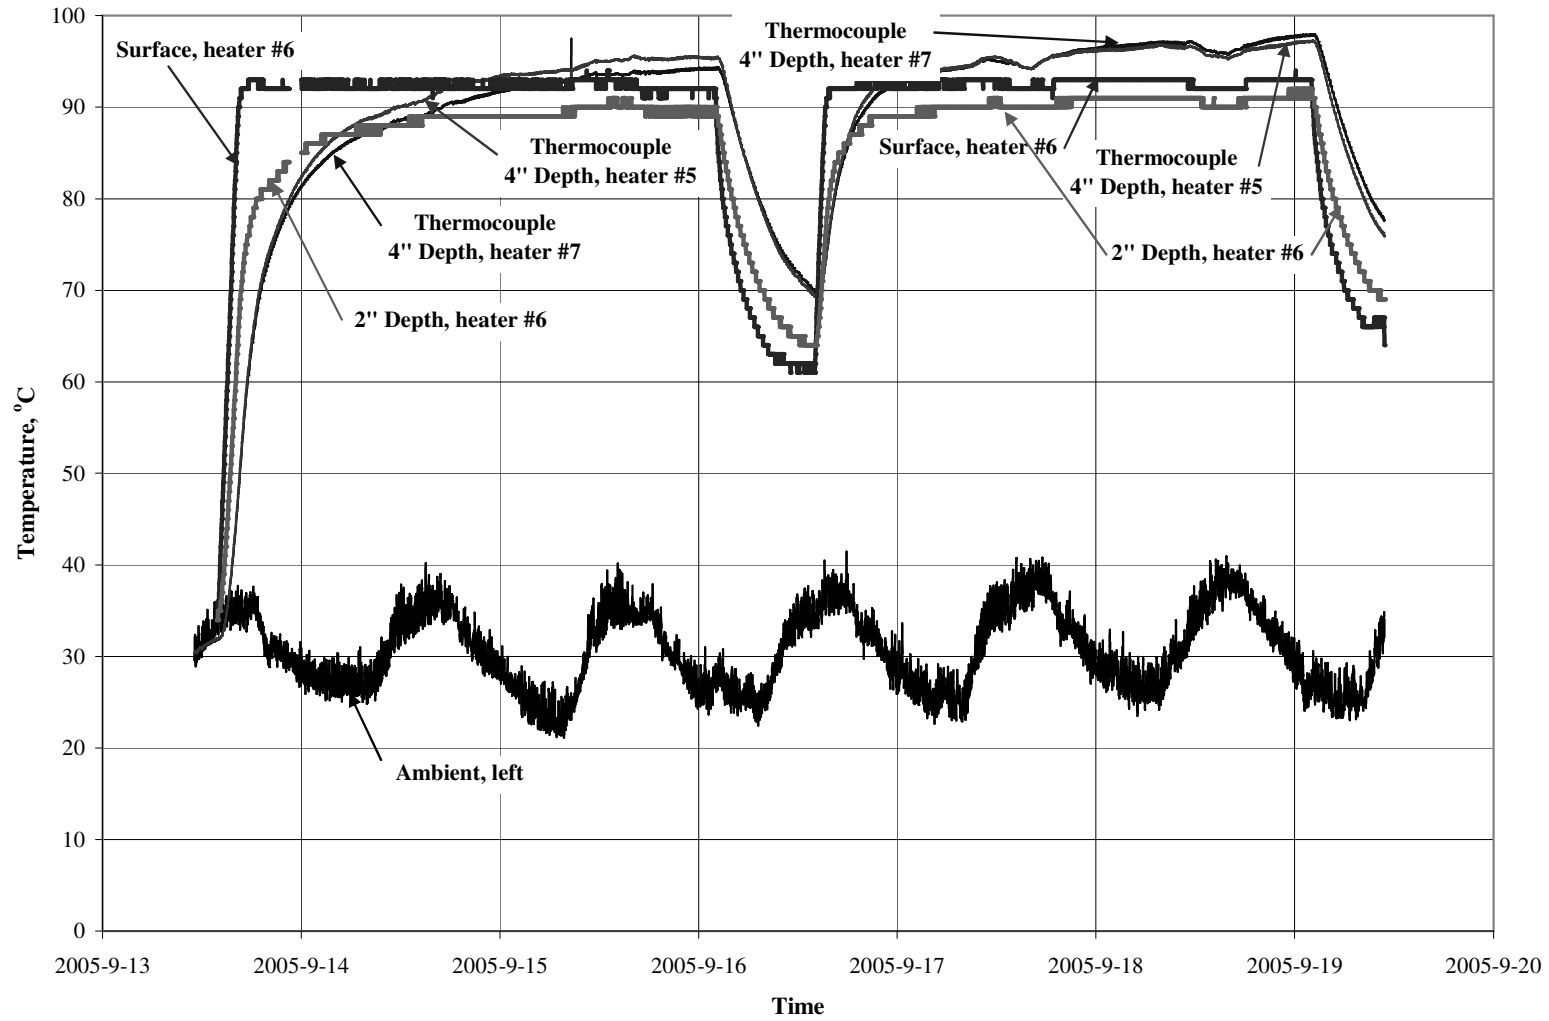
Figure 3.5 Typical Temperature plot during Heating Cycle at Section 1B

Based on the above observations, a completely different aging procedure was used for Section 1B, for which each cycle consisted of a heating-cooling-heating sequence. The set-up for the auxiliary temperature measurement system was modified. A typical heating cycle plot for this section is shown in Figure 3.5. The measurements were very similar to those obtained on section 1C. However, it doesn't make sense that the 4" value is higher than the 2" and surface values, except for the very beginning of the heating sequences, which might indicate there is something wrong with auxiliary temperature measurement system. Therefore, for consistence purpose, only temperatures

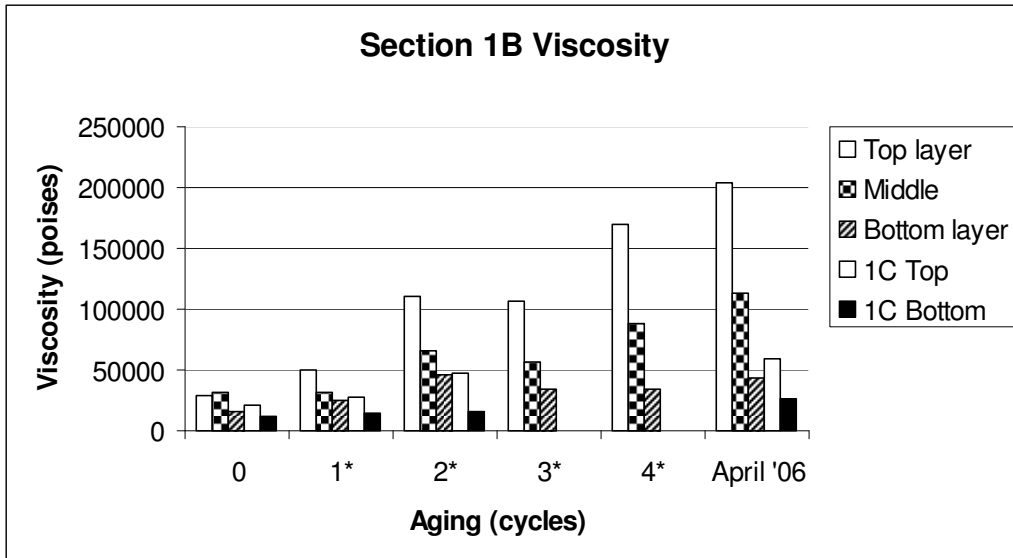
Figure 3.6 Recovered viscosity at different levels of aging at Section 1B and Section 1C

Only viscosity measurements were carried out for the specimens from Section 1B. Figure 3.6 shows the viscosity of recovered binder from the Section 1B specimens before and during aging, with results from some additional cores taken in April '06 before HVS loading started. For comparison, the concurrent results from Section 1C are shown in the same figure. In this figure, the results are presented with labels "0", "1", "2" and so on, for which the labels "1" and higher represent the aging cycles, and "0" is before artificial aging started.

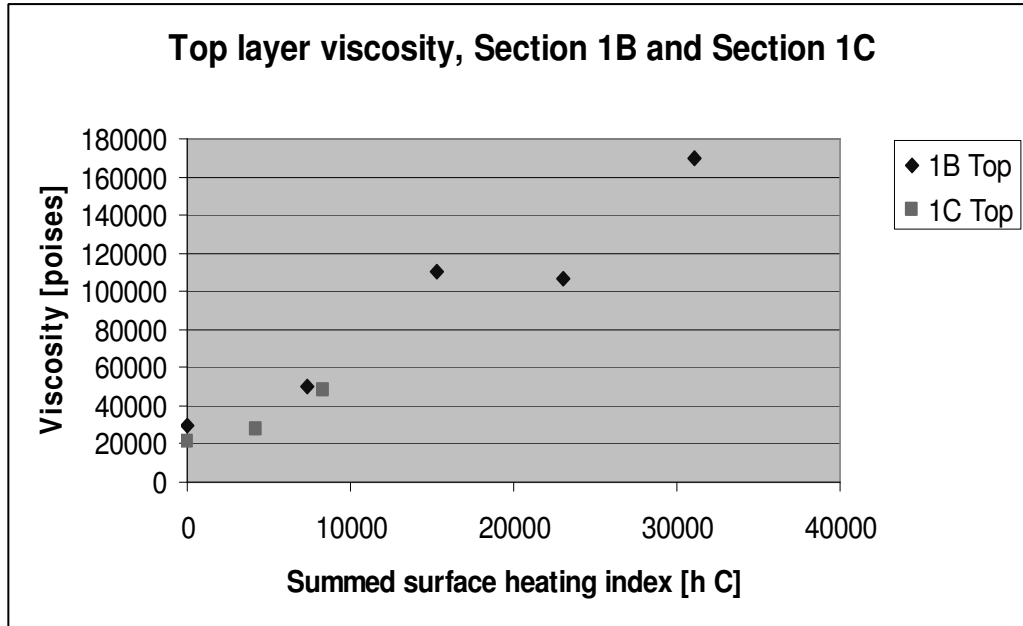
Figure 3.7 Recovered viscosity for top layer specimens from Section 1B and Section 1C

Because the aging effort is so different for Section 1C and Section 1B, Figure 3.7 was created to show how viscosity varies with summed surface heating index. Only the top layer specimens from Section 1B and Section 1C are included. Figure 3.7 indicates that there is a fairly nice relationship between binder viscosity and imposed aging effort, which is relatively independent of the origin of the specimens.

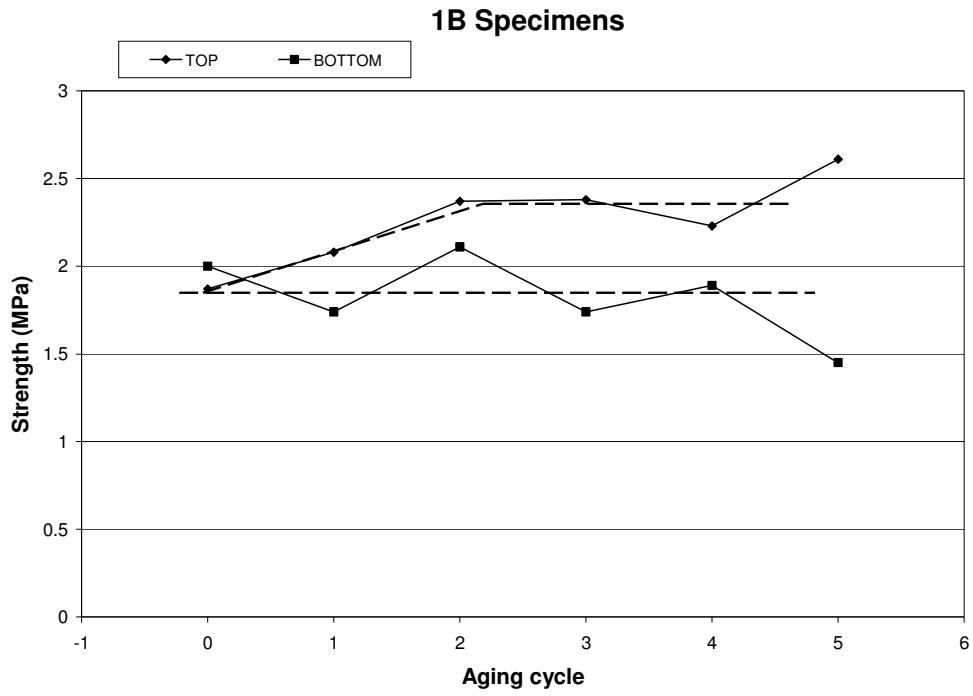
Figure 4.13 Failure strength for specimens from cores taken at different levels of aging at Section 1B

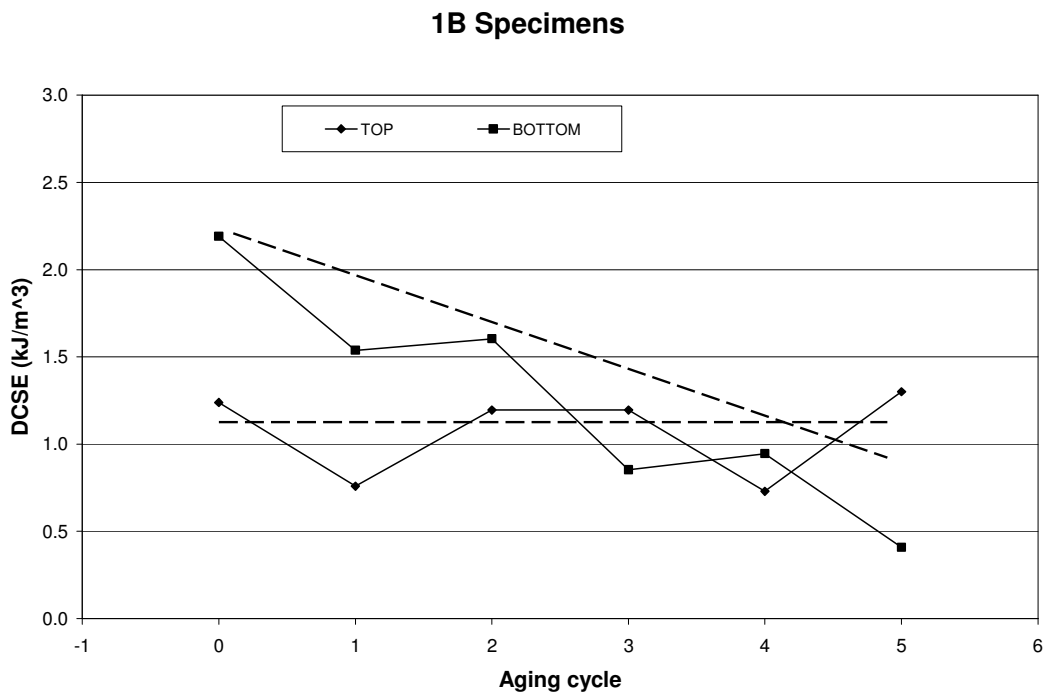
Figure 4.14 Dissipated creep strain energy for specimens from cores taken at different levels of aging at Section 1B

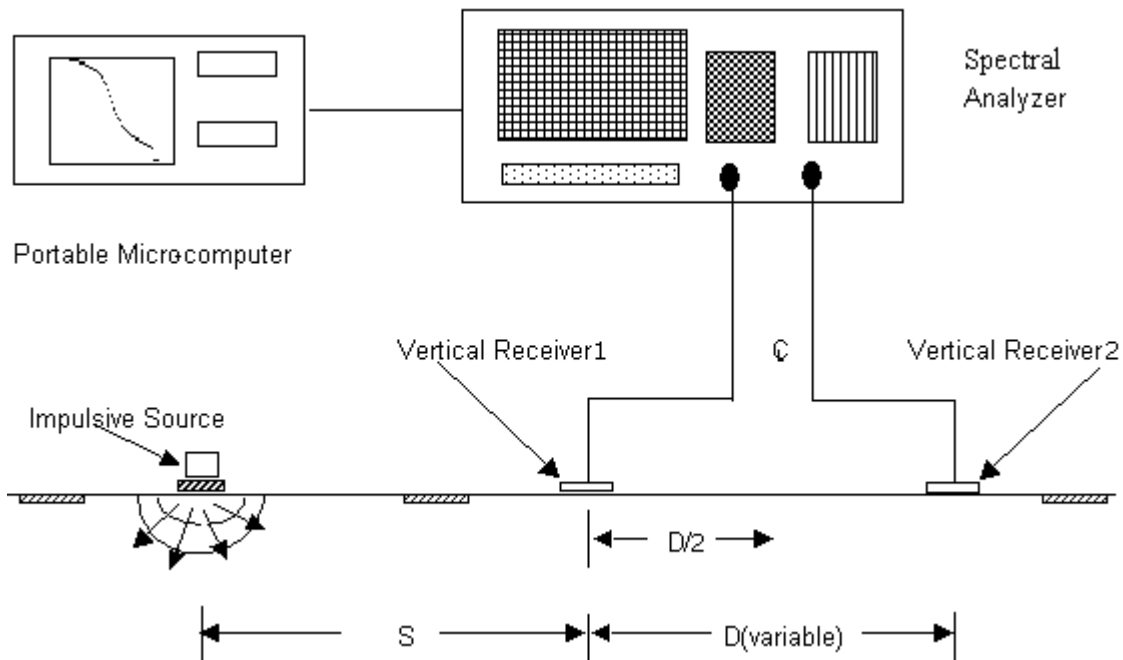
Figure 5.7. Layout of the testing setup of the SASW method

SASW (Joh,1996) is a seismic method developed for determining shear wave velocity and shear modulus profiles of geotechnical sites; this is not a routine technique for detecting cracks or damage in asphalt concrete (AC). However, some SASW tests were conducted prior to the HVS loading to measure the pavement's characteristics in the uncracked state. These SASW tests indicated that existing measurement techniques and interpretation methods were not optimized for purposes of detecting the near-surface changes resulting either from age-hardening or damage. Also, the system was rather cumbersome in its current state and required high level technical expertise to perform and interpret the tests at this time. Figure 5.7 shows the typical setup for SASW test.

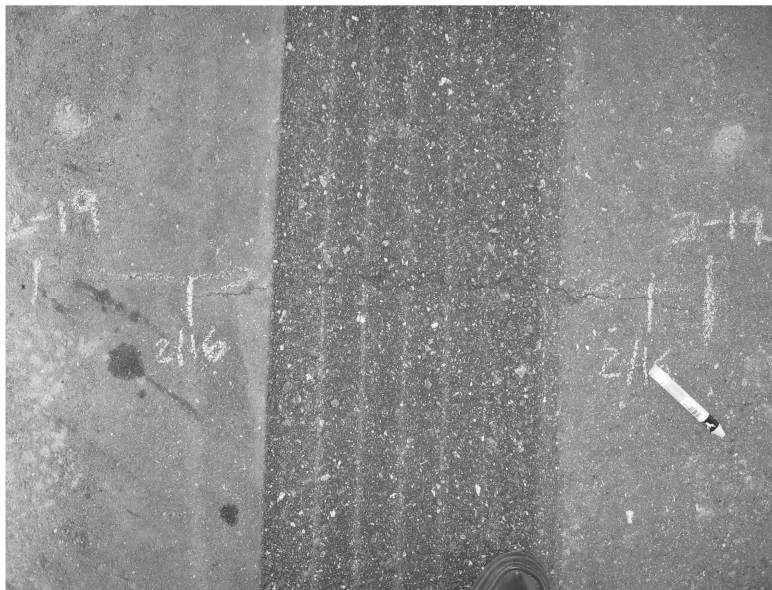
Figure 6.22 Transverse Cracking Developed in Section 1A

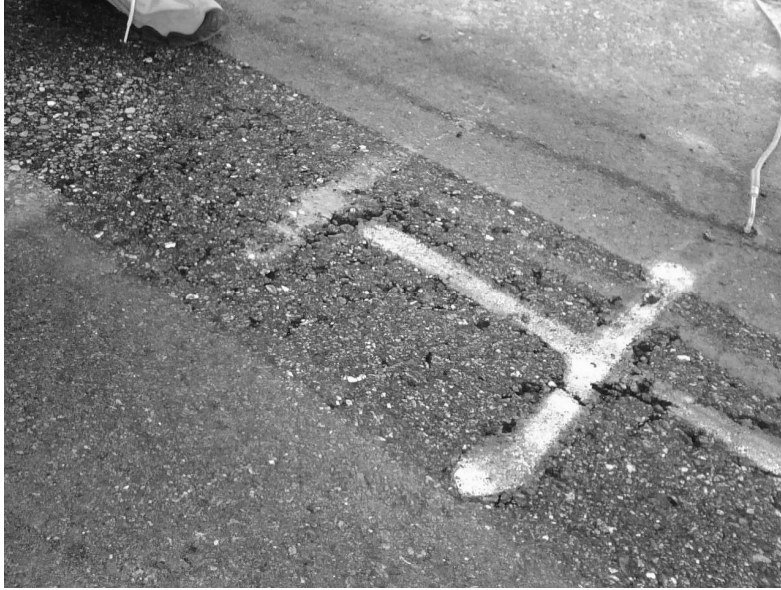
Figure 6.23 Cracking Induced at Paints in Section 1A

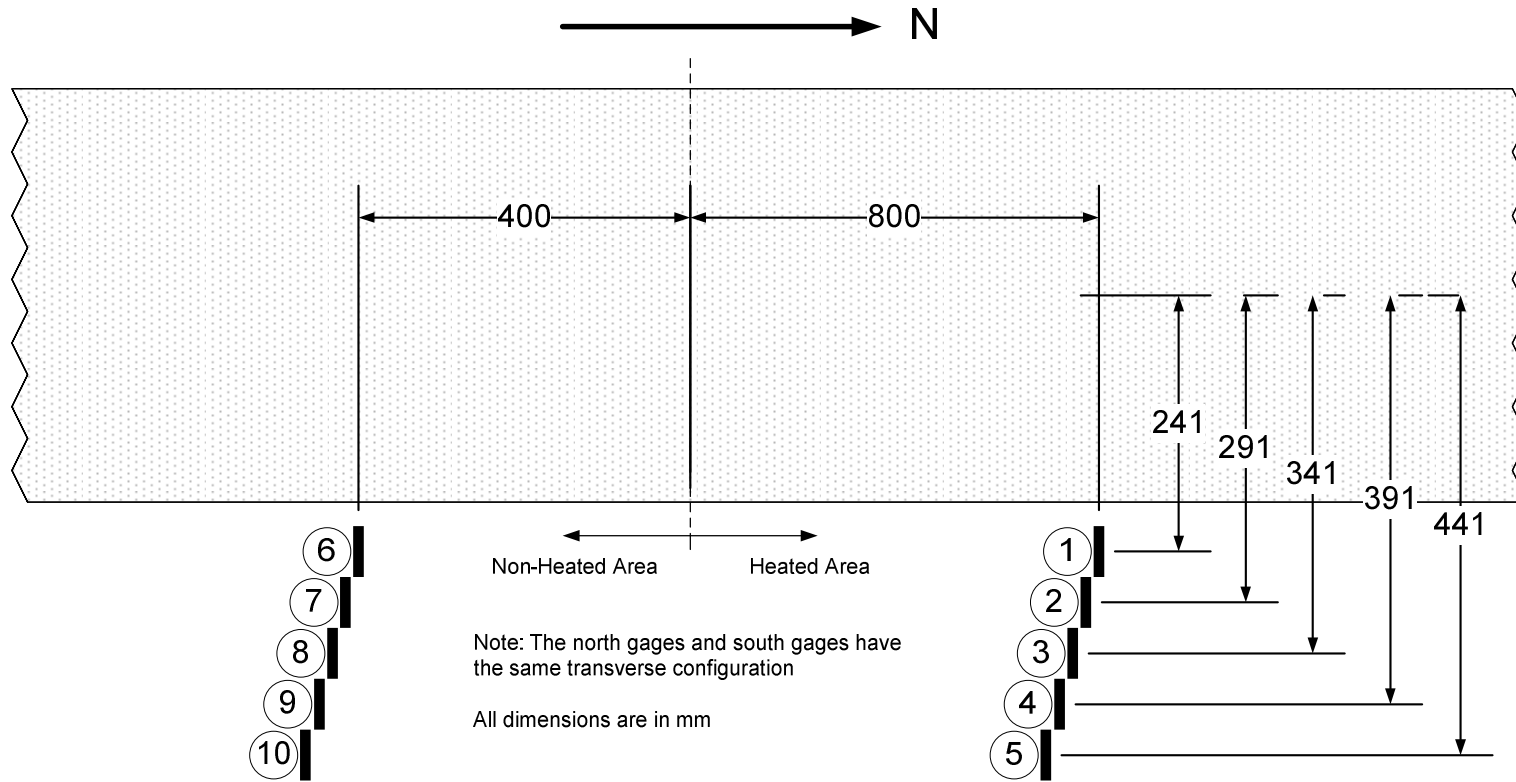
Figure 6.24 Strain Gages in Section 1A Layout

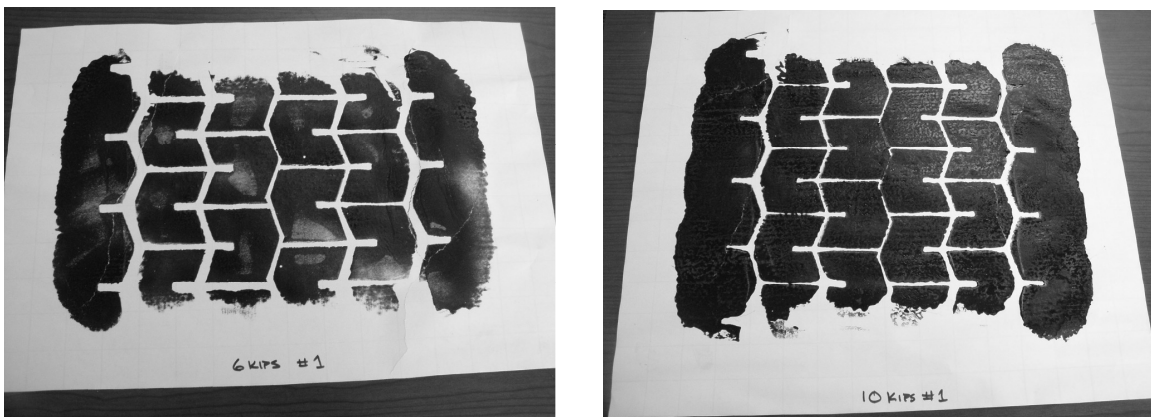
Figure 6.31 HVS Tire Footprints
