**Detection of Microcracks in Concrete Cured at  
Elevated Temperature**

**Final Report**

**Florida Department of Transportation  
(Contract No. BD 545 - 50)**

**July 2006**

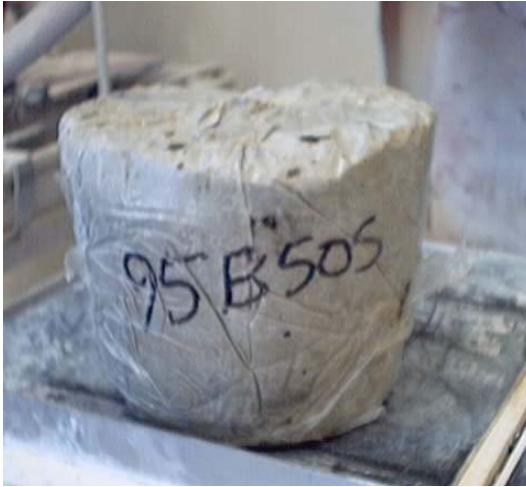
Figure 3-1 Concrete sample

adiabatic condition. The chambers were connected with thermocouples to a micro-controller that regulated temperature and documented the adiabatic temperature rise during curing. Figure 3-1 shows one of the samples used for this study.

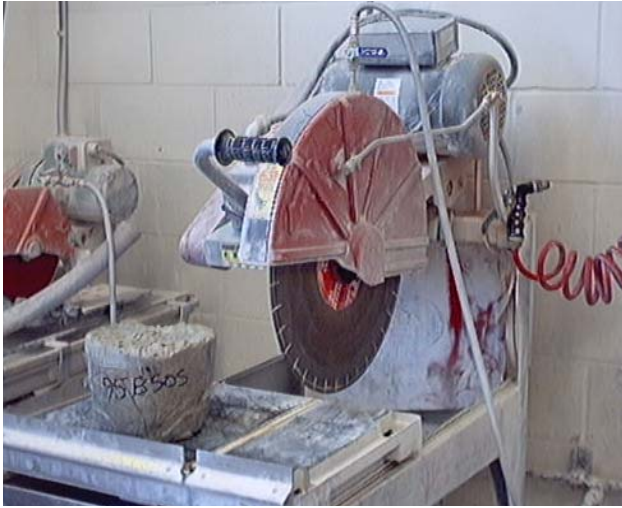
Figure 3-2 Diamond blade saw used for first cutting operation

FDOT Materials Lab in Gainesville, Florida. Figure 3-2 shows the samples and diamond saw equipment from the FDOT lab facilities.

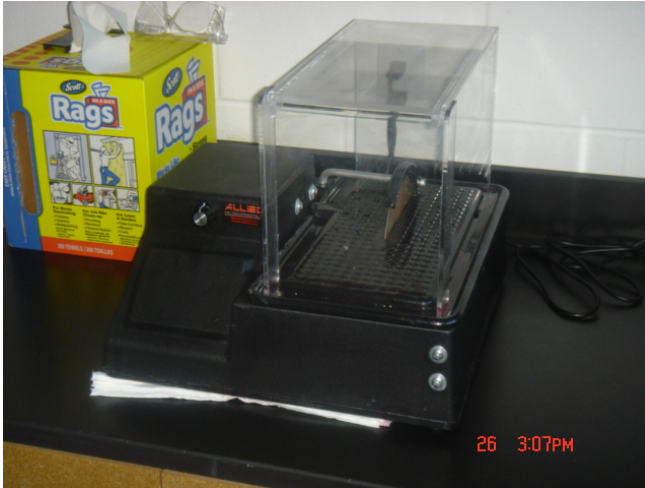
Figure 3-3 Trim saw

The concrete samples were cut to 1/2" (13 mm) thick pieces with the diamond saw. After that the samples were cut down to squares of 1.5" (38 mm) and 1/4" (6.3 mm) thick. These fine cuts were done with a diamond wafer saw, Trim Saw by Allied High Tech, Inc. shown in Figure 3-3. The cuts were performed at 480 RPM with a 6" (15.24 cm) diameter diamond metal bond blade, 0.02" (0.5mm) thick. The cuts were performed manually and the blade was constantly lubricated with a low speed propylene-glycol based cutting fluid by Allied High Tech, Inc. The cutting fluid is designed exclusively for low speed cutting (<500 RPM) applications where a thicker formula is needed to lubricate blades, remove debris from the cut, and reduce friction.

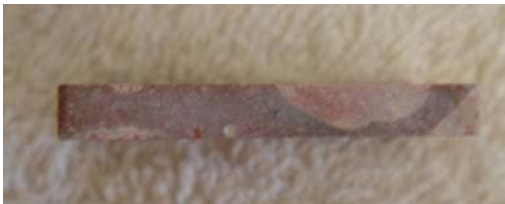
Figure 3-4 Red-dye water-ethanol replacement in control sample

depth of dye coloration. On average, alcohol-pore water replacement was found to be approximately 1mm/day. After three days the control sample was cut and the red coloring showed evidence of the replacement to a noticeable depth (Figure 3-4).

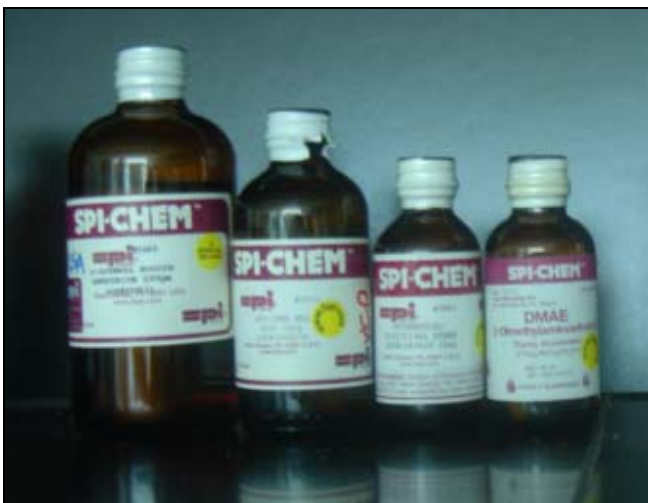
Figure 3-5 Ultra Low Epoxy Kit

Once the ethanol replacement was complete, the samples were infiltrated with epoxy. The replacement with epoxy was performed as specified by a company representative and the product's manual. The product is an ultra-low viscosity epoxy kit from Structure Probe, Inc. shown in Figure 3-5. The epoxy kit is made up of four chemicals and mixed to obtain the desired quantity as described in Table 3-3.

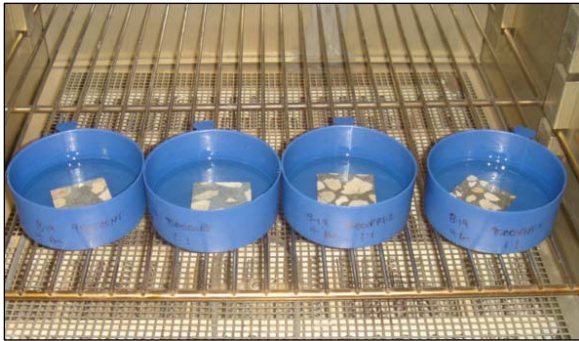
Figure 3-7 Samples inside oven

For curing of epoxy during all stages of replacement, the samples were kept in an oven at 140°F (Figure 3-7). At the final stage, the samples were ready for the cutting and polishing steps. Grinding and polishing are vital steps in the sample preparation process. Grinding is used to expose a clear surface layer and to remove excessive epoxy coating on the surface. However, excessive grinding could cause damage to the concrete sample

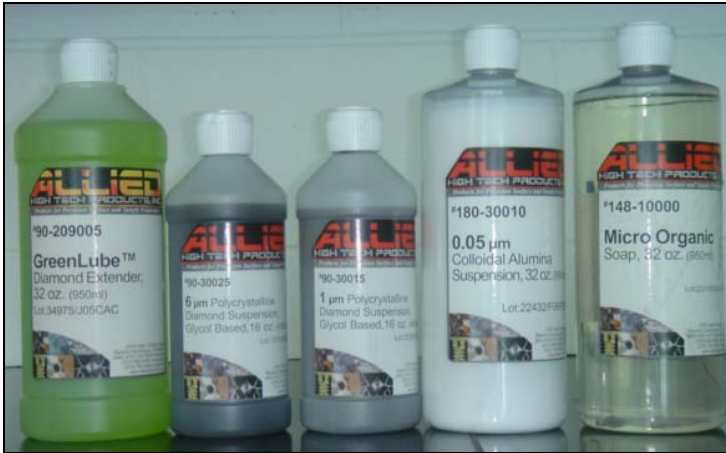
Figure 3-9 Consumables from Allied High Tech, Inc. used for grinding/polishing

The grinding and polishing procedure is a multi-step process that involves the use of various materials and techniques that are best described and illustrated in Table 3-4 and Figures 3-9 and 3-10. The process for grinding and polishing was developed in conjunction with the product application specialists from the manufacturer of the consumables and equipment used in this project, Allied High Tech, Inc.

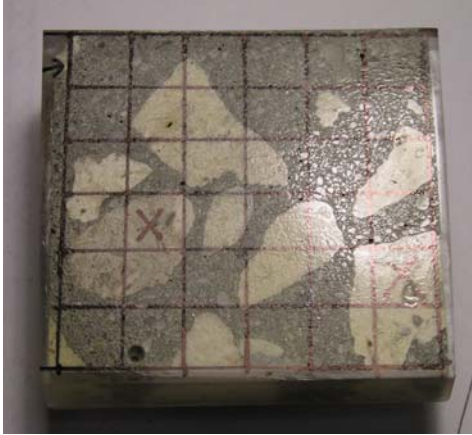
Figure 3-12 Finished polished sample

This marker works well with the SEM image acquisition system since it provides a detectable coordinate grid system for identifying the location of each image being scanned. For each of the grid's cells a single image was scanned and analyzed. The samples were turned over to the SEM technician for imaging as seen in Figure 3-12. Notice the reflection obtained from the polishing process. Additionally, Figure 3-12 illustrates the X marks written onto the sample surface to identify the cells which were predominantly aggregate instead of the cement paste areas, which are of most interest for identifying microstructural cracking. The cells marked with an X were not scanned.

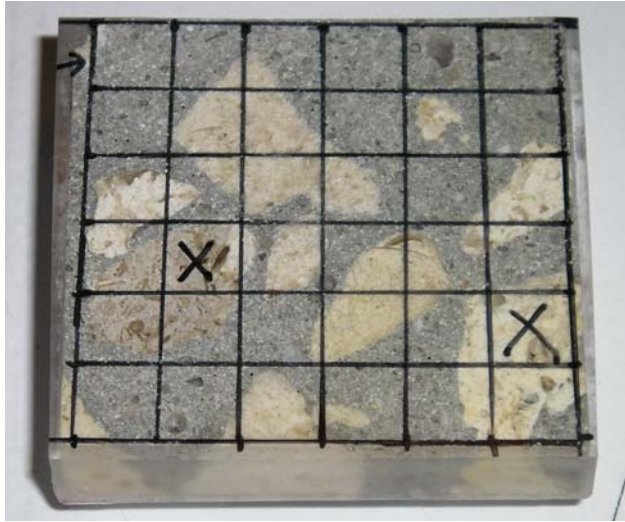
Each image was labeled with a grid system that was used to identify individual matrix cells and areas of particular interest. The grid system is shown in Figure 4-1.

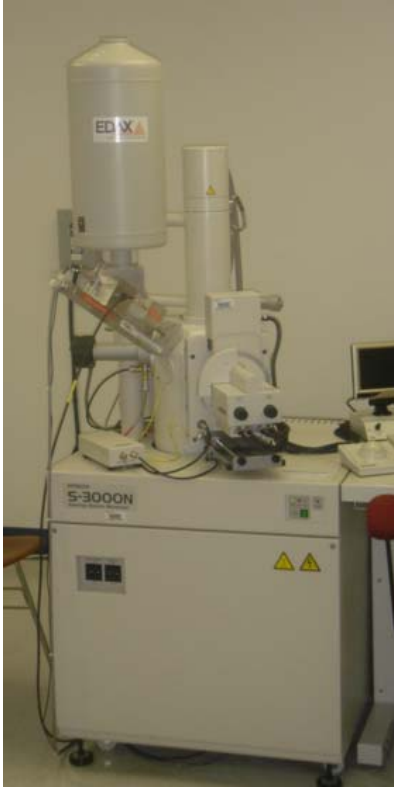
Figure 4-2 Hitachi S-3000N SEM from the University of Florida  
Advanced Material Characteristic Lab

Image acquisition was performed at the Advanced Material Characteristic Lab of the Department of Civil and Coastal Engineering, University of Florida, Gainesville. The facility houses a Hitachi S-3000N, variable pressure Scanning Electron Microscope (SEM) shown in Figure 4-2.

This SEM allows for the viewing of the concrete samples without the need to cover the samples with a conductive surface. The samples are highly polished to obtain optimum imaging results. The SEM machine scans a focused beam of electrons across the specimen and measures any of several signals resulting from the electron beam interaction with the surface of the concrete sample. The three major types of signals generated by the SEM are secondary electrons, backscattered electrons, and x-rays. Backscatter electrons are highly energized beams that can be used to distinguish between the particles in the concrete surface on the basis of variation in brightness and grayscale value. As reported by Stutzman (2001), the backscatter electron and x-ray imaging tools
