**Final Report**

**Protection of Reinforced Concrete Bridge Substructures using  
Submerged Bulk Anodes  
(BD 546-3)**

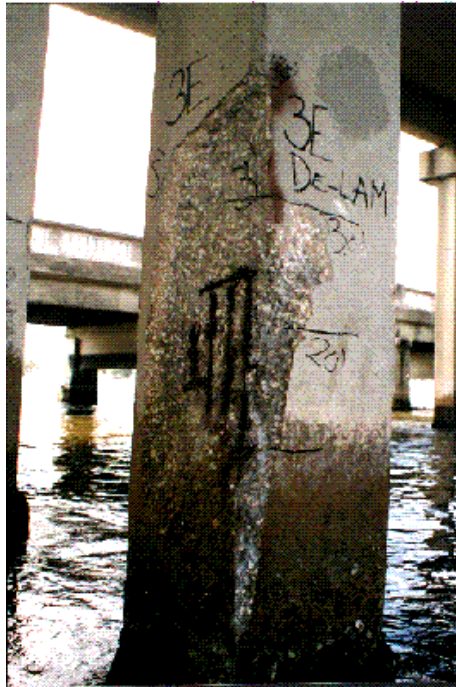
Figure 1 shows a photograph of a cracked and spalled prestressed piling and exposed, corroding reinforcement.

Figure 1: Photograph of a cracked and spalled marine bridge piling.

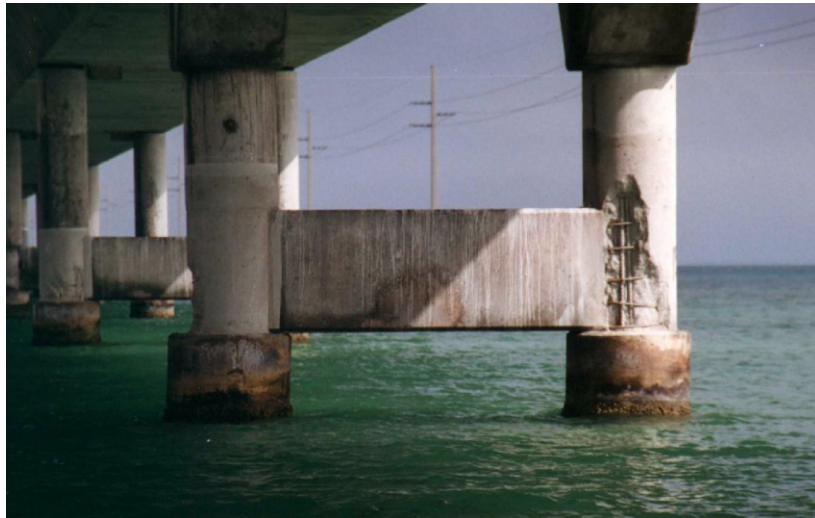
Figure 2: Seven Mile Bridge pier with thermal spray zinc applied to the two columns and strut.

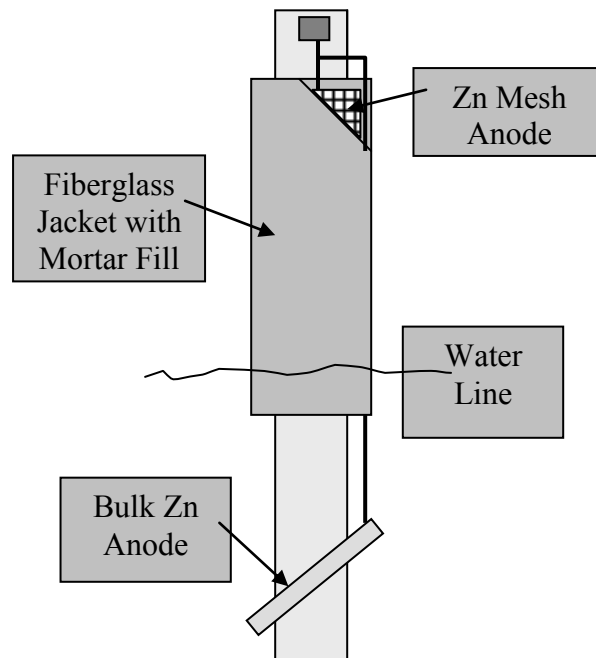
Figure 3: Schematic illustration of a zinc mesh jacket.

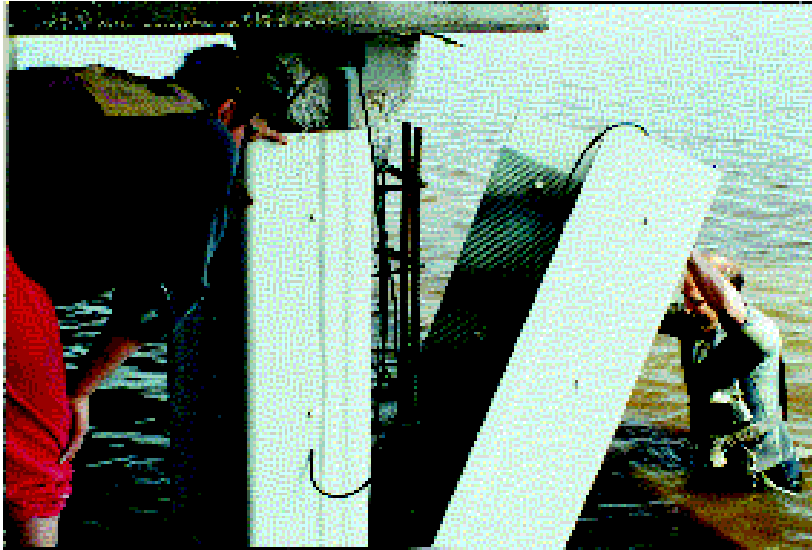
Figure 4: Photograph of a zinc mesh jacket installation (courtesy of D. Leng).

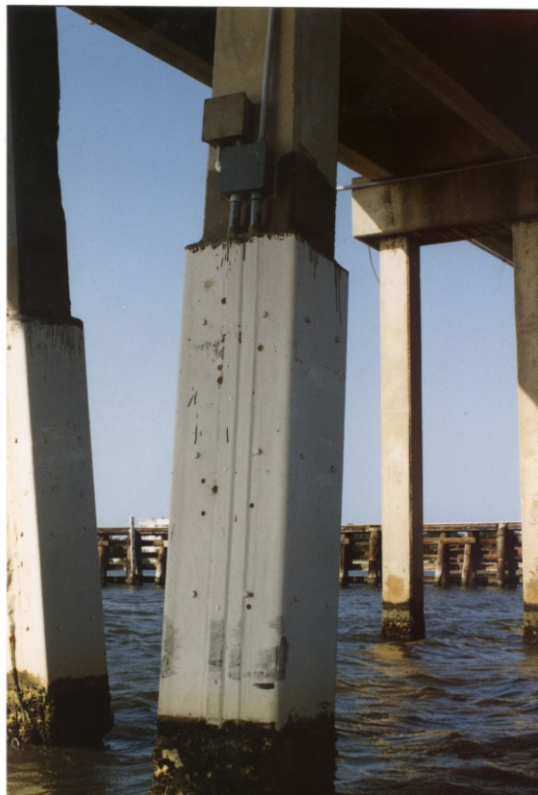
Figure 5: Photograph of an installed zinc mesh jacket.

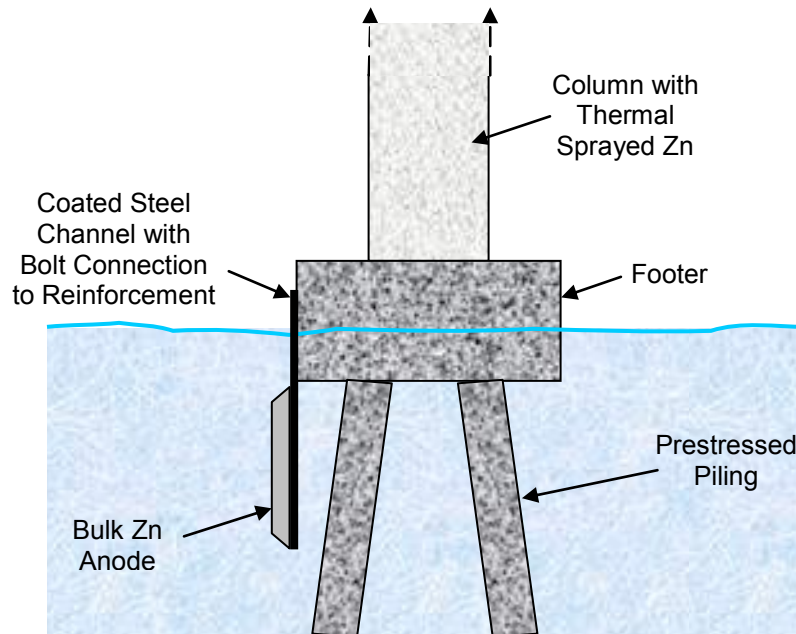
Figure 6: Schematic illustration of a thermal spray Zn/SBA GACP system on a substructure.

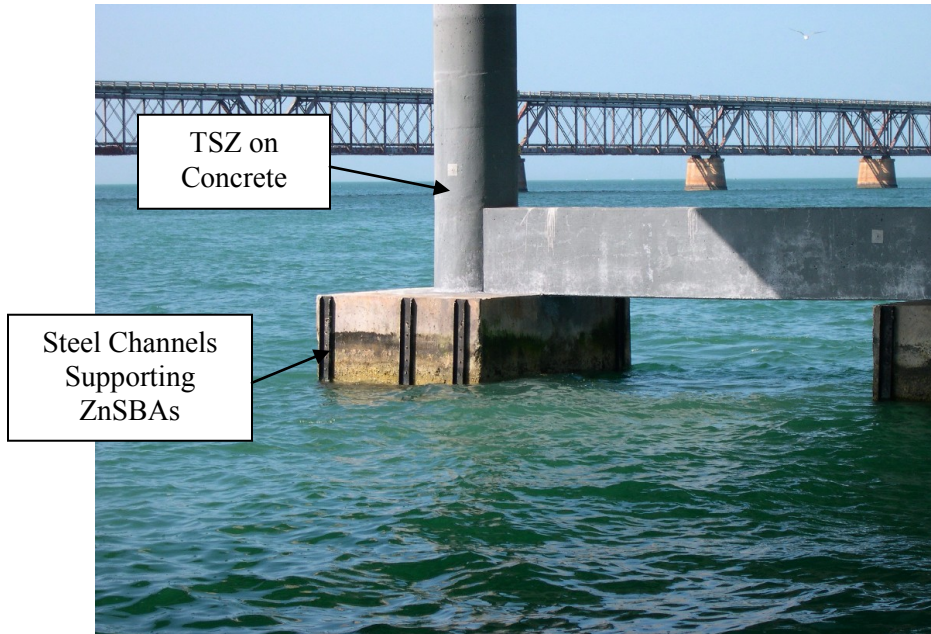
Figure 8: Photograph of a footer/column/strut unit on the Bahia Honda Bridge.

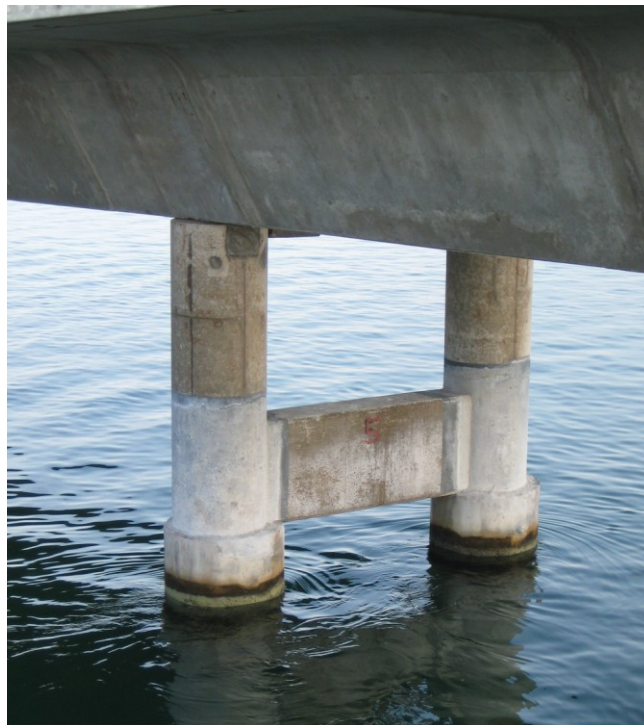
Figure 10: Photograph of a typical pier on the Niles Channel Bridge.

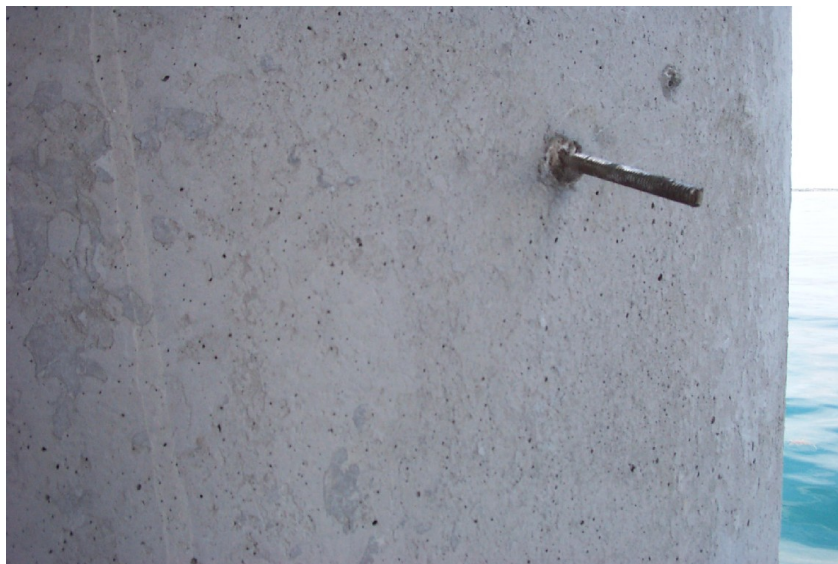
Figure 11: Photograph of the threaded stainless steel ground connection rod on the column of Pier 40W-East.

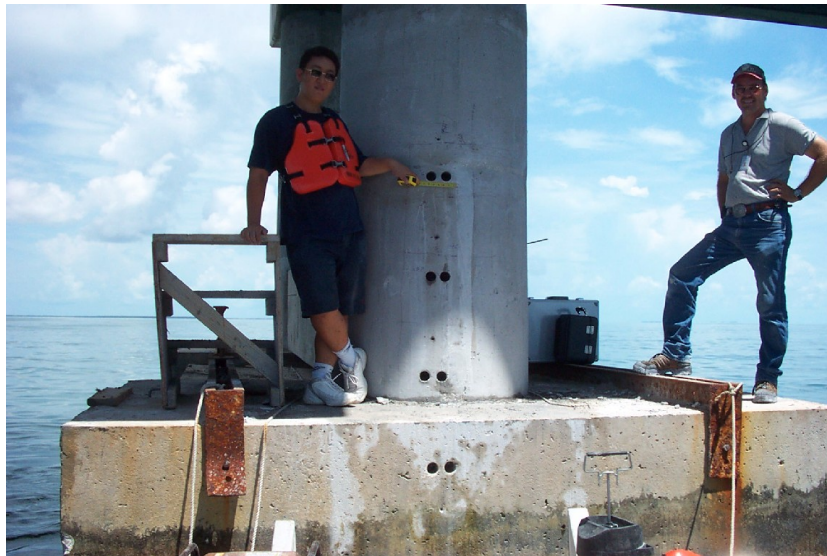
Figure 12: Photograph of Pier 40W-East of the Bahia Honda Bridge subsequent to drilling the four pairs of probe core holes.

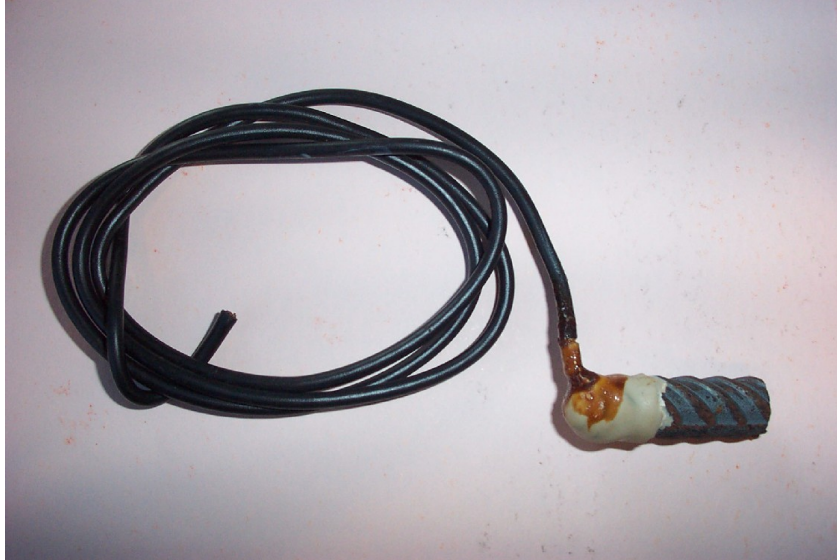
Figure 13: Photograph of a monitoring probe and connection cable prior to embedment.

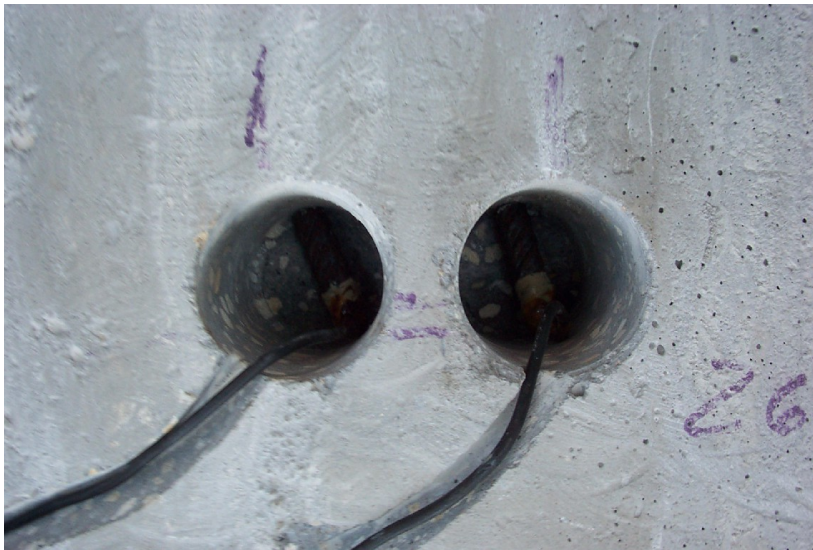
Figure 14: Photograph of two core holes with positioned reinforcing steel probes.

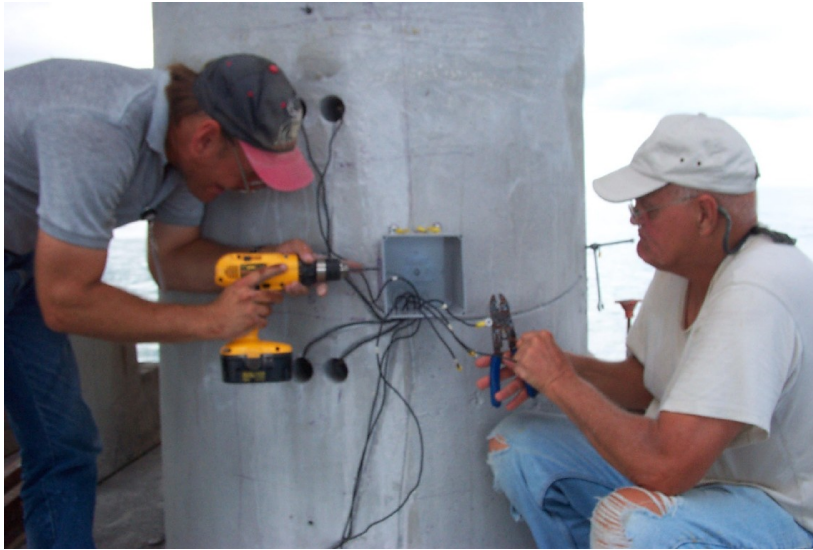
Figure 15: Photograph of the junction box installation and probe wiring on Pier 40W-East.

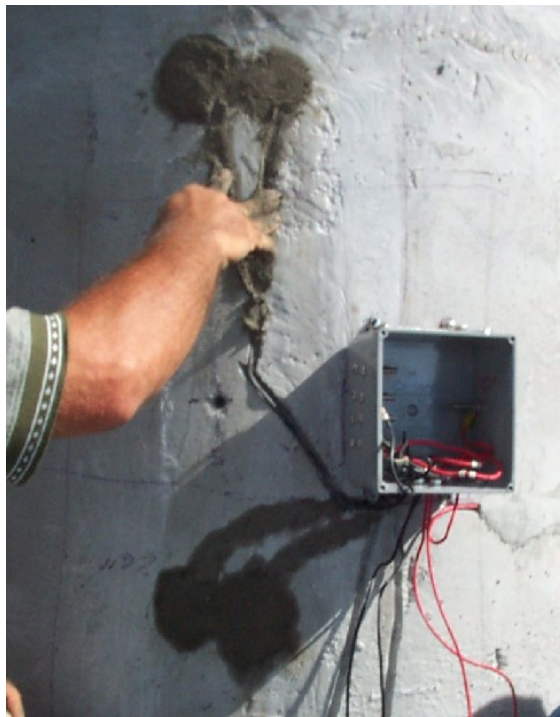
Figure 16: Photograph of the upper two core holes, grouted wire routing slots, and junction box on Pier 40W-East subsequent to installation.

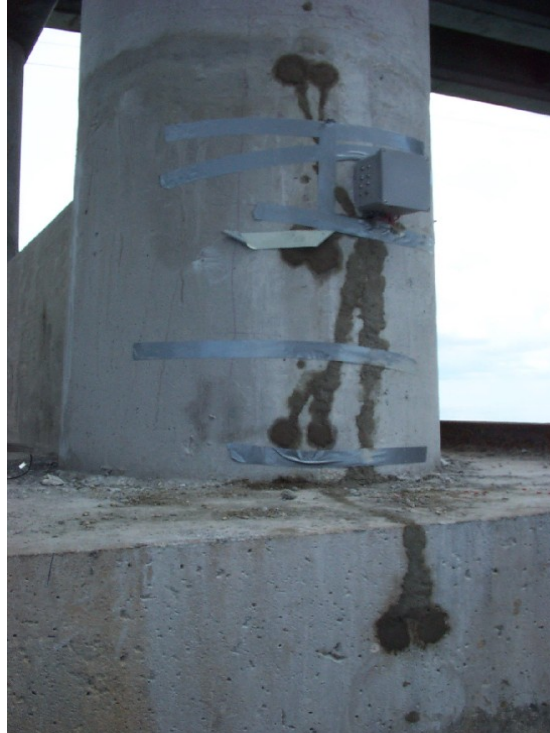
Figure 17: Photograph of Pier 40W-East upon completion of probe installation, wiring, and grouting.

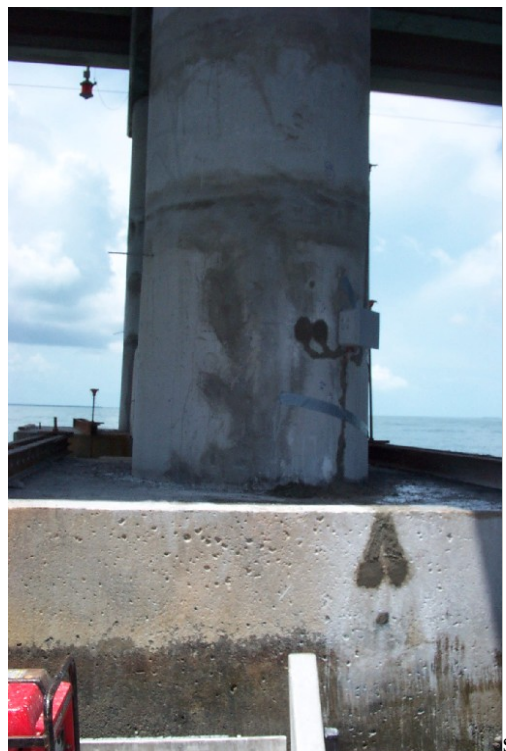
Figure 18: Photograph of Pier 39W-East upon completion of probe installation, wiring, and grouting.

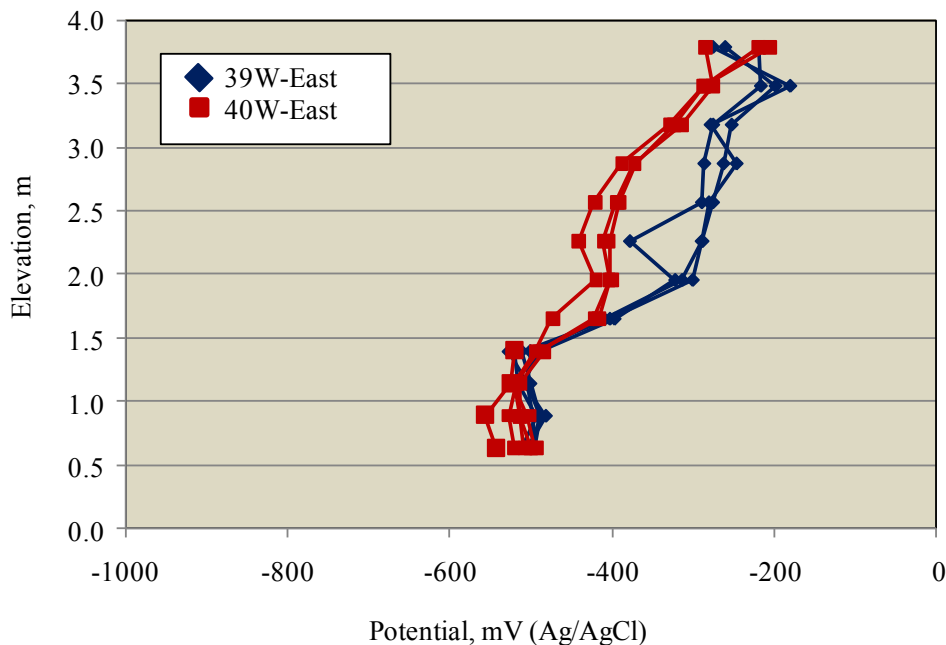
Figure 19: Free corrosion potential versus elevation for the footer and column on each of the two piers. Elevation is referenced to the bottom of the footer.

Table 2 lists free corrosion rebar potentials as a function of elevation for both piers as measured during the initial site visit (August, 2004), Figure 19 provides a plot of these. The trend in each case is similar in that potential was relatively constant and negative over the entire footer elevation (footer height was 1.52 m) but was progressively more positive with increasing height on the columns. The relatively negative potentials for the footer reinforcement are thought to reflect the fact that this concrete was water saturated (or nearly so). As such, corrosion rate of the reinforcement is expected to be nil, which is consistent with the fact that no previous repairs had been made on the footers (unlike the columns) and instances of cracking and spalling were few. Alternatively, it may be that only the lower region of the

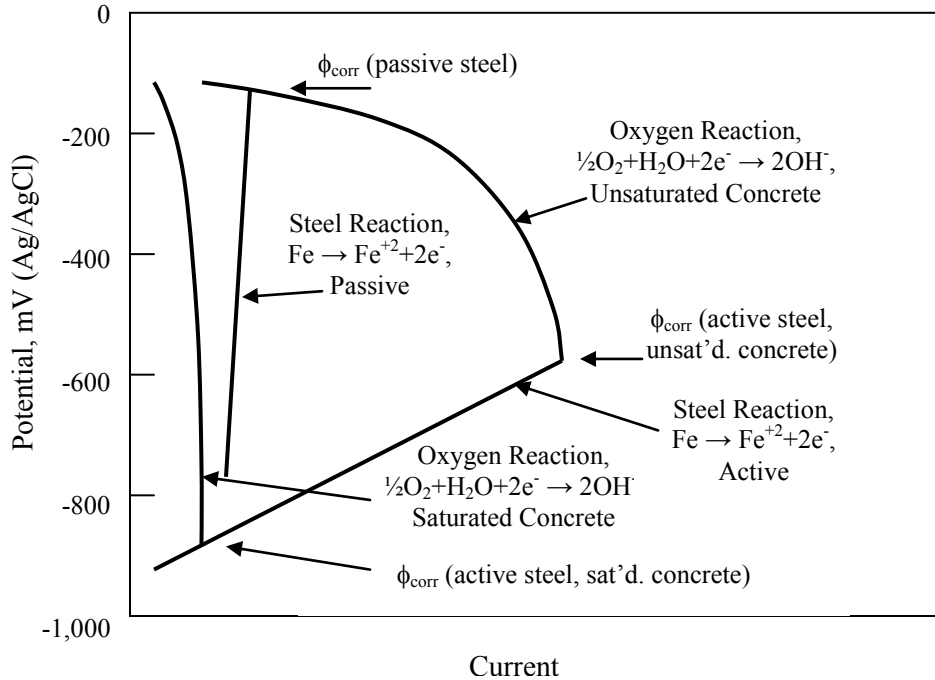
Figure 20: Schematic representation of the corrosion potential ( $\phi_{\text{corr}}$ ) and potential-current kinetics relationships for steel in concrete.

footers was water saturated and that the relatively negative potentials here cathodically polarize the more elevated footer steel. Figure 20 shows a schematically illustrated polarization diagram that explains the potential difference for active versus passive reinforcing steel in both water saturated and unsaturated concrete and why a relatively positive potential is expected for passive steel in aerated concrete and a less positive one for actively corroding steel. This projects the most negative potential to occur in water saturated concrete because, first, embedded steel is likely to be active due to lack of O<sub>2</sub> availability and, second, concentration polarization of the O<sub>2</sub> electrode for the same reason.

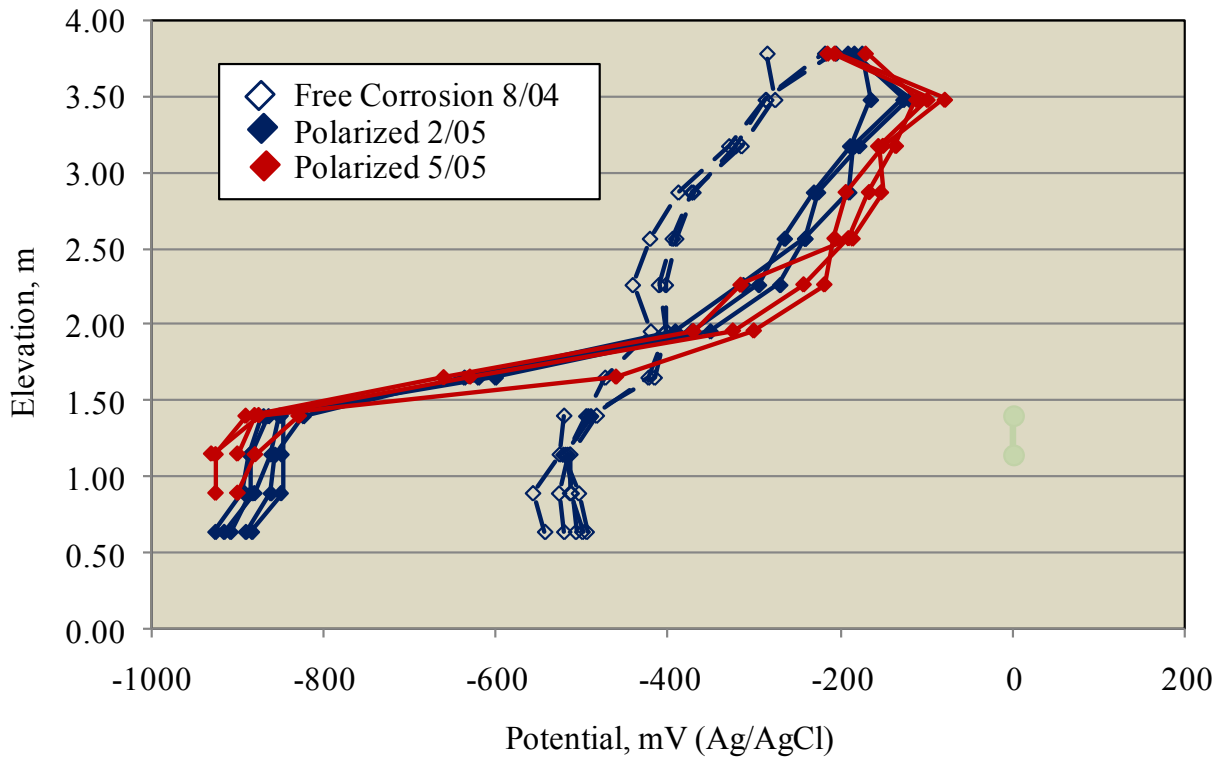
Figure 21: Footer and column reinforcing steel potential data for Pier 40W-East as a function of elevation for each of the three site visits. Elevation is referenced to the bottom of the footer.

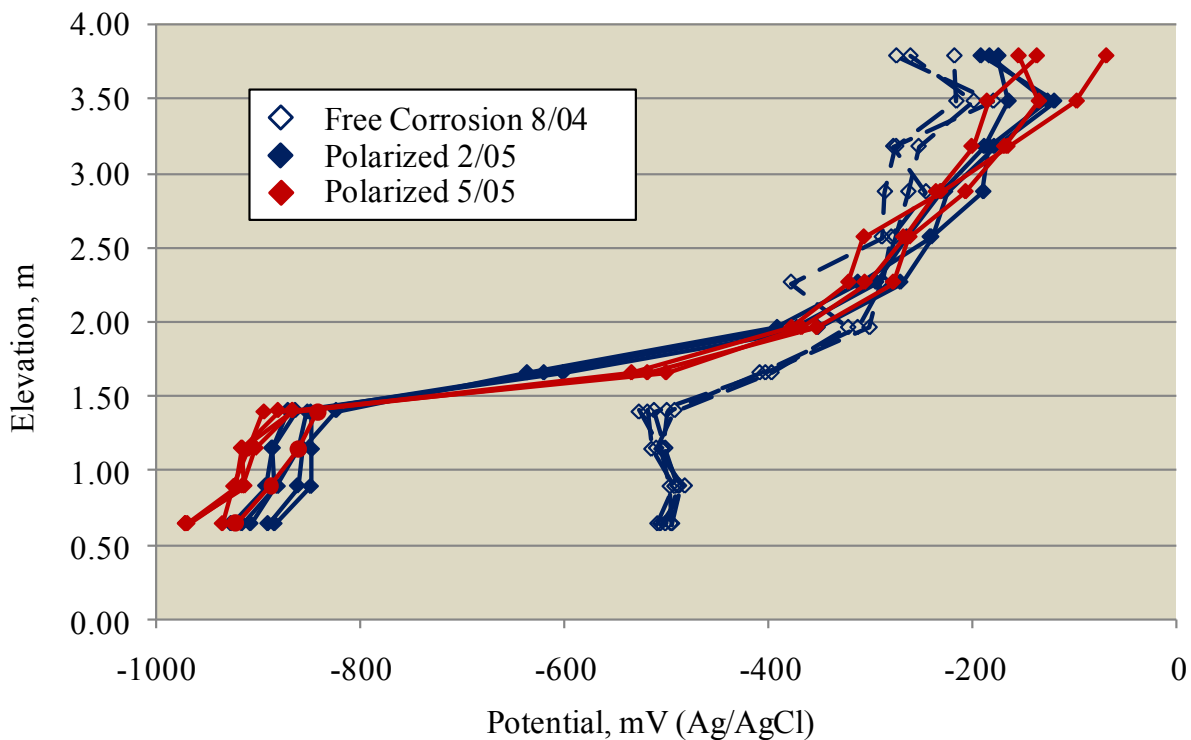
Figure 22: Footer and column reinforcing steel potential data for Pier 39W-East as a function of elevation for each of the three site visits. Elevation is referenced to the bottom of the footer.

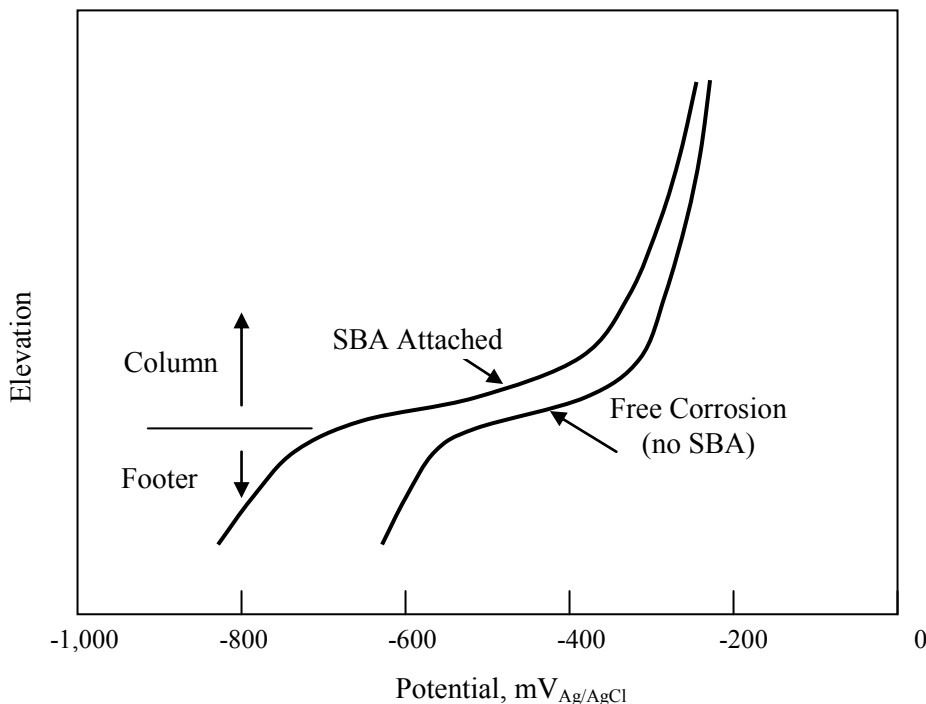
Figure 23: Schematic illustration of the potential shift of footer and column reinforcement that is expected to accompany SBA activation.

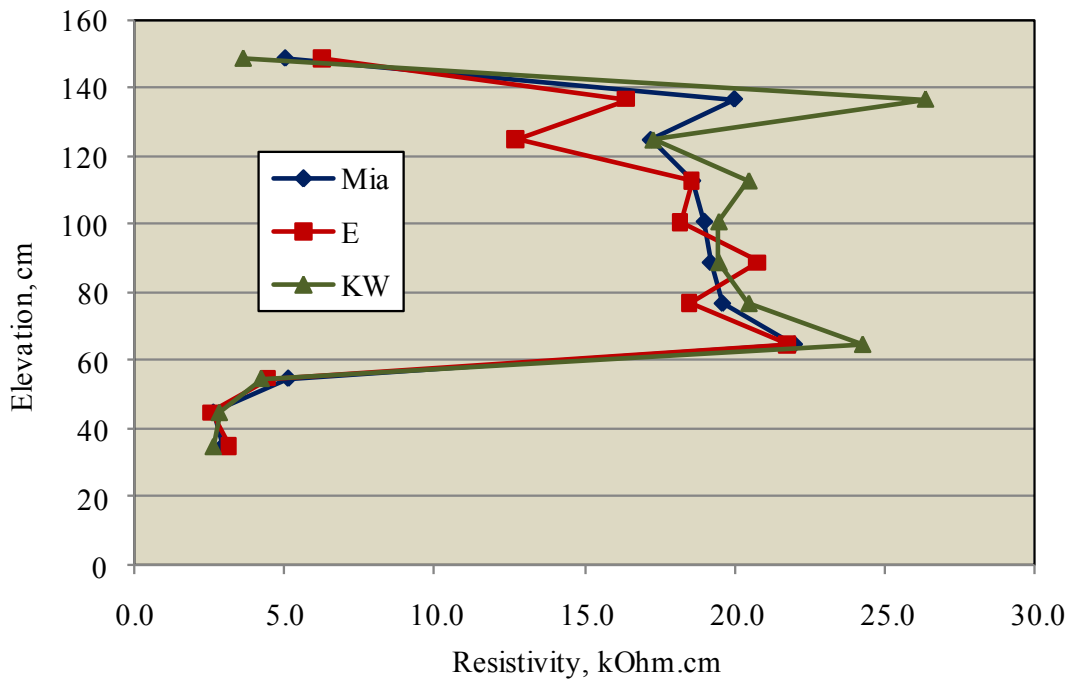
Figure 24: Resistivity versus elevation data for various positions on Pier 40W-East as acquired during the May, 2005 site visit (top of the footer is at approximately 0.6 m elevation).

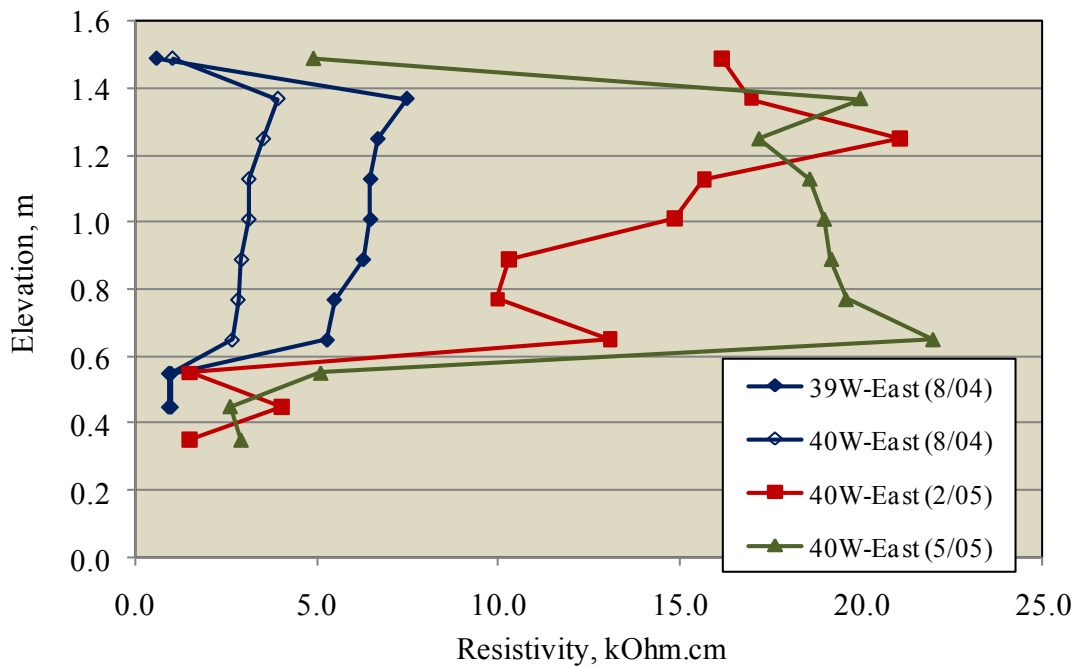
Figure 25 Resistivity versus elevation data for Pier 40W-East as measured during each of the three site visits (top of the footer is at approximately 0.6 m elevation).

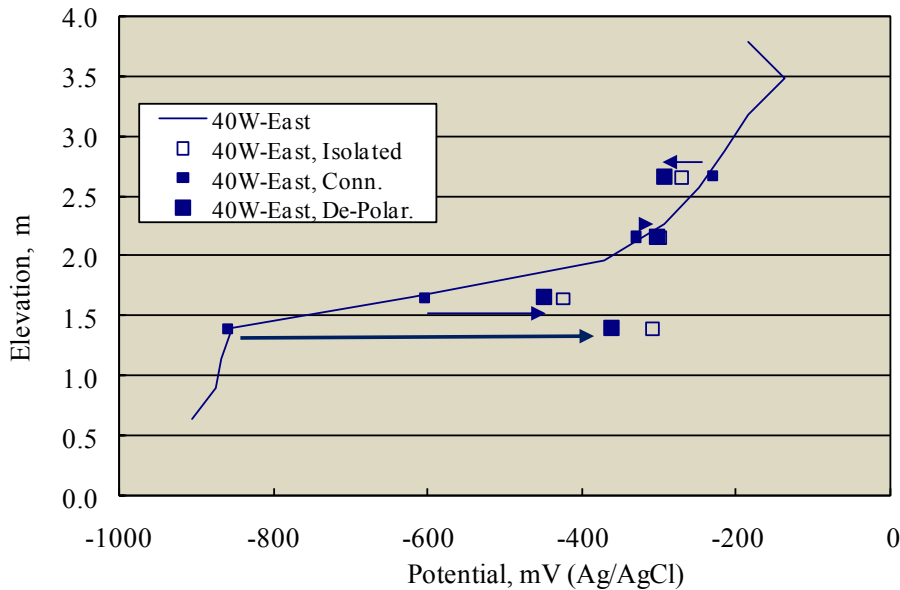
Figure 26: Polarized potential data for reinforcement and probes (isolated, connected, and depolarized) for Pier 40W-East.

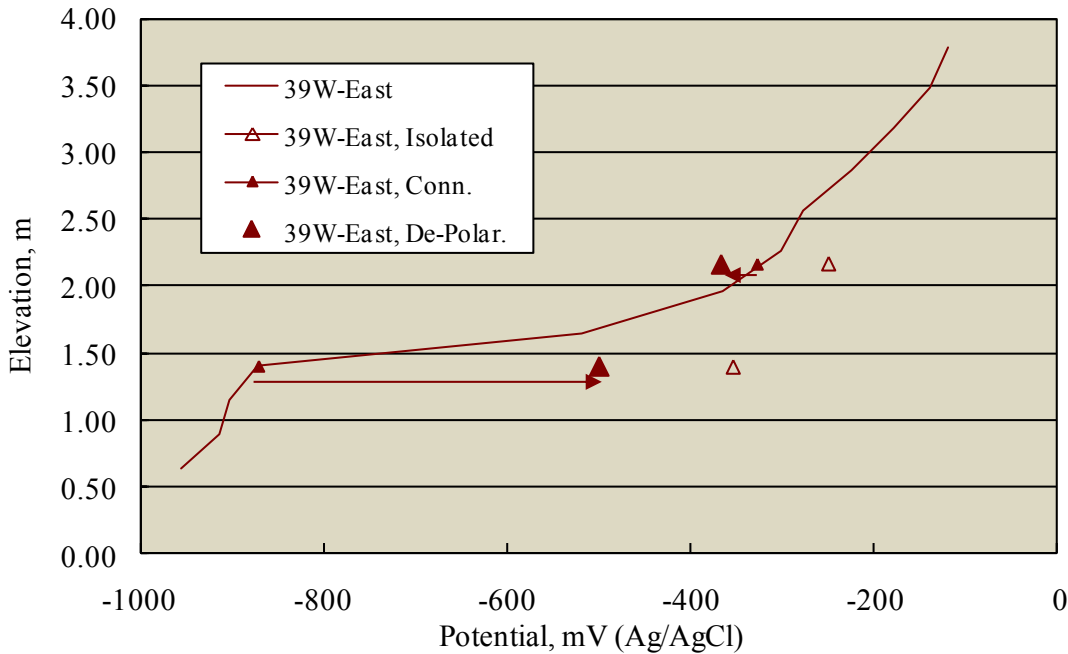
Figure 27: Polarized potential data for reinforcement and probes (isolated, connected, and depolarized) for Pier 39W-East.

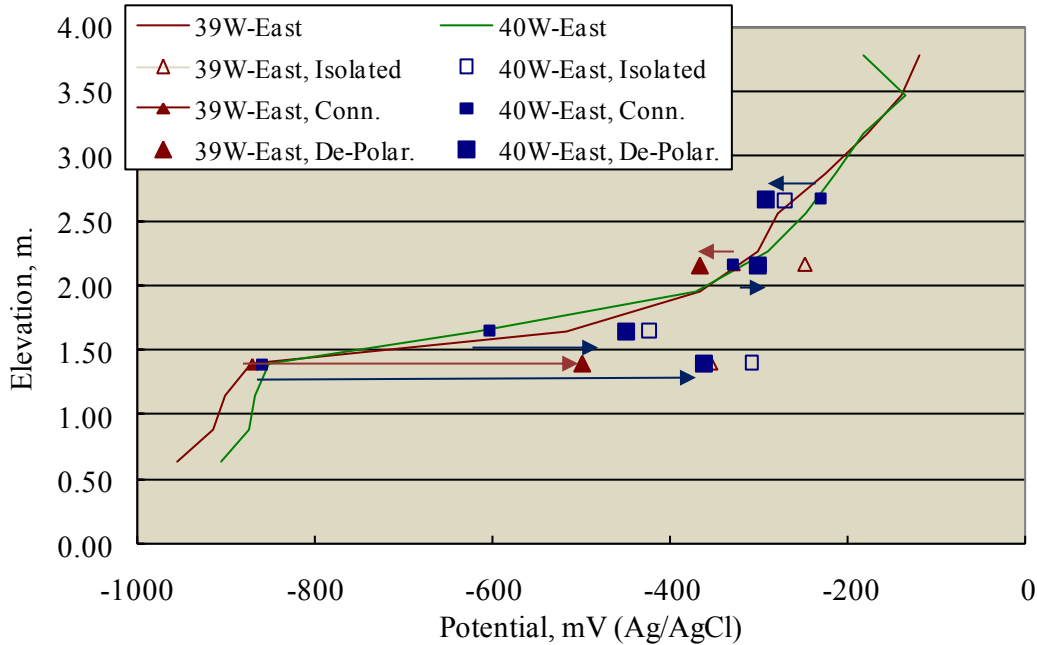
Figure 28: Plot of 1) isolated and 2) connected and depolarized probe potentials according to elevation for both piers at the time of the February, 2005 site visit. Average values for the reinforcement on this same pier are also indicated. Elevation is referenced to the bottom of the footer.

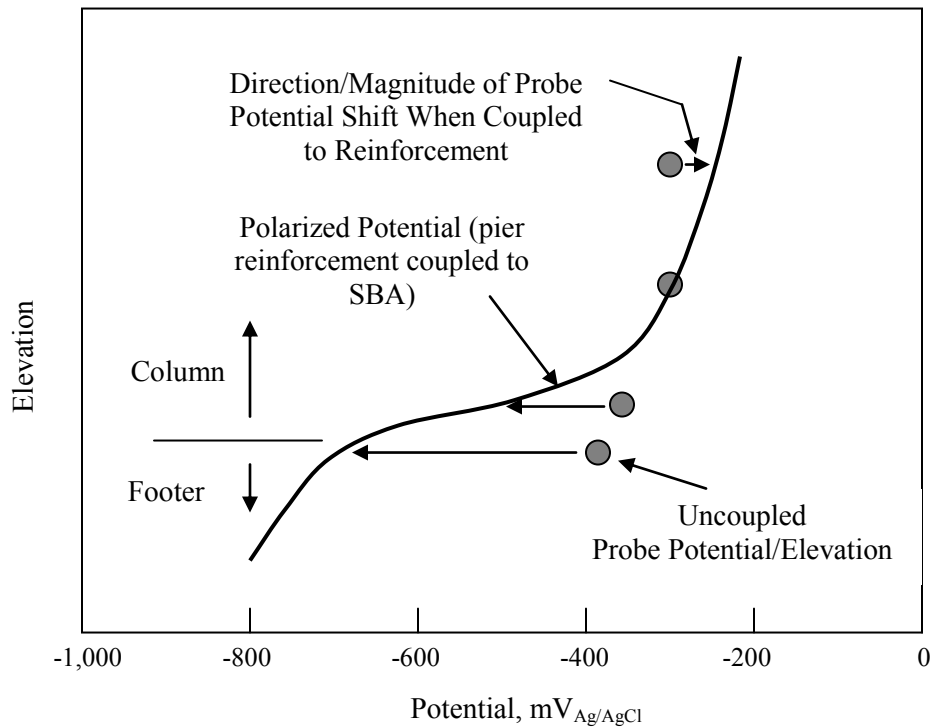
Figure 29: Schematic illustration of the probe potential shift that accompanies coupling to pier reinforcement.

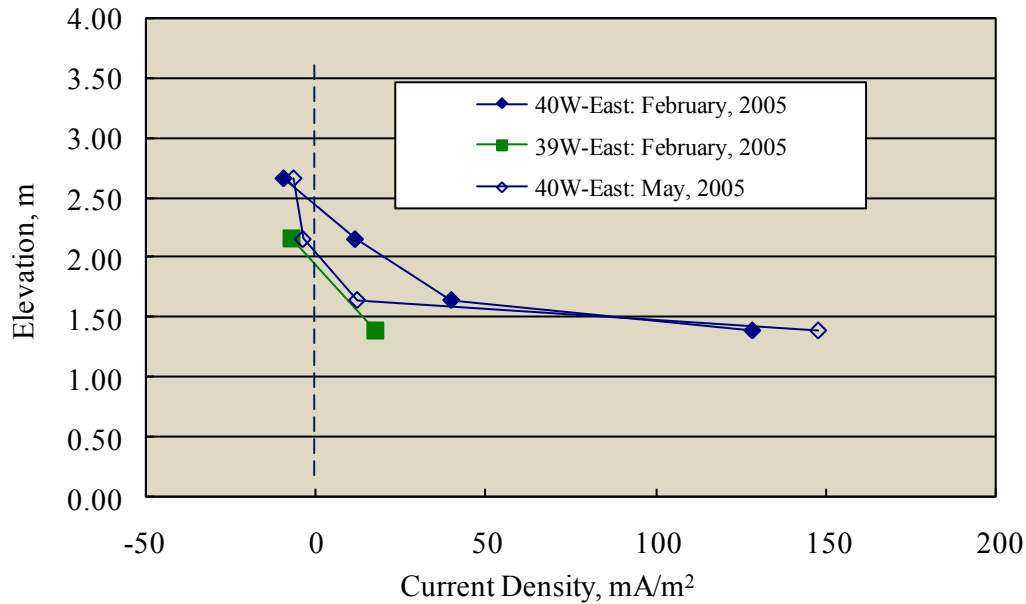
Figure 30: Plot of probe current density versus elevation.

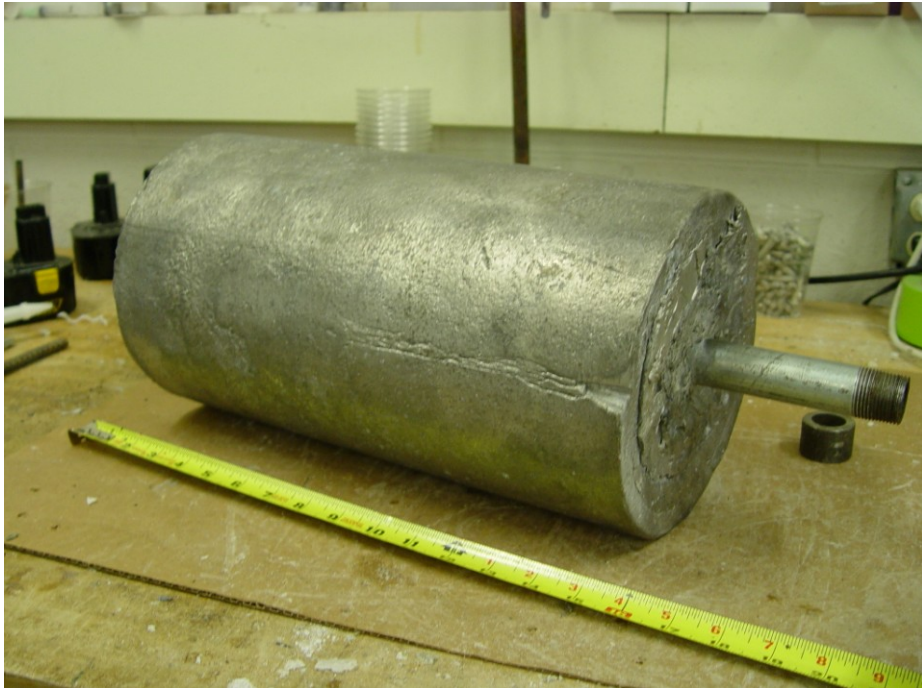
Figure 31: Photograph of a 22.6 kg pier type Mg anode as-received.

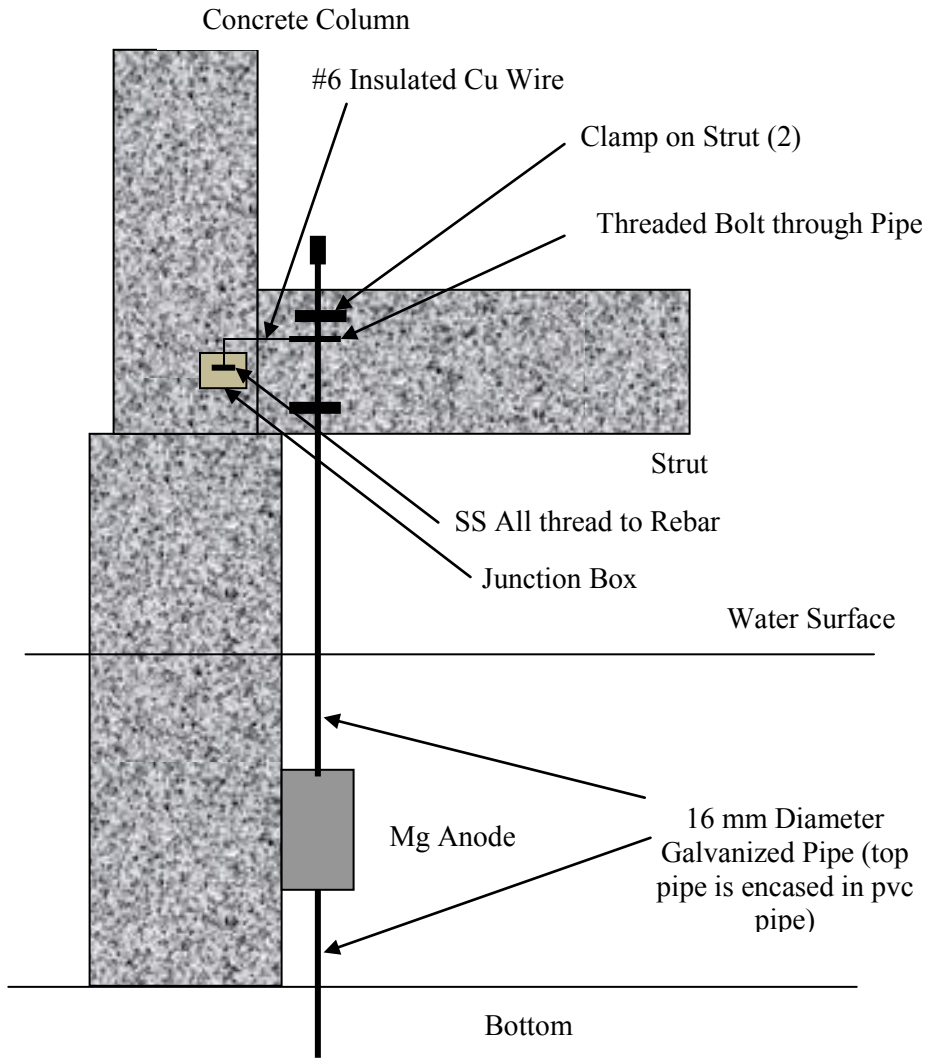
Figure 32: Schematic illustration of the MgSBA installation scheme.

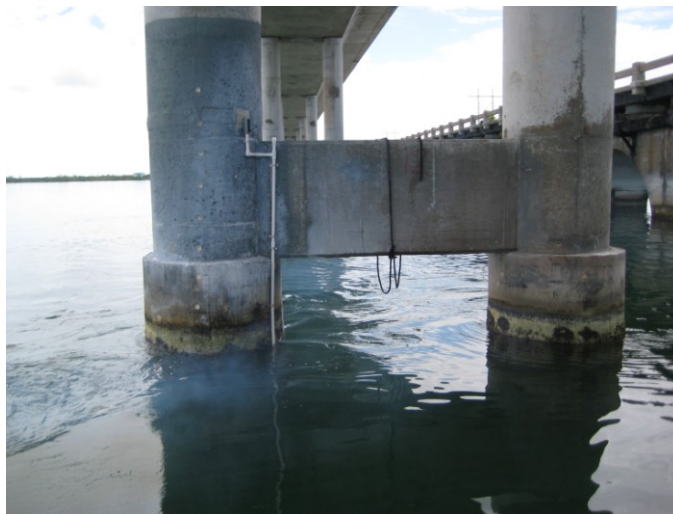
Figure 33: Photograph of Pier 2 subsequent to MgSBA installation.

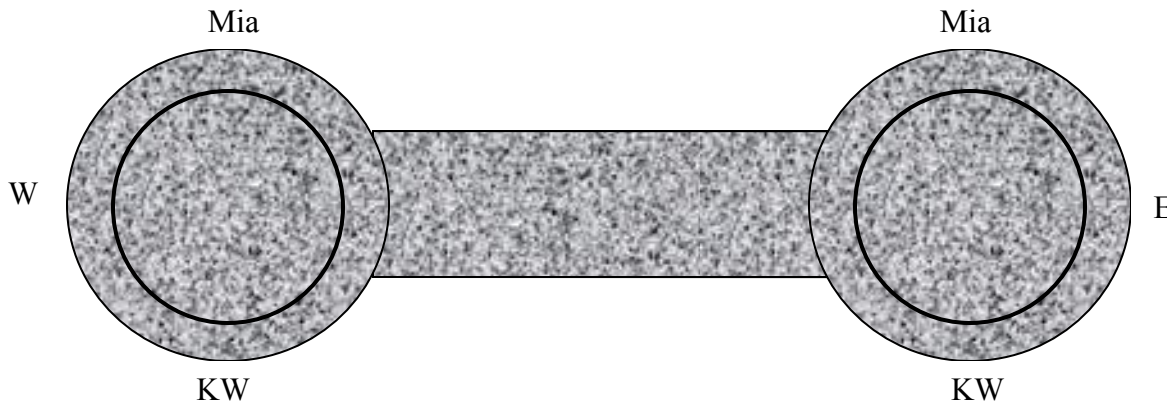
Figure 34: Plan view schematic illustration of a pier on the Niles Channel Bridge showing the orientations at which potential and resistivity measurements were made.

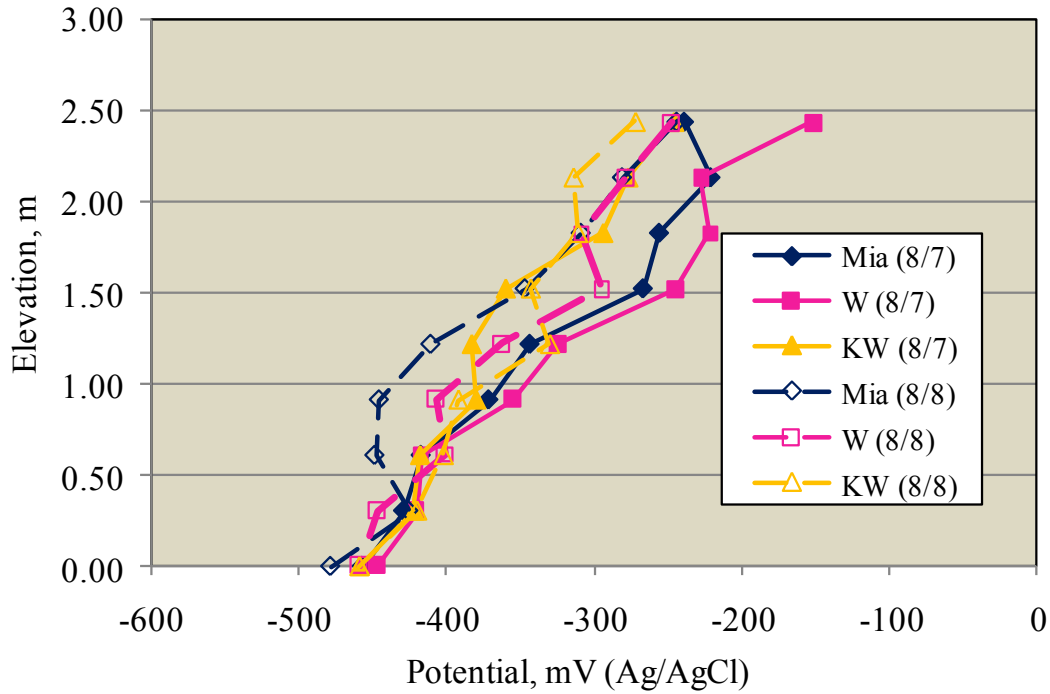
Figure 35: Free corrosion potential data for the west footer/column of Pier 2 as acquired during the August 7 and 8, 2007 site visit.

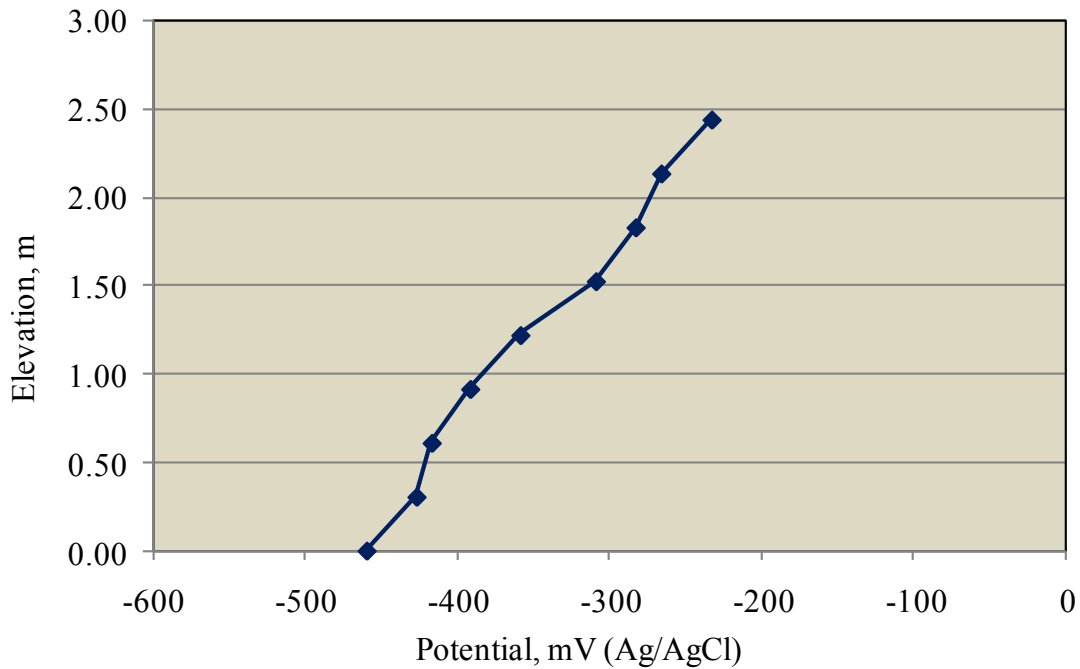
Figure 36: Average free corrosion potential data as a function of elevation from Figure 35.

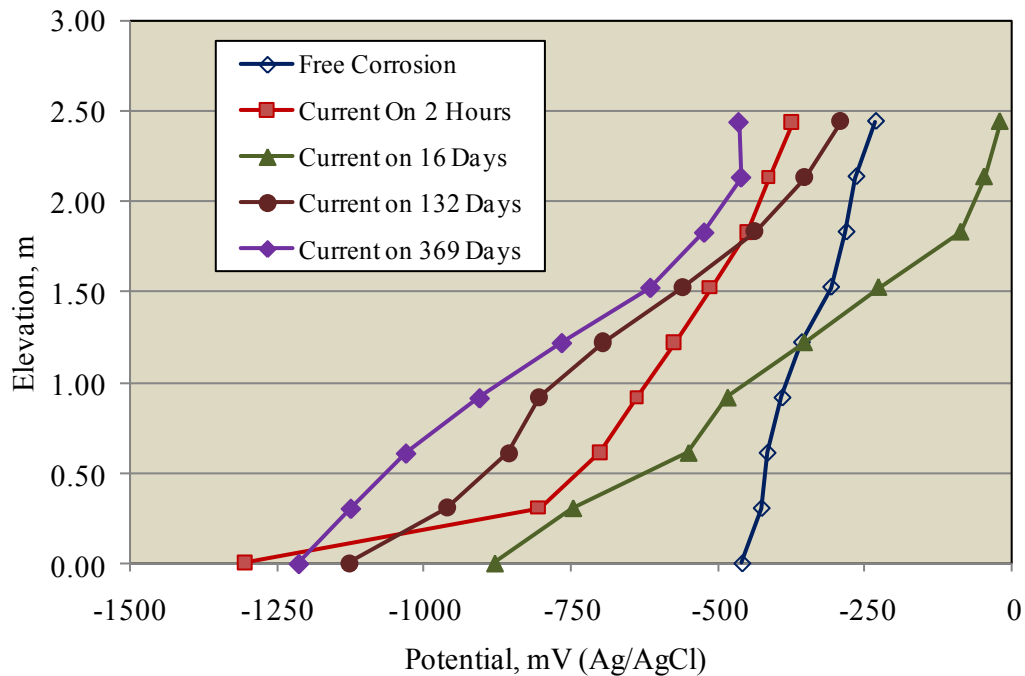
Figure 37: Plot of current-on potentials at each measurement elevation on the west footer/column of Pier 2 for each of the site visits in comparison to the free corrosion values.

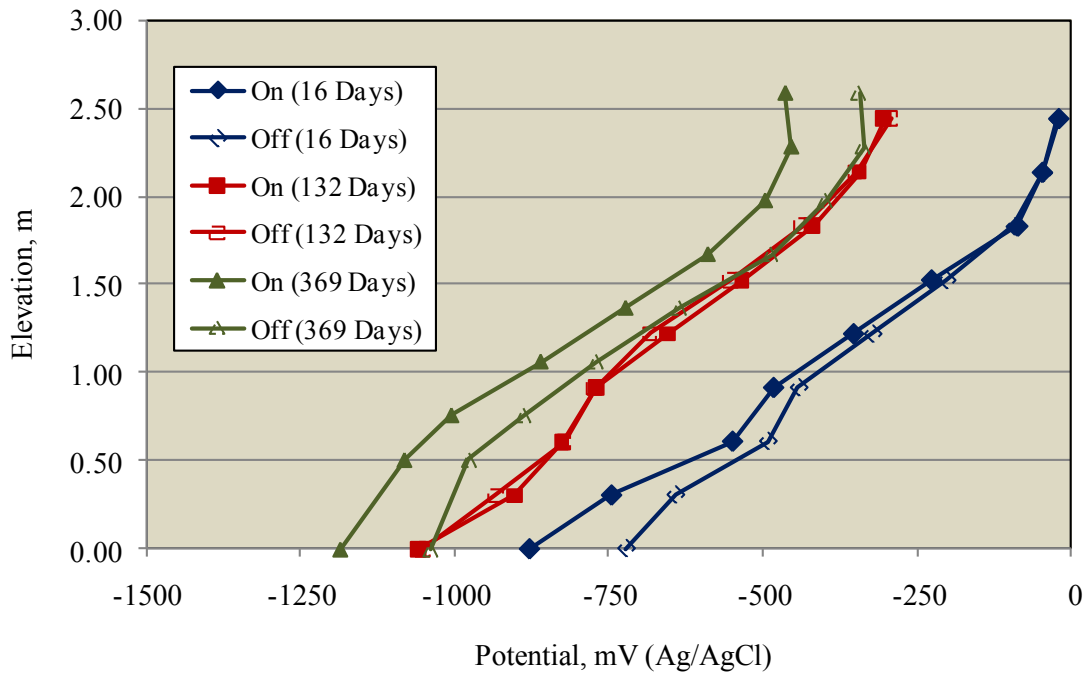
Figure 38: Comparison of current-on and current-off potentials for the west footer/column of Pier 2.

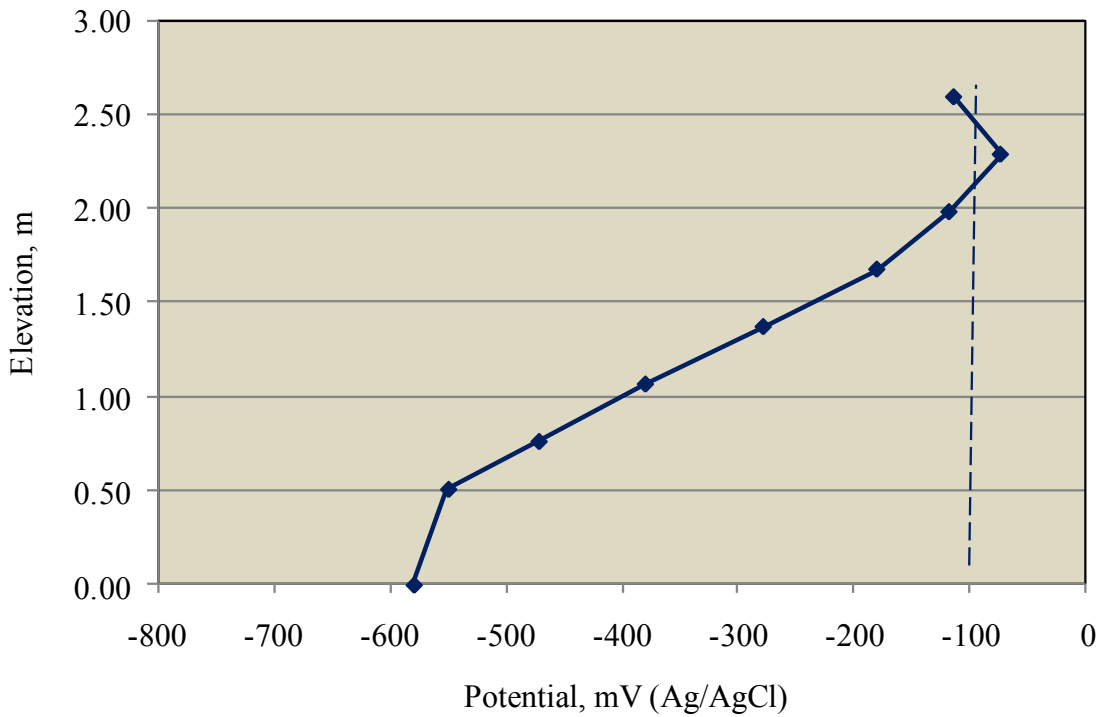
Figure 39: Magnitude of polarization after 369 days activation as a function of elevation for the west footer/column of Pier 2.
