**Final Report**

**Protection of Reinforced Concrete Bridge Substructures using  
Submerged Bulk Anodes  
(BD 546-3)**

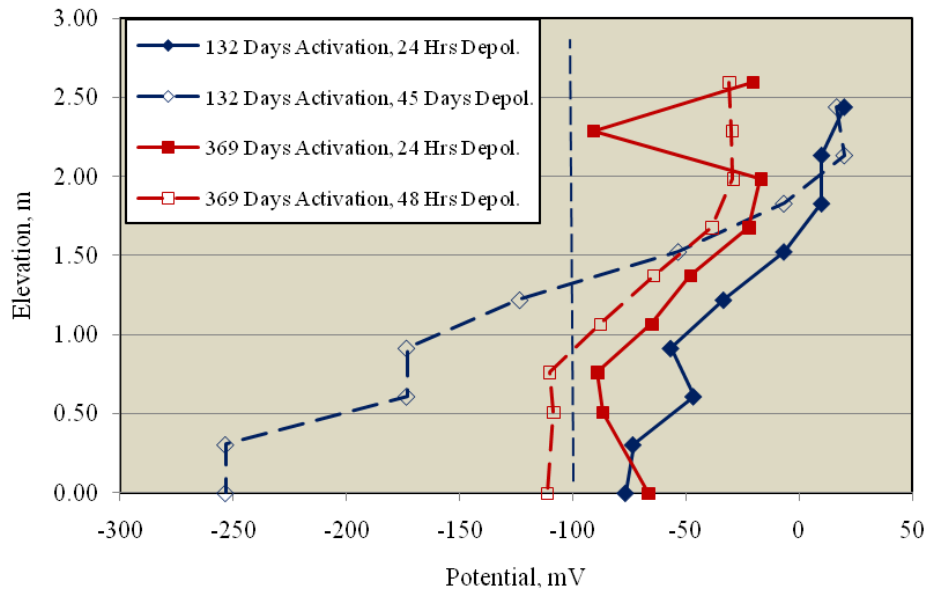
Figure 40: Magnitude of depolarization as a function of elevation after 132 and 369 days activation.

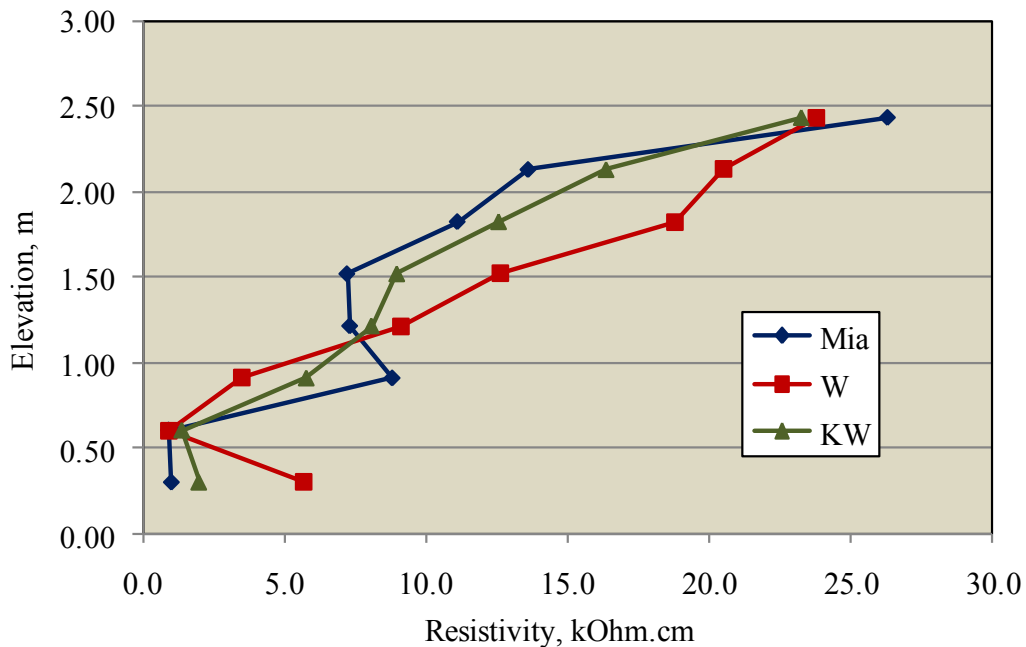
Figure 41: Resistivity data acquired on the west footer/column of Pier 2 during the 8/07 site visit.

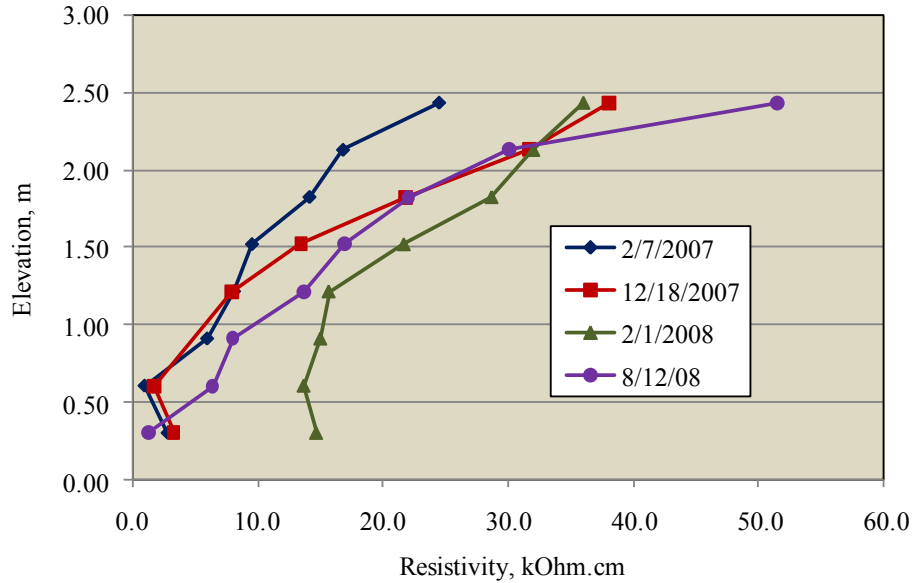
Figure 42: Average resistivity data as acquired on the west footer/column of Pier 2 during different site visits.

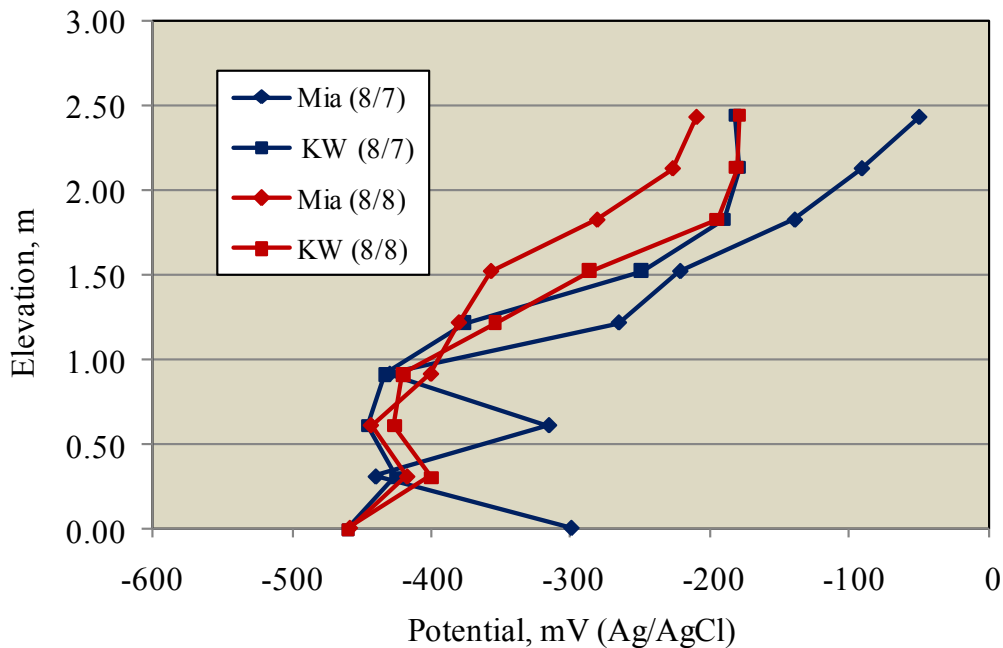
Figure 43: Free corrosion potential data for the east footer/column of Pier 2 as acquired during the August 7 and 8, 2007 site visit.

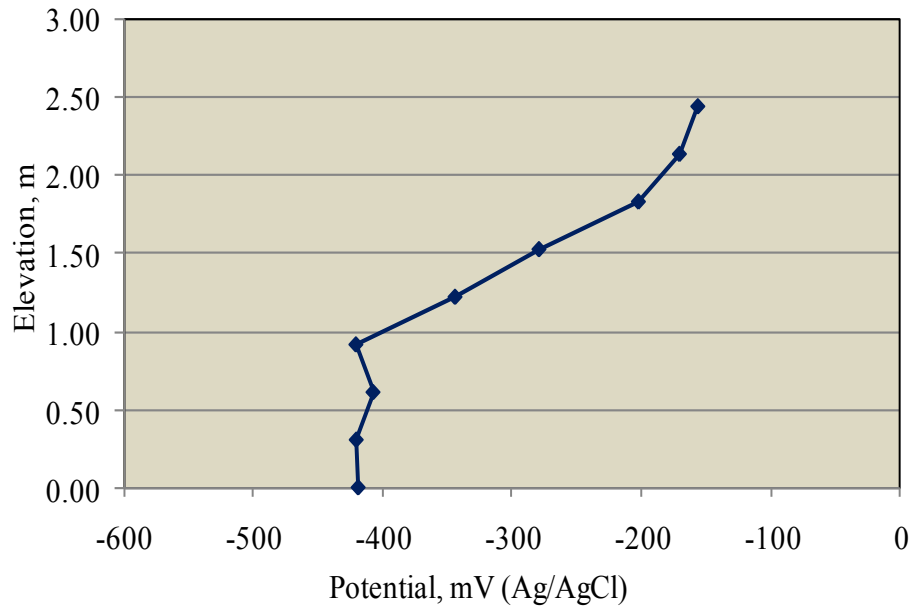
Figure 44: Average free corrosion potential data for the east footer/column of Pier 2 as acquired during the August 7 and 8, 2007 site visit.

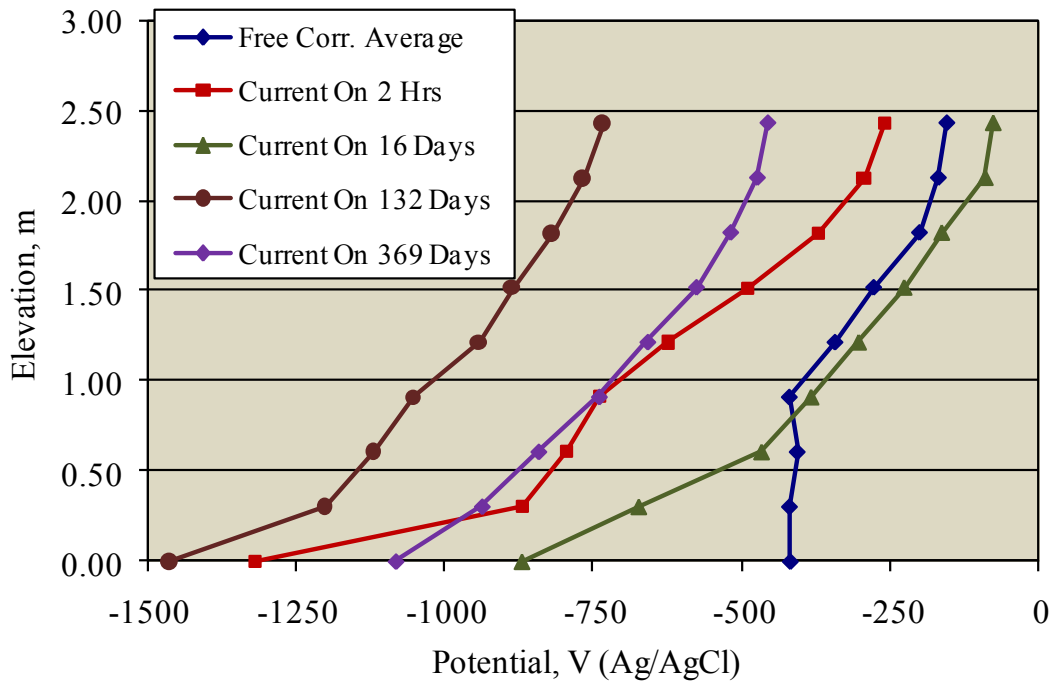
Figure 45: Plot of current-on potentials at each measurement elevation on the west footer/column of Pier 2 for each of the site visits in comparison to the free corrosion values.

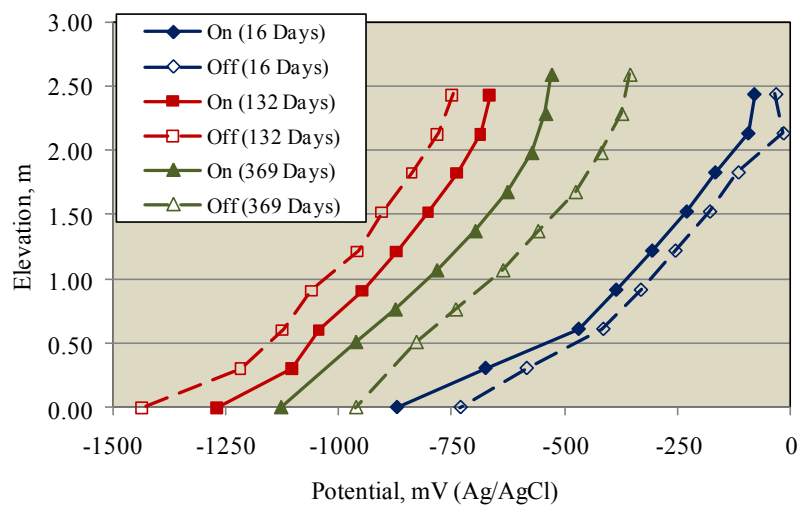
Figure 46: Comparison of current-on and current-off potentials for the east footer/column of Pier 2.

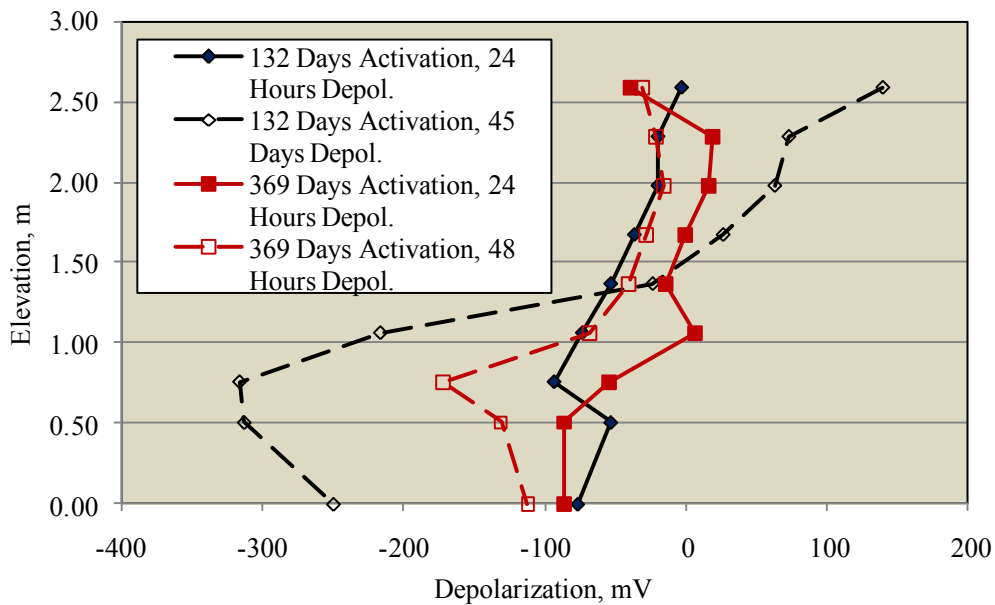
Figure 47: Magnitude of depolarization as a function of elevation after 132 and 369 days activation for the east footer/column of Pier 2.

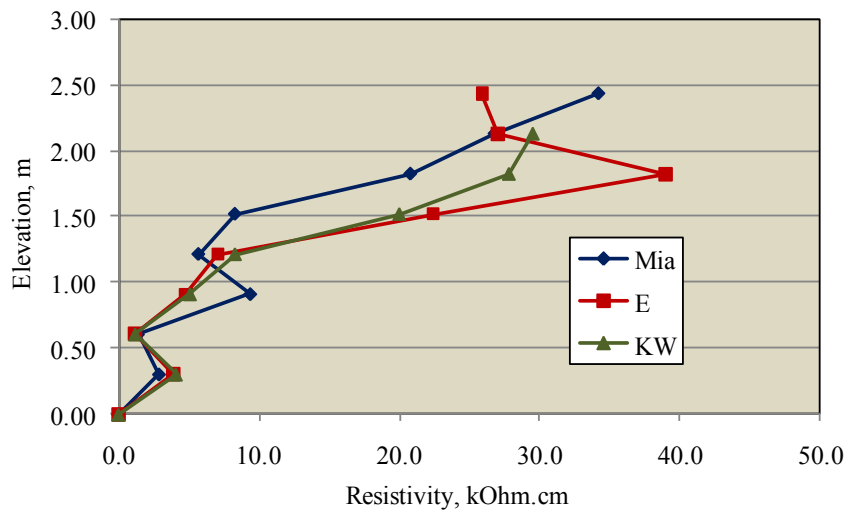
Figure 48: Resistivity data as acquired on the east footer/column of Pier 2 on August 7, 2007 (top of the drill shaft is at approximately 0.75 m elevation).

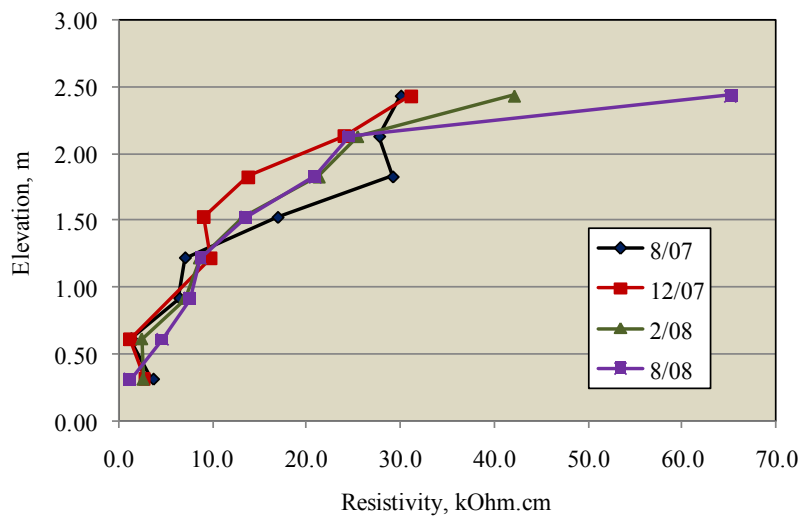
Figure 49: Average resistivity data as acquired during each of the four site visits Figure 48: Resistivity data as acquired on the east footer/column of Pier 2 on August 7, 2007 (top of the drill shaft is at approximately 0.75 m elevation).

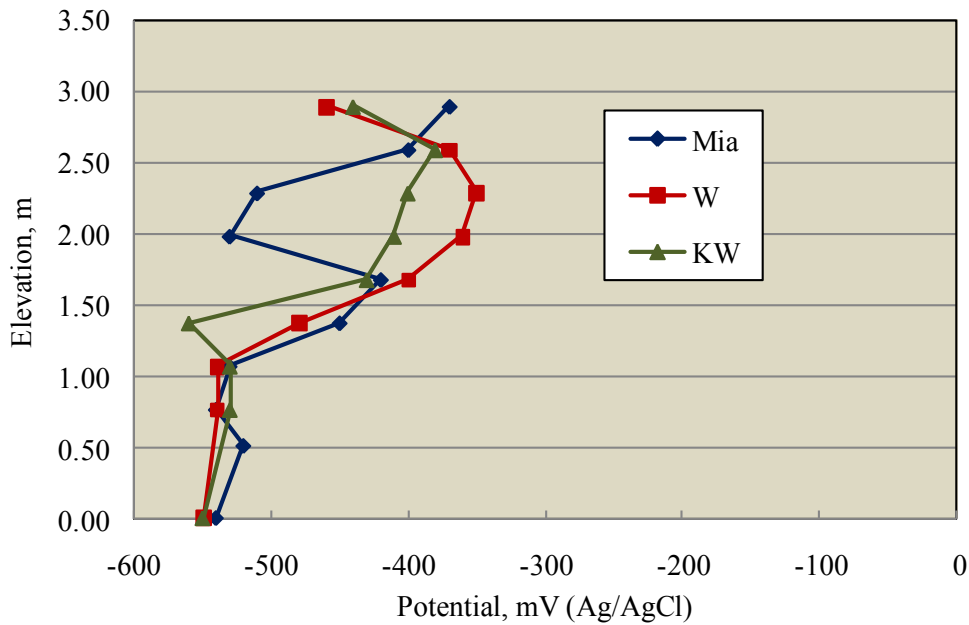
Figure 50: Free corrosion potential data for the east footer/column of Pier 12 as acquired during the August 7, 2007 site visit.

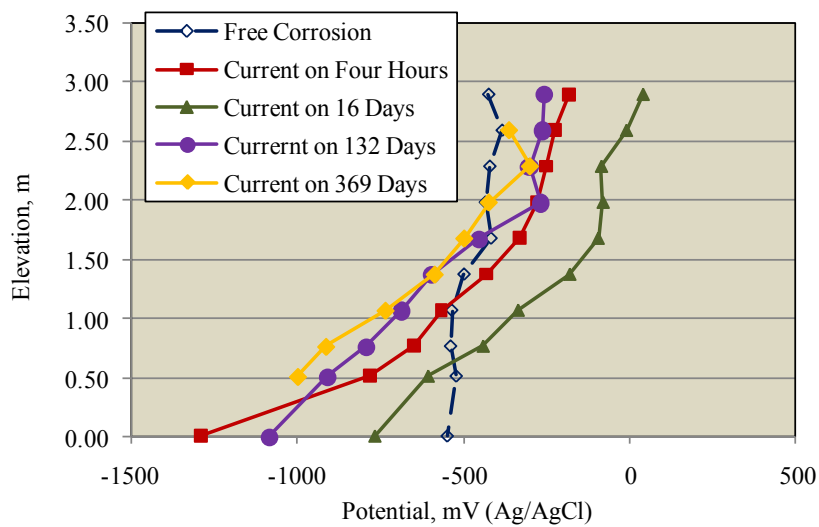
Figure 51 Plot of current-on potentials at each measurement elevation on the west footer/column of Pier 12 for each of the site visits in comparison to the free corrosion values.

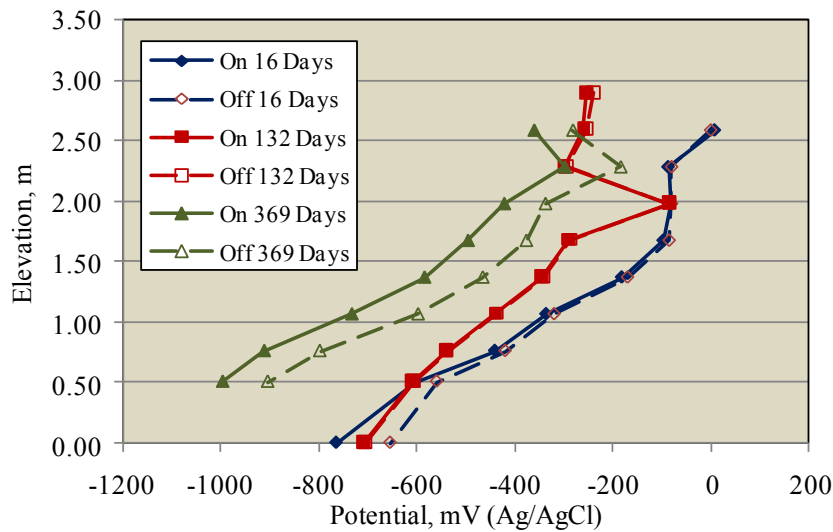
Figure 52: Comparison of current-on and current-off potentials for the west footer/column of Pier 12.

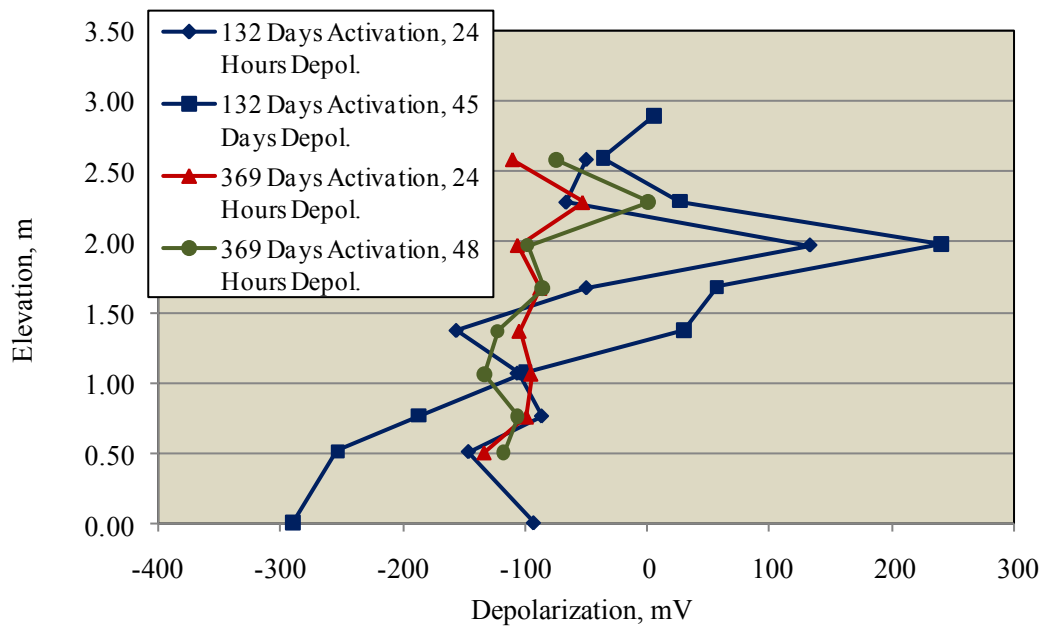
Figure 53: Magnitude of depolarization as a function of elevation after 132 and 369 days activation for the west footer/column of Pier 12.

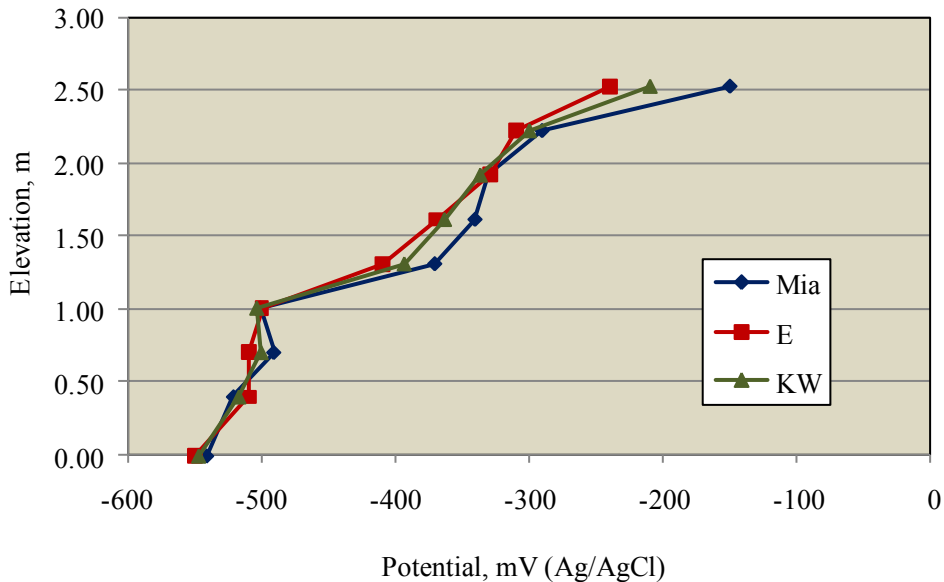
Figure 54: Free corrosion potential data for the east footer/column of Pier 12 as acquired during the August 7, 2007 site visit.

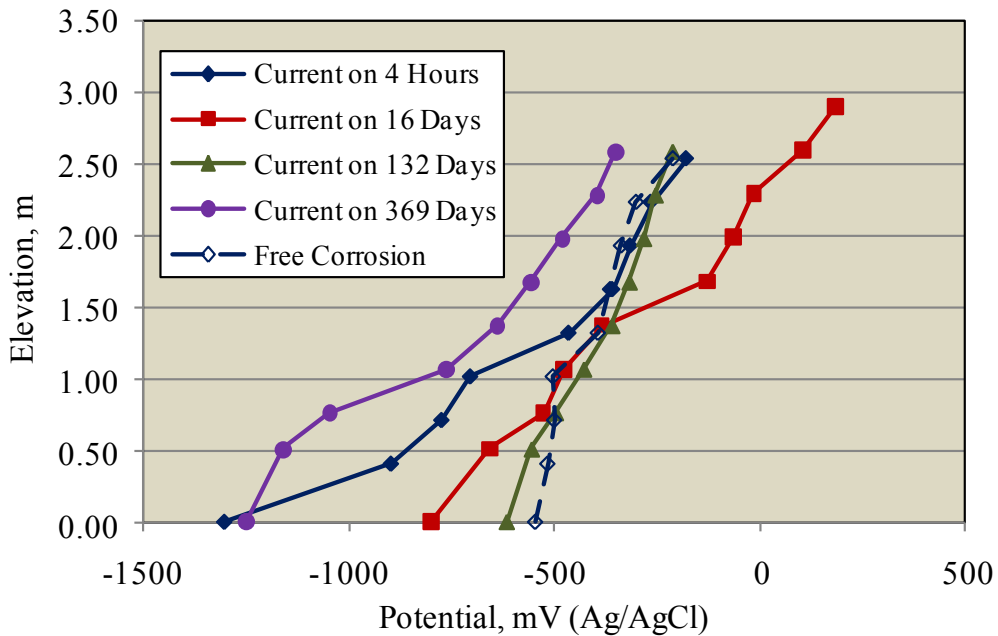
Figure 55 Plot of current-on potentials at each measurement elevation for the east footer/column of Pier 12 for each of the site visits in comparison to the free corrosion values.

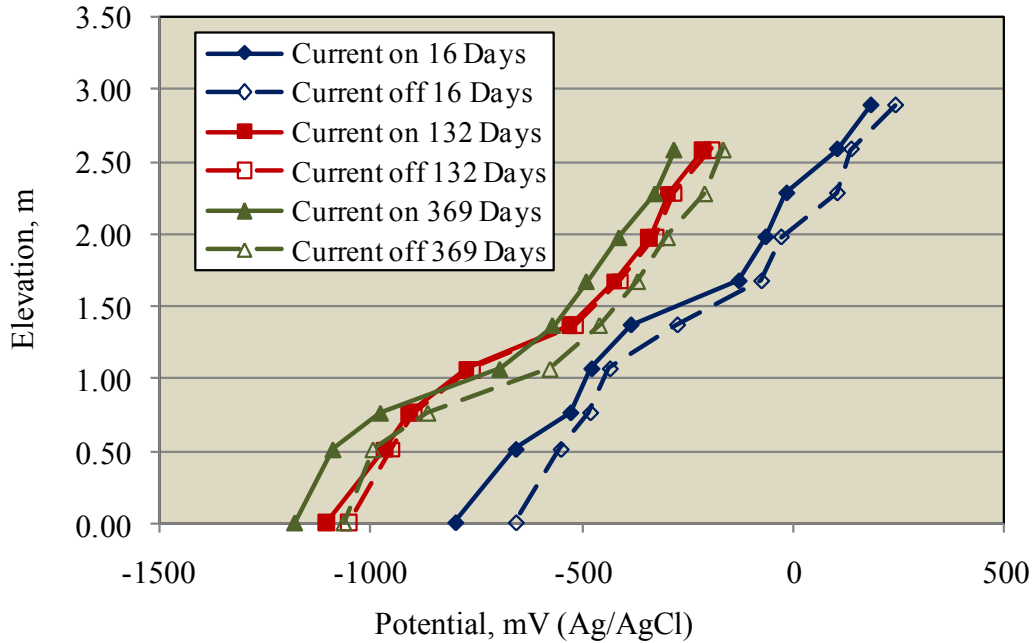
Figure 56: Comparison of current-on and current-off potentials for the east footer/column of Pier 12.

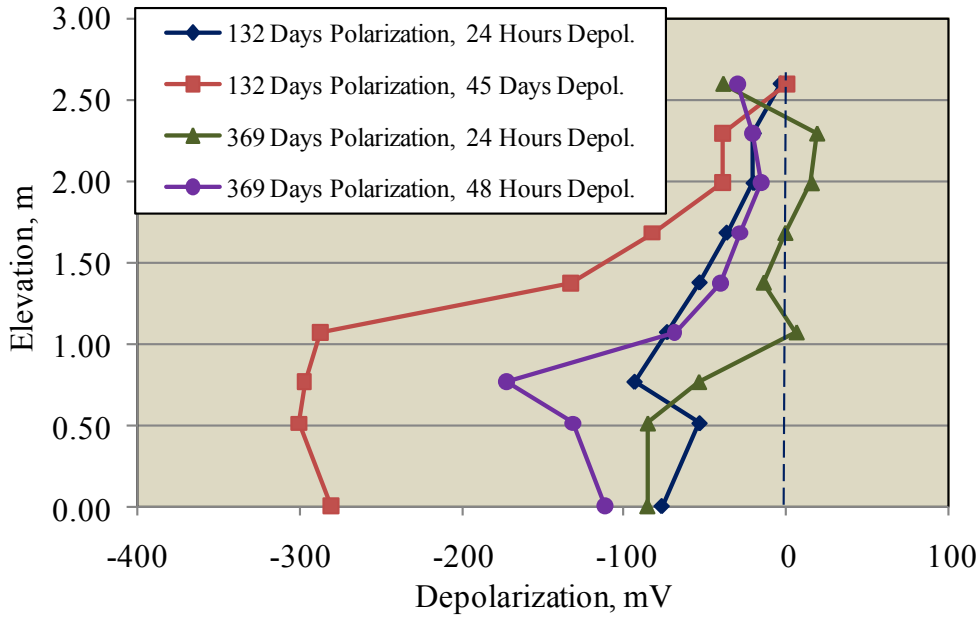
Figure 57: Magnitude of depolarization as a function of elevation after 132 and 369 days activation for the east footer/column of Pier 12.

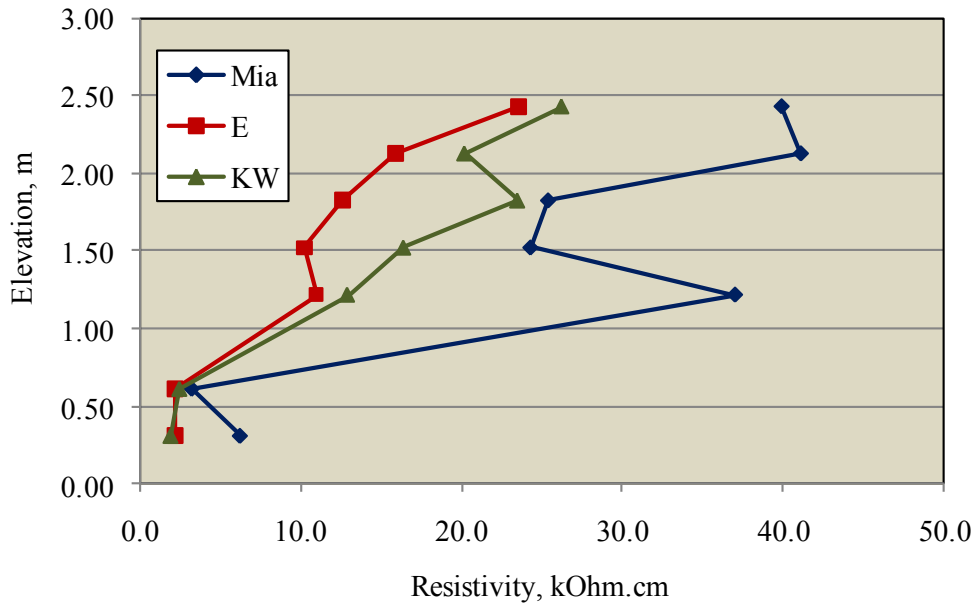
Figure 58: Resistivity data as acquired on the east footer/column of Pier 12 on December 18, 2007.

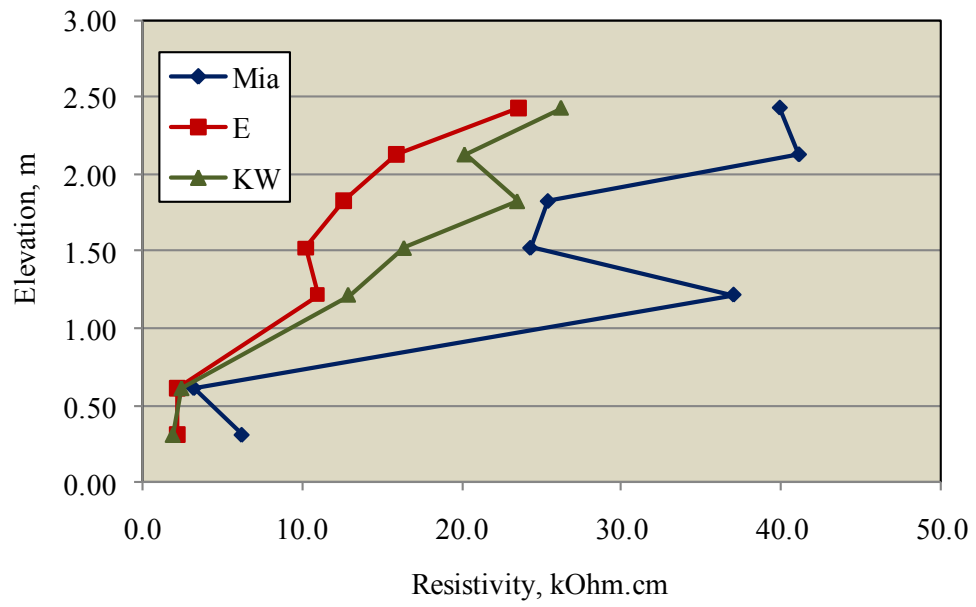
Figure 59: Average resistivity data as acquired on the east footer/column of Pier 12 during each of three site visits.

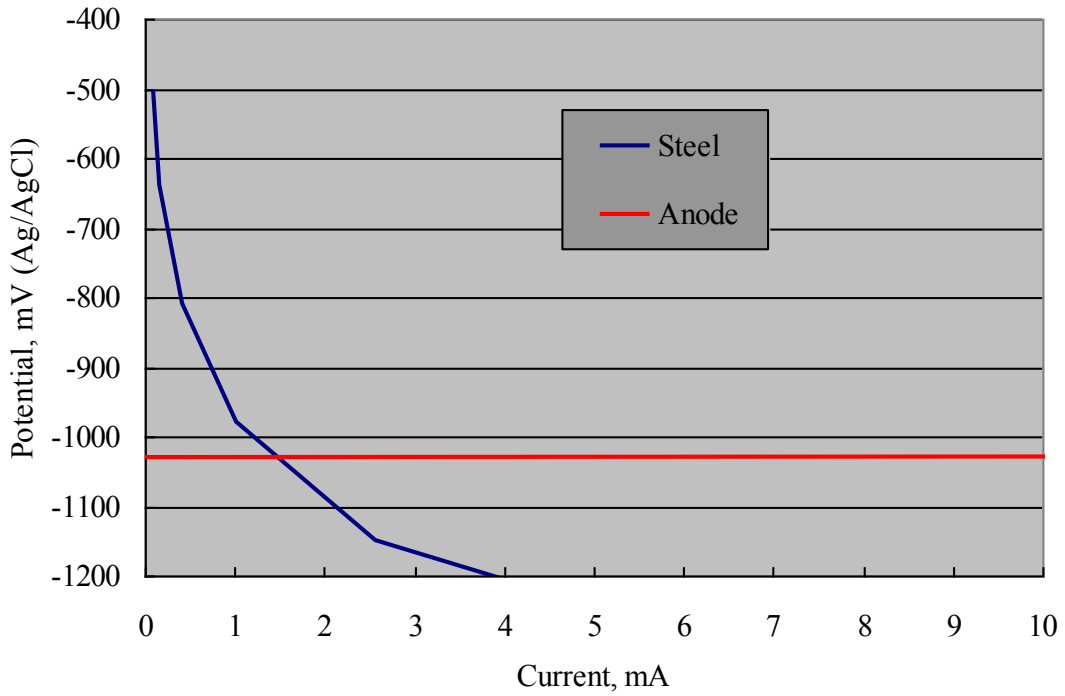
Figure 60: Assumed polarization curve for steel and anode that were employed in the BEM analysis.

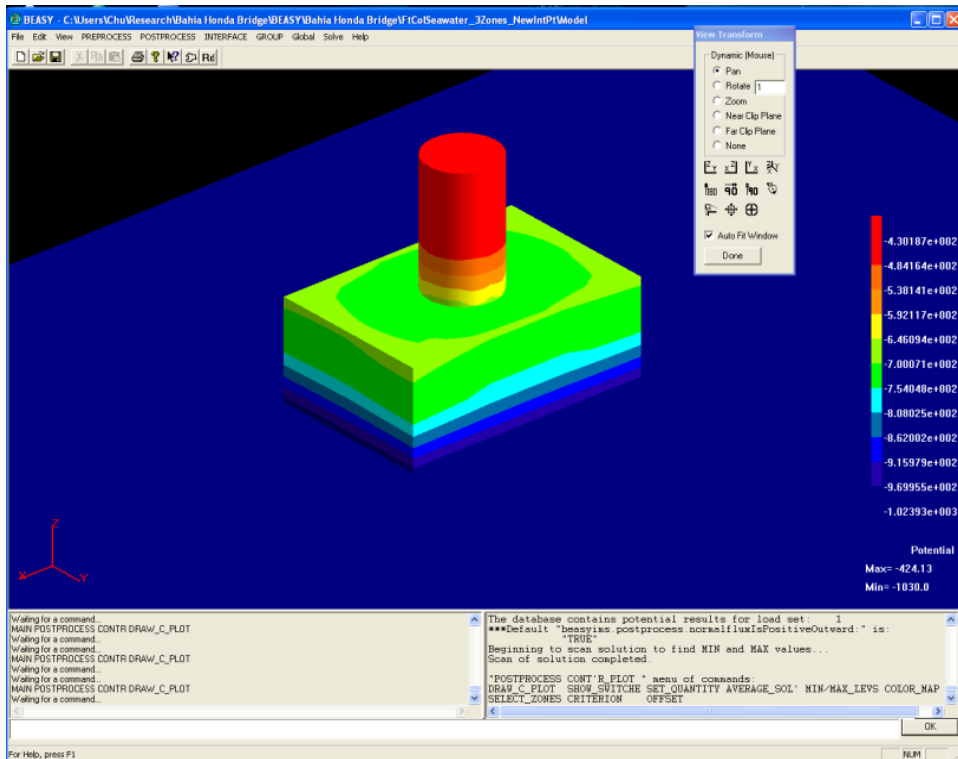
Figure 61: Beasy modeling results for potential on a footer and column of the Bahia Honda Bridge.

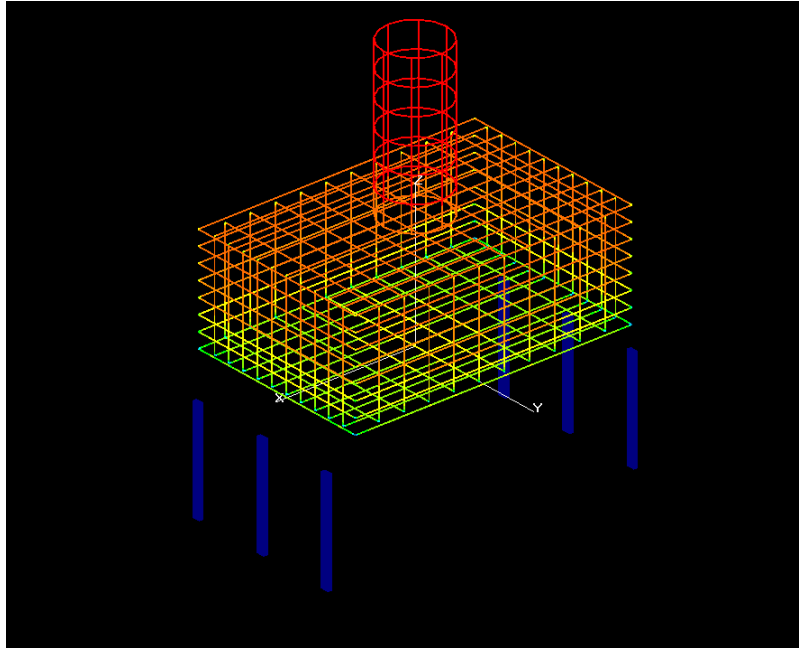
Figure 62: BEM model of the footer and column reinforcement and the submerged bulk anodes on a pier of the Bahia Honda Bridge.

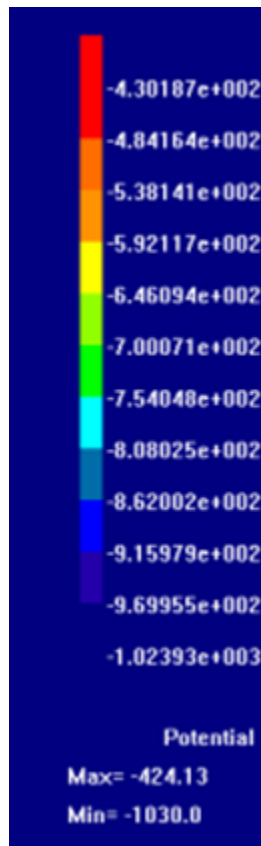
Figure 63: Enlarged view of the color coded potential scale from Figures 61 and 62.

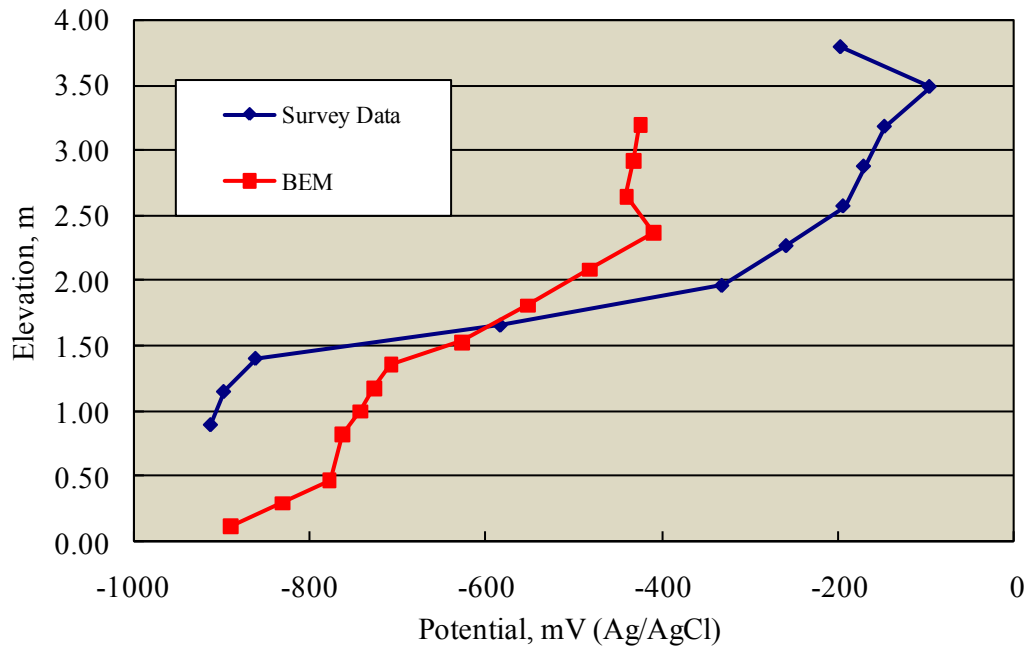
Figure 64: Comparison of the BEM potential versus elevation projection with the field survey results.

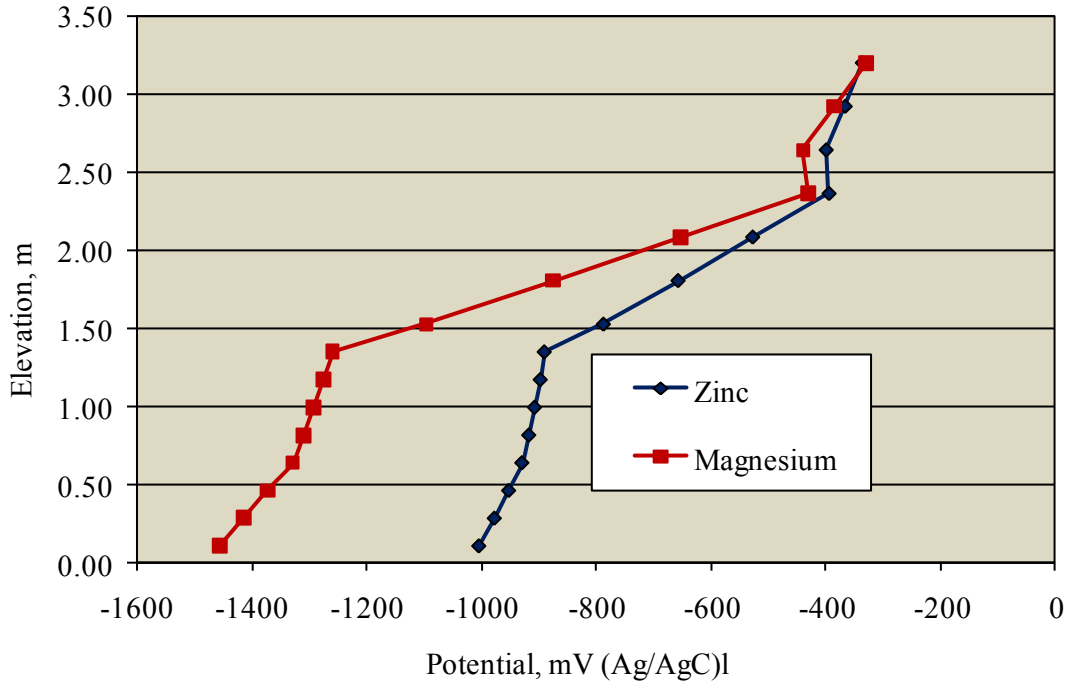
Figure 65: Comparison of the BEM potential versus elevation projections for a MgSBA and ZnSBA

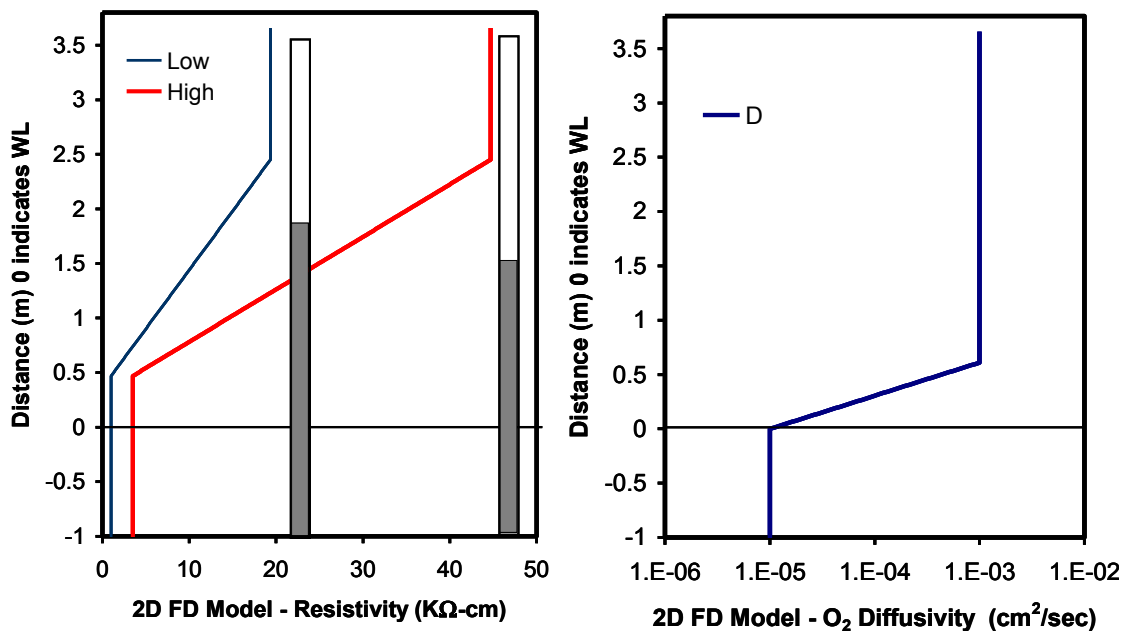
Figure 66: Resistivity and diffusivity profiles assumed for the 2D FD model. Active and passive regions are also indicated.

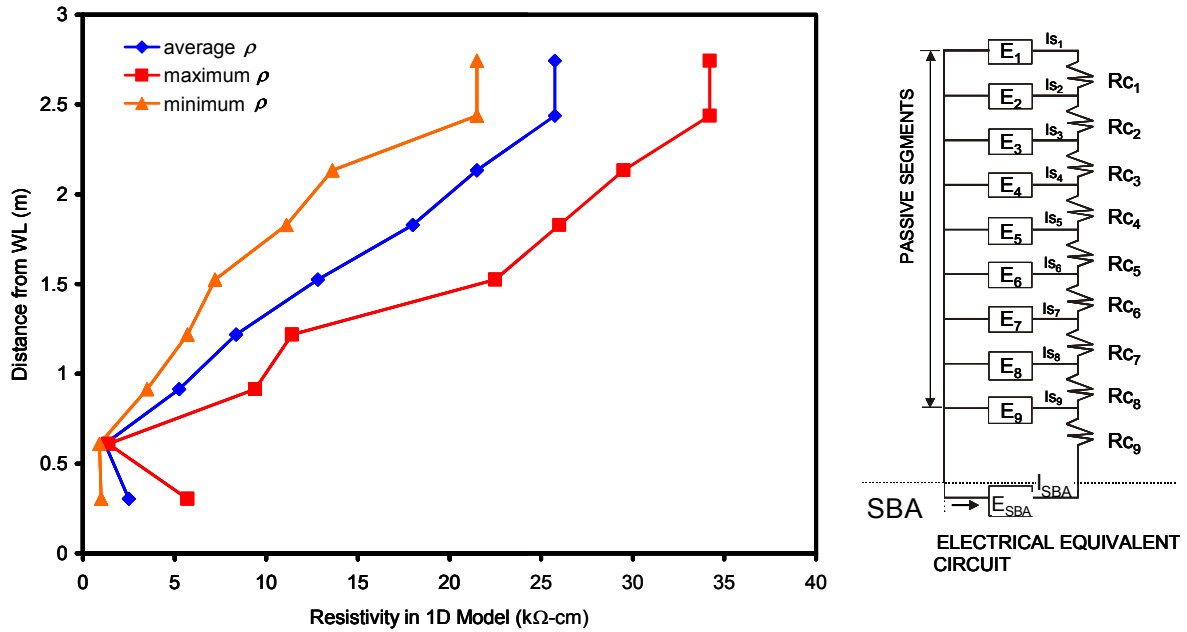
Figure 67: Resistivity profiles used with the 1D model.

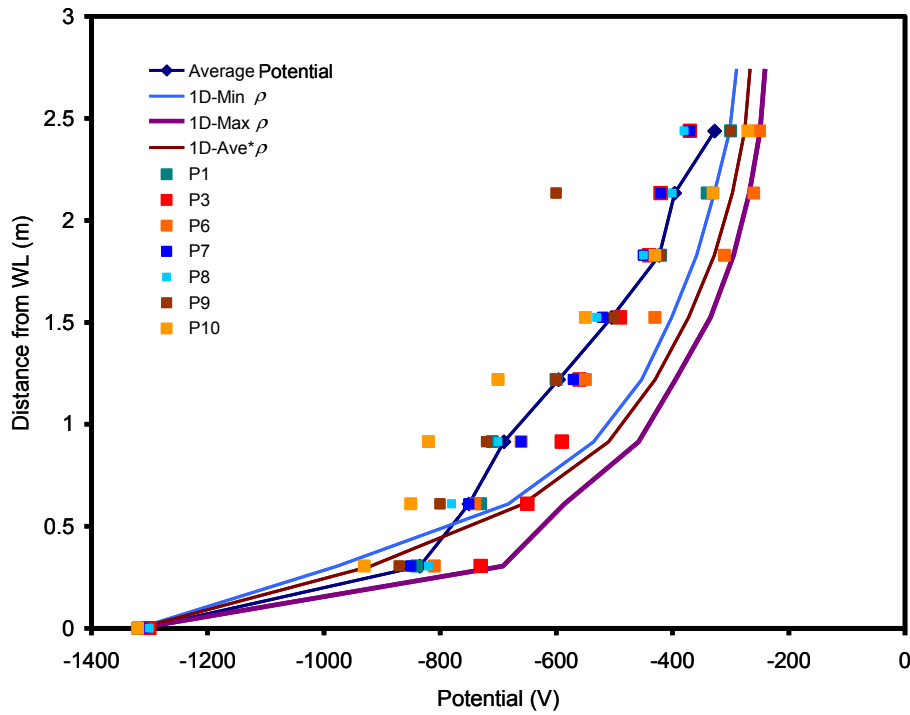
Figure 68: Comparison of 1D model results and experimental potential values after four hours of energizing the system (the average field measurement results are indicated by the series with symbols and connecting line).

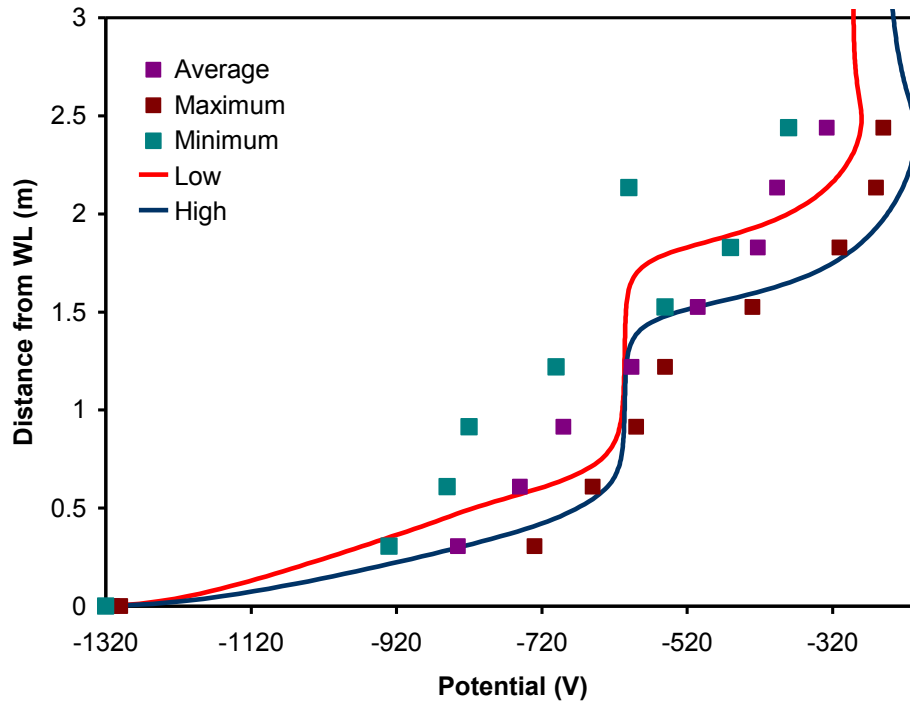
Figure 69: Potential profiles 2D FD versus experimental potential profiles (squares indicate experimental values)
