## **Appendix E–FIB-63 Tests**

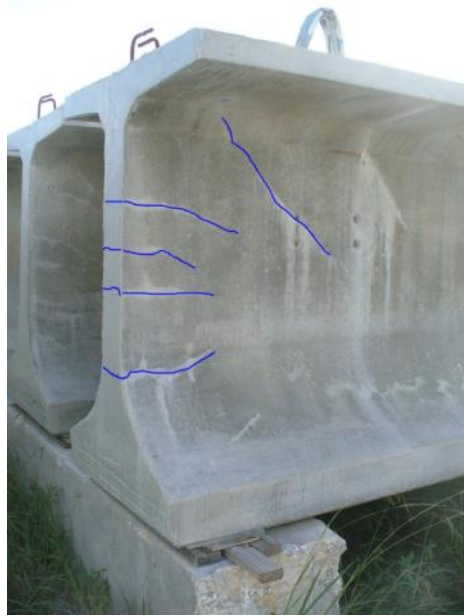
Web splitting cracks (Figure 1) typically form during prestress transfer, or in the days and weeks following transfer. They occur due to tensile stresses that are induced as prestressing forces in the bottom flange are distributed through the cross-section (Figure 2).

Figure 1–Web splitting cracks (enhanced in blue)

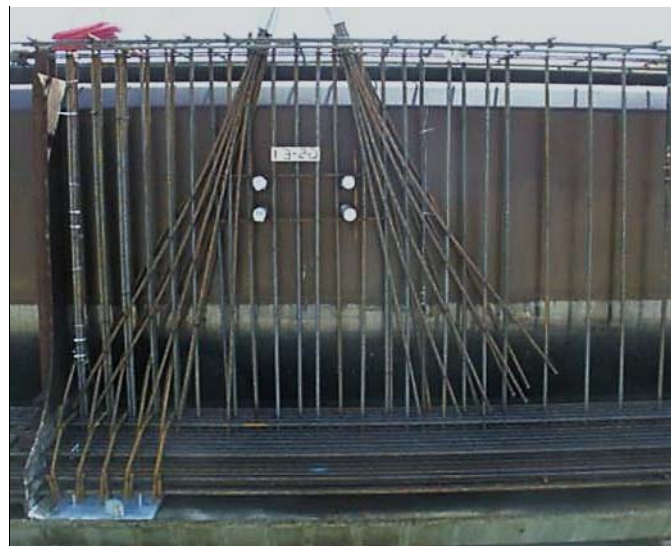
After tensioning, mild steel reinforcement was placed in each specimen. Select bars were instrumented with strain gages prior to placement in the girders. Figure 14 to Figure 17 show the reinforcement in each specimen. Diagonal strands shown in the web in the pictures are from the lifting loops. Close-ups of the post-tensioning system used in specimen PT are shown in Figure 18. As shown in Figure 18 pipes were placed at the top of two rods to act as spacers for load cells. Close-ups of the 1-in. diameter vertical bars in specimen LB are shown in Figure 19.

Figure 14–Specimen CT reinforcement

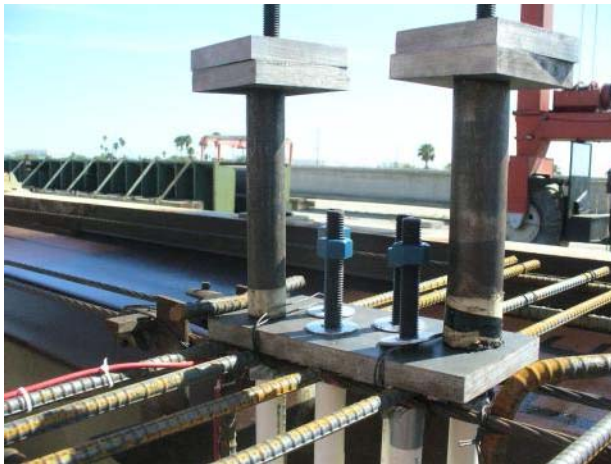
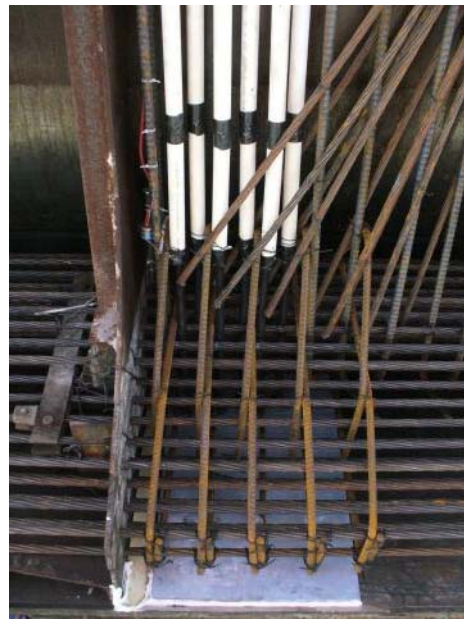
Figure 18—Top (left) and bottom (right) of post-tension rods in specimen PT

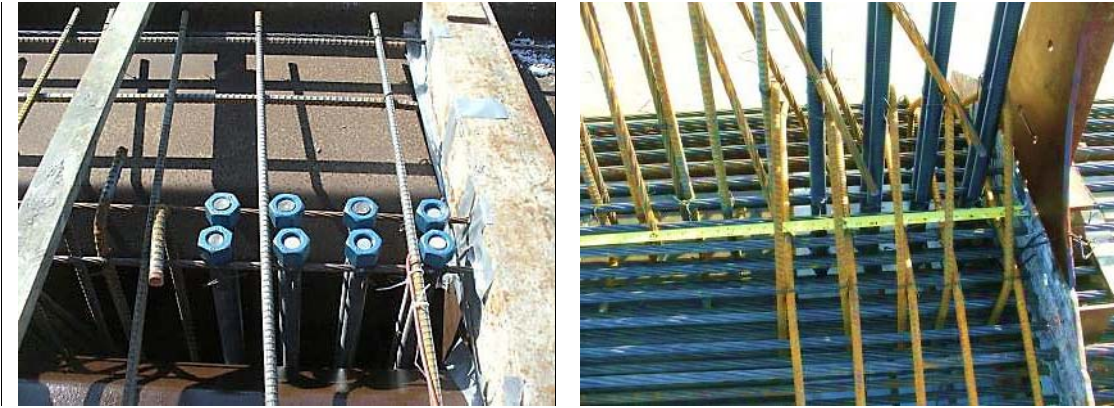
Figure 19–Top (left) and bottom (right) of all-thread rods in specimen LB

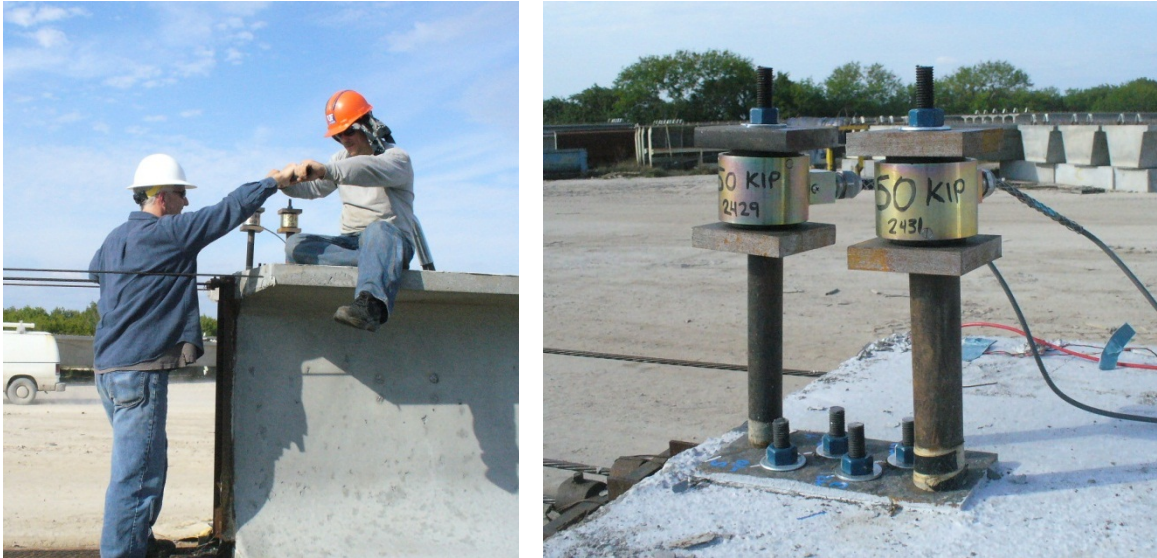
Forces in the individual rods were influenced by the relative difficulty of the post-tensioning process. In spite of these difficulties a total post-tensioning force of 77.9 kip was obtained. This value is within the acceptable range as determined from preliminary analysis conducted prior to fabrication. The total applied post-tension force was approximately 3.4% of the initial pretension forces.

Figure 24–Post-tensioning specimen PT (left) and load cells and anchor plate (right)

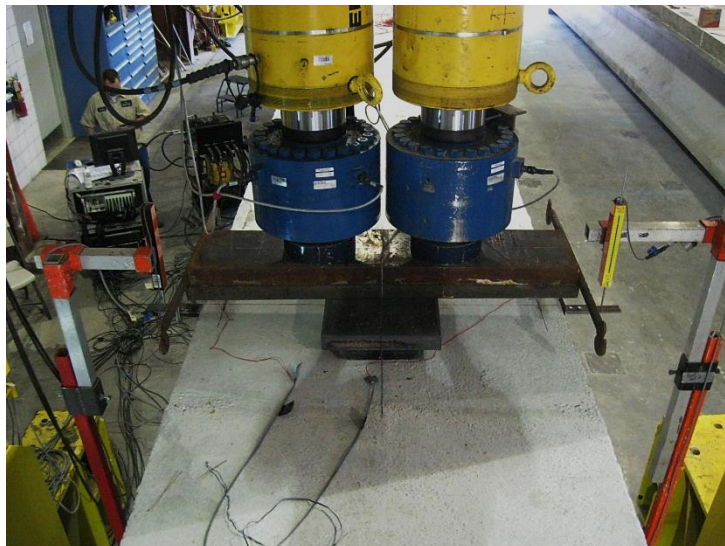
Figure 31–Support conditions at load point for specimens CT, SL, and PT

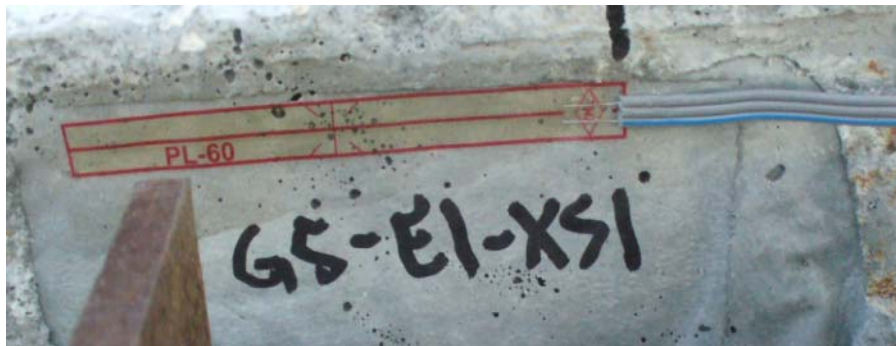
XS strain gages (Figure 35) were attached to the surface of test girders immediately after formwork was removed. These gages were used to measure concrete strains during prestress transfer. XS gages had a 60mm gage length.

Figure 35—XS gage installation

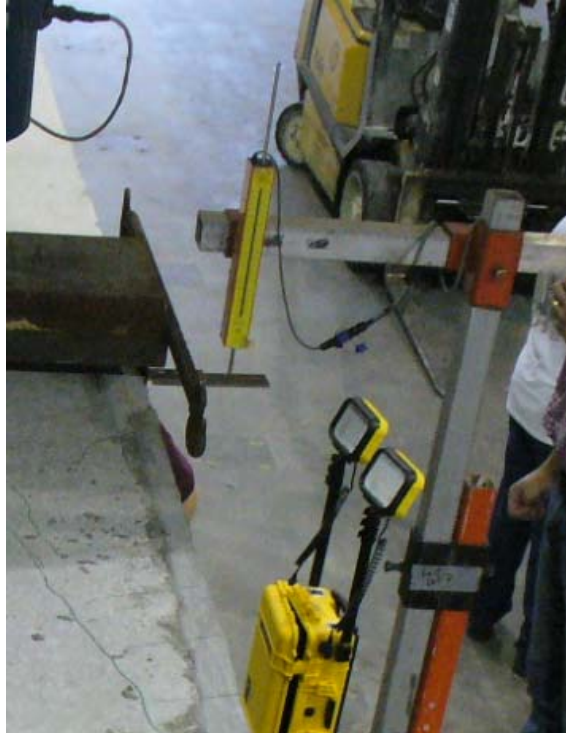
L series instruments were LVDTs used to monitor vertical displacement during load tests. Labels and locations of the LVDTs measuring vertical displacement are shown in Figure 39. LVDTs were mounted to fixed support structures as shown in Figure 40.

Figure 40–LVDT and support frame

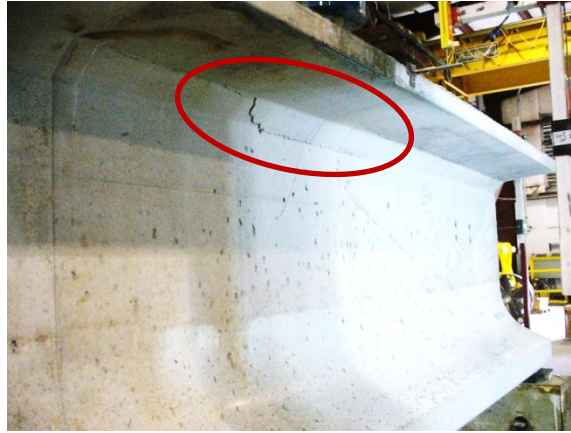
Specimen LB failed in the top flange due to punching failure (Figure 75). Punching failure occurred because load was applied across the width of the relatively thin top flange. Cracking associated with punching failure is shown in the photos in Figure 76 and Figure 77.

Figure 76–Punching shear failure in specimen SL
