**Final Report**

**December 2011**

## **Hillsboro Canal Bridge Monitoring**

**Sponsor:**  
Florida Department of Transportation (FDOT)  
Stephen Eudy – Project Manager

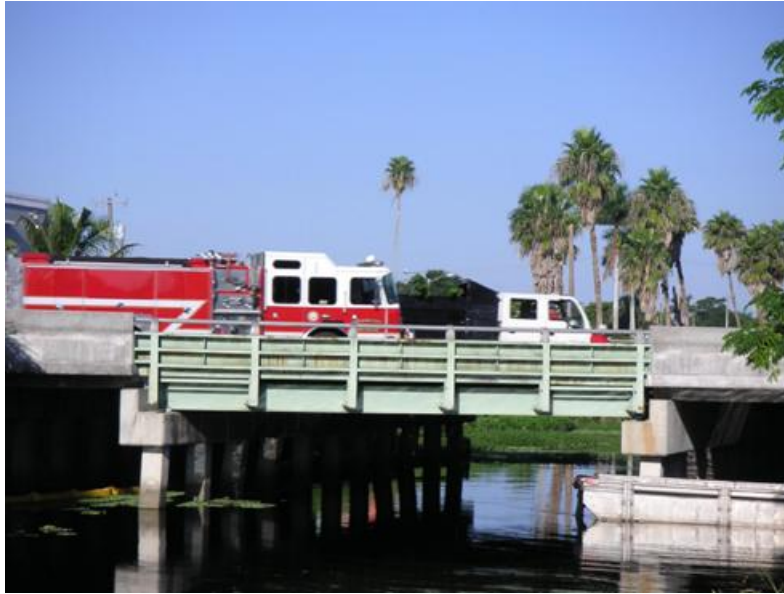
Figure 6 – Elevation view of main span

The superstructure crosses the canal with three short spans. Cast-in-place flat concrete slabs span 15 ft from the abutments to the pile bents (Figure 6). The middle span was a steel grid deck supported by structural steel framing.

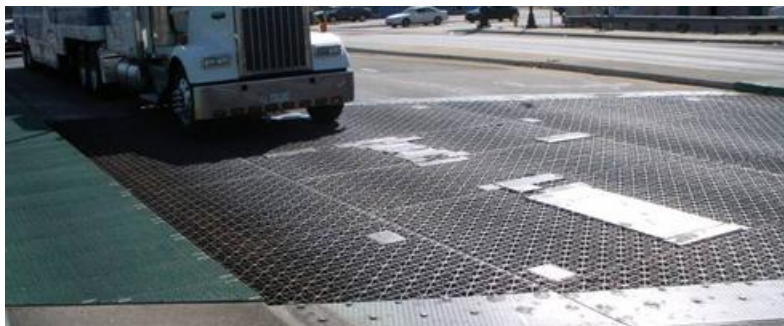
Figure 7 – Damaged and repaired existing steel grid deck

Heavy traffic occurs during the sugarcane harvesting season (from late October through mid-April). Sugarcane-laden trucks have been observed traveling in the two northbound lanes, noted as lane one and lane two in Figure 5. Figure 7 shows the local damage sustained by the steel grid deck and associated repairs using steel plates. This grid deck was replaced by the GFRP deck which is the focus of this study.

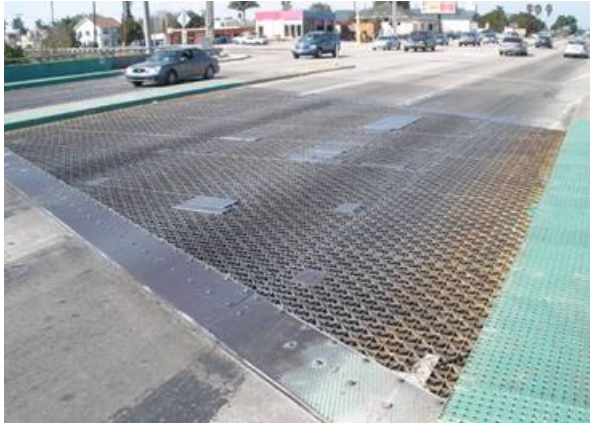
Figure 10 – Existing steel grid deck

The existing steel grid (Figure 10) was removed from the superstructure. A layer of leveling grout was placed between the top flange of the steel girders and the soffit of the GFRP deck to ensure that the finished wearing surface of the new deck aligned with the remainder of the bridge deck. Grout pads were poured using the formwork system shown in Figure 11.

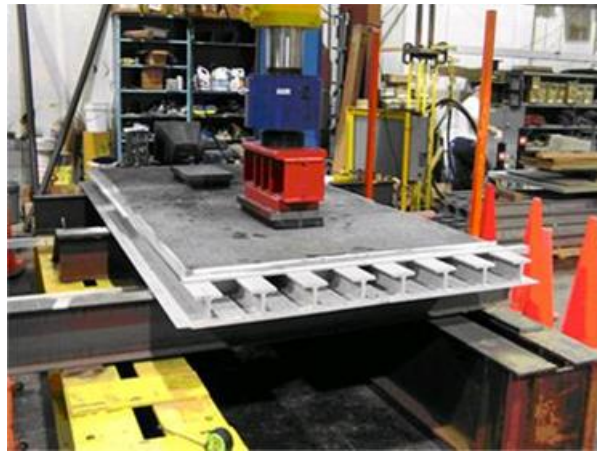
Figure 105 – Structural test of GFRP deck used in Belle Glade bridge (Vyas et al. [2009])

This section presents a comparison between laboratory tests conducted on the same type of GFRP deck that was installed on the Belle Glade bridge. Vyas et al. (2009) performed static and fatigue testing on the GFRP deck using the test setup shown in Figure 105. The specimen was supported in three locations and was continuous over the center support. The 4 ft spacing used for the supports was similar to that of the bridge. Load was applied over a 10 in. x 20 in. bearing pad; these are the same dimensions as the tire patch loading area specified in AASHTO Section 3.6.1.2.5.

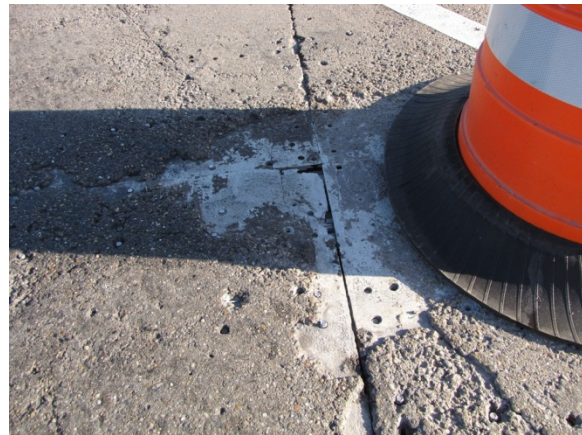
Figure 123 – Wearing surface damage at intersecting panels
