# Long Spans with Transportable Precast Prestressed Girders

**Final Report**

**December 2013**

Florida Department of Transportation (FDOT)

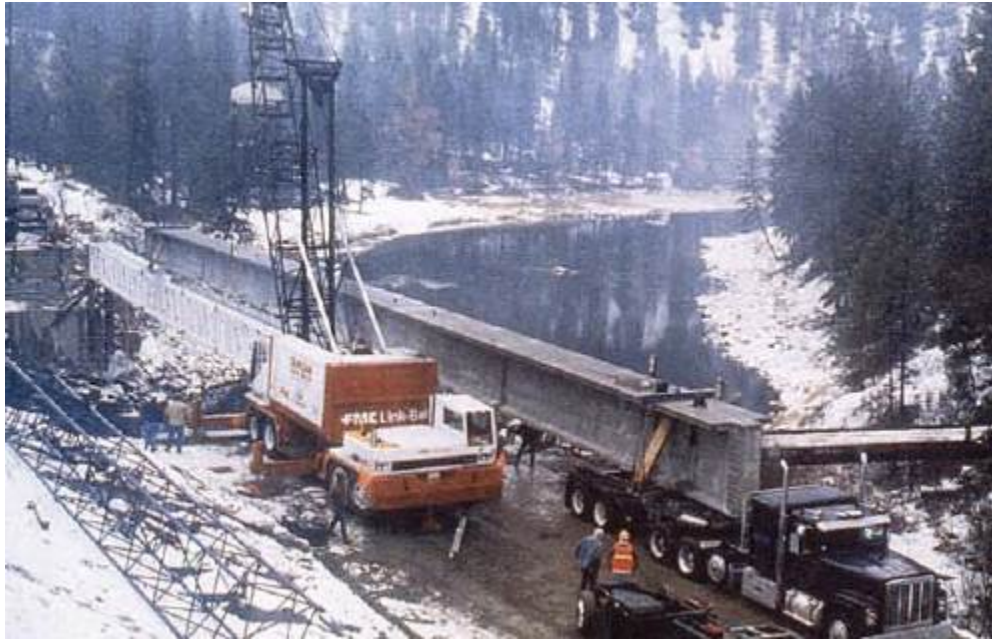
Figure 9—Launching assembled girder using trolley (Nicholls and Prussack 1997)

If the weight of an assembled girder is excessive, or if site conditions do not allow the girder to be lifted, the entire girder assembly may be loading onto a rolling trolley and moved laterally into place along a rail on an adjacent temporary structure. After sliding the girder onto the temporary support, two cranes, one on each end of the span, can then place the girder over the supports. An example of this procedure, as done during the construction of Rock Cut Bridge, is shown in Figure 9 (Nicholls and Prussack 1997; Joint PCI-PTI Committee 1982). For more details, see Nicholls and Prussack, 1997.

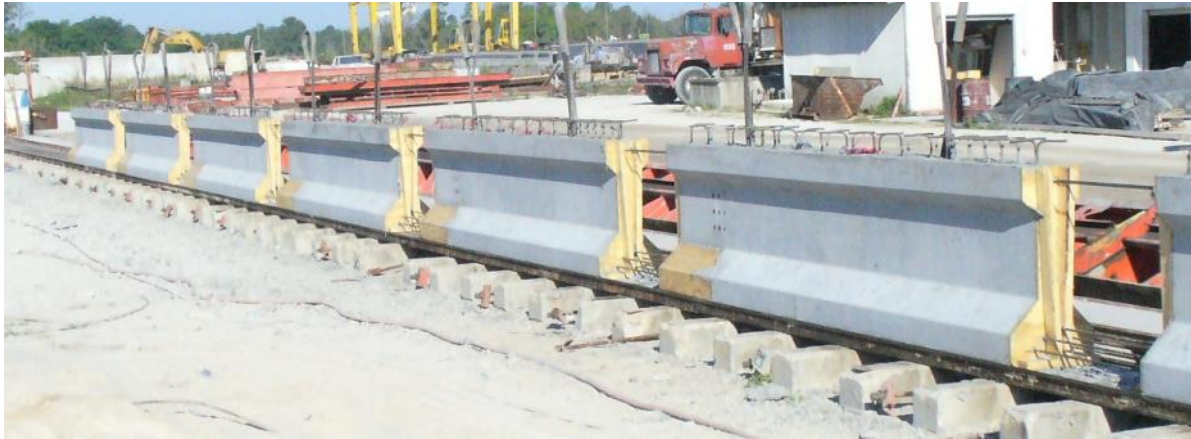
Figure 43–Bed layout

To reduce the likelihood of strand recoil during detensioning, segments for the first pour were arranged in the bed as shown in Figure 43; segments were located close to one another, but away from the abutments.

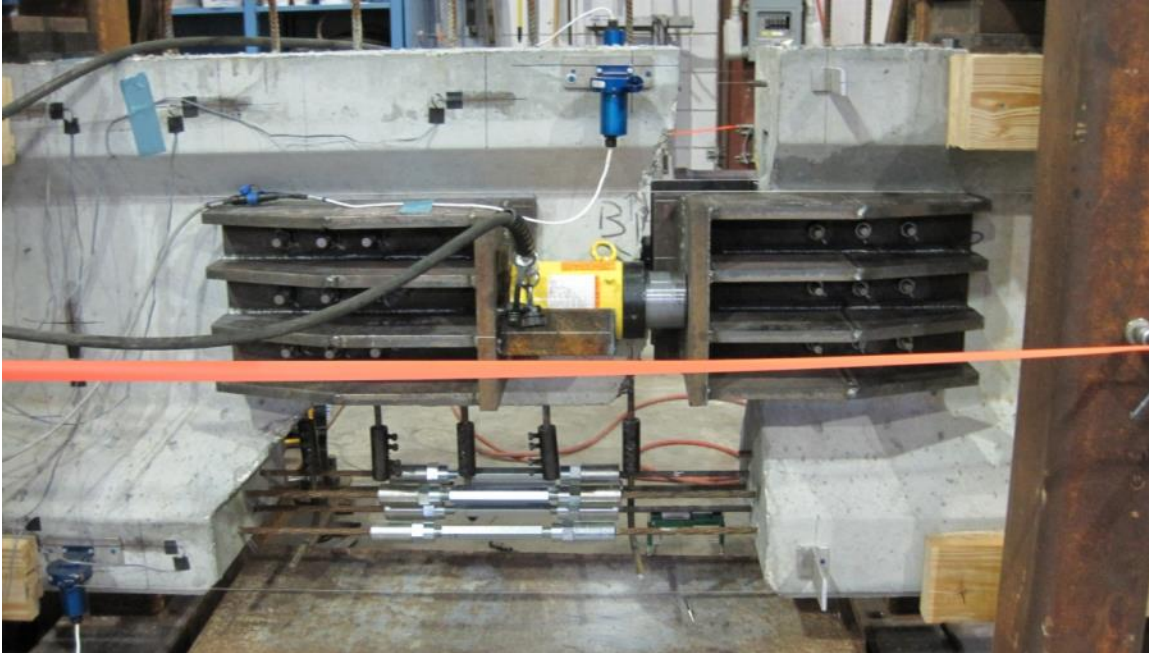
Figure 55—Splice stressed with lock-nuts engaged

At 5600 psi, the lock-nuts on both actuators were hand-tightened. In cases where the string-pots at the bottom of the closure indicated 1-in. of displacement prior to achieving 5600 psi in the prestressing jacks, the procedure was halted and the lock-nuts were tightened early. In cases where the gap opening between the segments and the load cell readings were both low, jacking was continued until the jack pressure reached 6100 psi. The hydraulic pressure was then simultaneously and slowly released from the jacks.

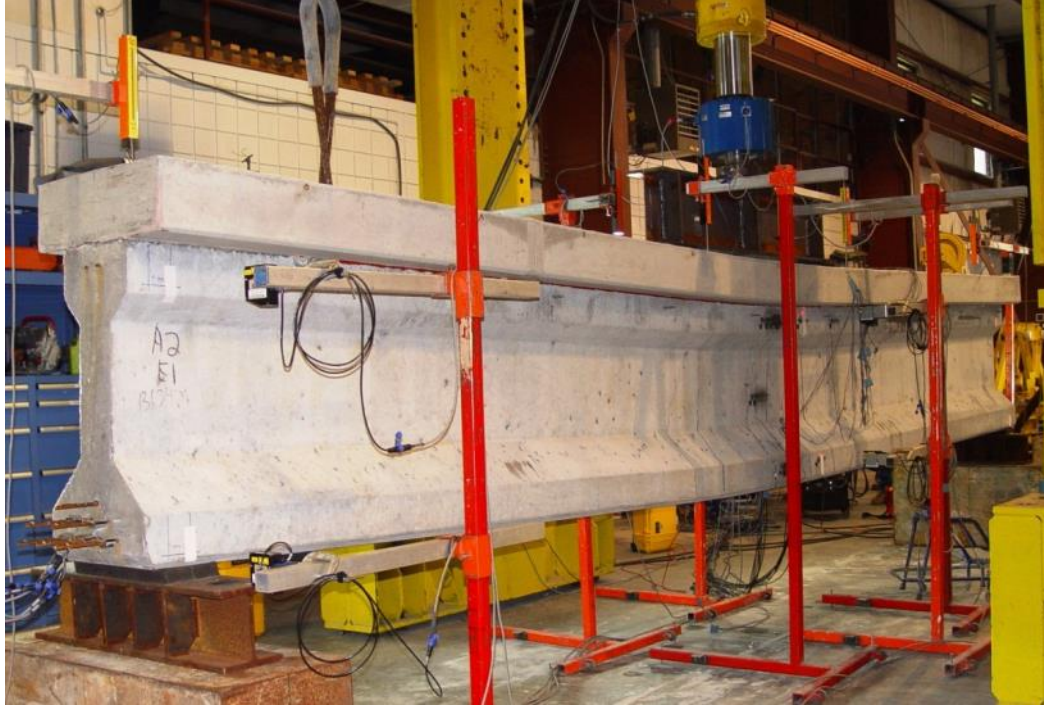
Figure 97–XC: Permanent set

As XC was loaded beyond cracking, sudden minor load decreases occurred periodically until the midspan deflection reached just less than 1 in. These decreases indicated flexural crack formation and were confirmed with audible cracking sounds and visual observations. Although the peak load had not been reached, the test was terminated at a deflection of approximately 4 in. (maximum load of 158 kip) to avoid damage to instrumentation. After the applied load was removed from the beam, a permanent set of 2.38 in. was measured at midspan (Figure 97).

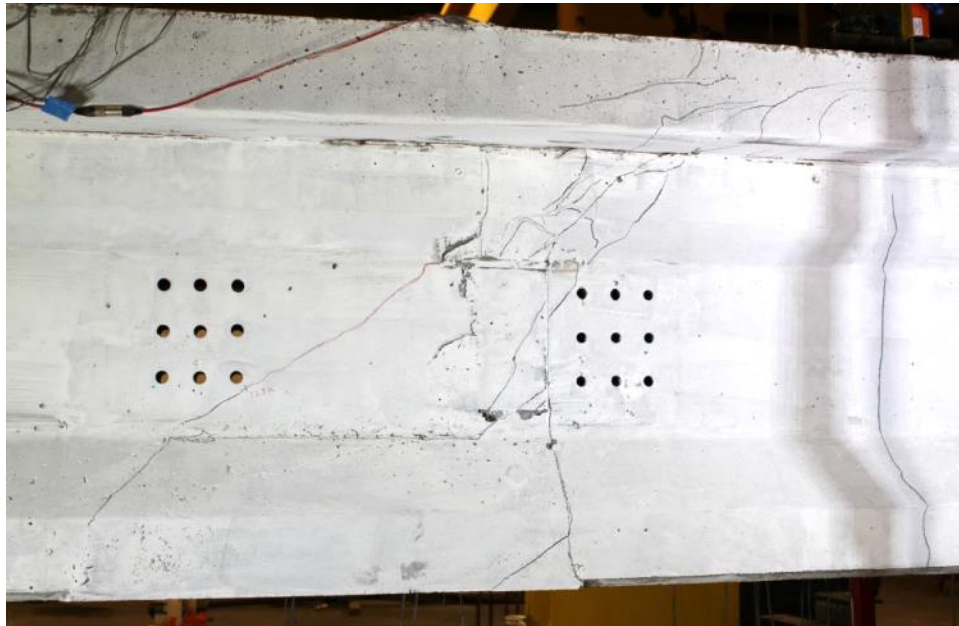
Figure 131–SU2: Joint at failure

At the peak load of 202 kip, SU2 deflected approximately 0.6 in. at the load point. A combined flexural-shear failure mode was observed as the main flexural crack under the load point continued to open and the web-shear crack (the first crack) propagated diagonally toward the load point; slip between the two segments at the vertical interface of the closure joint was again observed, similar to the test of the SU specimen (Figure 131).
