Florida Department of Transportation Research

Investigation of Erosion Rates of Field Samples Using FDOT's Enhanced Sediment Erosion Rate Flume (SERF)
BDK75-977-53

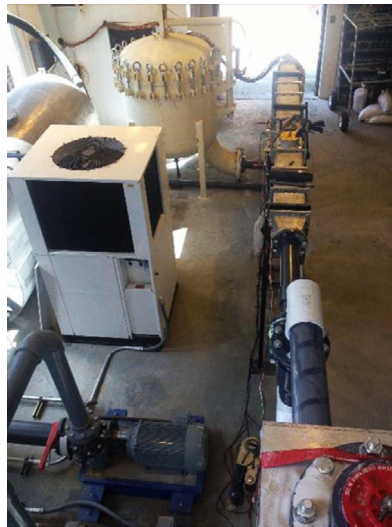
A bird's eye view of SERF. The test chamber is on the right; support devices, such as pumps and filters, are on the left.

In this project, University of Florida researchers used the Sediment Erosion Rate Flume (SERF) to measure erosion rates of cohesive sediments. The researchers made significant improvements to SERF, including pump repairs, laser system enhancements, installation of a digital video camera, updated graphical user interface, a rebuilt pump drive, and an increased capacity filter. The new laser system permitted accurate sample leveling; the previous ultrasonic system tended to penetrate cohesive sediments and give a "false bottom reading." The enhanced SERF led to a number of important findings.
