Final Report

Movable Bridge Maintenance Monitoring

A Report on a Research Project Sponsored by
Florida Department of Transportation
Contract No. BDK78-977-10
Alberto Sardinias, Project Manager, FDOT

October 2013

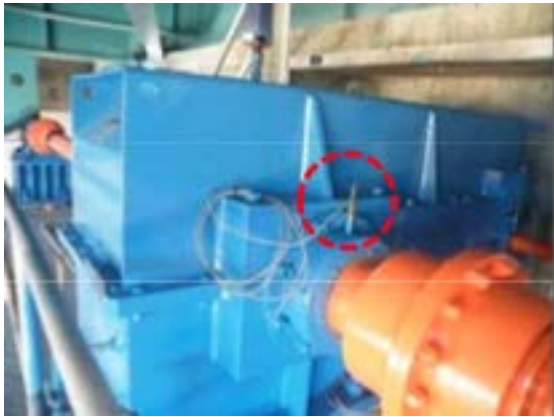
Figure 3-Gearbox acceleration and sample data

The gearboxes contain the assembly that transmits the torque generated by the motor to the shafts (Figure 3). When the gearboxes experience deterioration or lack of lubrication, some change in the vibration and sound characteristics during the bridge operation should be noted. Abnormal vibration is an indicator of wear in the gears. Oil viscosity is also an important parameter for proper functioning of the gearbox. Considering these issues, the monitoring system included accelerometers to measure the vibration of the gearbox during bridge opening/closing events. Furthermore, microphones were also installed in the vicinity of the gearbox to determine its acoustic signature for opening/closing events. The vibration and acoustic signatures associated with a bridge opening/closing event are shown in Figure 3 and Figure 4, respectively.

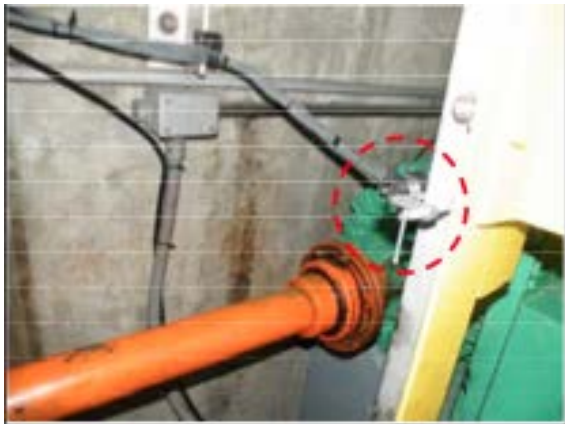
Figure 4-Gearbox microphone and sample data

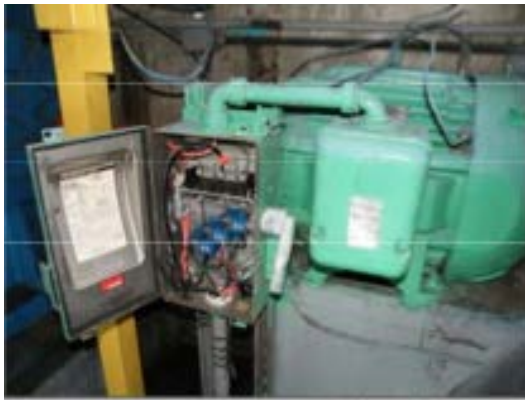
Figure 7-Electrical motor amp meter and sample data

The electrical motors generate the torque required for the opening and closing of the bridge. Some of the indicators for improper functioning of the electrical motors are high amperage, high temperature, high vibration level and high revolution speed. Therefore, it was decided that the monitoring system would include ammeters to measure the amperage levels for each one of the electric motor phases (Figure 7), accelerometers to measure the vibration on the motor during the bridge openings and closings (Figure 8), and infrared temperature sensors to monitor the temperature of the electrical motor (Figure 9).

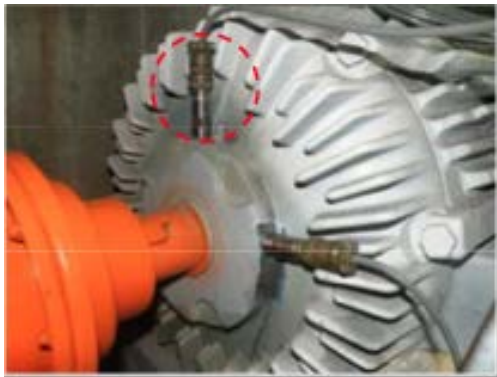
Figure 8-Electrical motor accelerometer and sample data

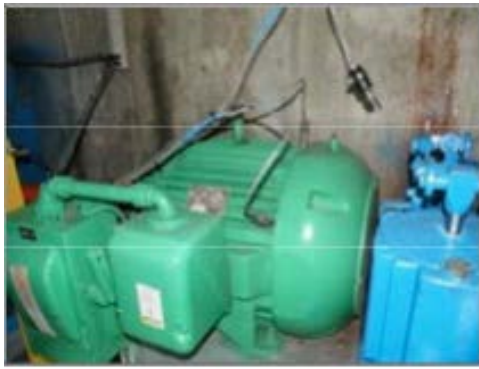
Figure 9-Electrical motor infrared temperature sensor and sample data

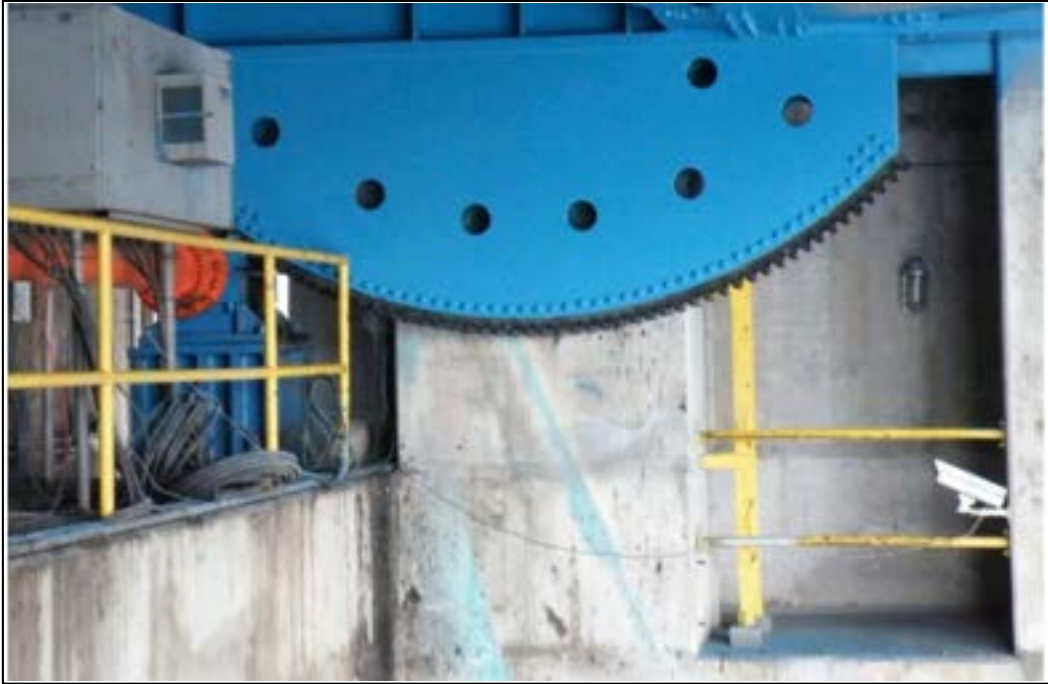
Figure 12- Open gear and video camera

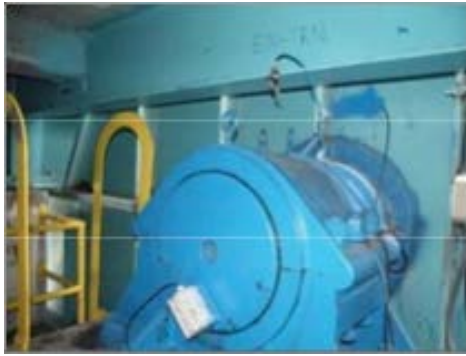
Figure 16- Trunnion tiltmeter and sample data

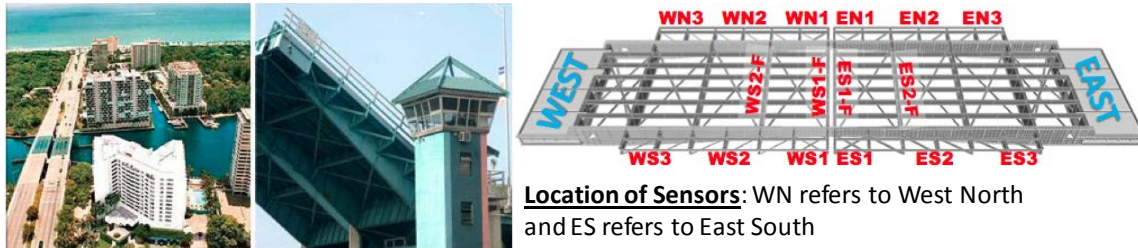
Figure 30-Sensor locations for structural components of Sunrise Boulevard Bridge

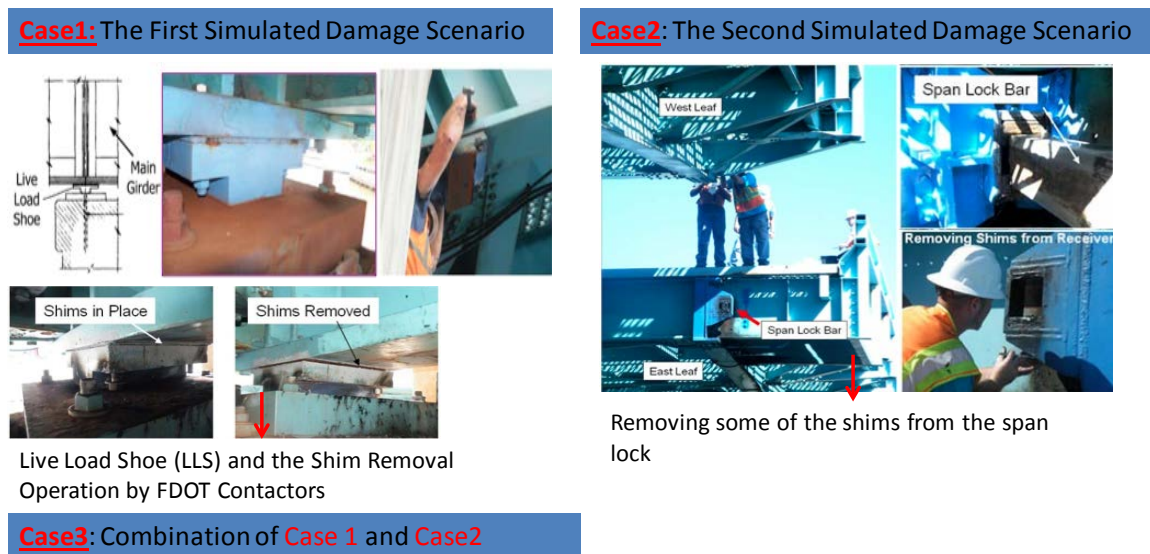
Figure 31 -Implemented damage scenarios on the Sunrise Bridge

In double leaf bascule bridges, Span Locks (SL) are used to connect the tip ends of two cantilever bascule leaves; therefore, both leaves are forced to deflect equally (Figure 31). This ensures compatibility of the deck deflections from the opposing span leaves under traffic loads. The span locks typically consist of two main components: the receiver and the rectangular lock bar.

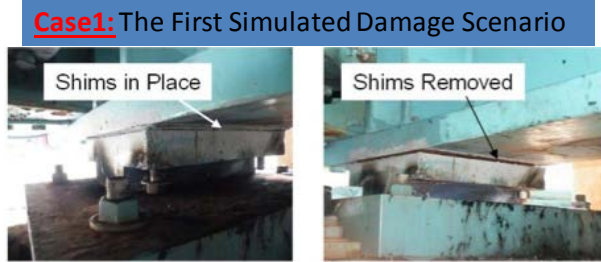
Figure 32- Results for damage Scenario 1

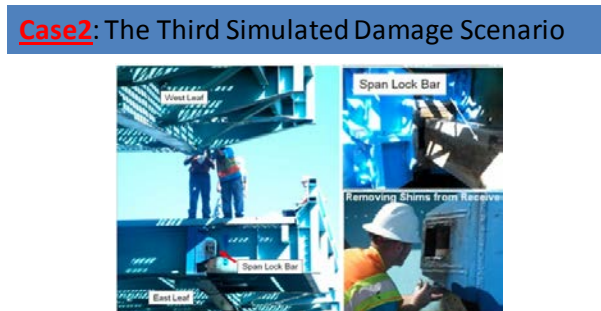
Figure 33- Results for damage scenario 2

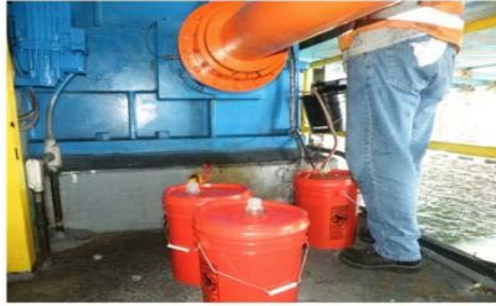
Figure 37-Results of MPCA application for gearbox malfunction detection
