# **Investigation of Reflective Cracking Mitigation Techniques**

FDOT Contract No.: BDK78-977-17

March 2014

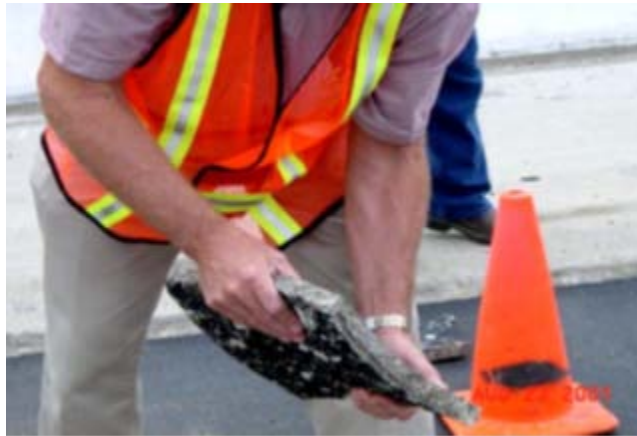
**Figure C.2: Flexibility illustration of Strata**

HMA overlay is placed on top of Strata. SBS modified asphalt mixture is the recommended HMA overlay for this system. Figure C.2, shows the flexibility illustration of Strata.

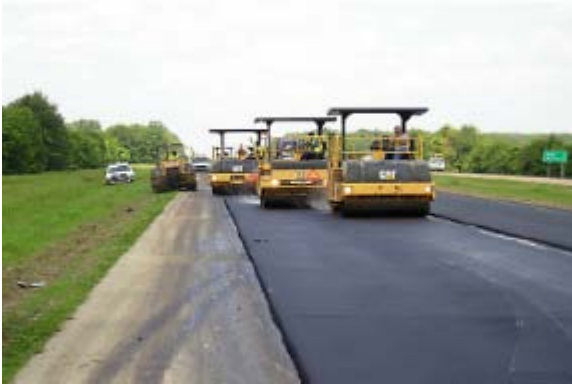
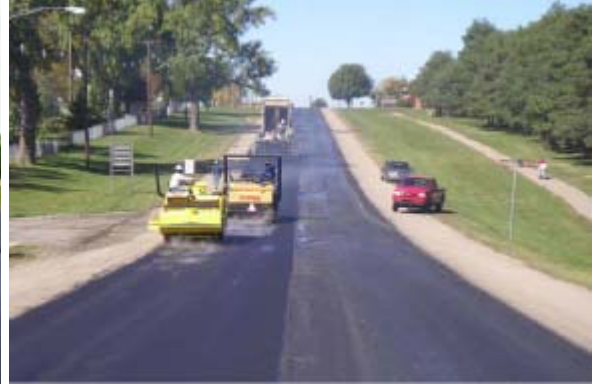
(a) Construction compaction of Strata project (Initial stage)

(b) Construction compaction of Strata project (Final stage)

**Figures C.3: Construction compaction of Strata project**

Figure C.3 (a and b) shows the construction compaction of two projects using Strata interlayer.

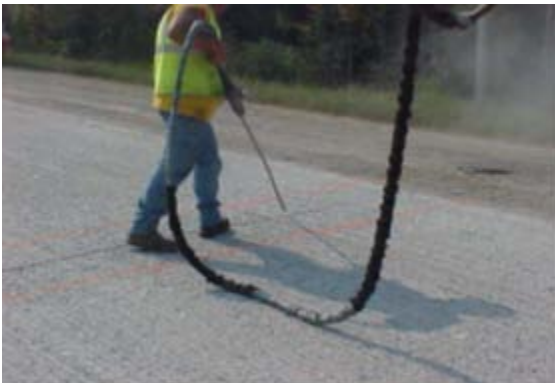
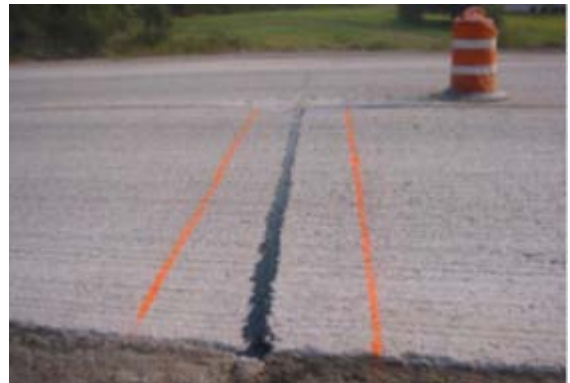
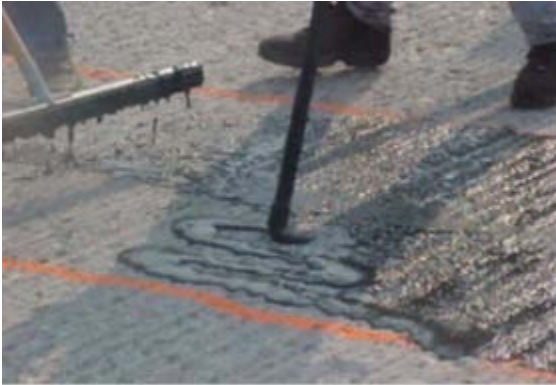
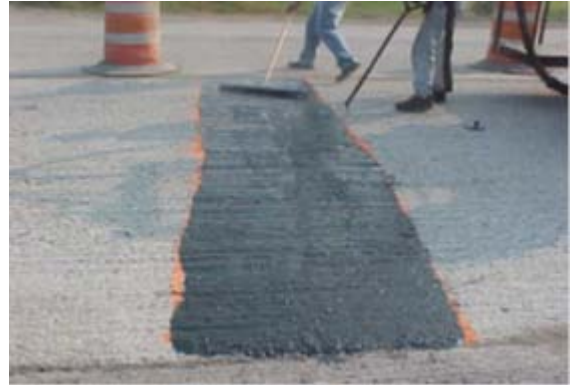
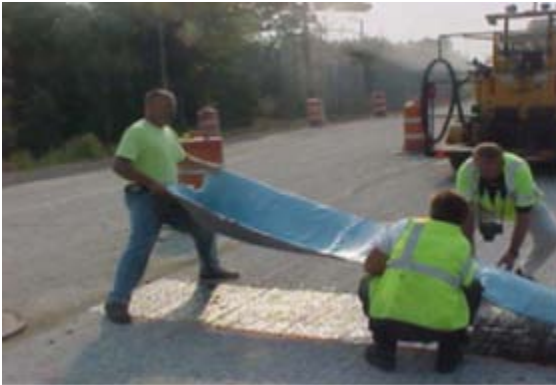
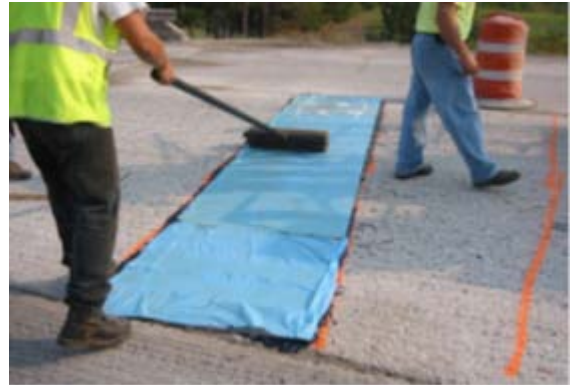
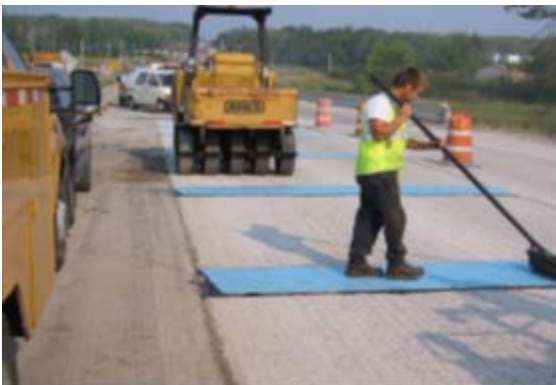
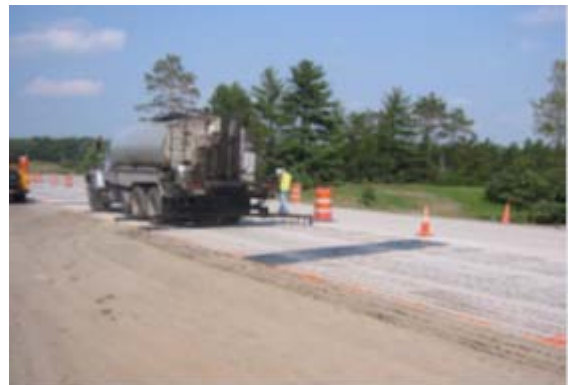
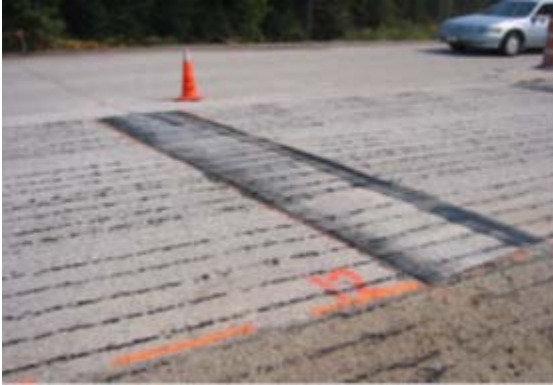
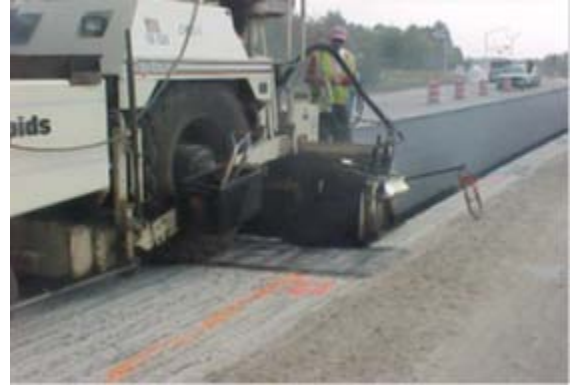
**Figure C.4: Construction procedure of ISAC [14]**

The Interlayer Stress-Absorbing Composite (ISAC) is a composite made of a low stiffness geotextile at the bottom, a highly flexible bituminous material layer as a core and a high stiffness geotextile on the top to combine the effect of both geotextile and SAMI. The construction procedure is shown in Figure C.4, (a-k) [14].

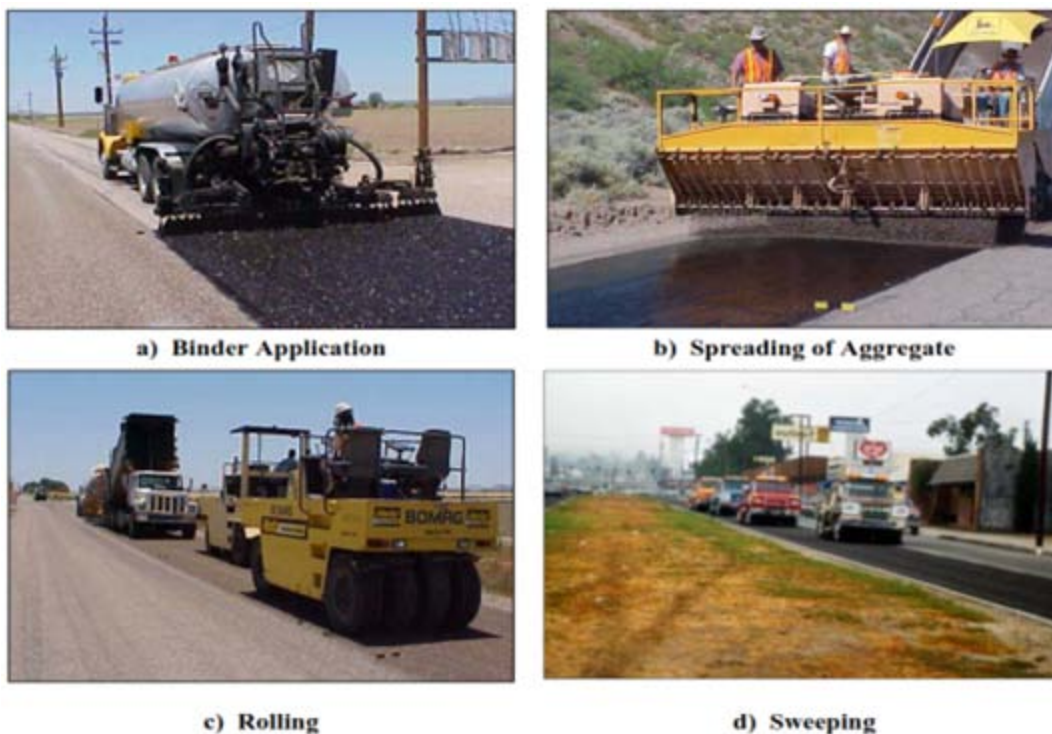
**Figure C.5: Construction procedure of chip seal**

- First, cleaning the surface of road is necessary to remove debris and any holes patched.
- Second, an asphalt distributor truck begins to spray each lane with hot liquid asphalt. A chip spreader follows the asphalt distributor, and disperses the chips aggregate. The specified aggregate size varies by each state DOT; however, the recommended thickness of chip seal as an interlayer is 9.5 to 12.5 mm.
- Third, a rubber-tire roller is used to set the rock into the liquid asphalt. It takes two to four passes of the roller to set the rock.
- Fourth, sweeping the surplus aggregate and HMA overlay is a necessary step [31, 87].
