Improved Inspection Techniques for Steel Prestressing/Post-tensioning Strand

FDOT Contract No. BDK80 977-13
Final Report- Volume I

June 2012

Atorod Azizinamini, Ph.D., P.E., Florida International University
Jawad Gull, Florida International University

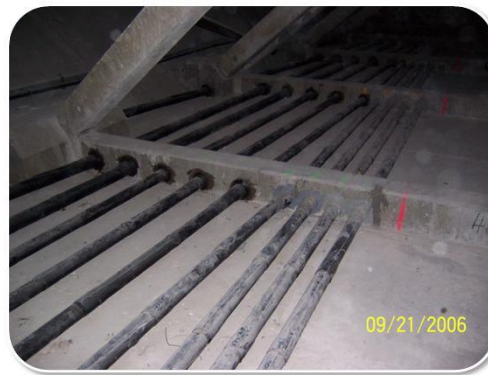
Figure 1.4: External duct

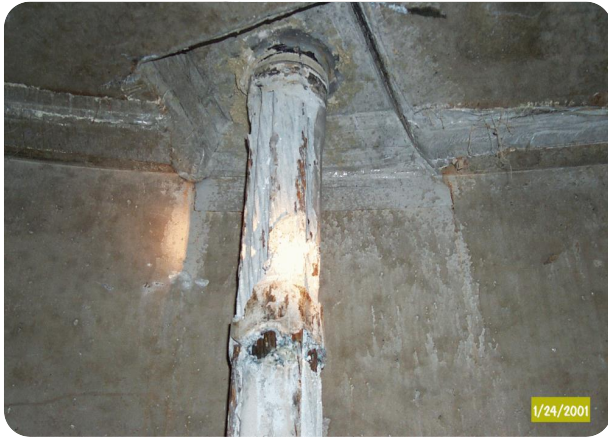
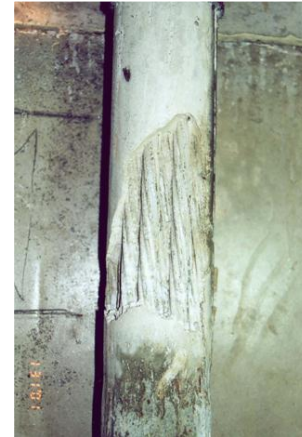
(a): Corrosion activity in the voided area

(b): Lack of corrosion activity in the voided area

Figure 1.5: Corrosion Activity in the Voided Area

The existence of void does not necessarily translate to having corrosion at those locations. Figure 1.5(a) and Figure 1.5(b) show examples of strand conditions in the vicinity of voided areas in duct.

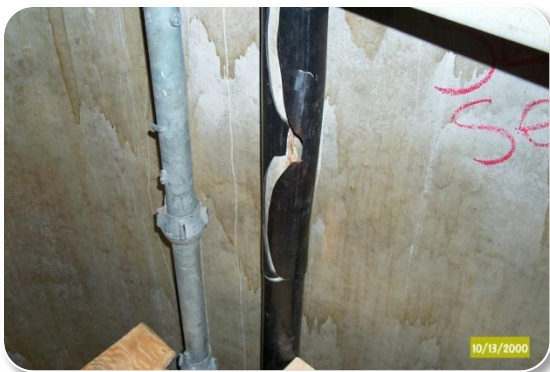
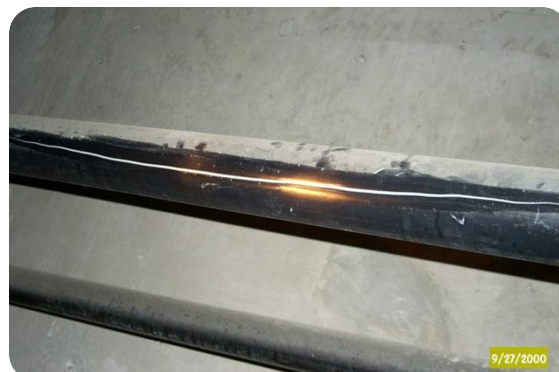
Figure 1.6: Examples of types of observed cracking of ducts

Figure 1.6 shows examples of cracking of the duct. These observed cracking are mainly related to old duct types used and were not created by grouting process. Cracking is mainly attributed to age and durability of the types of materials used. In some cases, corrosion of strands is observed at the vicinities of duct cracking. This is especially true when steel strands are exposed at cracked locations.

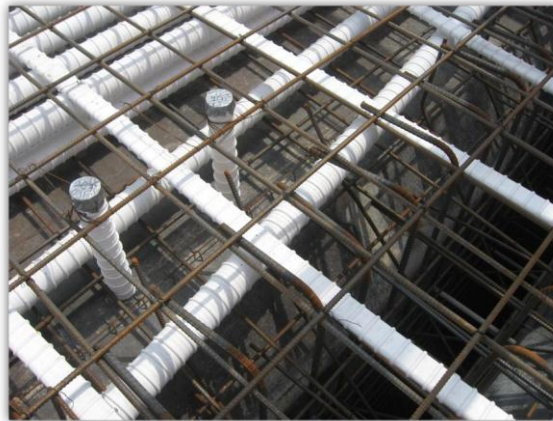
Figure 2.1: Plastic ducts

One of the major improvements from past practice is the use of plastic duct. Field performance and research has indicated that galvanized metal ducts offer little corrosion protection. Plastic ducts, on the other hand, as shown in Figure 2.1, provide an added layer of protection. Further, plastic ducts are air- and watertight. The quality of grout prior to 2000 was not good. Use of new and proprietary grout types are now the norm with many DOTs.

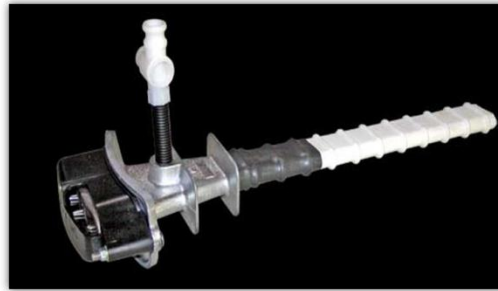
Figure 2.2: New generation of anchorage devices

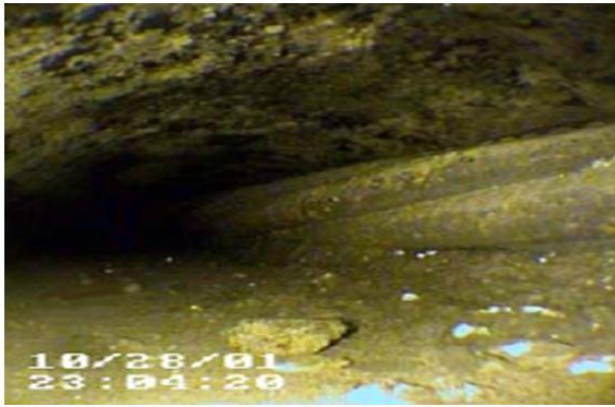
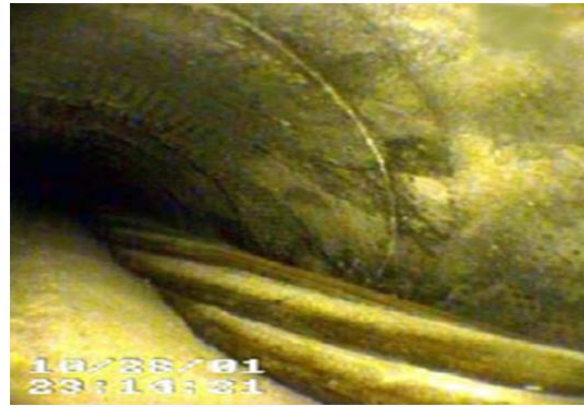
Partially grouted duct

Partially grouted duct with partially exposed strands

Voided duct with fully exposed strands

Partially grouted duct but no strand exposure

Figure A.1: Photos of the inside of post-tensioned duct taken by borescopes (DMJM Harris, 2003)

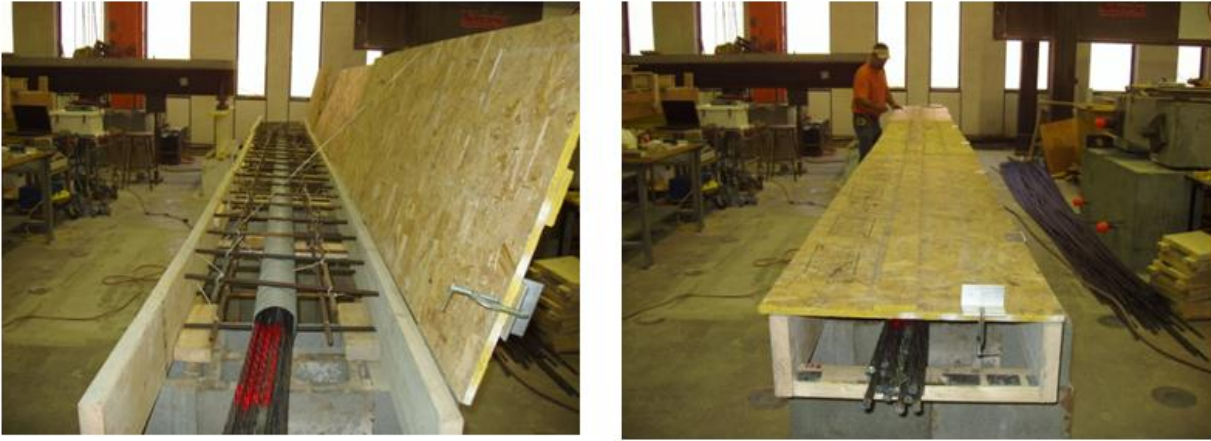
Figure A.5: MFL test setup used by Atorod Azizinamini

In the experiment, 19 strands are placed inside a corrugated and galvanized pipe as shown in Figure A.5.

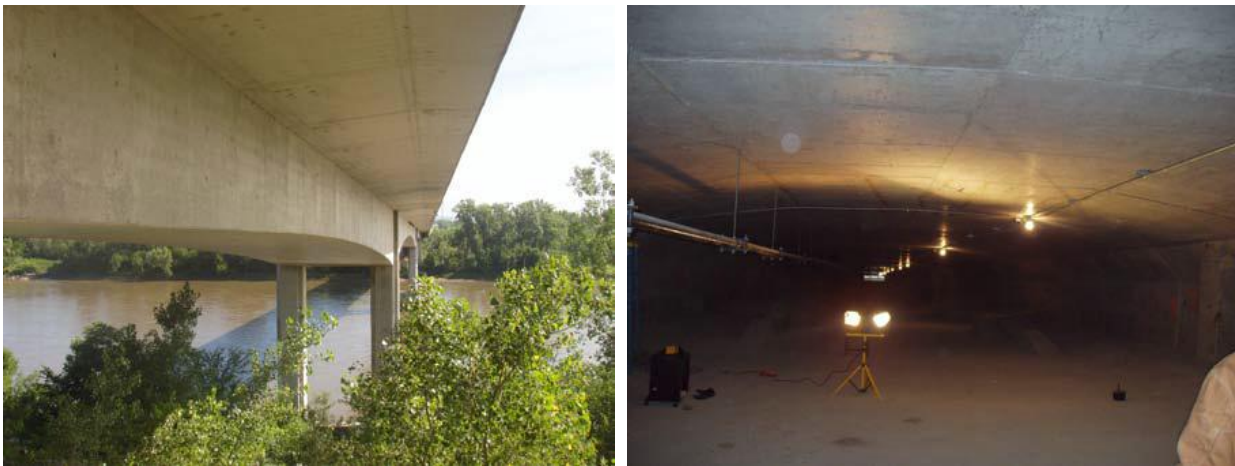
Figure A.7: An example of major segmental post-tensioned bridge inspected by P.I.

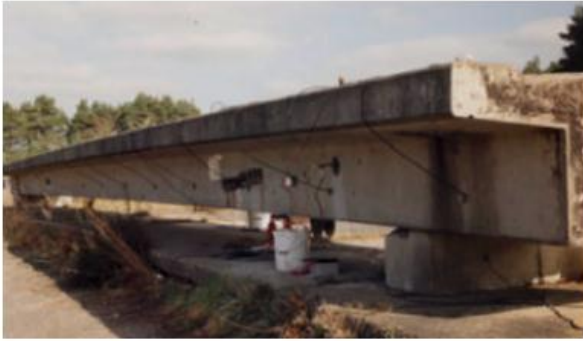
Instrumented Bank Lane Unit

Sensor installation details

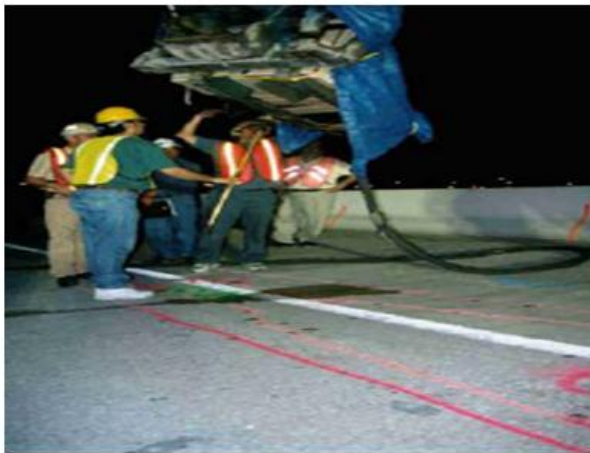
Figure A.13: X-Ray inspection of post-tensioned deck ramp D in Fort Lauderdale: x-ray inspection equipment (left) and example film radiograph (right) (DMJM Harris, 2003)

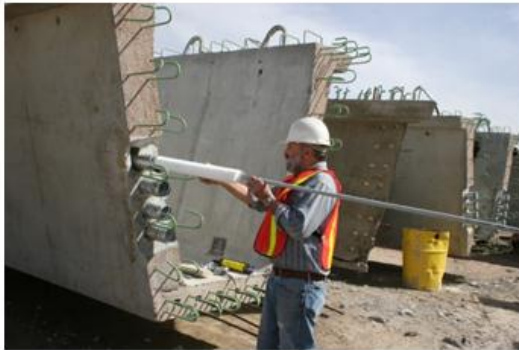
Figure A.17: Insertion of void (left) for Olson NCHRP idea 102 grant for impact echo scanning sensitivity research and grout/void defect plan built for south wall of PT bridge girder (right).

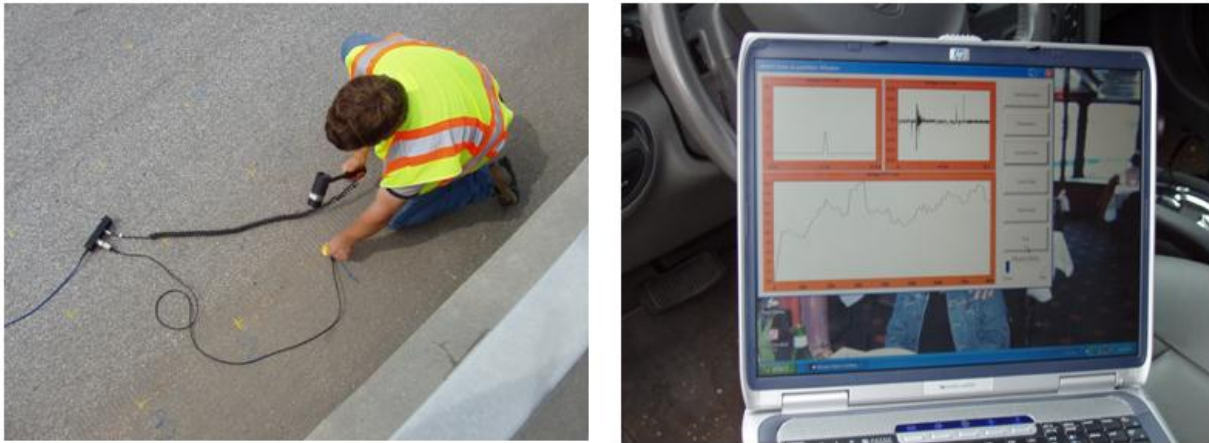
Figure A.19: Impulse response test equipment (left) and data acquisition software showing sensor outputs and computed mobility signal
