# In-Service Performance Evaluation (ISPE) for G4 (1S) Type of Strong-Post W-Beam Guardrail System and Cable Median Barrier: Volume I

Final Report

Contract No. BDK80 977-19

Prepared by:  
Lehman Center for Transportation Research  
Florida International University

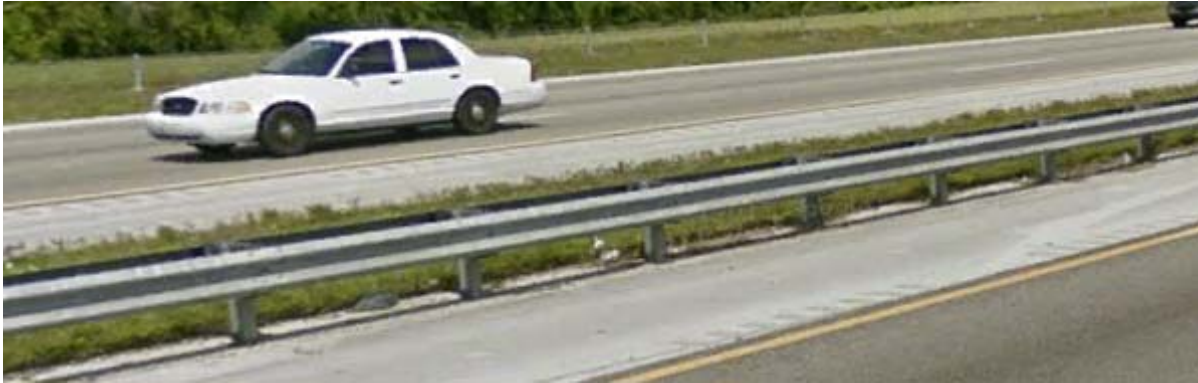
**Figure 1-1: G4 (1S) Strong-post W-beam Guardrail without a Rub-rail  
on Florida Turnpike in Miami-Dade County**

Dakota DOT 2012) and to increase the barrier stiffness (Bullard et al. 2010). Figures 1-1 and 1-2 show G4 (1S) W-beam guardrails without and with rub-rail, respectively.

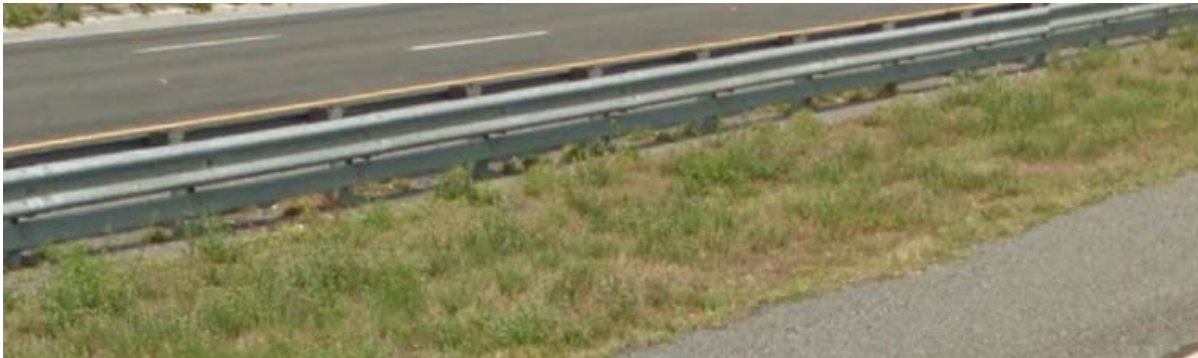
**Figure 1-2: G4 (1S) Strong-post W-beam Guardrail with a Rub-rail  
on I-95 in St. Johns County**
