## Florida Department of Transportation Research Sealing of Cracks on Florida Bridge Decks with Steel Girders BDK82 977-02

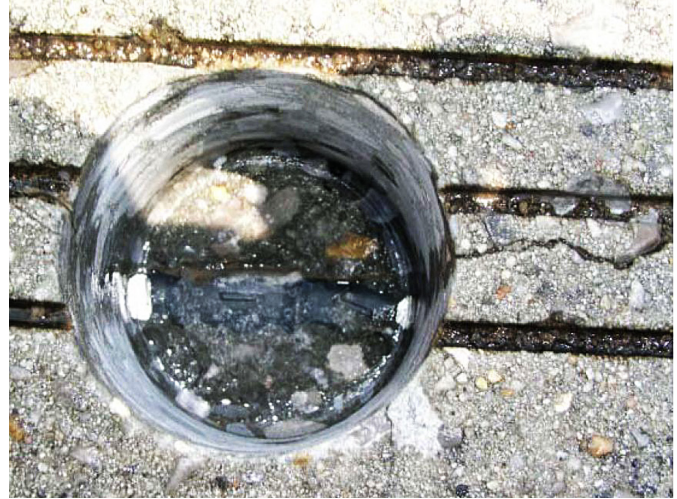
*The development of a transverse deck crack, at the right, is examined by taking a core sample.*

deck cracking in different structural settings. Core samples were taken in some cases to examine the mechanisms of cracking.
