## **FINAL REPORT**

### **REINFORCED CONCRETE PIPE CRACKS – ACCEPTANCE CRITERIA**

**Contract No. BDK84 977-06  
Final Report to Florida Department of Transportation**

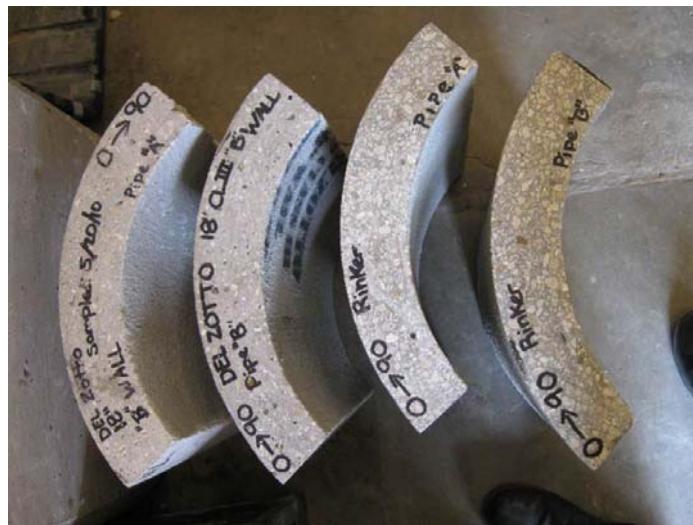
Figure (3.2) RC pipe specimens as received with FDOT identification

The specimens were labeled (R1 to R14, RA & RB) and (Z1 to Z14, ZA & ZB). Four specimens, two of each type, were used for preliminary testing. Table 3.3 cross-references each specimen with the original FDOT identification for traceability purposes. Appearance is illustrated in Figure 3.2.

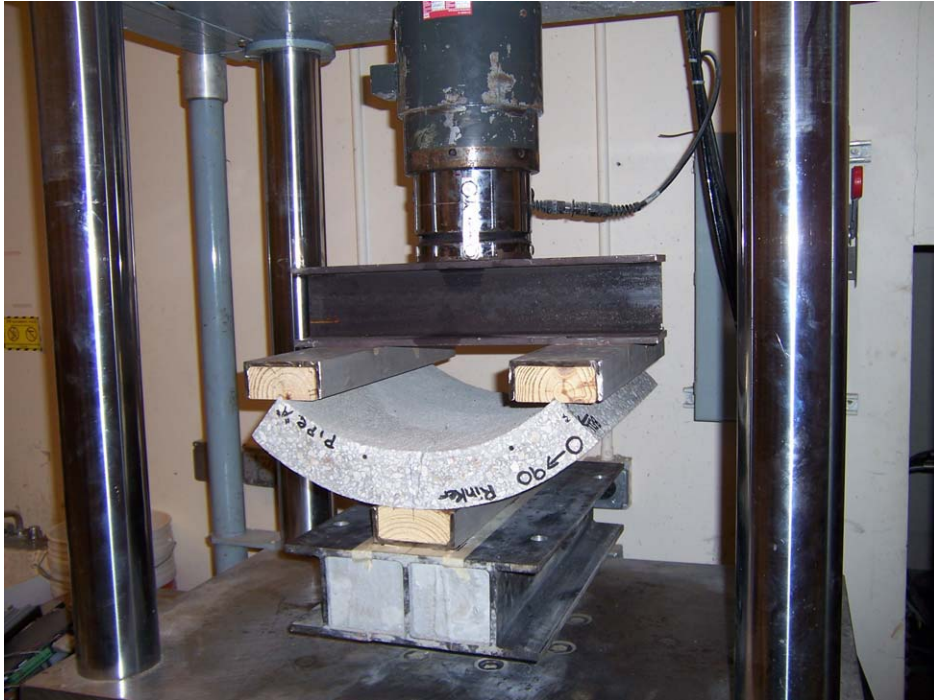
The cracks were intended to be single, extending lengthwise from the bell side to the spigot side of a specimen for a total length of 18 in. Figure 3.12 shows the cracking rig, operated with an MTS 810 (model # 204.91) testing frame using three-point loading.

Figure (3.12) Cracking rig used to generate cracks in RC culvert pipe specimens

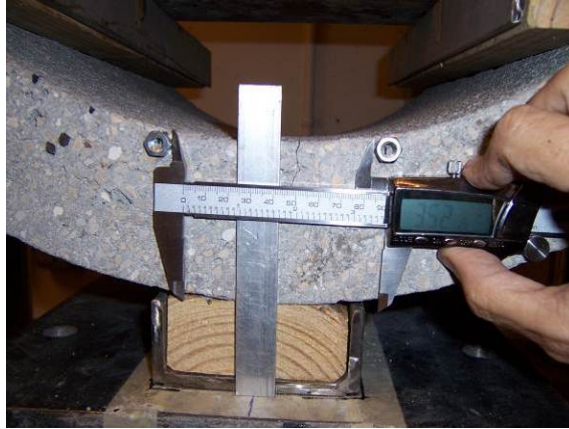
The crack width was controlled with a measuring gauge comprised of two nuts bonded to the surface of concrete on either the bell or spigot end, on both sides of the area in which a crack was to be induced. The distance between the nut edges was measured using a digital caliper before and during cracking as shown in Figure 3.13. Trial tests established the amount of loaded deviation between the nut edges needed to achieve the desired crack width upon release of the load. The cracks were, as intended, generally single and quite uniform as exemplified in Figures 3.14 a & b. Force application was increased by manual control with the procedure completed in about 5 minutes. The amount of force required to achieve a final relaxed crack opening of 0.02 in was about 6000 to 8000 lb. For the 0.1-in-openings the force was about 8000 to 10000 lb for both the Z-Type and R-Type specimens.

Figure (3.13) Crack width measuring procedure

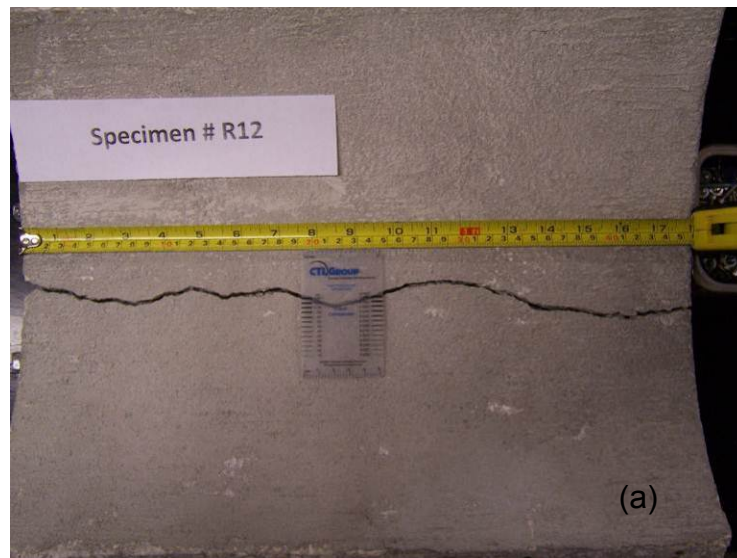
After cracking was completed, more detailed measurements of crack width were performed using a CTL crack comparator at  $\frac{1}{2}$  in intervals along the entire length of a crack. An approximate measurement to establish the apparent crack depth was also conducted using an insertion gauge. The insertion gauge was a 0.3 mm diameter wire in the case of specimens having a crack width of 0.02 in. In the case of specimens having a crack width of 0.100 in a thin gage of dimensions  $\sim 4$  mm x 0.75 mm was used.

Figure (3.14) Crack width measurement using a crack comparator along the entire crack length at 0.5 in intervals for (a) 0.100 in-R-type specimen and (b) 0.020 in-Z-type specimen

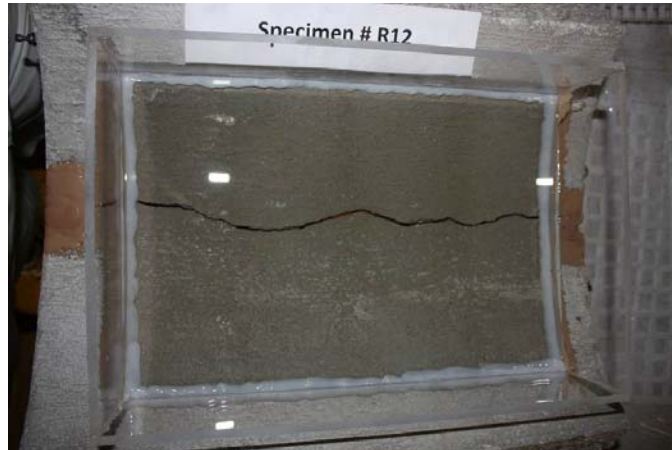
Figure (3.18) A cracked specimen during exposure to the chloride solution

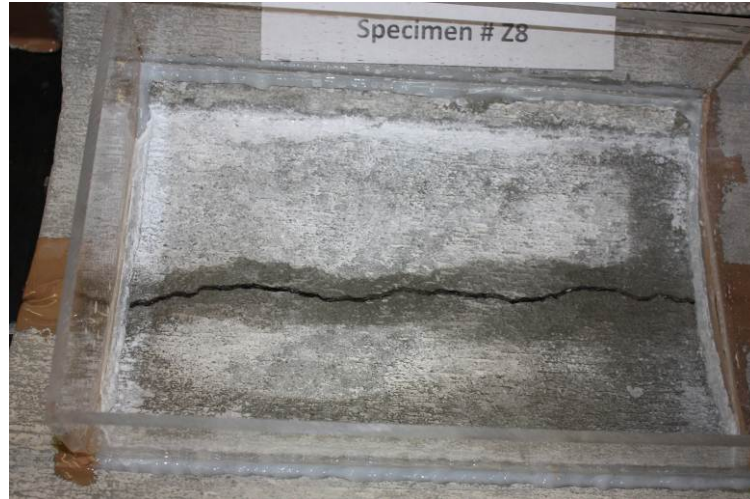
Figure (4.1) Z-type specimen with 0.100-in-wide crack after exposure to saturated calcium hydroxide solution

Upon exposure for 2 months, visual examination of the specimens, subjected to wet / dry cycling of saturated calcium hydroxide solution, revealed that no clear signs of healing of the cracks (Figures 4.1 to 4.4). There was no change in crack size detected when the crack width and depth were measured.

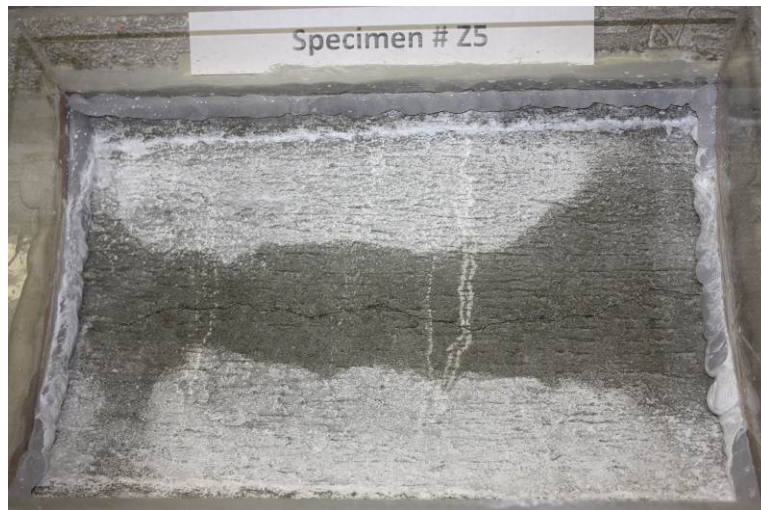
Figure (4.2) Z-type specimen with 0.02-in-wide crack after exposure to saturated calcium hydroxide solution

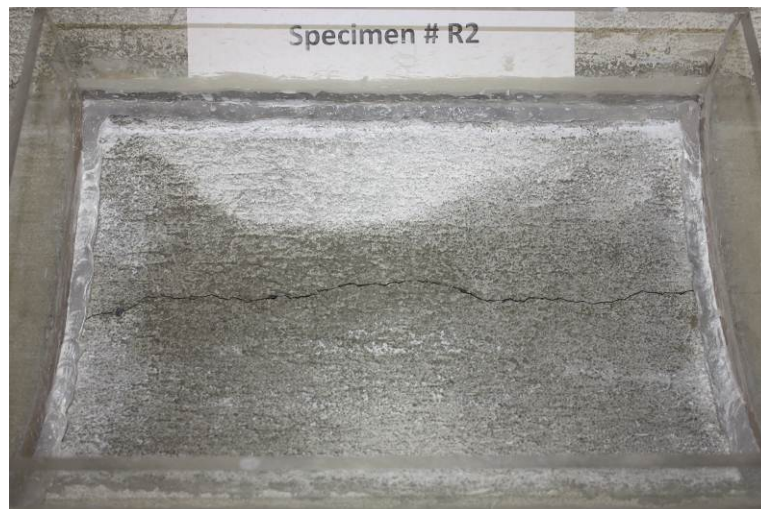
Figure (4.4) R-type specimen with 0.02-in-wide crack after exposure to saturated calcium hydroxide solution

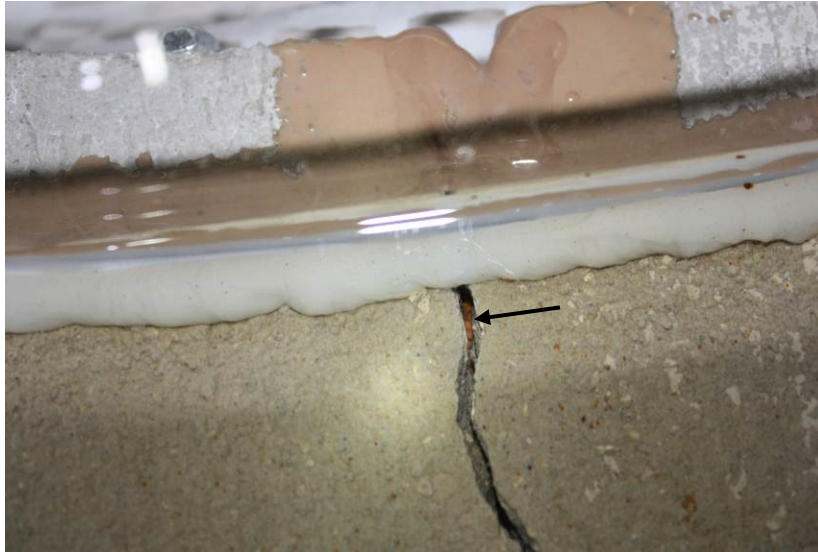
Figure (4.10) Specimen R12 (0.100-in-wide crack class) showing a corrosion spot at a crack-steel wire intersection close to the specimen edge about 52 days after the ponding solution started to incorporate chloride ion

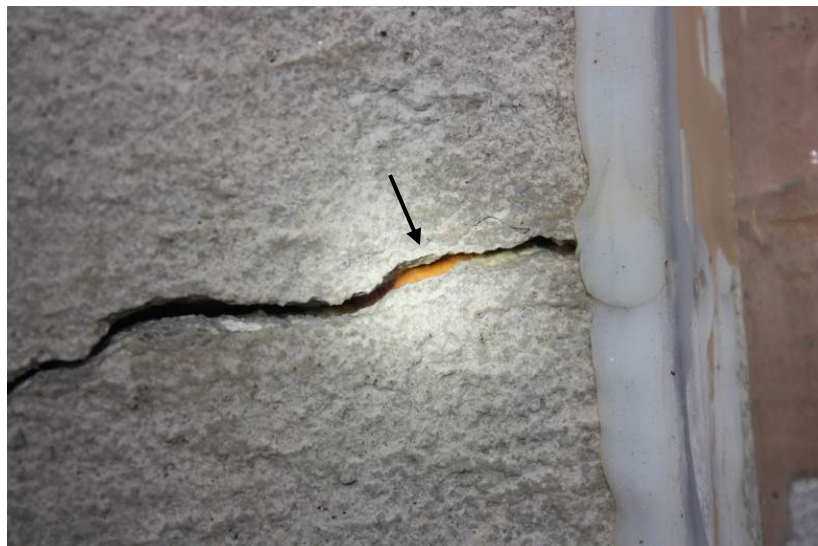
Figure (4.11) Specimen R4 (0.100-in-wide crack class) showing a corrosion spot at a crack-steel wire intersection close to the specimen edge about 52 days after the ponding solution started to incorporate chloride ion

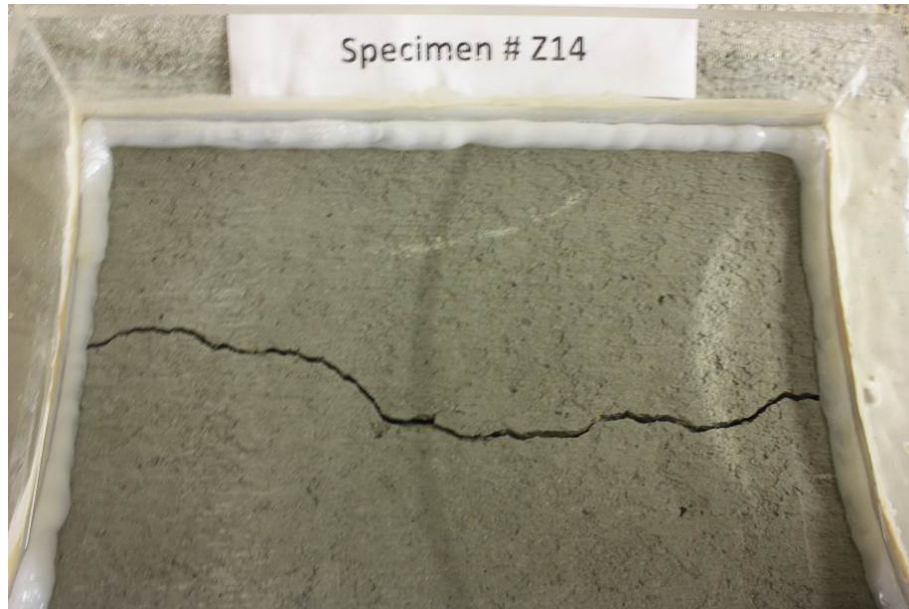
Figure (4.12) Specimen Z14 (0.100-in-wide crack class) showing no corrosion product spots about 52 days after the ponding solution started to incorporate chloride ion

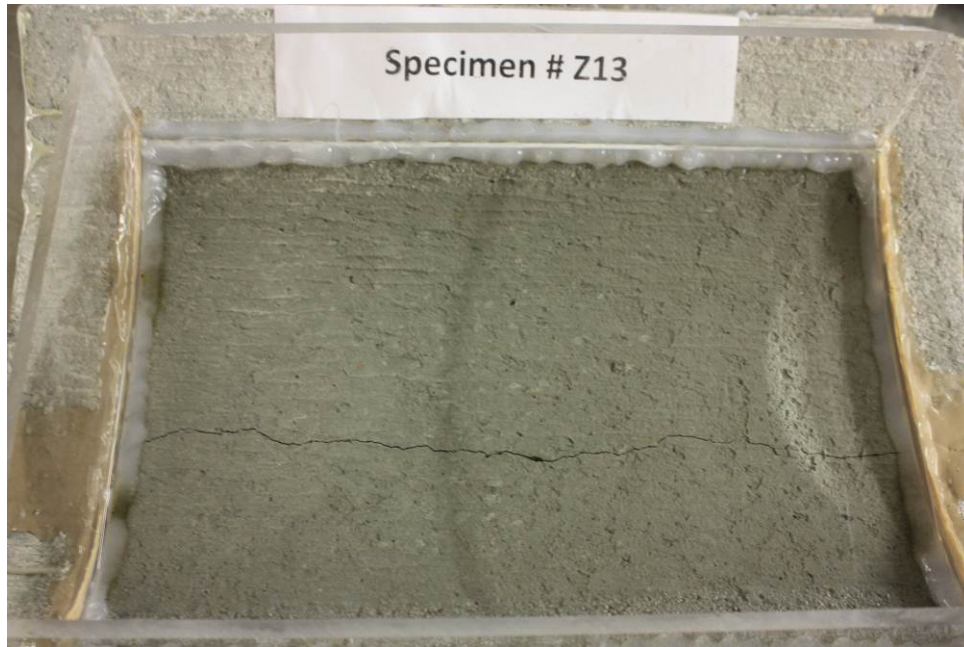
Figure (4.14) Specimen Z13 (0.020-in-wide crack class) showing no corrosion product spots about 52 days after the ponding solution started to incorporate chloride ion

There was no sign of any corrosion product observed in any of the R- or Z-type specimens having 0.020-in-wide cracks, Figures (4.13 and 4.14).
