## Florida Department of Transportation Research Corrosion Characteristics of Unprotected Post-Tensioning Strands under Stress BDK84-977-22

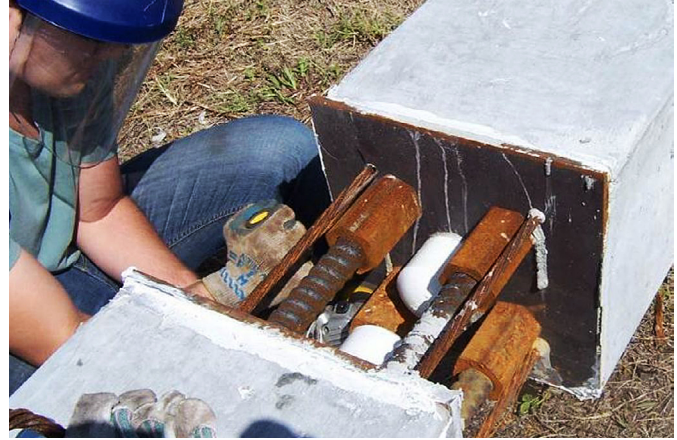
*A worker puts the finishing touches on a test pile. The ducts containing the steel strand are visible here by the white caps that seal them.*

Field testing was conducted in duplicate with near-full-scale ducts at various levels of moisture exposure, salt exposure, and with and without desiccant. Ducts containing either stressed or

unstressed strands were tested and were located at both inland and seaside facilities. Each duct contained two seven-wire strands. Exposure periods were 1, 2, and 4 weeks. After exposure, tendons were de-tensioned and extracted for testing. Strands were examined for surface rusting and hydrogen pickup and evaluated mechanically with standardized tensile tests and limited reverse bending tests.
