EVALUATION OF SHARED LANE MARKINGS IN MIAMI BEACH, FLORIDA

**FDOT Contract BDM10 977-01
Final Report**

**University of North Carolina
Highway Safety Research Center**

March 2012

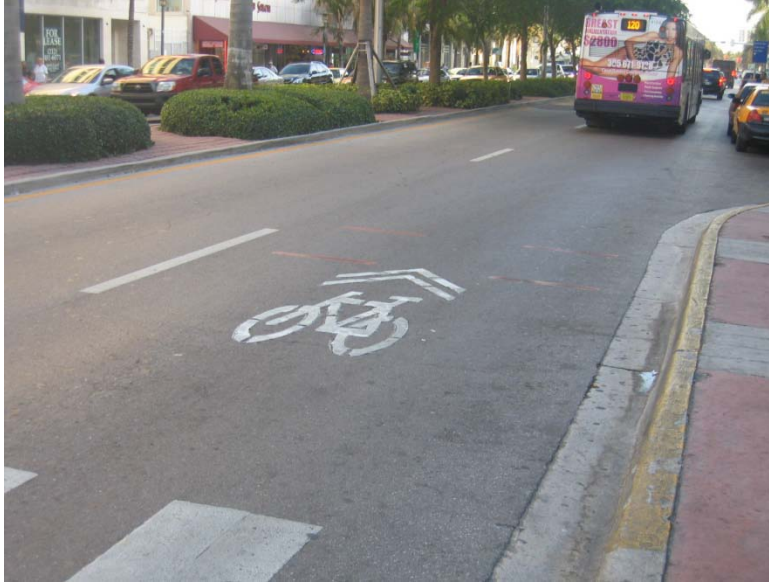
Figure S1. View of sharrow in middle of lane.

tracking over the markings to be out of the door zone and also to take control of the lane. Figure S1 shows a view of a symbol just past an intersection with a bulb-out and no parking. The block lengths were such that shared lane markings were typically placed near an intersection crosswalk, at mid-block, and near the end of the block. Spacing was approximately 200-250 feet in such a situation.

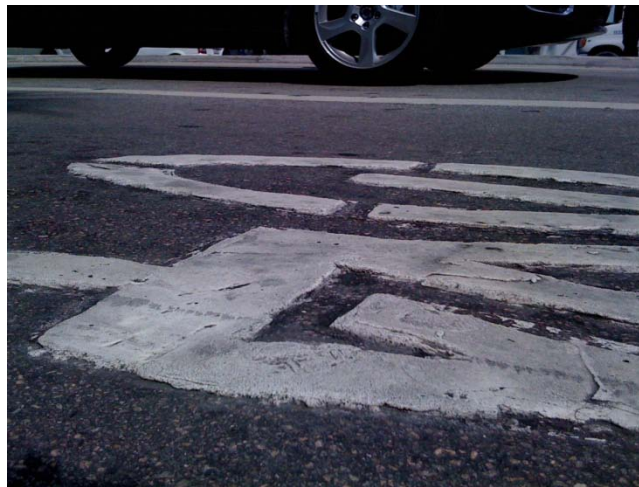
Figure S2. View of bumpy sharrow.

The decision was made to use thermoplastic for the markings. Unfortunately, the contractor who was hired to install the shared lane markings decided to use a thick application, and the result was a symbol that was rough or bumpy in appearance (Figure S2).

The appearance was pointed out to City officials relatively soon after installation, and the decision was made to proceed with data collection to see if the roughness would have an effect on where the bicyclists rode in the vicinity of the marking. As will be shown in the results section of the report, many bicyclists chose to avoid riding over the marking. Several months after completion of the first set of “after” data, the City was able to get the contractor to attempt to smooth the roughness, and a second set of “after” data was collected to see if the smoothing had an effect on riding position, but the results were about the same.

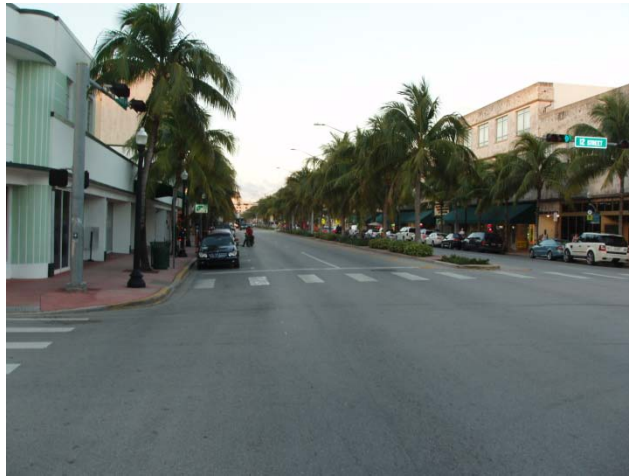
Figure 3. Street view of Washington Avenue.

The Washington Avenue speed limit is 30 miles per hour, and the street is a main transit corridor. In addition, many taxis operate on the street, and double parking and parked vehicle turnover is frequent. The situation can be somewhat chaotic for bicyclists when traffic is heavy, and bicyclists frequently ride between vehicles in the travel lane and parked vehicles. There are bicyclist interactions with pedestrians crossing the street at mid-block and intersections. The mix of bicyclists is extremely variable and includes a considerable number of tourists. The cyclist skill level is also variable, and it would appear that the vast majority of bicyclists are recreational. There are many instances of bicyclists using cell phones (Figure 4). On the other hand, there are times when the street is quite calm, and bicycling would be an easy task. The data collection covered a variety of situations as depicted by the various scenes in Figure 5.

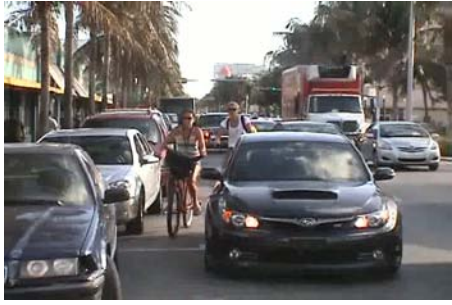
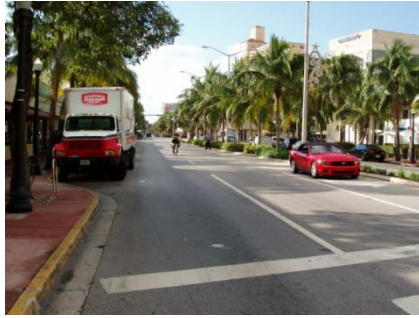
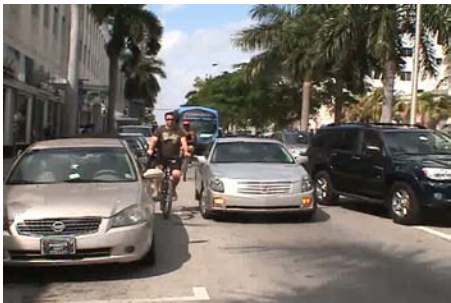
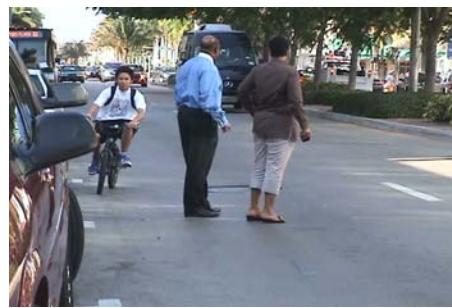
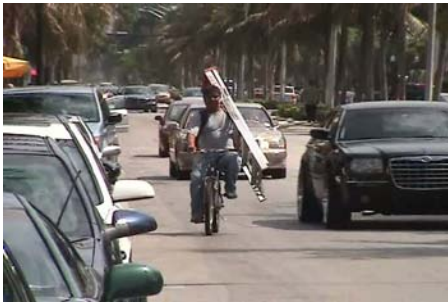
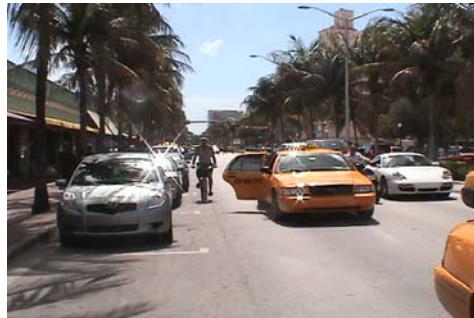
Figure 5. A variety of bicycling scenes on Washington Avenue.

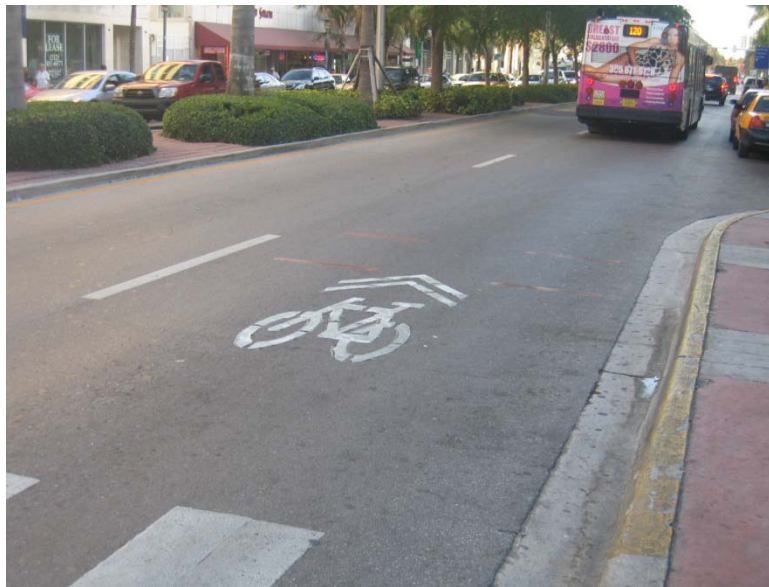
Figure 6. View of sharrow in middle of lane.

The City decided that the most appropriate placement for the shared lane markings was in the middle of the lane near parked vehicles, which would place the center of the marking approximately 13.5 feet from the curb. The City felt that normal spacing of 11 feet from curb next to parked vehicles would not allow enough room for motor vehicles to pass bicycles in the lane next to parking. Middle of the lane placement would allow bicyclists to be out of the door zone and also to take control of the lane. Figure 6 shows a view of a symbol just past an intersection with a bulb-out and no parking. The block lengths were such that shared lane markings were typically placed near an intersection crosswalk, at mid-block, and near the end of the block. Spacing of markings along the street was approximately 200-250 feet.

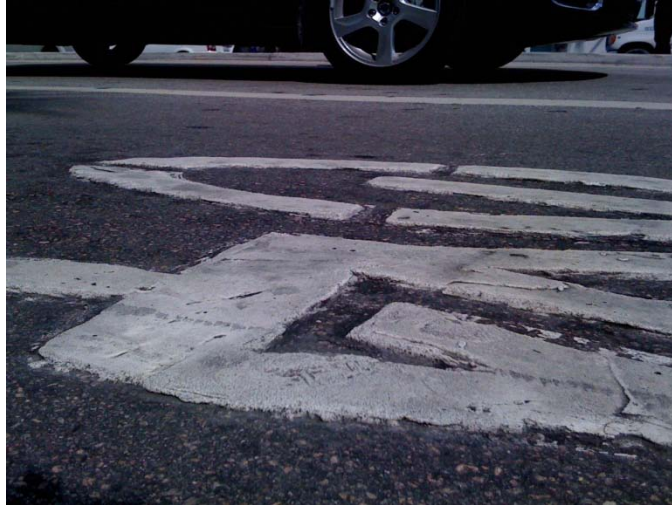
Figure 7. View of bumpy sharrow.

The decision was made to use thermoplastic for the shared lane markings. Unfortunately, the contractor who was hired to install the markings decided to use a thick application, and the result was a symbol that was rough or bumpy in appearance (Figure 7). The appearance was pointed out to City officials relatively soon after installation, and the decision was made to collect data to see if the roughness would have an effect on where the bicyclists rode in the vicinity of the marking. As will be shown in the results section of the report, many bicyclists chose to avoid riding over the marking. Some time after completion of the first set of “after” data, the City was able to get the contractor to attempt to smooth the roughness, and a second set of “after” data was collected to see if the smoothing had an effect on riding position, but the results were about the same.

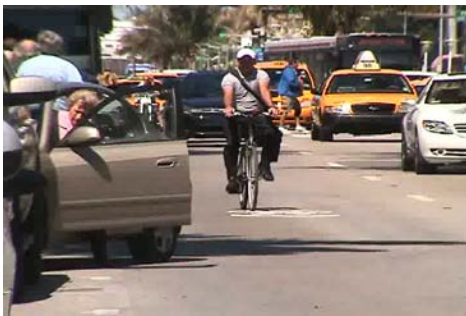
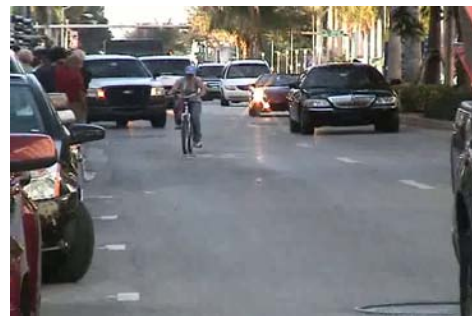
Figure 8. Southbound bicyclist riding over shared lane marking and away from an opening door (left) and bicyclist avoiding the marking (right).

Table 5 examines whether the bicyclist rode over the shared lane marking in the after period. Interestingly, 18.4 percent actually rode over any part of the marking, while another 8.9 percent avoided the marking. “Avoided” was coded if the bicyclist approach path would have clearly resulted in riding over the marking, but then a shift in direction was made to avoid the marking (Figure 8). The sum of the “Yes” and “Avoided” rows equals 27.3 percent and approaches the percentage (29.6 percent) first observed near the center of the lane in the after period in Table 4. “Unable to Ride Over” was coded when a vehicle was blocking the ability to ride over the marking, and “Unsure” was used when the view was such that the decision could not be made with certainty. Removal of these last 2 rows would change the “Yes” value to 19.9 percent and the “Avoided” value to 9.7 percent. The sum of these values is 29.6 percent and can be said to represent the percent riding over or very near the shared lane marking. It is certainly plausible that the bicyclists avoiding the marking were bothered by the rough appearance mentioned earlier.

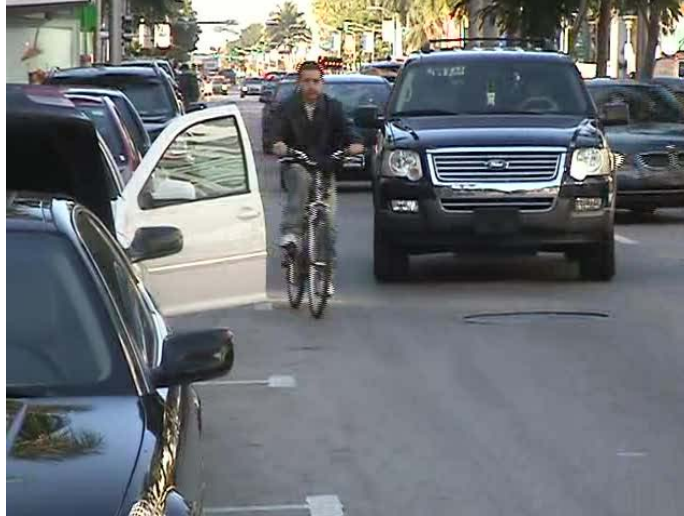
Figure 9. Southbound bicyclist weaving between vehicles in travel lane and parked vehicles.

Figure 9 shows a bicyclist weaving between motor vehicles in traffic and parked vehicles. The opening of the parked vehicle door shows the danger of this maneuver.

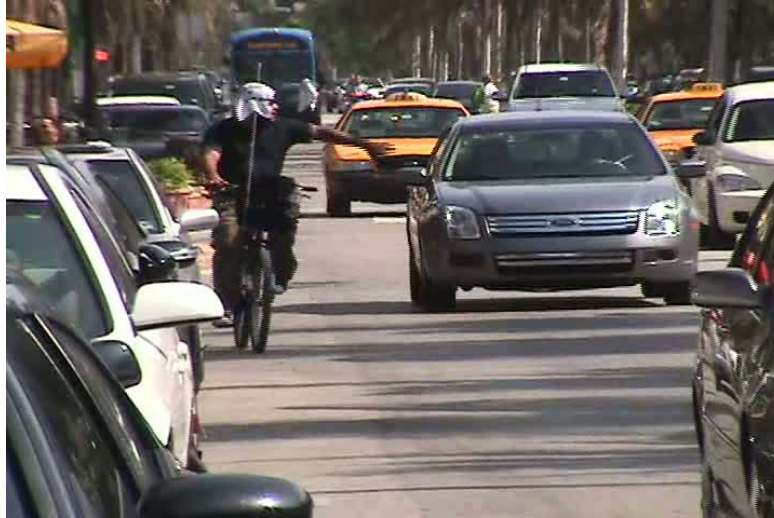
Figure 10. Northbound bicyclist riding out from parking space into travel lane.

Figure 10 shows a bicyclist riding out of a parking space and into the travel lane. Note the waving of the hand to indicate his maneuver.

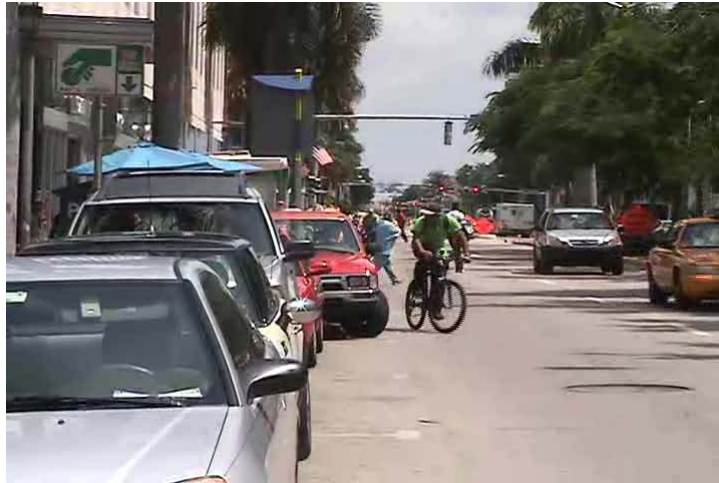
Figure 11. Bicycle-motor vehicle conflict in southbound direction.

A conflict between a bicyclist and a parked vehicle pulling out of a parking space is shown in Figure 11.
