# **EVALUATION OF WARNING LIGHTS ON MAINTENANCE OF TRAFFIC DEVICES AND DEVELOPMENT OF POSSIBLE ALTERNATIVES**

TTI Final Report 478660  
FDOT Final Report BDR74 977-01  
Project Title: Evaluation of Warning Lights on Maintenance of Traffic Devices and  
Development of Possible Alternatives

Performed in cooperation with the  
Florida Department of Transportation

July 2013

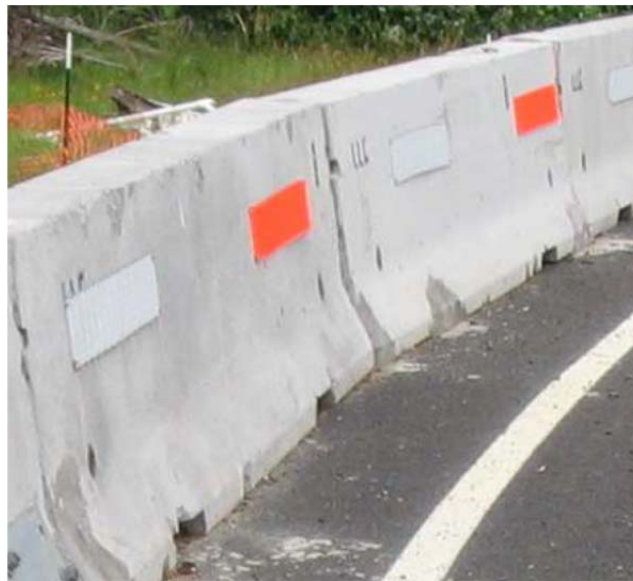
Some state DOTs have established minimum dimension(s) or surface areas for each retroreflective device, while others specify an exact size. The researchers found size specifications for 25 of the 31 states shown in the table. The most unique delineation standard was found in Oregon. The Oregon DOT *Traffic Control Plans Design Manual* (23) calls for reflective barrier panels to be used to delineate the face of temporary concrete barrier wall and enhance conspicuity. A typical panel installation is shown in Figure 2-1. These panels are unique because they are not mounted perpendicular to traffic, so the retroreflective surface area is much smaller than the actual panel dimensions (4 inches wide and 36 inches long). The panels are made from corrugated aluminum and are either fluorescent orange or silver-white in color.

**Figure 2-1. Oregon Department of Transportation Reflective Barrier Panels (23).**

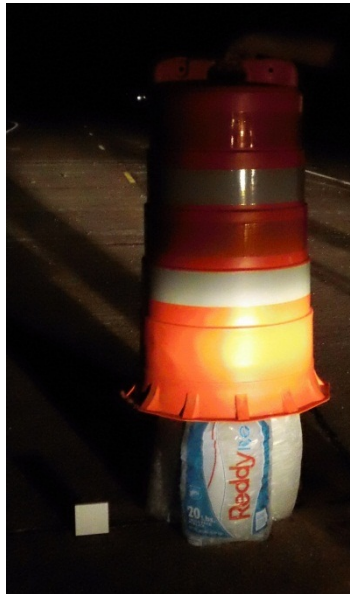
The researchers determined the luminance of the retroreflective portion of each channelized drum using Prometric 10.0 software. The researchers selected large regions of retroreflective area on the drum to measure luminance, and then a smaller area where retroreflective sheeting was not present in order to mask out the area in the background not associated with the drum. Figure 3-6(d) shows the two regions reduced from each image. The researchers chose to take the background reading from the bottom of the drum because it was shown that the luminance from the plastic drum surface was greater than the luminance of the image background, which included the pavement, horizon, and anything else near and around the drum. The average luminance provided from the background reading was used to set a threshold in the software that represented a minimum pixel luminance for the image. Using this threshold value, researchers could then remove any image pixels that were at or below the threshold value from the image calculations, and thus only assess the luminance of the sheeting itself. The researchers measured and recorded the drum luminance without the presence of surface dew at predetermined distances. The researchers then chilled the drum below the dew point in order to create dew on the drum surface. To accomplish this, the researchers laid the drum horizontally on the pavement and loaded the inside of the drum with ice until dew formed. Once the dew formed, the drum was gently stood upright over the ice bags with the dew-covered side facing the test vehicle, as shown in Figure 3-7.

**Figure 3-7. Formation of Dew on Surface of Channelizing Drum for Luminance Evaluation.**

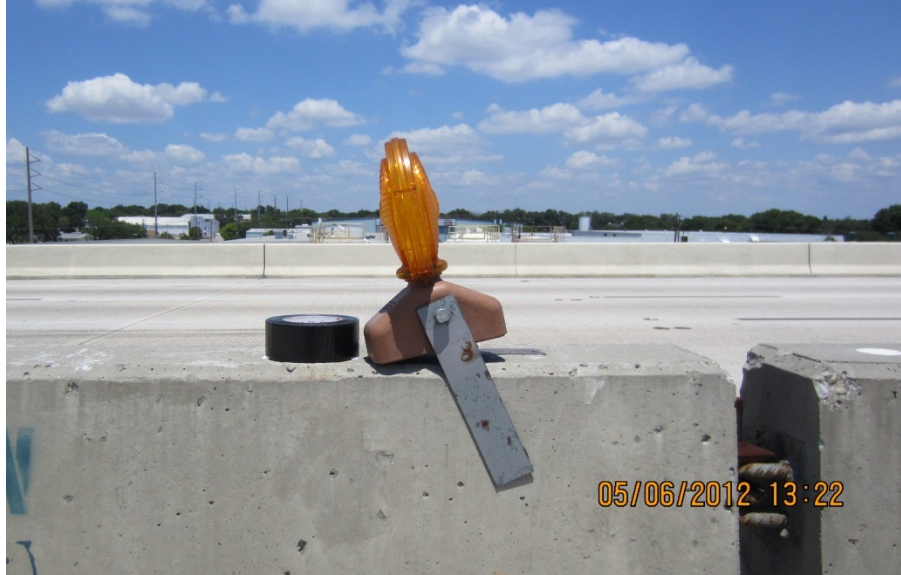
During the field visits, the researchers also found that warning lights placed on barrier walls were also subject to misalignment. In this scenario, misalignment was primarily due to leaning of the lights, as shown in Figure 3-16. It appears that slack in the mounting bracket contributed to the misalignment, allowing for vertical rotation of the warning light.

**Figure 3-16. Example of Warning Light Misalignment on Temporary Barrier Wall.**

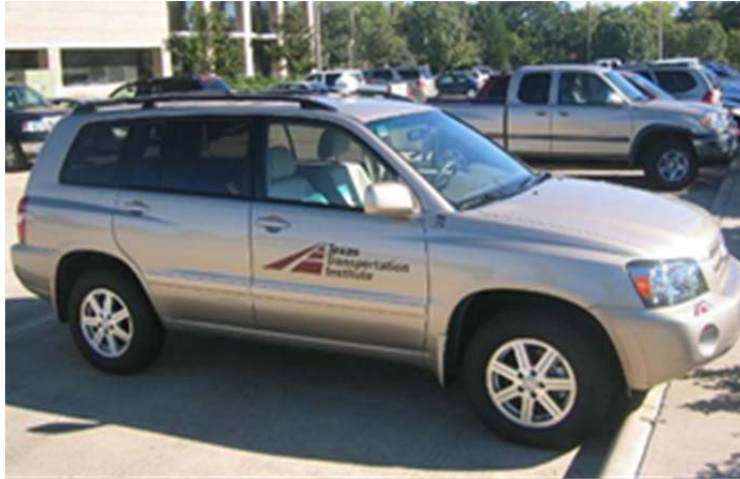
Study participants drove a 2006 Toyota Highlander, shown in Figure 4-1. The vehicle was equipped with a faceLAB™ eye-tracking system, which was used to record driver glances via in-vehicle video cameras.

**Figure 4-1. Instrumented Vehicle Used During Human Factors Study.**

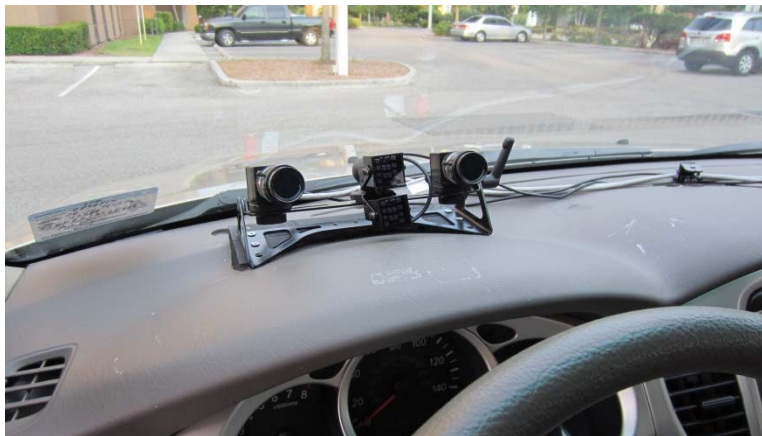
Figure 4-2 shows the faceLAB™ dash-mounted eye-tracking infrared (IR) transmitters and cameras. The transmitters emitted a very low level of light and did not impact the driving task. The left and right cameras recorded pupil information for each eye, respectively, which was used to estimate the location of the driver's glances. Although not shown in the figure, a forward scene camera was also mounted behind the vehicle's rear-view mirror and was used to capture the view out in front of the vehicle. All of this information was recorded by equipment that was stored in the rear of the vehicle.

**Figure 4-2. Dash-Mounted Eye-Tracking Equipment.**

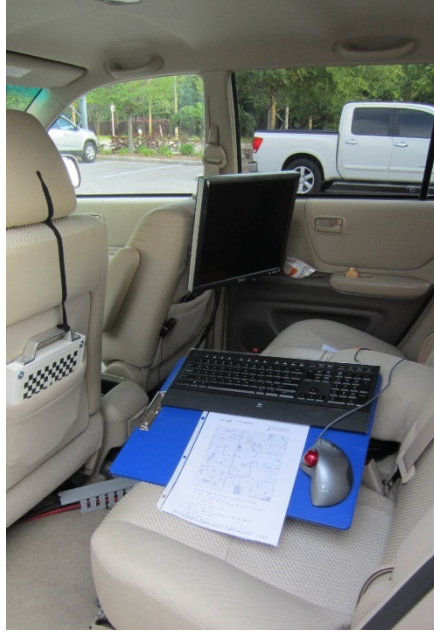
Figure 4-3 shows the researcher's station in the back seat of the vehicle. The researchers used the keyboard and monitor to the run the equipment.

**Figure 4-3. Eye-Tracking Researcher's Station.**

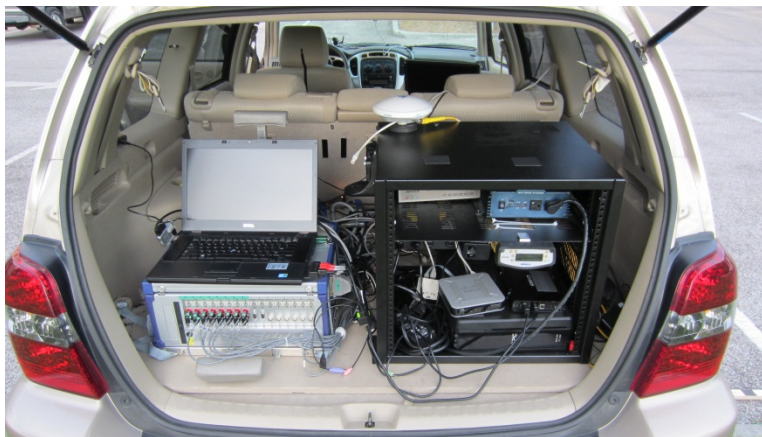
Figure 4-4 shows the equipment in the rear of the vehicle. It includes a global positioning system (GPS), computer, power inverter, backup power supply, and external hard drive. This equipment collectively stored the vehicle's position and speed data, as well as the study participant's eye glances and the forward scene video.

**Figure 4-4. Data Collection Equipment in the Instrumented Vehicle.**

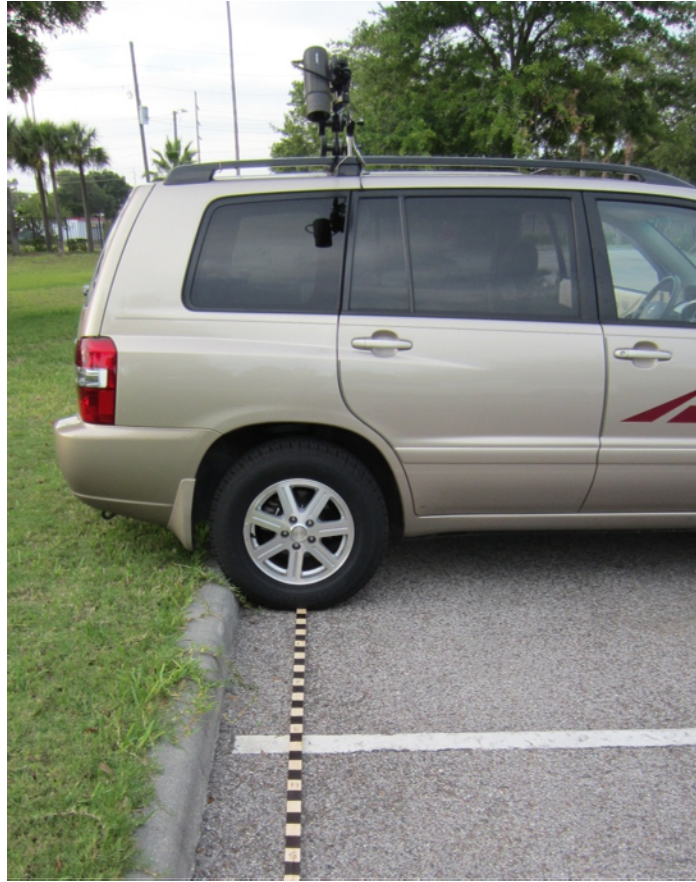
Lane-keeping data were recorded with an outboard video camera mounted on the side of the instrumented vehicle. Prior to each evening of data collection, the camera was installed and calibrated using a marked board placed on the ground and extending out from the rear tire of the vehicle. The board was marked in 2-inch increments. This setup is shown in Figure 4-5.

**Figure 4-5. Lane-Keeping Video Camera and Calibration Board.**

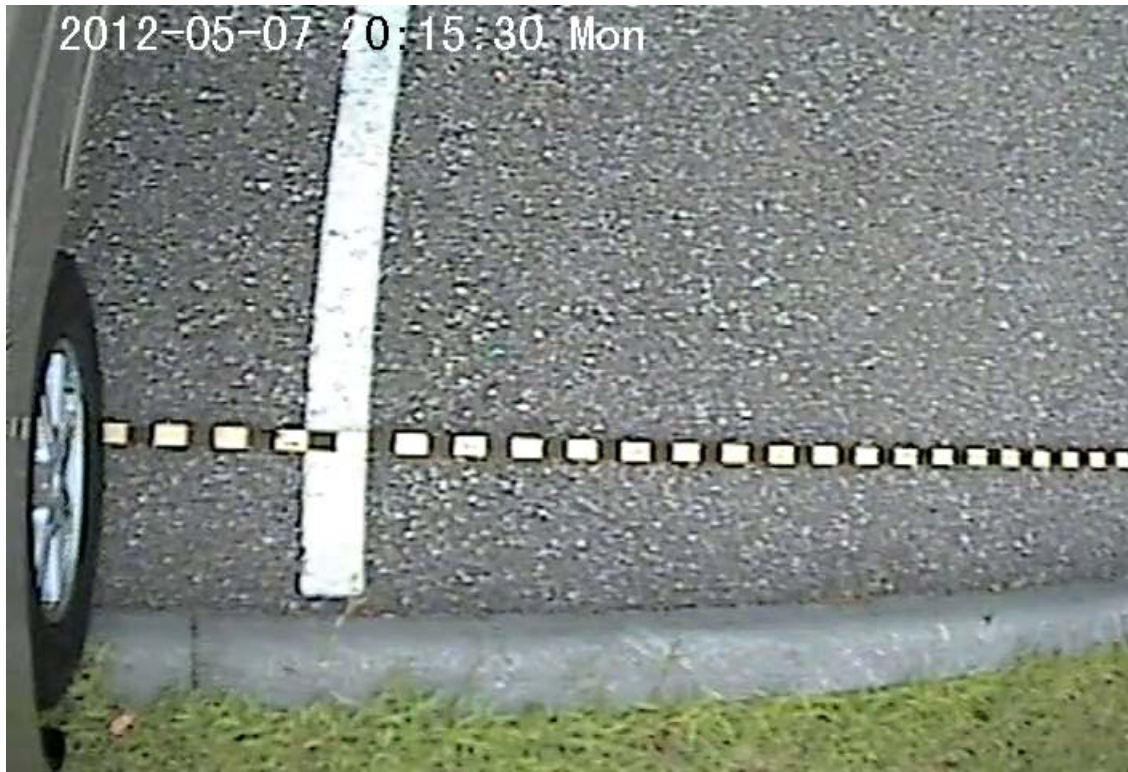
Using video from the lane-keeping camera, a screenshot of the calibration video was used to determine the offset distance from the rear tire to the edge of the lane line. For example, in Figure 4-6, the lane line in the parking lot was approximately 14 inches from the tire.

**Figure 4-6. Video Image of Calibration Board from Outboard Lane-Keeping Camera.**

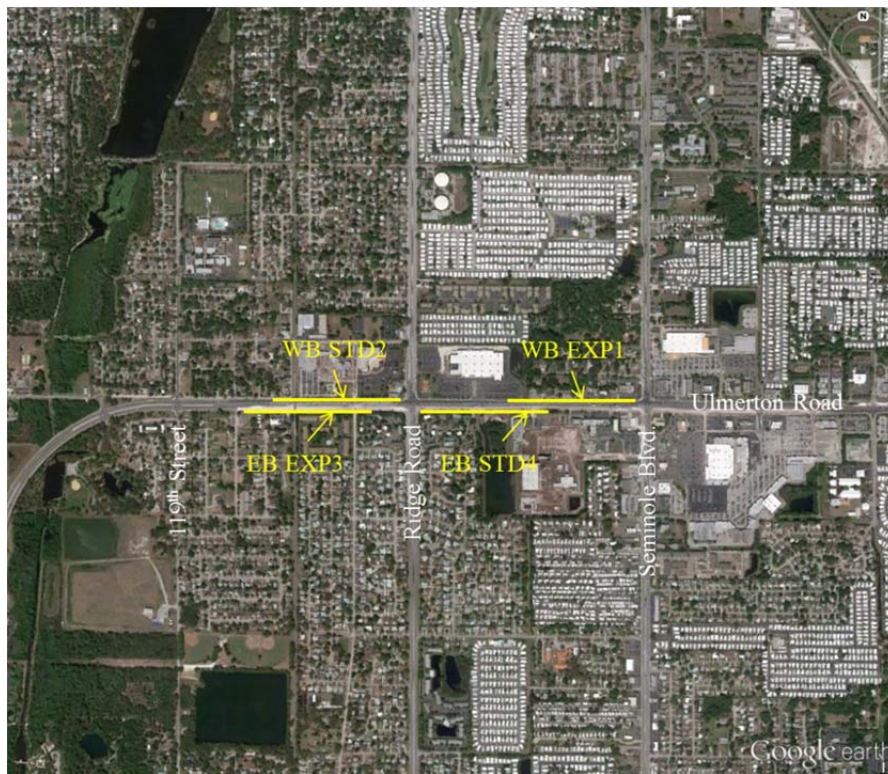
EXP=Experimental Section, STD=Standard Treatment Section, WB= Westbound, EB=Eastbound

**Figure 4-8. Treatment Locations at the Ulmerton Road Work Zone.**

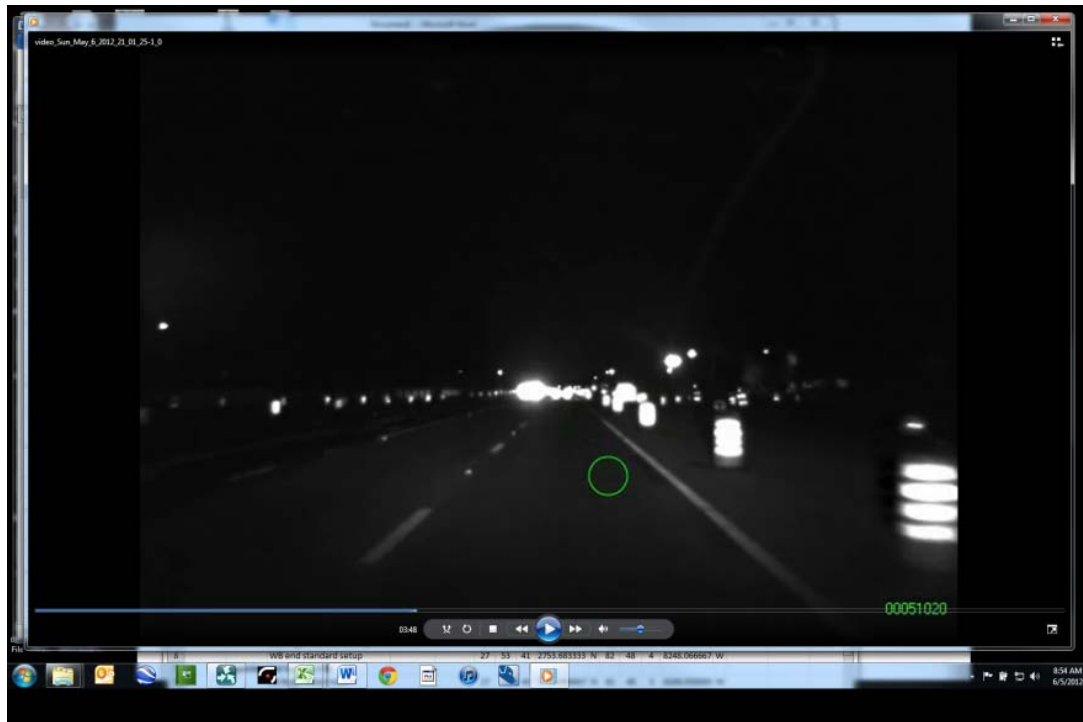
Once the equipment was ready, the study participants drove through the work zone and the equipment recorded a continuous video of the driving task. The time-synchronized eye-tracking video and forward scene view videos were overlaid to create the driving video for each participant. A screenshot from a sample video is shown in Figure 4-11. The green circle indicates the location of the driver's glance.

**Figure 4-11. Scene View with Driver Glance Location.**
