Longitudinal Channelizing Devices along Business Entrances in Work Zones

TTI Final Report 600261
FDOT Final Report BDR74-977-02
Project Title: Longitudinal Channelizing Devices along Business Entrances in Work Zones

Performed in cooperation with the
Florida Department of Transportation

April 2015

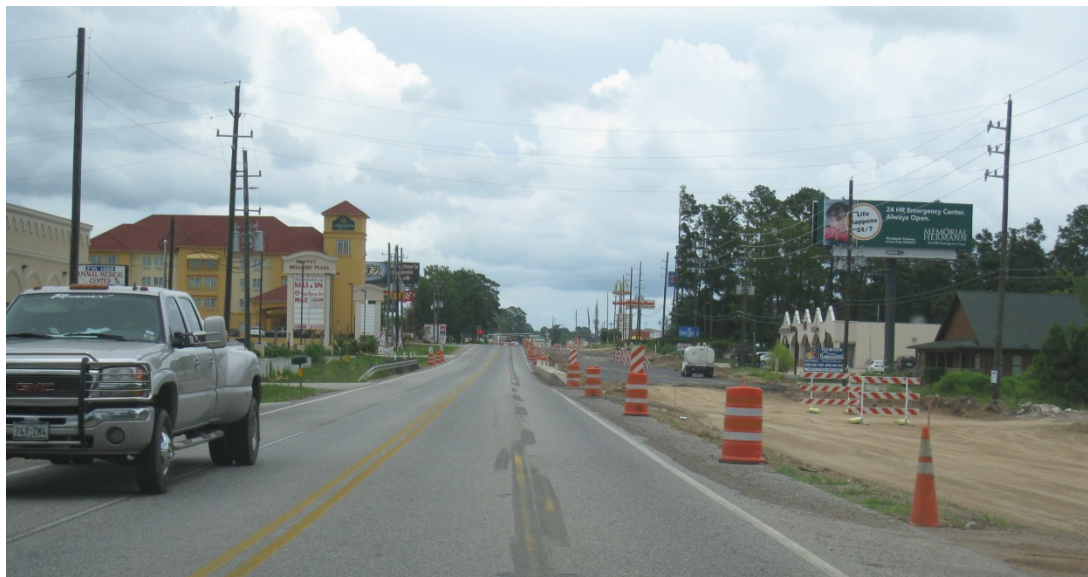
Figure 1-3. Example of an Urban Roadway Work Zone in Texas

Unfortunately, the driveway detection challenge is not mitigated simply by reducing the spacing of channelizing devices around the driveway. For example, Figure 1-3 shows an example of standard channelizing drums deployed in a Texas work zone. Although it is difficult to discern, there is a business entrance located between the third and fourth drum on the right. This figure demonstrates that motorists may find it difficult to locate driveways in urban arterial work zones, even at longer drum spacings.

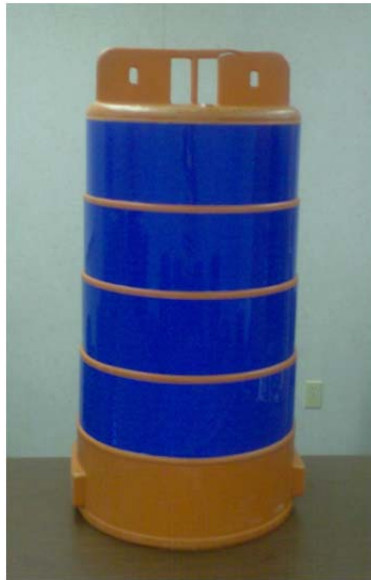
Figure 1-4. Initial FDOT Proposed Device for Evaluation

To help address the driveway detection challenge, FDOT personnel began to explore other options for delineating driveways in work zones. On June 15, 2011, FDOT submitted a Request for Experimentation to the Federal Highway Administration (FHWA) (2). The request specifically indicated the desire to experiment with blue-striped channelizing drums, such as the one shown in Figure 1-4. FDOT proposed to use the blue devices only in the curve radii of the

business driveways. The color blue was selected to match the blue business entrance signs currently used in Florida.

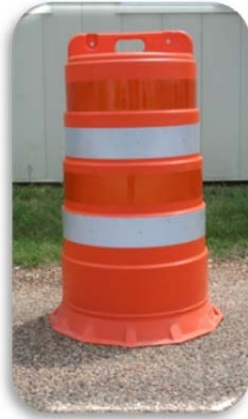
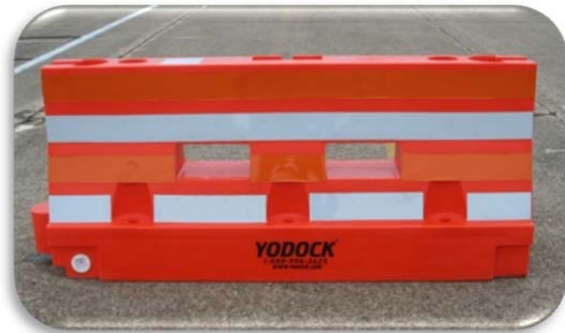
Figure 2-1. Devices Tested in TxDOT Research Project 0-6103 Luminance Evaluation (5)

More recently, TTI researchers completed a study of longitudinal channelizing devices for TxDOT (5). This research project sought to determine if the use of LCDs could improve work zone channelization in various applications. The research included a luminance evaluation of 32-inch-tall LCDs. Luminance is the amount of light reflected from a surface or emitted by a light source and is roughly equated to brightness. LCDs are manufactured and sold without any retroreflective material. Since retroreflectivity is required for nighttime use on state roadways, the researchers added sheeting to the LCDs that would imitate the materials found on drums (shown in Figure 2-1).

While the drum was found to have approximately the same luminance when viewed from any angle, the luminance of the LCDs was found to decrease significantly when the LCDs were not perpendicular to the driver's line of sight (i.e., when used in a longitudinal application, such as along the edge of the travel way). The researchers further experimented with other types of retroreflectivity for the LCDs in longitudinal applications, including delineators such as those used for permanent concrete barrier wall. The results indicated that the luminance values of the delineators at a 6-ft spacing (placed one on the top and one on the side of each 6-ft-long LCD) were only half of the luminance values of the drum arrays. However, this delineation of the LCDs was still easily visible to the human eye at night. In addition, the researchers noted that the LCDs were definitely different in appearance than the drums and that the delineators effectively accentuated this difference at night.

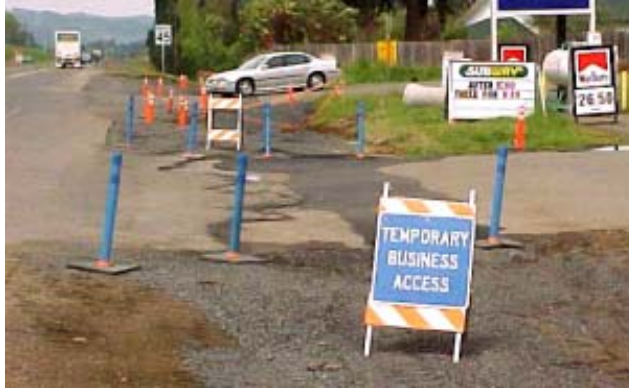
Figure 2-2. Blue Delineation of a Business Driveway in Oregon

The study primarily used telephone surveys of motorists and business owners to determine the usefulness of the signs and markers. Sixty-two percent of the 381 area motorists surveyed noticed the blue signs and markers at the test driveways, while 78 percent of that group felt that these devices helped them locate the driveways into the businesses. Of course, the novelty effect of the unique color of the markers may have contributed to this opinion. In any event, owners at half of the 12 businesses that had the blue signs and markers at their business entrance stated that they thought the blue signs and markers helped customers locate their business driveway. However, no operational data were collected. The research report summary indicates that no negative impacts were found, and the authors recommended continued use of the blue signs and tubular markers. ODOT implemented the use of the blue signs and markers, including language and the photo shown in Figure 2-3 in its *Traffic Control Plans (TCP) Design Manual* (7).

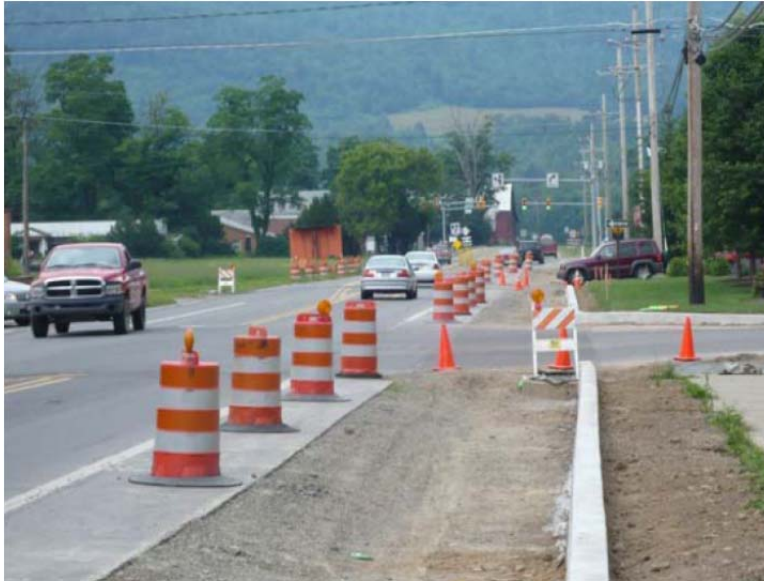
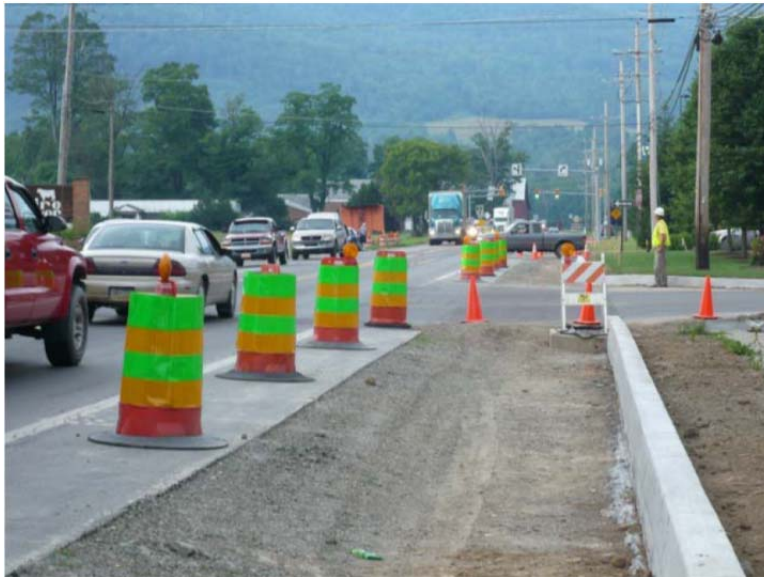
Figure 2-4. Driveway Delineation Research in Pennsylvania

The Pennsylvania Department of Transportation (PennDOT) sponsored an evaluation of green and yellow drums at business access points in work zones (8). One of the driveways studied is shown Figure 2-4. It should be noted that the green and yellow drum is not currently an MUTCD-compliant channelizing device.

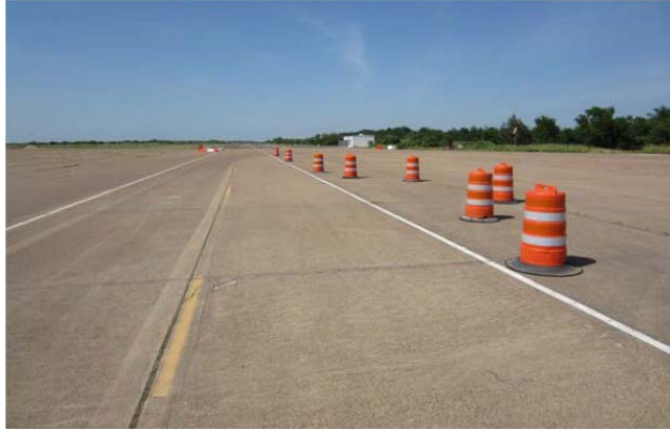
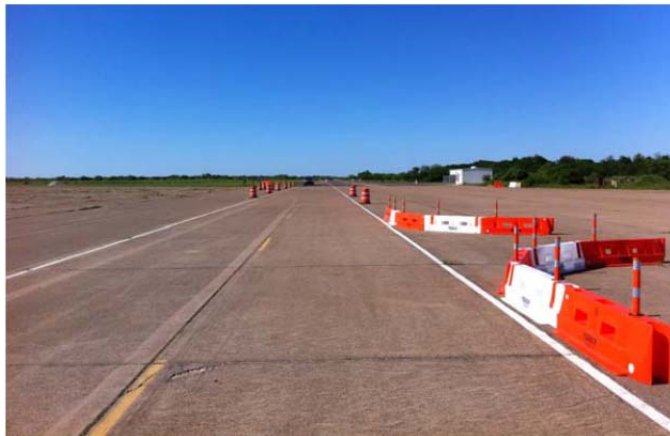
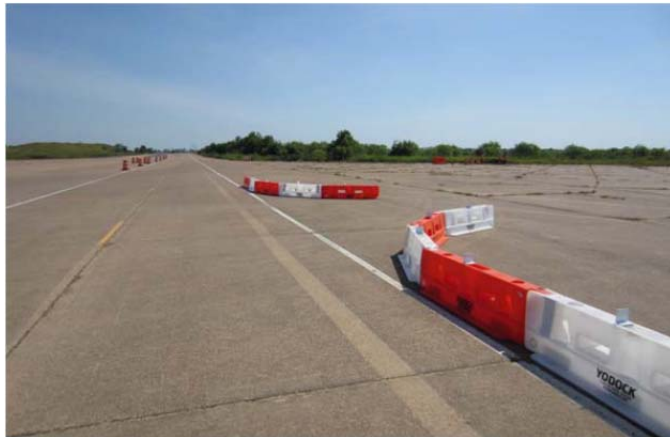
Figure 3-1. Treatments Evaluated in FDOT Closed-Course Study

The treatments tested are shown in Figure 3-1. The throat widths of the driveways were 20 ft regardless of treatment to represent a worst-case condition for driveway detection. The standard drum treatment, shown in Figure 3-1a, consisted of drums at 40-ft spacing along a tangent, with drums at 10-ft spacing in the radii of the driveway entrance. Two LCD treatments were included in the study. LCDs are not manufactured with any retroreflective material adhered to them, but the MUTCD requires that they have retroreflective material during nighttime use. The researchers developed two options for the LCD: tubular markers, such as those required for low-profile concrete barrier in Florida, and delineators, such as those commonly used for permanent barrier wall in Florida. The treatment using LCDs with tubular markers, shown in Figure 3-1b, had a total of 10 LCDs. One tubular marker was placed in each LCD, creating a 6-ft spacing between markers. The treatment using LCDs with delineators and a longer upstream tangent, shown in Figure 3-1c, had the same LCD geometry as the tubular marker treatment with six additional LCDs added to the upstream tangent. One top-mounted delineator was placed on each LCD, giving them a 6-ft spacing. No warning lights were on the drums or the LCDs. Also, no blue business entrance signs were at the closed-course driveways. By evaluating the driveway setups in their simplest form (i.e., channelizing devices only), any differences could be attributed to the devices and not the learned behavior associated with the blue signs or other confounding factors.

Using a statistical test of two means and a 95 percent confidence interval, the researchers found that the LCDs with tubular markers had a shorter detection distance than the drums. While the LCDs with delineators and longer upstream tangent appeared to have a slightly longer detection distance than the drums, this difference was found to be not significant.

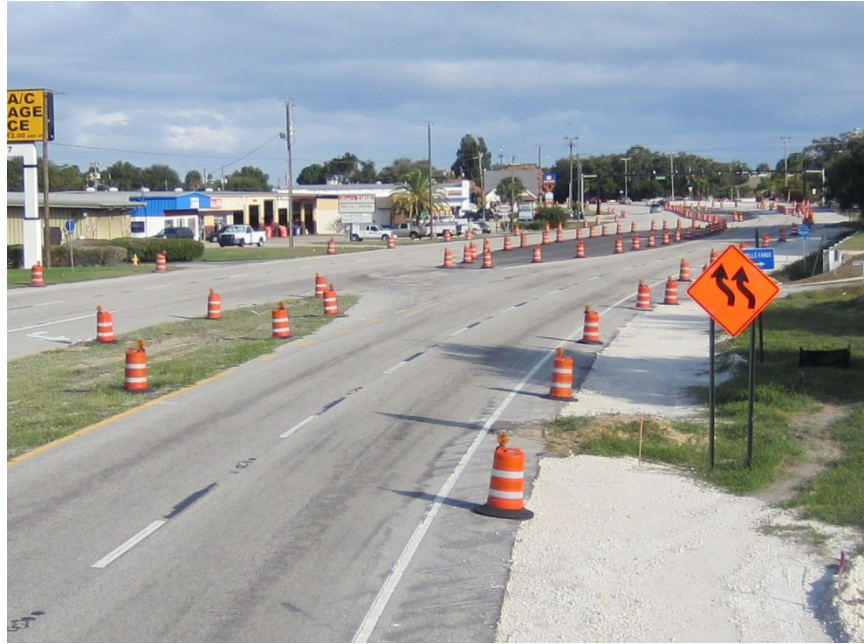
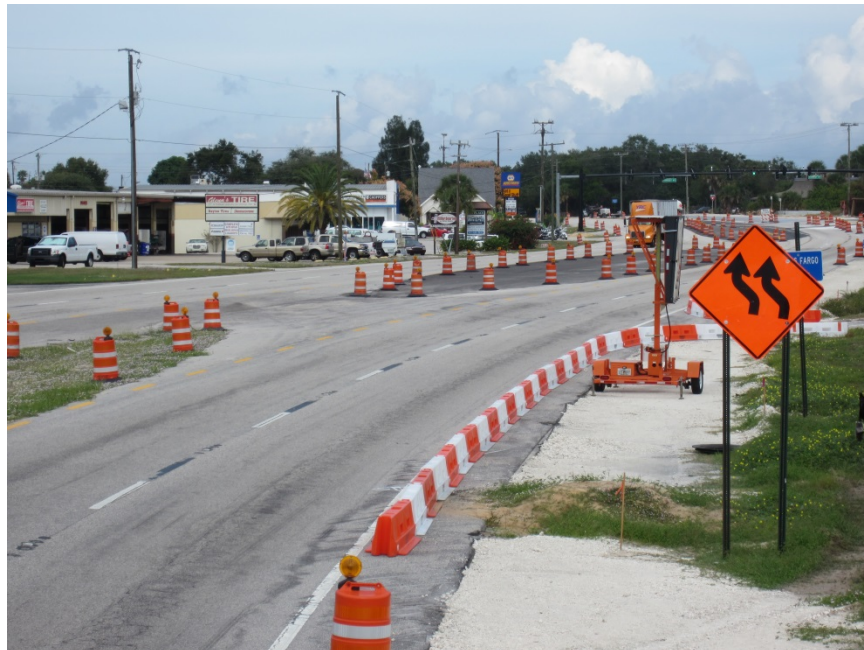
Figure 4-2. Treatments Used at Wells Fargo Driveway on Cocoa Boulevard

The researchers collected video data of turning movements at each driveway during daytime hours only. No surveys were collected during this trip. The purpose of the video data was to document traffic conditions and turning movements for the erratic maneuvers study. The video data were recorded from a camera mounted on an aerial lift platform located approximately 200 ft upstream of the driveway. During this data collection, the researchers used an enhanced tangent section upstream of the driveways while the LCD treatment was in place. The tangent section was approximately 132 ft long. Figure 4-2 shows the two treatments deployed at the Wells Fargo Bank driveway. The setup at Gatto's Tire and Auto Service was similar to the one shown in Figure 4-2.

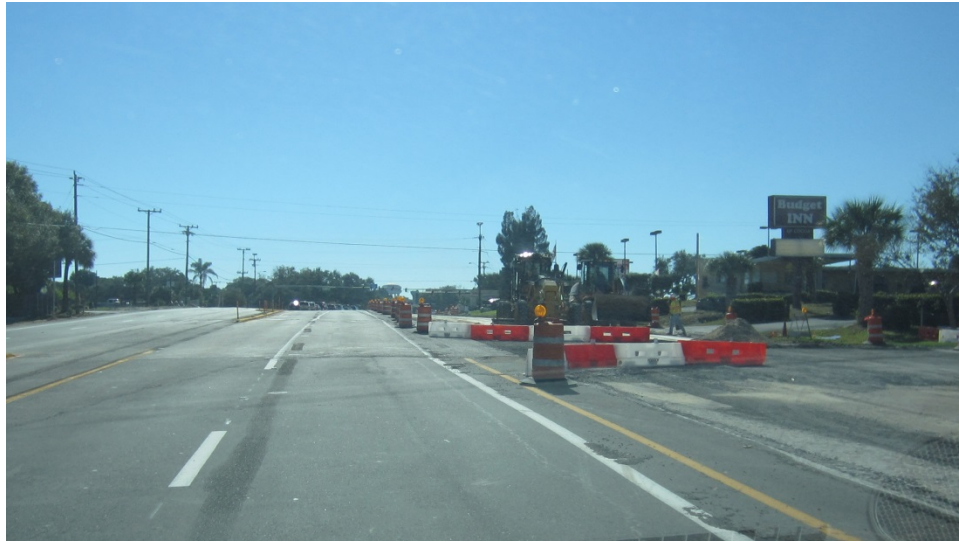
Figure 4-3. LCD Treatment Used for the Remainder of the Study

At this driveway, the researchers modified the LCD treatment in an effort to keep the treatments looking the same at all study driveways for the remainder of the project. Since the length of upstream tangent space available at future study locations was not known, the researchers relied on findings from the TxDOT driveway delineation study. Recalling that the device type located on the radii of the driveway was noticed five times as often as the device type located on the tangent section, the researchers minimized the treatment by removing the upstream tangent and limiting the use of LCDs to the driveway radii. In addition, the line of LCDs from the driveway radii to the edge of the right of way was also eliminated, significantly reducing the number of LCDs required to deploy the treatment. This LCD configuration would also allow room for the contractor to traverse the work zone driveways without removing the LCDs. This new LCD

treatment could be deployed using eight LCDs (four on each side of the driveway), as shown in Figure 4-3.

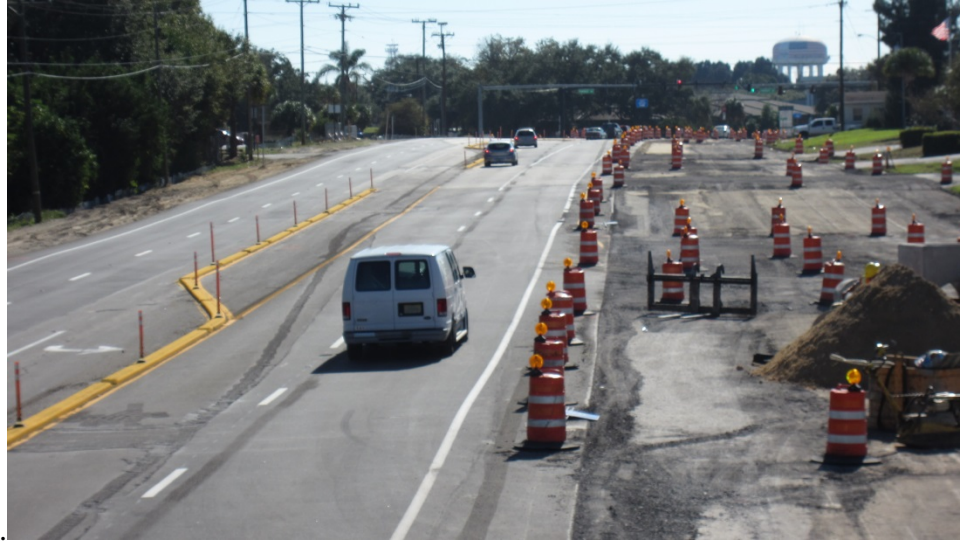
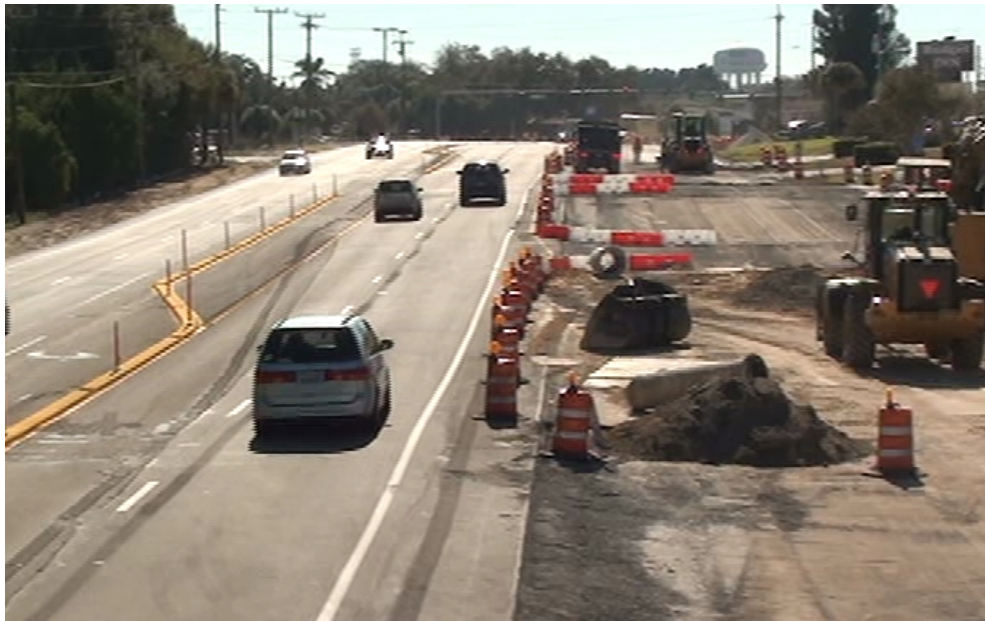
Figure 4-4. Treatments Used at Burger King Driveway on Cocoa Boulevard

Figure 4-4 shows the two treatments deployed at the Burger King driveway. The drum treatment shown Figure 4-4a shows a CITGO driveway located immediately upstream of the Burger King driveway. Unfortunately, the contractor closed the driveway overnight to reclaim asphalt, so the same upstream driveway is not shown in Figure 4-4b when the LCD treatment was deployed. The LCD treatment consisted of four LCDs on each radius of the driveway and did not include the longer upstream tangent section. During periods of darkness, the LCDs had white delineators on top (one per LCD) and were placed perpendicular to the length of the LCDs.

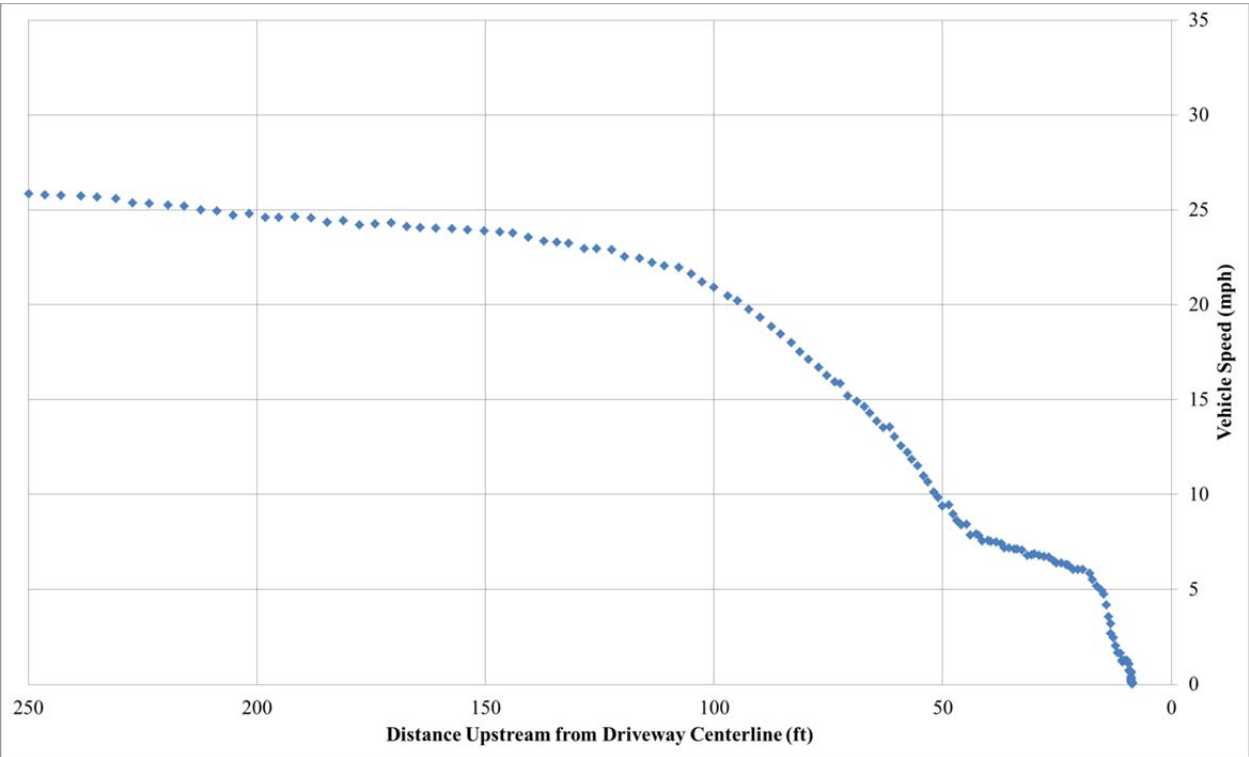
Figure 4-5. Speed Profile Example

Speed data were recorded using laser speed measurement instruments (i.e., LIDAR) to collect speed profiles of vehicles approaching the driveways. The instruments were connected to laptops to electronically download speed and distance measurements every half second for as long as the device was locked on to a vehicle. This method allowed the researchers to create speed profiles for vehicles as they approached the driveways. If the vehicle did not turn, it was not included in the dataset. The position of the researcher was recorded at each site so that all profiles could be adjusted to reflect the vehicles’ actual distances from the beginning of the upstream driveway radius. An example of a speed profile is shown in Figure 4-5.

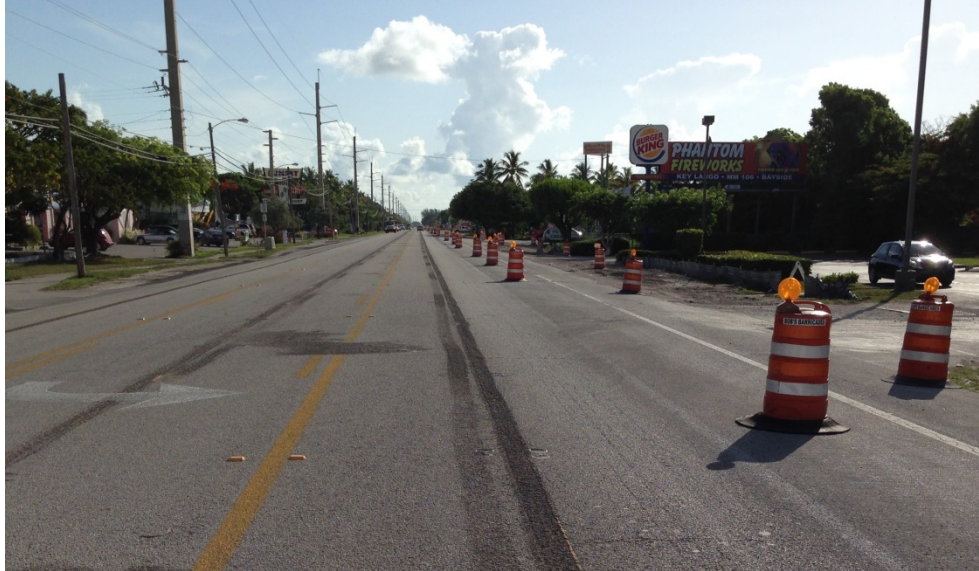
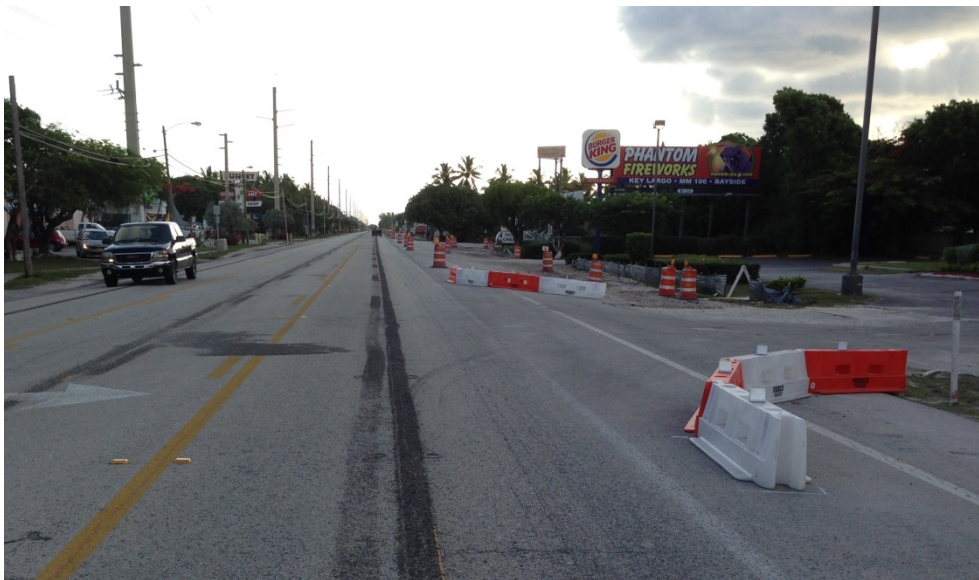
Figure 4-7. Treatments Used at Burger King Driveway on Overseas Highway

The researchers repeated the treatments that were used at the Cocoa Boulevard Burger King. Figure 4-7 shows the two treatments deployed at the Burger King driveway in Islamorada. Again, the LCDs were placed only in the radii of the driveways and were not used in the upstream tangent.

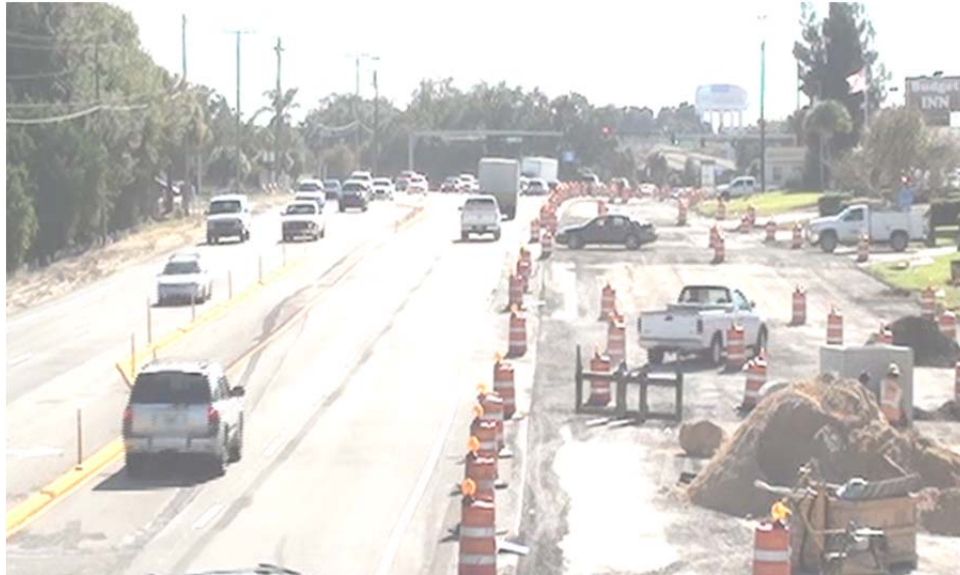
Figure 4-8. Vehicle Intrusion into Cocoa Boulevard Work Zone

In the cases of vehicle intrusion into the work zone, the researchers recorded two vehicles cutting between the drums to access a driveway. One such intrusion occurred at the Cocoa Burger King while drums were deployed at the driveway and is shown in Figure 4-8. The figure shows a

white truck cutting between the drums at two closely spaced driveways. The other intrusion occurred at the Islamorada Post Office driveway while drums were deployed. In both cases, the turn was made into the second of two driveways that were closely spaced. It is not known if the driver was attempting to make a higher-speed turn (in lieu of remaining on the main lane and making a 90-degree right turn) or if the drums were confusing to the driver. The researchers noted that this type of maneuver would not have been possible with the LCDs because they were connected with no spaces between them.
