**Final Report No. 605601**  
**Report Date: July 2016**

## **Development of Delineator Material/Impact Testing Specific to Managed Lane Use for Optimization of Service Life**

Contract No.: BDR74-977-06  
Test Nos.: 605601-1-6

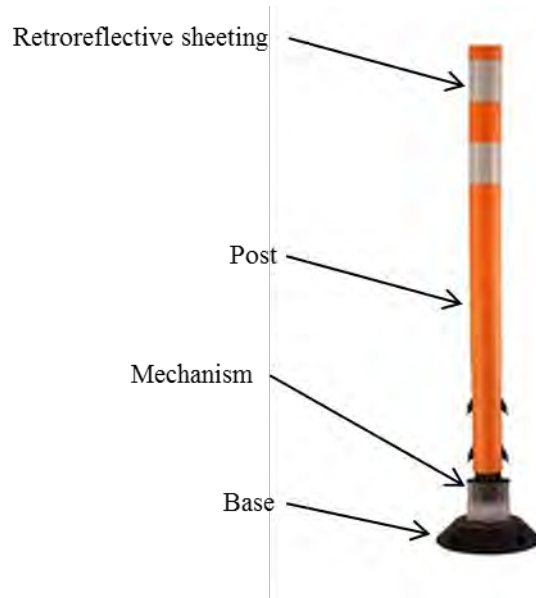
Delineators have four main parts: the retroreflective sheeting (required for nighttime use), the post (can be various colors), the mechanism that connects the post and the base (typically a proprietary component), and the base. Figure 1 shows these parts that compose one delineator.

**Figure 1. Delineator Parts**

When installed, there are two additional parts to consider: the epoxy (which connects the base to the pavement) and the pavement itself. Any of these parts may fail when the delineator is struck. Based on past efforts, the researchers developed a list of failure modes, which are described below:

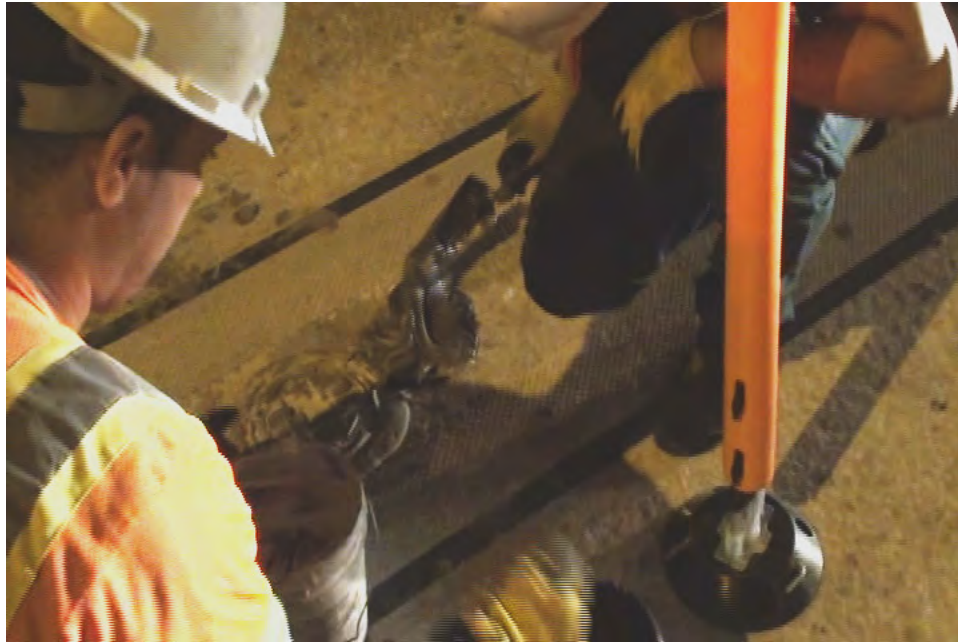
When the epoxy or the pavement has failed, a new delineator was installed. The workers swept a small area of the pavement by hand and mixed a small batch of two-part epoxy directly on the pavement (as shown in Figure 5). A new delineator was placed and the workers set the

delineator by rotating it in the wet epoxy, checking for proper alignment, and stepping on the top of the base to force the epoxy up into the pockets in the bottom of the base. This process took about 4 minutes for two workers to perform.

**Figure 5. Epoxy Failure and Pavement Failure Replacement.**

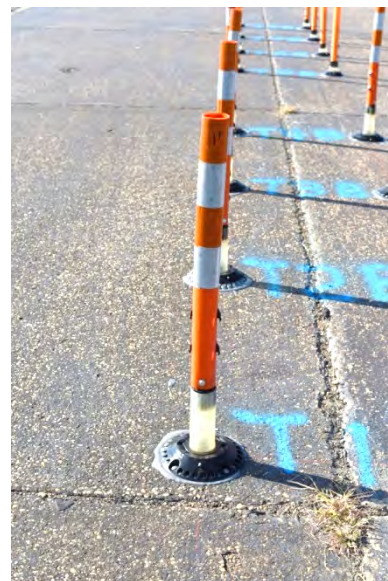
The products currently installed in the I-95 corridor were tested according to the procedure established in Texas A&M Transportation Institute (TTI)/Texas Department of Transportation (TxDOT) Research report 0-6772-1, which is based on the existing National Transportation Product Evaluation Program (NTPEP) Temporary Traffic Control Devices (TTCD) evaluation standard (1). Figure 6 shows the products installed at the TTI testing facility.

(a) Phase 1 delineator  
(42-in Flexstake TM754)

(b) Phase 2 delineator  
(36-in Flexstake TM754)

**Figure 6. Products Tested during Task 1.**

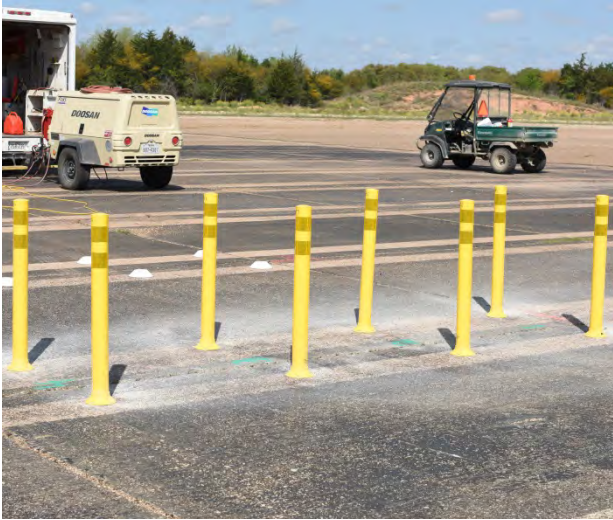
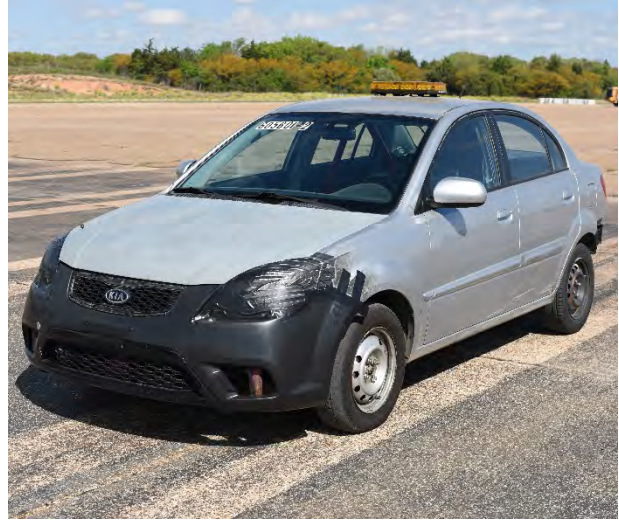
**Figure 13. 605601-2 before Testing.**

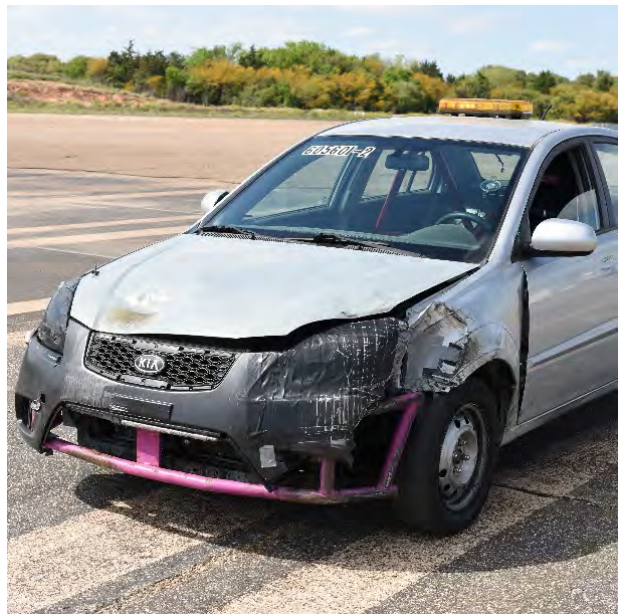
**Figure 14. 605601-2 after Testing.**

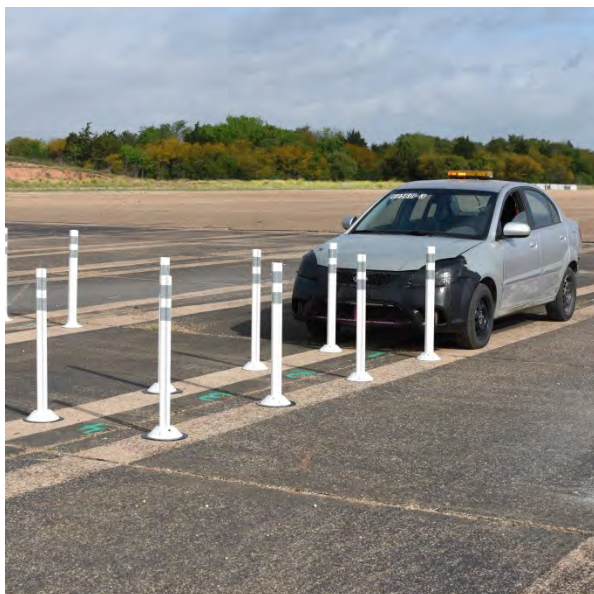
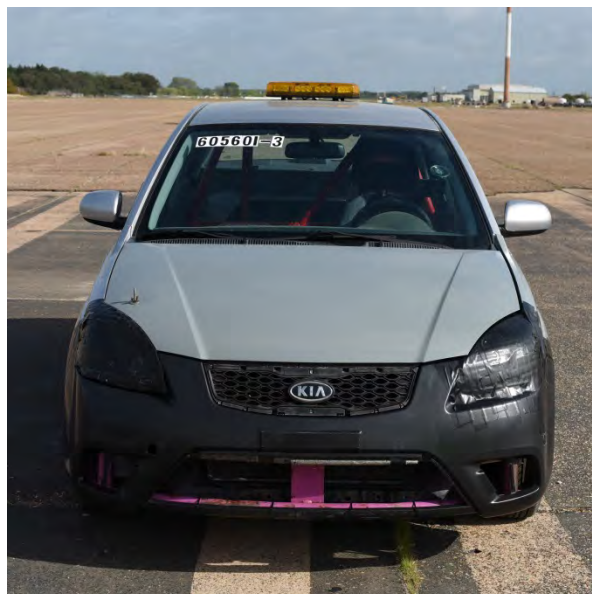
**Figure 16. 605601-3 before Testing.**

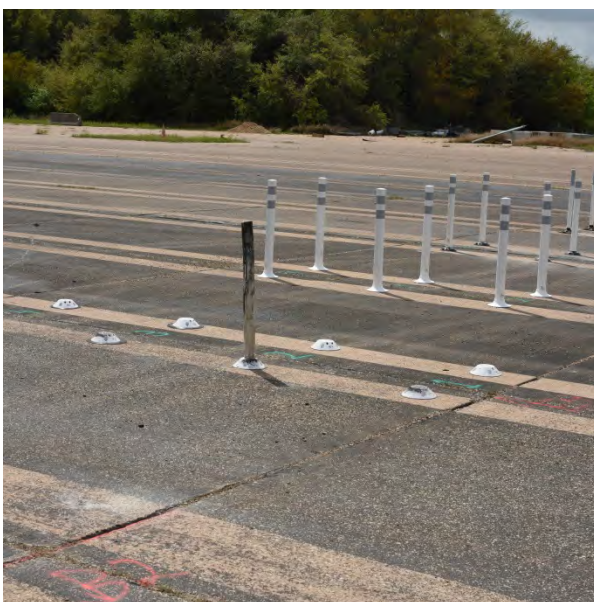
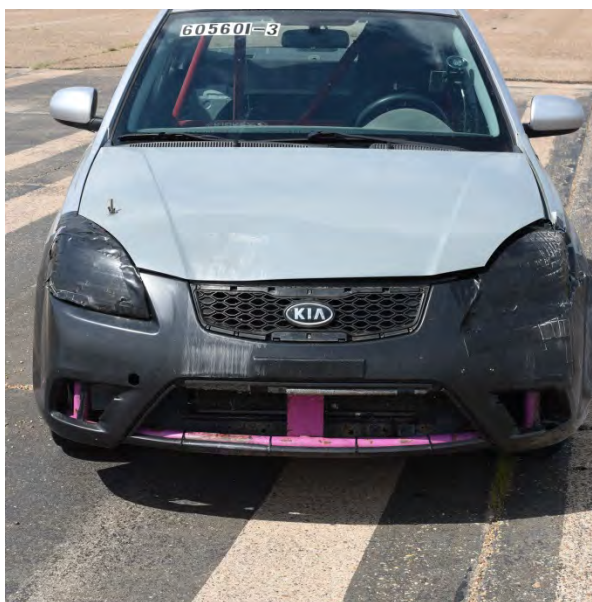
**Figure 17. 605601-3 after Testing.**

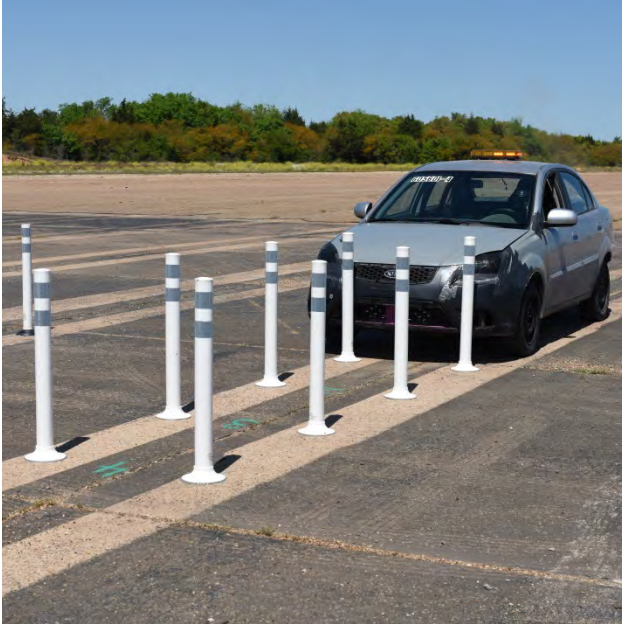
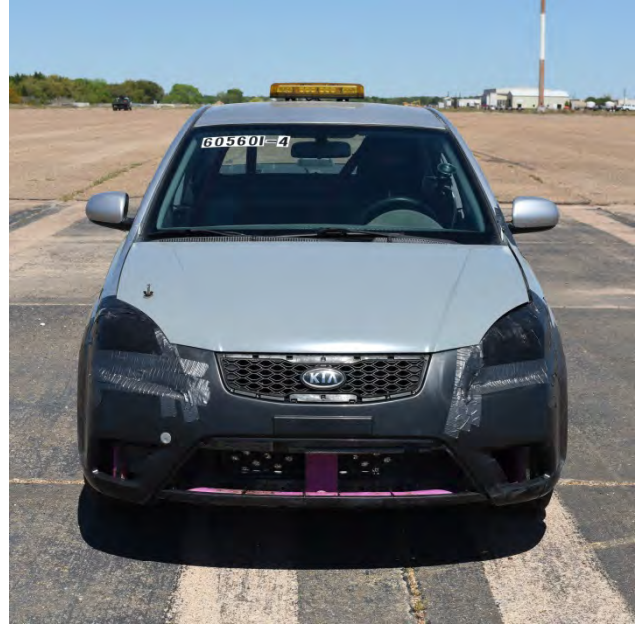
**Figure 19. 605601-4 before Testing.**

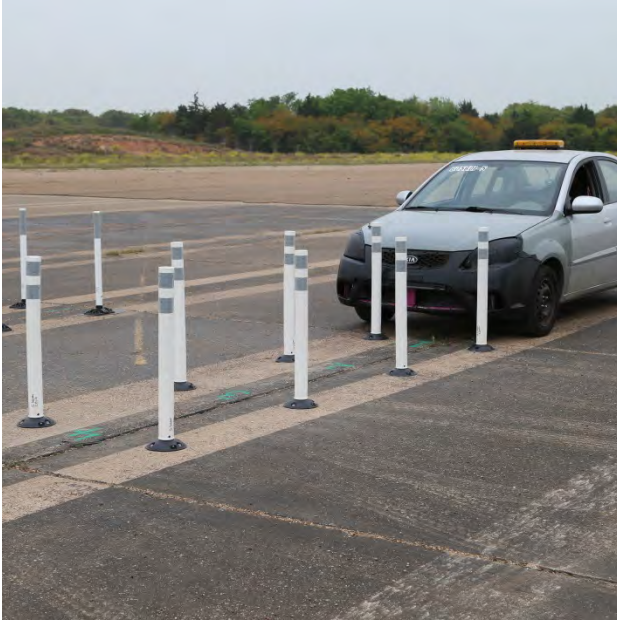
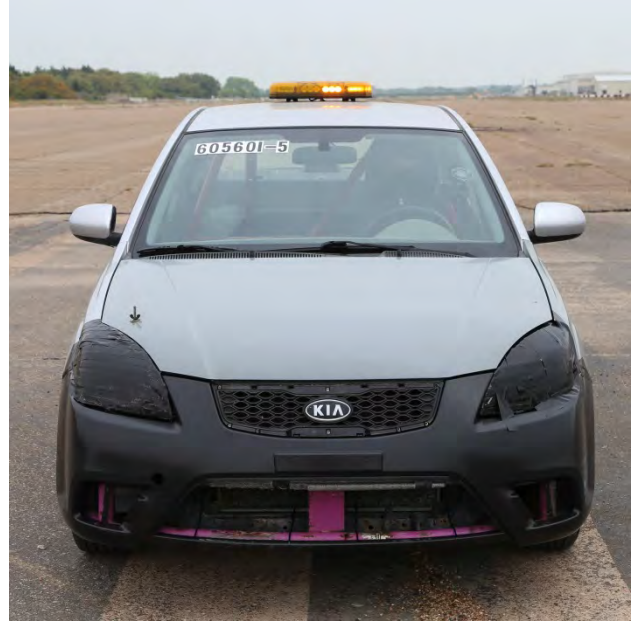
**Figure 22. 605601-5 before Testing.**

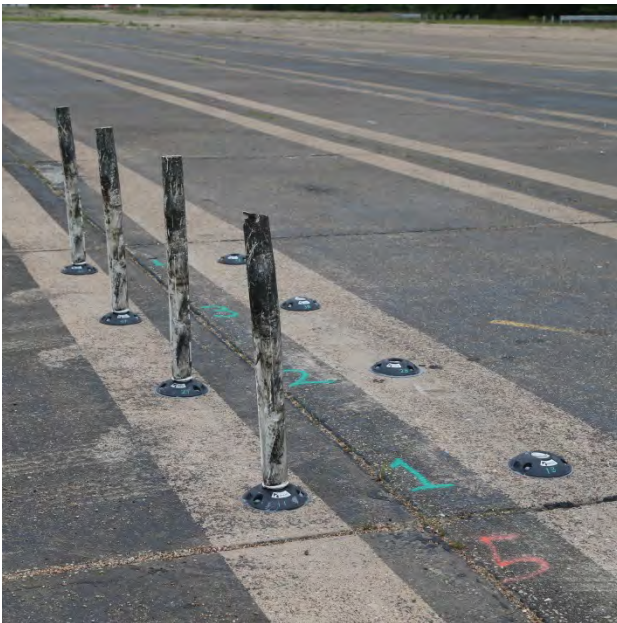
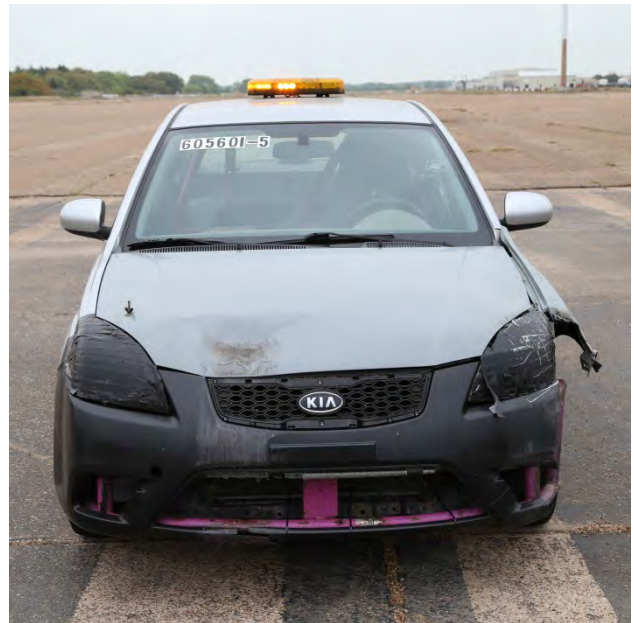
**Figure 23. 605601-5 after Testing.**

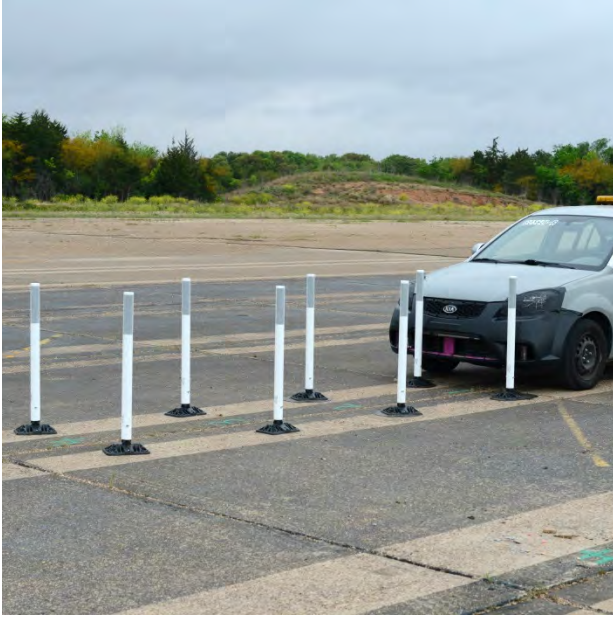
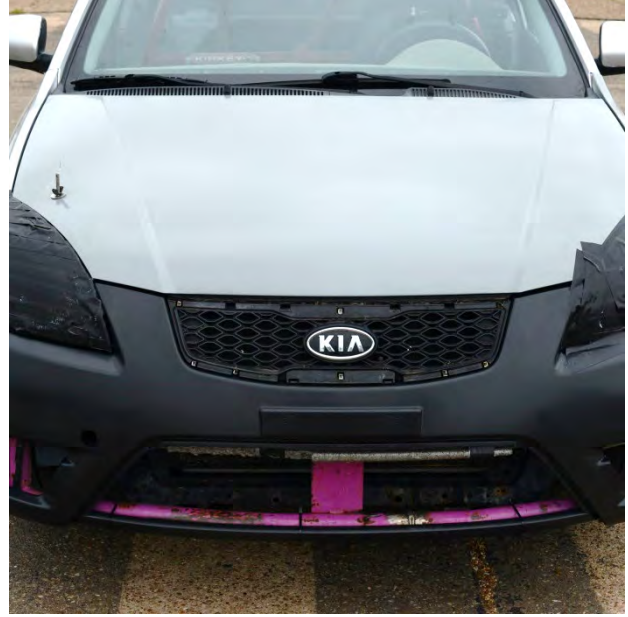
**Figure 25. 605601-6 before Testing.**

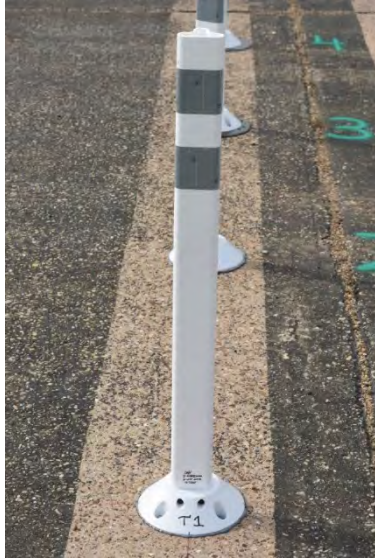
Test #605601-3, performed on March 23, was an impact durability test performed on FG300 samples secured with two different epoxy adhesives as shown in Figure 28. The first four samples were secured with FIRMmarker™ #18M900C20 2-part epoxy adhesive, and the second four samples were secured with Crafcro Hot-Applied Bituminous Marker Adhesive #34269. The product resisted an average of 95 tire impacts. The product resisted an average of 14 bumper impacts. The product resisted a combined average of 54 tire and bumper impacts. Table 9 shows a summary of the results. The primary failure mode of the sample was failure at retention pin holes.

**Figure 28. 605601-3 Sample.**

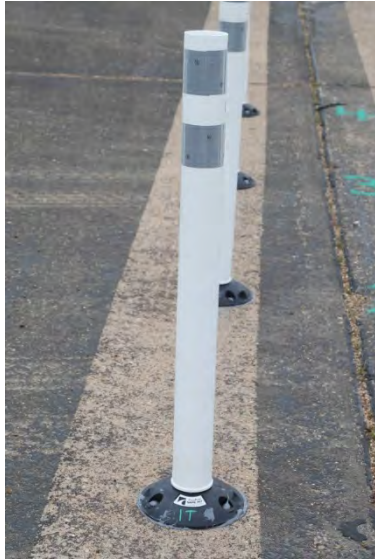
Test #605601-5, performed on March 29, was an impact durability test performed on Dura-Post samples secured by both epoxy and mechanical methods. The first four samples were secured with SHEPX-13-K1 epoxy, and the second four samples were secured with 20 mm × 90 mm plastic anchor sleeves and 3/8-inch × 4-inch lag screws as shown in Figure 30. The product resisted an average of 200 tire impacts. The product resisted an average of 81 bumper impacts. The product resisted a combined average of 141 tire and bumper impacts. Table 11 shows a summary of the results. The primary failure mode of the sample was exceeding the maximum allowable degree of lean.

Figure 30. 605601-5 Sample.

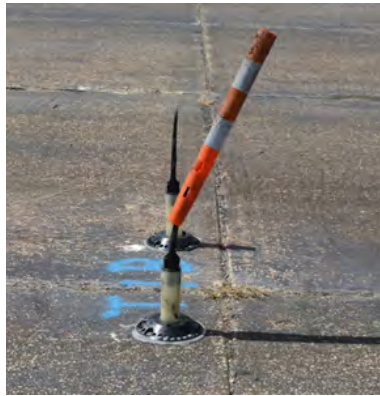
| FDOT<br>I-95<br>Phase | Test Post<br>Number | Before<br>Testing | | After 1st<br>Impact | | After 5th<br>Impact | | After<br>10th Impact | | After<br>50th Impact | | Failure | |
|---|---|---|---|---|---|---|---|---|---|---|---|---|---|
| 2 | 1T | 89.5 | 89.5 | 89 | 89 | 90 | 88 | 90 | 90 | 90 | 84 | 53 | Post failure at connection |

**Figure A-1. Sample 1T Failure at 53 Impacts.**

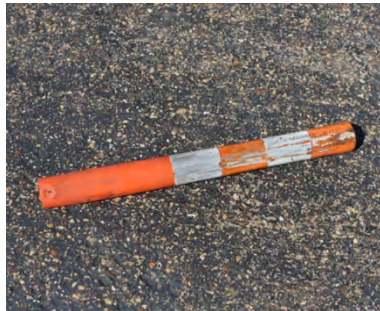
| FDOT<br>I-95<br>Phase | Test Post<br>Number | Before<br>Testing | | After 1st<br>Impact | | After 5th<br>Impact | | After<br>10th Impact | | After<br>50th Impact | | Failure | |
|---|---|---|---|---|---|---|---|---|---|---|---|---|---|
| | 1B | 90 | 89 | 90 | 89 | 89 | 88 | 88 | 89 | | | 27 | Post failure at connection<br>(loss of post) |

**Figure A-2. Sample 1B Failure at 27 Impacts.**

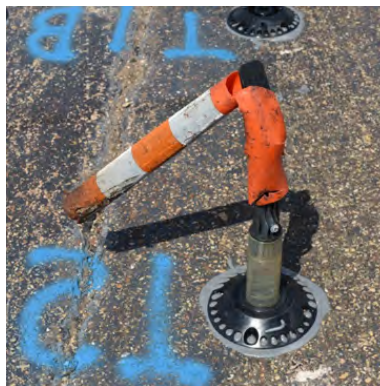
| FDOT<br>I-95<br>Phase | Test Post<br>Number | Before<br>Testing | | After 1st<br>Impact | | After 5th<br>Impact | | After<br>10th Impact | | After<br>50th Impact | | Failure | |
|---|---|---|---|---|---|---|---|---|---|---|---|---|---|
| | 2T | 90 | 88 | 88 | 88 | 88 | 89 | 88 | 89 | 89 | 90 | 66 | Post failure to restore and<br>Post failure at connection |

**Figure A-3. Sample 2T Failure at 66 Impacts.**

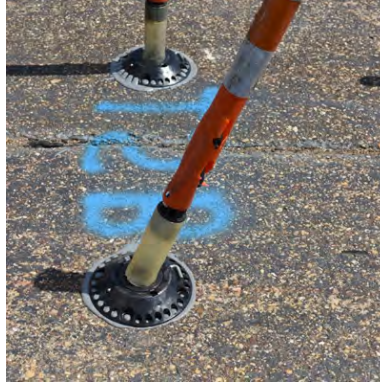
| FDOT<br>I-95<br>Phase | Test Post<br>Number | Before<br>Testing | | After 1st<br>Impact | | After 5th<br>Impact | | After<br>10th Impact | | After<br>50th Impact | | Failure | |
|---|---|---|---|---|---|---|---|---|---|---|---|---|---|
| | 2B | 89 | 89 | 89 | 88 | 89 | 88 | 90 | 88 | | | 44 | Mechanism failure |

**Figure A-4. Sample 2B Failure at 44 Impacts.**

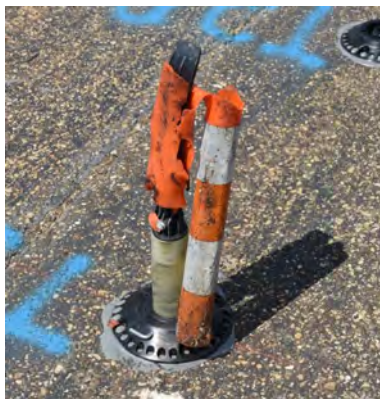
| FDOT<br>I-95<br>Phase | Test Post<br>Number | Before<br>Testing | | After 1st<br>Impact | | After 5th<br>Impact | | After<br>10th Impact | | After<br>50th Impact | | Failure | |
|---|---|---|---|---|---|---|---|---|---|---|---|---|---|
| | 3T | 88.5 | 88.5 | 89 | 88 | 90 | 88 | 90 | 87 | 90 | 89 | 71 | Post failure to restore and<br>Post failure at connection |

**Figure A-5. Sample 3T Failure at 71 Impacts.**

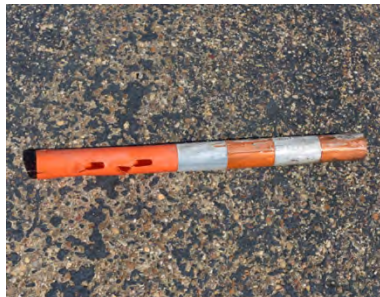
| FDOT<br>I-95<br>Phase | Test Post<br>Number | Before<br>Testing | | After 1st<br>Impact | | After 5th<br>Impact | | After<br>10th Impact | | After<br>50th Impact | | Failure | |
|---|---|---|---|---|---|---|---|---|---|---|---|---|---|
| | 3B | 90 | 88.5 | 90 | 88 | 89 | 89 | 89 | 90 | | | 28 | Post failure at connection<br>(loss of post) |

**Figure A-6. Sample 3B Failure at 28 Impacts.**

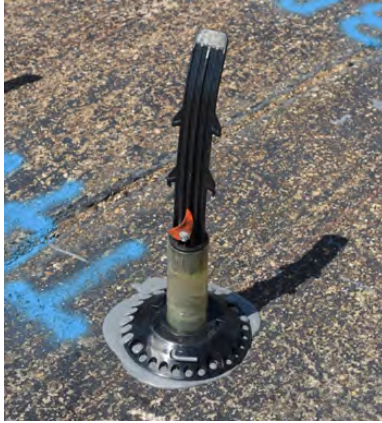
| FDOT<br>I-95<br>Phase | Test Post<br>Number | Before<br>Testing | | After 1st<br>Impact | | After 5th<br>Impact | | After<br>10th Impact | | After<br>50th Impact | | Failure | |
|---|---|---|---|---|---|---|---|---|---|---|---|---|---|
| | 4T | 88.5 | 90 | 90 | 89 | 89 | 89 | 90 | 88 | 88 | 85 | 56 | Post failure at connection<br>(loss of post) |

**Figure A-7. Sample 4T Failure at 56 Impacts.**

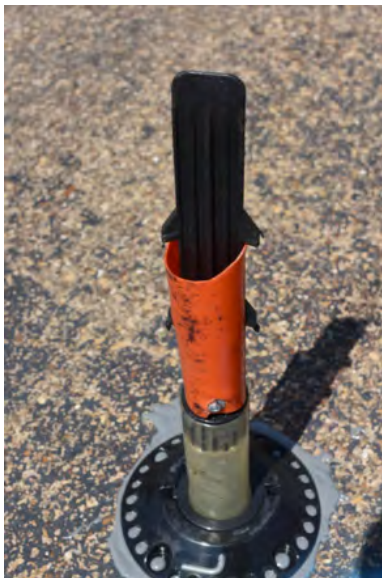
| FDOT<br>I-95<br>Phase | Test Post<br>Number | Before<br>Testing | | After 1st<br>Impact | | After 5th<br>Impact | | After<br>10th Impact | | After<br>50th Impact | | Failure | |
|---|---|---|---|---|---|---|---|---|---|---|---|---|---|
| | 4B | 90 | 90 | 89 | 90 | 89 | 89 | 89 | 89 | | | 42 | Post failure at connection<br>(loss of post) |

**Figure A-8. Sample 4B Failure at 42 Impacts.**

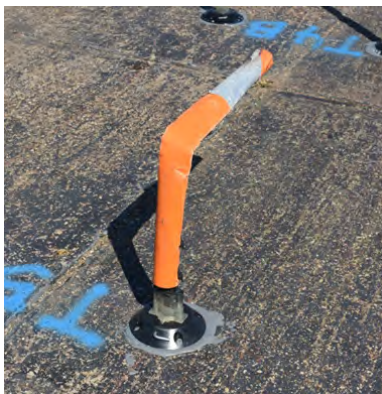
| FDOT<br>I-95<br>Phase | Test Post<br>Number | Before<br>Testing | | After 1st<br>Impact | | After 5th<br>Impact | | After<br>10th Impact | | After<br>50th Impact | | Failure | |
|---|---|---|---|---|---|---|---|---|---|---|---|---|---|
| 1 | 5T | 89.5 | 88 | 89 | 90 | 89 | 89 | 90 | 90 | | | 32 | Post failure to restore (40°) |

**Figure A-9. Sample 5T Failure at 32 Impacts.**

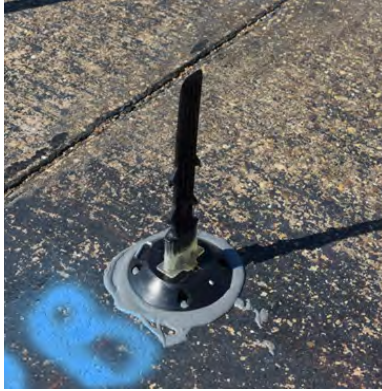
| FDOT<br>I-95<br>Phase | Test Post<br>Number | Before<br>Testing | | After 1st<br>Impact | | After 5th<br>Impact | | After<br>10th Impact | | After<br>50th Impact | | Failure | |
|---|---|---|---|---|---|---|---|---|---|---|---|---|---|
| | 7B | 89.5 | 88 | 90 | 89 | 88 | 88 | 88 | 89 | | | 18 | Post failure at connection<br>(loss of post) |

**Figure A-14. Sample 7B Failure at 18 Impacts.**

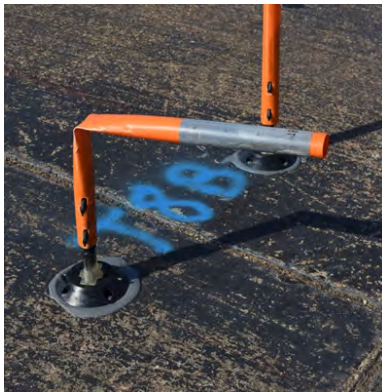
| FDOT<br>I-95<br>Phase | Test Post<br>Number | Before<br>Testing | | After 1st<br>Impact | | After 5th<br>Impact | | After<br>10th Impact | | After<br>50th Impact | | Failure | |
|---|---|---|---|---|---|---|---|---|---|---|---|---|---|
| | 8T | 89 | 89 | 90 | 90 | 89 | 87 | | | | | 6 | Post failure to restore (43°) |

**Figure A-15. Sample 8T Failure at 6 Impacts.**

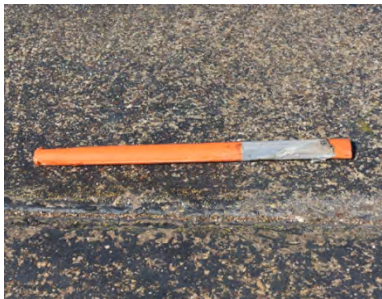
| FDOT<br>I-95<br>Phase | Test Post<br>Number | Before<br>Testing | | After 1st<br>Impact | | After 5th<br>Impact | | After<br>10th Impact | | After<br>50th Impact | | Failure | |
|---|---|---|---|---|---|---|---|---|---|---|---|---|---|
| | 8B | 88 | 89 | 89 | 89 | 89 | 87 | 88 | 87 | | | 26 | Post failure at connection<br>(loss of post) |

**Figure A-16. Sample 8B Failure at 28 Impacts.**
