FINAL REPORT

**EVALUATE THE CONTRIBUTION OF THE MIXTURE
COMPONENTS ON THE LONGEVITY AND
PERFORMANCE OF FC-5**

FDOT Contract No. BDS15 977-01

**Thomas Bennert, Ph.D.
Center for Advanced Infrastructure and Transportation (CAIT)
Rutgers University
100 Brett Road
Piscataway, NJ 08854**

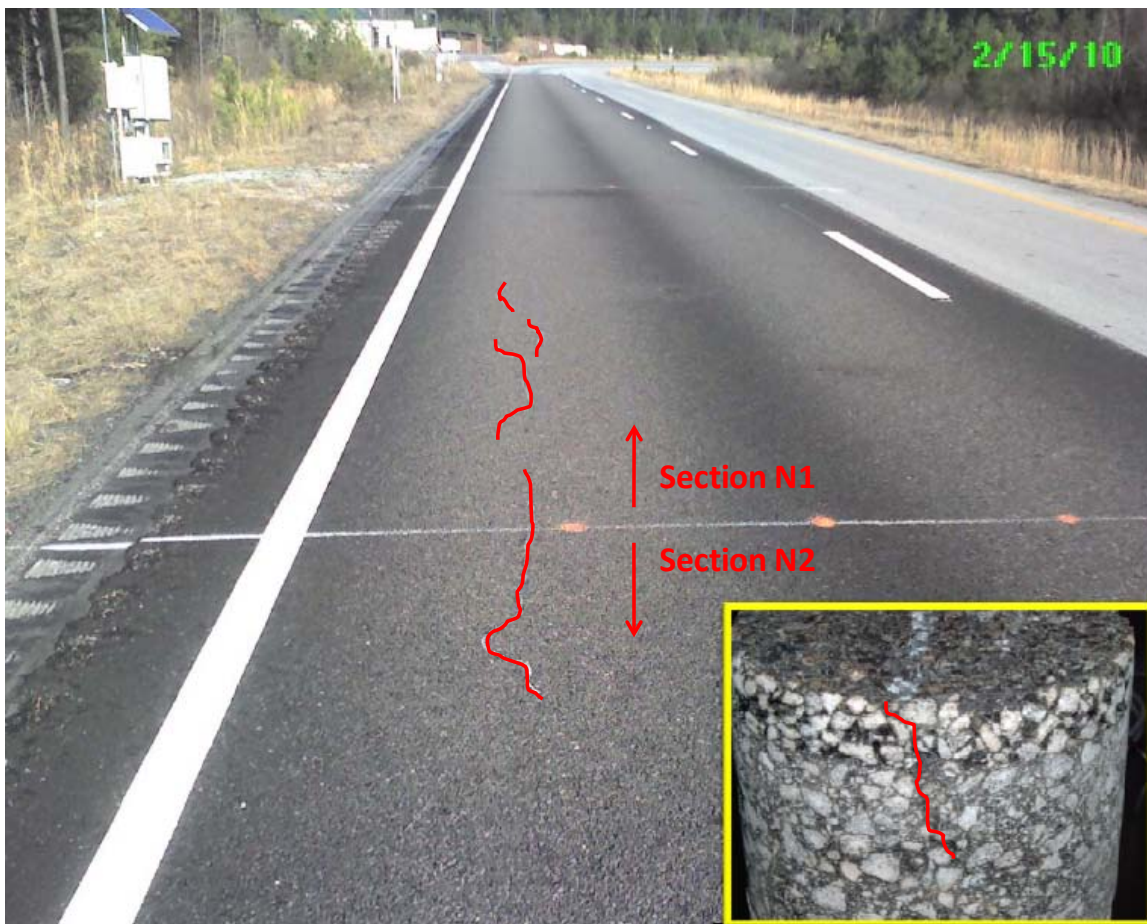
Figure 1.1 - Top-down Cracking at the NCAT Test Track for FDOT's FC-5 Mixtures

1. The OGFC layer on Section N1, in which a heavier tack coat was applied, performed better than that of Section N2, in which a conventional tack coat was used.
2. While both sections had cracking, the level of severity and the area of severe cracks were greater in Section N2 than Section N1.
3. It was recommended that to help resist cracking in OGFC layers, heavier tack coats be used.

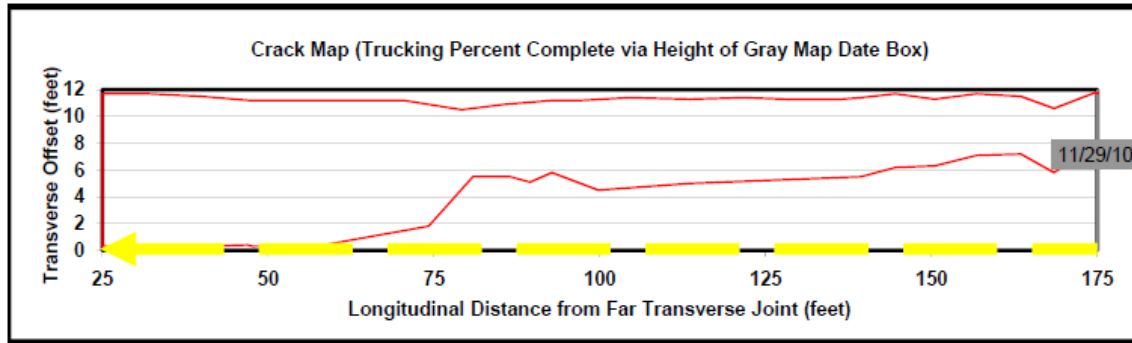
Figure 1.2 - Crack Mapping at the NCAT Test Track - Test Section N1

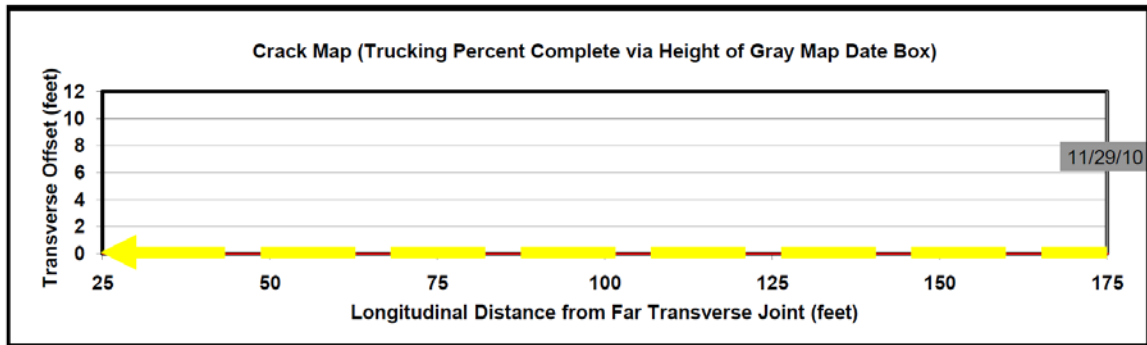
Figure 1.6 – Crack Mapping at the NCAT Test Track – Test Section S3 (Chert Gravel OGFC)

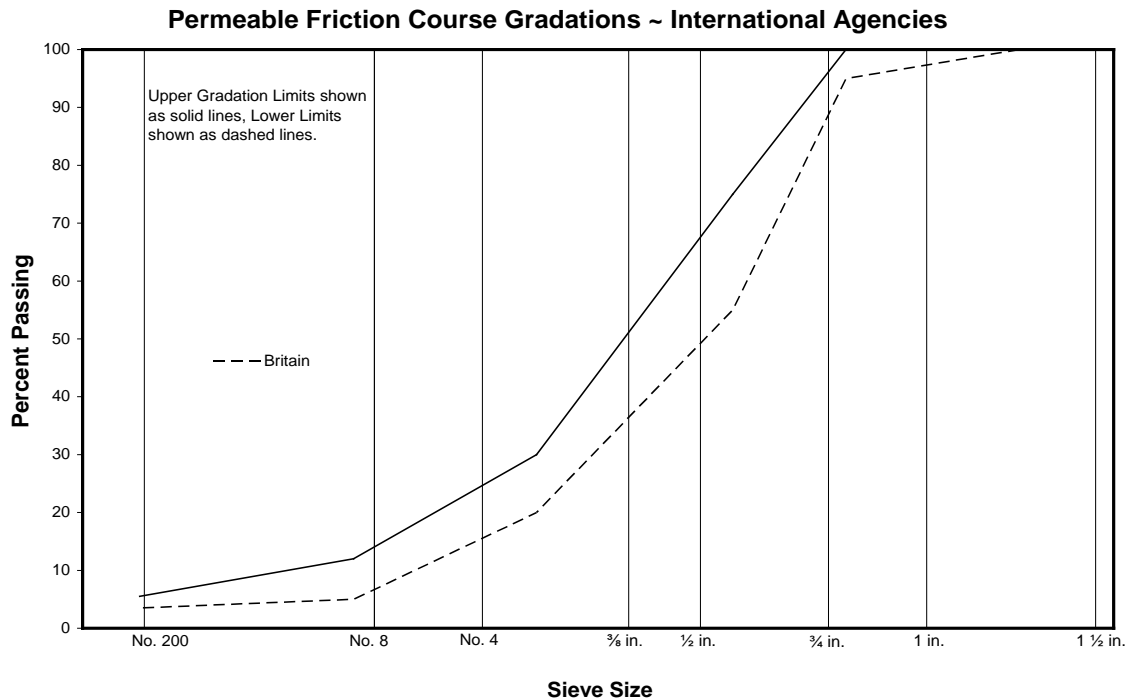
Figure 2.6 - 1 inch PFC Gradation Requirements from International Agencies

From an international standpoint, there are a number of agencies that specify open-graded mixes. A single 1 in. (25 mm) maximum aggregate size gradation was encountered in the literature which was from Britain. This gradation is illustrated in Figure 2.6. According to the gradation band, the gradation is gapped near the No. 4 sieve and the allowable filler content is between 3.5 and 5.5 percent.

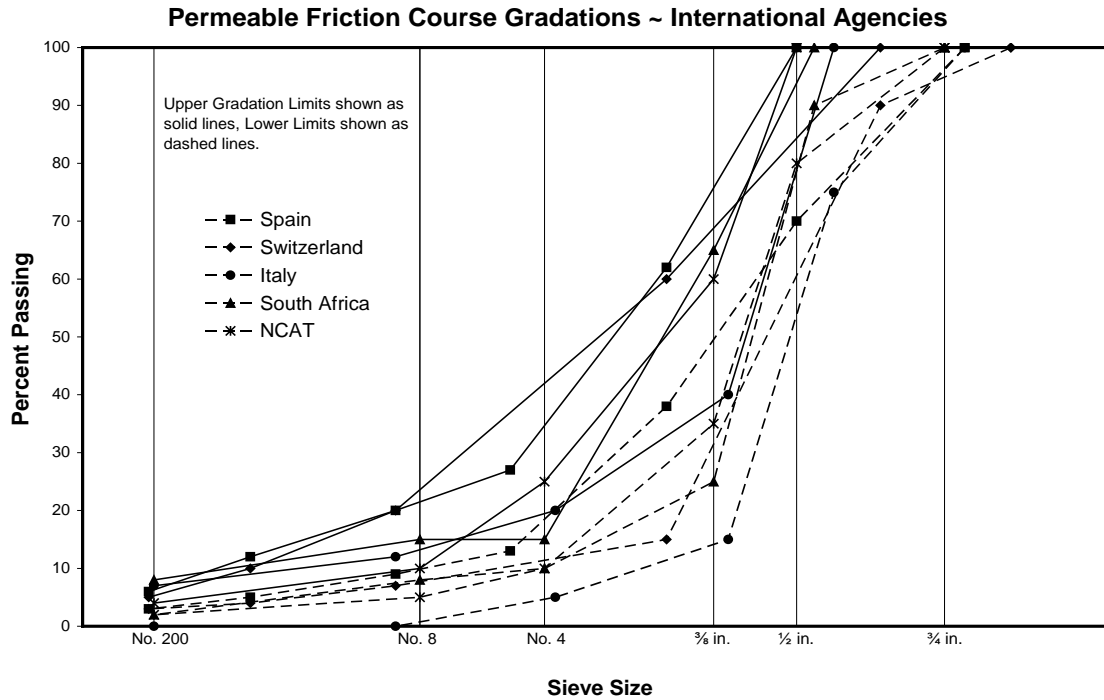
Figure 2.7 - 3/4 inch PFC Gradation Requirements from International Agencies

Most of the gradation requirements specified by international agencies are for a $\frac{3}{4}$ in. (19mm) maximum aggregate size gradation. Figure 2.7 shows the various gradation bands for $\frac{3}{4}$ in. maximum aggregate size OGFC mixes. Again, customary US sieves are shown on the figure. Also shown on this figure is the gradation band recommended by the National Center for Asphalt Technology (Watson et al, 2003). This gradation band is shown to provide a comparison between the typical gradation used in the US (as described above) and those used in other countries. As shown on this figure, there is a wide range of allowable gradations. For instance, on the $\frac{3}{8}$ in. (9.5 mm) sieve, gradation requirements range from a high of approximately 75 percent passing (Spain) to a low of approximately 10 percent passing (Italy). The majority of gradation bands would force the aggregate blend to be gapped somewhere between the $\frac{3}{8}$ in. (9.5 mm) sieve and the No. 4 (4.75mm) sieve. Filler contents encountered in the various gradation bands also vary significantly. Italy provides a lower limit of 0 percent passing the No. 200 (0.075mm) sieve while South Africa allows as much as 8 percent passing the No. 200 sieve.

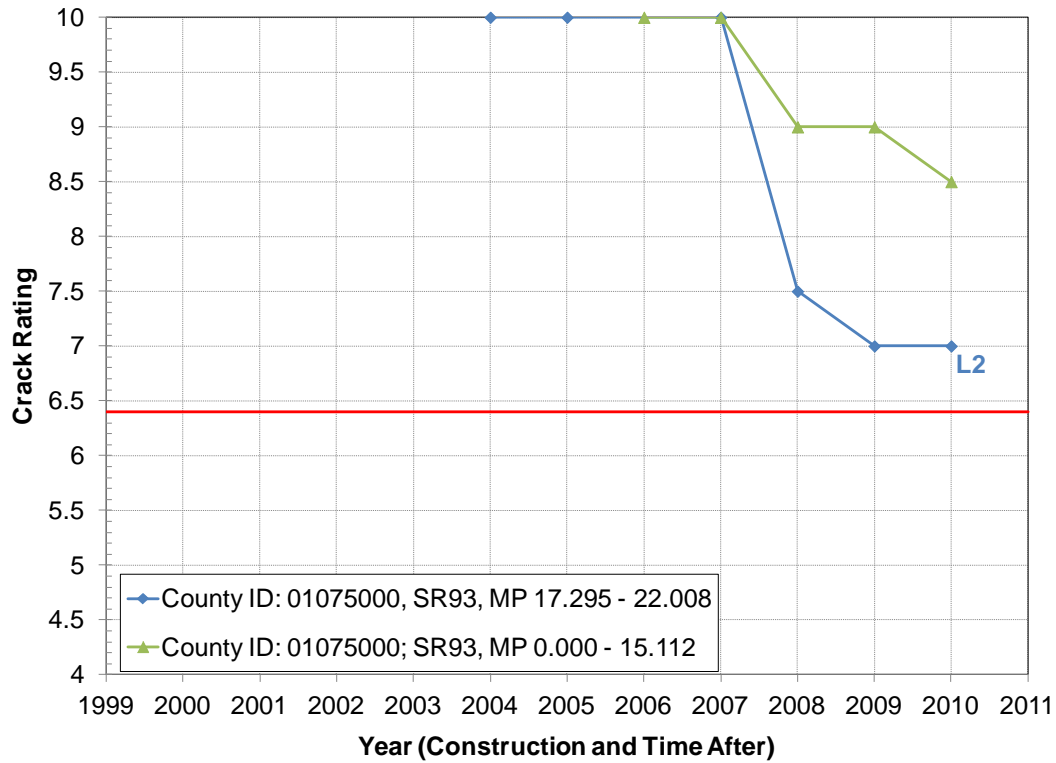
Figure 3.3 – FC-5 Cracking and Raveling Performance in District 1

Each figure shows a plot of the PMS crack rating vs. year. In all cases, the time period shown in the graphs starts as a new pavement section and dates until the last PMS data collection cycle in the PMS database. Along with the Crack Rating, the level of Raveling is also shown, corresponding to the codes in Table 3.1. For example, County ID: 01075000, SR-93, MP 17.295 – 22.008 was constructed in 2004, where the initial crack rating was a 10.0. Figure 3.1 continues to show this section decrease to a crack rating of 7.0 in year 2010. It also shows that raveling in this section was first noted in 2010 with a level of “L2”.

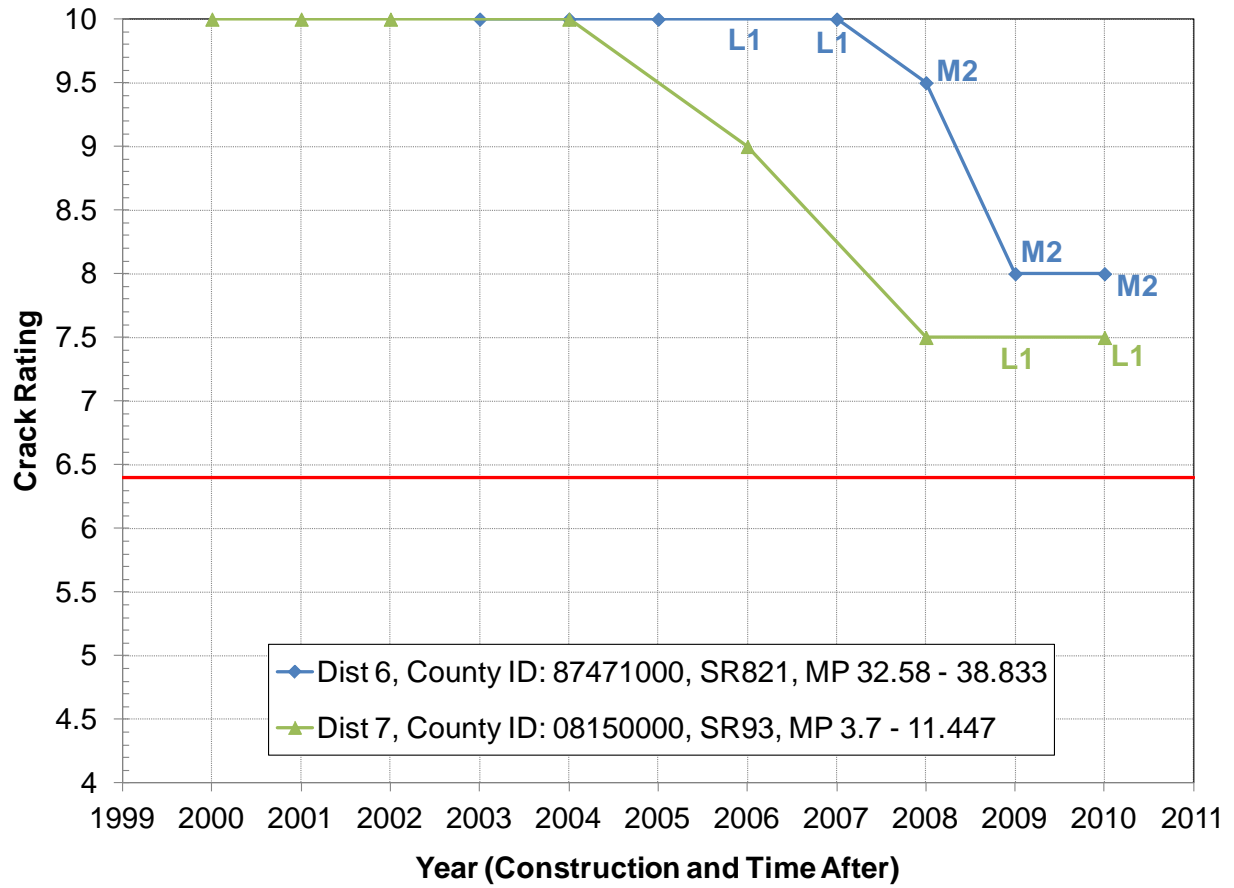
Figure 3.8 - FC-5 Cracking and Raveling Performance in District 6 and 7

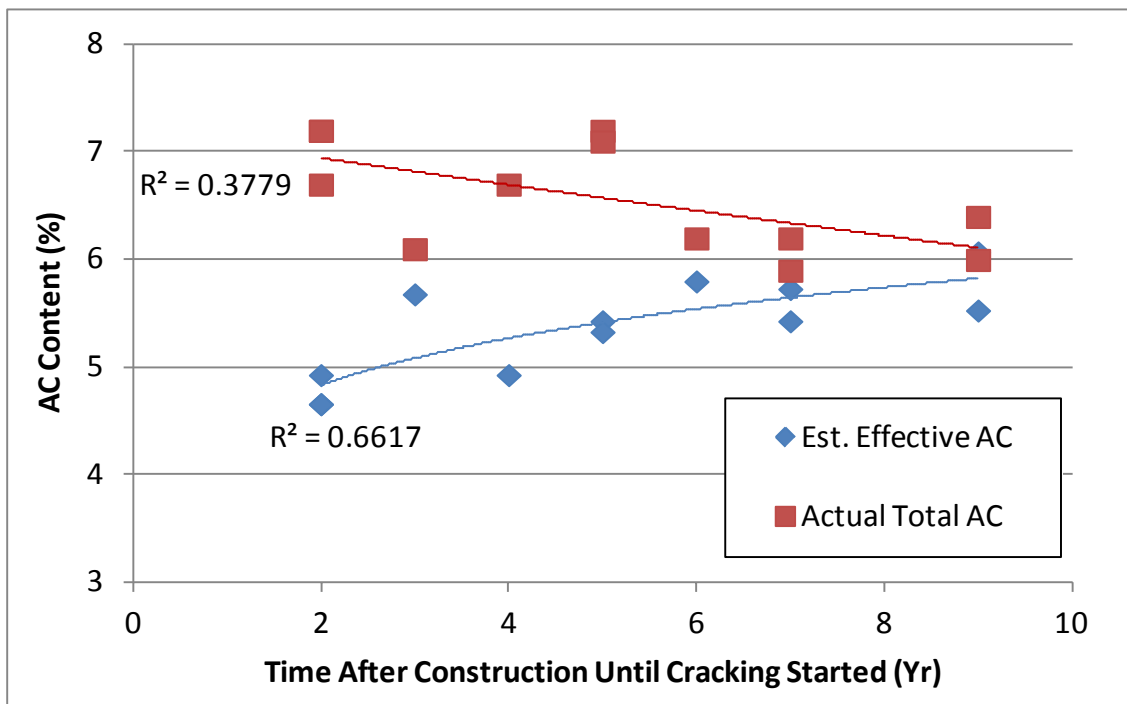
Figure 3.9 - Asphalt Binder Parameters vs Time After Construction Until Cracking Started

The first set of mixture parameters to be compared to the pavement cracking performance was the asphalt binder contents; Actual Total AC (from construction QC data) and Estimated Effective AC. A comparison of these parameters to the “Time After Construction Until Cracking Started” is shown in Figure 3.9. The results in Figure 3.9 show a relatively good correlation between the Estimated Effective AC and the Time After Construction Until Cracking Started. In fact, the trendline seems to plateau at 6% Estimated Effective AC, indicating that at effective asphalt contents of this level, superior cracking performance in the FC-5 pavement sections would be observed.

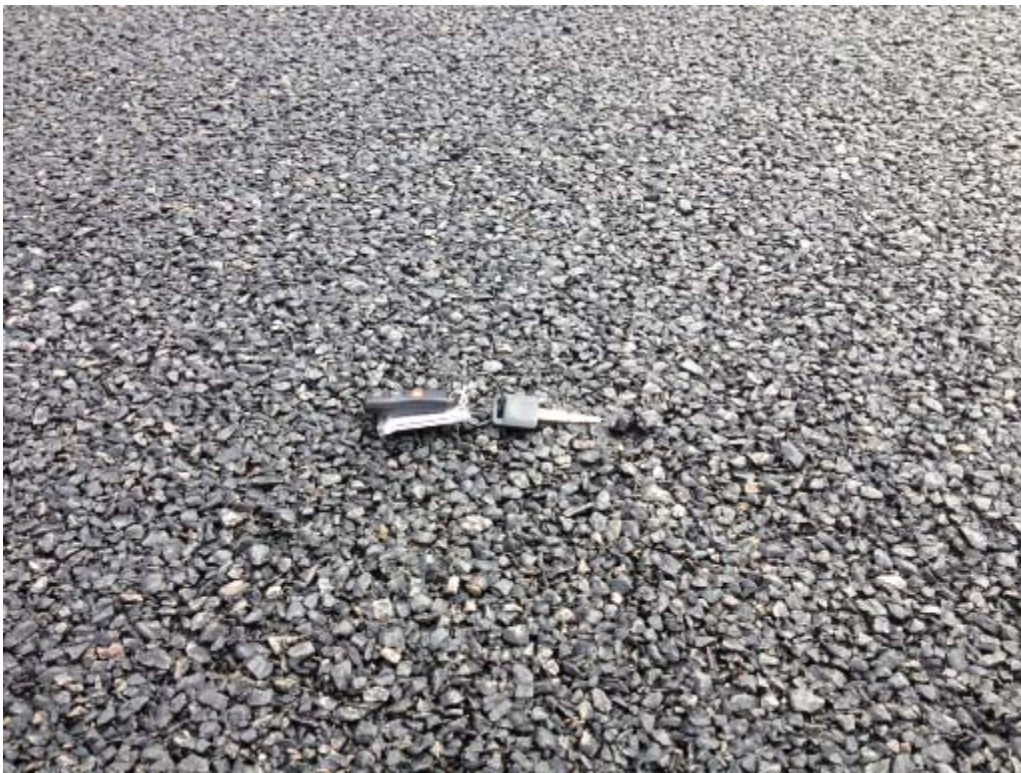
Figure 3.14 - Aggregate Pop-out on SR-20

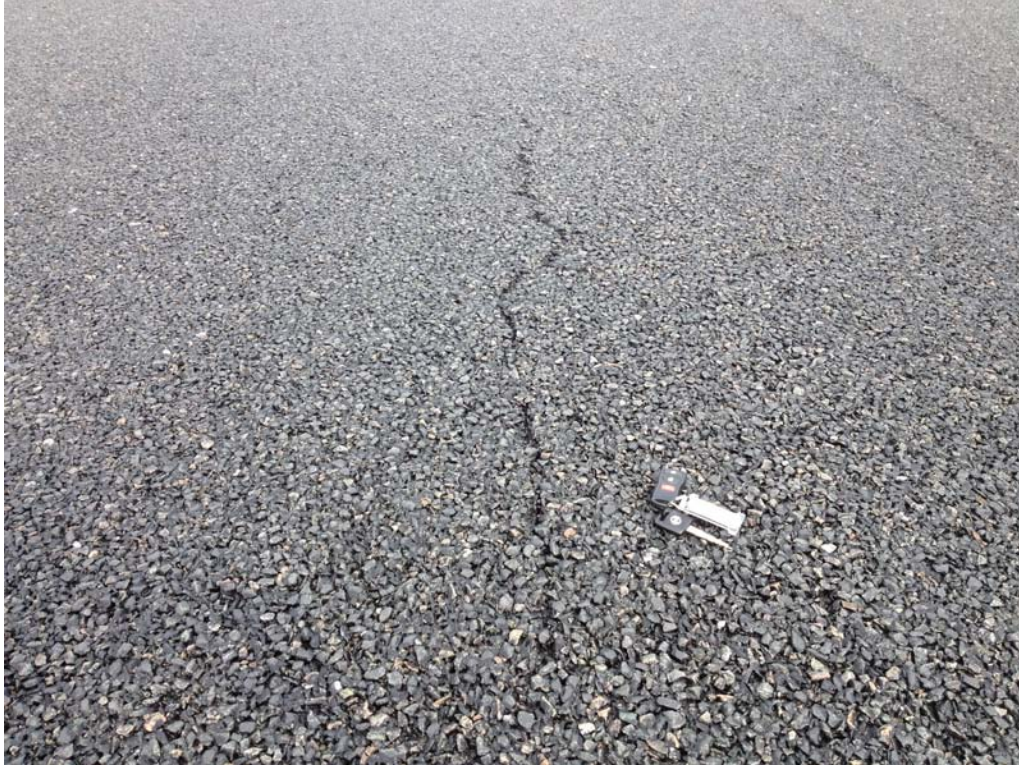
Figure 3.15 - Longitudinal Crack on SR-20

longitudinal cracks were observed within this section. The cracks were not continuous and were observed sporadically over the entire project. Typically, the longitudinal cracks were 4 to 6 ft in length (Figure 3.15) and observed within the wheelpath. There did not appear to be any production or construction issues that caused the distresses. Visually (and this can be observed in Figure 3.14), the FC-5 appeared to be slightly under-asphalted. Not only had the asphalt binder been worn away from the pavement surface by the action of tires, but the aggregates visible under the surface appeared to have very thin asphalt films.

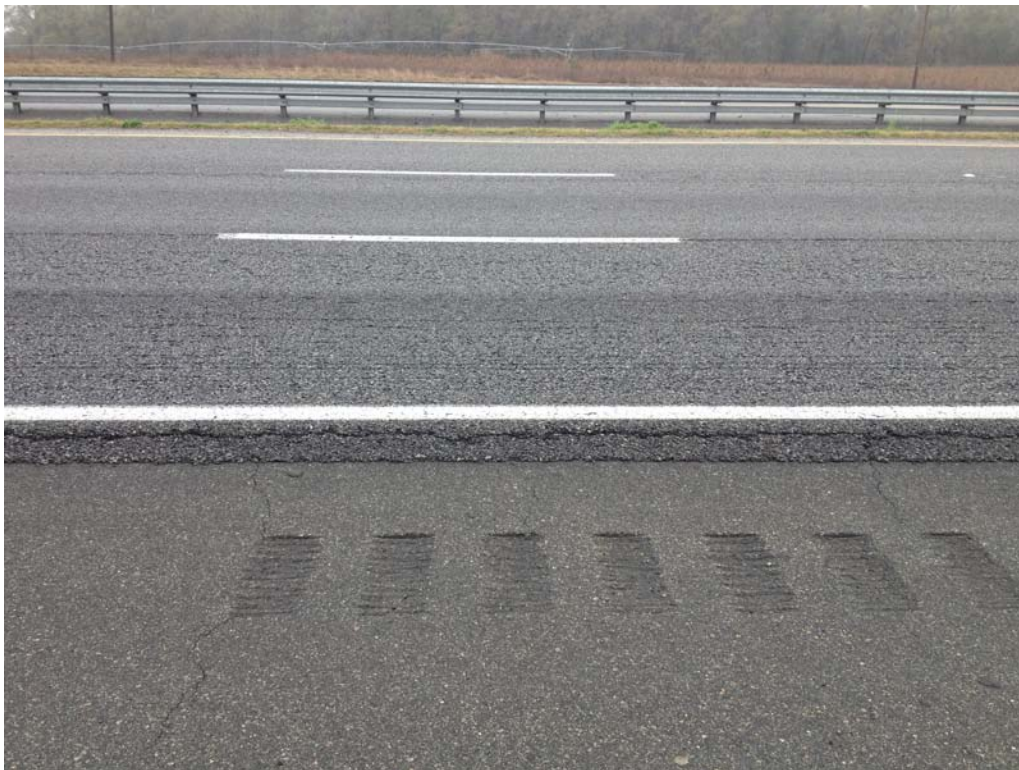
Figure 3.16 - Rutting on I-75 in Hamilton County (MP461-462)

Another section evaluated on I-75 in Hamilton County was in the northbound lanes between Mile Posts 461 and 462, which was last resurfaced in 1998. It was evaluated because of rutting, cracking and raveling. As shown in Figure 3.16, the outside lane was experiencing rutting. It was not discernible whether the rutting was limited to the FC-5 layer or whether the rutting resulted from issues in an underlying layer. Cracking was observed within the wheelpaths. These cracks had an appearance similar to fatigue cracks and were low severity. A significant amount of raveling had also occurred within the wheelpaths (Figures 3.17 and 3.18). It was unclear from the visual examination of the pavement what caused the issues; however, the probable cause was from an underlying layer. It did not appear to be a materials issue with the FC-5. One possibility is that stripping had occurred in an underlying layer.

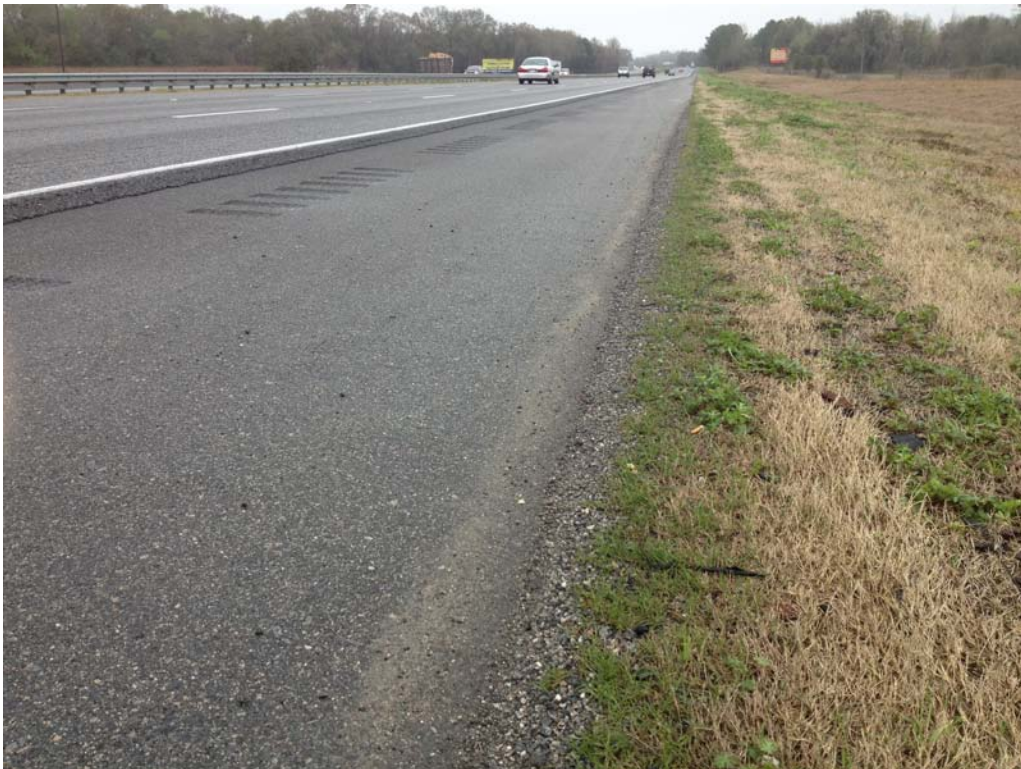
Figure 3.18 - Raveled Aggregates on Shoulder, I-75 Hamilton County (MP 461-462)

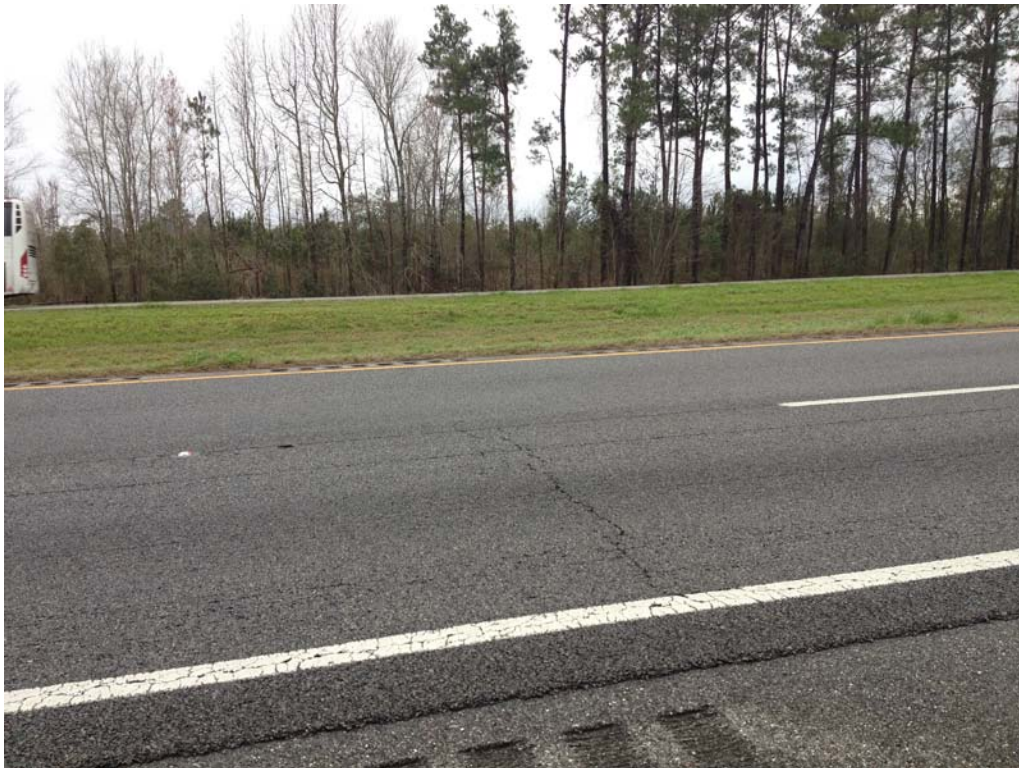
Figure 3.19 - Transverse Crack on I-10 (MP 229-230)

The final section evaluated on Day 2 was on I-10 in Jefferson County, w between Mile Posts 229 and 230. Within this section of roadway, which was last resurfaced in 1999, transverse cracks were observed within the FC-5 mix (Figure 3.19). The spacing and shape of the transverse cracks indicate that they were likely reflected upwards from an underlying concrete pavement. Additionally, in some locations, diagonal cracks had reflected to the surface from broken slabs (Figure 3.20). These distresses were not deemed to be FC-5 material related distresses.

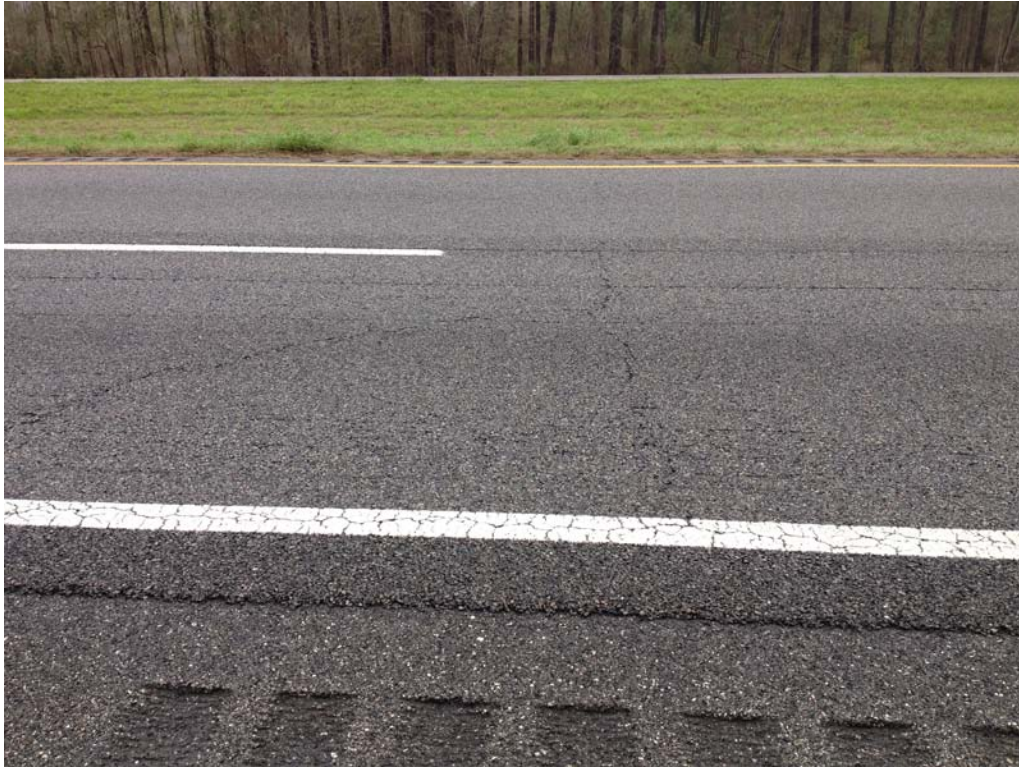
Figure 3.20 - Transverse Cracking on I-10 (MP 229-230)

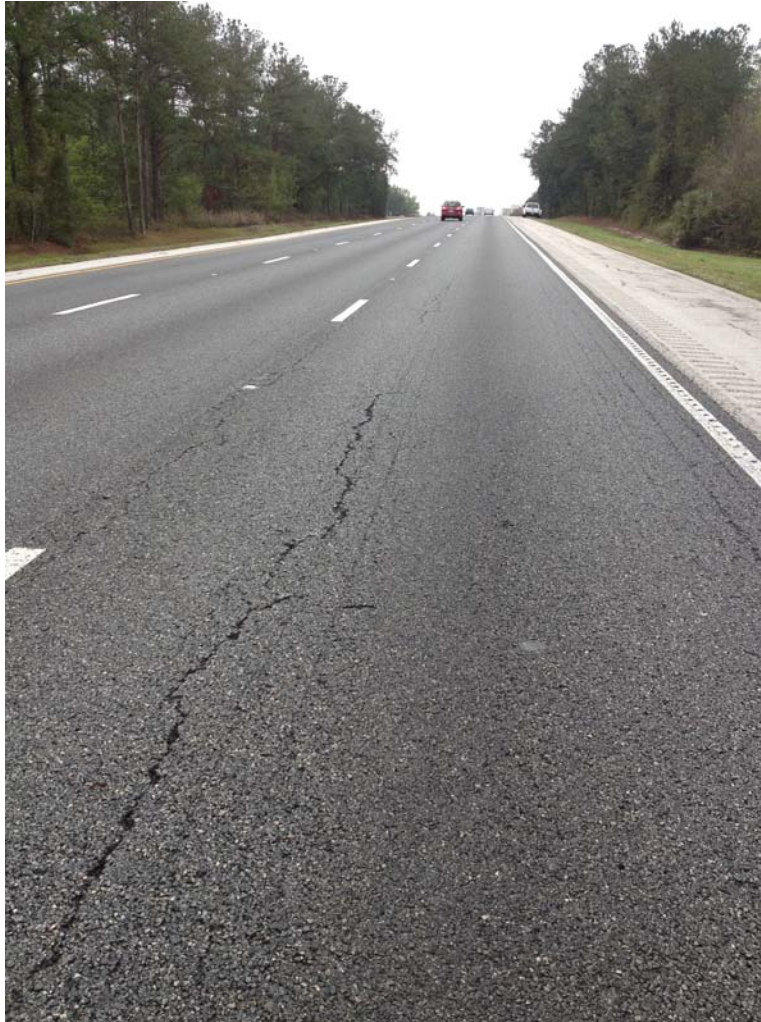
Figure 3.21 - Longitudinal Crack on I-75 in Marion County

In addition to the longitudinal cracks, transverse cracks were observed in some locations. These transverse cracks appeared to begin at the longitudinal crack and extend into the shoulder (Figure 3.23). Raveling was observed within the section. Within some areas, the raveling would be considered moderate severity, especially within the wheelpath. It was unclear if the longitudinal or transverse cracking was material related. However, it is assumed that the cracking was caused by an issue within underlying layers. This was assumed because of the transverse cracks that extended into the shoulder.

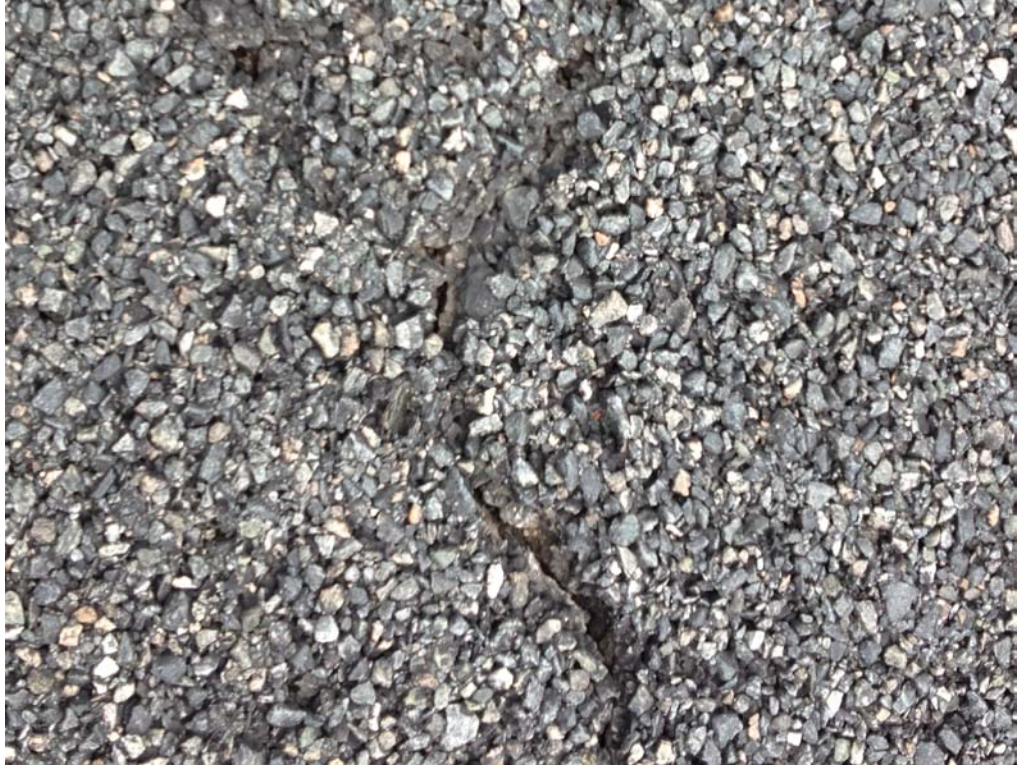
Figure 3.22 - Close-up of Longitudinal Crack on I-75 in Marion County

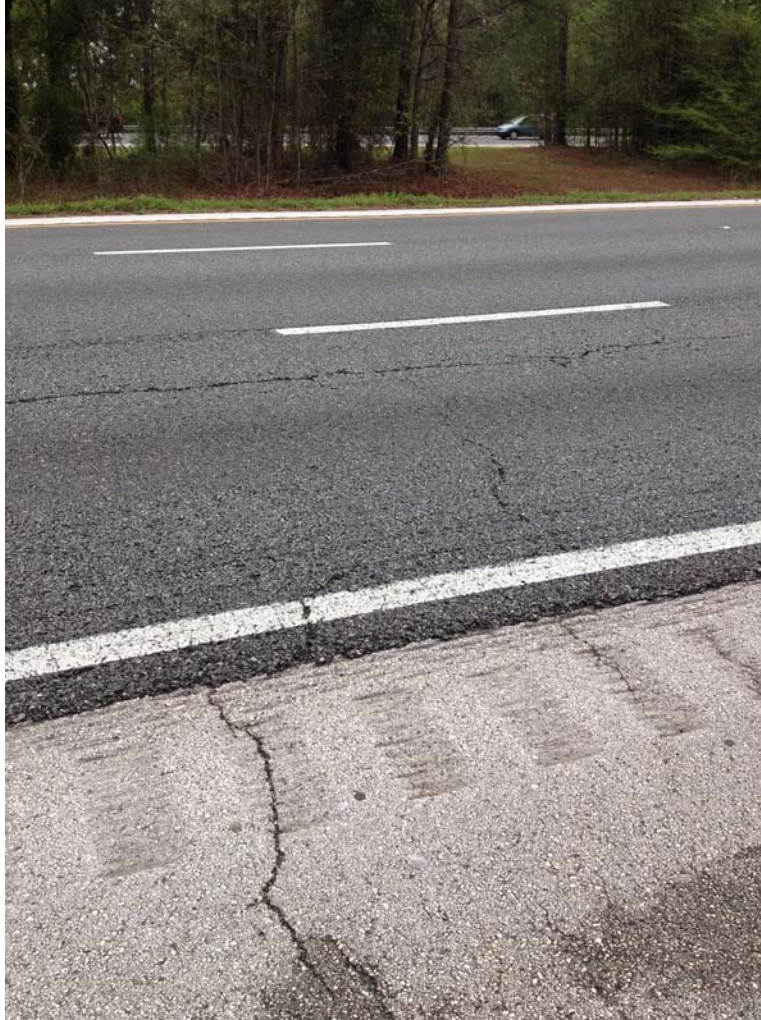
Figure 3.23 - Transverse Crack on I-75 in Marion County

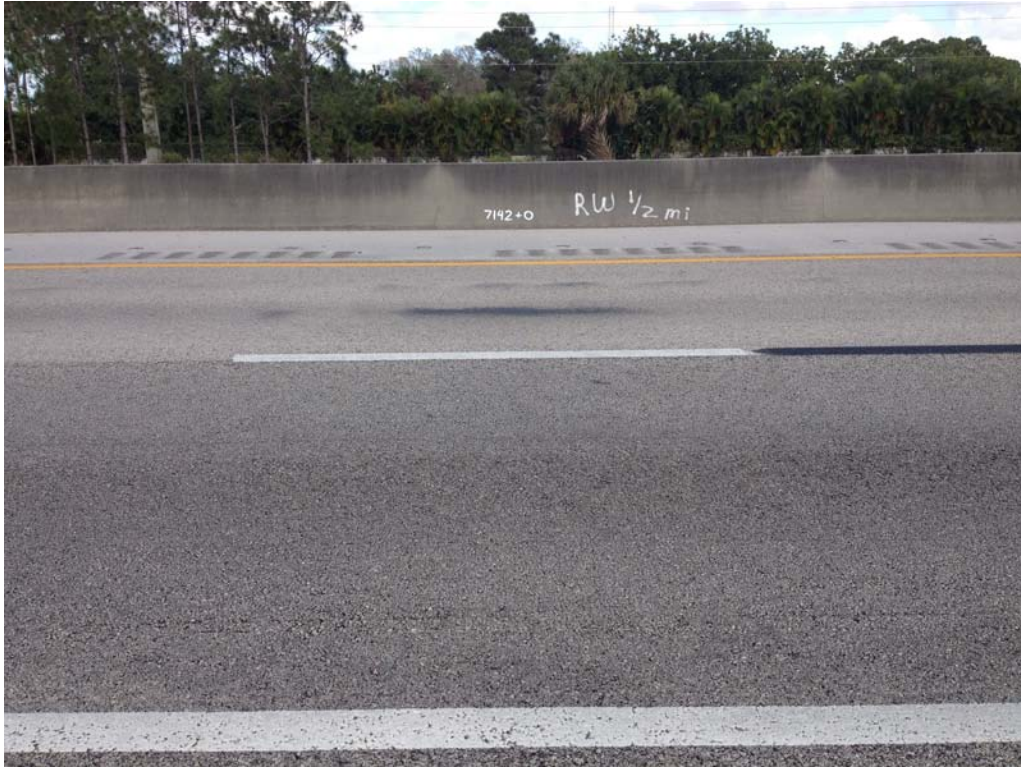
Figure 3.24 - Flushed Area on Florida Turnpike near MP 133

The second and last section evaluated on the third day was just north of Exit 133 on the Florida Turnpike. This section was in Martin County, and was previously resurfaced in 2008. Flushing was observed on the inside lane (Figure 3.24). The flushing was observed within the wheelpath. Typically, the flushed areas were about 8 to 10 ft long and as wide as the wheelpath. Additionally, flushed spots were observed at approximately equal spacing down the pavement that suggested that their occurrence was construction related. Maurice McReynolds indicated that the haul time from the nearest asphalt plant was approximately 1 hour. The flushed areas could have been caused by draindown occurring during transportation of the mix. Raveling was also observed, but was low severity.

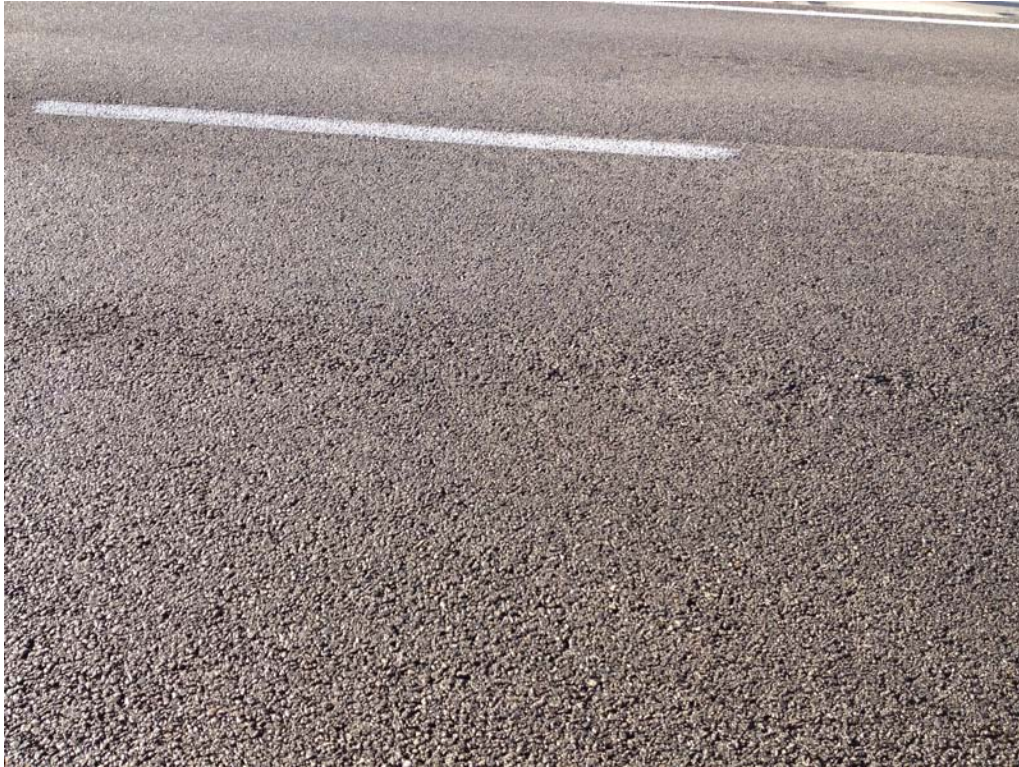
Figure 3.25 - Raveling on I-75 in Broward County near MP 30

The first section evaluated was in the northbound direction of I-75 in Broward County near Mile Post 30, which was resurfaced in 2011. Within this section, raveling was observed between the wheelpaths (Figure 3.25). Occurrence of the raveling was cyclical and may have been construction related.

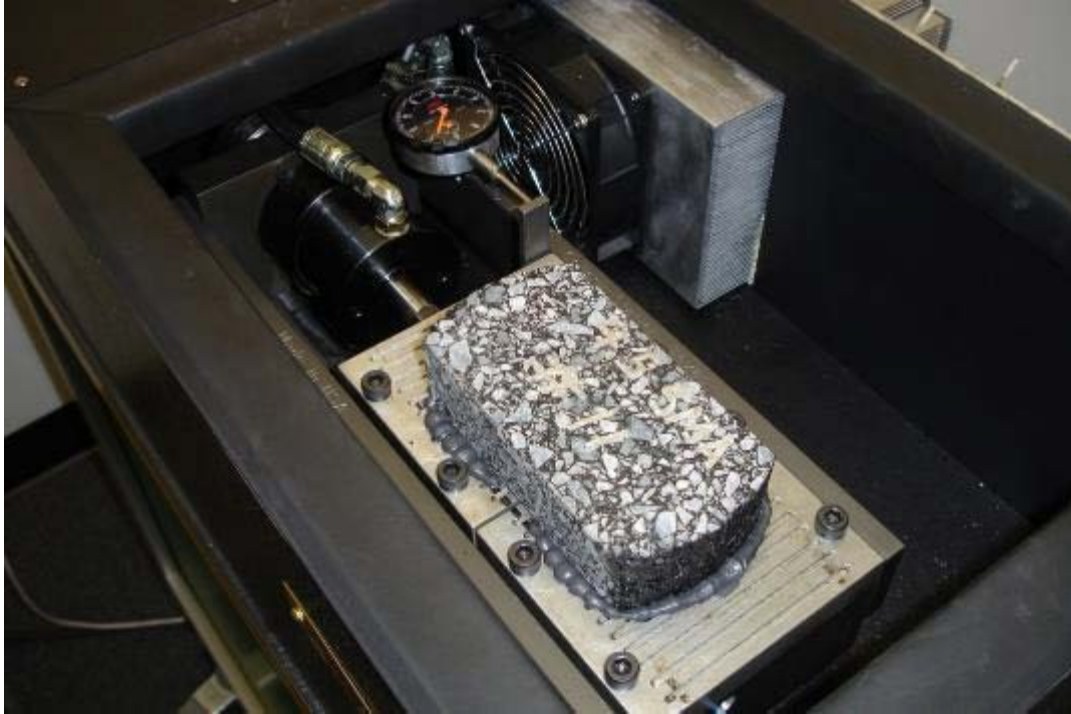
Figure 6.5 – Overlay Tester Device Used for Fatigue Cracking Assessment

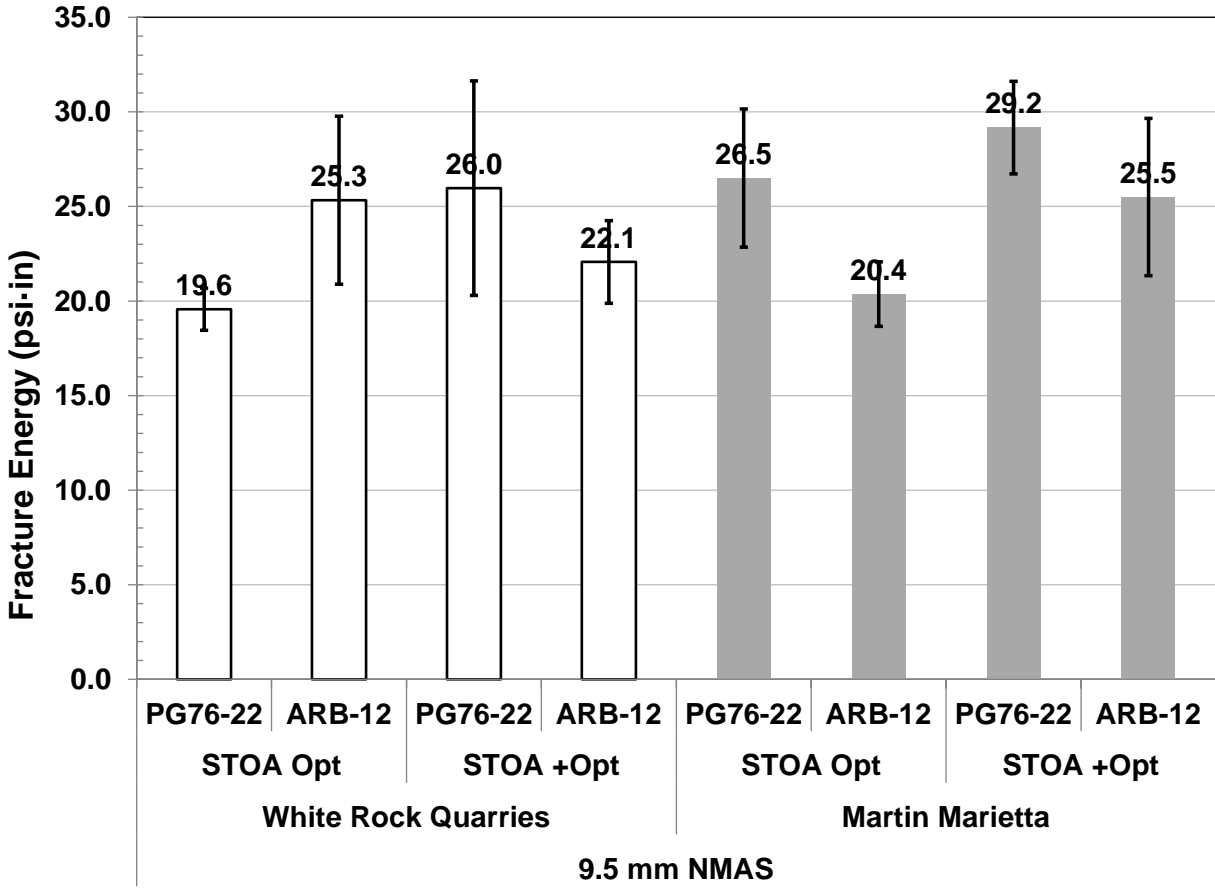
Figure 6.13 - IDT FE for 9.5 mm NMAS FC-5 Mixtures – Short-Term Aged

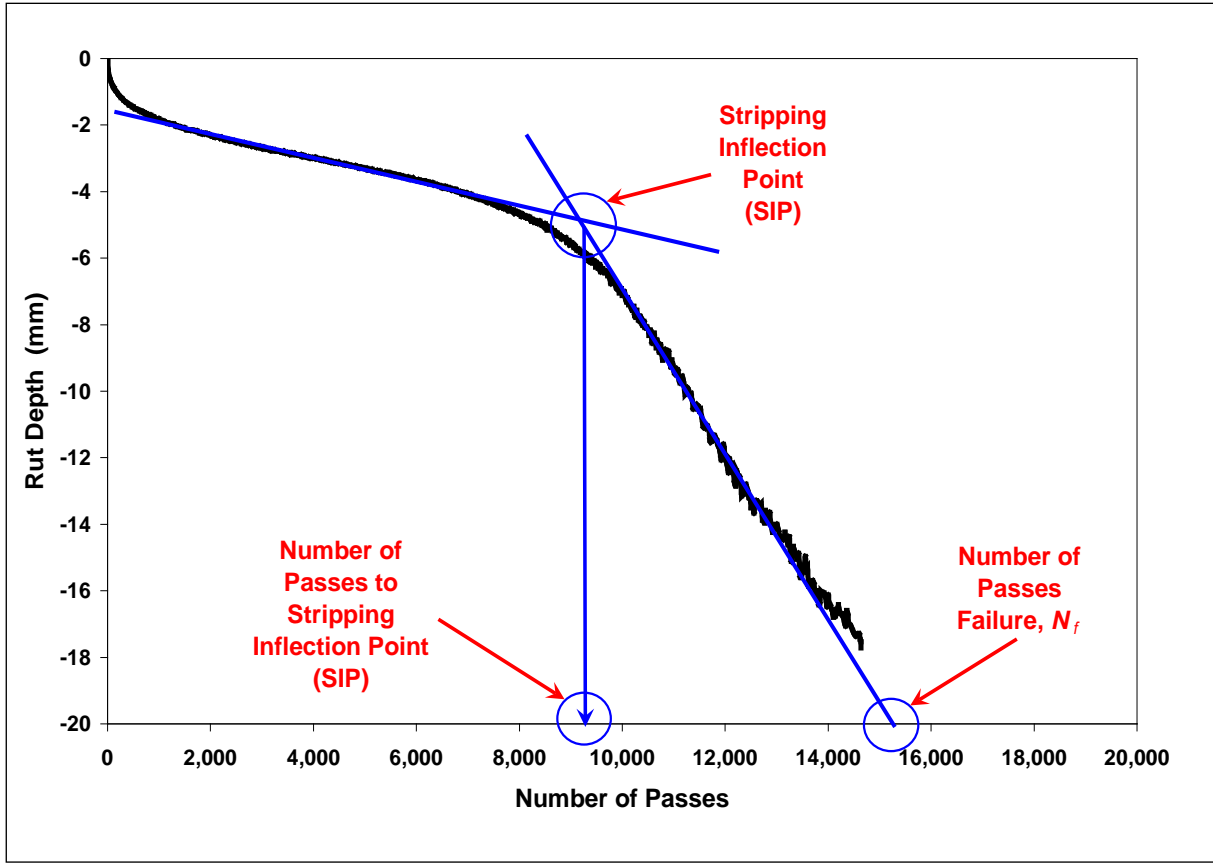
Figure 6.15 – Determination of Stripping Inflection Point (SIP) from Wet Hamburg Wheel Track Test

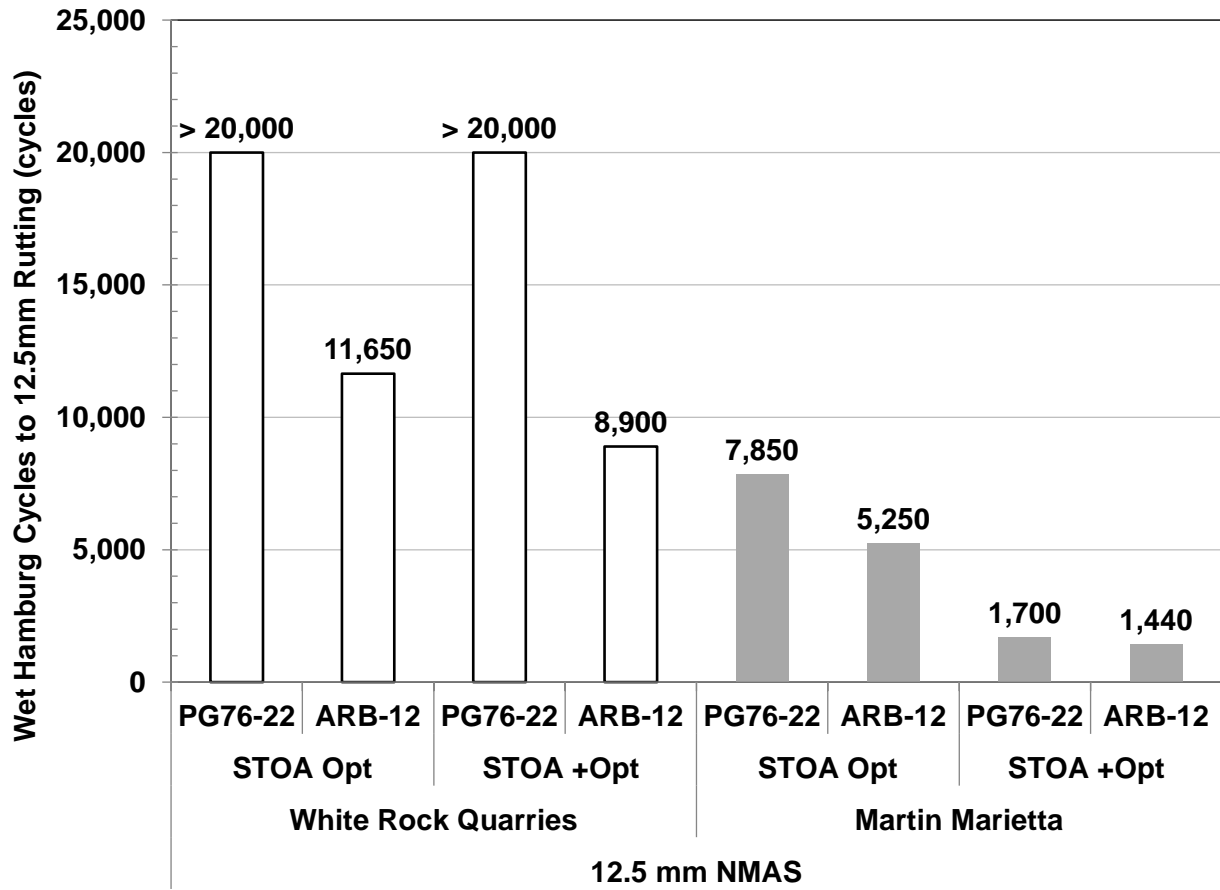
Figure 6.17 - Wet Hamburg Wheel Track Test Results for 12.5 mm NMAS Mixtures – Short-Term Aged – Cycles to 12.5 mm Rutting

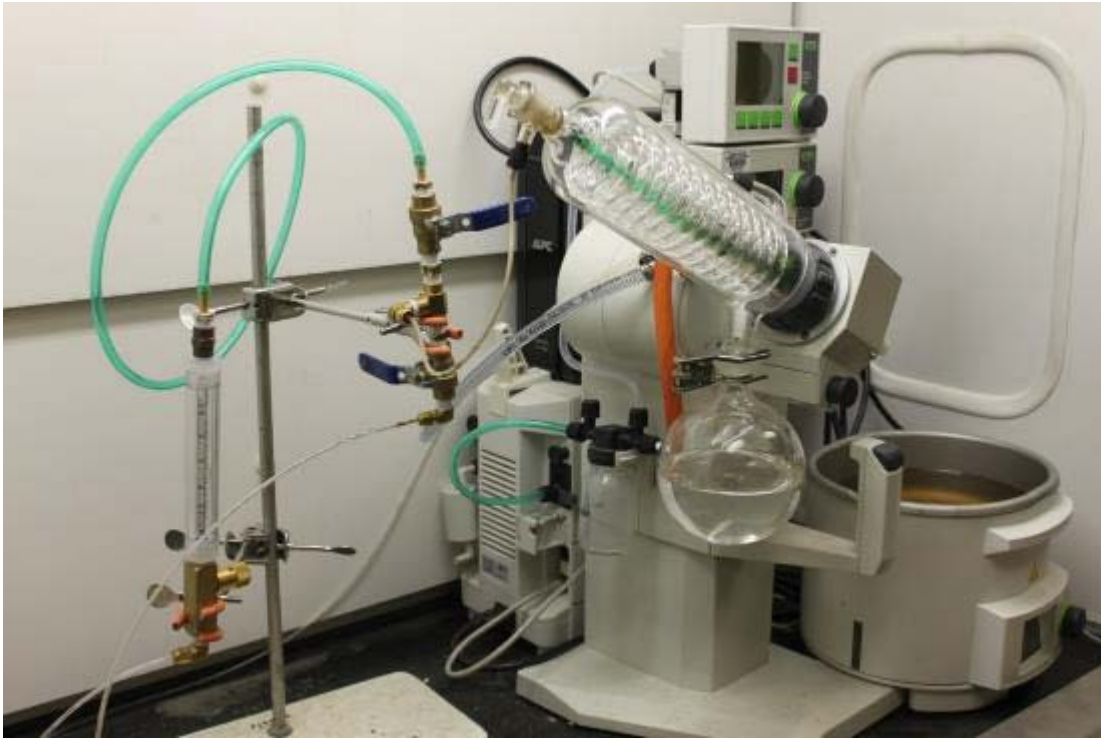
Figure 6.20 – Asphalt Binder Recovery Equipment at Rutgers University (Rotavap System)

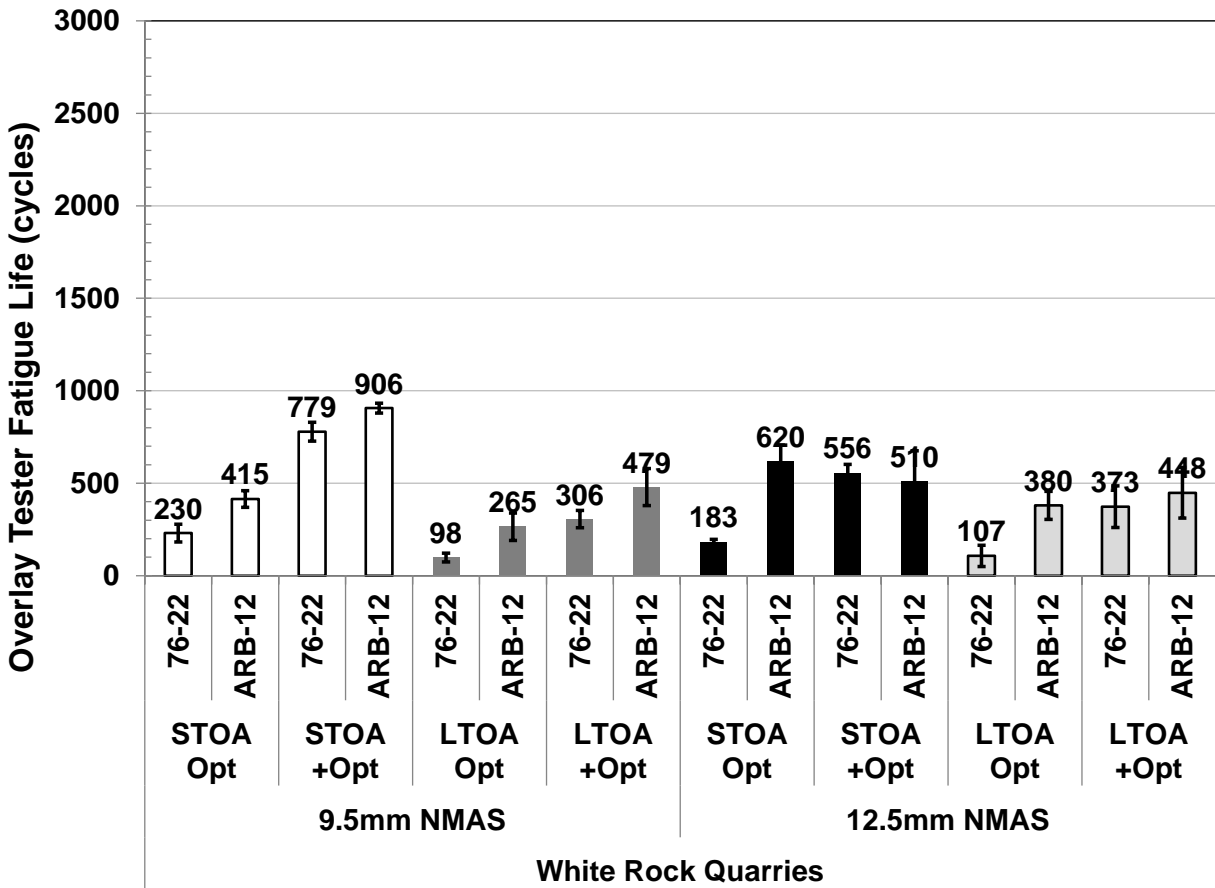
Figure 6.22 – Overlay Tester Results for White Rock Quarries FC-5 Mixtures – Short-Term and Long-Term Oven Aged Conditions
