FINAL REPORT

**EVALUATE THE CONTRIBUTION OF THE MIXTURE
COMPONENTS ON THE LONGEVITY AND
PERFORMANCE OF FC-5**

FDOT Contract No. BDS15 977-01

**Thomas Bennert, Ph.D.
Center for Advanced Infrastructure and Transportation (CAIT)
Rutgers University
100 Brett Road
Piscataway, NJ 08854**

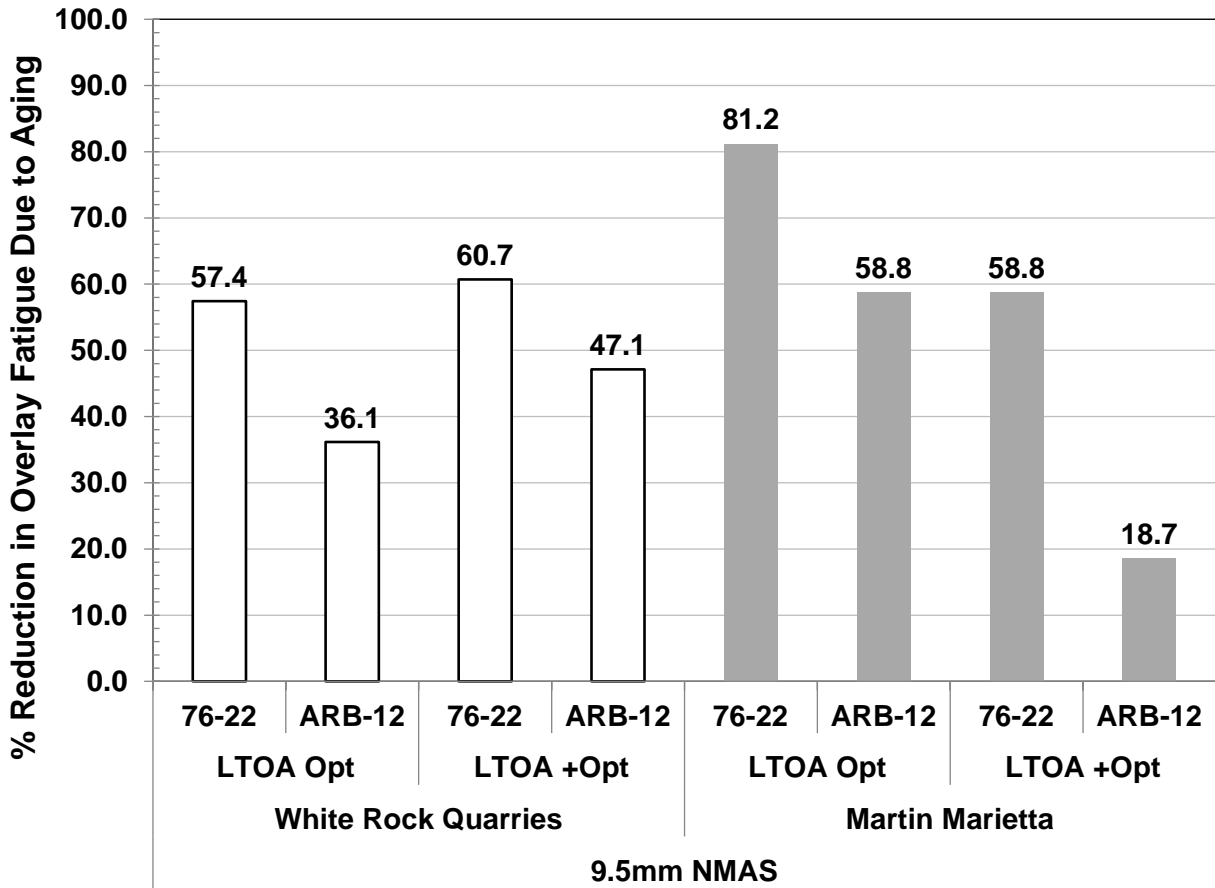
Figure 6.24 – Percent Reduction in Overlay Tester Fatigue Life Due to Laboratory Aging for the 9.5 mm NMAS FC-5 Mixtures

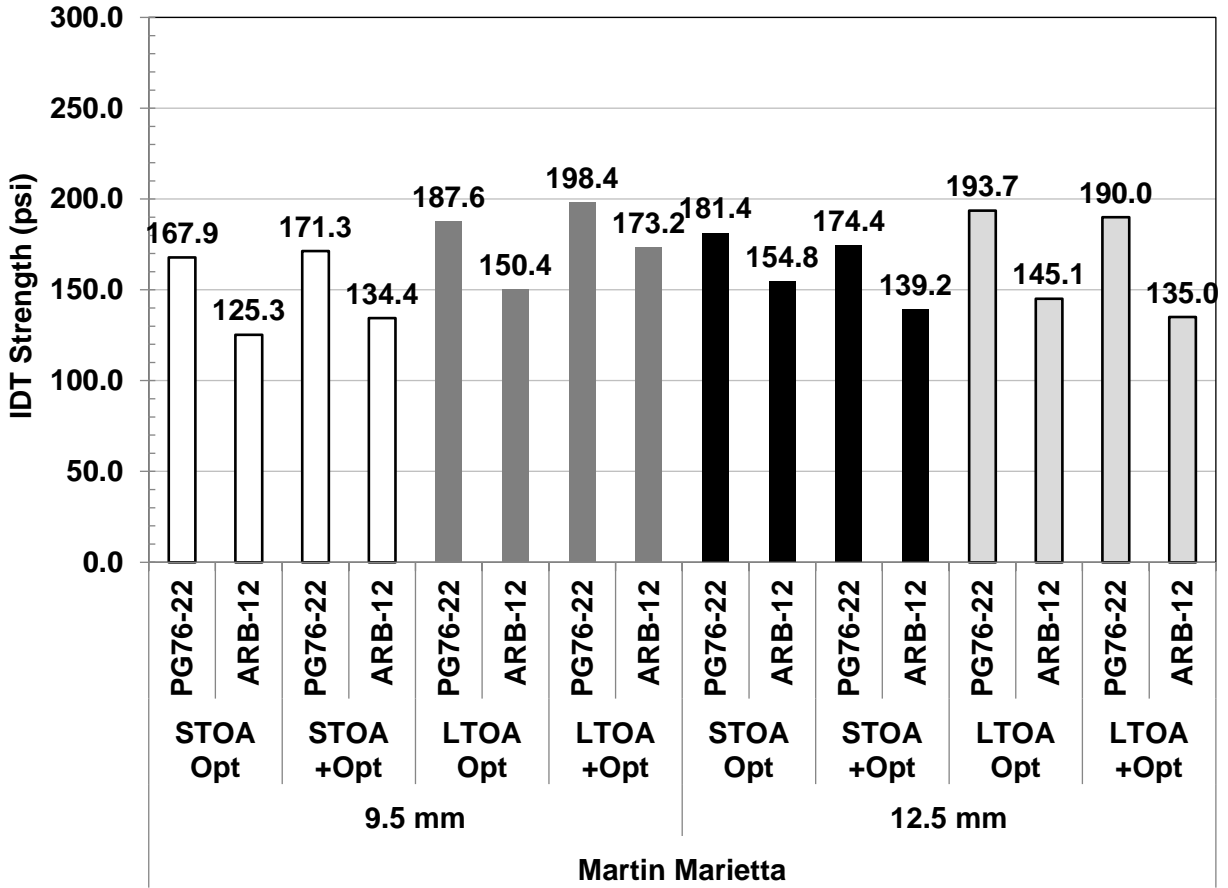
Figure 6.27 – IDT Strength of Martin Marietta FC-5 Mixtures – Long-Term Oven Aged Condition

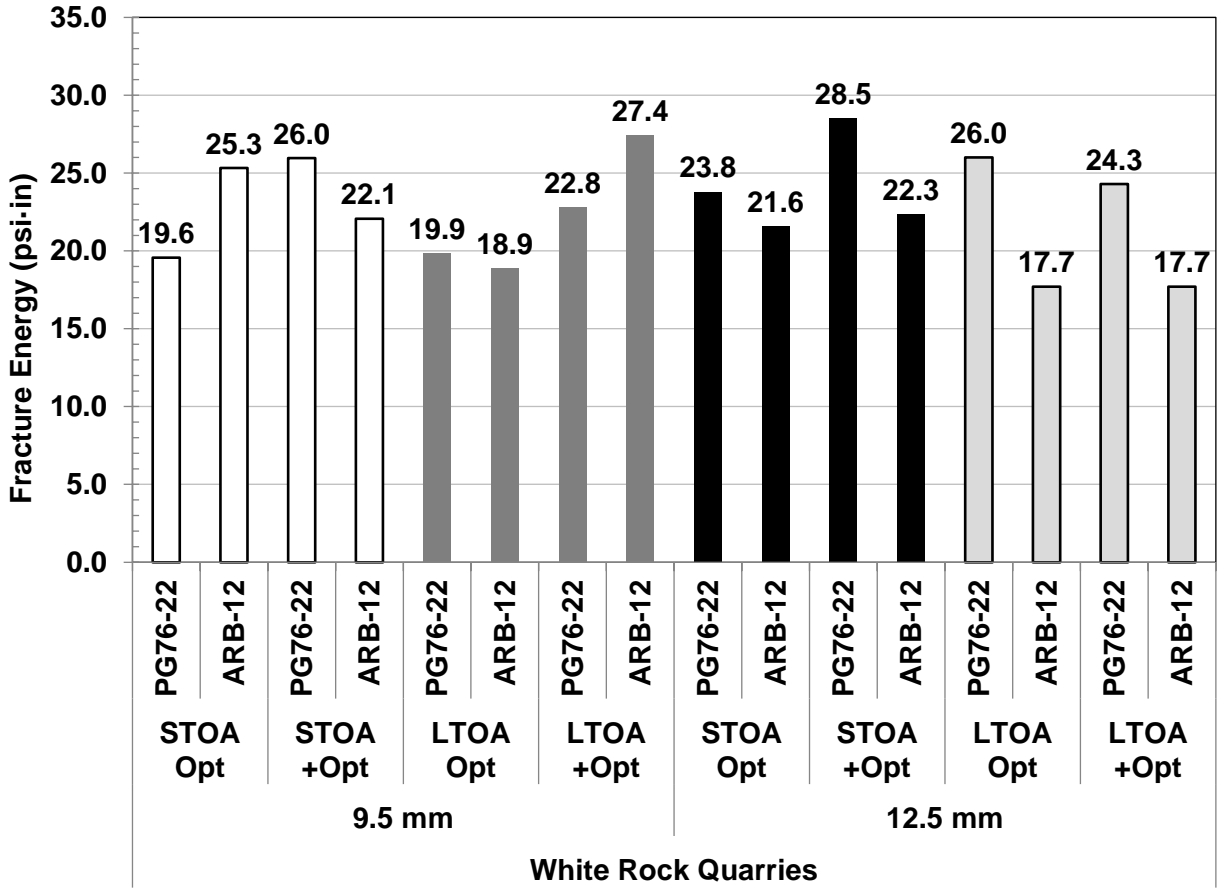
Figure 6.28 – IDT Maximum Strength FE for White Rock Quarries FC-5 Mixtures – Long-Term Oven Aged Condition

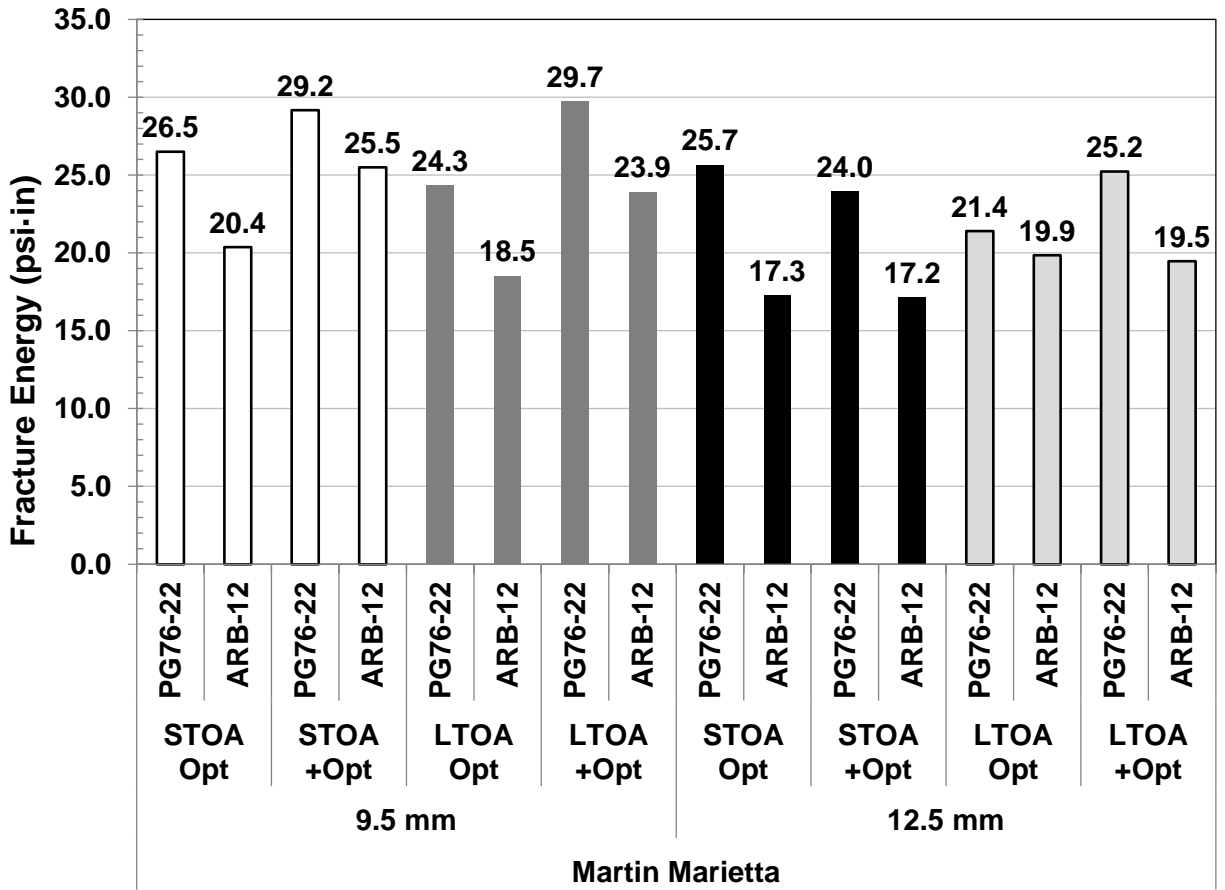
Figure 6.29 – IDT Maximum Strength FE for Martin Marietta FC-5 Mixtures – Long-Term Oven Aged Condition

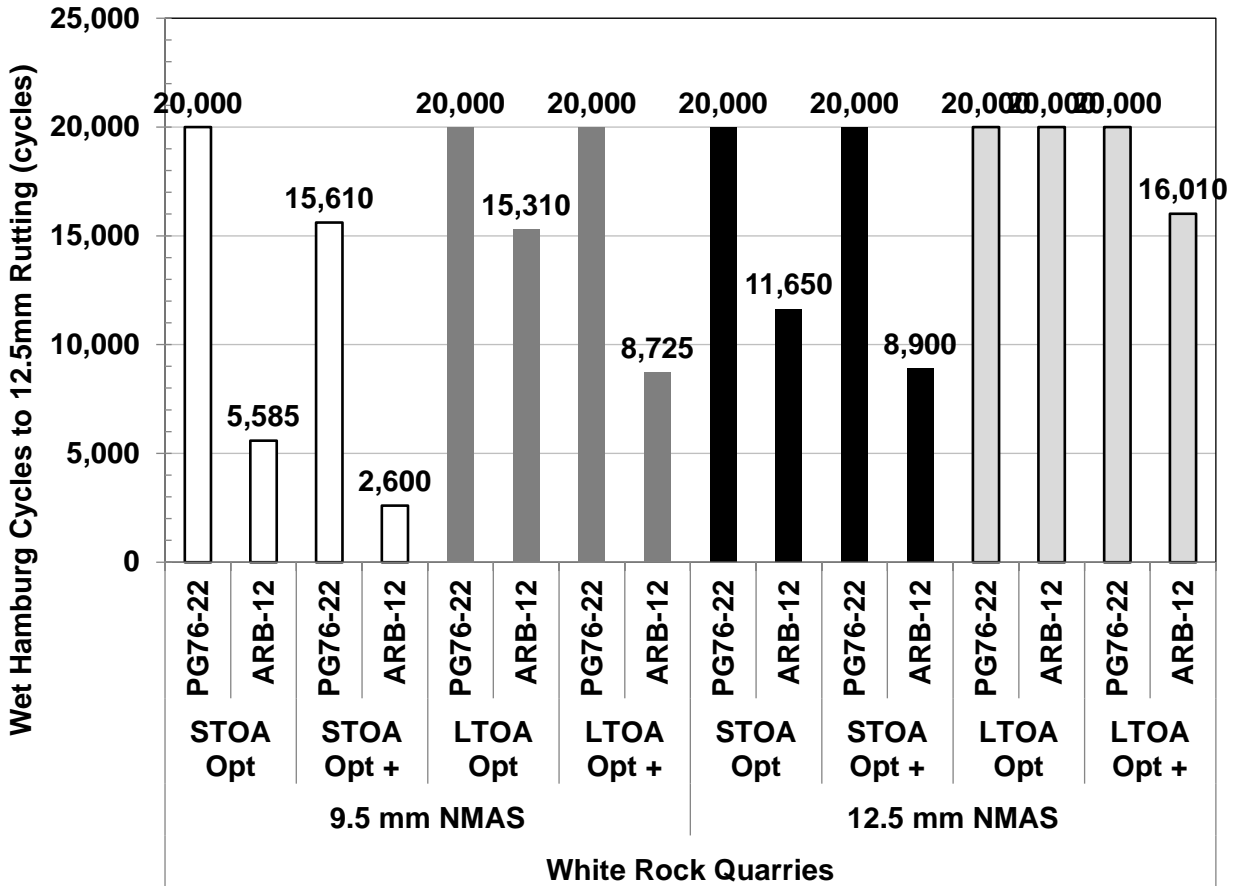
Figure 6.30 – Wet Hamburg Wheel Tracking Test Results for White Rock Quarries FC-5 Mixtures – Long-Term Aged Condition

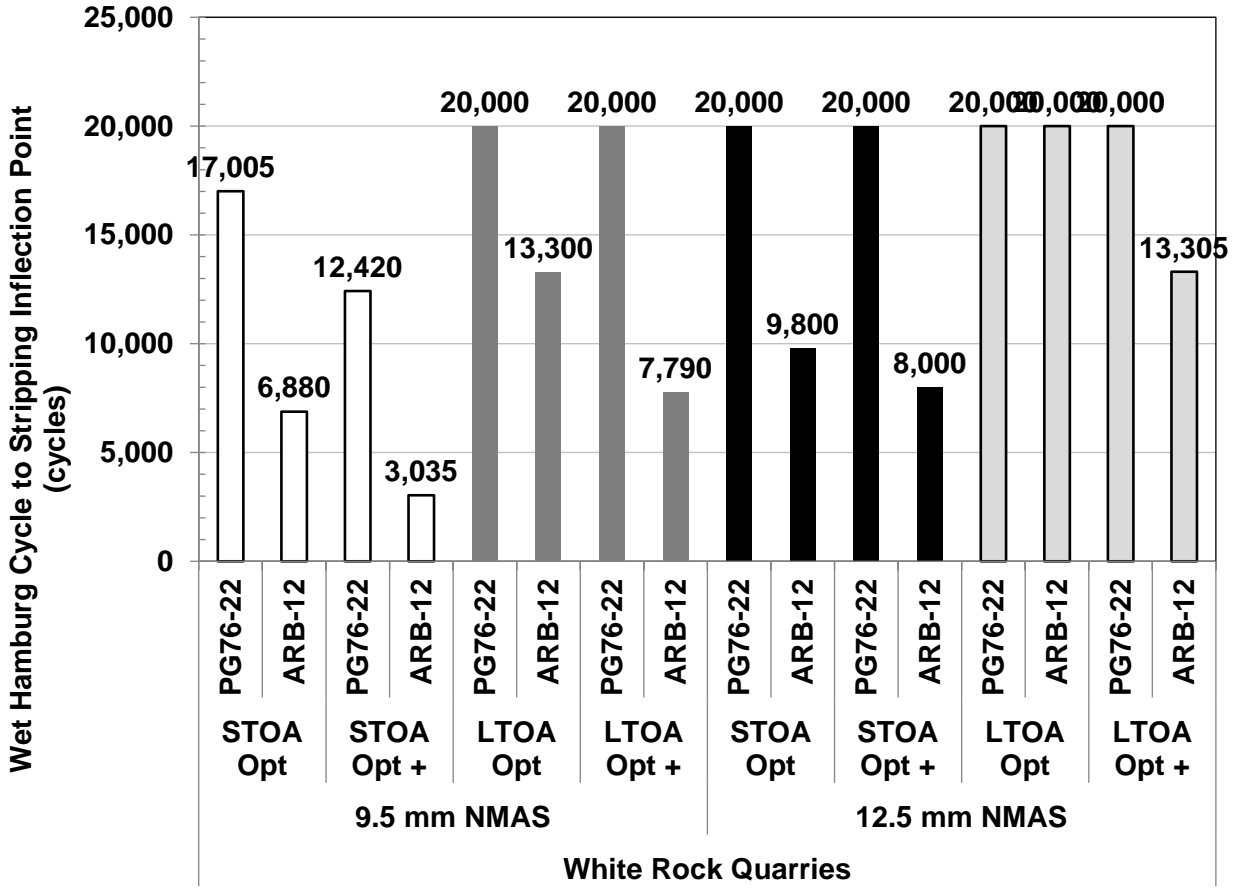
Figure 6.32 - Hamburg Wheel Track Testing for White Rock Quarries FC-5 Mixtures – Stripping Inflection Point (SIP) – Long-Term Aged Condition

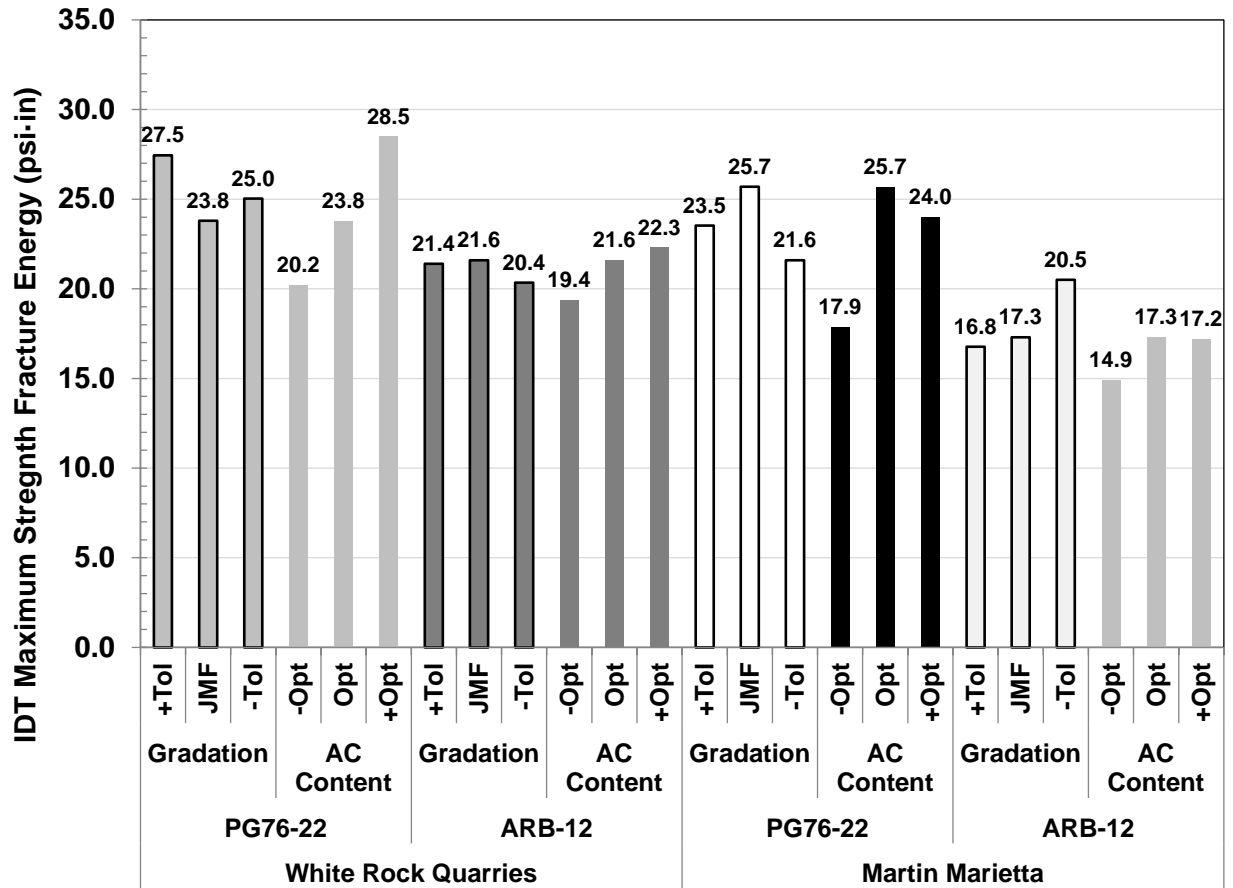
Figure 7.8 – IDT Maximum Strength Fracture Energy Due to Changes in Production Tolerances

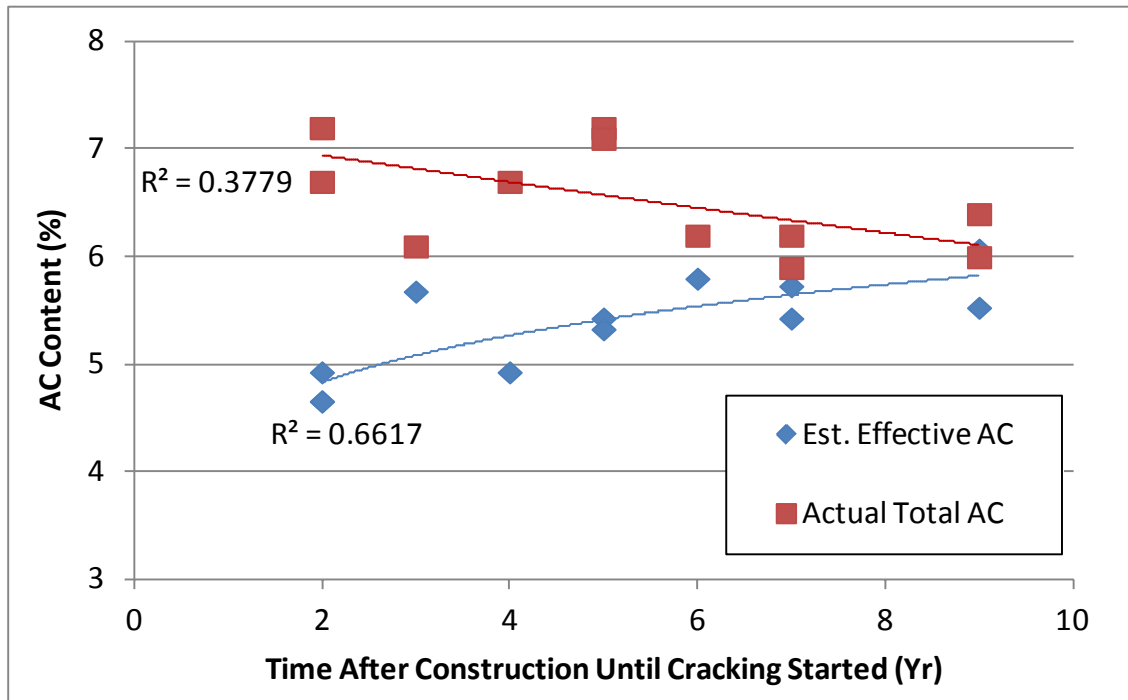
Figure 8.1 – Asphalt Binder Parameters vs Time After Construction Until Cracking Started

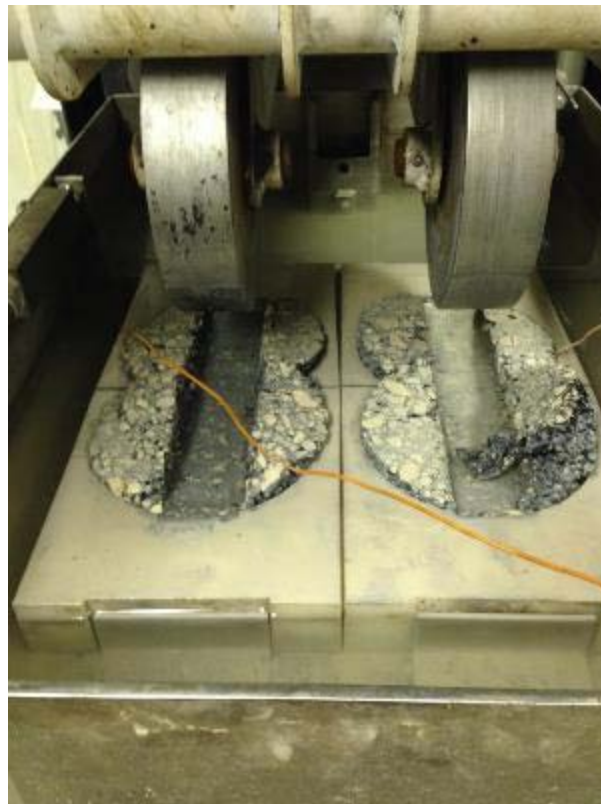
Figure 8.2 – Failed 9.5 mm NMAS FC-5 Specimens with ARB-12 Asphalt Binder
