On-Board Sound Intensity (OBSI) Study

Phase 2

FDOT Project No. #BDT06

Final REPORT

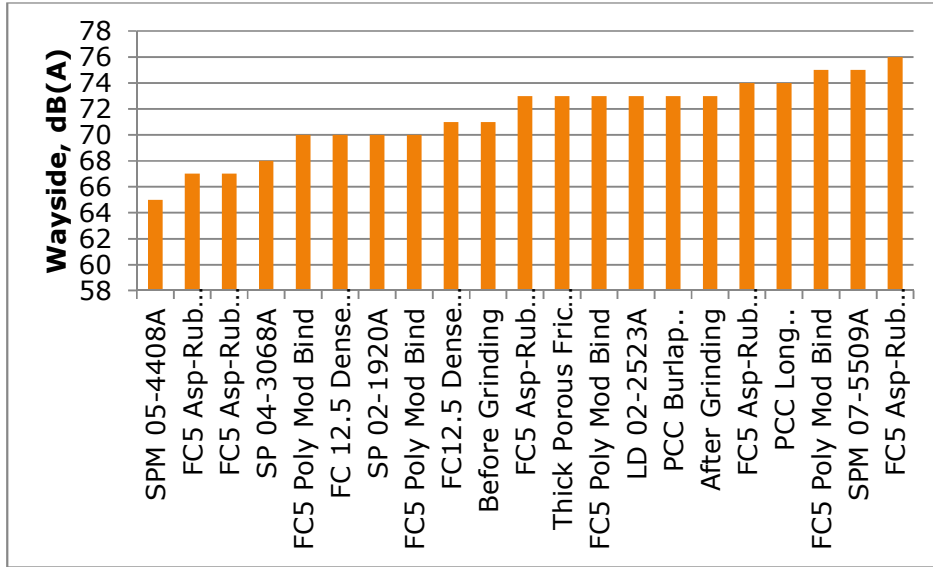
Figure 3. Ranking of Surface Textures by Wayside Sound Pressure Levels, Phase 1

Note: 04-3068A – FC9.5 – ARB5 – Granite; 05-4408A – FC9.5 – PG76-22 – Granite
 02-1920A – FC-6 – ARB5 – Limestone; 07-5509A – FC5 – PG 76-22 - Granite
 LD 02-2523A – FC5 – ARB12 – Granite

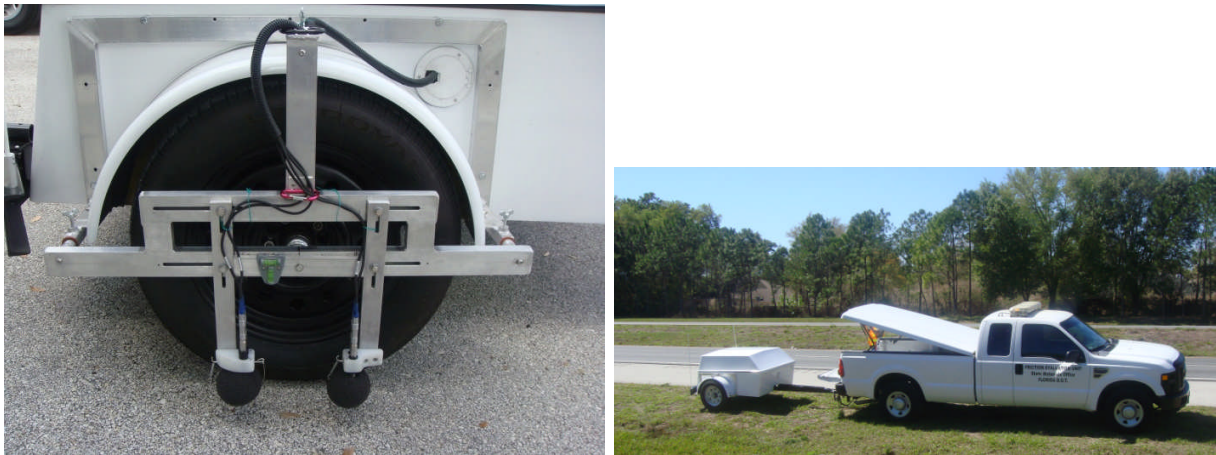
Figure 7. Final Rig, Intensity Probes, and Overall Vehicle System, Phase 2

As shown in Figure 7, the rig holds the preamplifiers and microphones in sets (test probe) which are connected via the cables shown to the analyzer. Exact location of the microphones is crucial and follows the standard established by the American Association of State Highway and Transportation Officials (AASHTO).⁶ Figure 8 shows the critical distances from the AASHTO standard.

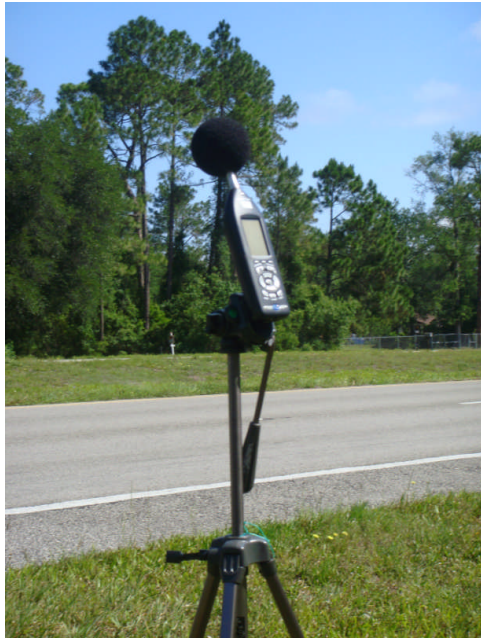
Figure 11. Sound Analyzer at Near Location Along SR 24

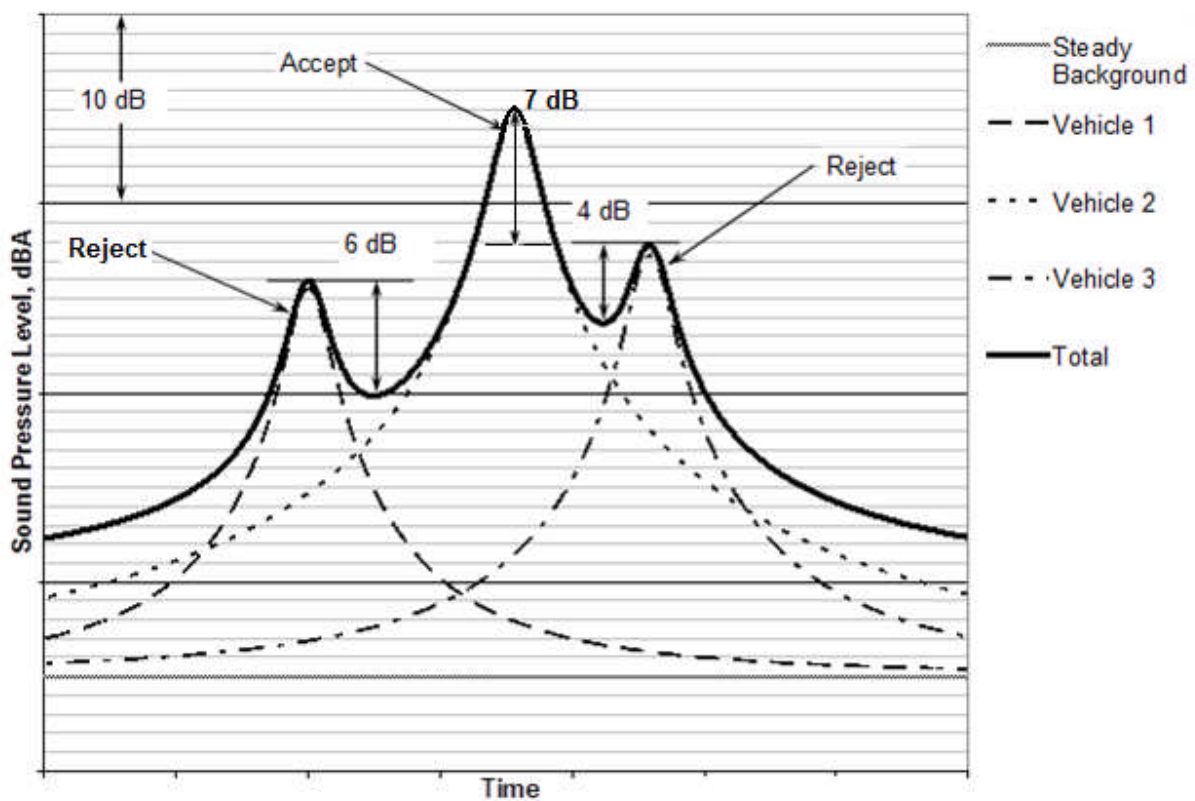
Figure 13. Idealization of Multiple Vehicle Passes and Acceptable Passby
(Note: 10 dB was goal but 7 is acceptable)

During quality control, only “clean passbys” were included in the wayside data base. A clean passby requires vehicle separation from all other vehicles, including both sides of the highway, sufficient for at least a 7 dB(A) difference in SPL from the passby and all other noise sources. This required careful observation of the traffic and when a quality passby was thought to occur, the time, vehicle type, measured speed, and comments were recorded. These passbys were later reviewed using custom software created for this project to determine if the criteria were met to allow inclusion in the final data base. Figure 13 shows graphically how the criteria are applied to vehicle passbys. While 7 dB(A) is acceptable, a goal of 10 dB(A) was also included and information stored based on both criteria. The project concentrated on the vehicle class known as automobiles of the Traffic Noise Model⁹ (4 tires and 2 axles) but good passby events of other vehicle types (medium trucks, heavy trucks, motorcycles and buses) were also included in the data base for comparative purposes although not discussed in this report.

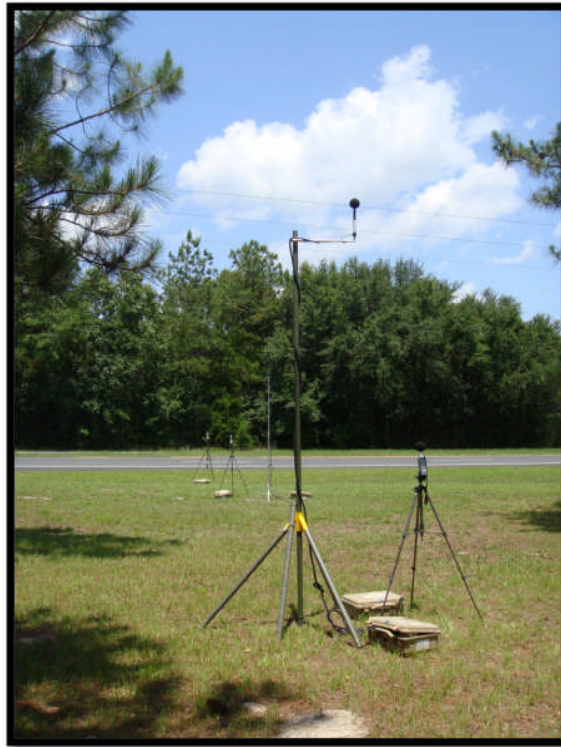
Figure 14. Typical Passby Equipment Configuration (sound level analyzers at five and twelve feet above pavement [Nearby meteorological station is not shown.]

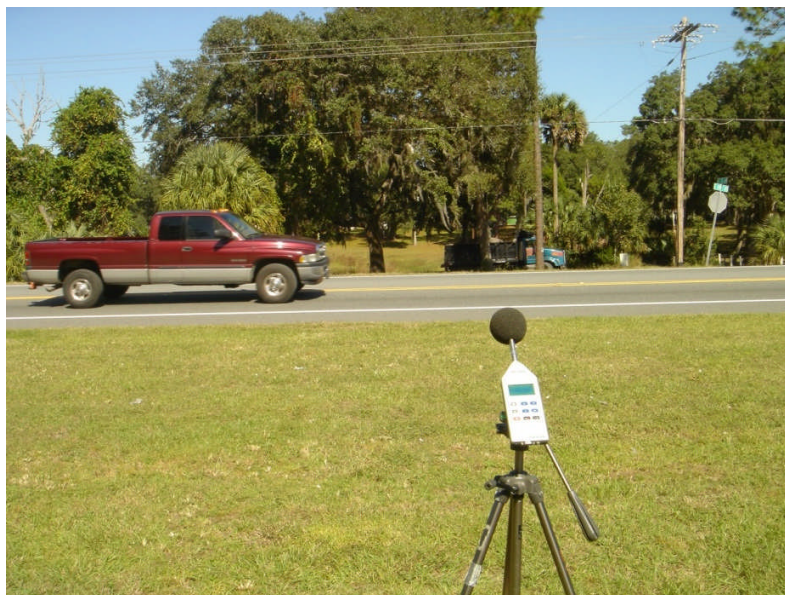
Figure 15. Nearby Passby Microphone Location During Tire/Pavement Test

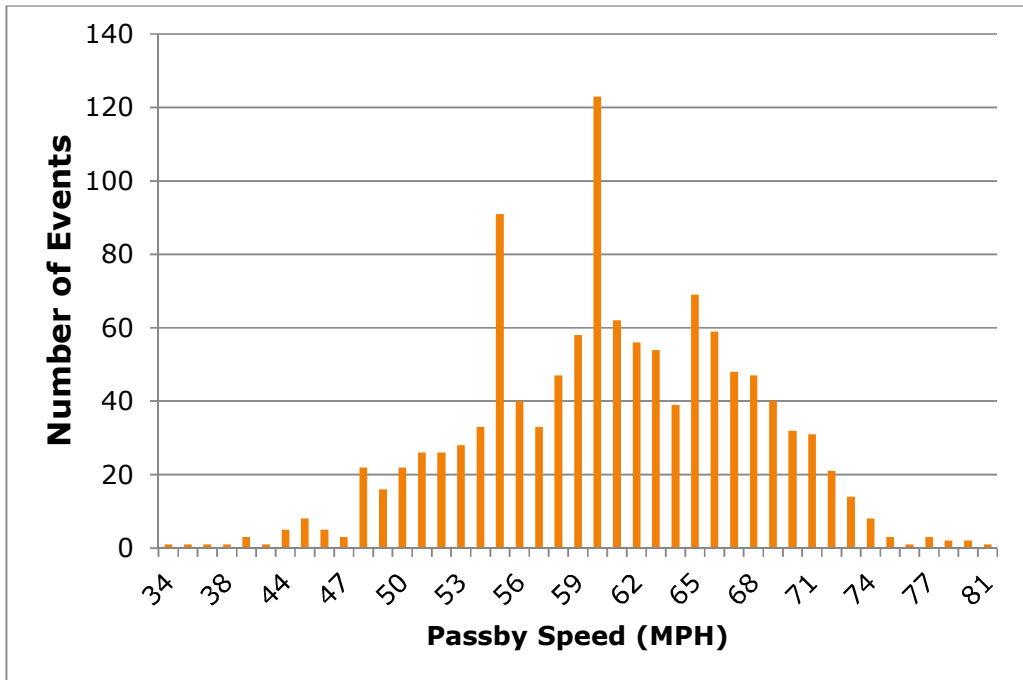
Figure 25. Measured Vehicle Speed Distribution

Additionally it should be noted that the passby data in the final data base did not all occur at 60 MPH (97 kph). To determine the needed values at or near 60 mph as shown in Table 9, a regression analysis was required at each location based on multiple events. Figure 25 has been included to show the real speed variation. All data were statistically analyzed with regression techniques to determine the average 60 mph sound pressure level which is reported and used in this analysis. The two peaks in the results are due to events at the test speed from the test vehicle that was measured to provide a quality control among final data for frequency analysis.

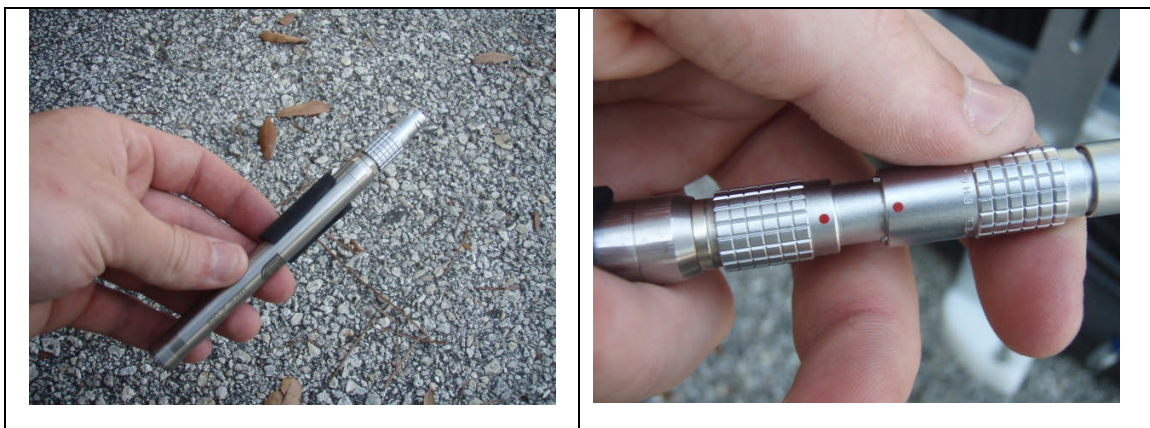
Figure A.1.8. Microphone/preamplifier assembly (left) and proper connection of cable (right)

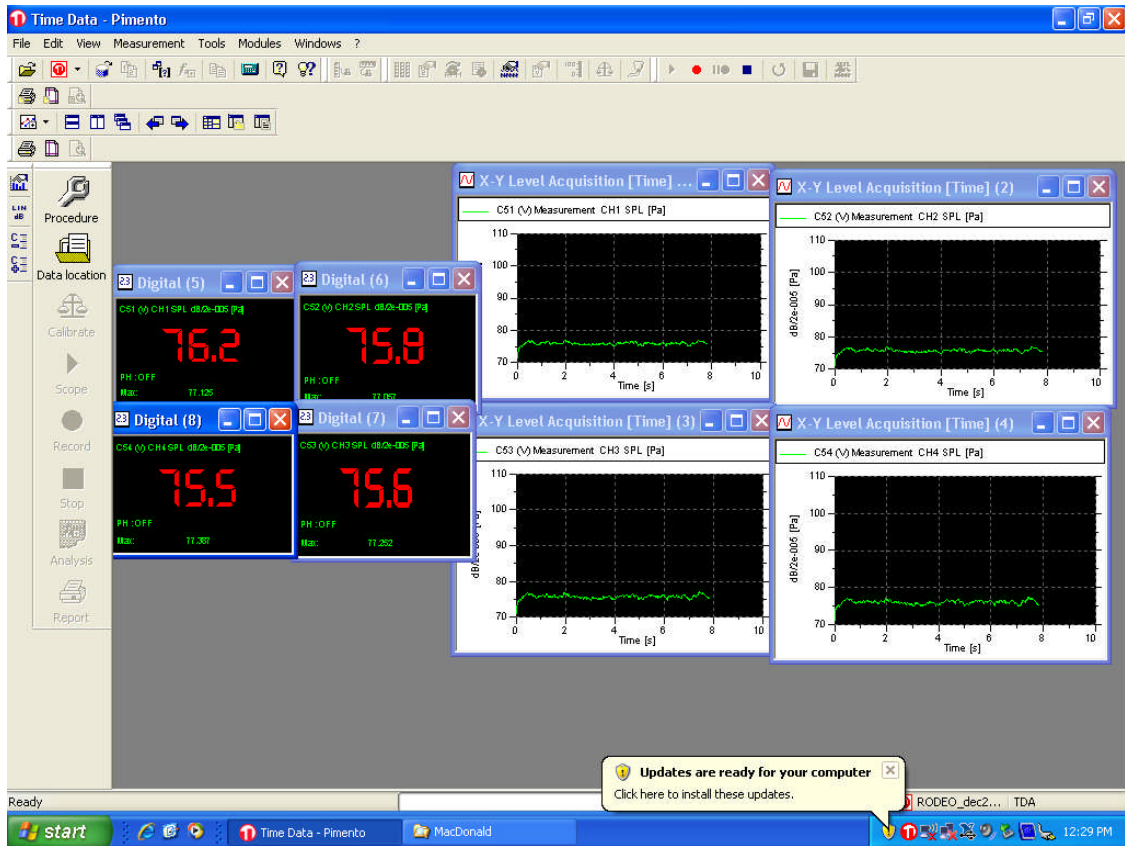
Figure A.1.11. Start of calibration with screen showing all four channels related to each microphone

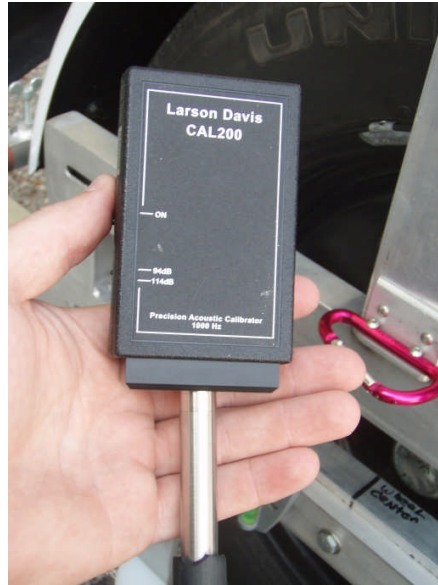
Figure A.1.13. Sound pressure calibrator applied to end of microphone/preamp combination, a switch is visible that adjusts the calibrator from a 94 dB tone to a 114 dB tone, this is to be set to 94 dB

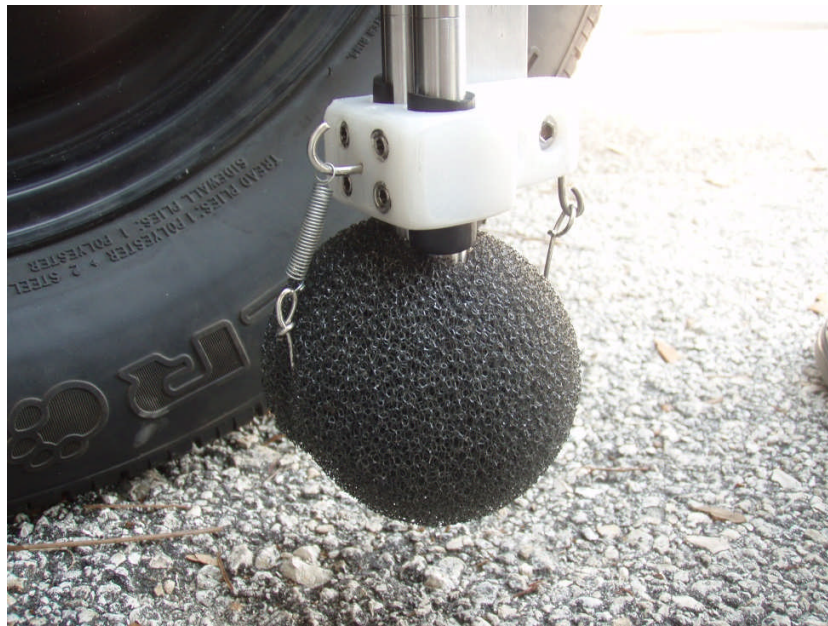
Figure A.1.18. Windscreen placed and secured over two microphones that comprise an intensity probe

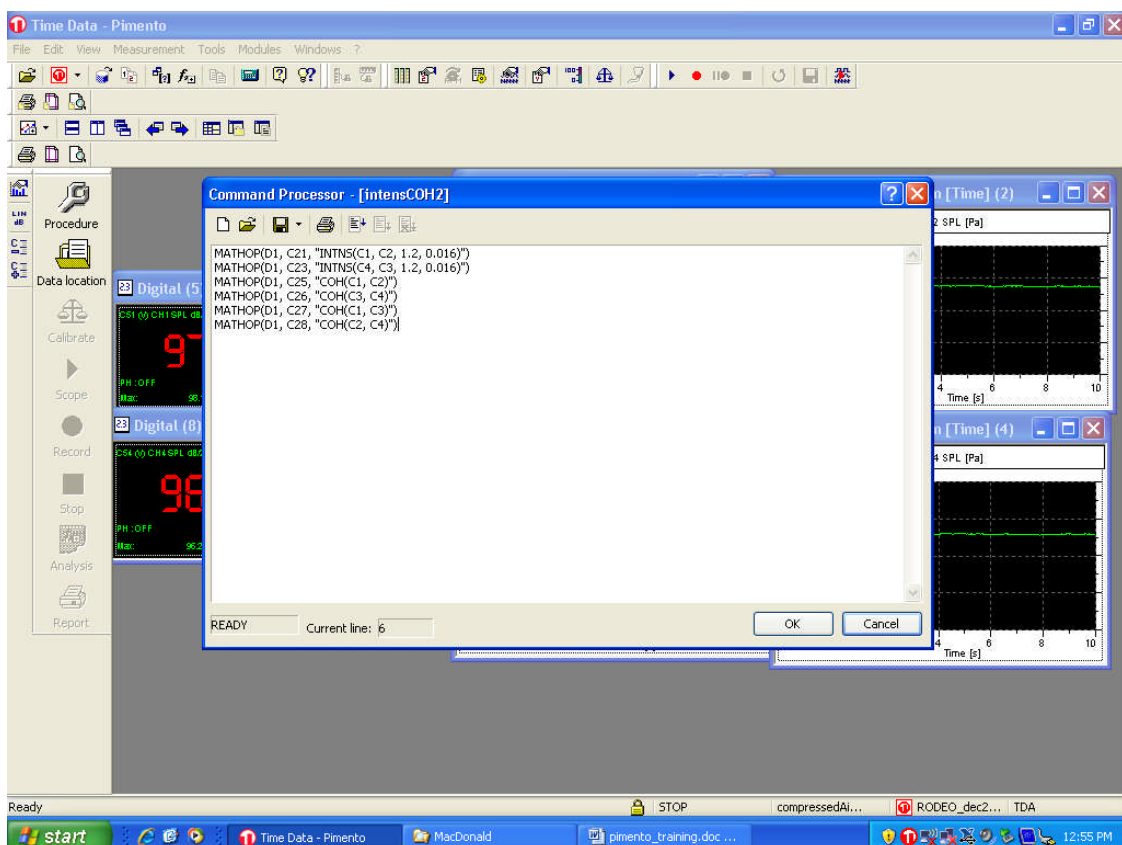
Figure A.2.3. Files are created for intensity levels
