Maintenance Practices for Stormwater Runoff - Phase 2

Phase 2 Final Report
Submitted May 2015

Florida Department of Transportation

Agency Number: BDV24-977-02

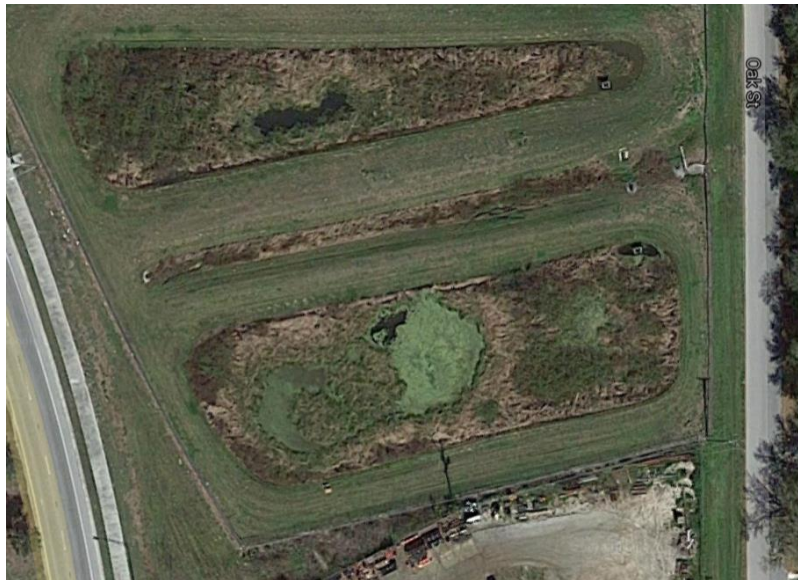
Figure 2: Zolfo Springs pond

This 0.49-acre pond is immediately adjacent to a forest to the east. North of the pond lies a residential area, and a piping warehouse is uphill of the pond to the south. State Road 35 borders the western edge of the pond. Surrounding the pond are grass swales and as the pond reaches max capacity, the excess water is carried through a culvert into the central ditch. The water then flows from the central ditch into the grass swales to the north, east, and west of the pond. Immediate intake locations that feed into the pond are placed along State Road 35. No intake locations were observed on the roads to the north and east of the pond. Apparent algal growth was the only maintenance issue reported for this pond. During the initial site visit the algal growth was readily

visible. In addition to the algal problems, there was a heavily overgrown littoral zone. An image of the Zolfo Springs pond is presented in Figure 2.

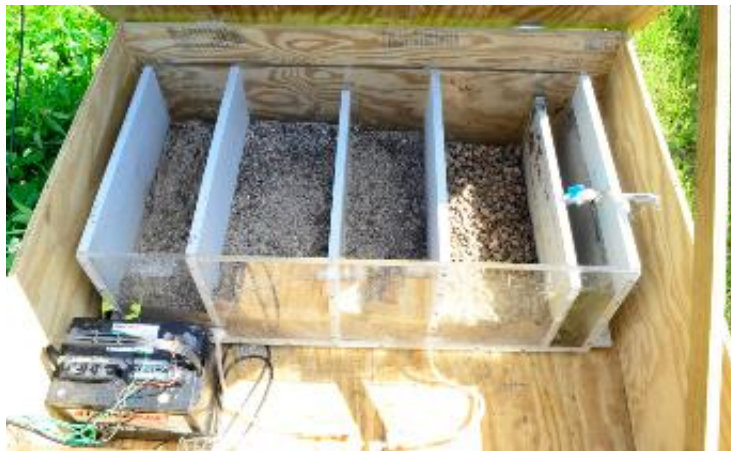
Figure 4: Sloped media bed reactor at Zolfo Springs pond

The BMP chosen for this pond was a Sloped Media Bed Reactor (SMBR). The treatment media bed reactor was designed to remove nutrients at the Zolfo Springs pond. The media mixture used in the SMBR was 50% 5/8^{ths} expanded clay and 50% tire chunk. The SMBR was chosen for this pond because of its nutrient removal capacity as well as simplicity in installation and operation. The SMBR utilizes solar energy for pump operation, therefore cutting down on potential future expenses and utilizing clean renewable energy. A cross-sectional side view of the SMBR is given below in Figure 3 and a picture of the SMBR in the field in Figure 4.

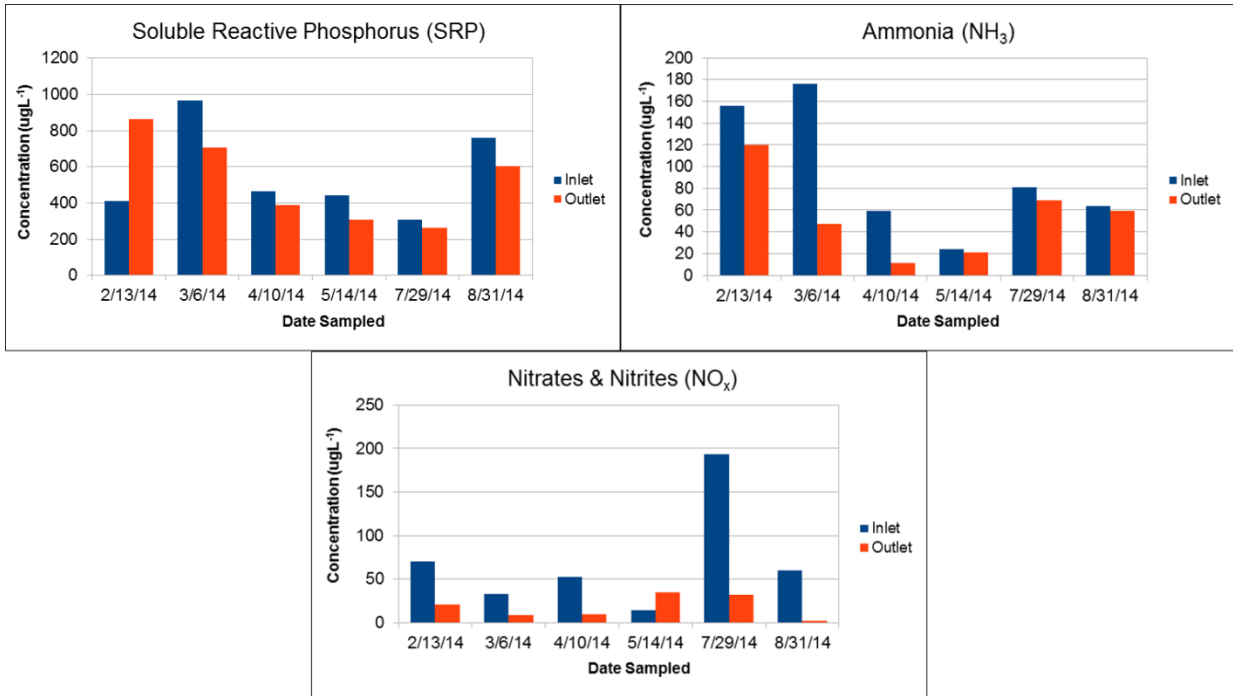
Figure 5: Soluble nutrient levels in the Zolfo pond for the post-BMP condition

The lab results displaying the ponds removal performance for soluble (Figure 5) and total (Figure 6) nutrient species are presented below. As seen in the below figures, the pond generally appears to consistently remove nitrates/nitrites and ammonia with recorded average removal rates of 74% and 42%, respectively. This may be explained by biological processes which function within the water column and sediments, coupled with frequently recorded low dissolved oxygen measurements which are indicative of denitrifying conditions. The total nitrogen levels appear to remain constant, while the total phosphorus removal efficiency appears to generally remove phosphorus consistently at an average rate of 17% or greater, with the exception of the first sampling date.

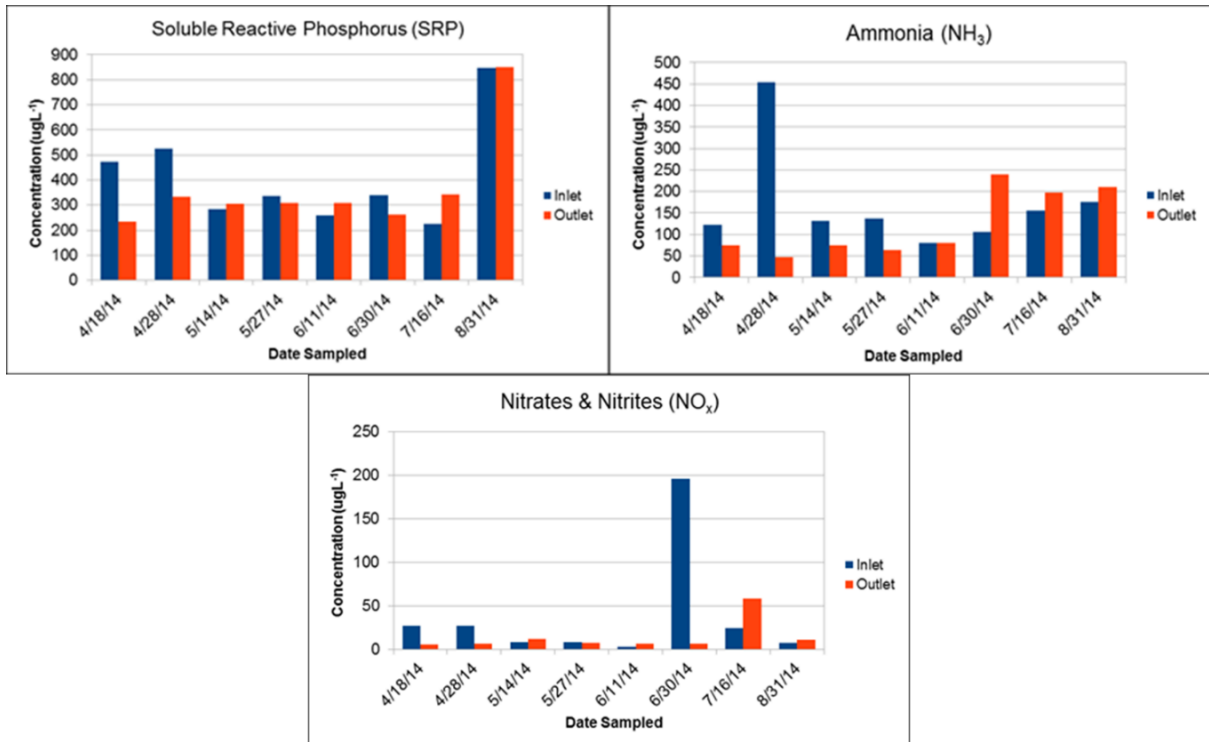
Figure 7: Soluble nutrient levels for SMBR for the post-BMP condition

Ammonia where removal rates saw a decrease during the time period of June through August. The average removal rates for SRP, NH_3 , and NO_x for the 8 sampling dates were 10.7%, 27.7% and 63% respectively. The SMBR appears to have consistent removal of TP, averaging 21.5%, while TN species appear to vary more, however total an average of 28.0%.

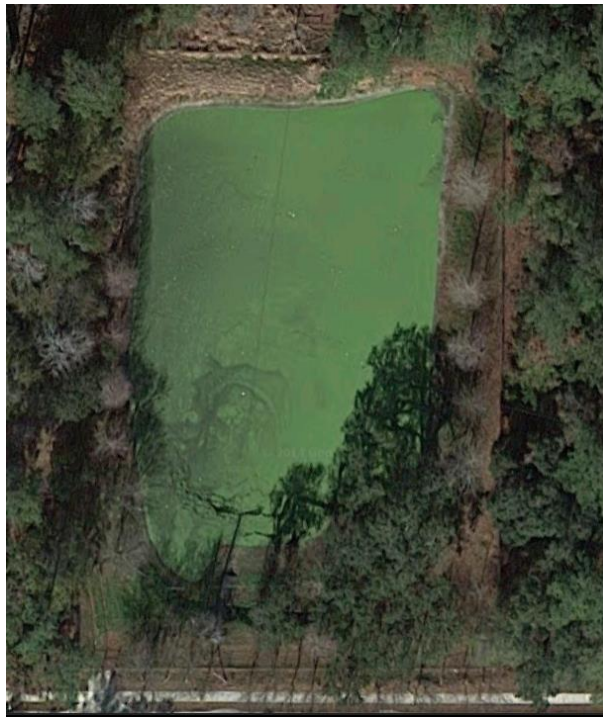
Figure 9: Gainesville pond

This 0.58-acre pond lies at the low point between two hills to the east and west. Runoff pooling at the low point of State Road 26 to the south is discharged into the pond through stormwater piping. District 2 reported major algae growth within the pond, in addition to significant amounts of floating debris. During the initial site visit, the entire surface of the pond was covered in a layer of algae. Since the pond is surrounded by forest that is at higher elevation, the nutrients from the forest floor are collected during storm events and carried downhill into the pond. Bottles and miscellaneous floating debris were also observed on the surface on the pond. The chain-link fence around the pond should prevent debris from entering, which leads one to conclude that the majority of the floatables are being transported in through the stormwater inlet to the pond. An image of the Gainesville pond is presented in Figure 9.

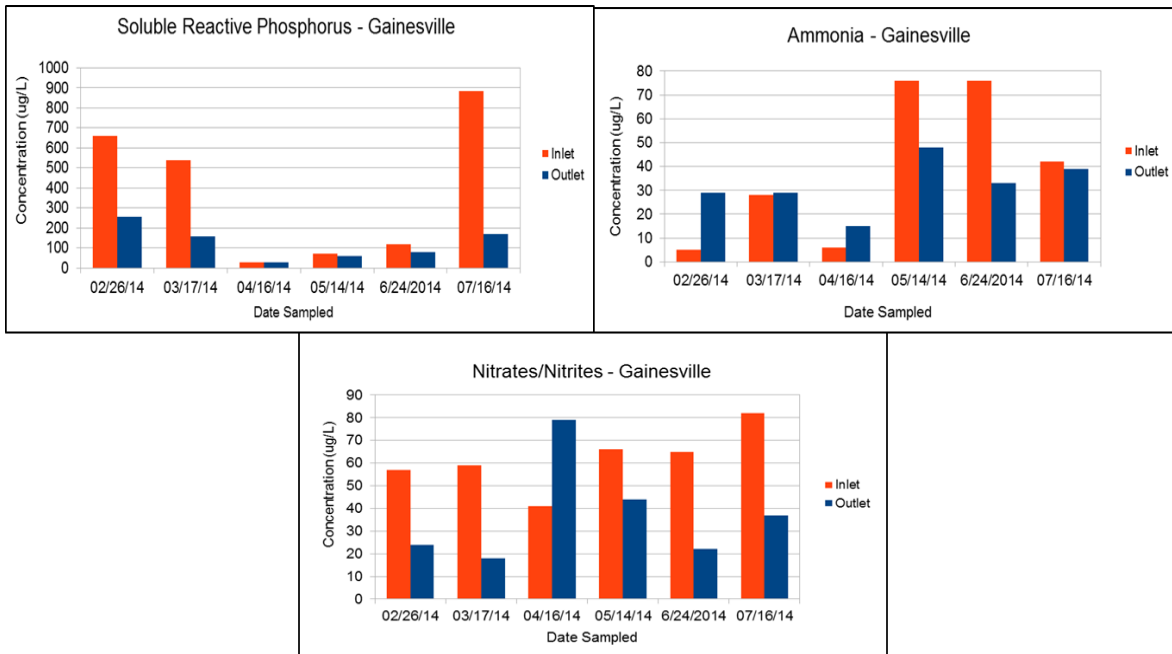
Figure 11: Soluble nutrient levels in the Gainesville pond for the post-BMP condition

As the primary removal mechanism of Floating Treatment Wetlands is through direct uptake of dissolved nutrient species, the Post-BMP results for SRP, NO_x, and NH₃ are presented in Figure 11.

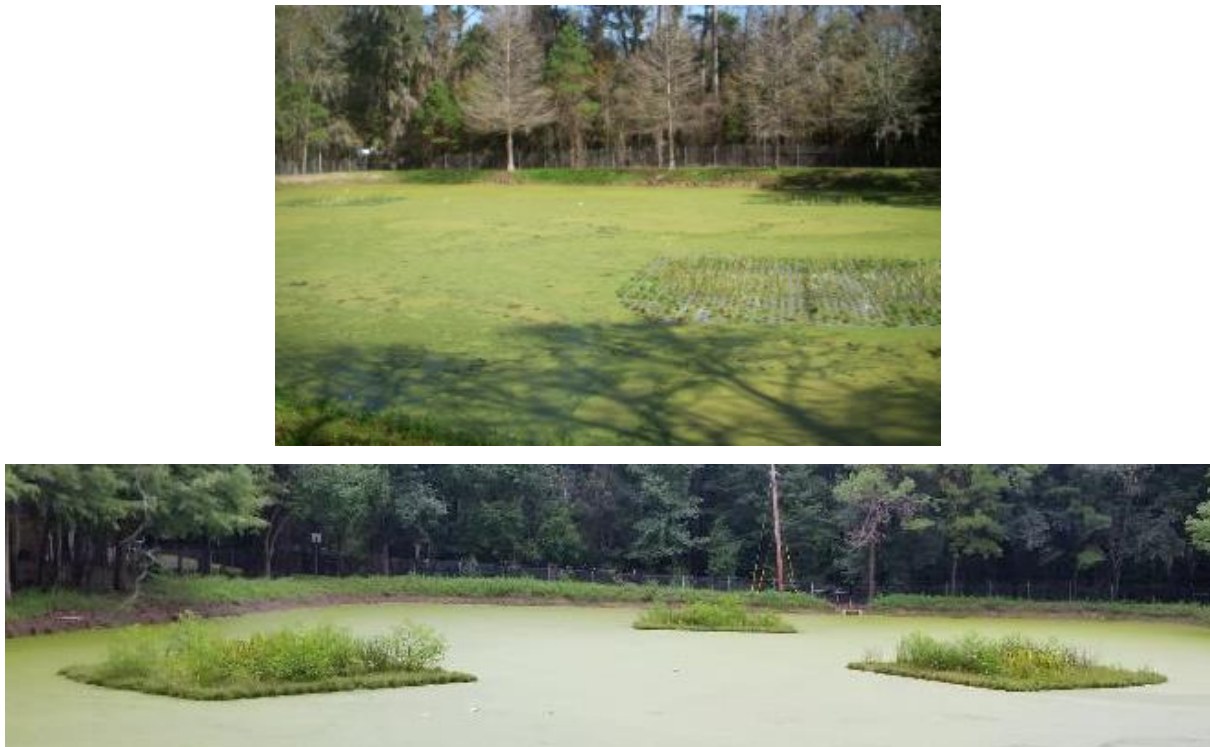
Figure 13: FTW plants right after deployment (above) and prior to plant replacement (below) that shows the growth of the plant species

The only vegetative growth observed at the Gainesville pond prior to BMP deployment was severe algal growth. Since BMP deployment the algal presence in the pond has transitioned to a thick layer of duckweed that covers the entirety of the pond surface. Although the duckweed is still well-established in the pond, suggesting that nutrient levels are still high enough to support their population, it has not established growth on the floating mats, and hence has not interfered with FTW growth. In addition, the placement of the mats in a staggered formation and the use of a single anchor per mat has proven to be effective and no maintenance concerns have been observed to date. A side-by-side comparison of the FTWs from deployment to before plant replacement provided in Figure 13.

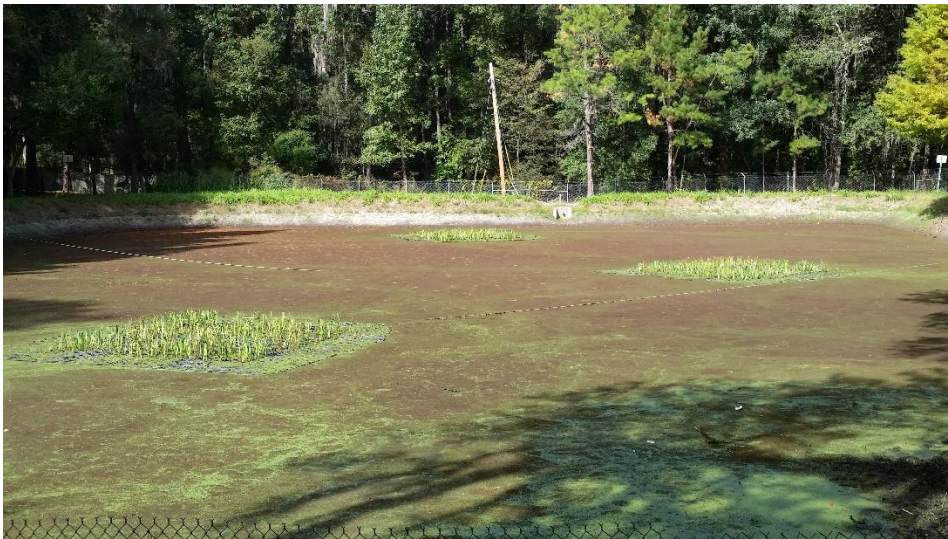
Figure 14: FTW plants after plant replacement

A complete replacement of the FTW plants was performed on October 10 and November 5, 2014. On October 10, 2014 all mature plants were removed from the FTWs and bagged for later disposal. On November 5, 2014 seedlings were delivered to the Gainesville pond, placed into the FTWs and the previously collected mature plants were taken away for disposal. The FTWs after plant replacement can be seen in Figure 14. Replacing the plants on FTWs allows us to observe nutrient removal throughout the FTW plant lifecycle and also prevents mature plants that may have otherwise died from falling into the pond, which would re-introduce nutrients back into the water column.

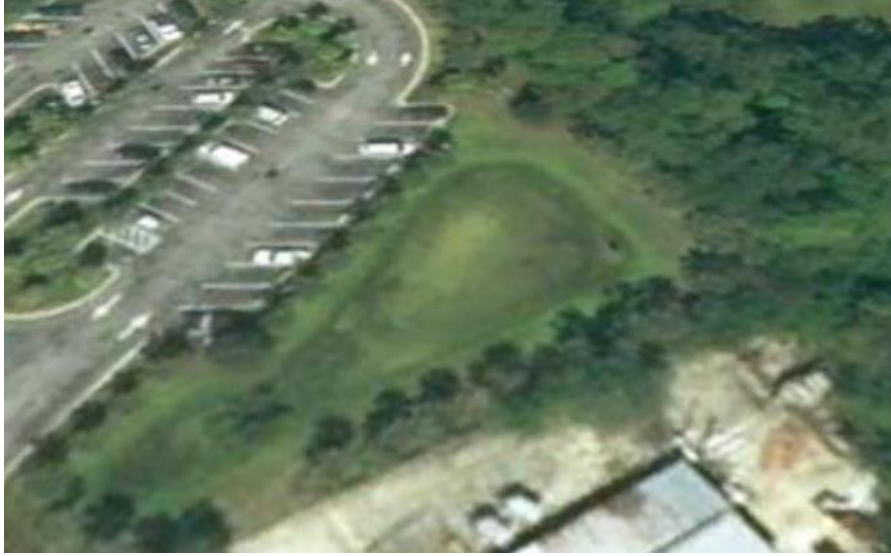
Figure 16: East Palatka pond

This 0.11 acre pond has parking lots to the north and south of it. US 17 runs along the western side of the pond and is directly connected to the parking lot to the south. A forested area and stream are downhill from the pond to the east. Sediment loadings, algal growth, and nuisance vegetation were the primary maintenance issues reported for this pond. The algal growth was quite apparent during the initial site visit. There is a mature forest area located across from US 17; this is one possible nutrient source that is contributing to the algae problem. A minor amount of nuisance vegetation was seen in the eastern portion of the pond, yet nuisance vegetation and sediment loading were visible near the pond inlet. An image of the East Palatka pond is presented in Figure 16.

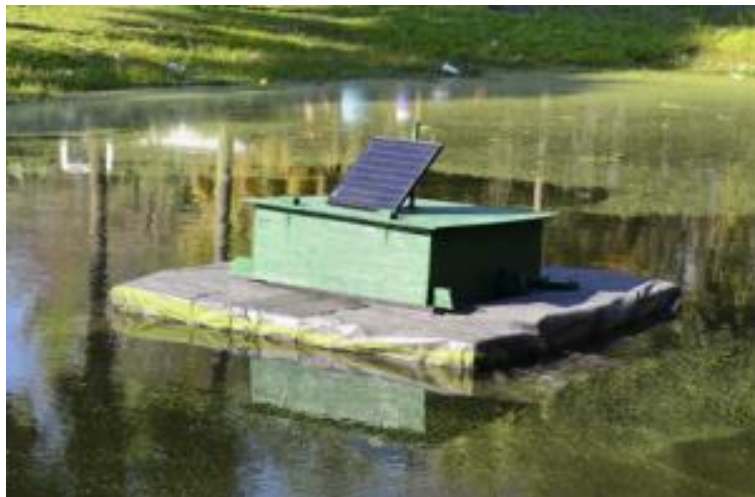
Figure 18: Floating media bed reactor at the East Palatka pond

The BMP chosen for this pond was a Floating Media Bed Reactor (FMBR). The treatment media bed reactor was designed to remove nutrients at the East Palatka pond. The media mixture used in the FMBR was 50% sand, 20% tire crumb, 20% fine expanded clay, and 10% limestone. The media bed reactor was designed to be floatable due to some nuisance vegetation around the pond, so placing the media bed reactor directly in the pond offered the most effective location. The FMBR was deployed at the East Palatka pond on February 13, 2014. The FMBR was chosen for this pond because of its nutrient removal capacity as well as simplicity in installation and operation. The FMBR utilizes solar energy for pump operation, therefore cutting down on potential future expenses and utilizing clean renewable energy. A cross-sectional view of the FMBR is given below in Figure 17 and a picture of the FMBR in the field in Figure 18.

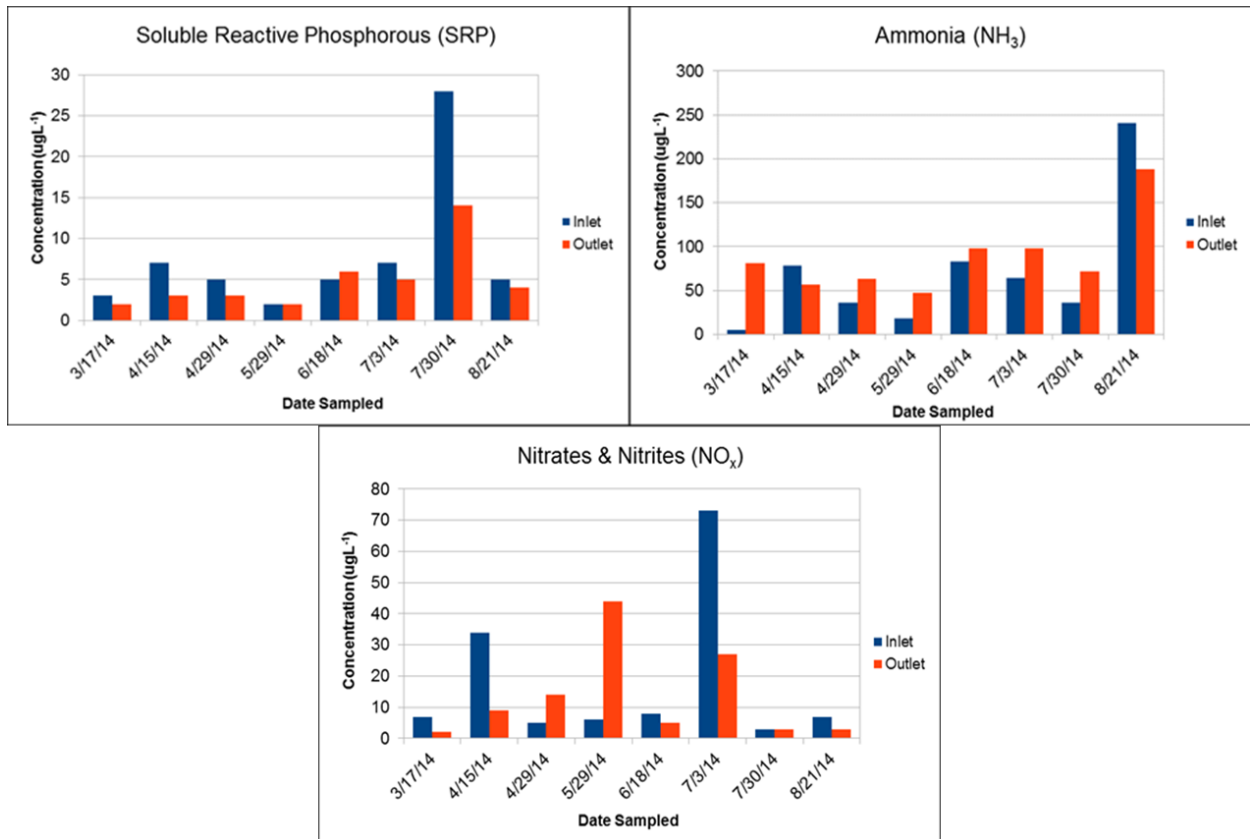
Figure 21: Soluble nutrient levels for FMBR for the post-BMP condition

conditions of dissolved oxygen (DO) from storm events which would affect the biological performance of the media especially with the relatively small size of the pond with two inlets (one of which entering midway), which when combined, typically may result in a higher degree of mixing with highly oxygenated runoff during rainfall events. The FMBR showed a very good and consistent removal of TP, amounting to an average removal efficiency of 52%. Whereas TN displayed varying removal efficiencies totaling 10.4%.

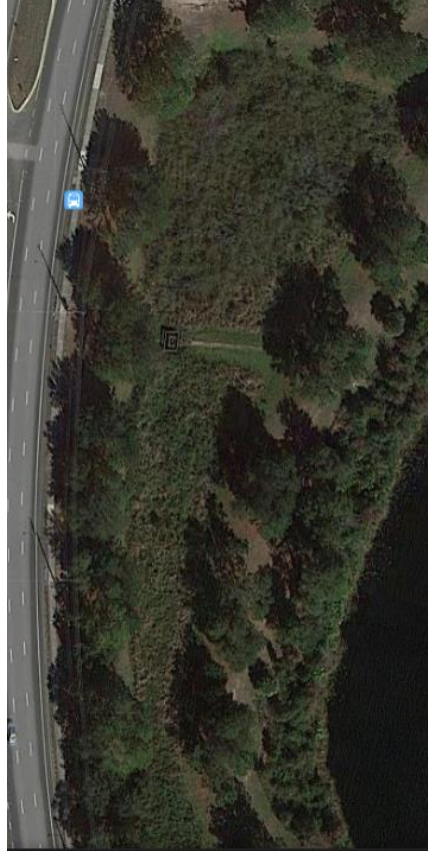
Figure 23: Orlando pond

This 0.98 acre pond is located in Orlando and the primary maintenance issues reported for the pond were algae and cattail growth as well as a heavily overgrown littoral zone. The initial site visit revealed that the pond was split by a berm. The pond section south of the berm suffered from algae and cattail growth. The pond section north of the berm was heavily overgrown with vegetation and small trees. It was recommended that the nuisance vegetation be removed prior to any BMP implementation. An image of the Orlando pond is presented Figure 23.

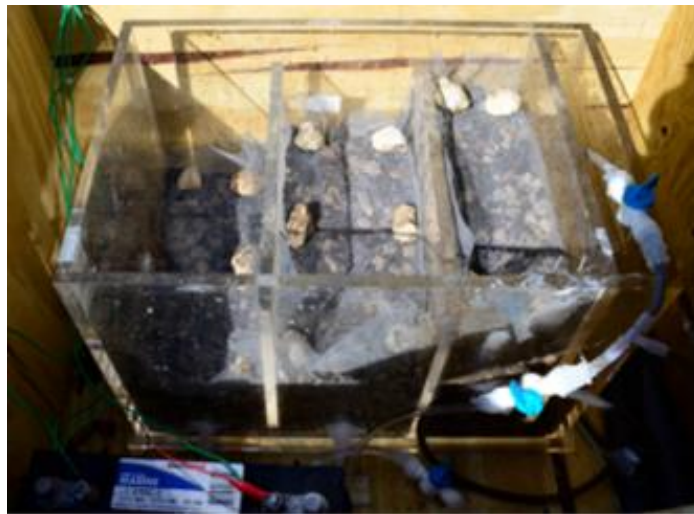
Figure 25: Horizontal media bed reactor at the Orlando pond

The BMP chosen for this pond was a Horizontal Media Bed Reactor (HMBR), which was installed at the site on April 1, 2014. The media mixture used in the HMBR was 50% 5/8ths expanded clay and 50% tire chunk. The HMBR was chosen for this pond because of its nutrient removal capacity as well as simplicity in installation and operation. The HMBR utilizes solar energy for pump operation, therefore cutting down on potential future expenses and utilizing clean renewable energy. A cross-sectional view of the HMBR is given below in Figure 24 and a picture of the HMBR in the field in Figure 25.

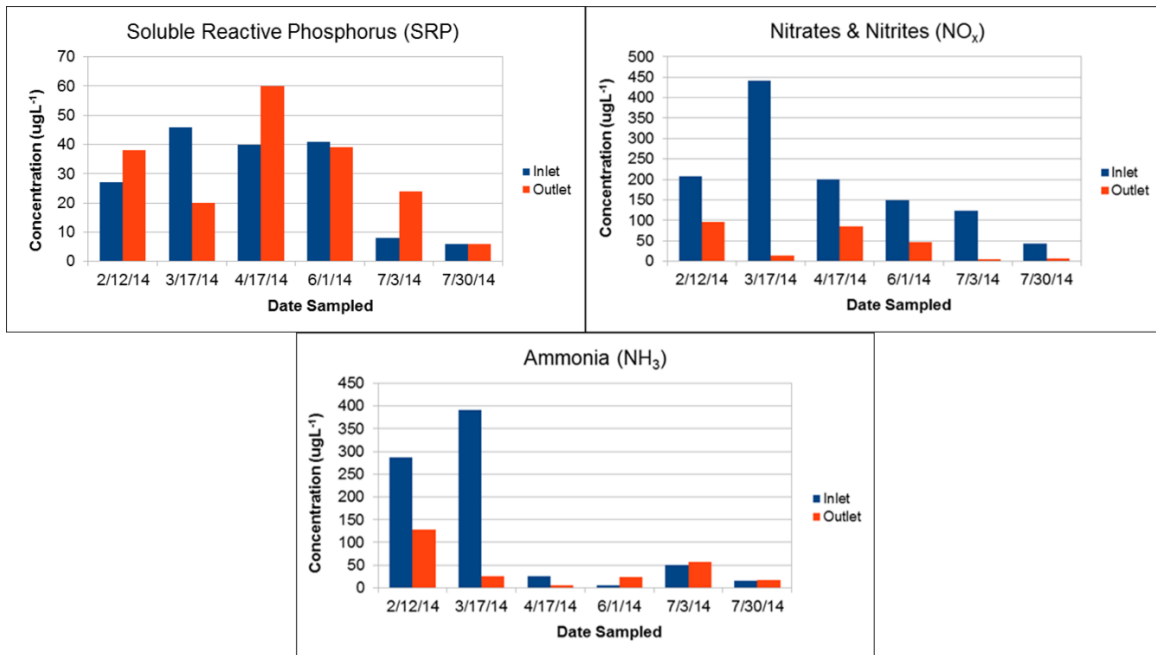
Figure 26: Soluble nutrient levels in the Orlando pond for the post-BMP condition

The lab results displaying the ponds removal performance for soluble (Figure 26) and total (Figure 27) nutrient species are presented below. As can be seen in Figure 26, the pond shows consistent removal efficiency of the NH_3 and NO_x species, 67% and 78%, respectively. The pond displayed good removal efficiencies for both TP and TN, averages totaling 35% and 56%, respectively. The pond did not exhibit effective removal of SRP, but SRP concentrations were much lower at this site than at other pond sites in this study that had issues with excess nutrients.

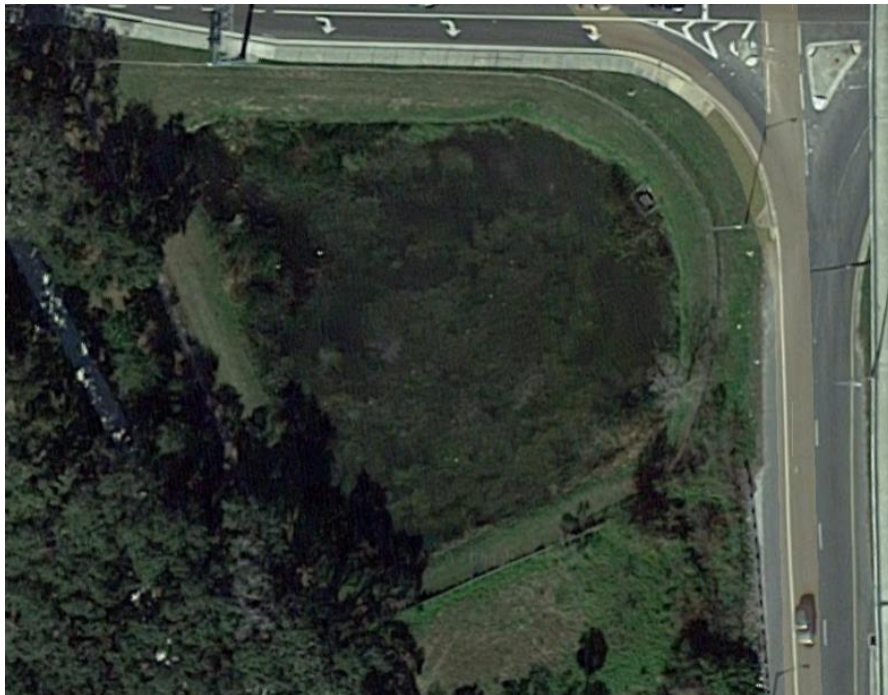
Figure 30: Clearwater pond

This 0.53-acre pond is located adjacent to a highway intersection and a residential park. The area to the west of the pond is a residential park, and a forest borders the southern end of the pond. Hidden beneath the trees in the southwest corner of the pond is a small parking lot. To the north is Gulf-to-Bay Boulevard, and County Road is to the east. With regard to the pond, it has a lengthy grass swale that runs along its perimeter. The inlet to the pond is located on the northwest corner, which is connected to the stormwater drain on Gulf-to-Bay Boulevard. Thick recurrent cattail growth was the major problem reported for this pond. During the initial site visit, it was seen that the entirety of the lake was clogged with cattail. It would appear that the cattail had not been cleared from the pond in recent years. As a result, the pond is covered from inlet to outlet, which has severely reduced the storage volume of the pond. Routine removal of the cattail should occur in order to prevent the nuisance vegetation from taking over the pond. An image of the Clearwater pond is presented in Figure 30.

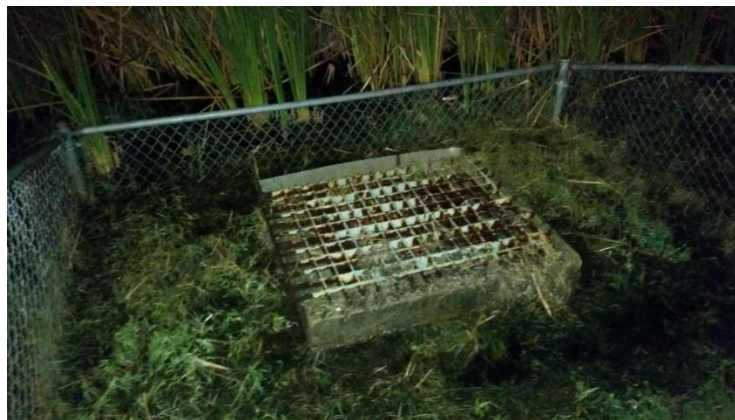
Figure 33: Grass clippings in Clearwater pond outlet

The final storm sample for Clearwater was collected on November 8, 2014. During the sampling trip a large quantity of grass clippings were observed in and around the pond outlet. These clippings may contribute to high organic nutrient concentrations, Figure 36 shows that there was a large spike in both TP and TN sediment concentrations near the outlet. A photo of the excessive grass clippings is shown below in Figure 33.

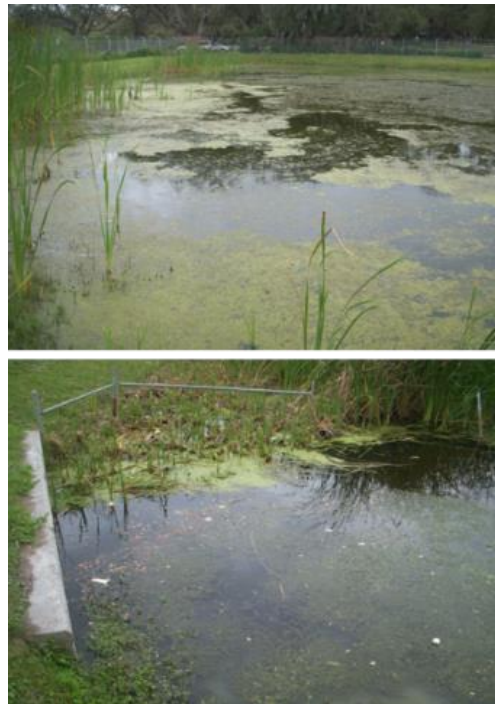
Figure 34: Filamentous green algae and hydrilla observed at the Clearwater pond

Early observations of the pond after the removal of the cattail showed that hydrilla and filamentous green algae took hold of the pond, as seen in Figure 34. This could explain why the increase in nutrient removal efficiency was so dramatic after cattail removal. The chlorophyll-a levels at the inlet, shown in Figure 35, did show an increase from February to May 2014, however this is most likely a seasonal fluctuation, attributed to the warmer temperatures. If it is the case that algae are the primary consumers of the nutrients, then the presently observed removal will likely decrease some overtime as the pond ecosystem returns to equilibrium.

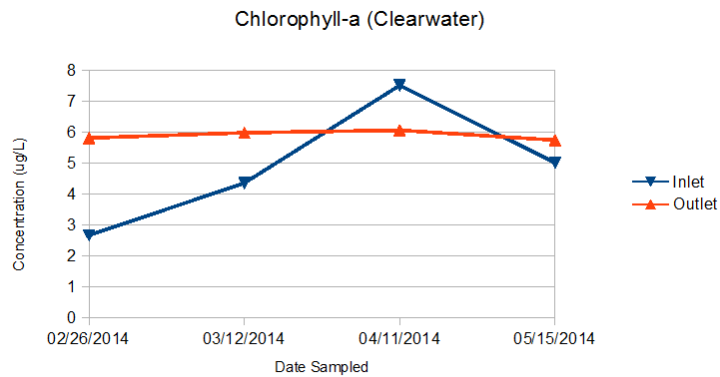
Figure 35: Chlorophyll-a levels in the Clearwater pond

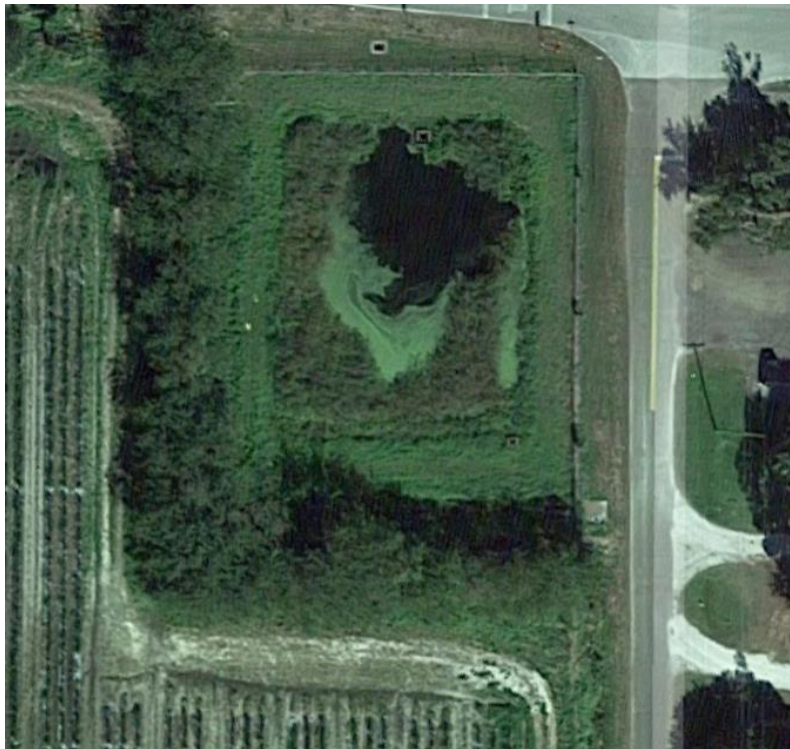
Figure 37: Ruskin pond

This 0.31 acre pond has a commercial shopping center to the east of it and a residential neighborhood to the north. The western and southern edges of the pond border a tomato field. This made the pond a prime candidate for selection, because the pond is exposed to very high nutrient concentrations as fertilizers are washed from the tomato field into the pond. A thicket of trees and shrubs are between the agricultural field and the pond, yet algal blooms still appear to be a problem. The brush bordering the pond exhibited significant growth and the littoral zone needed to have excess vegetation removed. Severe algal growth and an overgrown littoral zone were the primary maintenance issues with this pond. An image of the Ruskin pond is presented in Figure 37.

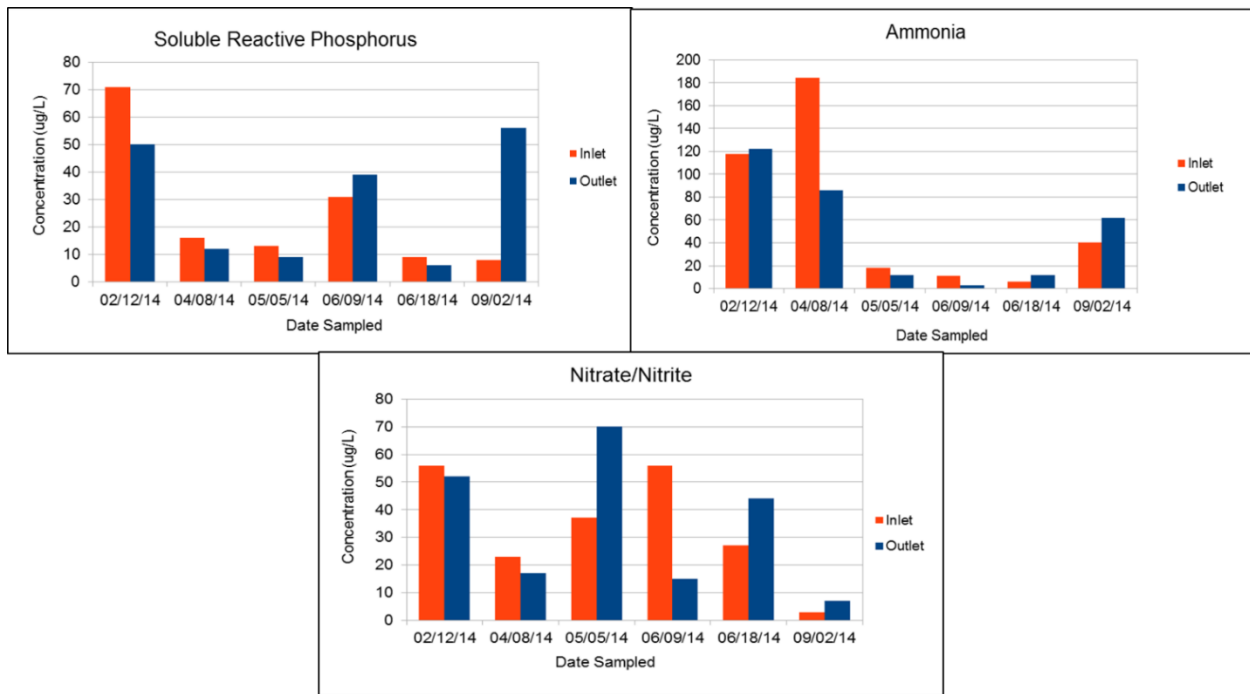
Figure 39: Soluble nutrient levels in the Ruskin pond for the post-BMP condition

As the primary removal mechanism of floating treatment wetlands is through direct uptake of dissolved nutrient species, the results for SRP, NO_x, and NH₃ are presented in Figure 39.

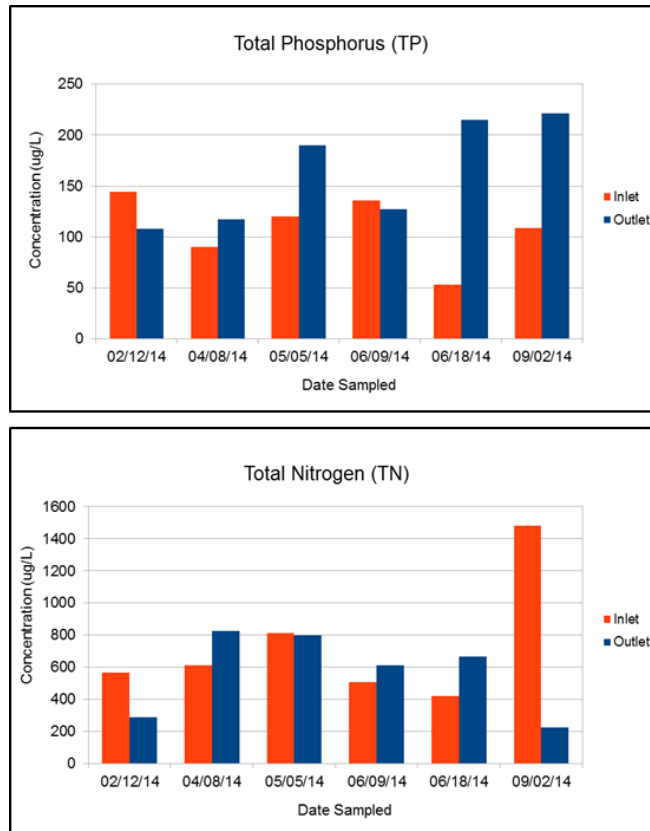
Figure 40: TP (above) and TN (below) for Storm and Non-Storm in Ruskin

In the post-BMP condition, a good improvement in soluble nutrient removal for the pond is exhibited, suggesting that nutrient uptake and assimilation by the FTW is contributing to improving water quality. The total phosphorus and nitrogen concentrations at the inlet and outlet are presented in Figure 40. Total P removal efficiency was greatly reduced in the post-BMP period mainly due to large outlet concentrations during the last two sampling dates. These two sampling dates included both storm and non-storm sampling events that included rainfall amounts in excess of 2 inches and the greater outflow TP concentrations during those dates may have been due to resuspension of sediments and flushing of particulate material on those sampling dates.

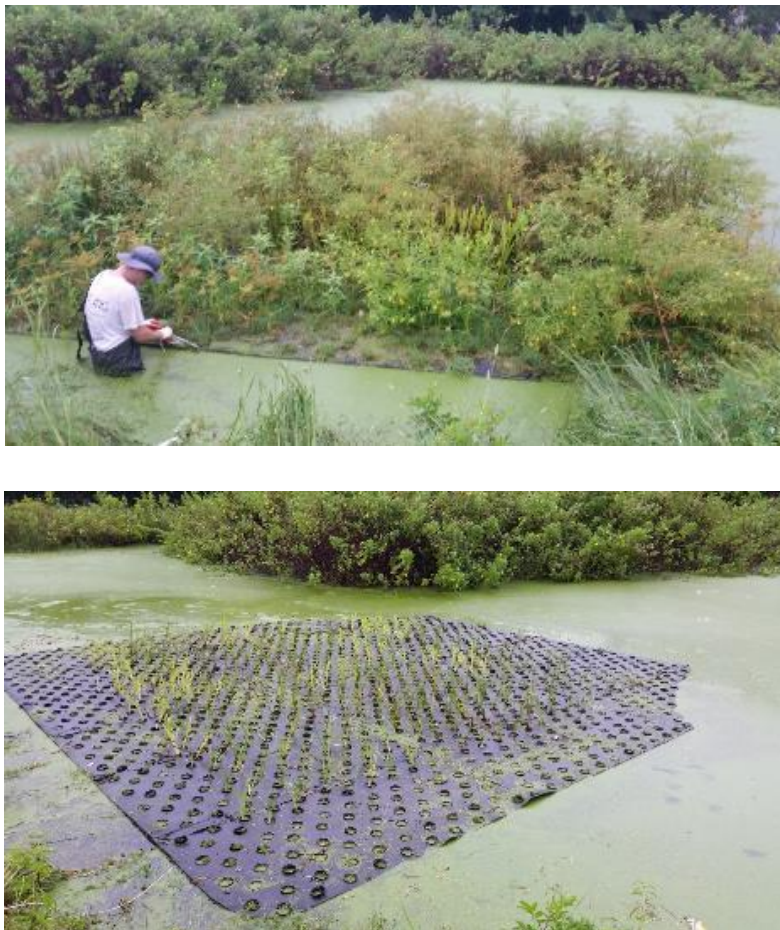
Figure 41: Plant replacement of Ruskin FTW, before (above) and after (below)

On September 17, 2014 a plant replacement of the FTW for Ruskin was conducted. This plant replacement entailed removing all mature plants from the FTW and replacing them with seedlings. Pictures of before and after the plant replacement can be seen below in Figure 41. This plant replacement allowed us to compare the efficiency of the FTW through two plant life-cycles and provided information on the optimal point for replacing plants on a FTW. One of the concerns and reasons for conducting this plant replacement was the invasion of unwanted plants onto our FTW. These plants, which can be seen all around the banks of the pond, began growing on the FTW and may have created unwanted competition between the different plant species and possibly impacted the removal of nutrients.

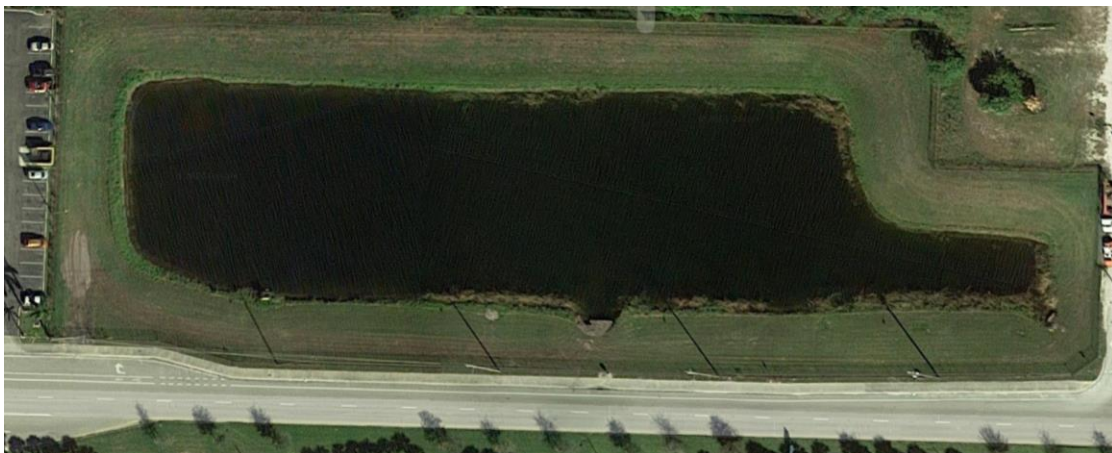
Figure 43: Royal Palm Estates pond

This 1.69 acre pond is located immediately north of State Road 80. An apartment complex lies to the west of the pond, and a commercial building is to the east. North of the pond is an undeveloped field. Erosion at the inlet structure was the reported problem for this pond. The initial site visit confirmed this. It appeared that the overland flow from State Road 80 was eroding the dirt from around the structure. The primary maintenance issue with this pond was bank erosion which can result in high levels of total suspended solids in the water and lead to unstable slopes surrounding the pond. This pond was selected in order to showcase erosion control BMPs that can be employed when the banks around pond structures are being washed away. An image of the Royal Palm Estates pond is presented in Figure 43.

Installation of Tri-Lock at the Royal Palm site has shown to assist in stabilization of the banks around inlet 1 and inlet 2 of the pond. Prior to Tri-Lock there was severe bank erosion around these inlets resulting in high concentrations of TSS in the pond as well as compromising the integrity of the inlet structures. Initial sampling results showed a reduction in TSS, indicating the Tri-Lock was working as intended. The final two samples, both storm events, actually showed increases in TSS concentrations, however, this may be attributed to two factors. Firstly, construction activities were observed around the banks of the pond during the March 28, 2015 site visit, as evident in Figure 54. It appeared that excess vegetation was being cleared away from the banks of the pond. These construction activities left large quantities of loose soil on the banks, which may have been carried into the pond during storm events. Secondly, pond water levels decreased significantly during the sampling period compared to baseline sampling conditions. A smaller volume of water in the pond may result in misleading TSS measurements, because the suspended solids will be more concentrated in the pond. Despite these two factors, TSS concentrations remained relatively constant throughout Phase 2, which is a promising result and evidence that the Tri-Lock played a beneficial role in stabilizing the banks and controlling TSS concentrations for the Royal Palm site. Please refer to section 4.6.12 of the *Best Maintenance Practices for Stormwater Runoff Handbook* for additional information and maintenance practices for bank stabilization products.

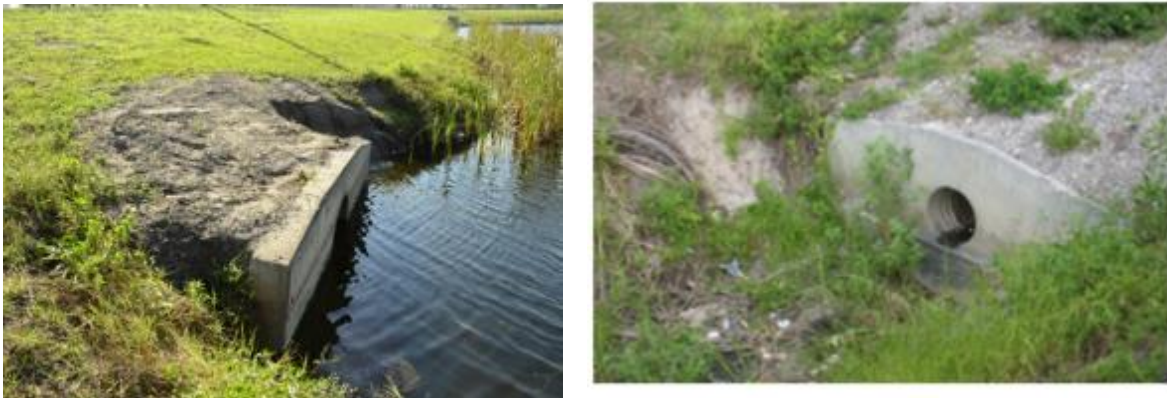
Figure 44: Pre-BMP conditions at S-139 (left) and S-145 (right), respectively

A site visit and meeting with key FDOT West Palm Beach operations staff occurred during the week of June 1-7. Upon the site visit, it was determined that the Tri-Lock would be necessary through a 10' offset from the back and sides of inlet structure S-145, and a 10' offset in all directions from S-139, in order to provide adequate stability. A measurement of the slopes around these structures revealed that the slopes were steeper than 2:1 throughout most of the proposed revetment area and as steep as 1:1 in some areas, as shown in Figure 44. During the meeting with the operations staff, it was agreed that FDOT would grade the area to a maximum of 2:1 slope and excavate approximately 4" over the site prior to installation, per the vendor's specifications.

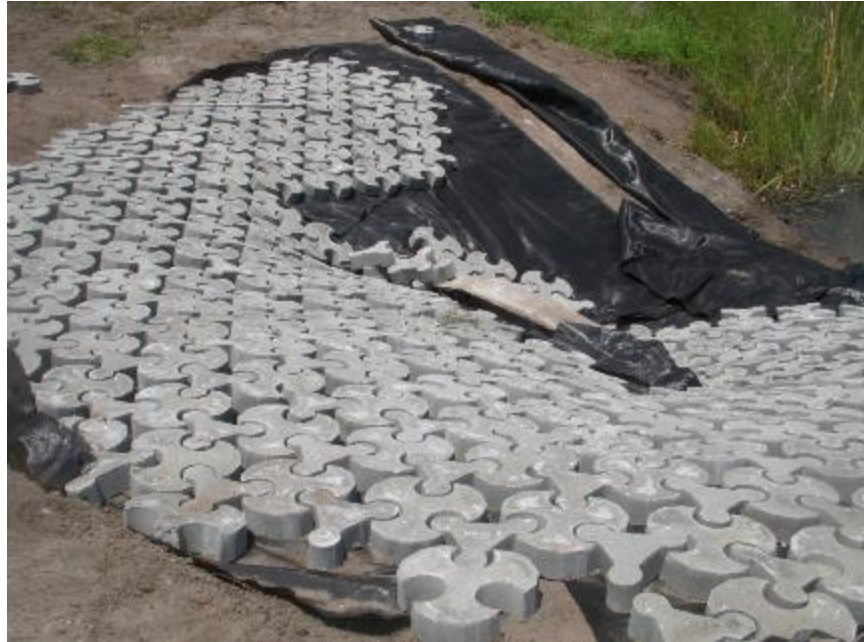
Figure 45: Tri-Lock installation around S-145 at the conclusion of the first day of work

On June 23 and 24 FDOT staff conducted the site preparation. On June 25, two representatives directed and assisted a crew of 2 UCF students and 6 FDOT workers in the installation. The site proved to be challenging due to the steep slopes, which were prepared to minimum specifications as constrained by the existing site conditions, and the geometry around S-145. After 5.5 hours of work, about 35% of the installation was completed, as shown in Figure 45.

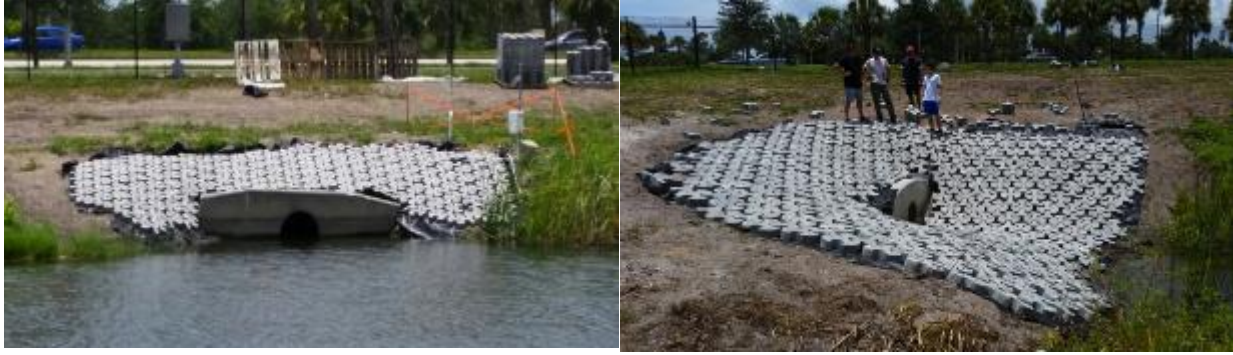
Figure 46: Tri-Lock installation at S-139 and S-145 at the conclusion of the second day of work

Work resumed on June 26, with a crew of 4 UCF students and 6 FDOT workers in addition to the 2 representatives from Midwest Construction. After 6 hours of work, the block-laying had been completed and backfilling commenced around structure S-145 as shown in Figure 46. At this point, work concluded for the week, with the remaining work consisting of digging a trench for the anchor rows, laying the block for the anchor rows, backfilling, and placement of rip-rap at the toe of the block in structure S-139.

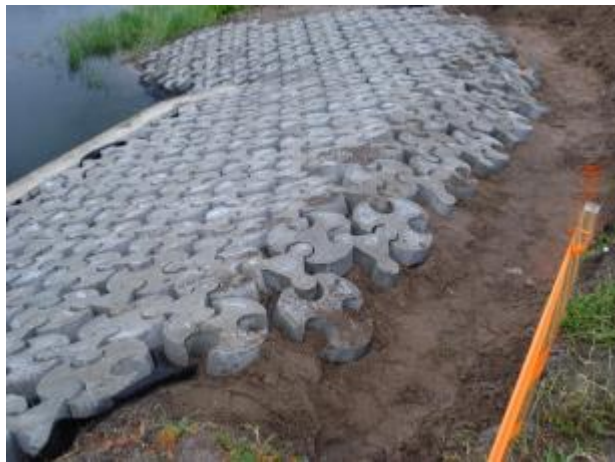
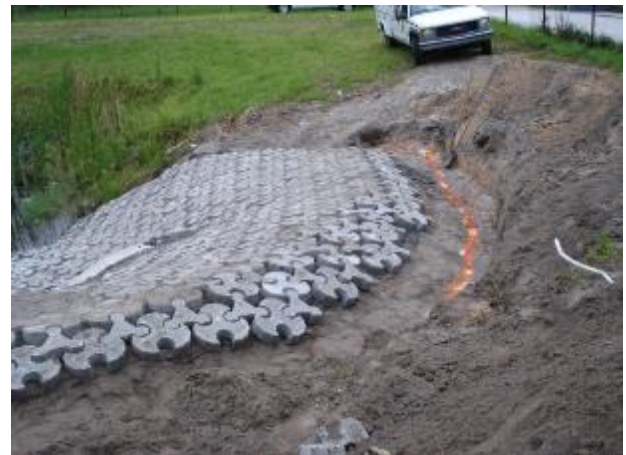
Figure 47: Anchor trench along top of S-139 and S-145

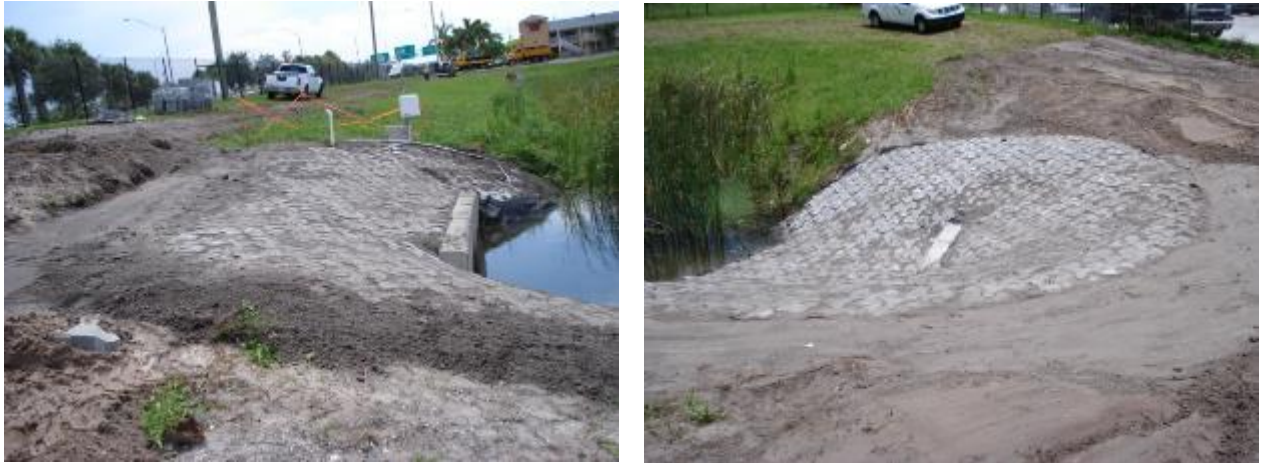
Figure 48: Finished installation of Tri-Lock around S-139 and S-145

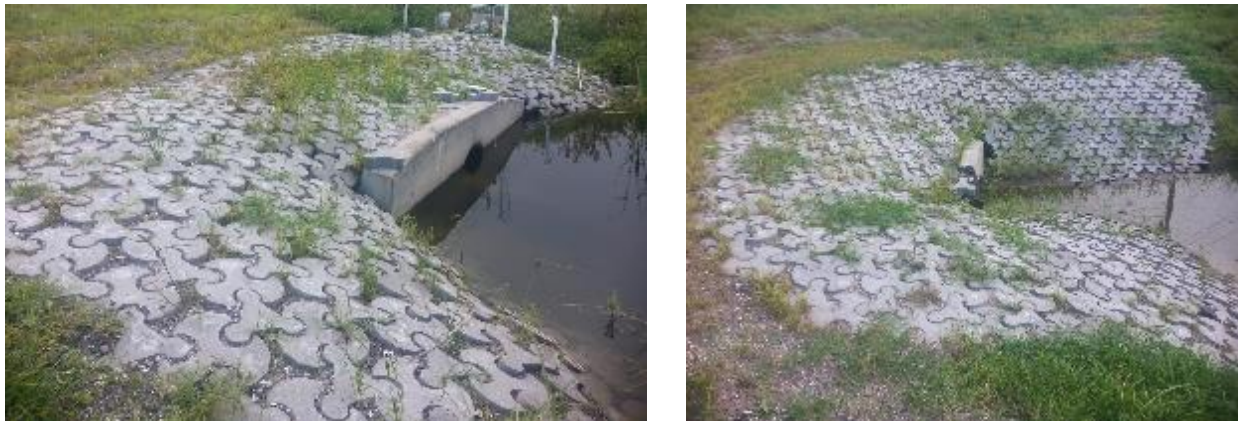
Figure 49: Tri-Lock erosion blocks around S-139 and S-145 80 days following installation

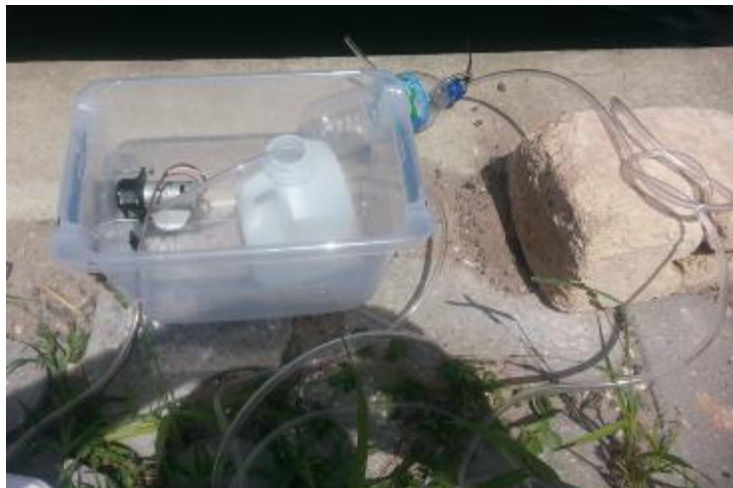
Figure 50: TSS Sampling Pump
