Maintenance Practices for Stormwater Runoff - Phase 2

Phase 2 Final Report
Submitted May 2015

Florida Department of Transportation

Agency Number: BDV24-977-02

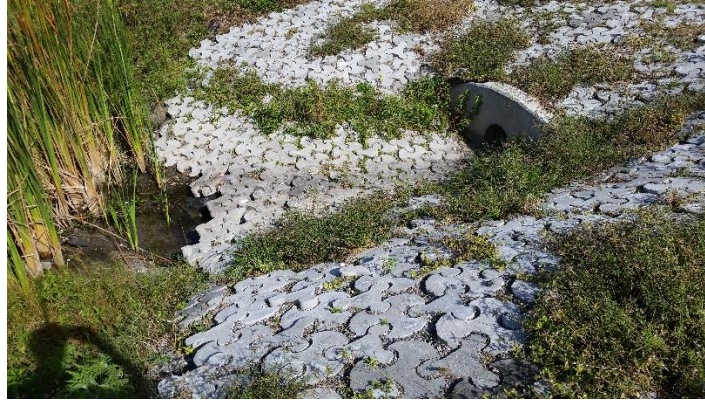
Figure 51: Tri-Lock and vegetation growth around inlet 1

A site visit to the pond on January 19, 2015 showed continued vegetation growth in and around the Tri-Lock installation area. Pictures of the Tri-Lock and surrounding conditions are presented in Figure 51 and Figure 52. It is interesting to note that the water level has fallen below the level of the Tri-Lock at inlet 1 shown in Figure 51, however the Tri-Lock is still intact and no

signs of structural damage were noticeable. Regrowth of vegetation in and around the Tri-Lock blocks is encouraged as the vegetation root systems will aid in bank stabilization, as well as giving the pond more natural looking aesthetics.

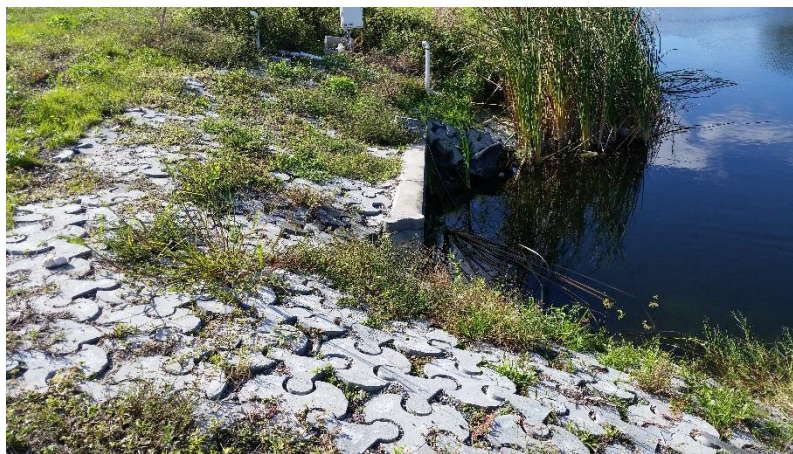
Figure 52: Tri-Lock and vegetation growth around inlet 2

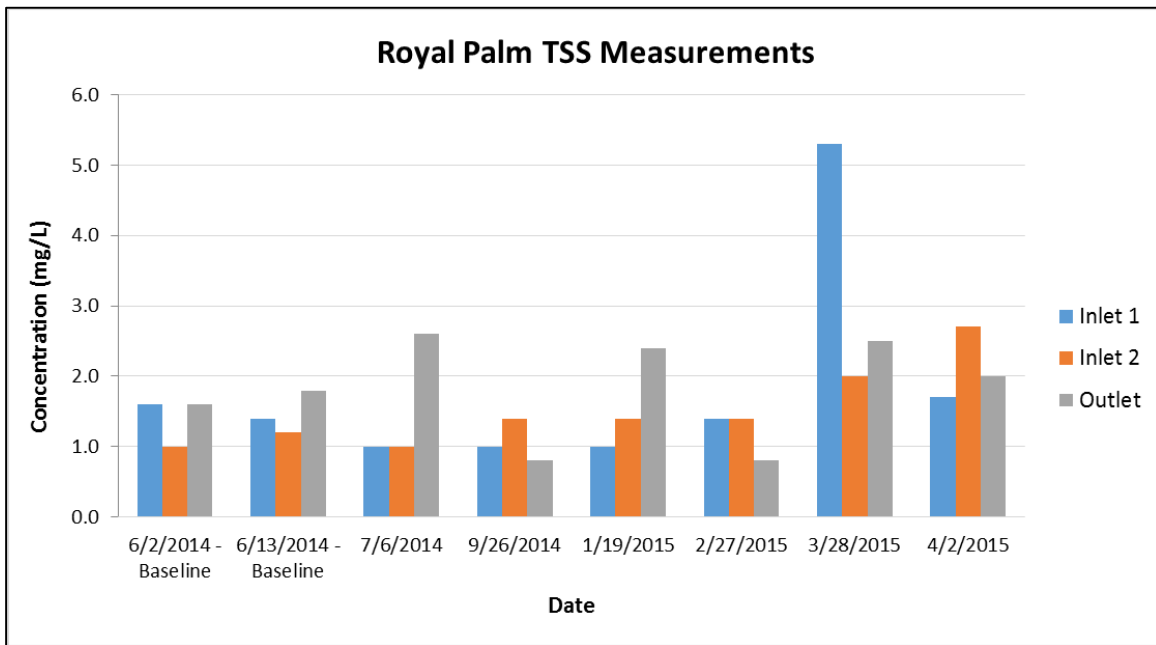
Figure 53: TSS Sampling Results

resulted in higher concentration readings even though there was the same or even less suspended solids present in the pond. Another interesting note is the large spike in TSS concentration at inlet 1 for the March 28, 2015 sampling date. During the site visit there appeared to be construction activities ongoing at the pond, as seen in Figure 54. It appeared the vegetation along the banks of the pond was being removed, which resulted in the destabilization of surrounding soil and left large quantities of loose soil on the pond banks. These destabilized and loose soils were likely carried into the pond by stormwater runoff, resulting in elevated TSS concentrations for the final two storm events. Due to this, the TSS readings on March 28 and April 2 of 2015 may have been elevated due to construction activities and not representative of normal conditions at the pond following a storm event.
